# Ocean Sweater Ltd.

Islampur, Joydebpur, Gazipur  
(23.980824N, 90.350873E)  
22<sup>nd</sup> March 2015

## Observations – Production Building

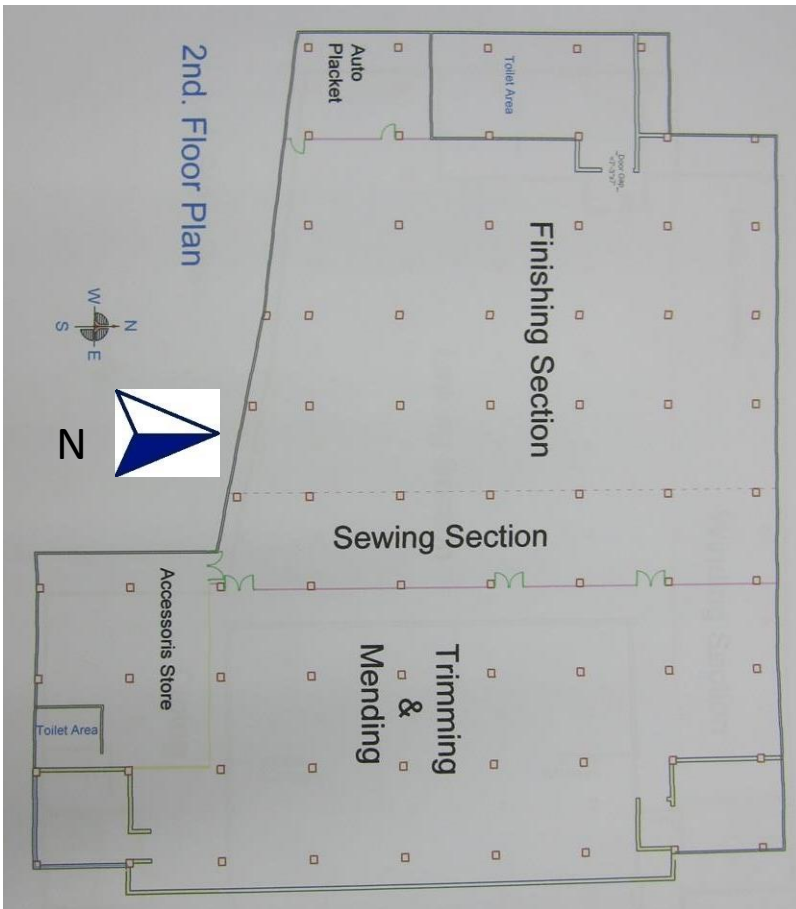
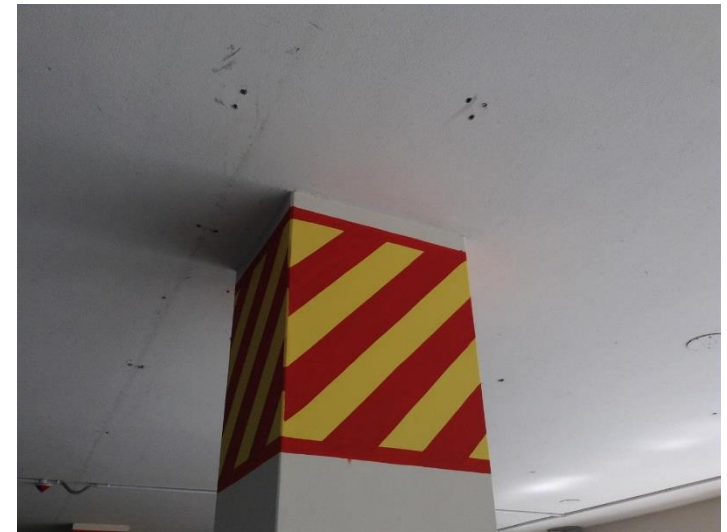
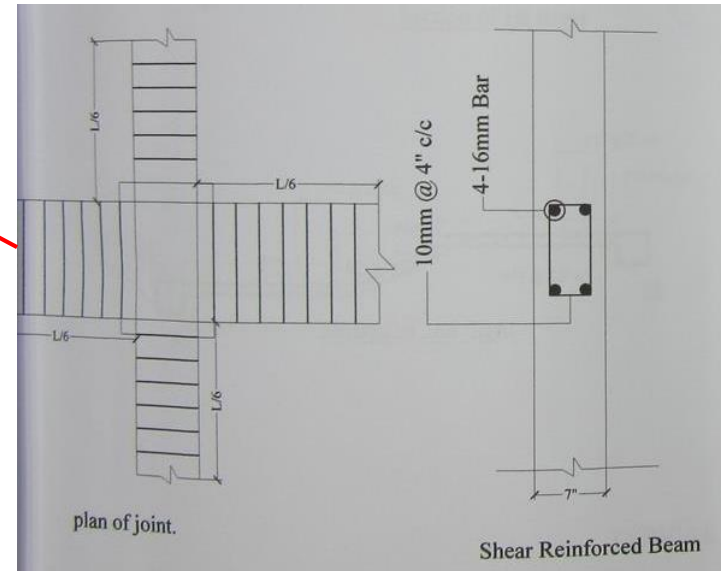
# Punching shear in flat slabs

- Hidden beam within slab depth (as per structural drawings) need to be confirmed

Cursory calculations show punching shear stress in flat slabs to be in excess of normal design limits if shear links are not provided.

Item No.	Observation	Recommended Action Plan	Recommended Timeline
1	Punching shear in flat slabs	Ascertain the presence of shear links in the slabs	6-weeks
2	Punching shear in flat slabs	Carry out any necessary strengthening or remedial measures to flat slabs arising from review.	6-months
3	Highly-stressed perimeter columns	Building Engineer to review design, loads and column stresses in the edge columns attracting loads from cantilevers and toilets.	6-weeks
4	Highly-stressed perimeter columns	Verify in-situ concrete stresses by 100mm dia. cores from min. 4 no. columns at ground floor level.	6-weeks
5	Highly-stressed perimeter columns	Produce and actively manage a loading plan for all floor plates within the Production Building, giving consideration to floor capacity and column capacity.	6-months
6	Heavy loading on 4th floor slab (current roof)	Building Engineer to check and verify the design capacity of the structural elements supporting the water tanks.	6-weeks

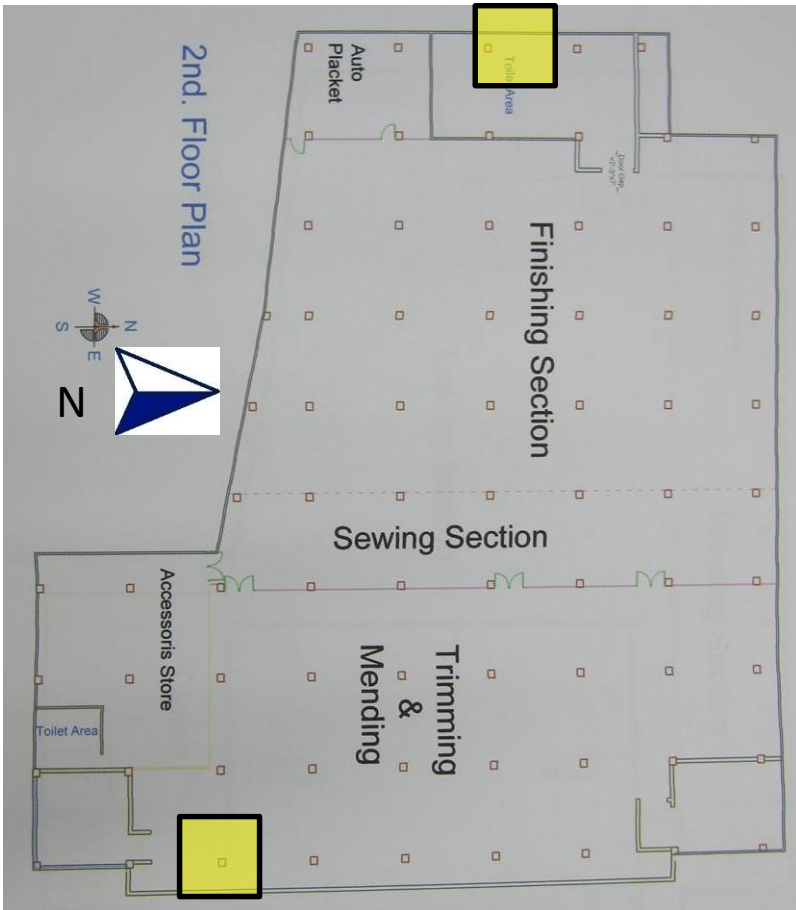
# Highly-stressed perimeter columns

Cursory calculations show stress levels in excess of normal design limits for some perimeter columns.

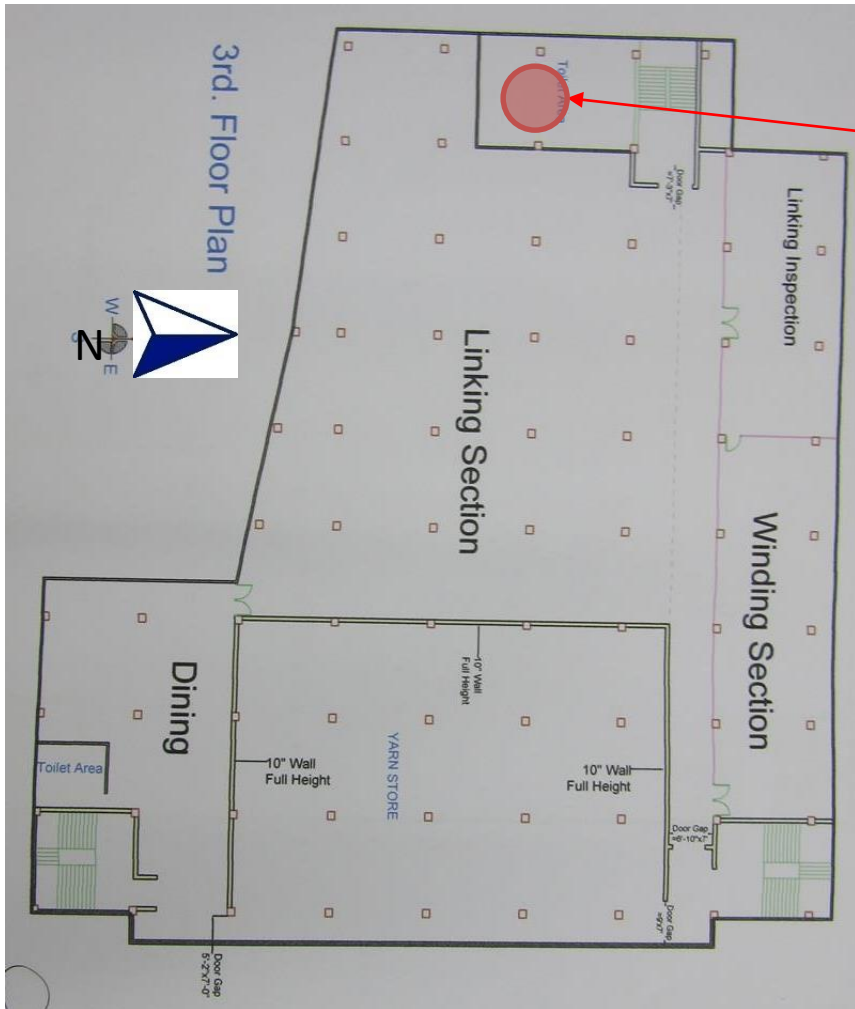
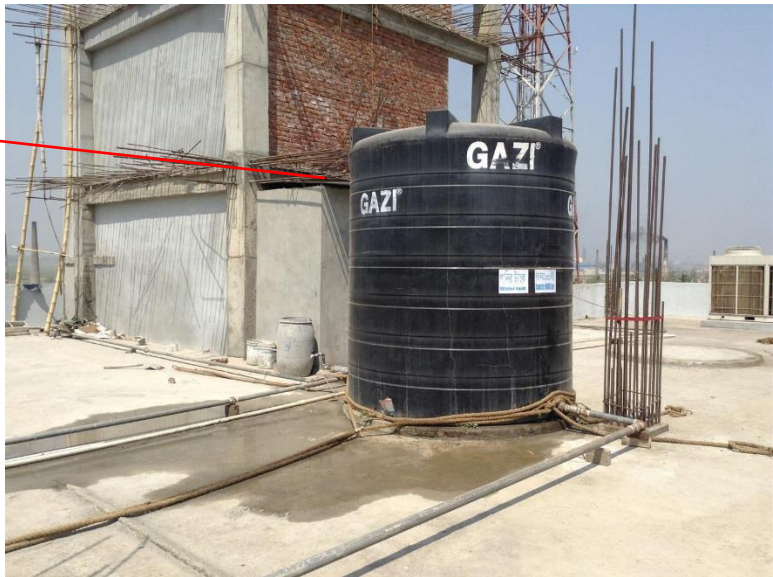
# Heavy loading on 4th floor slab (current roof)

- 10,000 litre Gazi water tank

Heavy loading due to water tank on 4<sup>th</sup> floor/roof.

7	Heavy loading on 4th floor slab (current roof)	The location of the future water tanks to be confirmed.	6-weeks
8	Heavy loading on 4th floor slab (current roof)	If necessary, Building Engineer to take appropriate action by reducing or removing water tanks loads where required, and/or spread the load of the roof water tanks over a bigger and more appropriate area.	6-months

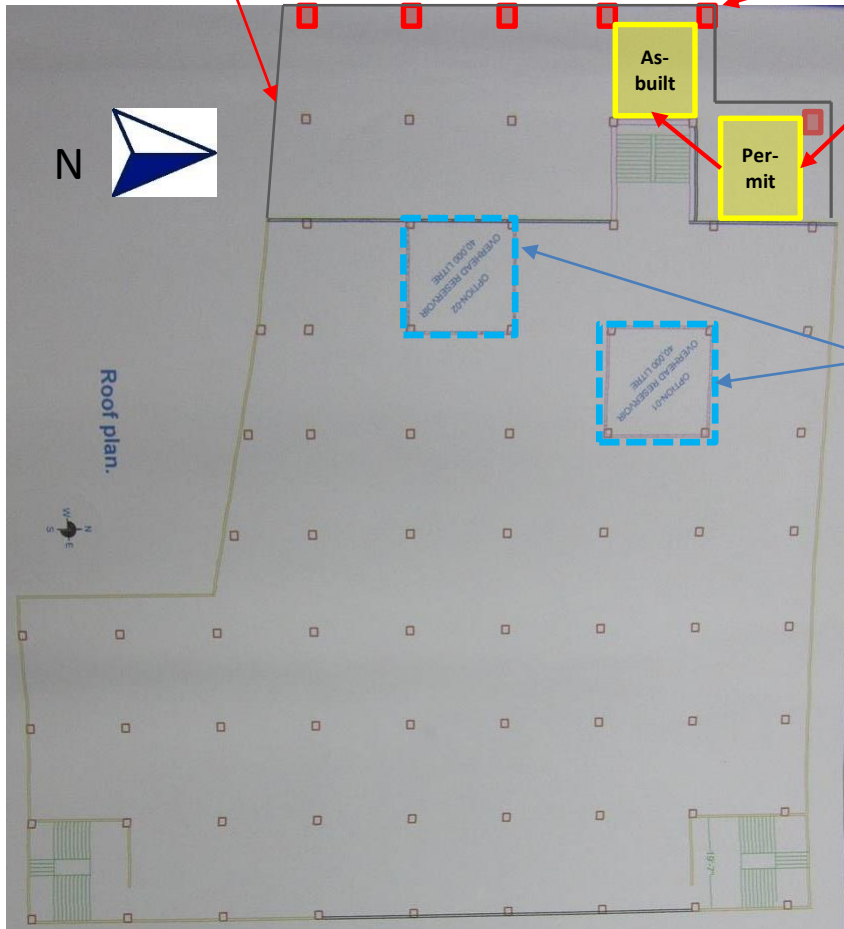
As-built perimeter

# Discrepancies between permit drawings, structural “as-built” drawings and observed structure

- Missing existing column line on drawing of 4<sup>th</sup> floor (current roof)
- Existing staircore moved south-west compared to permit drawings
- Cantilever spans appear to be larger than in structural drawings (no dimensions given)
- Position of future RC water tanks is unclear (water tank shown on as-built drawings above 5<sup>th</sup> floor slab). Future position of water tanks needs to be confirmed

Item No.	Observation	Recommended Action Plan	Recommended Timeline
9	Discrepancies between permit drawings, structural “as-built” drawings and observed structure	Building Engineer to survey the as-constructed building.	6-weeks
10	Discrepancies between permit drawings, structural “as-built” drawings and observed structure	Building engineer to produce accurate and complete as-built documentation showing as-built floor layouts, grids, column and slab dimensions.	6-months
11	Ground floor columns in parking/delivery area vulnerable to vehicle impact	Building Engineer to review and check the capacity of the columns in the parking/delivery area to resist possible vehicle impact.	6-weeks
12	Ground floor columns in parking/delivery area vulnerable to vehicle impact	Building Engineer to assign the required measures to ensure the columns are protected from vehicle impact following review, either by strengthening the columns or by cordoning them off to prevent impact.	6-months

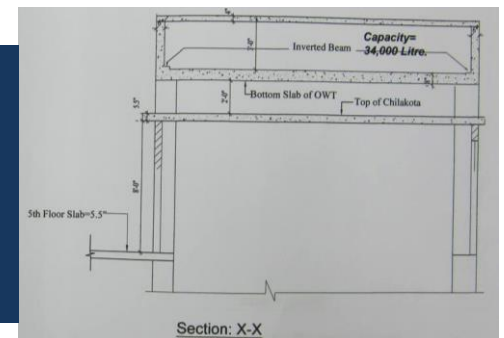
Drawing of future RC-water tank on roof

“As-built” drawings show two water tanks which are not yet constructed

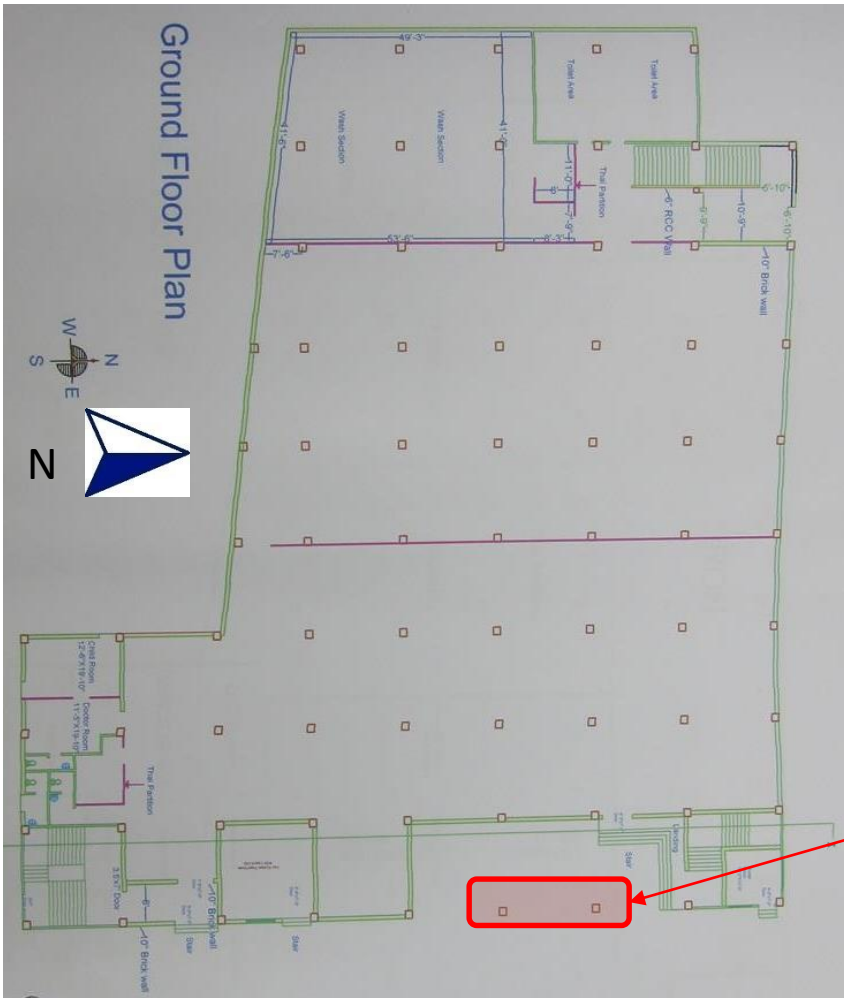
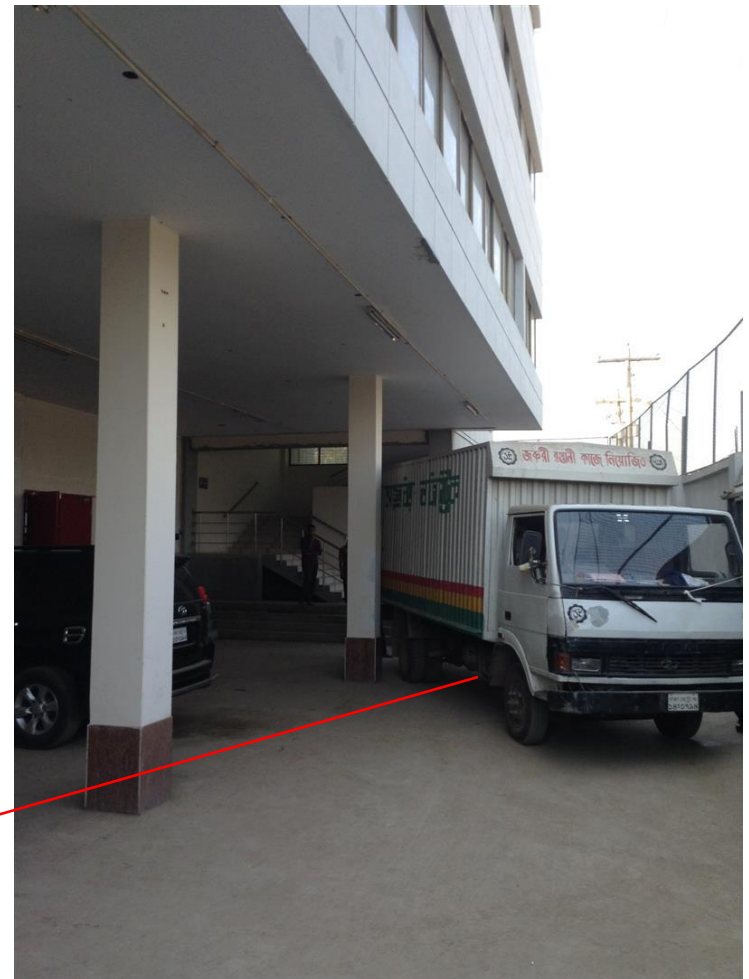
# Ground floor columns in parking/delivery area vulnerable to vehicle impact

Possible vehicle impact to Ground floor columns in parking/delivery area

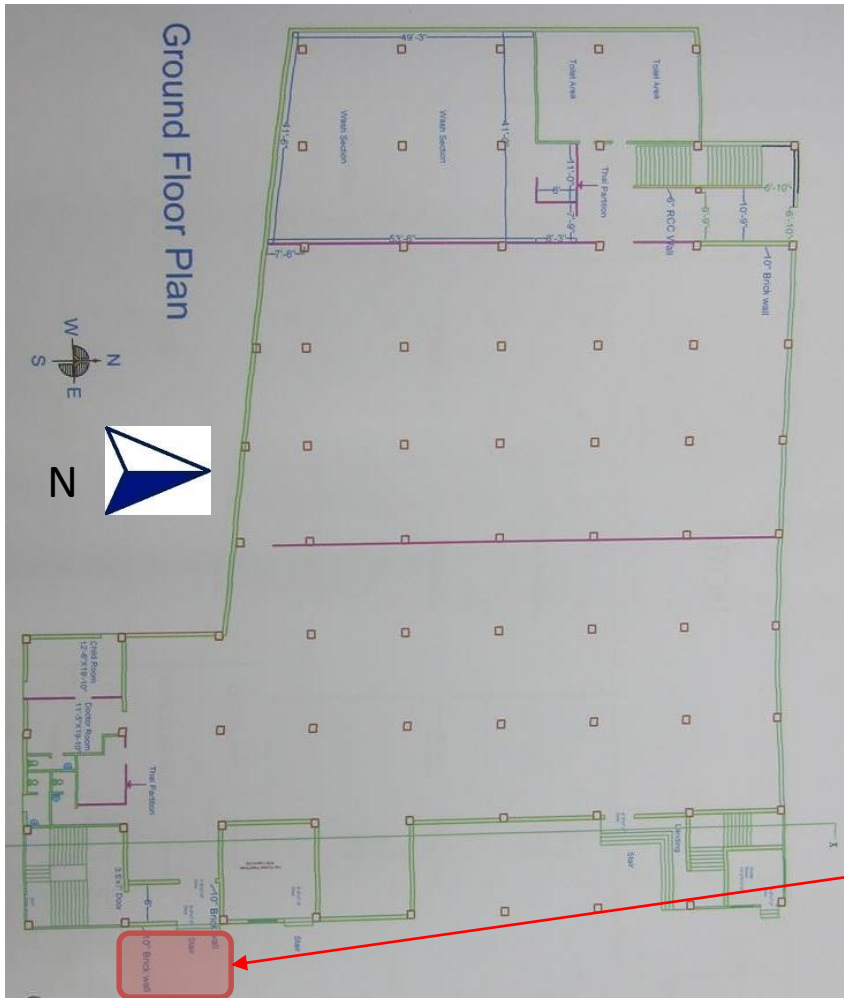
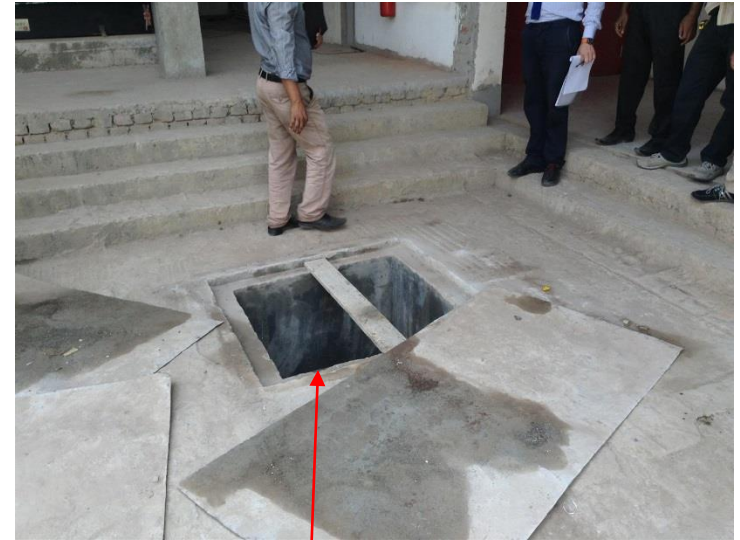
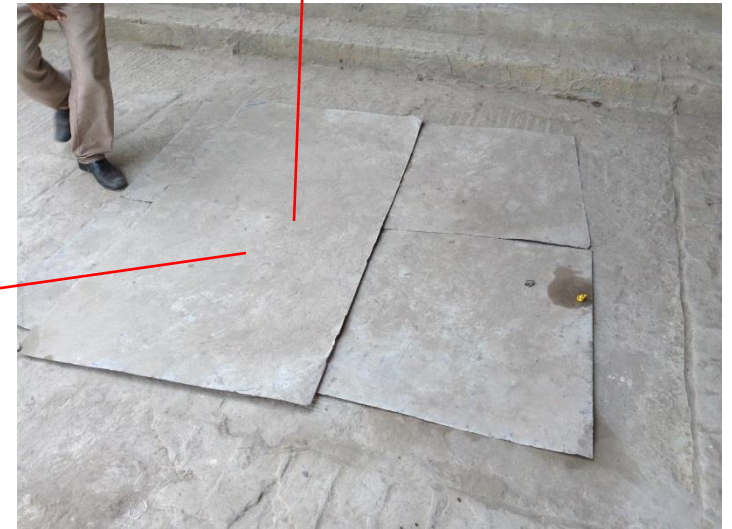
# Insufficient cover on manhole in evacuation route

Insufficient cover on manhole in evacuation route. Falling hazard

13	Insufficient cover on manhole in evacuation route	Cordon off area around manhole.	6-weeks
14	Insufficient cover on manhole in evacuation route	Provide proper covers to the manhole to safely transmit vertical loads to the manhole walls.	6-weeks
15	Lateral stability system is not apparent	Building Engineer to investigate the lateral stability of the building, ensuring compliance with Code requirements.	6-months
16	Lateral stability system is not apparent	Implement any structural alterations arising from investigation.	6-months

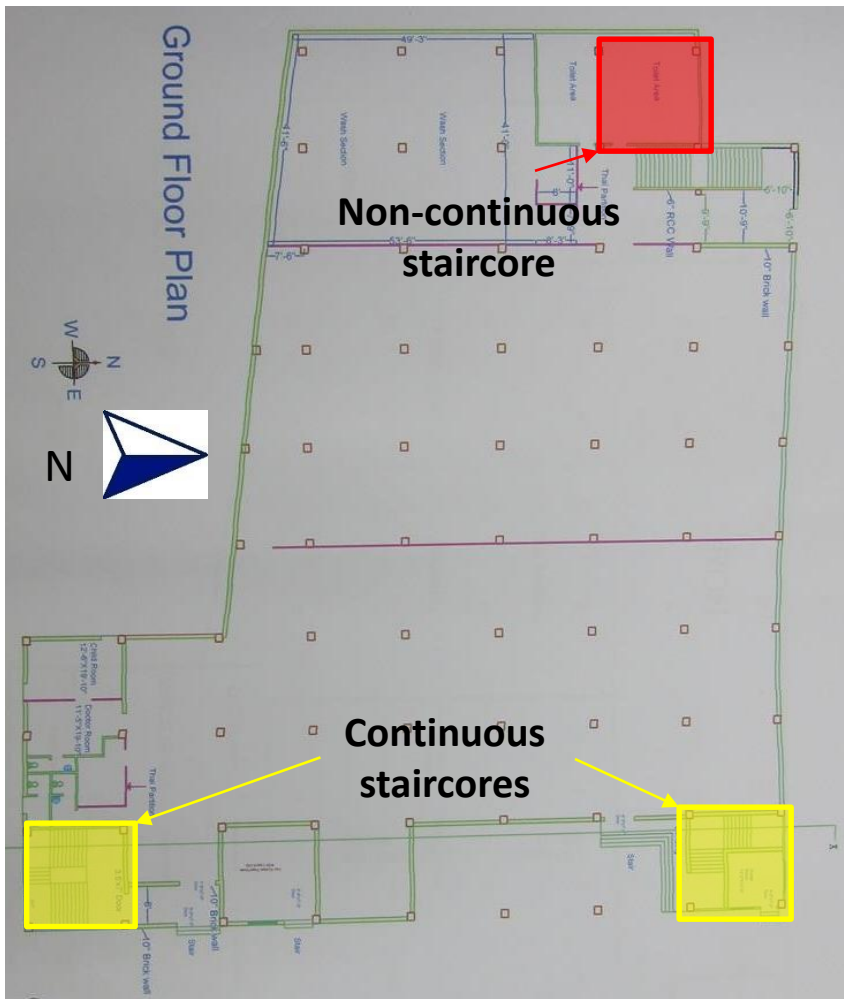
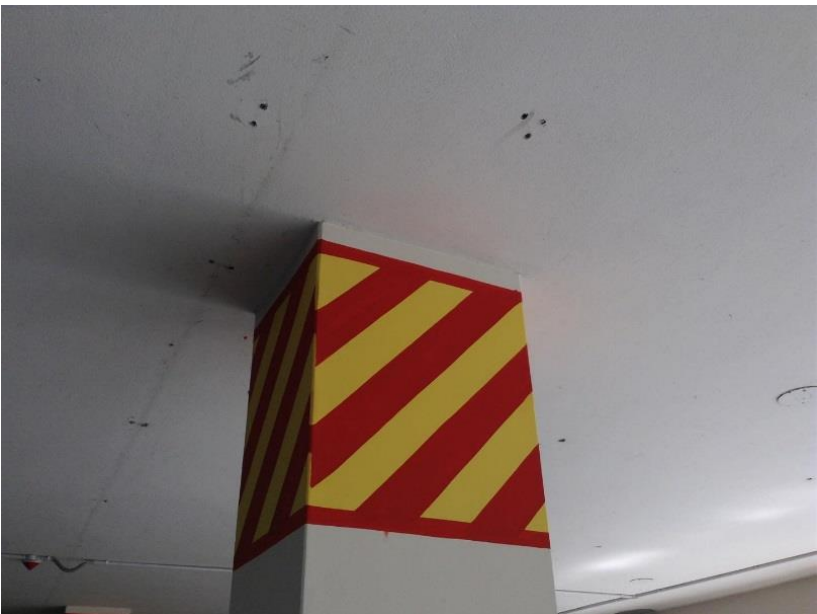
**Lateral stability system is not apparent**

**Lateral stability concerns:**

- Flat slabs on all floors
- 3 staircores, but only 2 of them continue down to ground floor

Lateral stability system is not apparent
