# Shanta Industries Ltd.

Plot # 198-201/220-223, DEPZ (Ext.), Ganakbari, Savar, Dhaka.

17<sup>th</sup> March 2015

# Observations Building 1

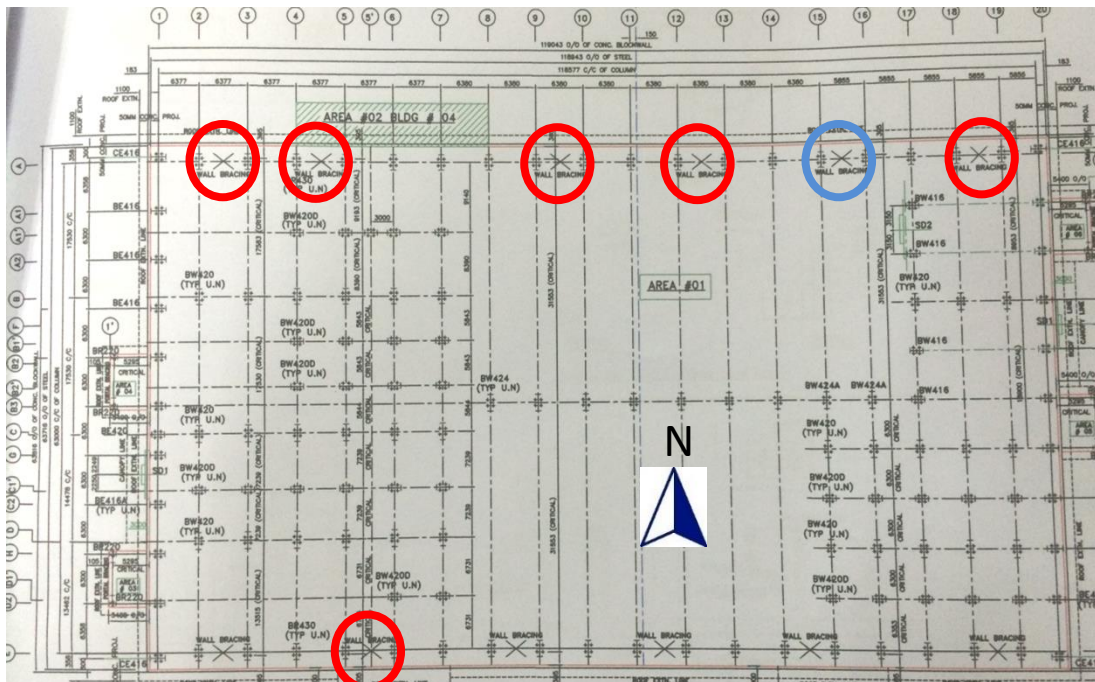
Plan of building 1 showing missing bracing

- Most of bracing shown on the North side of the building is not present in locations indicated on the drawings.
- Evidence that bracing has been removed.
- Building stability to be assessed by building engineer and bracing reinstalled so that it matches design drawing and calculations.

| Item No. | Observation | Recommended Action Plan | Recommended Timeline |
|---|---|---|---|
| 1 | Vertical ties missing in Buildings 1 and 2 | Building Engineer to assess lateral stability of Buildings 1 and 2. | 6-weeks |
| 2 | Vertical ties missing in Buildings 1 and 2 | Building Engineer to specify requirements for the replacement of missing ties, so that buildings withstand horizontal and vertical loads in accordance with statutory Codes. | 6-weeks |
| 3 | Vertical ties missing in Buildings 1 and 2 | Implement replacement of missing ties, as required. | 6-months |

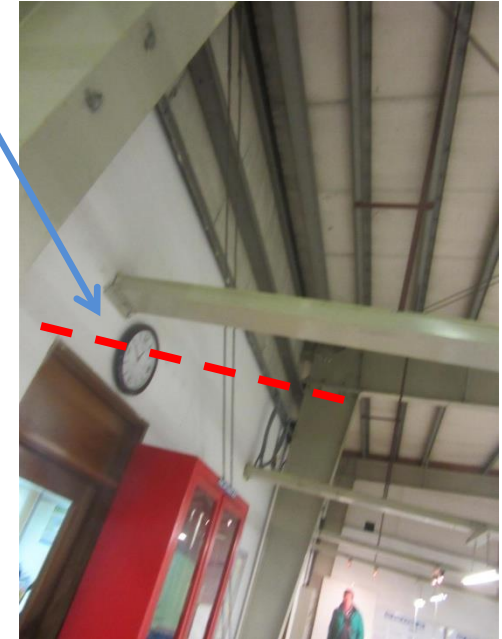
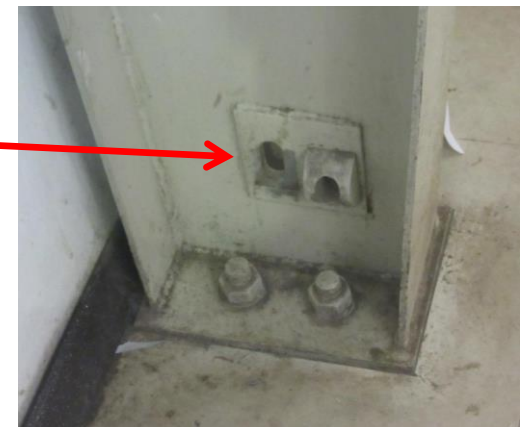
Location of missing vertical bracing.

Bracing in 1 direction only

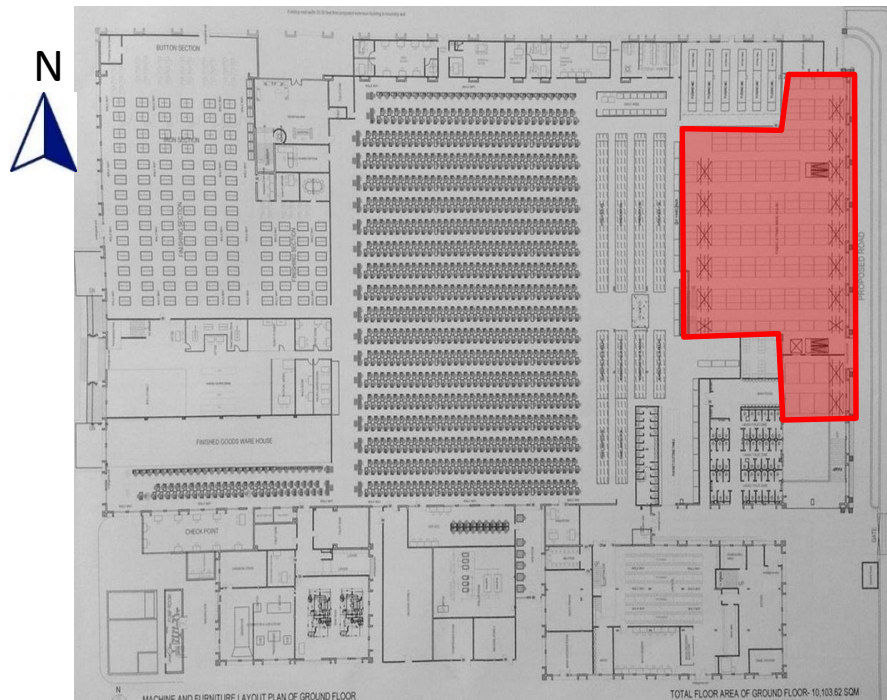
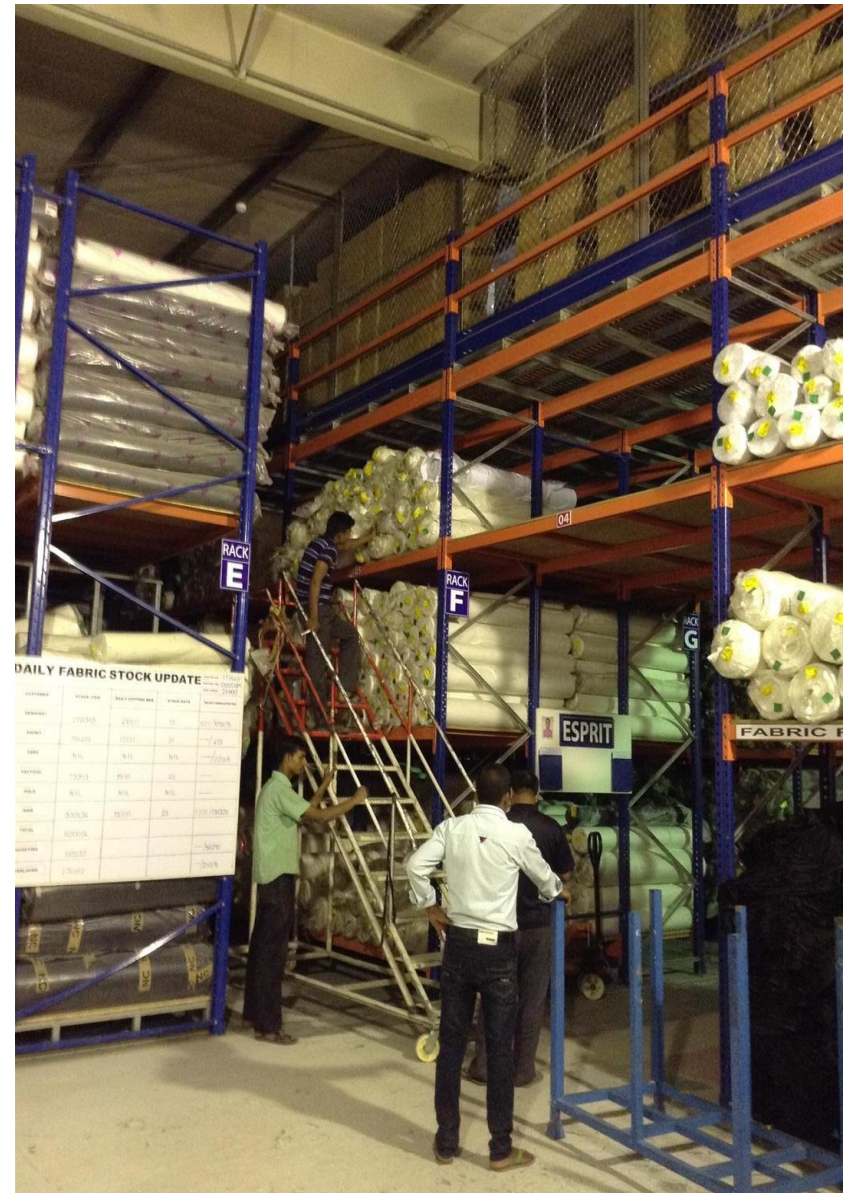
- High stacking loading on ground bearing slab in highlighted area.
- Building Engineer to assess if slab has capacity for the additional loading taking into account slab thickness, reinforcement and allowable bearing pressure.

Ground-bearing Slab with stacking load

| Item No. | Observation | Recommended Action Plan | Recommended Timeline |
|---|---|---|---|
| 6 | Stacking loads on ground floor slab in Building 1 | Building Engineer to assess ground floor capacity in terms of additional point loads from stacking structure. | 6-weeks |
| 7 | Stacking loads on ground floor slab in Building 1 | Implement any necessary structural works arising from assessment. | 6-months |

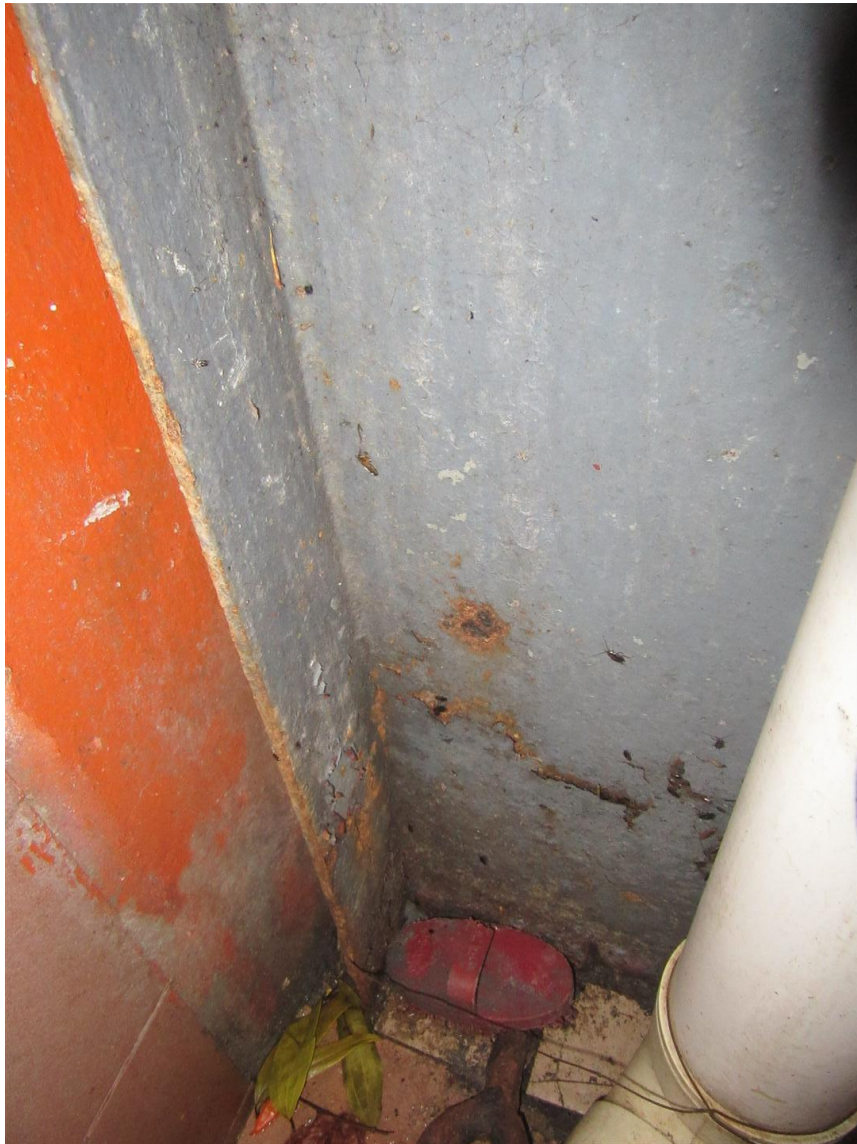
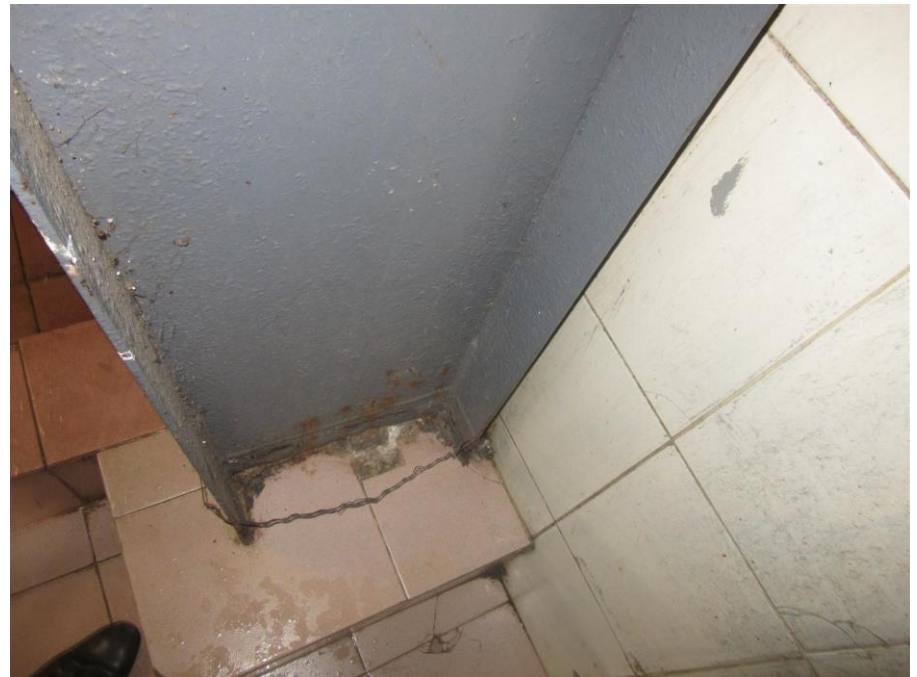
- Evidence of corrosion damage near the base of a number of columns on the ground floor
- Building Engineer to assess extent of corrosion, and specify preparatory work and protective coating to prevent further damage.

## Corrosion of ground floor columns

| Item No. | Observation | Recommended Action Plan | Recommended Timeline |
|---|---|---|---|
| 8 | Corrosion in columns in Building 2 | Building Engineer to assess extent of corrosion in ground floor columns. | 6-weeks |
| 9 | Corrosion in columns in Building 2 | Carry out preparatory works and remedial corrosion protection to columns, arising from assessment. | 6-months |

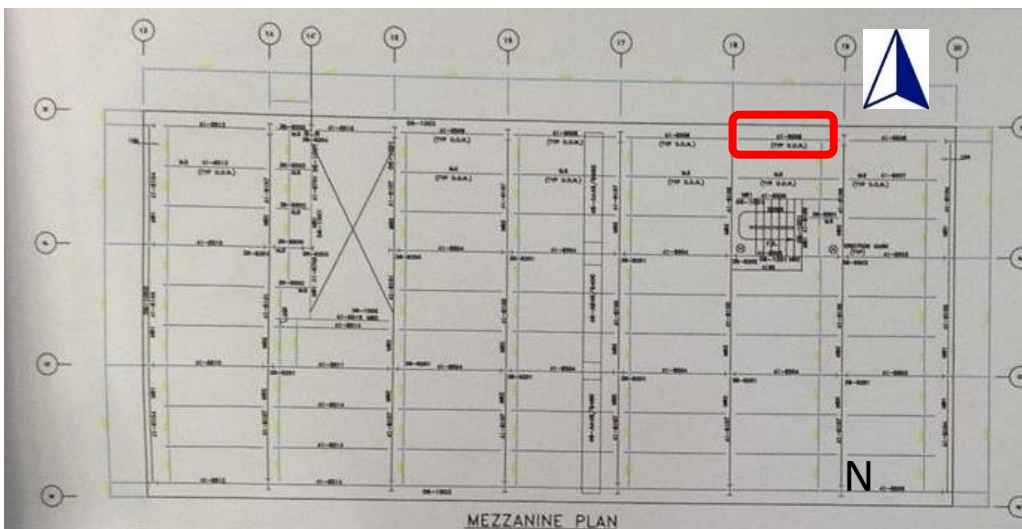
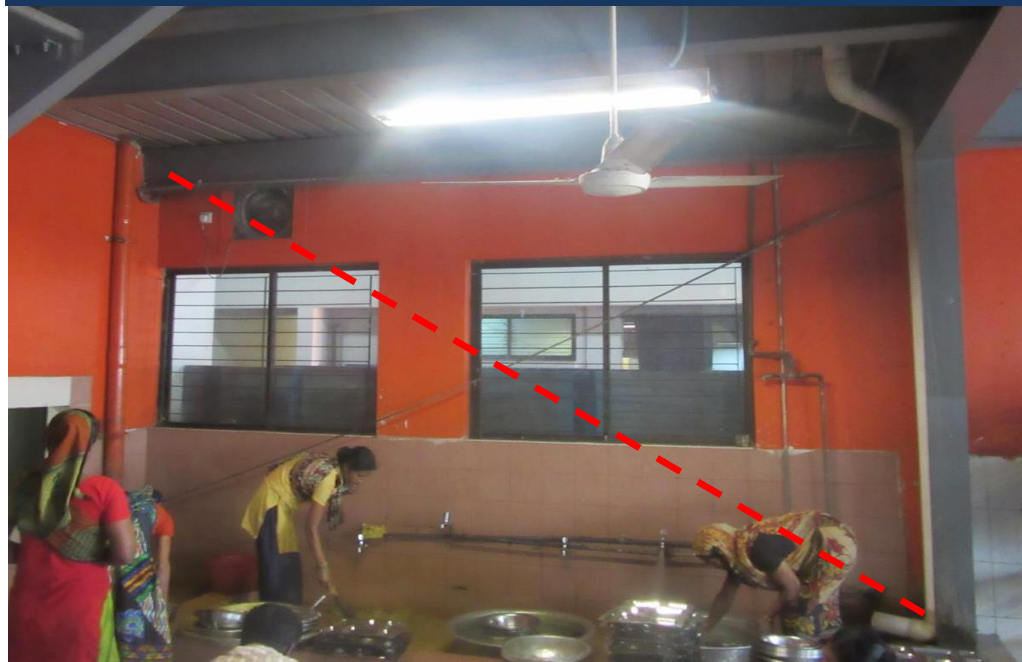
Location of missing vertical bracing.

- Vertical tie bracing missing on the ground floor in location shown.
- Evidence that bracing has been removed.
- Building stability to be assessed by Building Engineer, and bracing reinstalled to match design drawing and calculations.

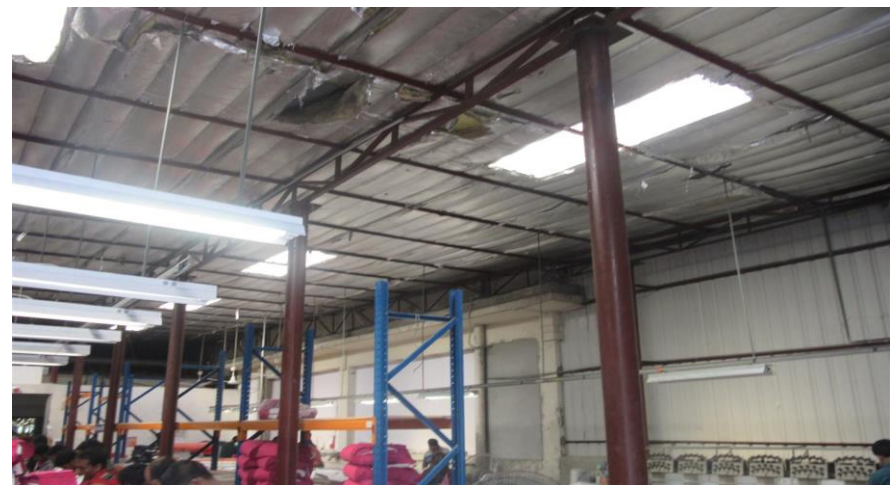
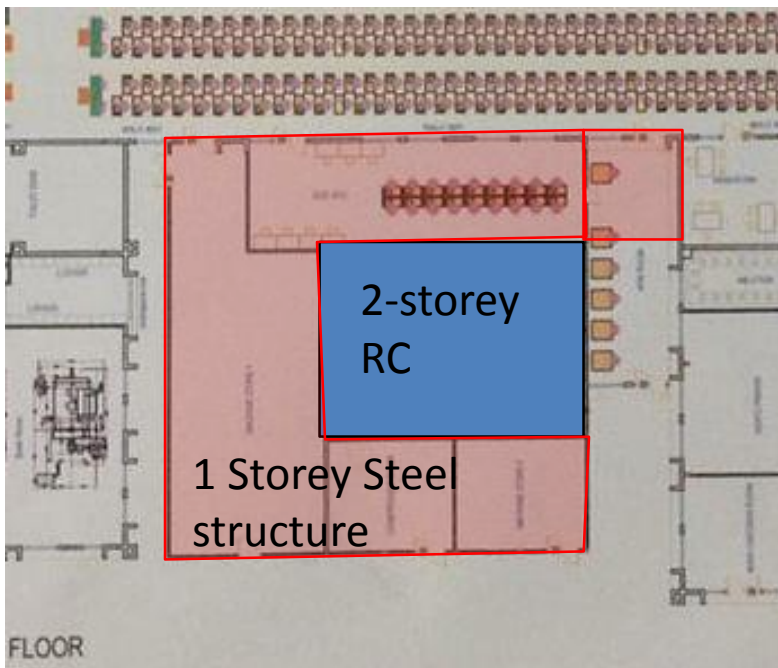
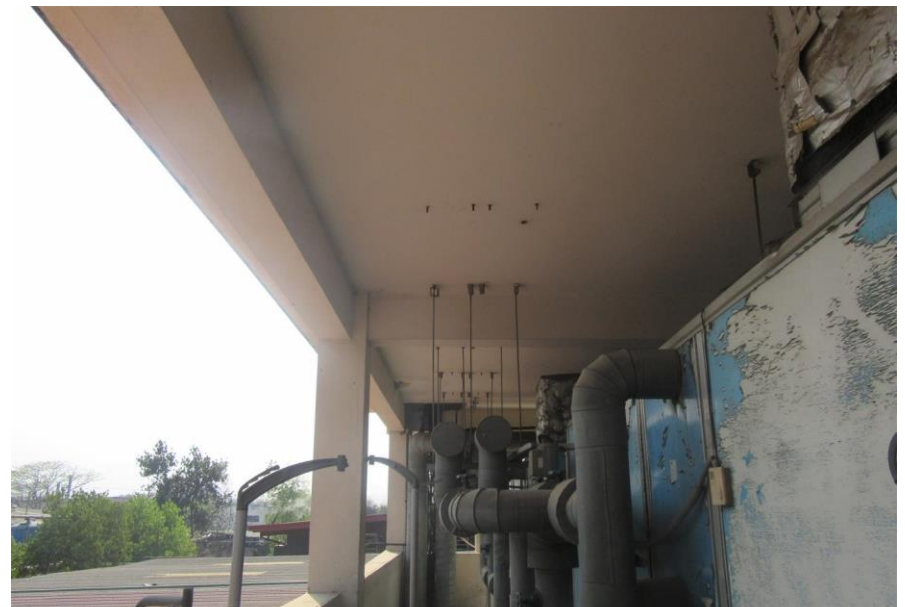
- No design or permit documents available for two storey building
- As-built drawings to be produced
- Lightweight roof to be assessed

1 Storey Steel structure

2 Storey RC Structure

| Item No. | Observation | Recommended Action Plan | Recommended Timeline |
|---|---|---|---|
| 13 | No documentation for Building 4 | Building Engineer to prepare structural as-built drawings for Building 4. | 6-months |

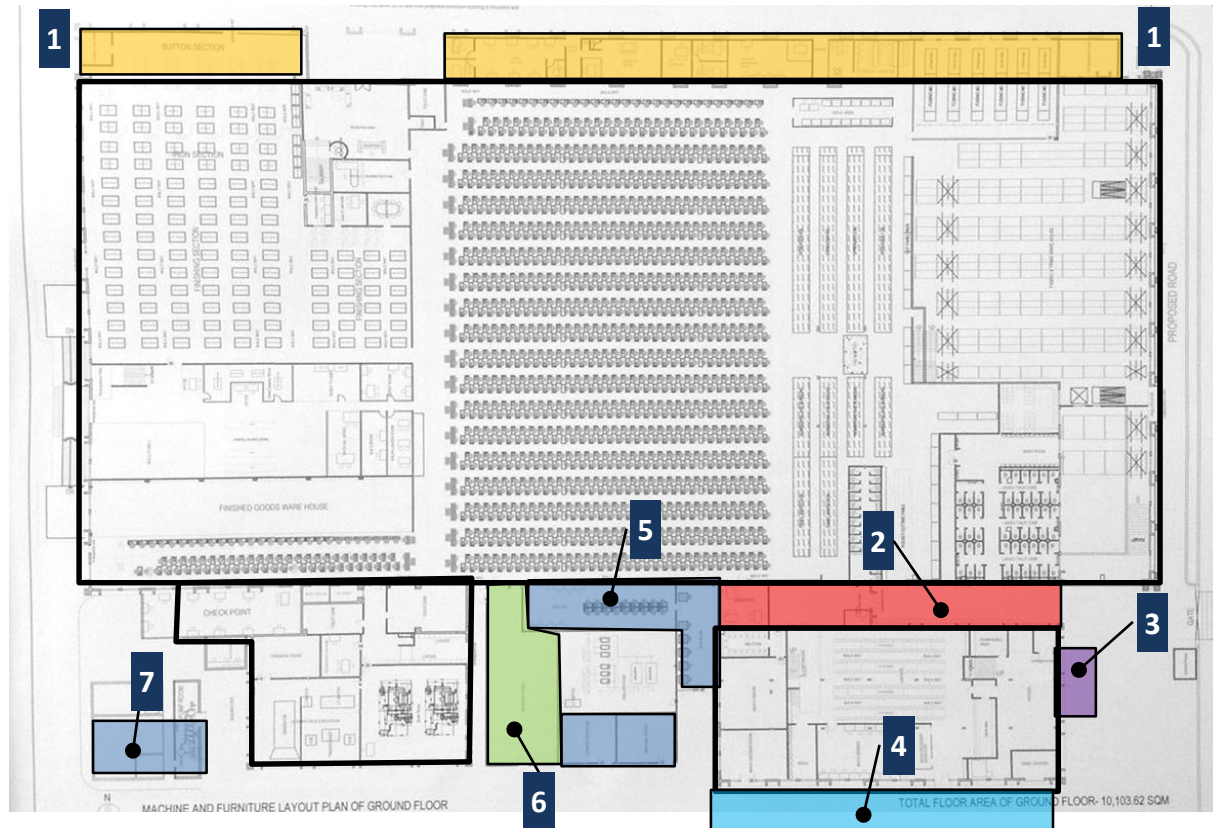
- Undocumented and apparently non-engineered roof structures in locations shown.
- Lightweight roof structures subject to uplift in high winds
- Building Engineer to assess structures and outline strengthening measures as necessary.
- Refer to next sheets for examples.

| Item No. | Observation | Recommended Action Plan | Recommended Timeline |
|---|---|---|---|
| 10 | Non-engineered infill roof structures | Building Engineer to perform design check for steel lightweight roofs for the infill and extension areas as well as for Buildings 3 and 4, taking into account vertical and horizontal load carrying capacity as well as uplift in high winds. | 6-weeks |
| 11 | Non-engineered infill roof structures | Building Engineer to assess the main building frame structures for additional loading from the undocumented infill roofs. | 6-weeks |
| 12 | Non-engineered infill roof structures | Carry out any strengthening or remedial works arising from assessments. | 6-months |
