# SQ Celsius Ltd. (Unit-2)

Jamirdia, Valuka, Mymensingh  
(24.285414 N, 90.394422 E)

21st March 2015

# Observations

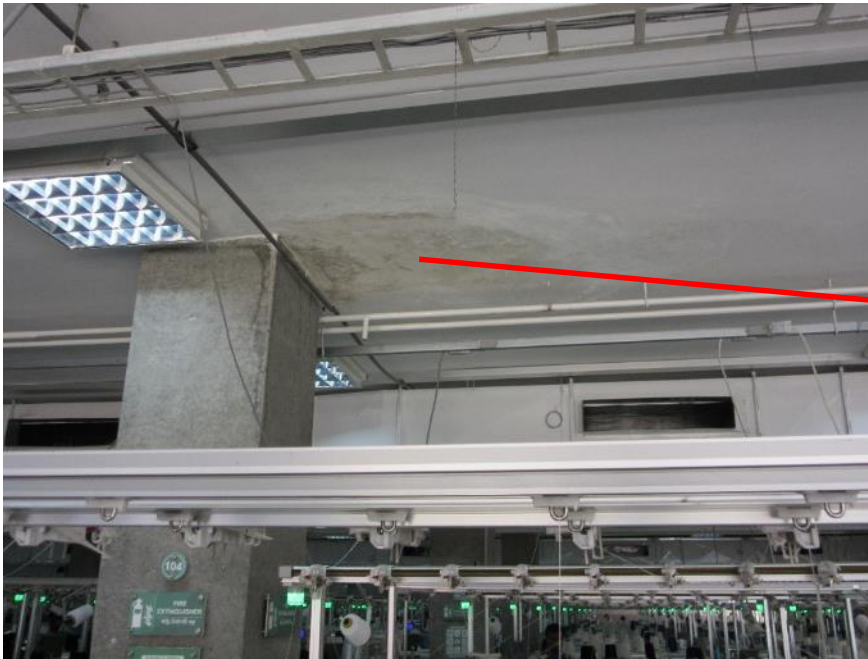
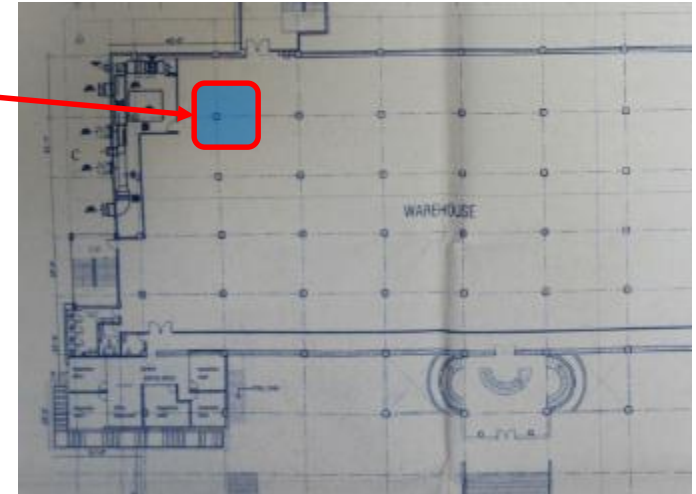
# Water penetration in one location

**Ground floor slab soffit.**

**ITEM 1:** Water penetration evident in one location

**Un-explained water damage to concrete floor to be investigated and water penetration stopped.**

| Item No. | Observation | Recommended Action Plan | Recommended Timeline |
|---|---|---|---|
| 1 | Water penetration evident in one location | Investigation of water penetration cause to be undertaken and remedial work undertaken | 6-months |

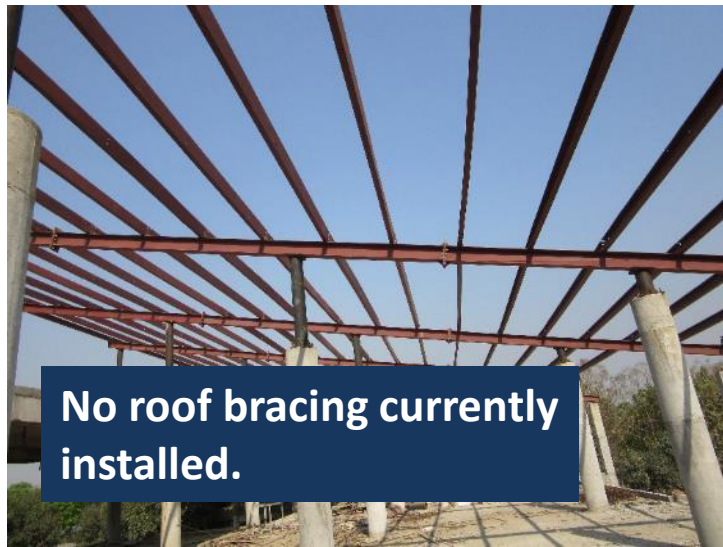
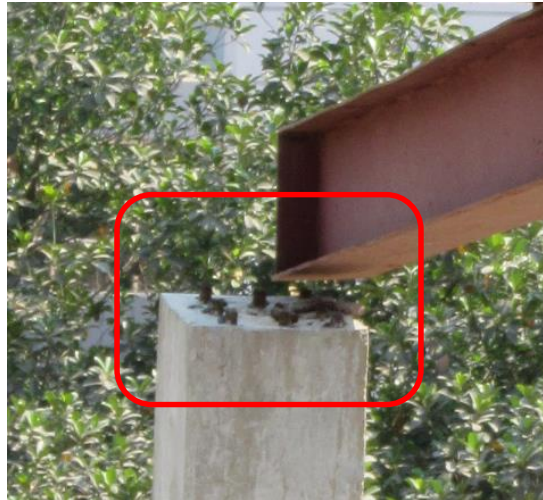
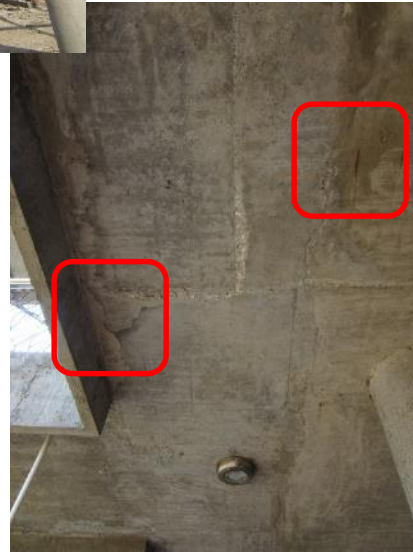
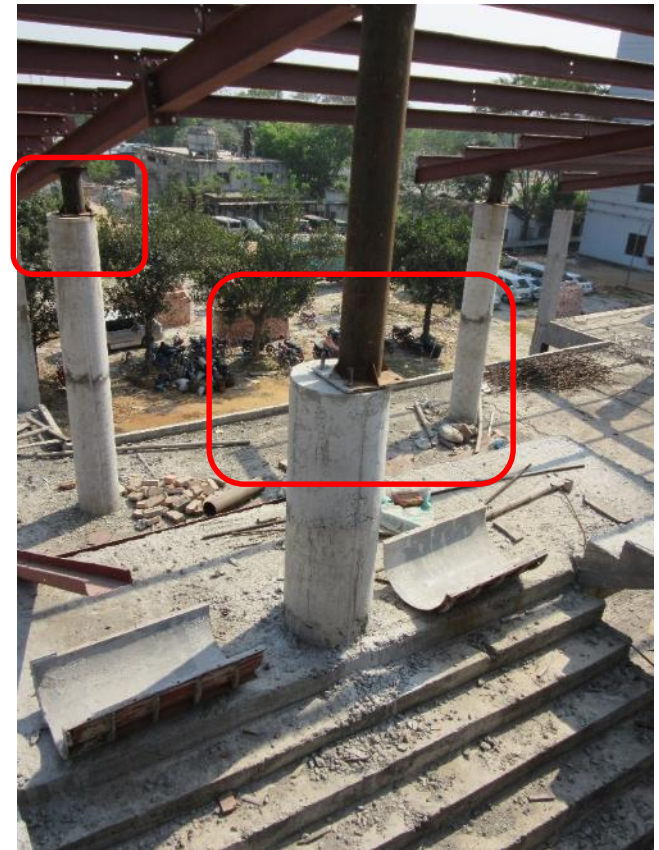
**Construction workmanship is variable with  
steelwork misalignment and variable  
concrete work**

**Column base plate hold down bolts misaligned.**

**Construction workmanship is variable with steelwork misalignment and variable concrete work**

**ITEM 1:** Construction workmanship is variable with steelwork misalignment and variable concrete work

| Item No. | Observation | Recommended Action Plan | Recommended Timeline |
|---|---|---|---|
| 3 | Construction workmanship is variable with steelwork misalignment and variable concrete work | Remedial works required to rectify mis-alignment of steelwork and repairs to variable concrete work | 6-months |
