Reedisha Texstripe Ltd

Teknogpara, Salna, Gazipur, Dhaka
(24.013801, 90.382815)

21st March 2015

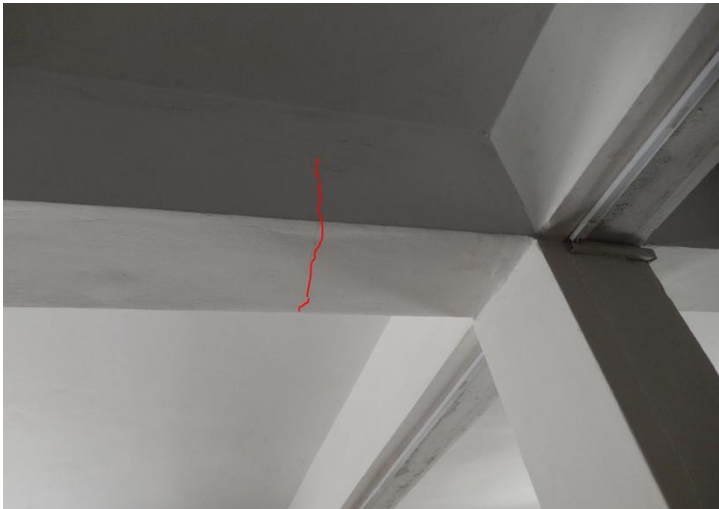
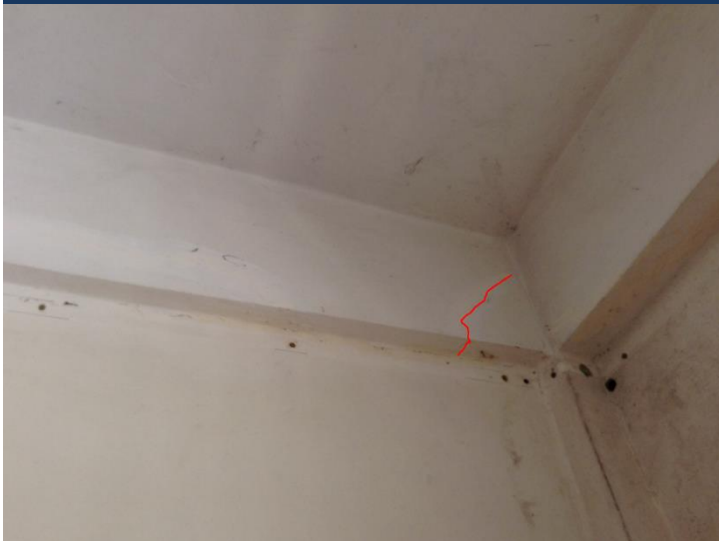
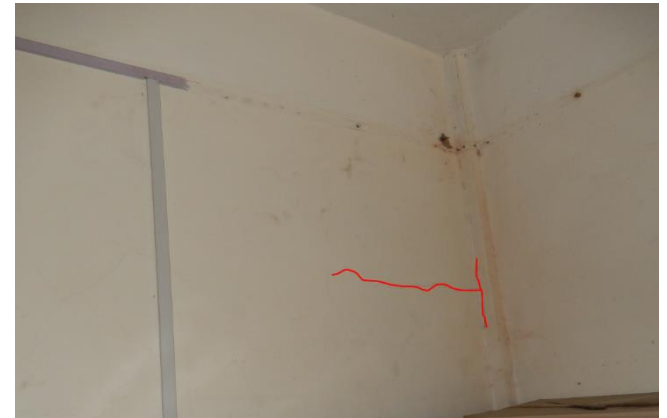
Cracking in Beams and Brick Walls

Cracking in beams

Cracking observed in beams, brick wall infills, and between brick wall infill and structure

Item No.	Observation	Recommended Action Plan	Recommended Timeline
1	Cracking in Beams and Brick Walls	Sections of plaster finish to beams to be removed to investigate if cracks penetrate the building structure	6-weeks
2	Cracking in Beams and Brick Walls	Building Engineer to carry out design check on beams to confirm that these cracks are non-structural.	6-months
3	Cracking in Beams and Brick Walls	Building Engineer to prepare Allowable Floor Loading Plans.	6-months
4	Non-engineered steel structures	Building engineer to check the steel structures on the roof of Building 1 and propose additional reinforcements and stability system, if required	6-months
5	Mast on roof not securely fastened	Building engineer to check the fixing of the mast on the roof of Building 1 and propose strengthening.	6-months
6	Lateral stability issues for steel frames for sheds	Building engineer to carry out a stability analysis and provide additional stability system if required.	6-weeks

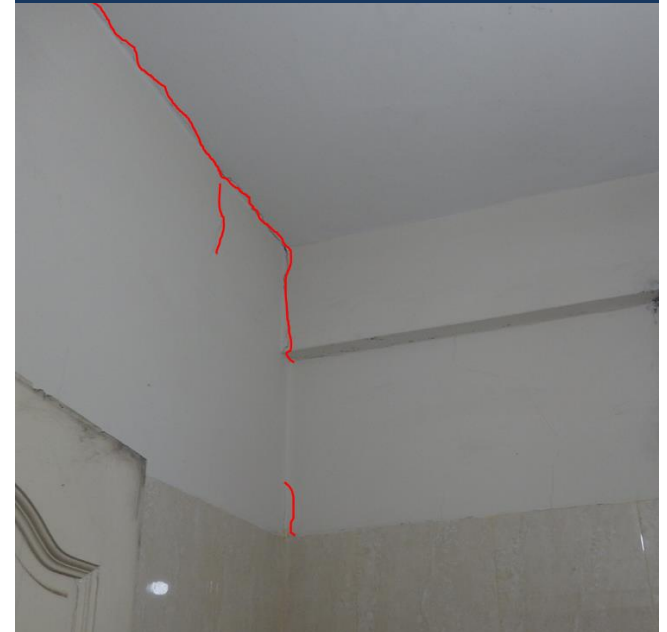
Cracking in walls

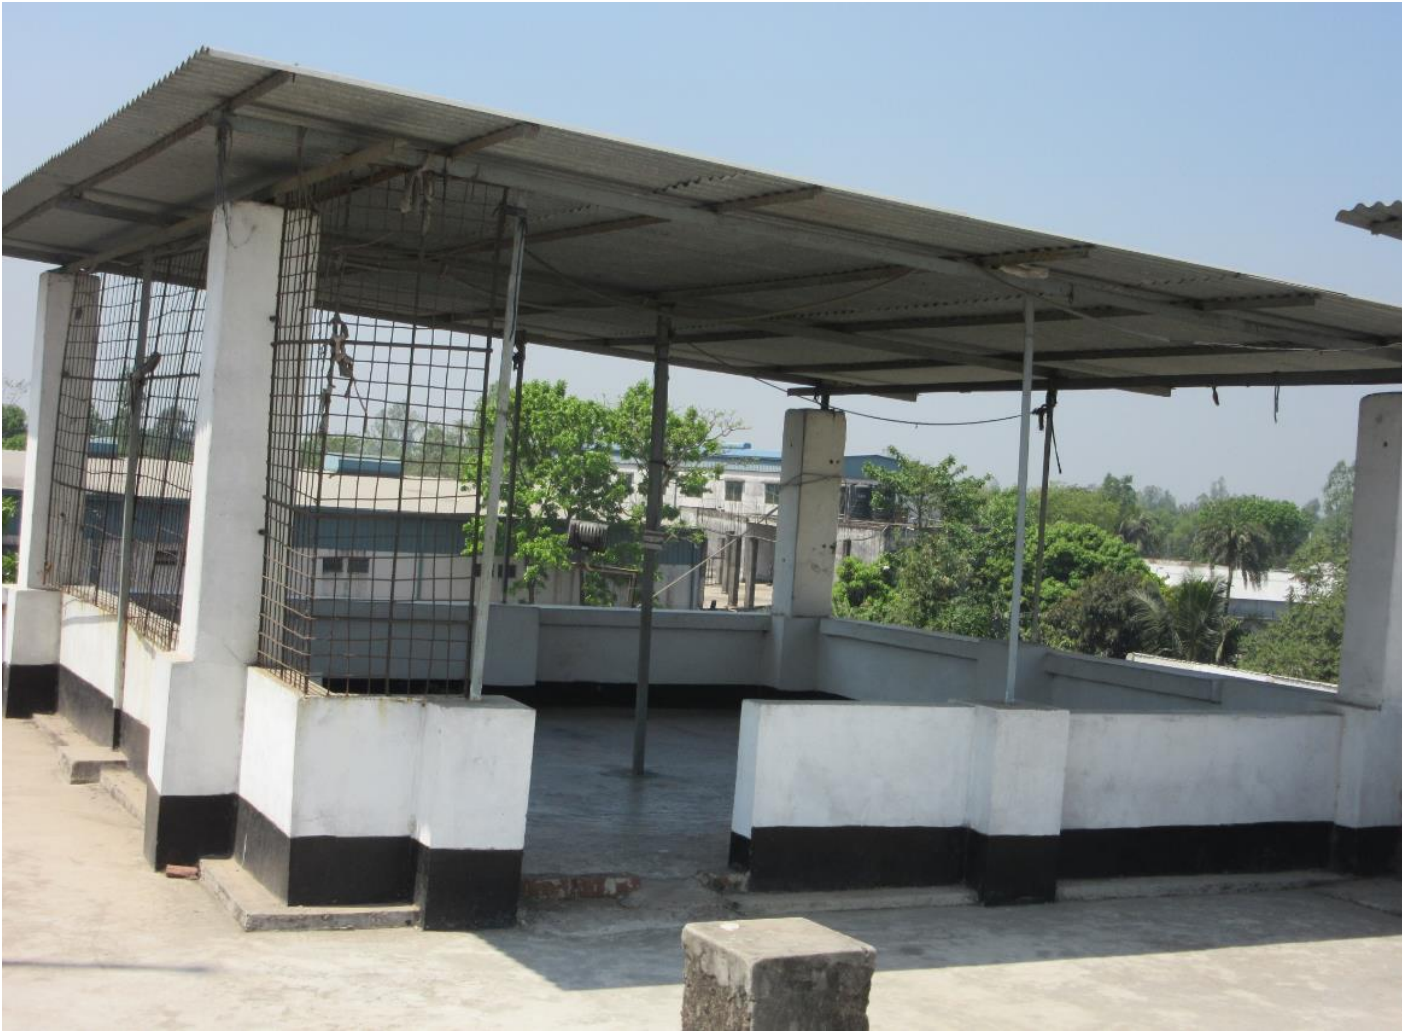
Non engineered roof structure

Roof structure appears not adequate to resist high wind loads

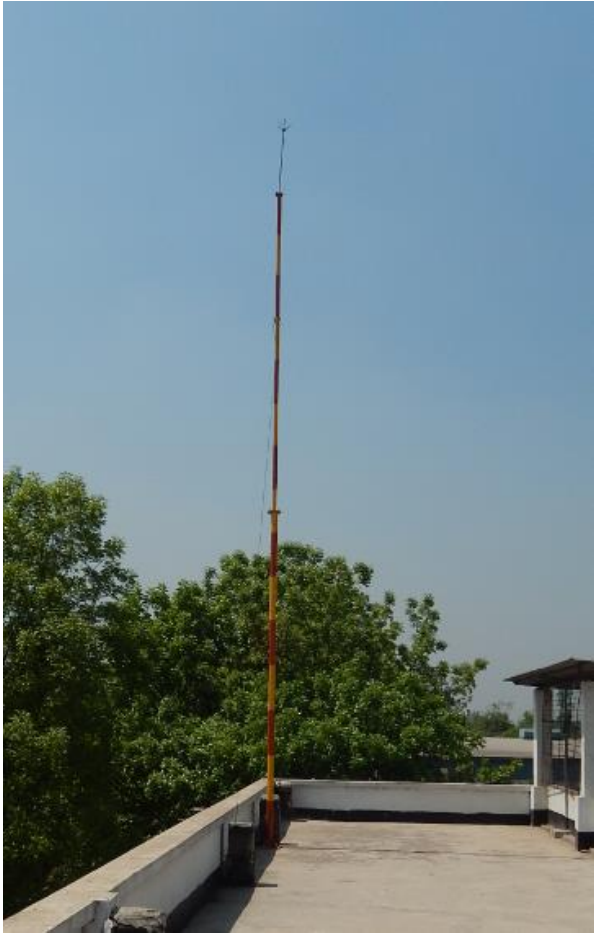
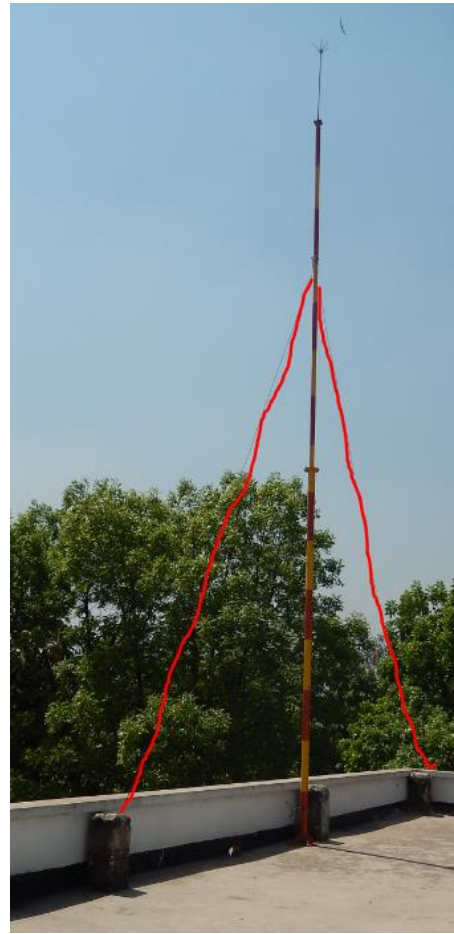
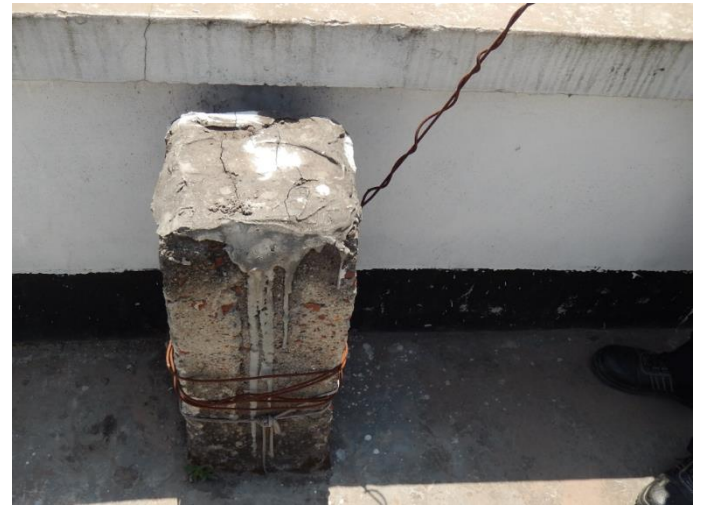
Mast on roof not securely fastened

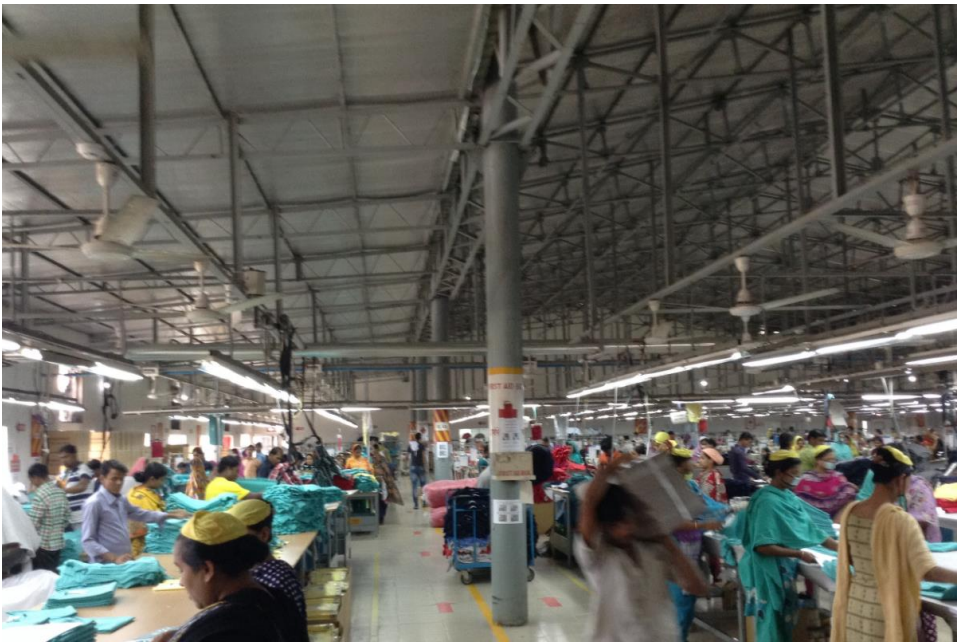
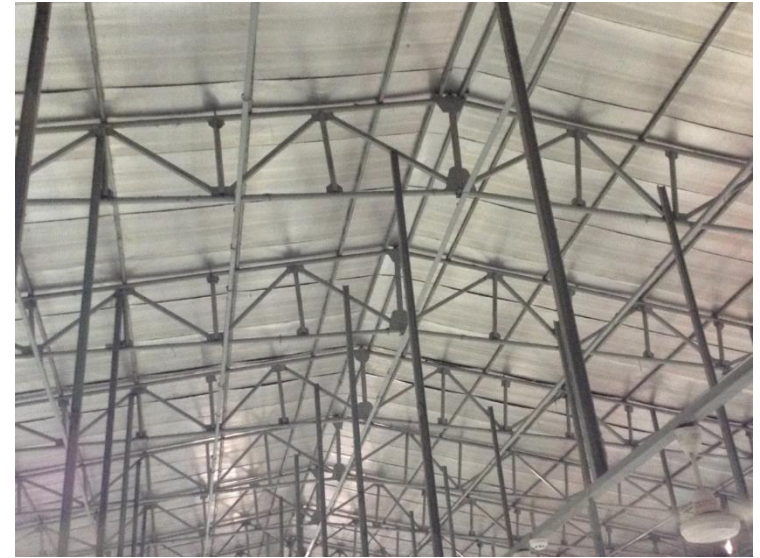
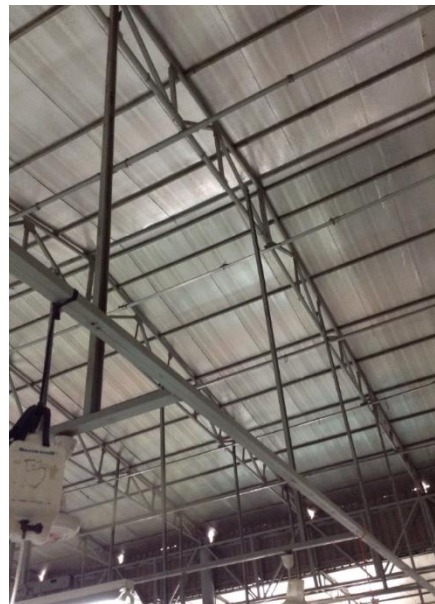
Lateral Stability Issues

Non-exhaustive list of lateral stability issues:

- No horizontal bracing in place.
- Trusses lack bottom chord restraint for wind uplift forces.
- Freestanding brickwall appears inadequate to give sufficient lateral restraint in out of plane direction.
- Insufficient information available to verify if steel column anchorage and foundation is able to provide lateral restraint by moment fixity at its base.

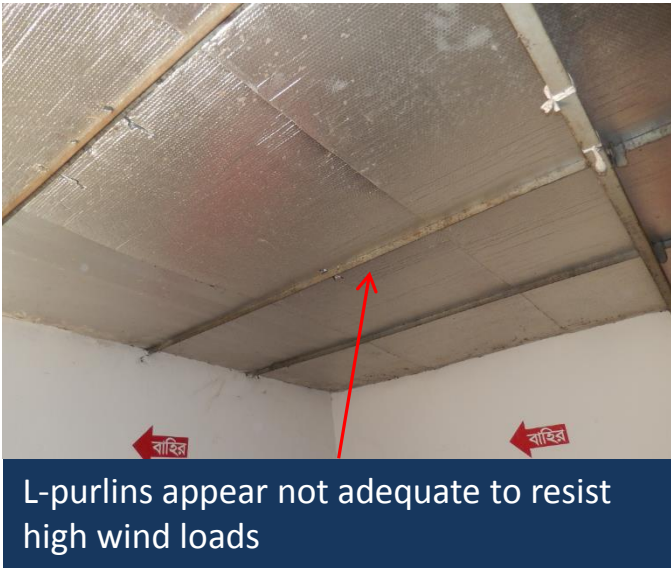
L-purlins appear not adequate to resist high wind loads

7	Non-engineered steel structures	Building engineer to carry out engineering calculations and propose strengthening where required.	6-weeks
8	Non-engineered steel structures	Building engineer to provide as built drawings of steel structure, including description of lateral stability philosophy.	6-weeks

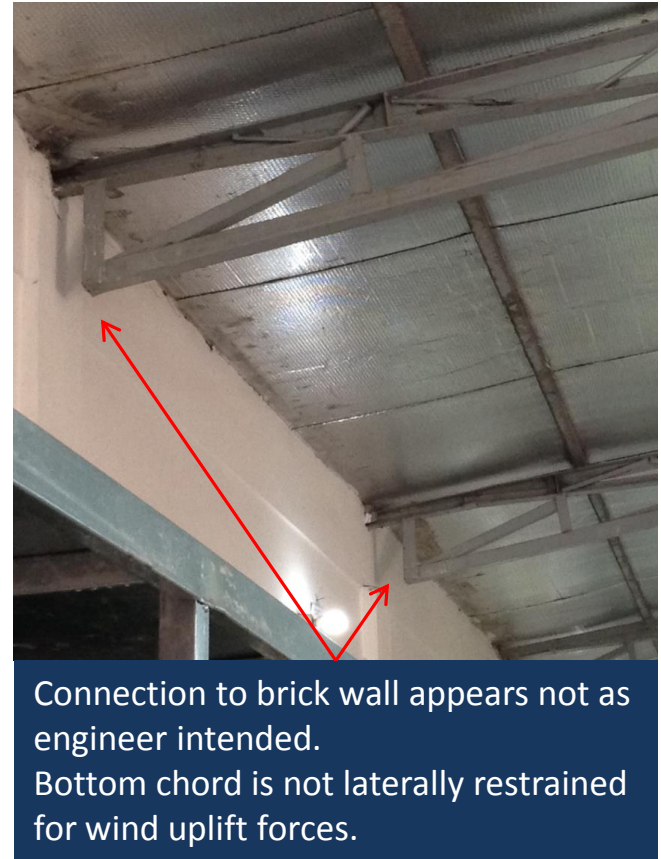
Connection to brick wall appears not as engineer intended. Bottom chord is not laterally restrained for wind uplift forces.

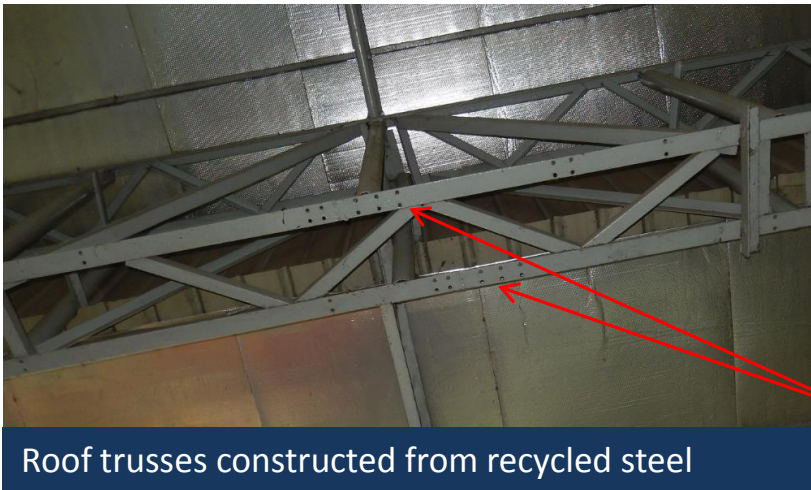
Roof trusses constructed from recycled steel

Holes in section from previous connections are weakening the steel capacity

Non-engineered steel roof trusses

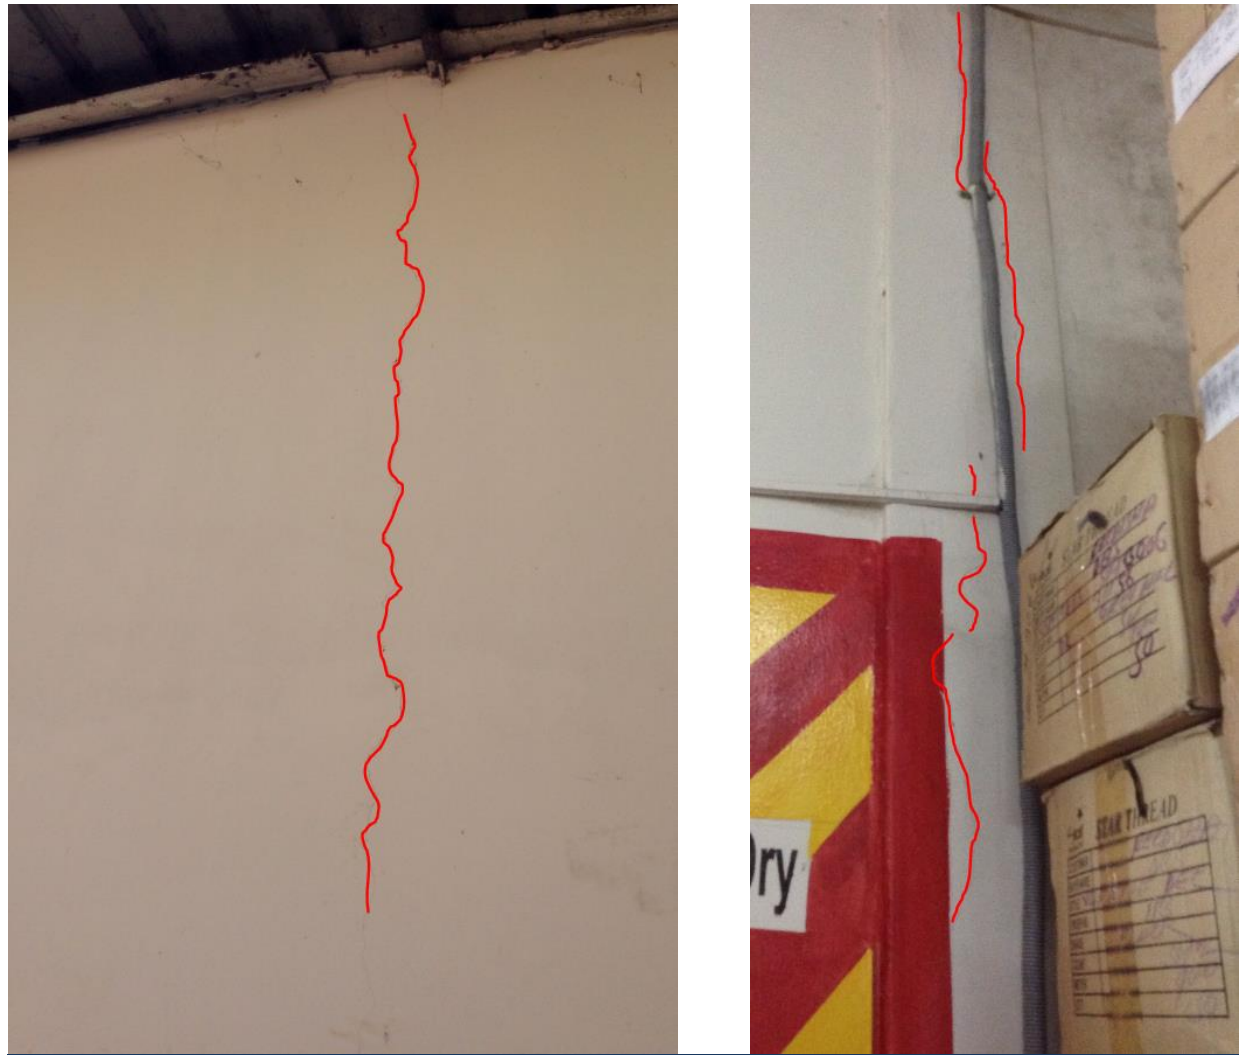
Brick walls appear to rely on steel roof for out of plane stability. Roof relies on brick wall for lateral stability.

Cracking noted in wall where steel columns are embedded.

Stability of freestanding perimeter brick wall

Item No.	Observation	Recommended Action Plan	Recommended Timeline
9	Stability of Perimeter Wall	Building engineer to carry out engineering calculations of perimeter wall and propose strengthening where required.	6-weeks
10	Stability of Perimeter Wall	Building engineer to provide as built drawings of perimeter wall with embedded steel structure, including description of lateral stability philosophy.	6-weeks
11	Robustness Issues of Sheds sharing the same support	Building engineer to propose solution for separation of the structures.	6-months
12	Water Damage in internal Wall	Engineer to review load transfer from steel roof supports into wall through the eccentric loading of the drain water channel.	6-weeks
13	Water Damage in internal Wall	Propose strengthening or additional supports.	6-weeks
14	Water Damage in internal Wall	Repair cracks and water tightness to avoid further water ingress in the wall.	6-months

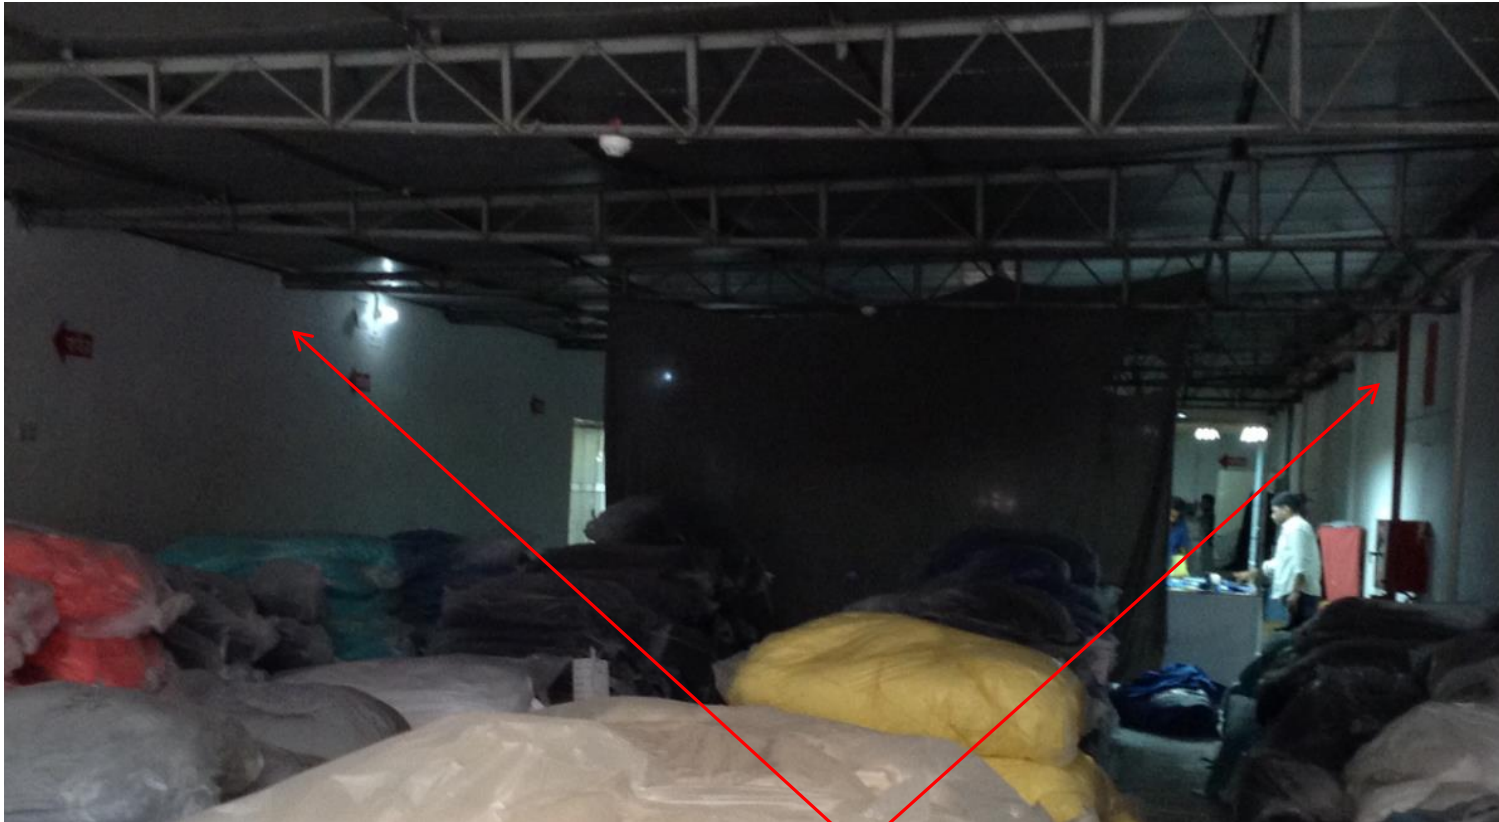
Single support for trusses from both sides of wall

Robustness issues. Collapse of one shed (due to fire, instabilities under wind, etc) can cause the collapse of the other shed as well

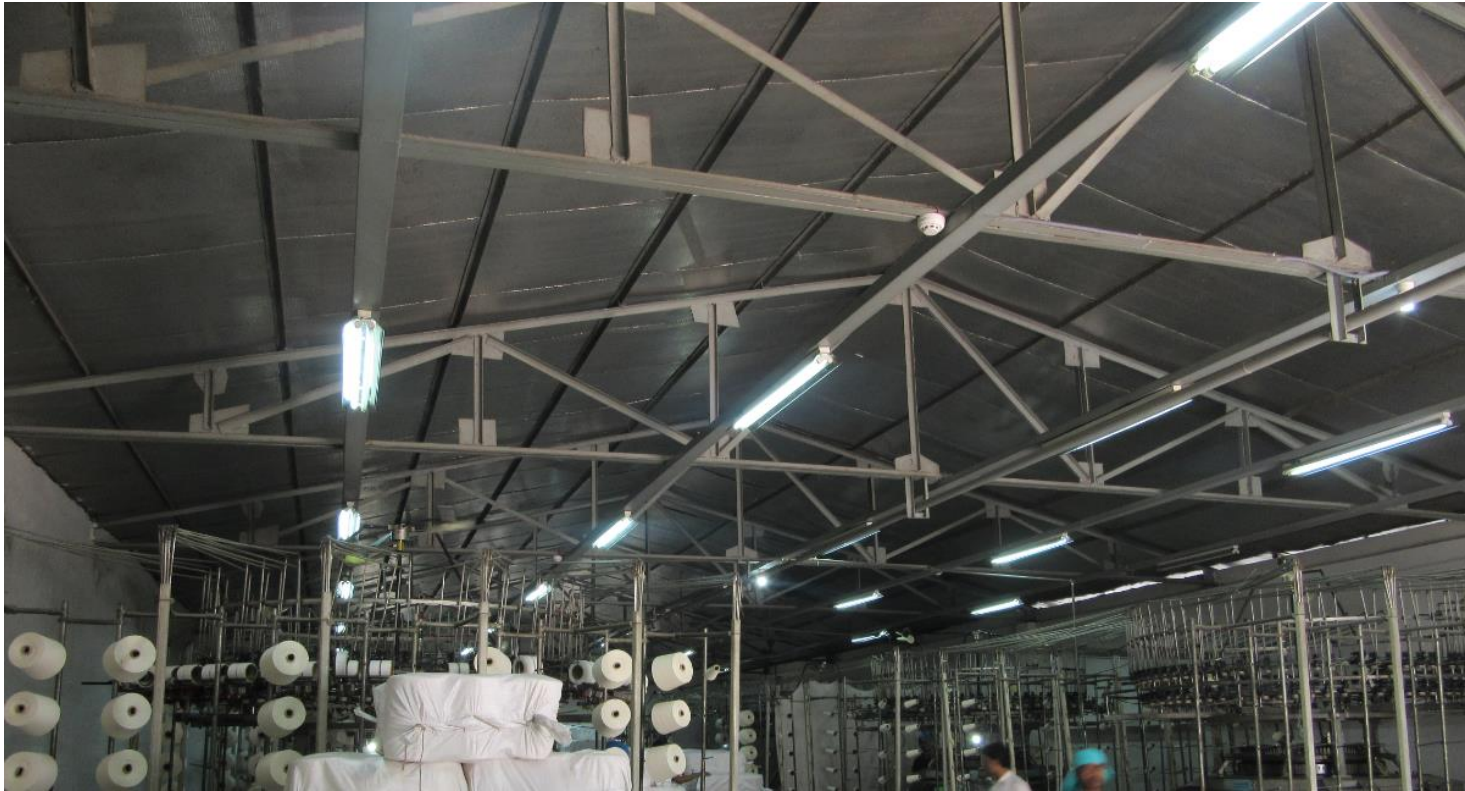
Non-exhaustive list of lateral stability issues:

- No horizontal bracing in place.
- Trusses lack bottom chord restraint for wind uplift forces.

Lateral Stability Issues

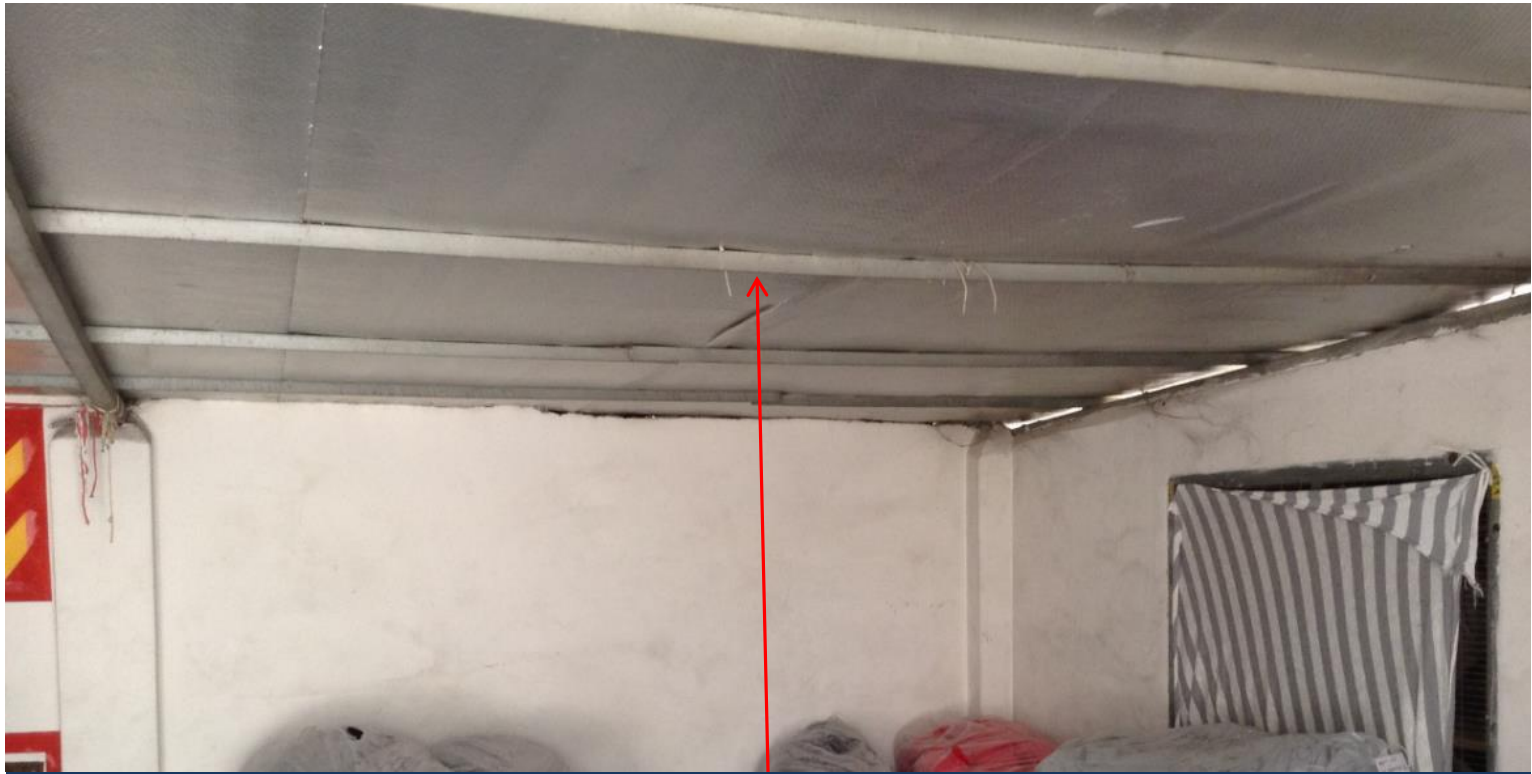
L-purlins appear not adequate to resist high wind loads

Non-engineered steel roof trusses

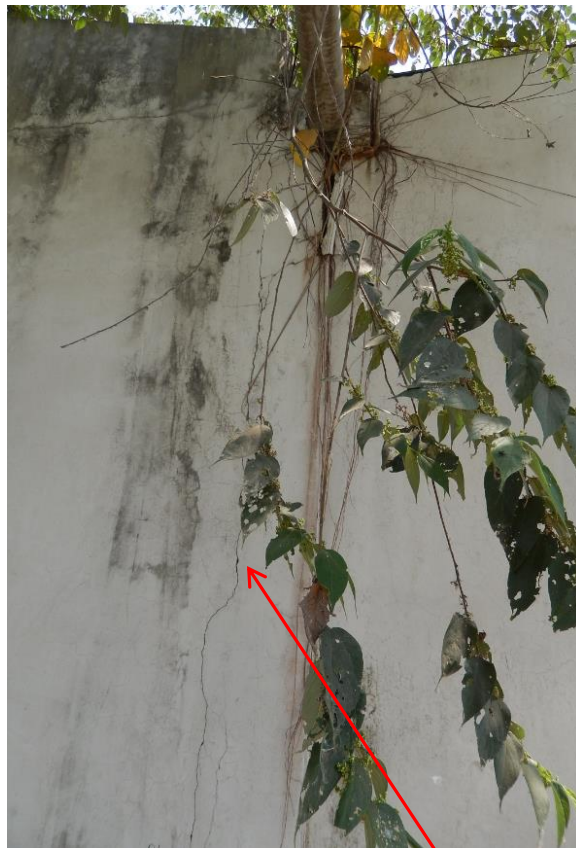
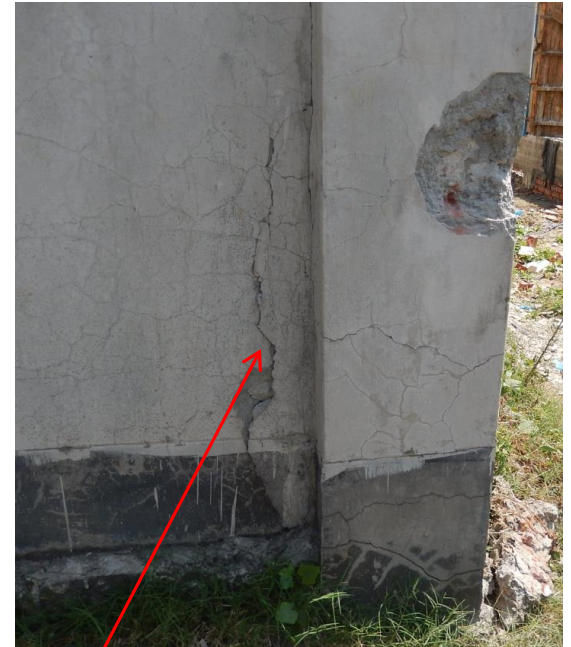
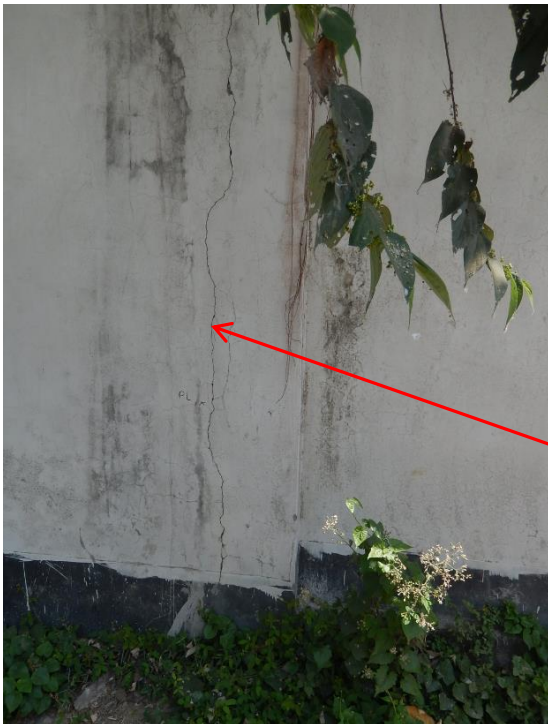
Brick walls appear to rely on steel roof for out of plane stability.
Roof relays on brick wall for lateral stability.

Cracking noted in wall where steel columns are embedded.

Stability of freestanding perimeter wall

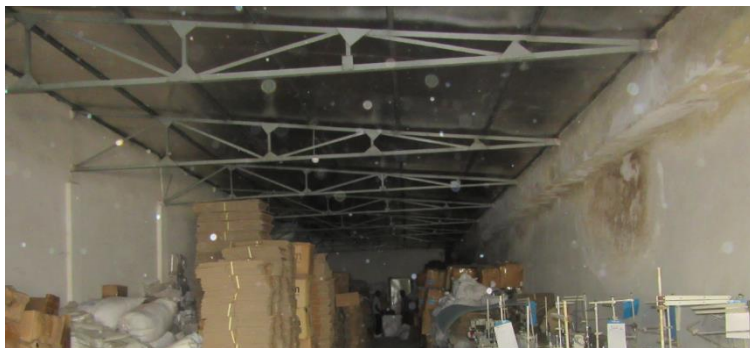
Internal wall with cantilevered cavity beam for rain water drainage

Steel truss support introduces eccentric load on wall

Cracking and water damage affecting support of steel truss

15	Water Damage in internal Wall	Inspect water damaged caused to date and propose appropriate repair if the damage caused compromises the structural integrity of the wall.	6-months
16	Deterioration of perimeter structure	Engineer to inspect all structural elements exposed to vegetation (columns, grade beams, foundations).	6-months
17	Deterioration of perimeter structure	Repair cracks and structure affected by environmental and vegetation growth	6-months
18	Deterioration of perimeter structure	Install protecting strip around perimeter of buildings to avoid vegetation grow and to protect structure from further deterioration.	6-months

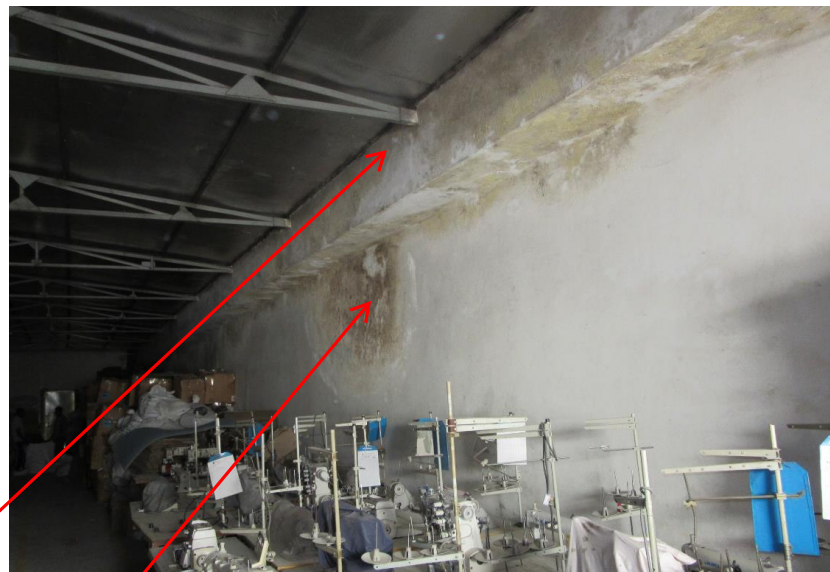
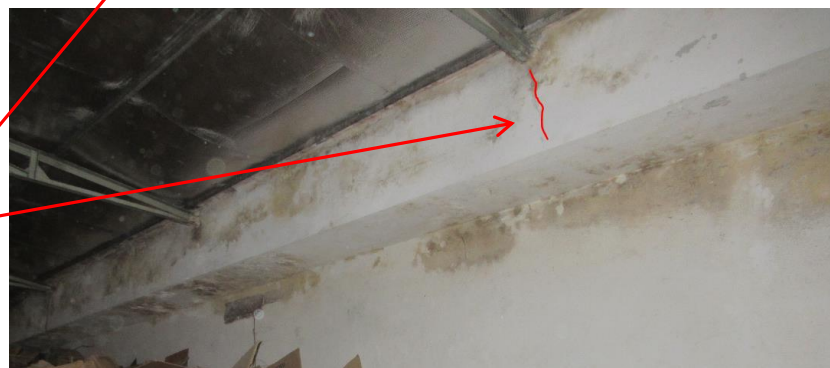
Water Damage in internal Wall

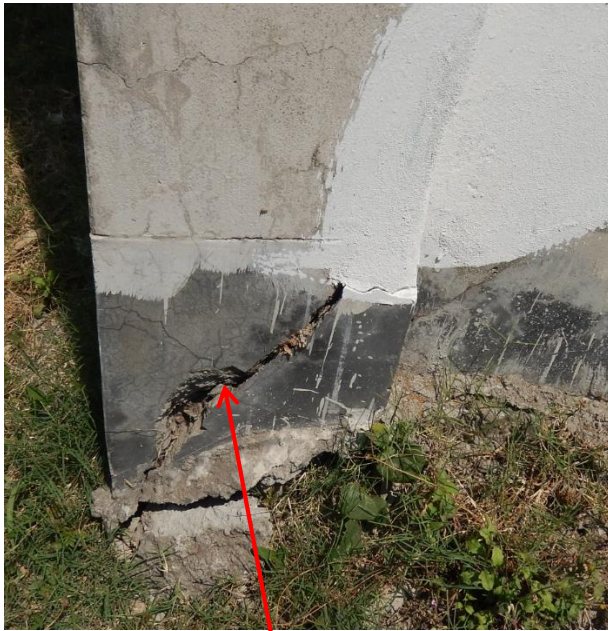
Cracking in base of column/foundation caused by / or worsened by vegetation growth

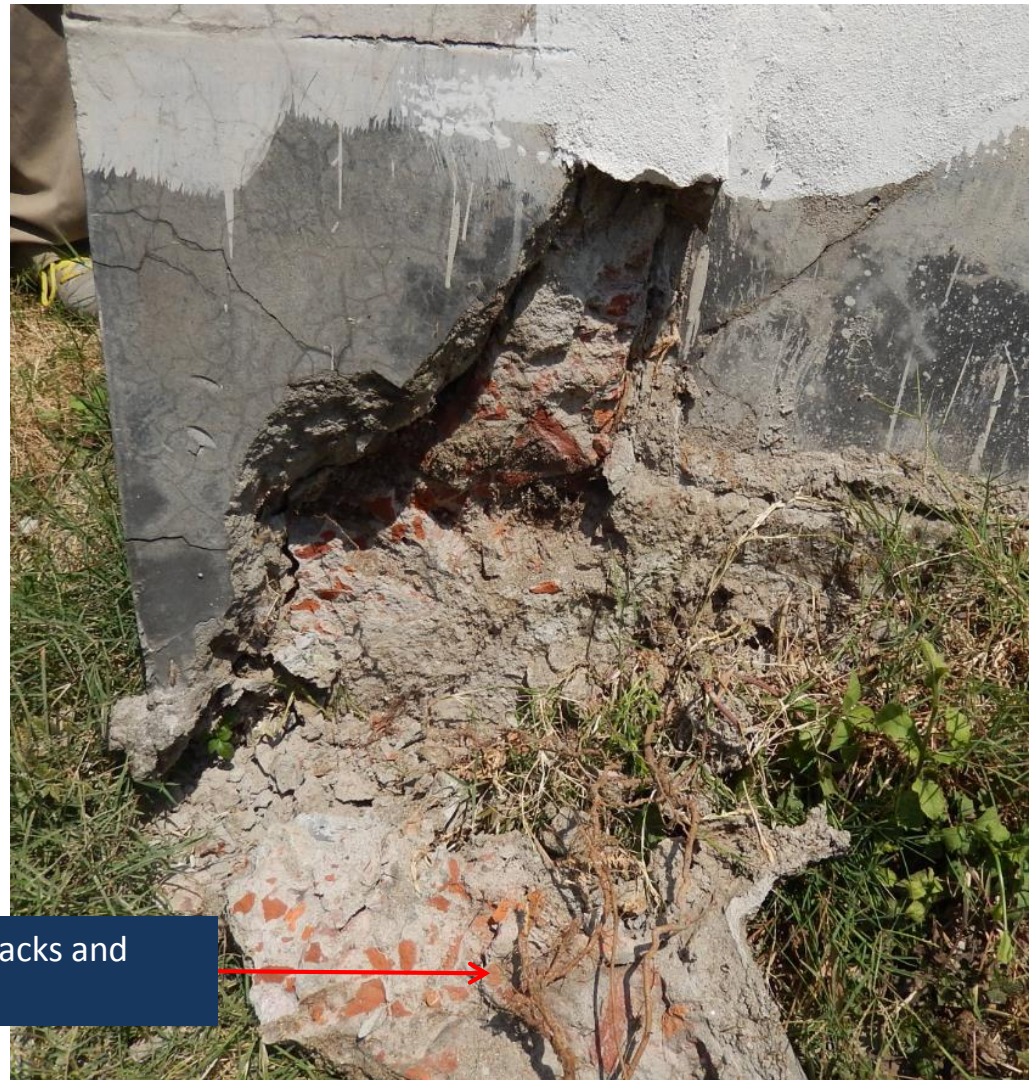
Roots penetrated into cracks and worsened deterioration

Deterioration of perimeter structure

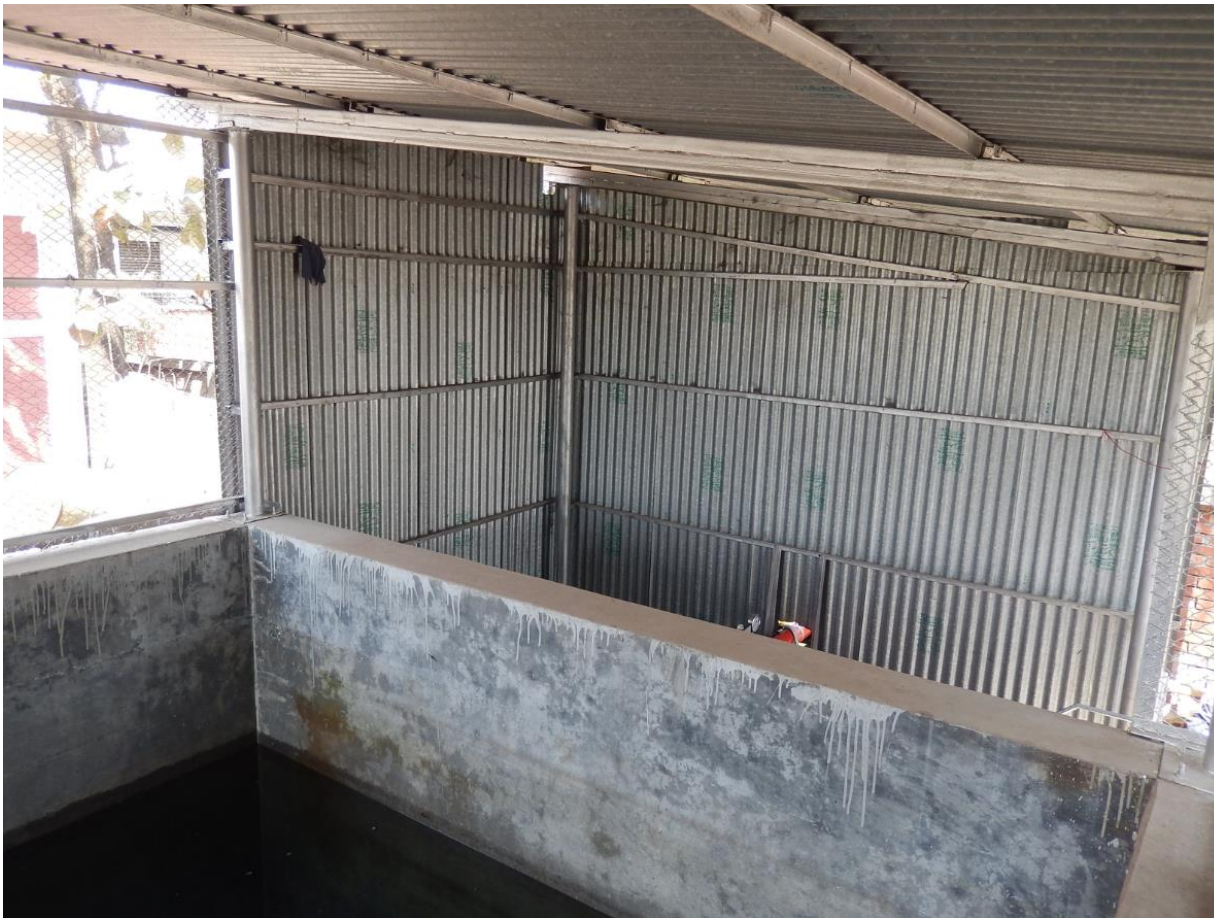
No bracing in place for lateral stability in fire house

Item No.	Observation	Recommended Action Plan	Recommended Timeline
19	Unclear stability	Engineer to review lateral stability of fire house structure (in particular capacity of moment fixity of column bases) and propose additional vertical bracing if required.	6-months
20	Drawing Discrepancies	Building engineer to check, collect information and produce accurate and complete as-built documentation soonest.	6-months
21	Drawing Discrepancies	Verify material strength by site testing.	6-months
22	Drawing Discrepancies	Document clearly between RC structure and brick structure	6-months
23	Drawing Discrepancies	Seek building permit for the new construction.	6-months

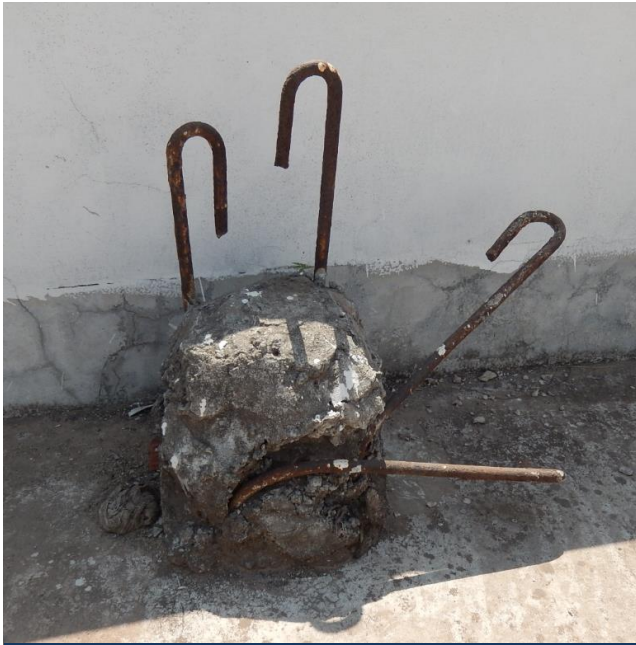
Evidence of low yield strength bars on roof

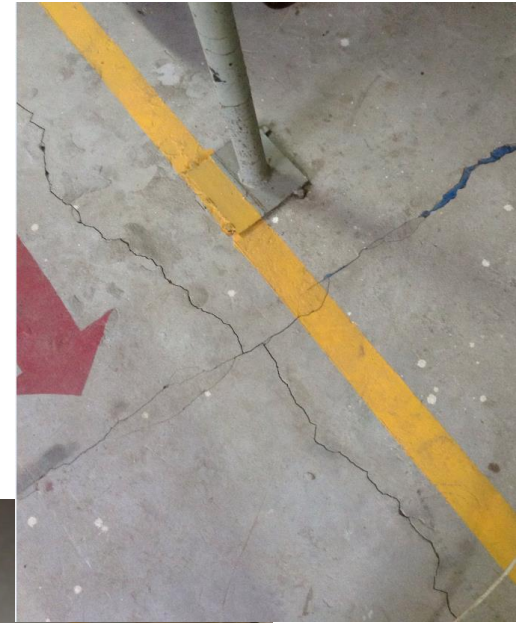
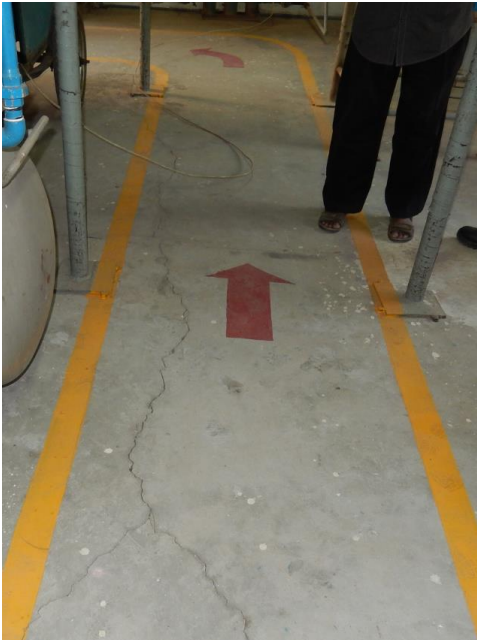
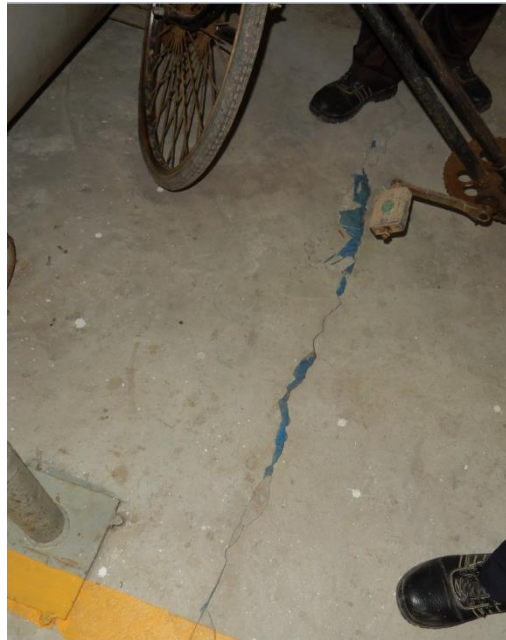
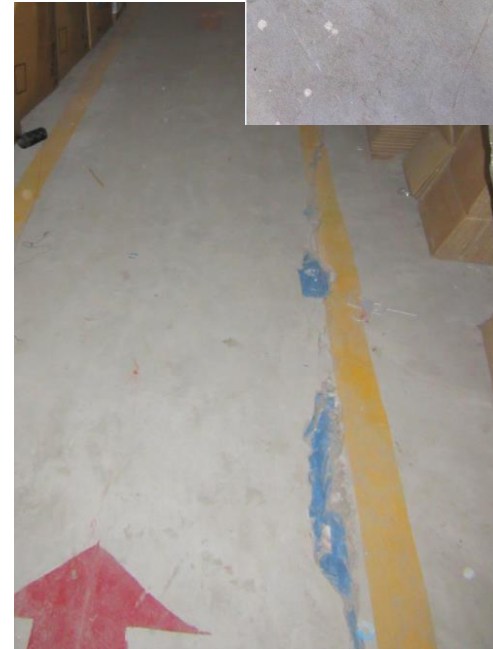
Ground floor slab appears to be a thin layer of unreinforced lean cement mix on PE sheet.

Cracking in ground floor plates

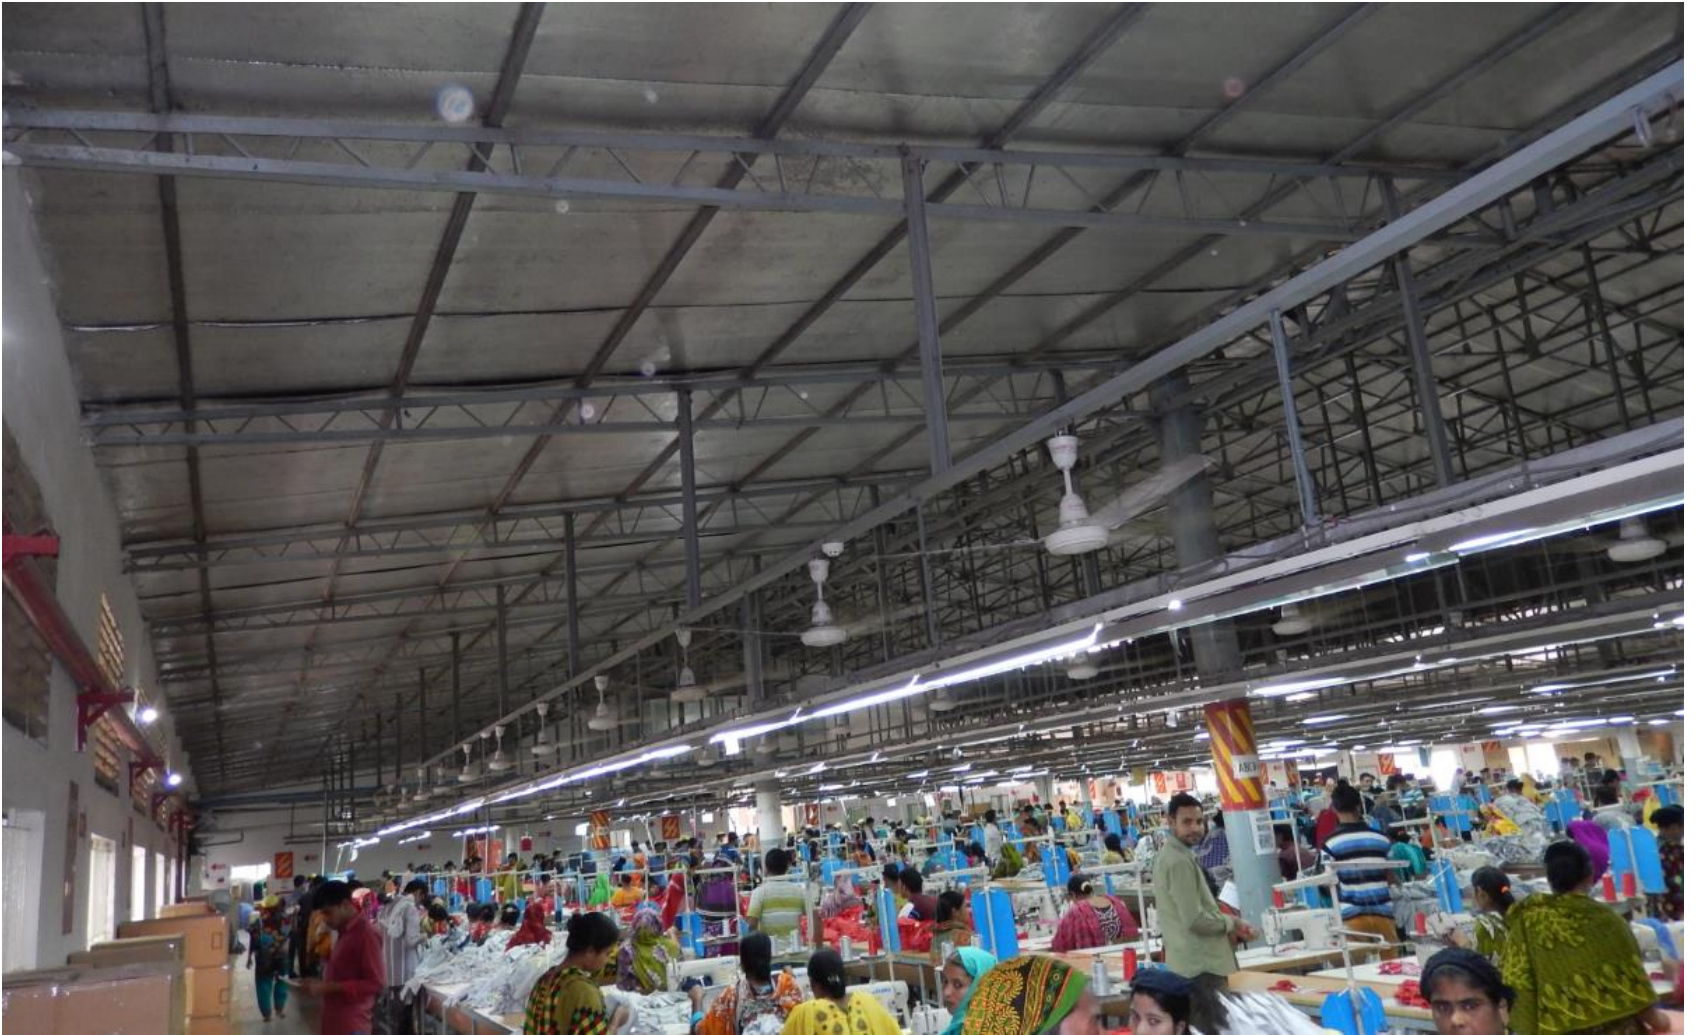
No fire protection evident for steel structures
