Reedisha Texstripe Ltd

Teknogpara, Salna, Gazipur, Dhaka
(24.013801, 90.382815)

21st March 2015

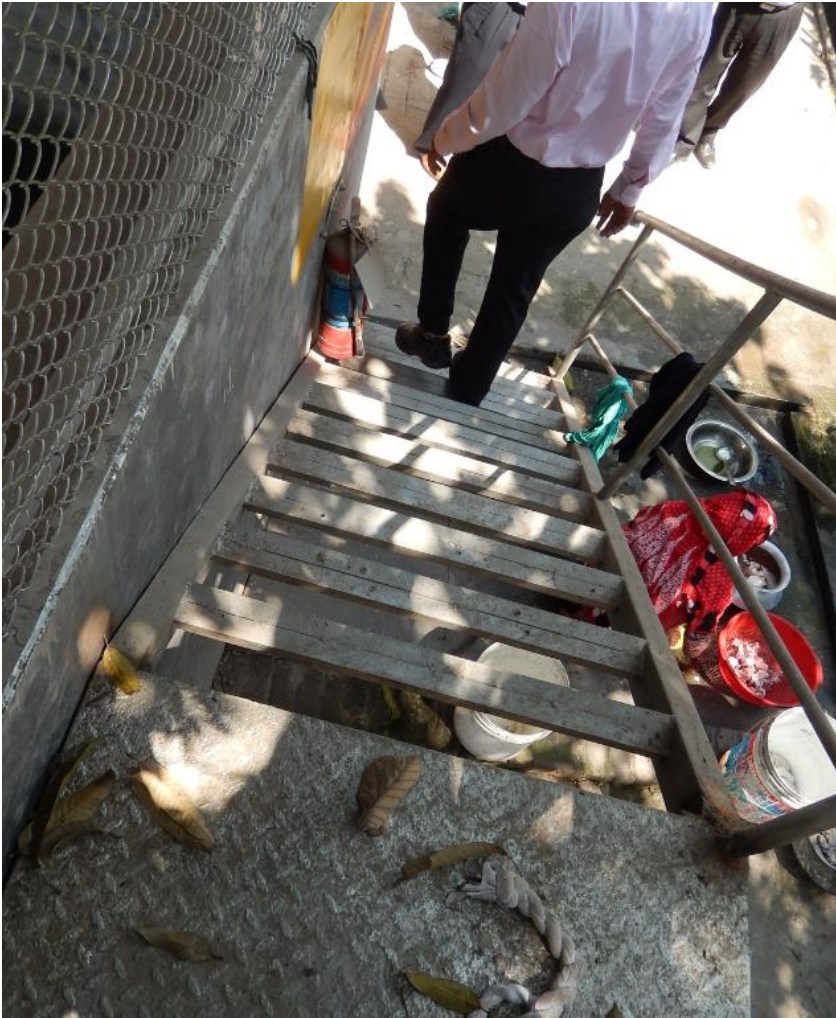
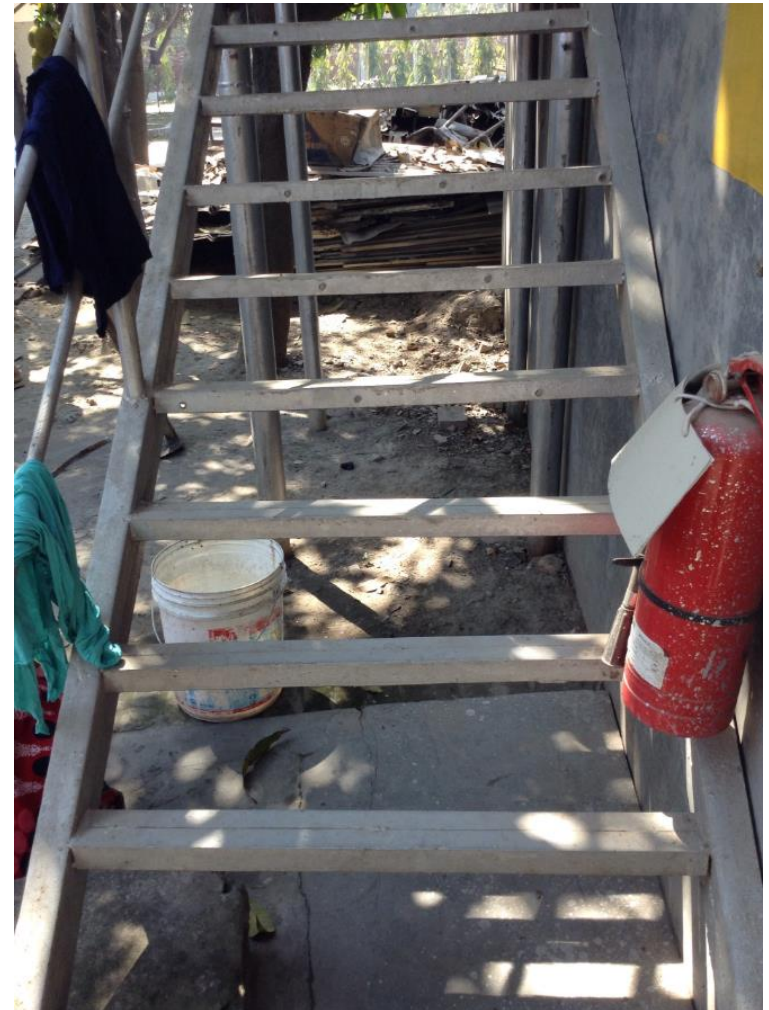
Unsafe access stair
