# Southern Garments Ltd

Zirabo, Ashulia, Savar, Dhaka  
(23.912349 N, 90.314662 E)  
21 March 2015

# Observations

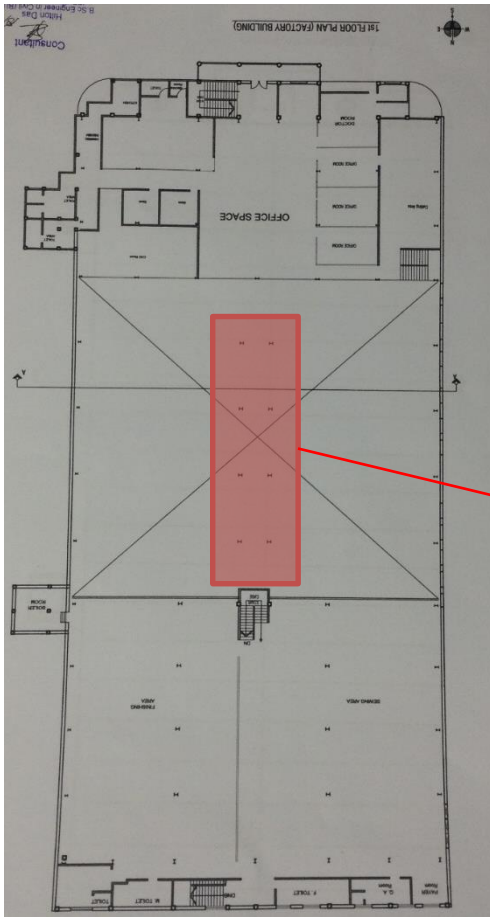
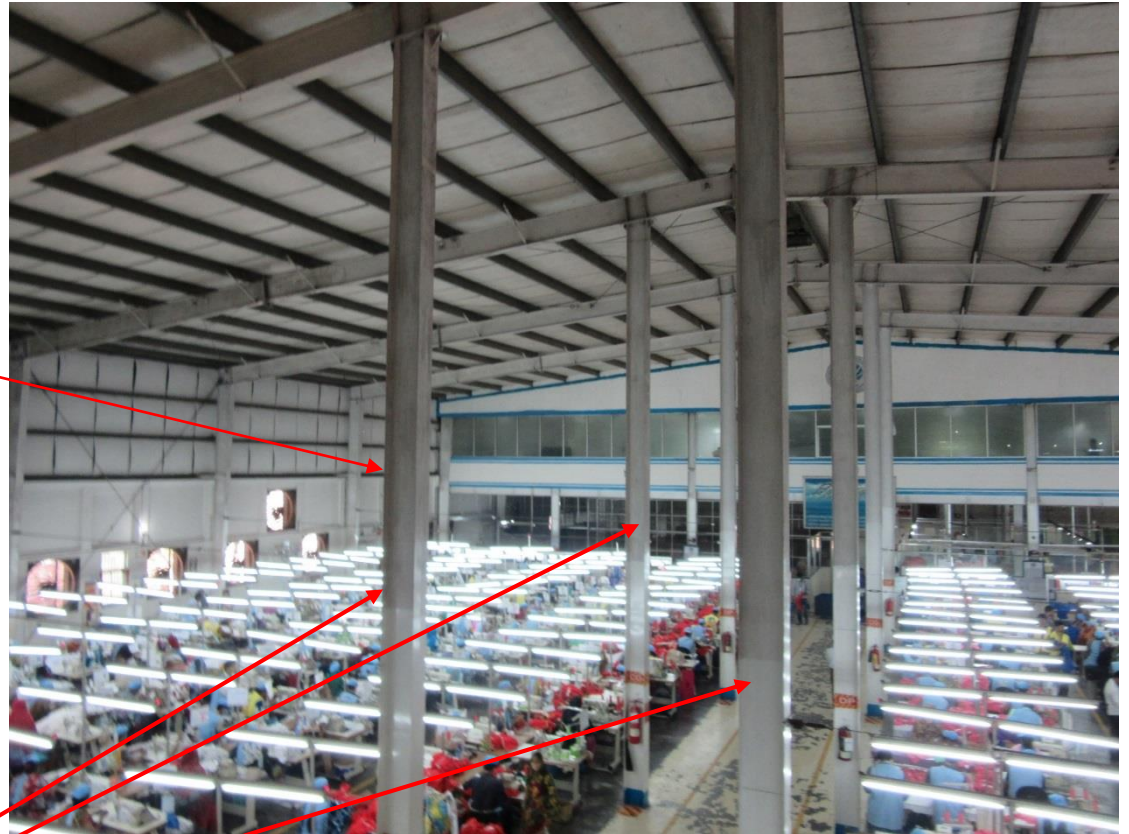
**Steel columns in Building 1  
appear to be too slender**

Steel columns in mid-span appear to be very slender.

| Item No. | Observation | Recommended Action Plan | Recommended Timeline |
|---|---|---|---|
| 1 | Steel columns in Building 1 appear to be too slender (risk of buckling) | Building engineer to check, collect information and confirm the structural stability capacity (lateral buckling) of the as built steel columns. | 6-months |
| 2 | Steel columns in Building 1 appear to be too slender (risk of buckling) | Perform any structural alterations as advised by Factory Engineer. | 6-months |

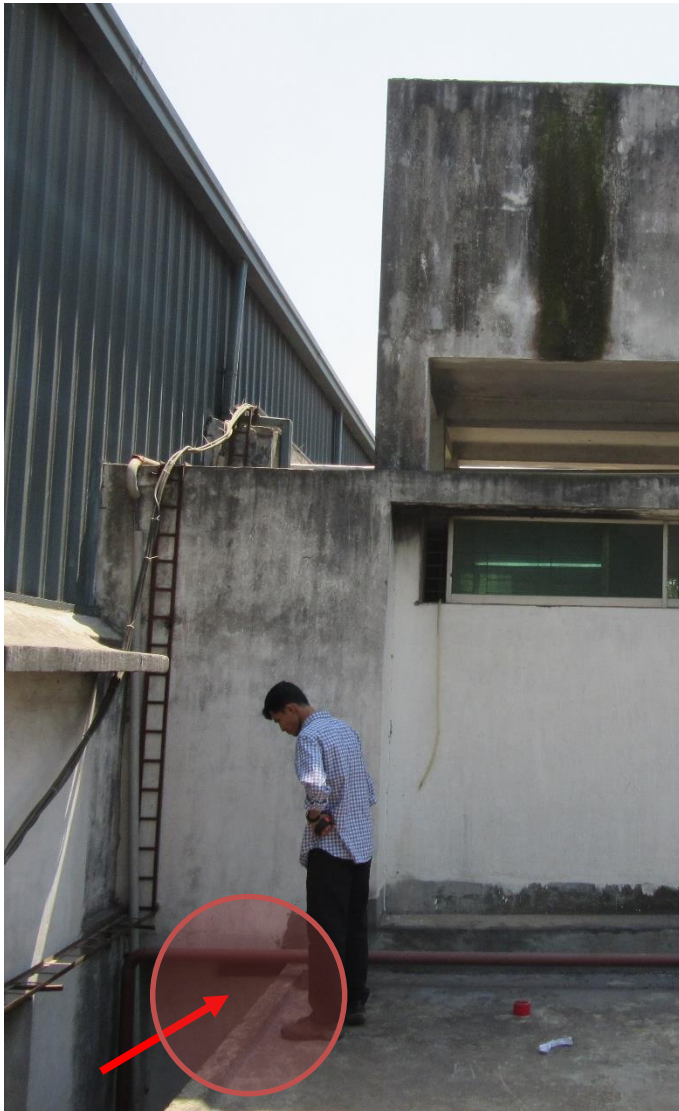
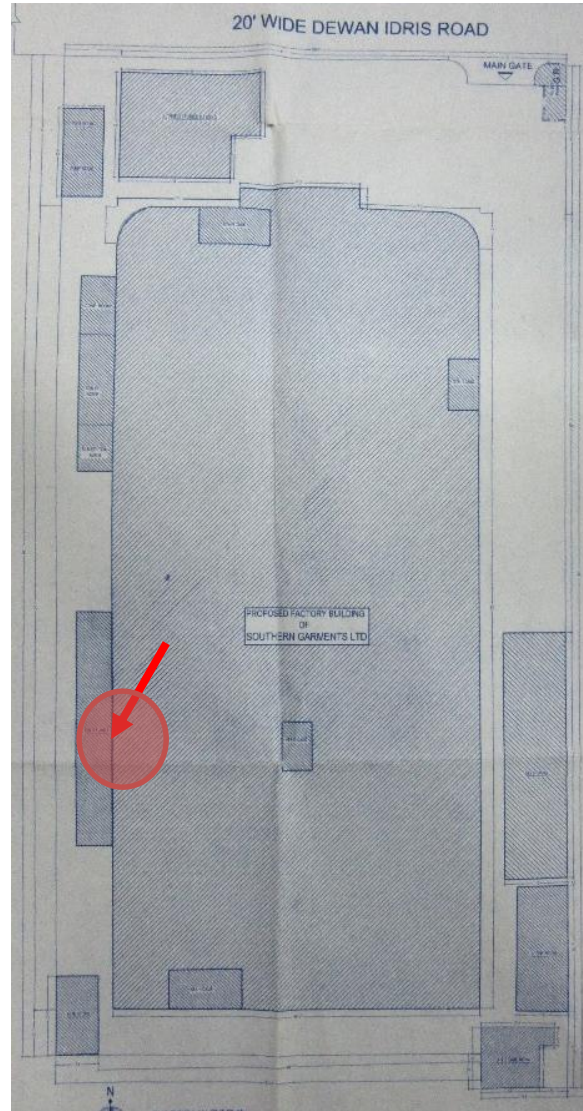
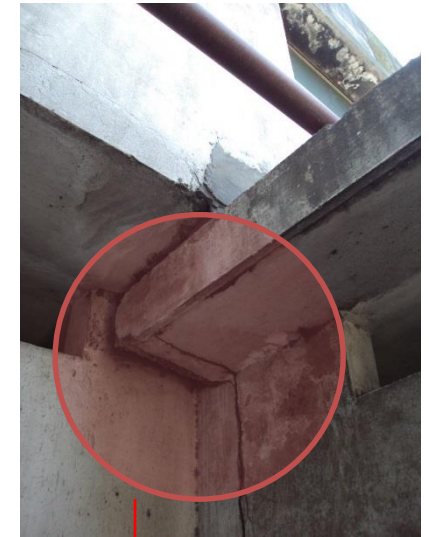
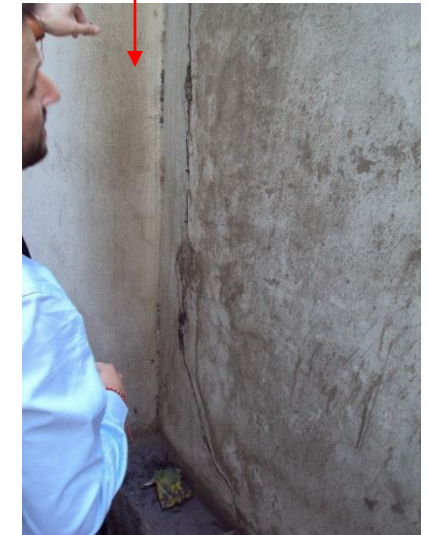
# Cracks in walls of male toilet below water tank

Vertical cracks in walls of male toilets underneath water tank

| Item No. | Observation | Recommended Action Plan | Recommended Timeline |
|---|---|---|---|
| 3 | Cracks in walls of male toilet below water tank | Building engineer to investigate cracks at occurring location to assess cause and extent of cracks. | 6-months |
| 4 | Cracks in walls of male toilet below water tank | Building engineer is to monitor the issue on an on-going basis and remediate as appropriate | 6-months |

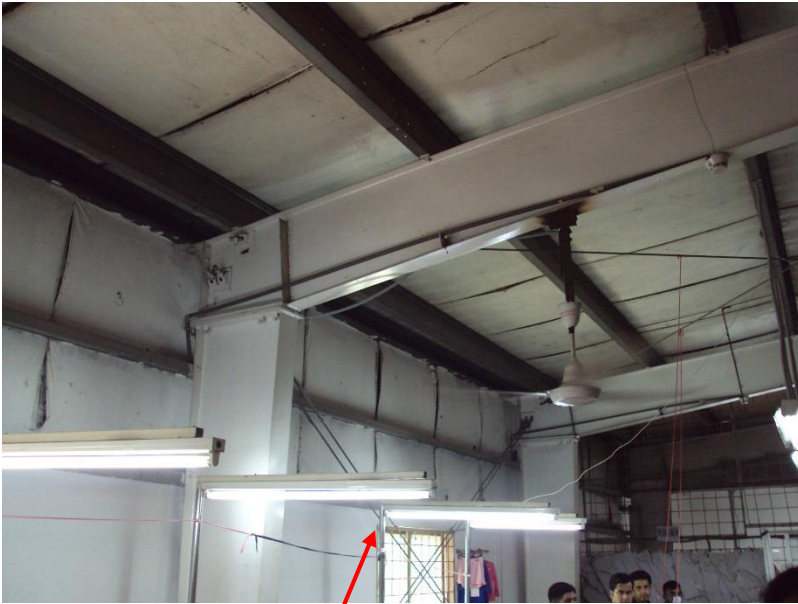
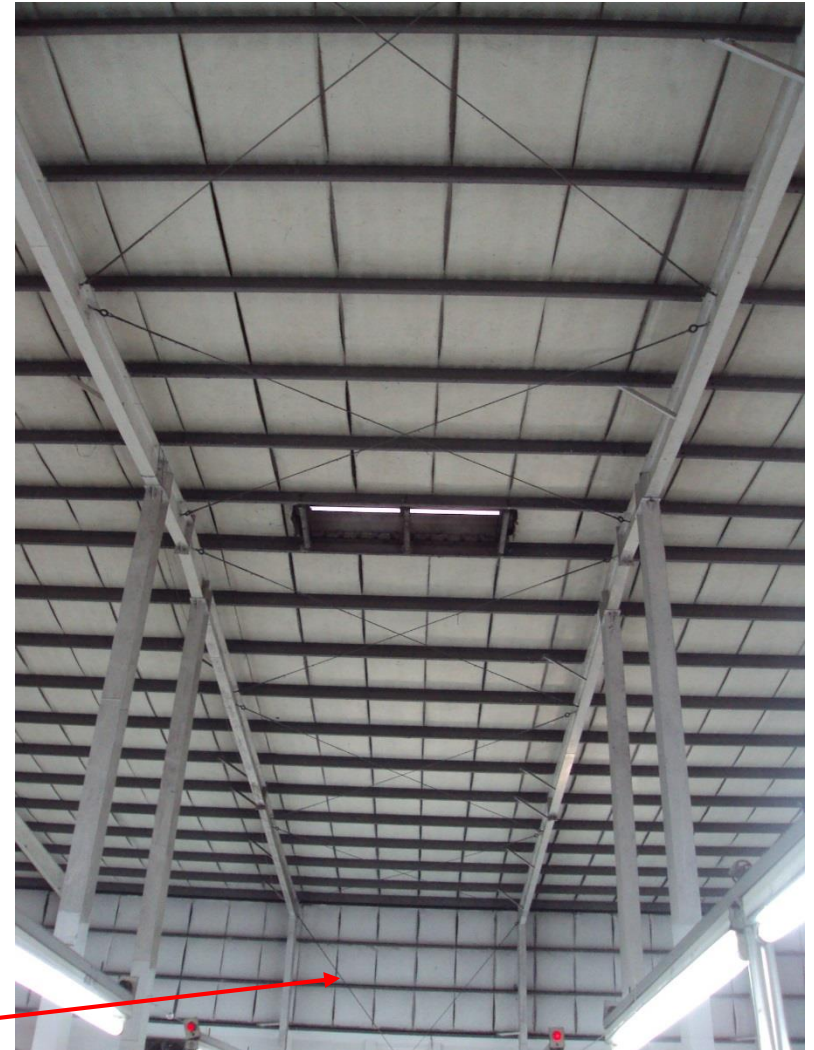
# **Bracing of Steel Shed/Portal Frame in Building 1 needs to be tied**

Bracing appear to be not tied in both directions.

| Item No. | Observation | Recommended Action Plan | Recommended Timeline |
|---|---|---|---|
| 5 | Bracing of Steel Shed/Portal Frame in Building 1 needs to be tied | Building engineer to check the functionality of bracing | 6-months |
| 6 | Bracing of Steel Shed/Portal Frame in Building 1 needs to be tied | If bracing requires to be tied Building Engineer is to arrange for necessary actions | 6-months |

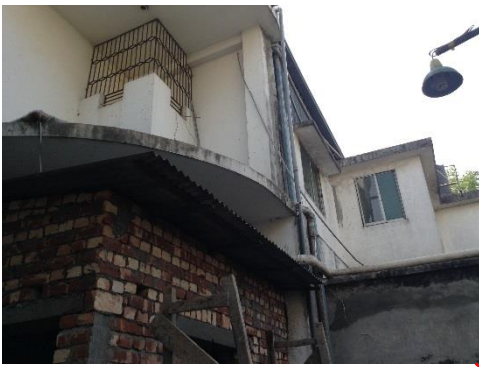
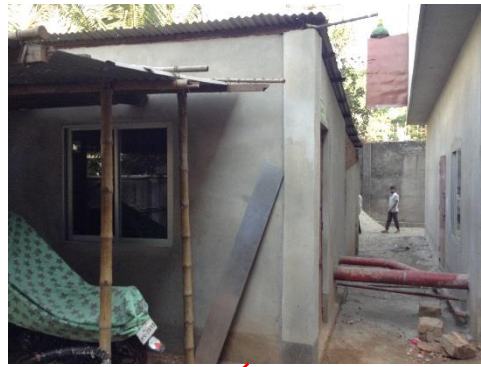
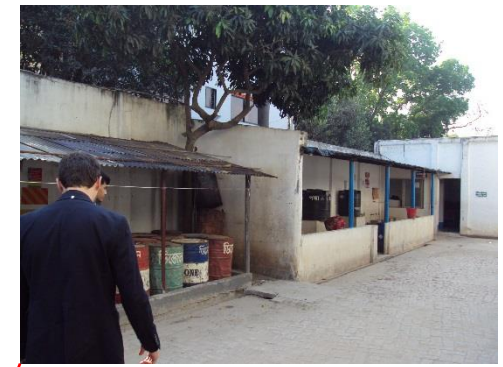
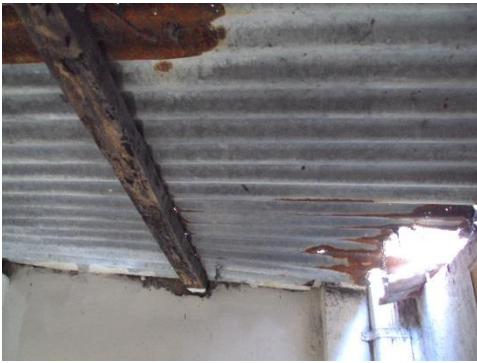
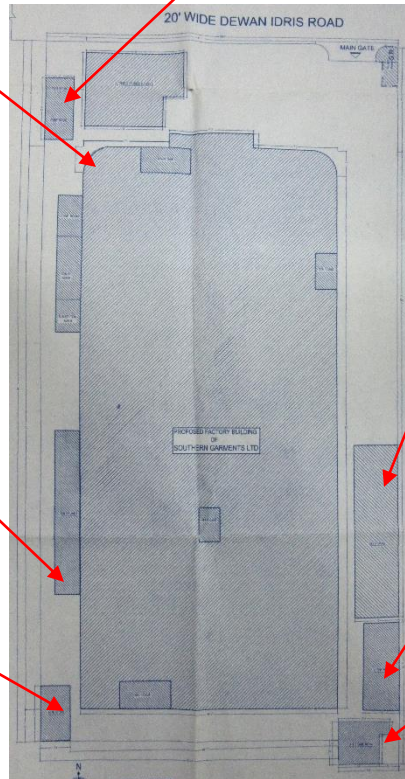
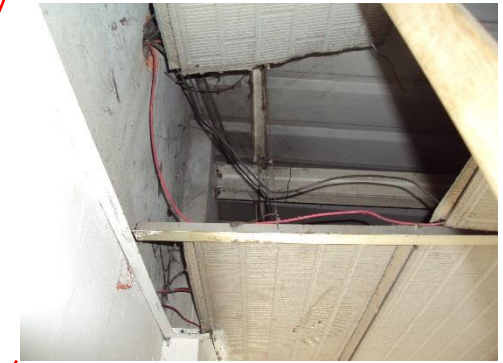
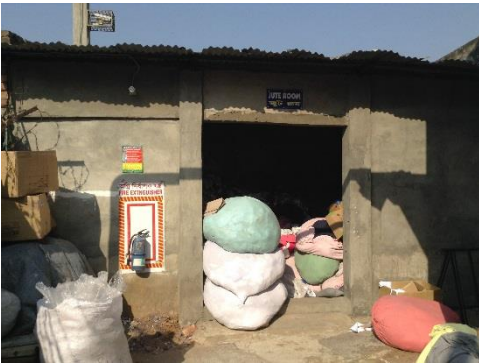
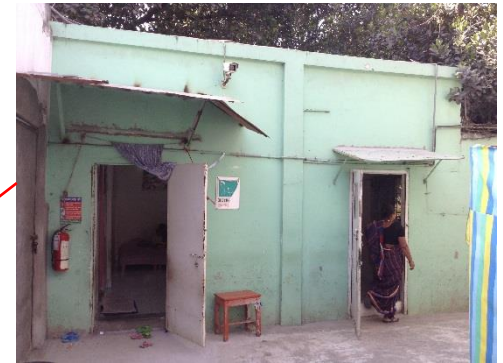
**Metal decking of several ancillary buildings  
appear to be non-engineered**

Metal decking of sheds appear to be non-engineered for several ancillary buildings.

| Item No. | Observation | Recommended Action Plan | Recommended Timeline |
|---|---|---|---|
| 7 | Apparently non-engineered lightweight roof of several ancillary buildings | Building engineer to survey and investigate the roof structures of all sheds and to ensure adequacy for code vertical and horizontal loads including wind and up-lift | 6-months |
| 8 | Apparently non-engineered lightweight roof of several ancillary buildings | Perform any structural alterations as advised by Factory Engineer. | 6-months |

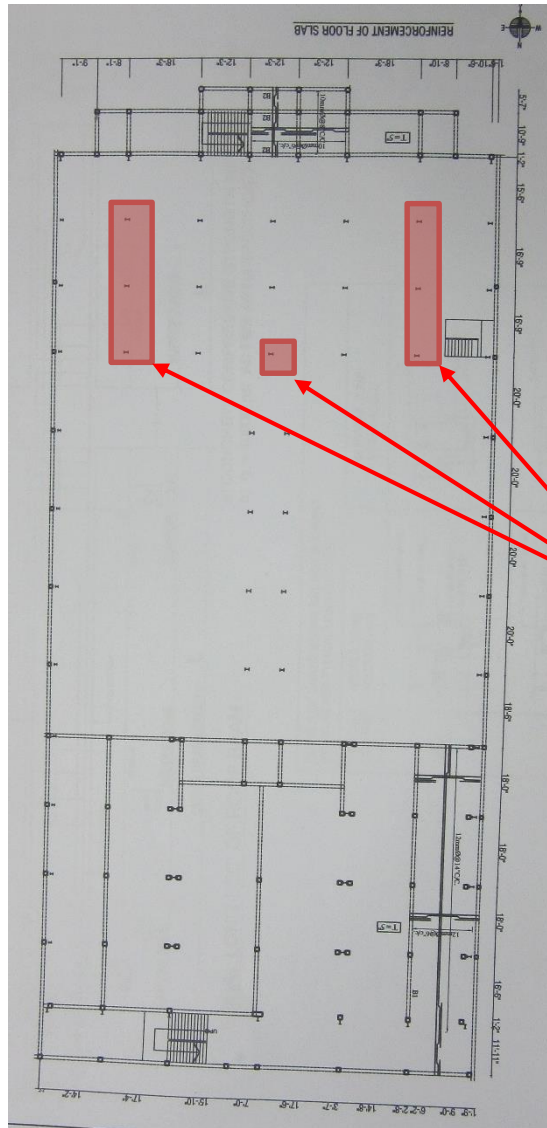
# **Discrepancies between the structural drawings and the As-Built structure**

- Missing columns in several locations on mezzanine floor in Building 1

## Beam layout for mezzanine floor with columns below on ground floor.

| Item No. | Observation | Recommended Action Plan | Recommended Timeline |
|---|---|---|---|
| 9 | Discrepancies between the structural drawings and the As-Built structure | Building engineer to check, collect information and complete design check of as built structure. | 6-months |
| 10 | Discrepancies between the structural drawings and the As-Built structure | Building engineer to produce accurate and complete as-built documentation. | 6-months |

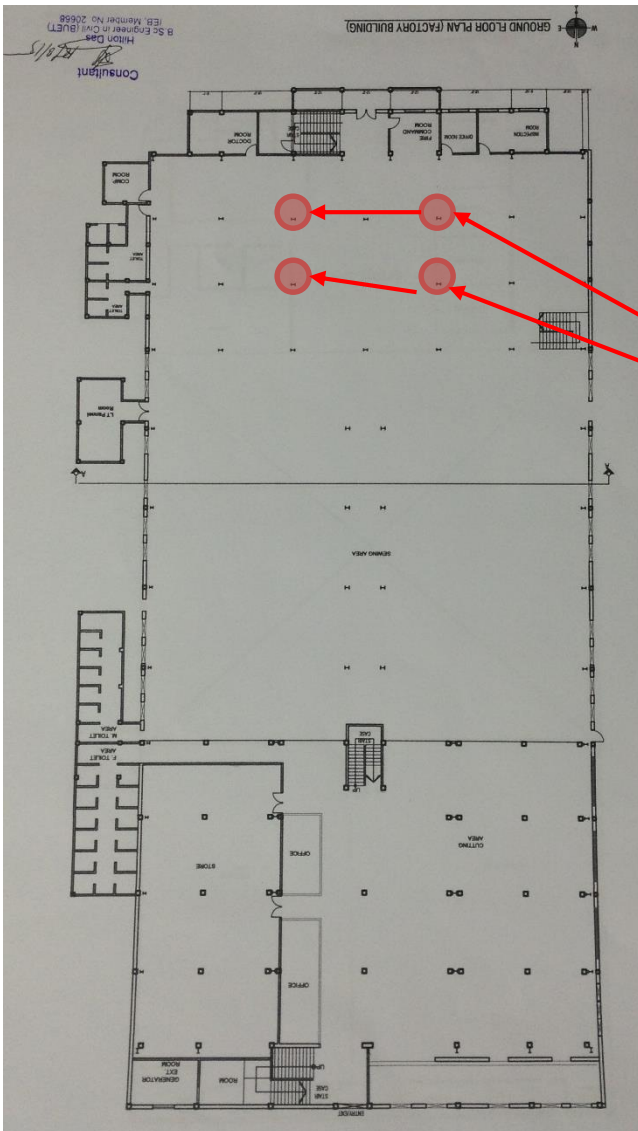
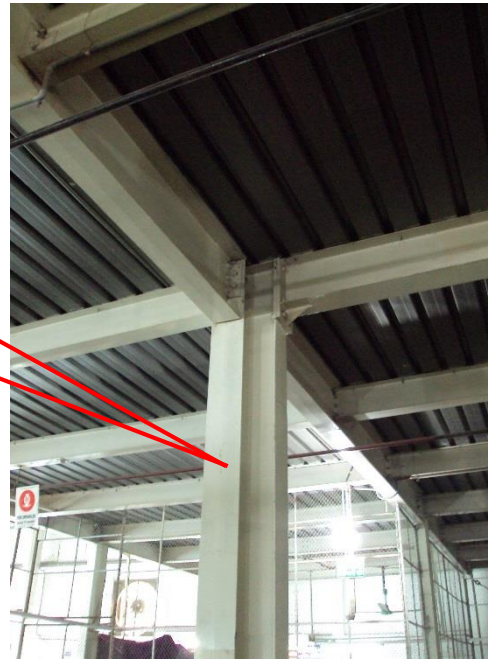
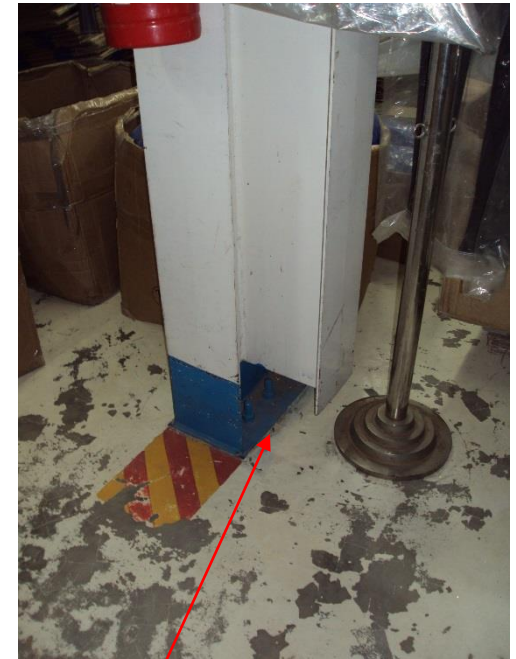
# Double column bolted together

- Double column bolted together (one of the two has no contact to foundation). This details is found on 4 locations on the ground floor.

Two columns bolted together in 4 locations on ground floor.

| Item No. | Observation | Recommended Action Plan | Recommended Timeline |
|---|---|---|---|
| 11 | Double column bolted together in Building 1 | Building engineer to check and collect information about the structural integrity of the column solution. | 6-months |
| 12 | Double column bolted together in Building 1 | Functionality of columns and bolted connection is to be confirmed by the Building Engineer. | 6-months |
| 13 | Double column bolted together in Building 1 | If required further actions are to be taken to ensure a proper performance of the steel structure. | 6-months |

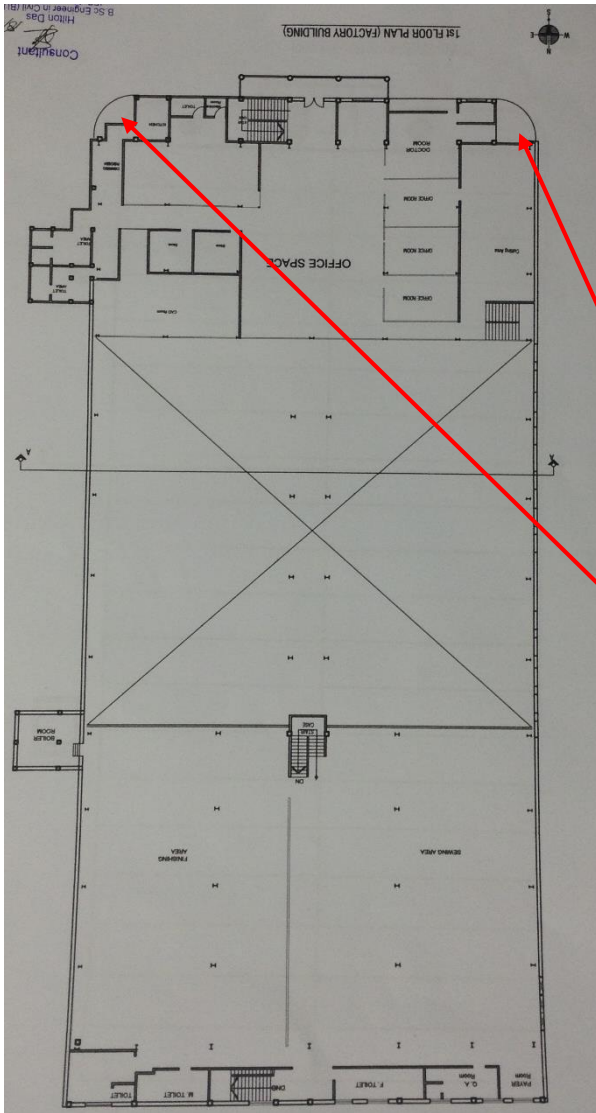
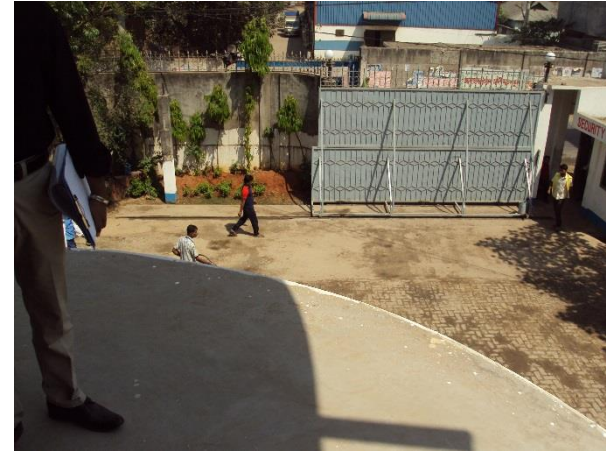
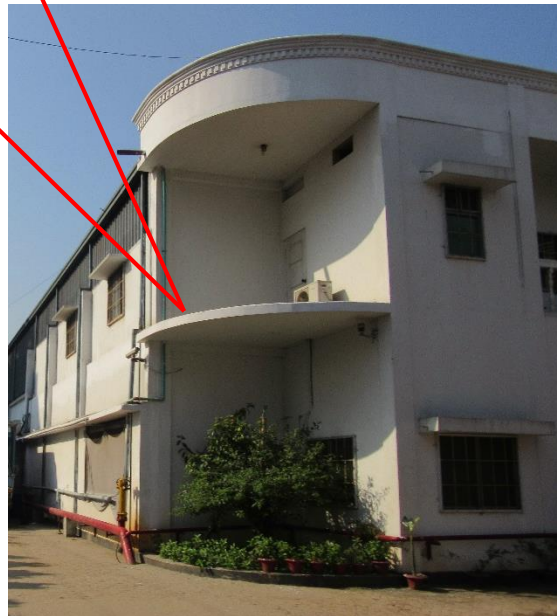
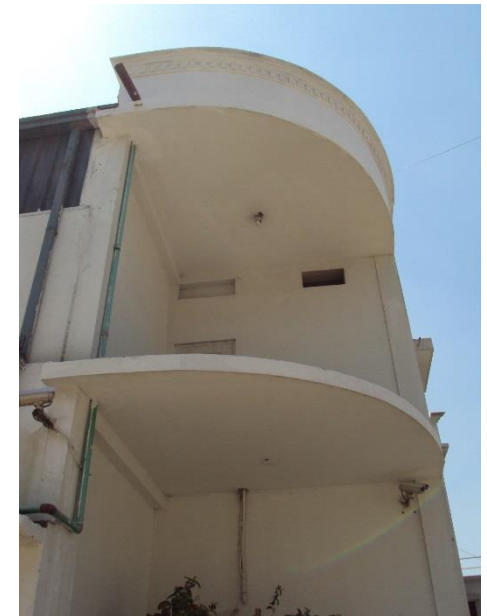
# Falling hazard at balconies of Building 1

Falling hazards at two balconies in Building 1 on first floor.

| Item No. | Observation | Recommended Action Plan | Recommended Timeline |
|---|---|---|---|
| 14 | Falling hazard at balconies of Building 1 | Secure appointed areas of balconies and provide an appropriate fall protection. | 6-months |

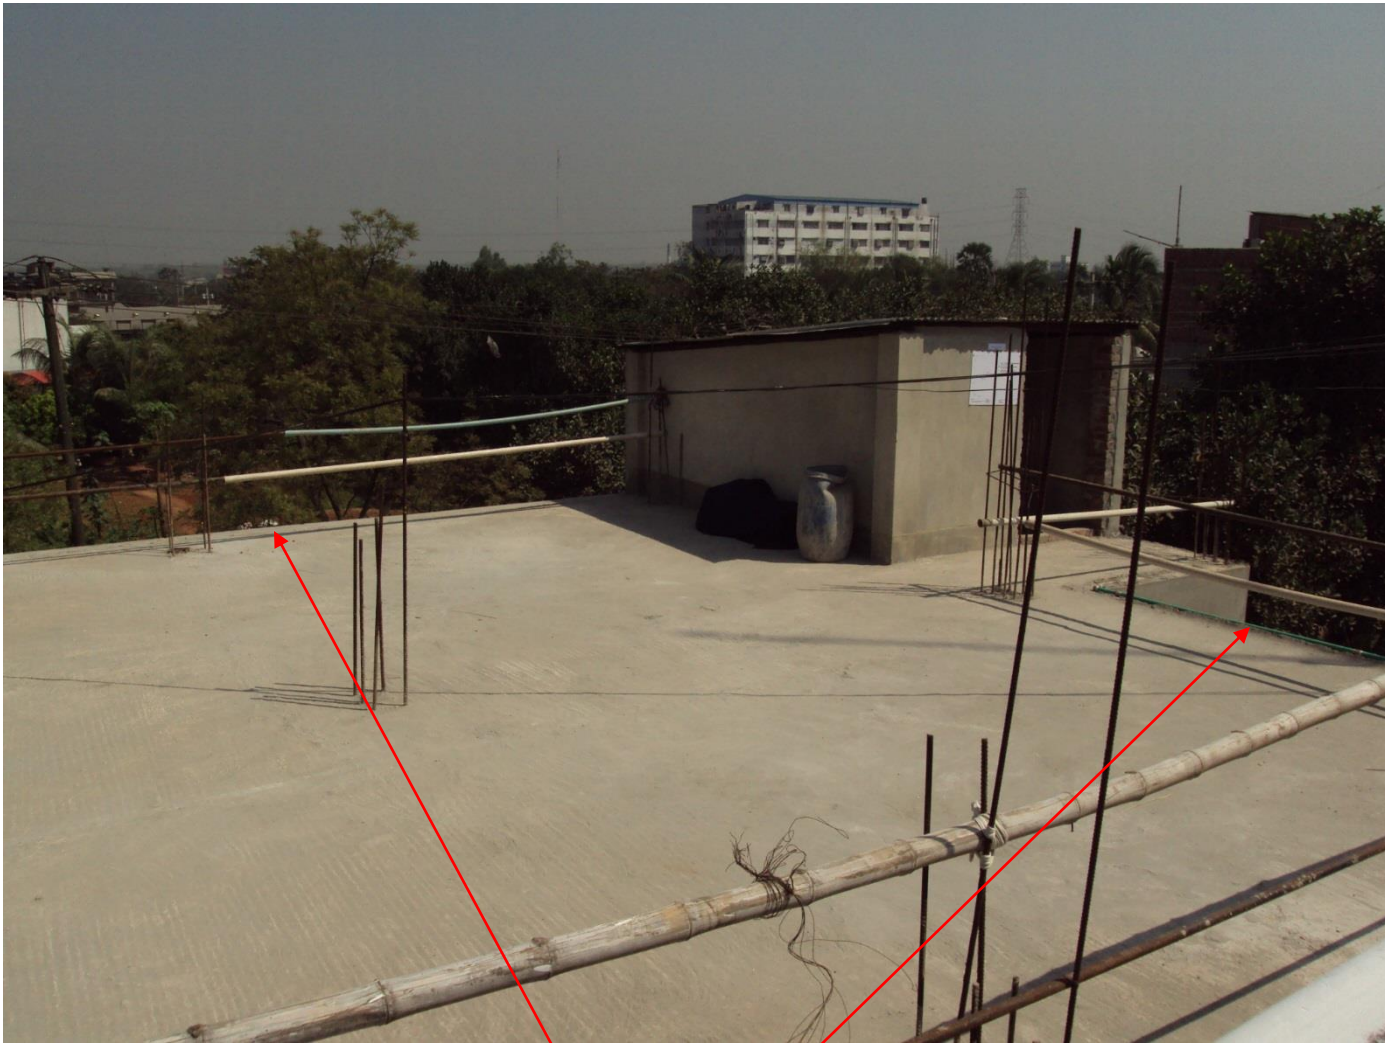
## **Falling hazard at roof of Building 2**

No proper falling protection at the perimeter on 2<sup>nd</sup> floor/roof of Building 2.

| Item No. | Observation | Recommended Action Plan | Recommended Timeline |
|---|---|---|---|
| 15 | Falling hazard at roof of Building 2 | Secure appointed areas of hazards and provide an appropriate fall protection. | 6-months |
| 16 | Falling hazard at roof of Building 2 | Monitor fall protection over time and insure their maintenance (identify possible falling hazards of future construction site and implement appropriate solutions). | 6-months |
