# **FIRE SAFETY INSPECTION REPORT**

**FARKANTEX LTD. (New shed building)**

**ACCORD ID: 23815**

**Date: 26th September, 2019**

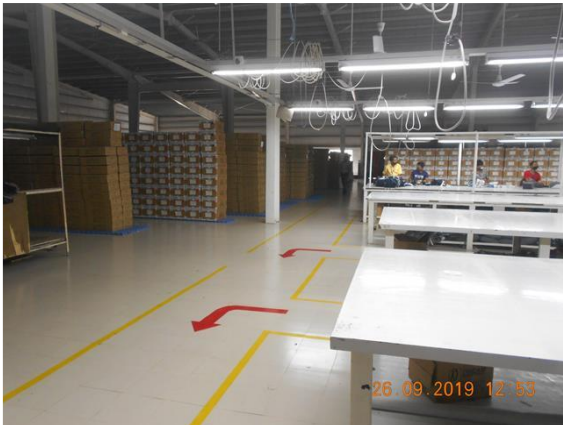
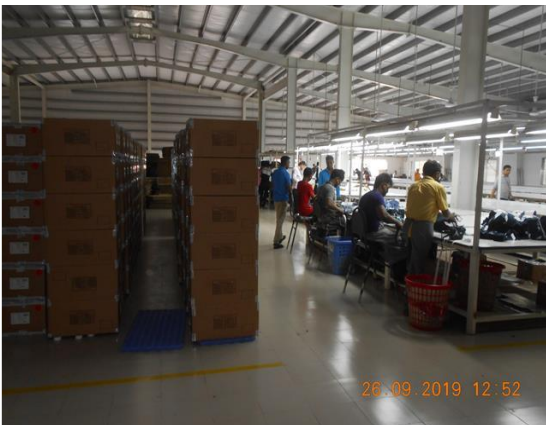
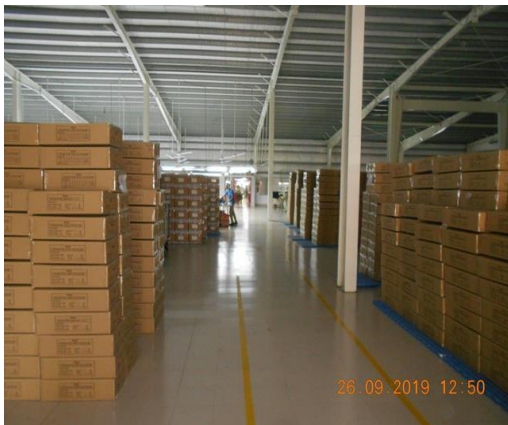
| Sl No. | Category | Findings | Required Action | Remediation Time Frame |
|---|---|---|---|---|
| 1 | Storage Areas | Areas used for combustible storage are not separated by fire-rated construction from production floor (cutting section). | <p>Provide dedicated storage rooms separated by minimum 1-hr fire-rated construction. Or</p> <p>Where separate storage rooms are not feasible, provide defined storage areas and limit the storage arrangement as follows:</p> <ul style="list-style-type: none"> <li>- Maximum height of 2.4m and maximum area of 23m<sup>2</sup> -</li> <li>If sprinkler protected: maximum height of 3.66m and maximum area of 93 m<sup>2</sup>.</li> </ul> <p>Separate areas of unenclosed combustible storage by a minimum clear distance of 3 m.</p> | Within 3 months |

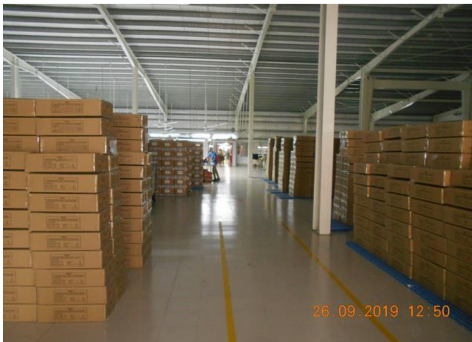
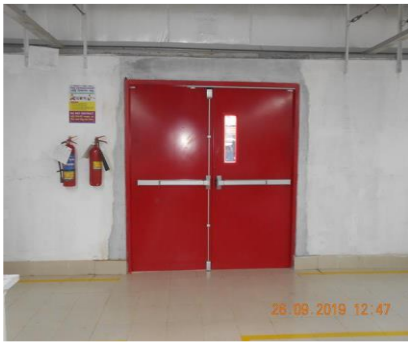
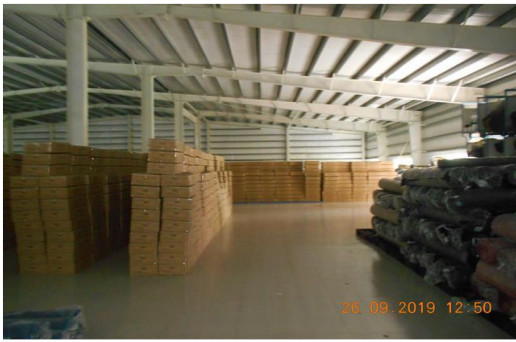
| 2 | Fire Detection and Alarm System | Automatic fire alarm and detection system was not installed in the shed-2(new). | Install automatic listed addressable fire alarm and detection system in the factory in accordance with NFPA 72. | Design within 4 months,<br>Install within 9 months |

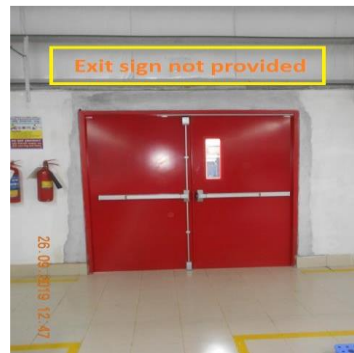
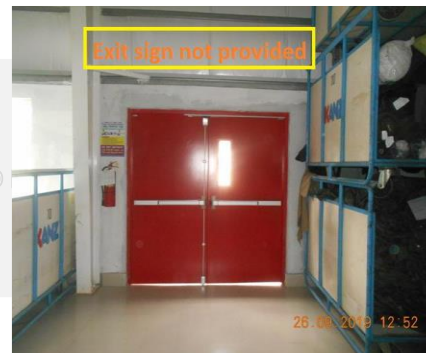
| 5 | Egress | Exit signs are not provided at exit.<br>Location: All exits. | Provide exit signs above all exits to the exterior and all doors to the exit stair. | Within 1 month |

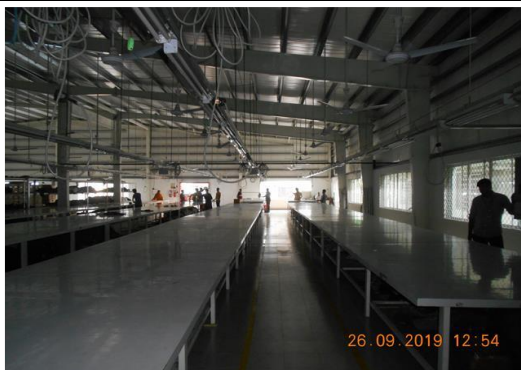
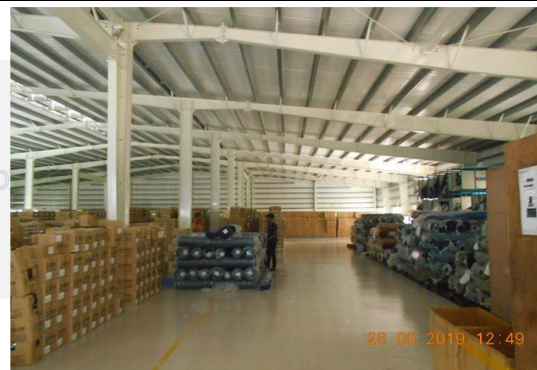
| 6 | Emergency Lighting | Based on the number and location of emergency lights observed, adequate illumination levels are not anticipated along egress routes. | Test the emergency lighting system on each floor and provide additional emergency fixtures to provide adequate illumination along the means of egress. Provide a minimum illumination of 10 lux at the floor level within exit stairs and exit discharge paths and minimum 2.5 lux along exit access aisles. | Within 3 months |
