Laila Styles Ltd.

Bahadurpur, Gazipur.
(24.077527, 90.369504)
27th January 2019 & 04th February 2019

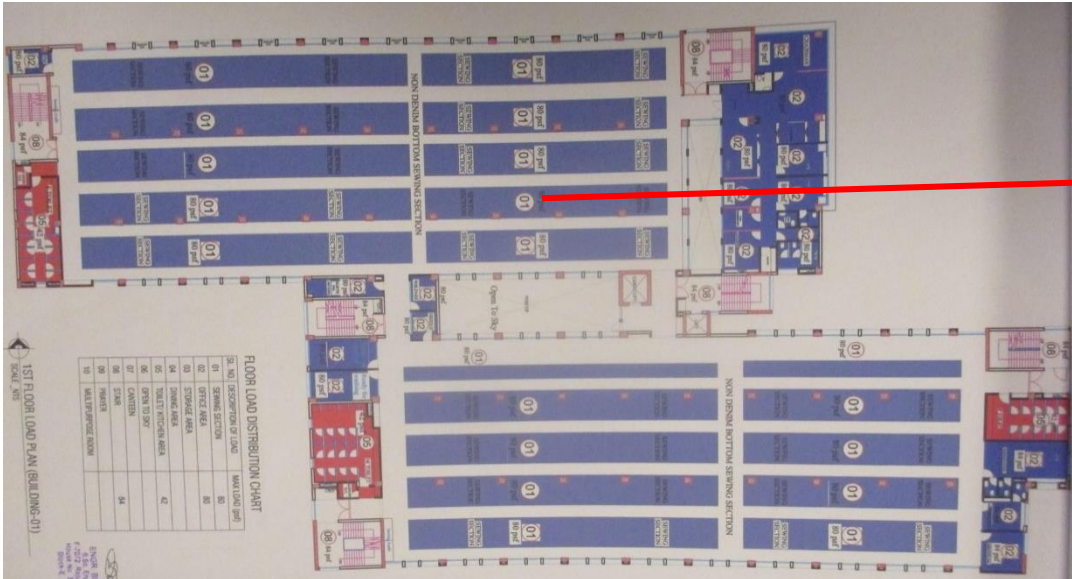
Floor loading plan

Load plan is required to be reviewed

We have checked the column capacity based on minimum concrete strength and found that the column stresses exceed above normal design limit considering the provided load plan. But considering 3 Kpa live load and minimum concrete strength, the column stresses are within normal design limit. The provided load plan was based on 4000 psi concrete strength of column. Insufficient number of cylinder test result from column were provided. Strength of two of the cylinder test result for column were found to be 4102 psi and 4303 psi which were not adequate for evaluation of the design concrete strength of column. Factory engineer is required to review the provided load plan.

Item No.	Observation	Recommended Action Plan	Recommended Timeline
1	Load plan required to be reviewed (Building-1 Production Building)	Maintain 3 Kpa load on all floors.	6-weeks
2	Load plan required to be reviewed (Building-1 Production Building)	Produce and actively manage a loading plan for all floor plates within the factory giving consideration to floor capacity and column capacity if loading above 3kpa is considered.	6-weeks
3	Load plan required to be reviewed (Building-1 Production Building)	Continue to implement load plan.	6-months
4	Discrepancy in as-built drawing (Building-1 Production Building)	Building Engineer to prepare accurate as-built structural drawing.	6-weeks
5	Columns susceptible to vehicle impact (Building-2 Warehouse Building)	Install safety guard to protect the columns from vehicular impact.	6-weeks
6	Implement the provided load plan (Building-2 Warehouse Building)	Maintain the load plan and ensure that the workers understand the loading requirements	6-weeks

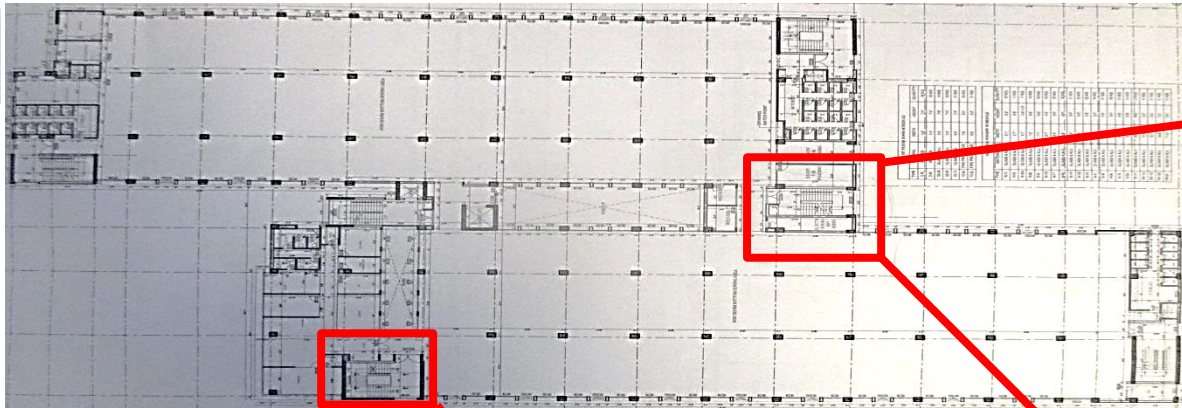
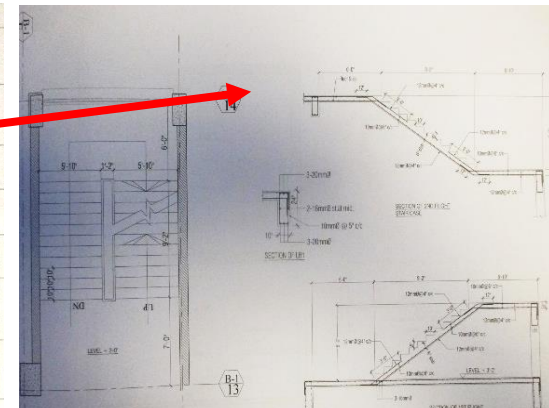
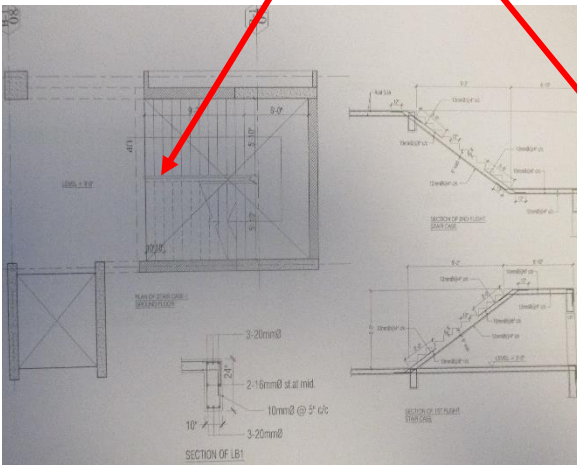
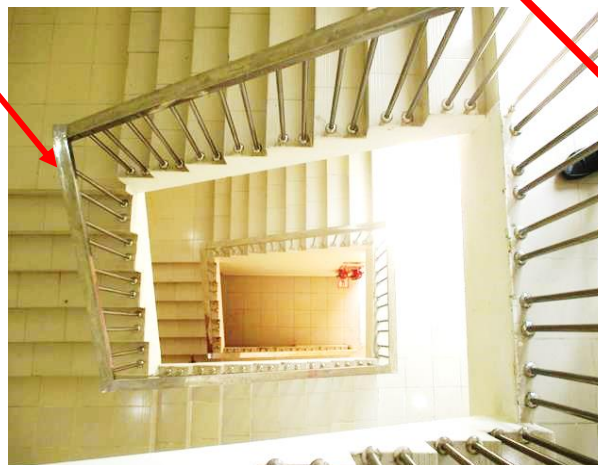
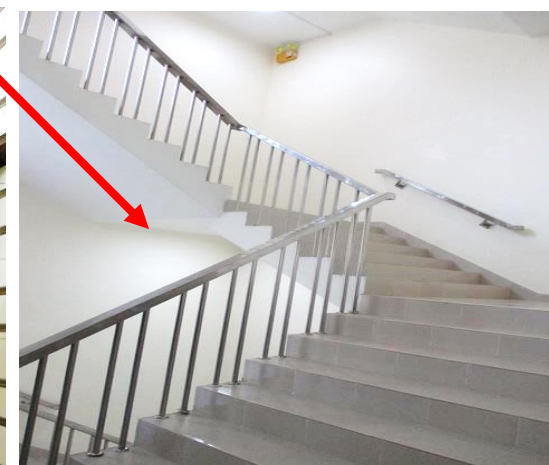
3 flights observed in staircase-1

For Stair case-1 and Stair case-4, as-built drawing do not match with as constructed condition. In as built drawing for staircase 1 shows two flights where as-constructed structure has three flights.

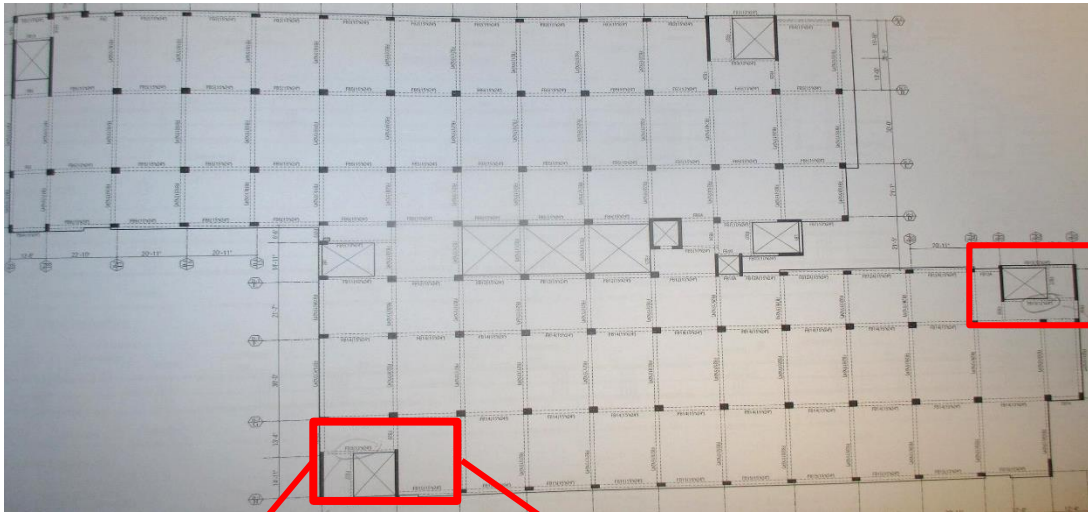
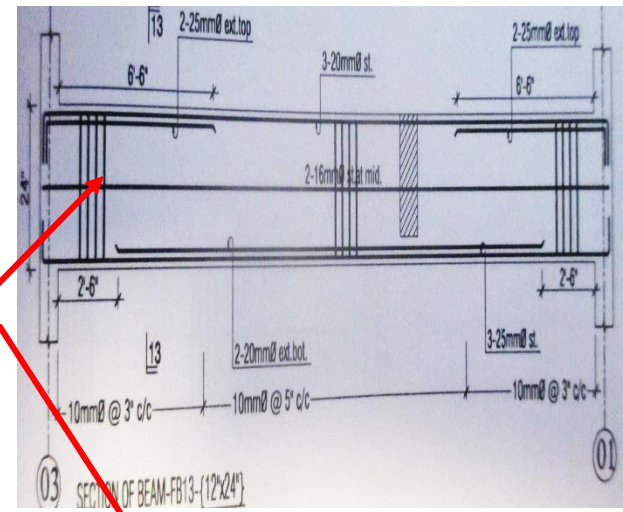
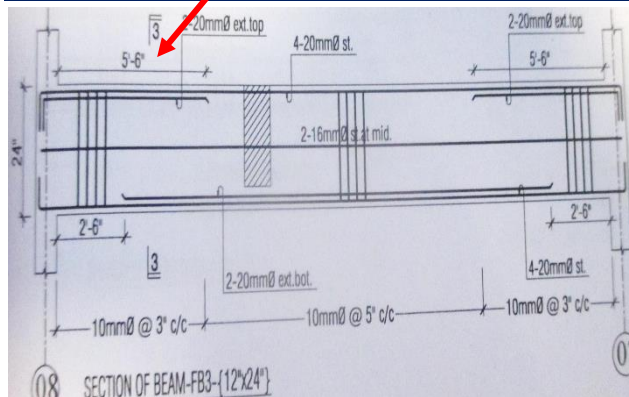
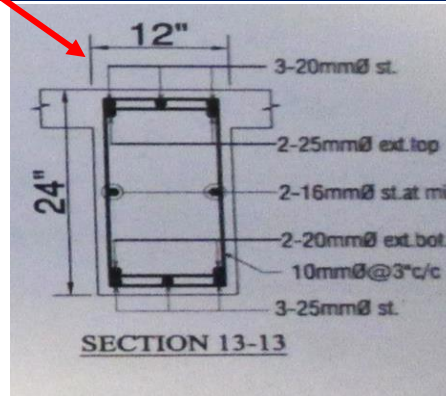
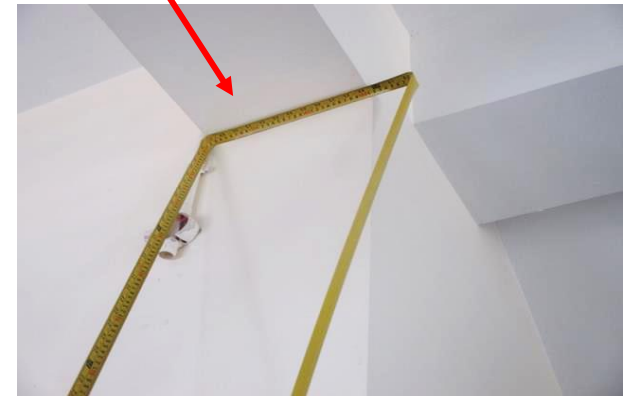
FB-3 & FB-13 measured 10"x24"

Floor beam dimension for FB-3 & FB-13 did not match with as constructed condition. In as built drawing, FB-3 & FB-13 are shown 12"x24" but as constructed size is 10"x24".

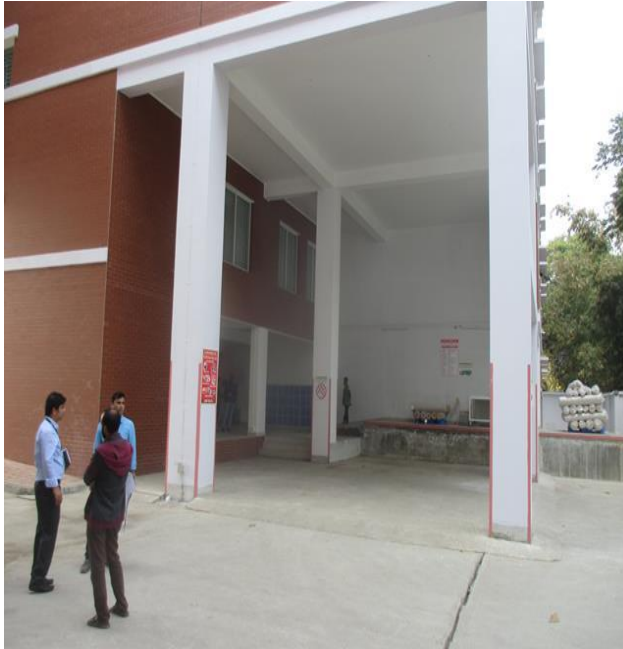
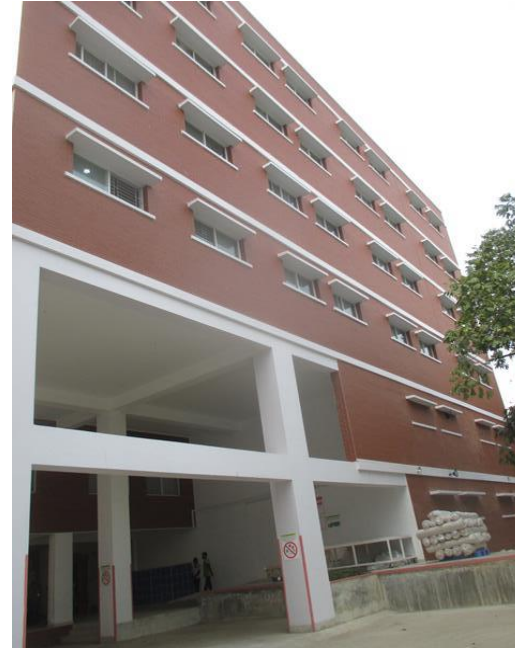
Columns susceptible to vehicle impact

There are no barrier around the columns at ground floor and those columns are susceptible to vehicular impact.

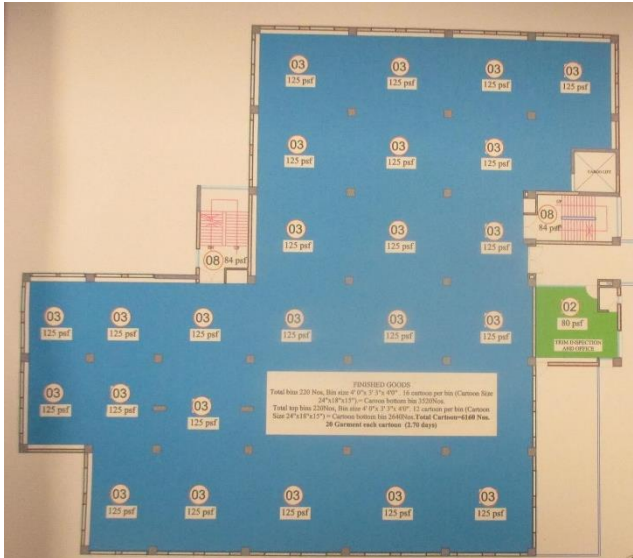
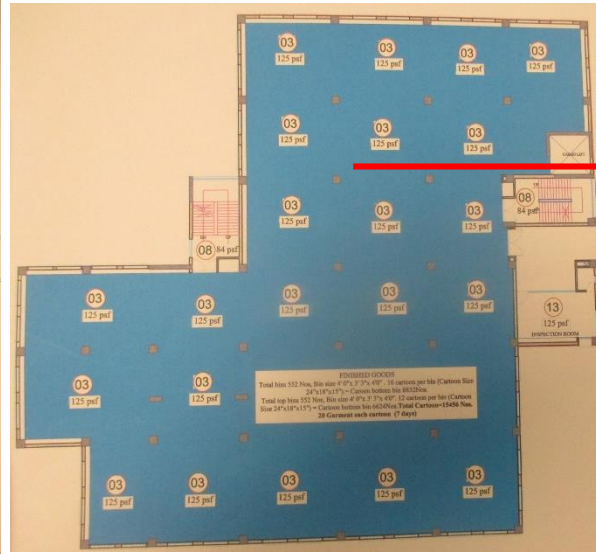
Implement load plan

Maintain the load plan and ensure that the workers understand the loading requirements. The load plans are required to be posted on each floor level.

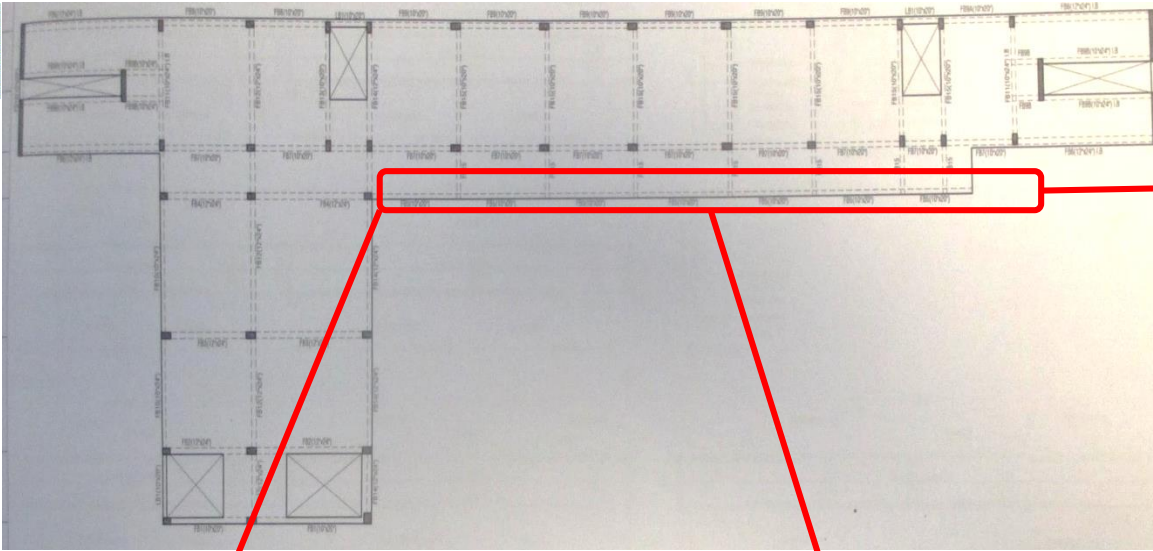
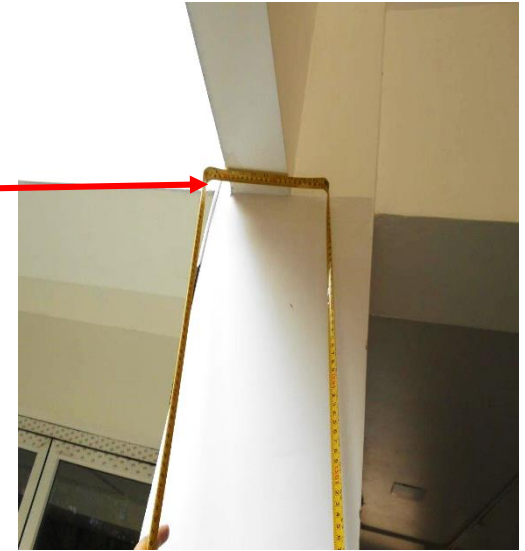
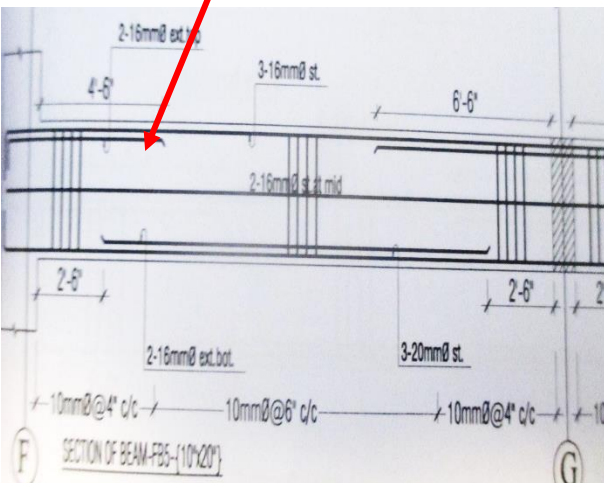
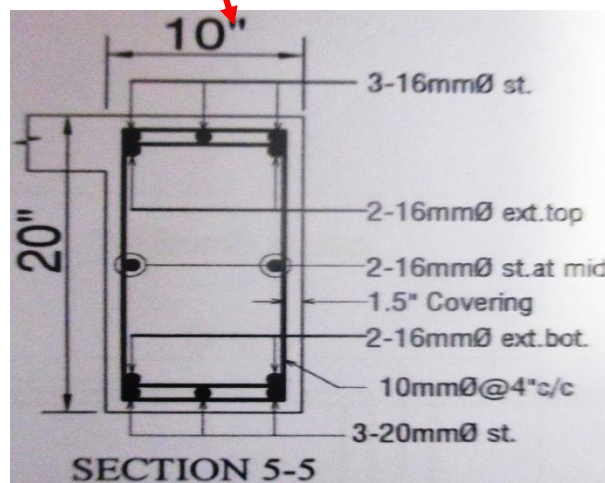
FB-5 measured to 5"x24"

First floor and roof level beam, FB5 measured to 5" x20" whereas it is shown 10" x20" in as built drawing.

7	Discrepancy in as-built drawing (Building-4 HR Building)	Building Engineer to prepare accurate as-built structural drawing.

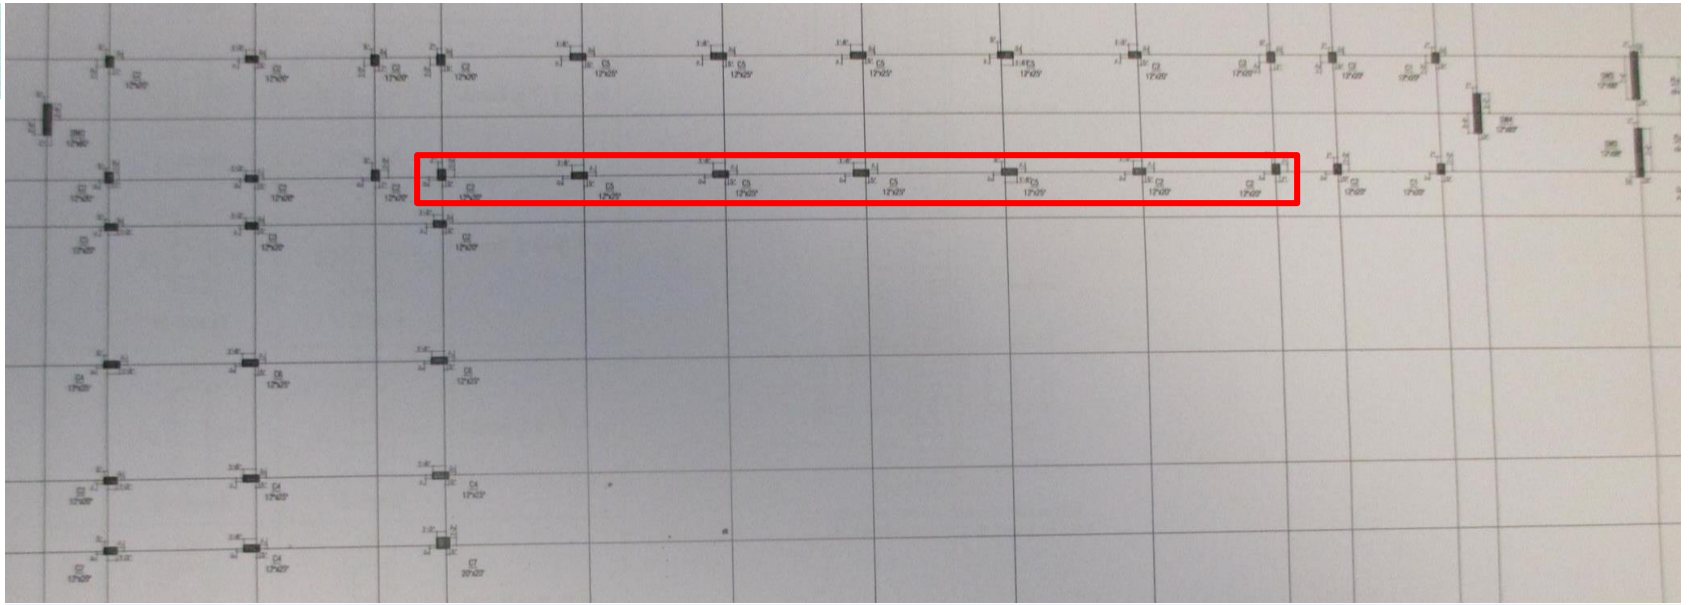
Column layout plan

Grid spacing at highlighted location do not match with on site condition.
