# Moonlux Knit Garments Ltd Safa Knitwear Ltd.

B/11, MS Tower-3, Siddhirgonj Pool, Siddhirgonj, Adamji, Narayanganj  
(23.689641, 90.51467)  
28<sup>th</sup> August 2016

# Observations

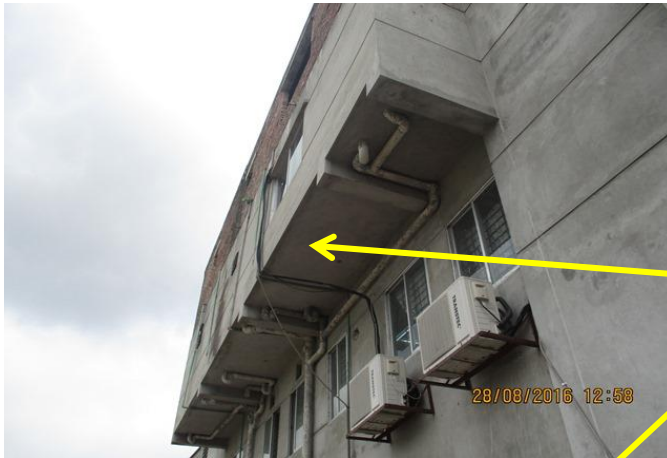
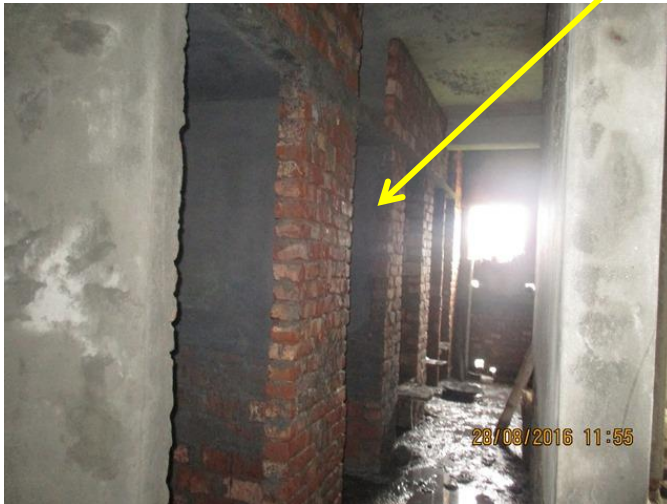
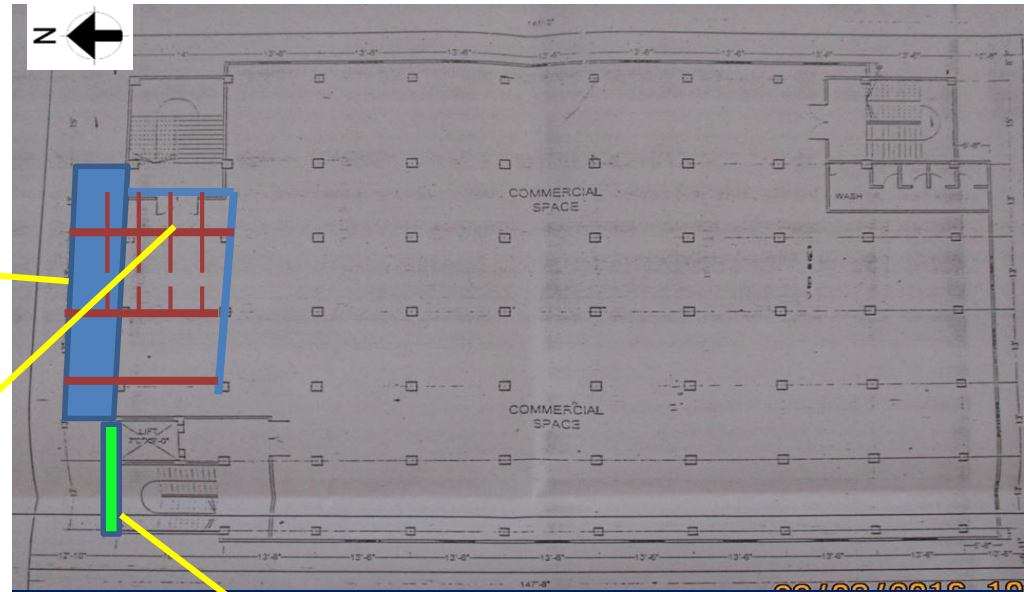
Typical floor layout plan

Beam layout  
plan on stair  
portion does  
not match  
with  
drawings.

| Item No. | Observation | Recommended Action Plan | Recommended Timeline |
|---|---|---|---|
| 2 | Inadequate documents and discrepancies between drawings & site observations | Building Engineer to survey as constructed building and prepare a set of as-built drawings. | 6-weeks |

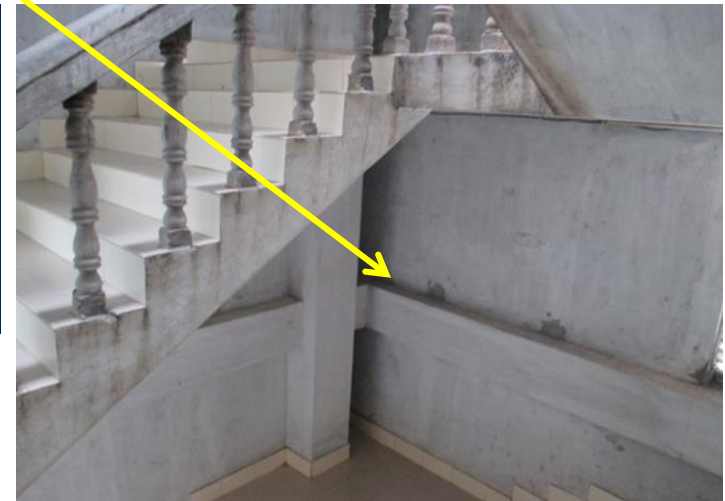
The North side cantilever of the factory building does not shown in both drawings. The toilets and walls position do not match with drawings.

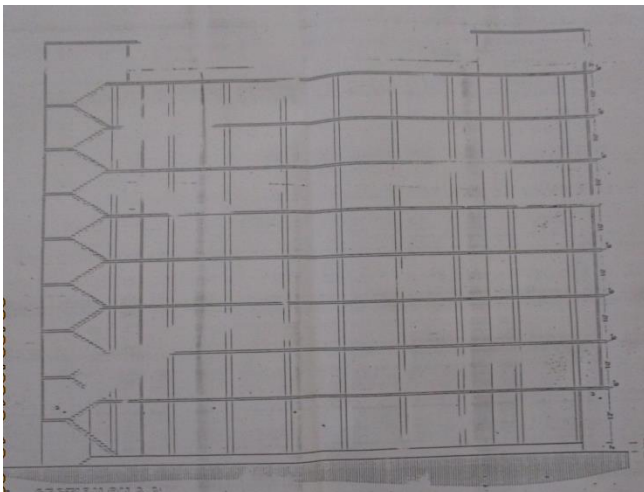
Local authority Permit drawing  
shown 8 storied building

The floor layout plan and section does not match with industrial permit and local authority permit drawings. The architectural drawings of the building wasn't available during inspection. The factory building was constructed only 4 storey.

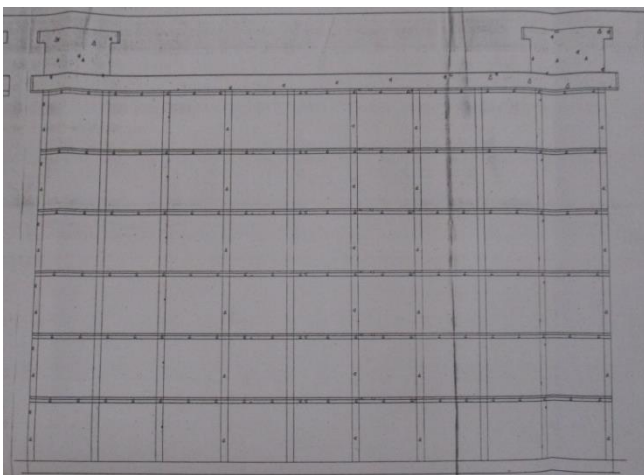
industrial permit drawing shown 6  
storied

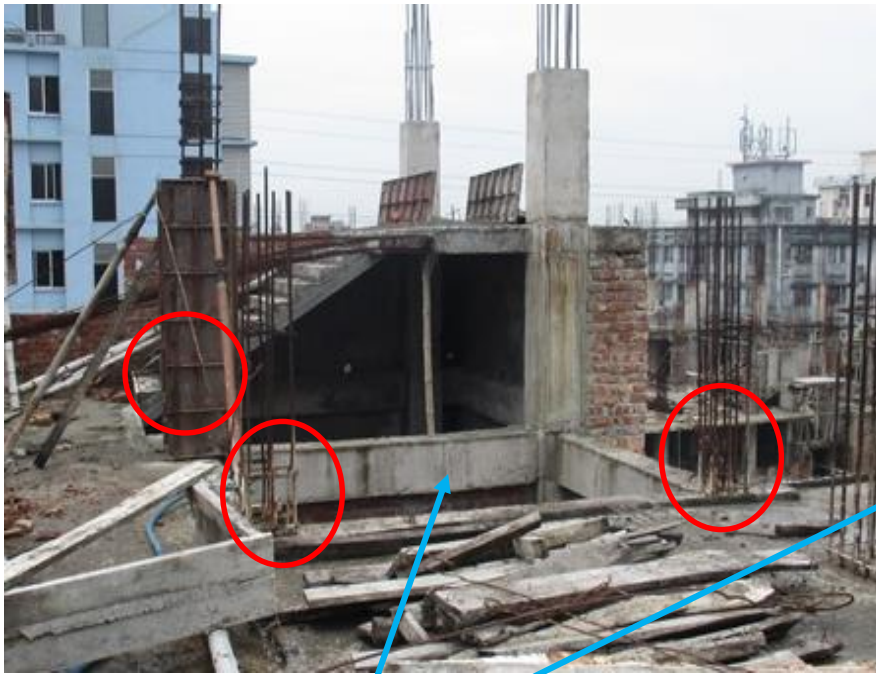
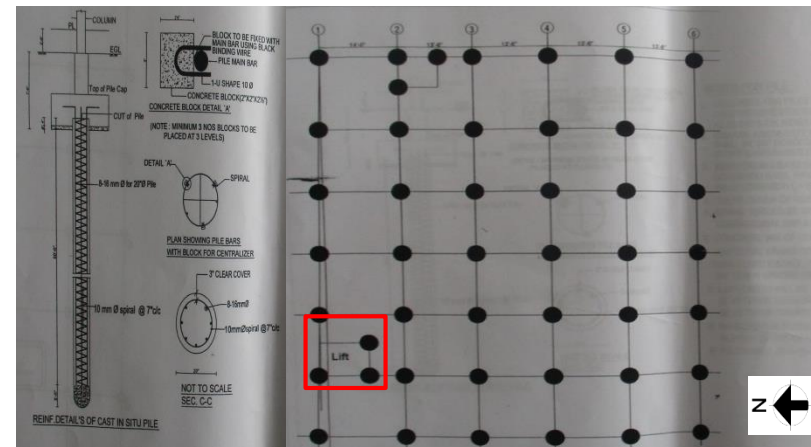
Section and Layout plan of Pile foundation

We were provided a set of structural drawings in which two type of foundation drawing was found which is vague. The lift core column and foundation drawing was not found in those drawings.

| Item No. | Observation | Recommended Action Plan | Recommended Timeline |
|---|---|---|---|
| 1 | Inadequate documents and discrepancies between drawings & site observations | Factory engineer to detail investigate the foundation system of the building and update the drawings accordingly. | 6-weeks |

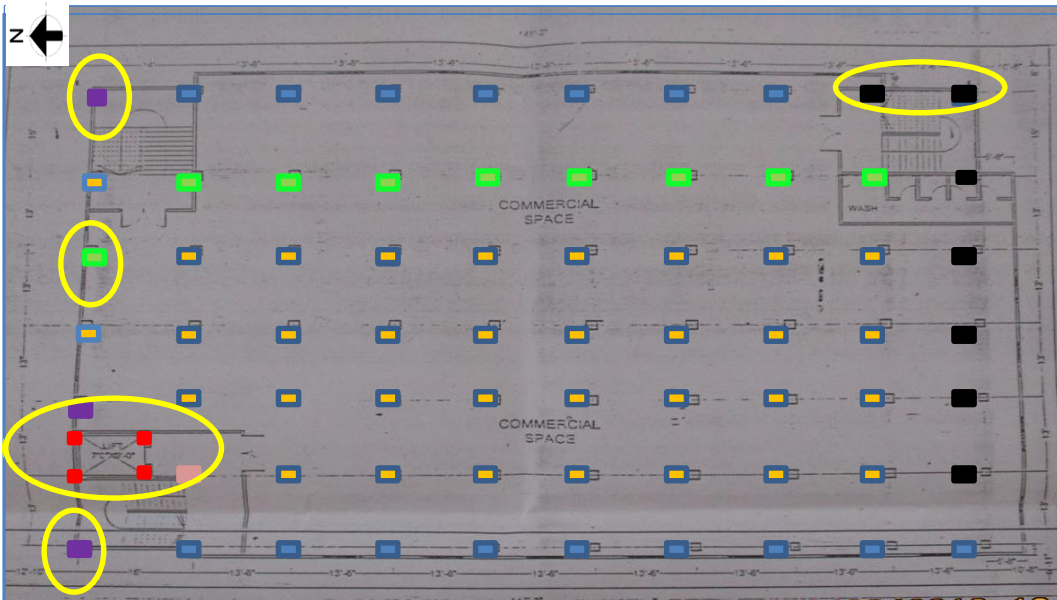
Column layout plan

L-shape columns shown as red mark does not exist in column schedule and layout plan. The no. of column reinforcement marked by yellow circle on column layout plan does not match with mentioned column schedule.

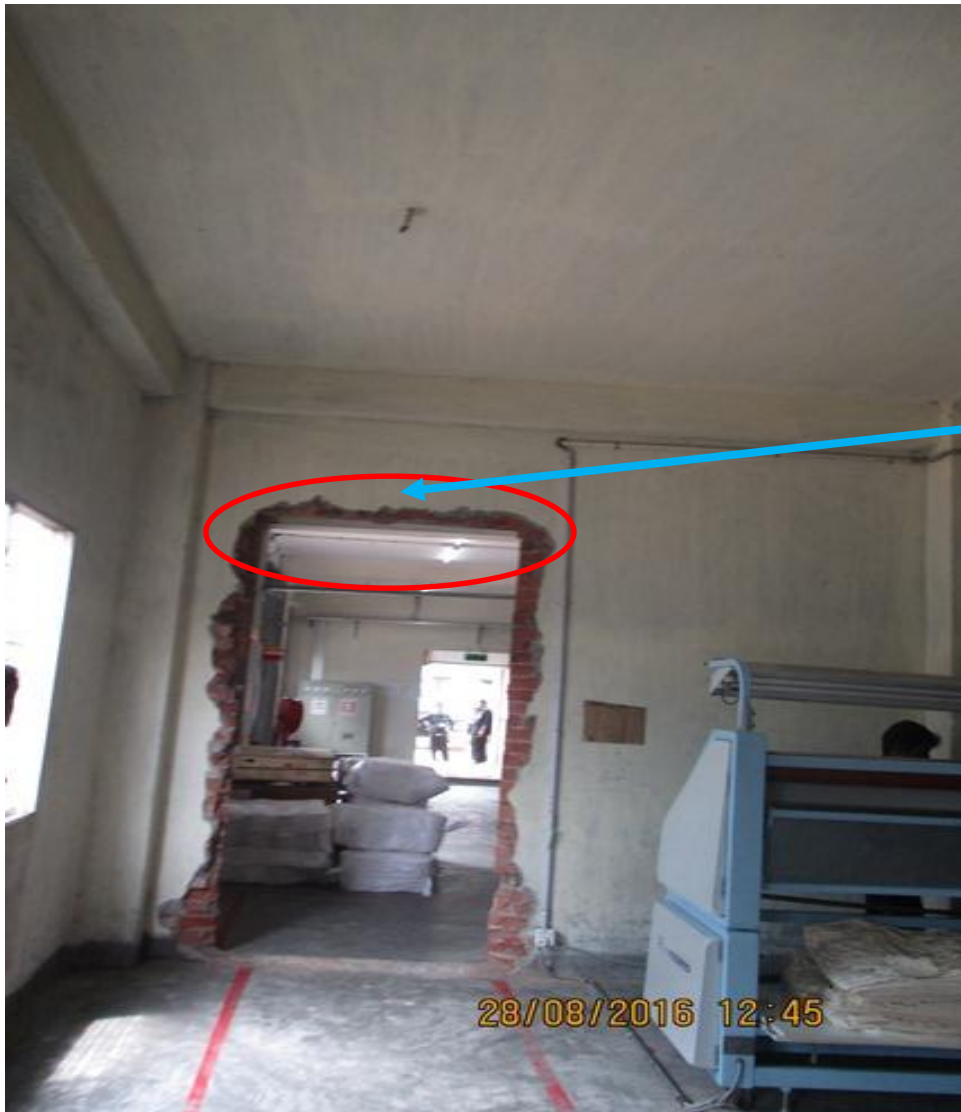
The masonry wall above door opening is not supported at ground floor. There is a probability of falling wall due to unsupported wall. Factory engineer is require to support the wall with proper load transfer system.

| Item No. | Observation | Recommended Action Plan | Recommended Timeline |
|---|---|---|---|
| 8 | Unsupported masonry wall above door opening | Factory engineer to investigate the door opening under unsupported masonry wall and install lintel to support the wall. | 6-weeks |

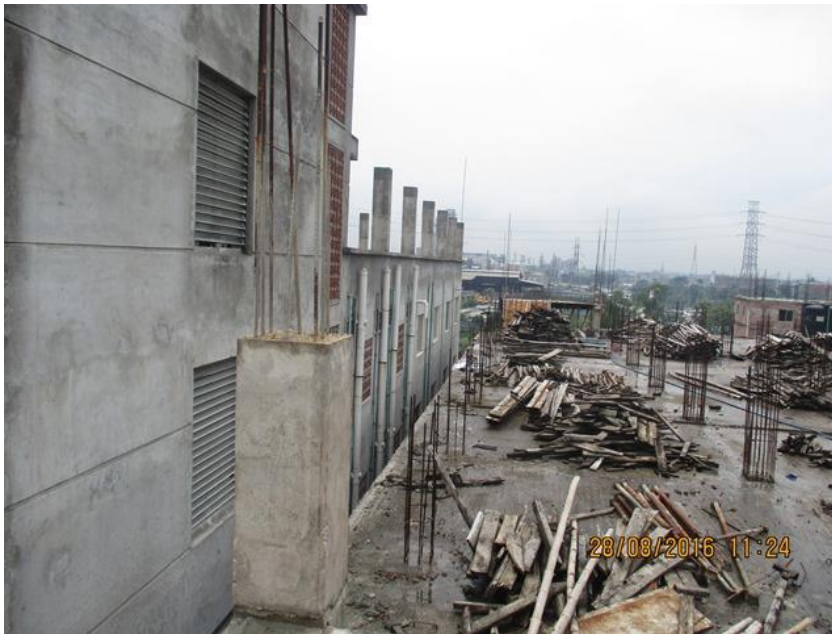
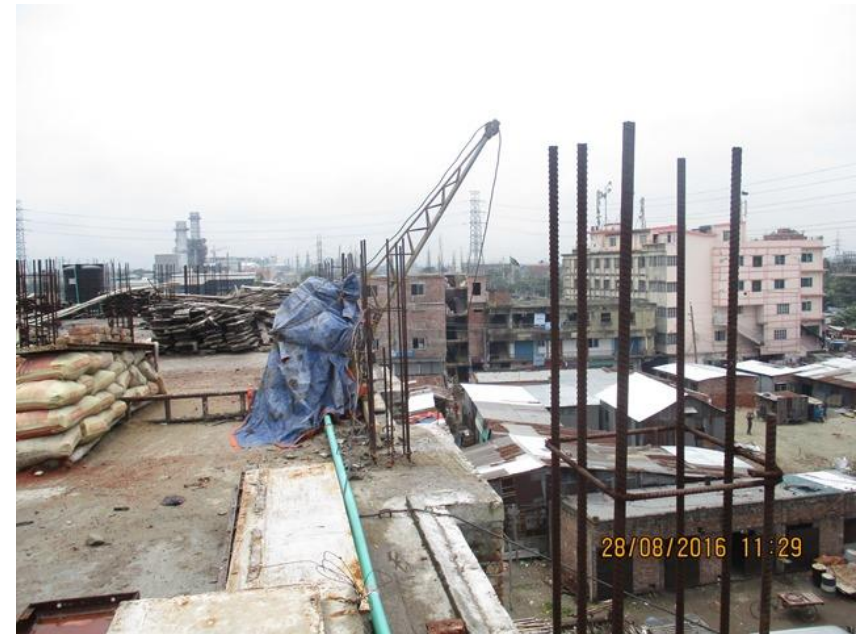
Falling hazards due to unprotected edge of under construction building. All exposed reinforcement must have adequate protection from the elements. Currently the exposed reinforcement is prone to corrosion.

| Item No. | Observation | Recommended Action Plan | Recommended Timeline |
|---|---|---|---|
| 3 | Falling hazards on the roof and protected reinforcement from corrosion | Secure constructed area around the perimeter wall to exclude any possible falling hazard. | Immediate - Now |
| 4 | Falling hazards on the roof and protected reinforcement from corrosion | All exposed reinforcement is to be protected from corrosion which may cause degradation of the concrete. | 6-weeks |

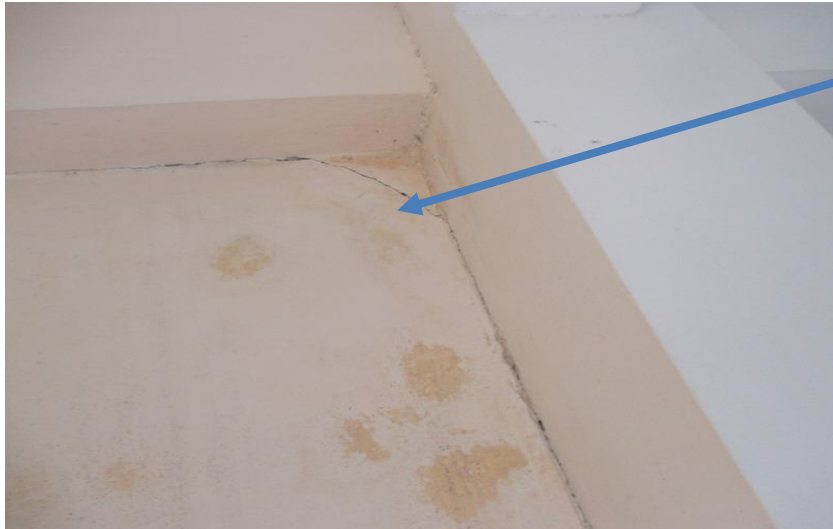
Cracks on wall was observed under cantilever beam at south-west corner of the building on 2nd floor.

| Item No. | Observation | Recommended Action Plan | Recommended Timeline |
|---|---|---|---|
| 5 | Dampness and cracks observed on walls | Sections of plaster finish to columns and beams to be removed to investigate if cracks penetrate the building structure at all cracked areas. | 6-weeks |
| 7 | Dampness and cracks observed on walls | Continue to monitor structural elements for cracking and carry out remedial work if required as directed by the Building Engineer. | 6-months |

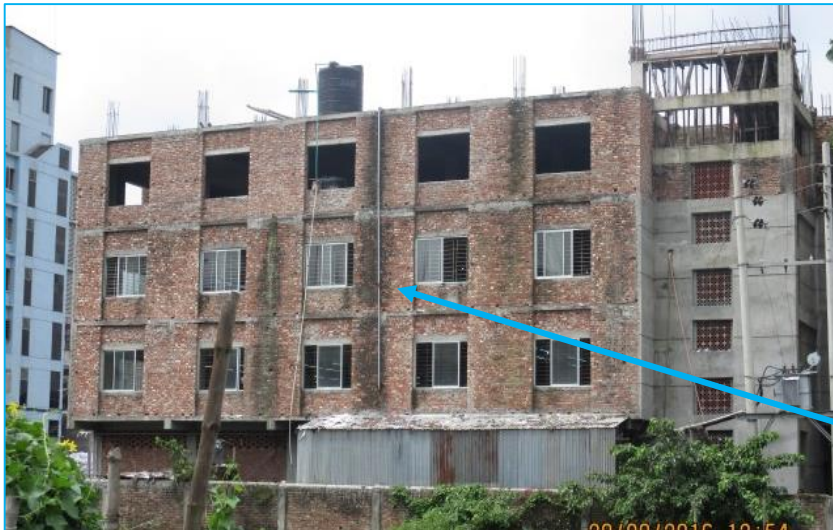
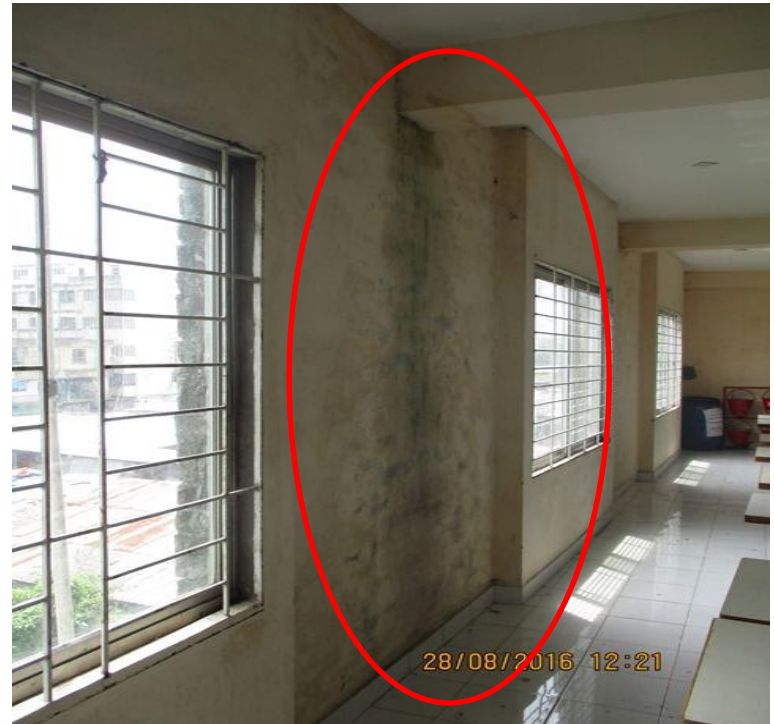
South façade walls are not plastered yet. Due leakage of water through pipe dampness causes in different floor of the building.

| Item No. | Observation | Recommended Action Plan | Recommended Timeline |
|---|---|---|---|
| 6 | Dampness and cracks observed on walls | Factory engineer to identify the cause of dampness & suggest appropriate remedial action. | 6-weeks |

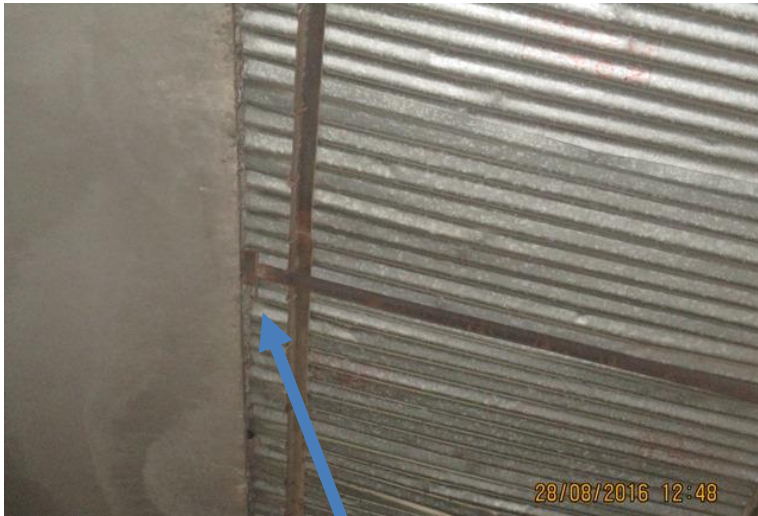
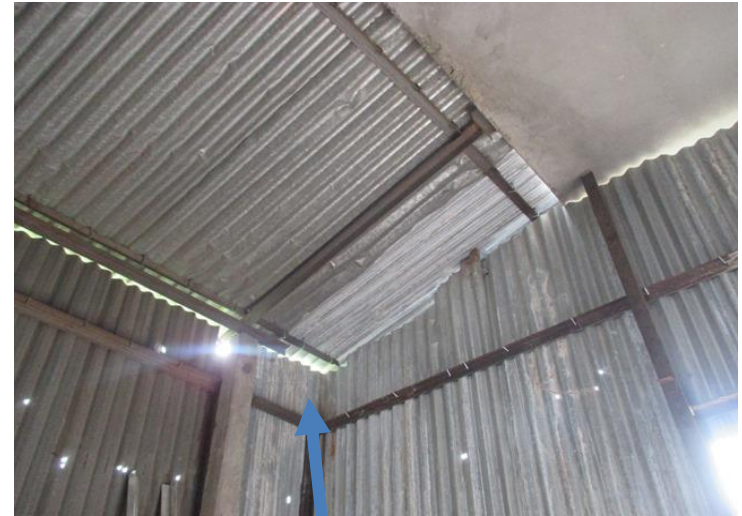
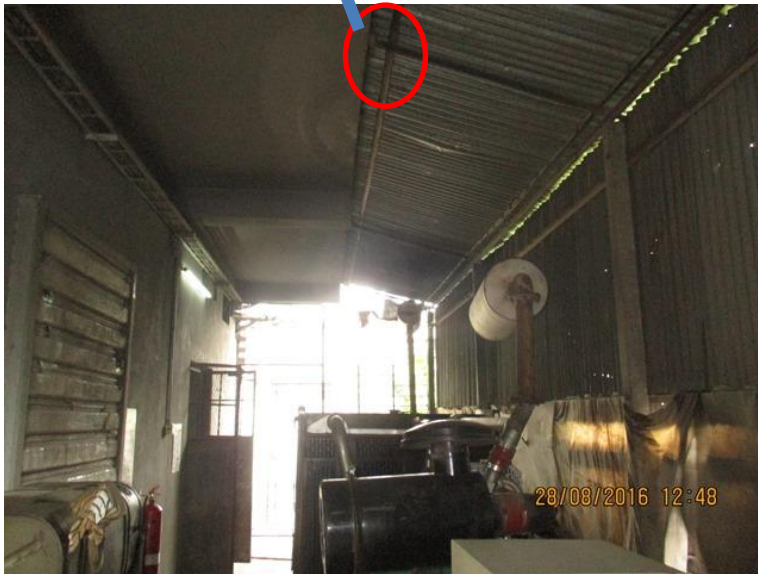
Non-engineered roof connected with cantilever

| Item No. | Observation | Recommended Action Plan | Recommended Timeline |
|---|---|---|---|
| 9 | Apparently non-engineered roof at Generator shed | Engage a qualified structural engineer to confirm satisfactory structural performance of the buildings under wind loading. | 6-weeks |

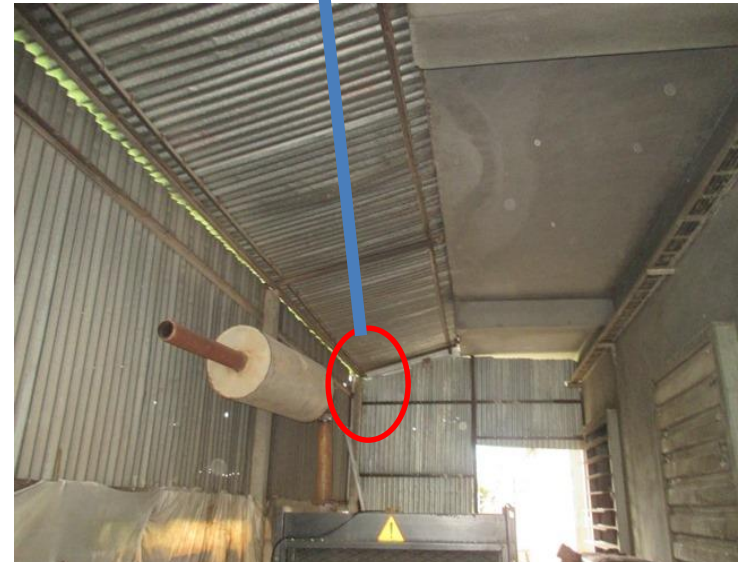
CI sheets are poorly connected with thin column and no lateral stability.
