# Work Field Fashion Wears

Bawpara, Kaultia, Gazipur Sadar , Gazipur

18 March 2015

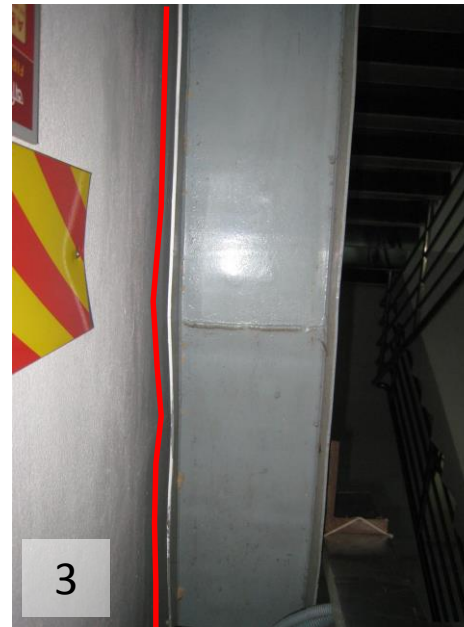
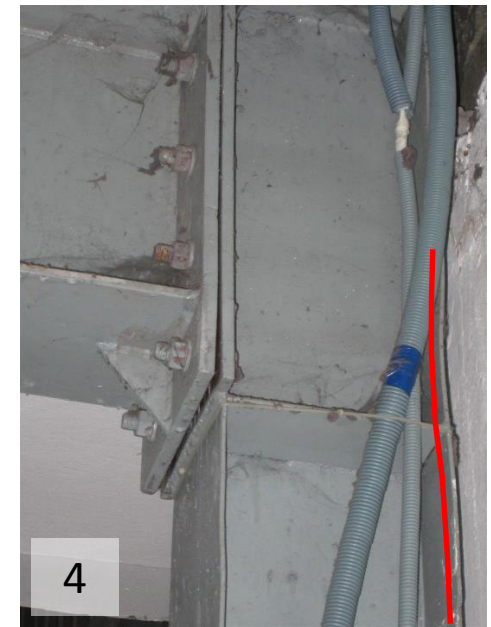
A number of elements are constructed with slender sections and may be susceptible to local section buckling. In addition flange straightness appears to be out of specification.

- 1 Standard AISC section classification limits
- 2 Section sizes
- 3 Column with wavy flange
- 4 Column with wavy flange

| Item No. | Observation | Recommended Action Plan | Recommended Timeline |
|---|---|---|---|
| 1 | Slender classification sections appear to have been used for some beam and columns | Building engineer to confirm that building calculations include necessary reductions for use of any slender sections. | 6-weeks |
| 2 | Slender classification sections appear to have been used for some beam and columns | Building engineer to review whether straightness of column flanges meets building specification | 6-weeks |
| 3 | Slender classification sections appear to have been used for some beam and columns | Implement any remedial measures recommended by building engineer. | 6-months |

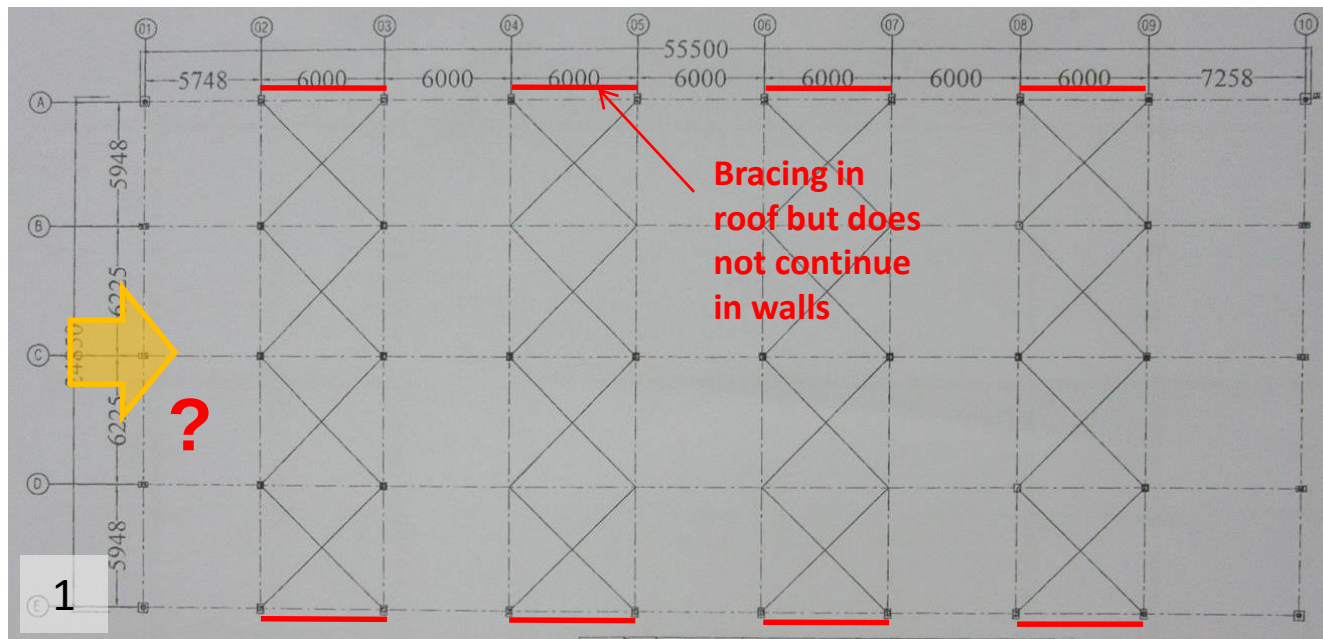
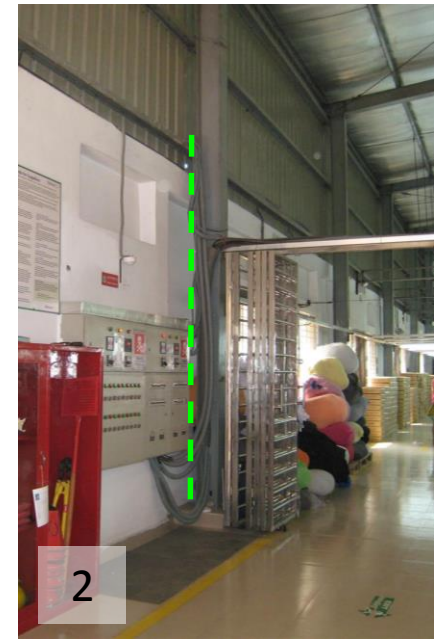
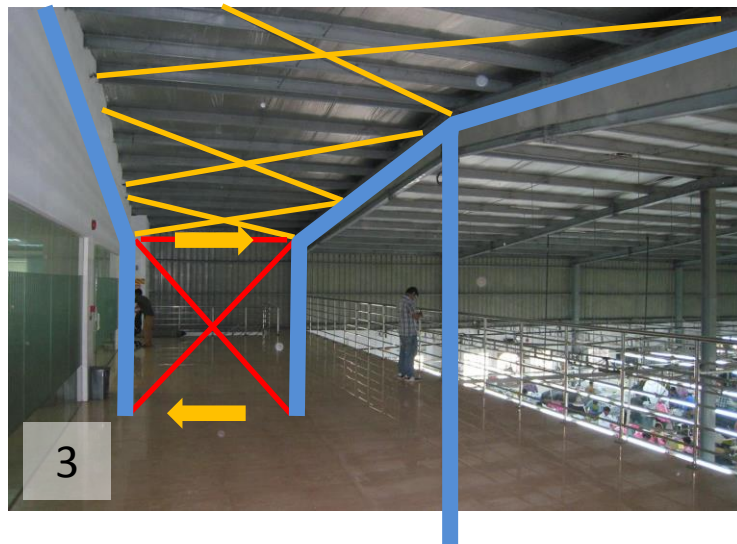
**Stability system is not completely apparent in the east-west direction**

- 1&2 Cross bracing in roof plane but how do these forces get to ground?
- 3 Void between steel column and masonry wall, i.e. masonry wall not participating in stability.

| Item No. | Observation | Recommended Action Plan | Recommended Timeline |
|---|---|---|---|
| 4 | Stability system not fully apparent in east-west direction | Building engineer to review stability analysis and determine any additional stability structure required to meet building code, e.g. cross bracing in east-west walls. | 6-weeks |
| 5 | Stability system not fully apparent in east-west direction | Implement any remedial measures recommended by building engineer. | 6-months |
