Soorty Textiles (BD) Ltd

Plot # 220-227, Comilla EPZ, Old Airport Area, Comilla 3500

17 March 2015

Observations

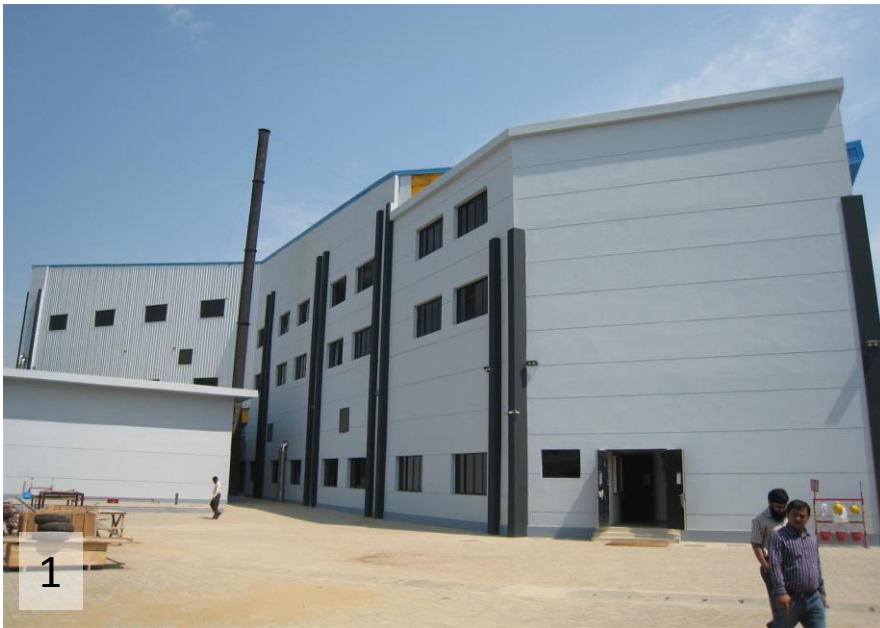
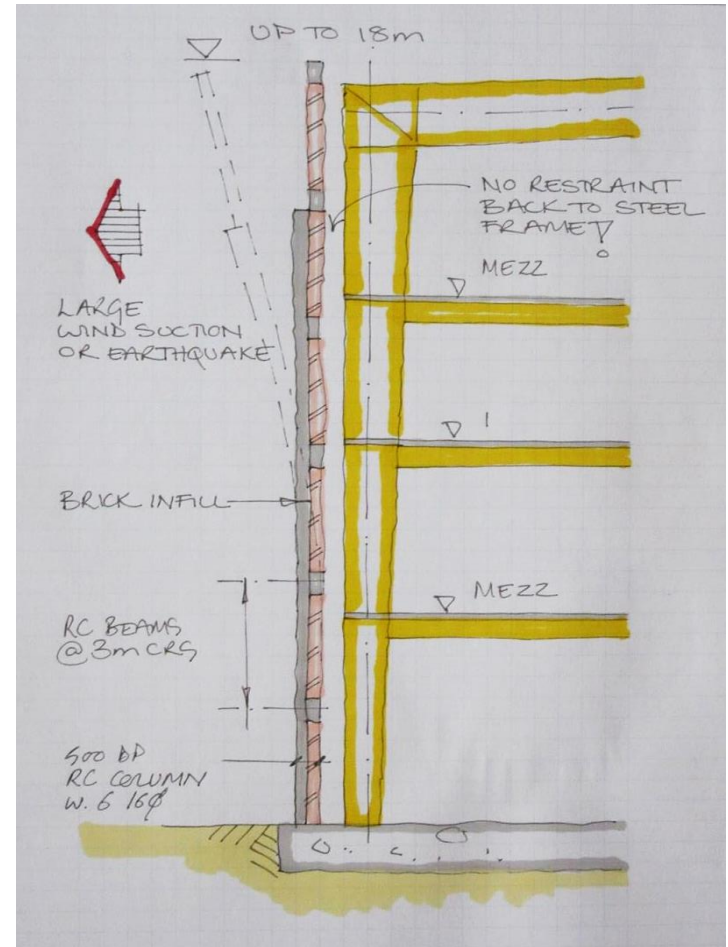
**Façade wall appears to require
additional restraint**

The façade wall appears to be unrestrained, i.e. it is an 18 m high free standing wall. Without restraint the wall may collapse in strong wind or in an earthquake.
 1. Concrete/masonry wall 2. Gap with polystyrene void former between steel and concrete column 3&4. Cracks between steel and concrete column after plastering

Item 1 - Façade wall appears to require additional restraint

Item No.	Observation	Recommended Action Plan	Recommended Timeline
1	Façade wall appears to require additional restraint	Structural Engineer to check lateral stability of façade wall for wind suction and earthquake loads.	6-weeks
2	Façade wall appears to require additional restraint	Implement any remedial measures recommended by the Structural Engineer and ensure that these are co-ordinated with the steel frame designer.	6-months
3	Check stability of portal frame compression flanges	Steel Frame Designer to review the lateral stability of portal frames paying particular attention to: 1 – effective length of columns 2 – connection loadpath between brace and portal frame	6-weeks
4	Check stability of portal frame compression flanges	Implement any remedial measures recommended by the Steel Frame Designer.	6-months

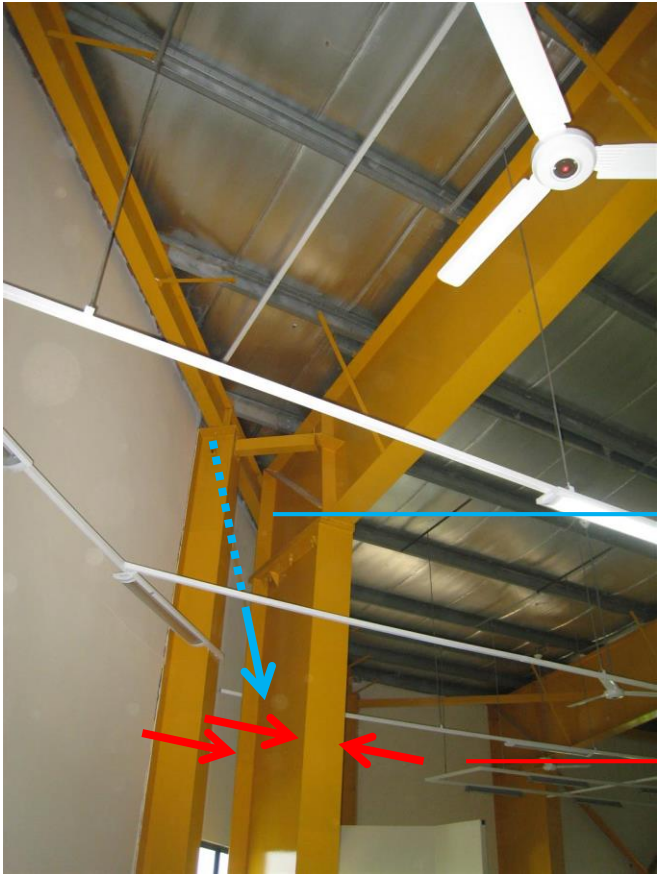
No apparent connection between edge beam and portal frame?

Loadpath from brace to lateral restraint of portal frame appears complex.

Lateral restraint required? Effective length > than 9m

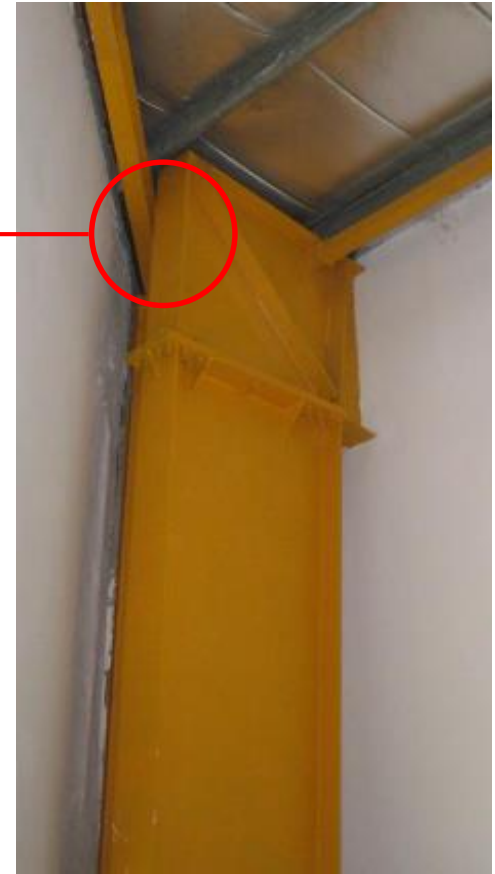
Check stability of portal frames

No apparent eaves strut or lateral torsional restraint to compression flange of columns. The connection between the braced wall bays and the portal frame appears indirect. Check lateral stability of portal frames.

Item 2 - Check stability of portal frames
