# INITIAL ELECTRICAL ASSESSMENT REPORT (EAR)

Factory Name: **MHC Apparels (Pvt.) Ltd.**  
Address: **Holding-297/1, Block-B Ward# 4, Vangnahati, Sreepur  
Gazipur Dhaka Bangladesh**  
Assessor: **Uttaron Technologies**  
Date: **19 Aug 2018**

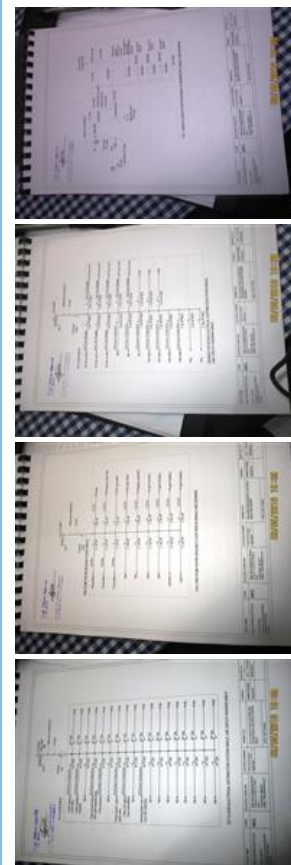
| Description: | As-built single line diagrams (SLD) for electrical safety features throughout the buildings are available on site. The SLD has been checked with the practical installations and some inconsistencies were noted: 1) Rating of the VCB is not mentioned. 2) Three phase HT cable is identified as single phase cable. 3) Intermediary wiring between generator and BBT system is not shown. 4) Copper bus bar has not been shown or identified. Note: As-built SLD indicating electrical safety features of the buildings have not been sent for review yet. |

| Suggested Plan of Action: | Have a qualified electrical engineer update and correct the as-built single line diagram by detailing key components and capacity of the electrical system. The updated drawing should be sent for Alliance review. |

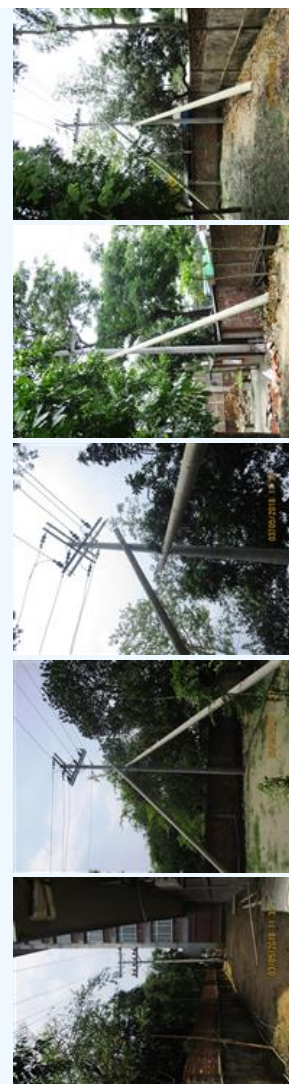
| Description: | Overhead service connections inside the factory premises do not have covered or insulated conductors. HT supports are not secured using gate with locking mechanism or anti-climbing devices. Danger or warning signs are also missing on all HT poles. |
| Source of Findings: | Photograph: Covered conductors have not been seen for service connections. |

| Suggested Plan of Action: | Ensure overhead service conductors are covered by replacing the existing conductors or by covering the existing conductors with an approved material. Consult a qualified electrical engineer before completing work. |

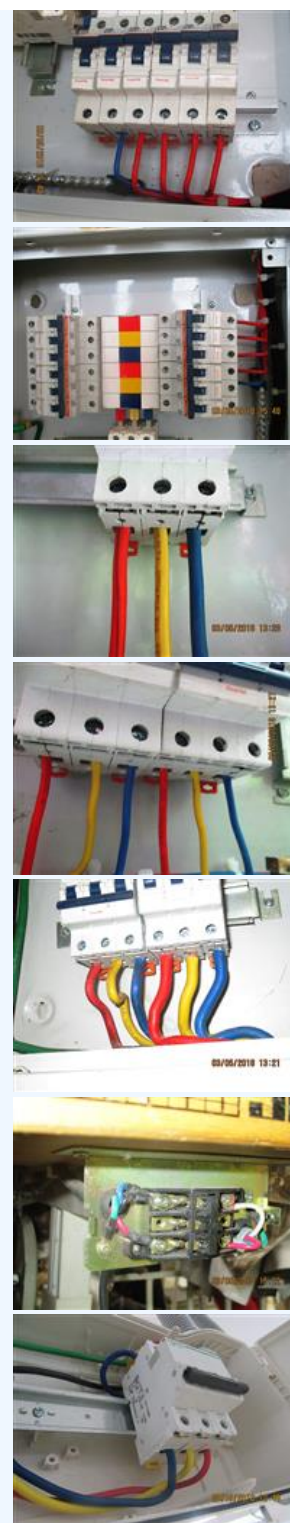
| Description: | Flexible, fine-stranded cables with a nominal cross-sectional area of 6 mm <sup>2</sup> or greater are connected to terminals by soldered or welded lugs. However, conductors with a nominal cross-sectional area below 6 mm <sup>2</sup> are not crimped using suitable sleeve or ferrules. Location: Garments Building |
| Source of Findings: | Photograph: Sleeves and ferrules have not been found for wire termination inside some assessed panel boards. |

| Suggested Plan of Action: | Use cable sockets for all stranded conductors having a nominal cross-sectional area of 6 mm <sup>2</sup> . For conductors below 6 mm <sup>2</sup> , solder all strands at the exposed ends or crimp them using suitable sleeve or ferrules. |

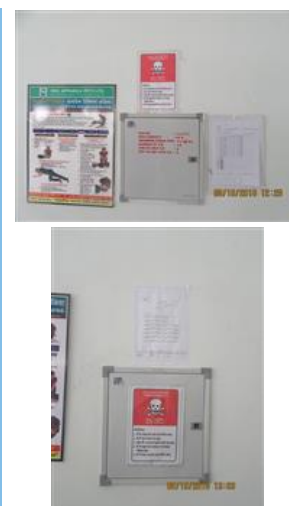
| Description: | Emergency power switchboards and/or distribution boards and emergency circuit components such as emergency lighting have not been properly identified. Location: Garments Building |
| Source of Findings: | Photograph: Proper identification markings have not been seen for emergency power switchboards and/or distribution boards and emergency circuit components. |

| Suggested Plan of Action: | All boxes and enclosures (including transfer switches, generators, and power panels) for emergency circuits shall be permanently marked so they will be readily identified as a component of an emergency circuit or system. The required marking can be by color code, the words "emergency system," or any other method that identifies the box or enclosure as a component of the emergency system. |

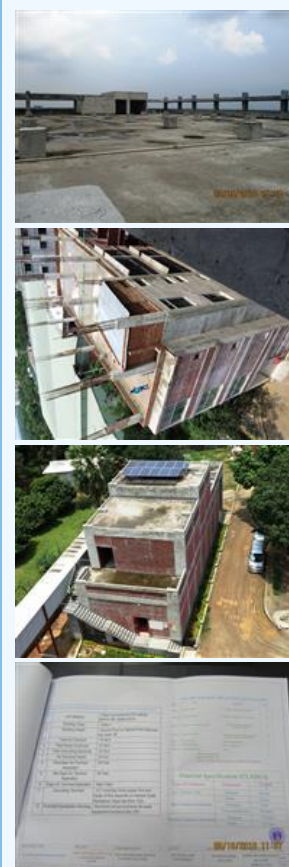
| Description: | A lightning protection system has been designed for all the required buildings. However, the proposed system has not been installed yet. |
| Source of Findings: | Document Review: Proposed drawings for the lightning protection system has been found and reviewed., Photograph: The lightning protection system has not been found to be installed yet. |

| Suggested Plan of Action: | Have a licensed electrician install the lightning protection system according to the BNBC requirements. |
