# Ornob Fashion Wear Ltd

Kathora, Joydebpur, Gazipur, Bangladesh

25th March 2015

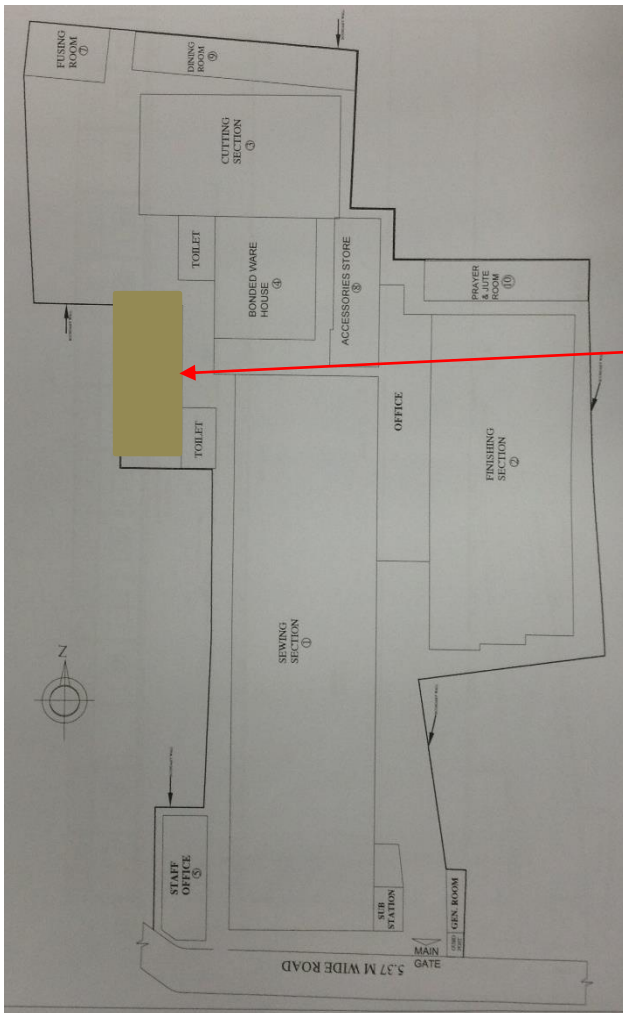
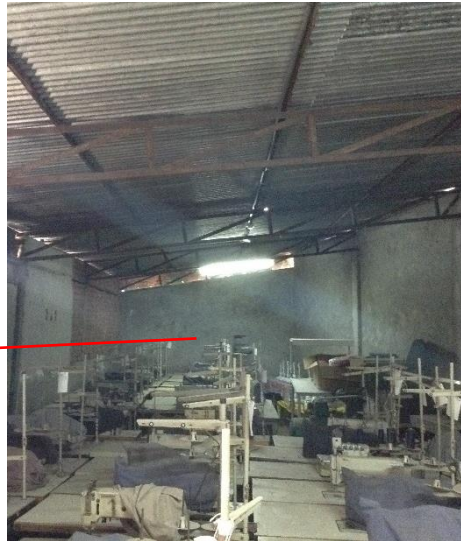
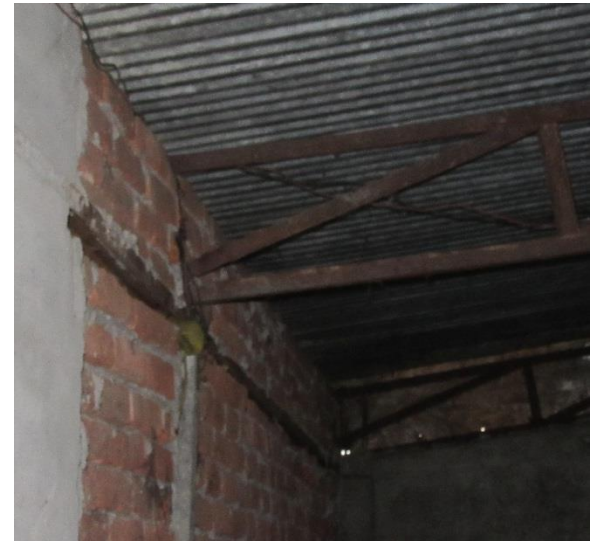
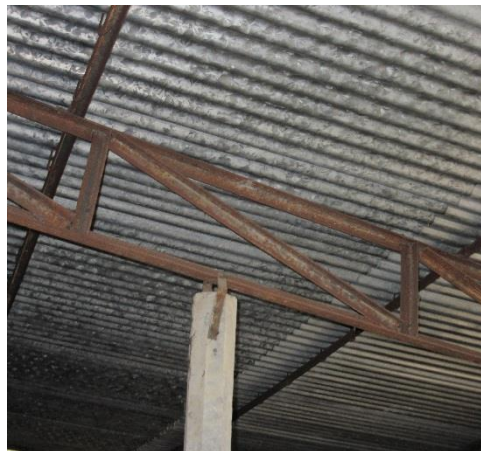
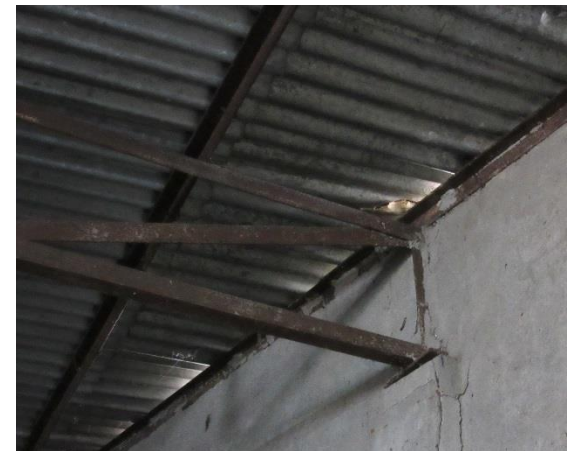
# **Cracking in column, wall and roof connection - (Shed 6)**

# Corroded steel roof structure - (Shed 6 )

Roof steel beams structure appears to be corroded.

| Item No. | Observation | Recommended Action Plan | Recommended Timeline |
|---|---|---|---|
| 1 | Cracking in column, wall and roof connection - (Shed 6) | Building Engineer to investigate the possible reasons of the crack, top of column and the roof connections. | 6-weeks |
| 2 | Cracking in column, wall and roof connection - (Shed 6) | Carry out any remedial structural works arising from the investigation. | 6-months |
| 3 | Corroded steel roof structure - (Shed 6) | Building Engineer to investigate the degree of corrosion and the capacity of the corroded structure. | 6-weeks |
| 4 | Corroded steel roof structure - (Shed 6) | Connections of the roof structure to the vertical load bearing elements to be verified for conformity. | 6-weeks |
| 5 | Corroded steel roof structure - (Shed 6) | Carry out any remedial structural works arising from the investigation. | 6-months |

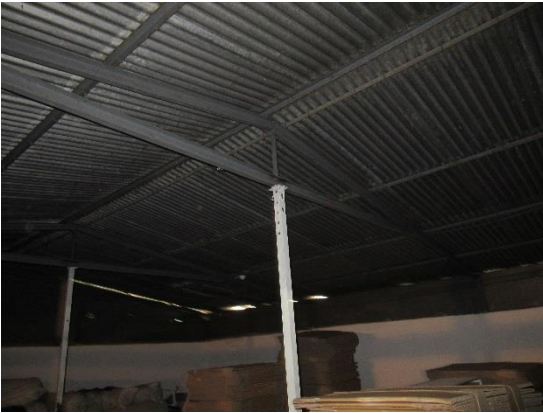
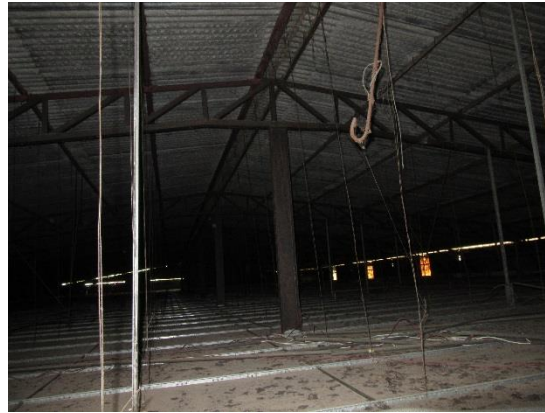
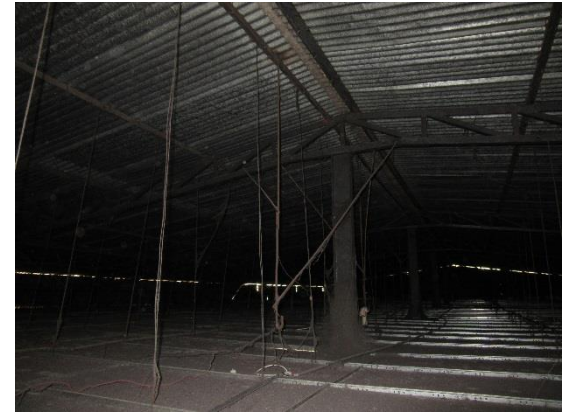
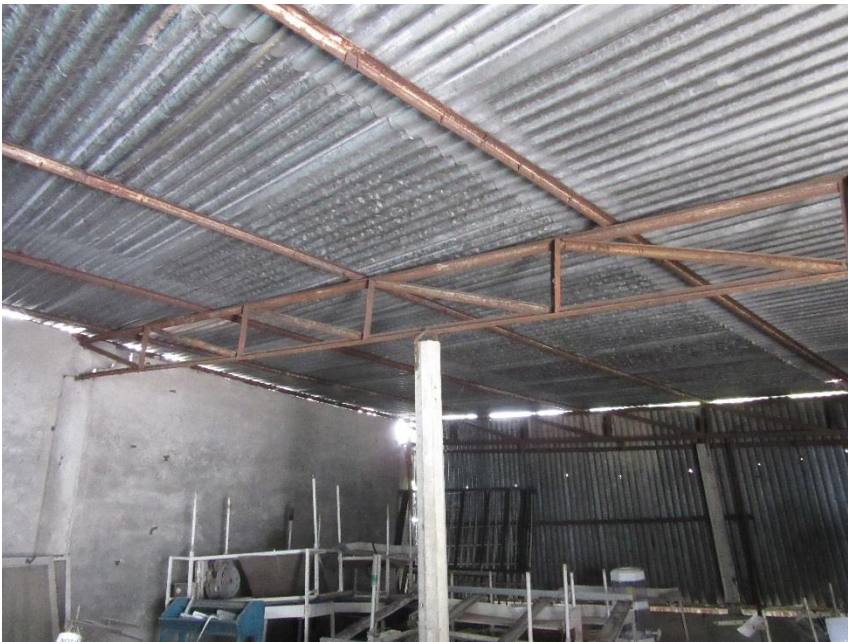
# **Apparently non-engineered roof structures (all sheds)**

Roof shed appears to be non-engineered steel structure:

- Condition of steel structure itself appears not sufficient
- Poor connections to substructure
- No apparent measures against up-lift

Roof sheds appear to be non-engineered

| Item No. | Observation | Recommended Action Plan | Recommended Timeline |
|---|---|---|---|
| 6 | Apparently non-engineered roof structures (all sheds) | Building engineer to survey and investigate the roof structures of all sheds and to ensure adequacy for code vertical and horizontal loads including wind and up-lift. | 6-months |
| 7 | Apparently non-engineered roof structures (all sheds) | Connections of the roof structure to the vertical load bearing elements to be verified for conformity. | 6-months |
| 8 | Apparently non-engineered roof structures (all sheds) | Perform any structural alterations as advised by Factory Engineer. | 6-months |

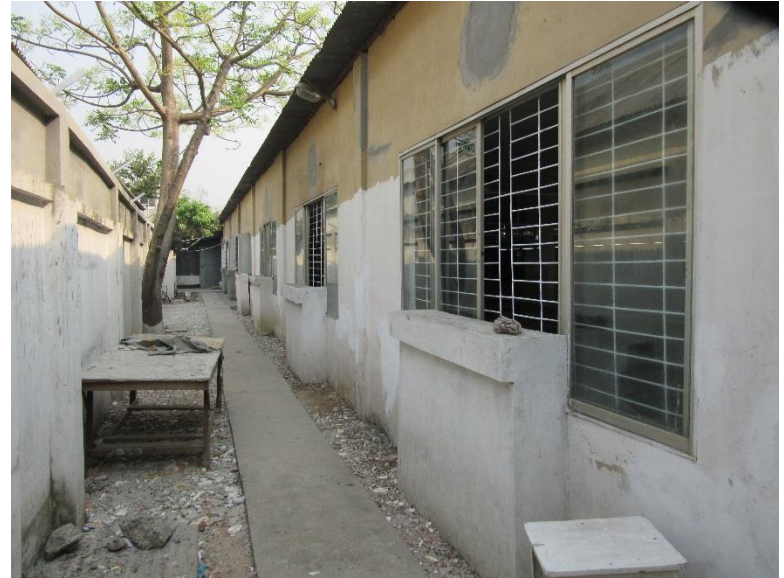
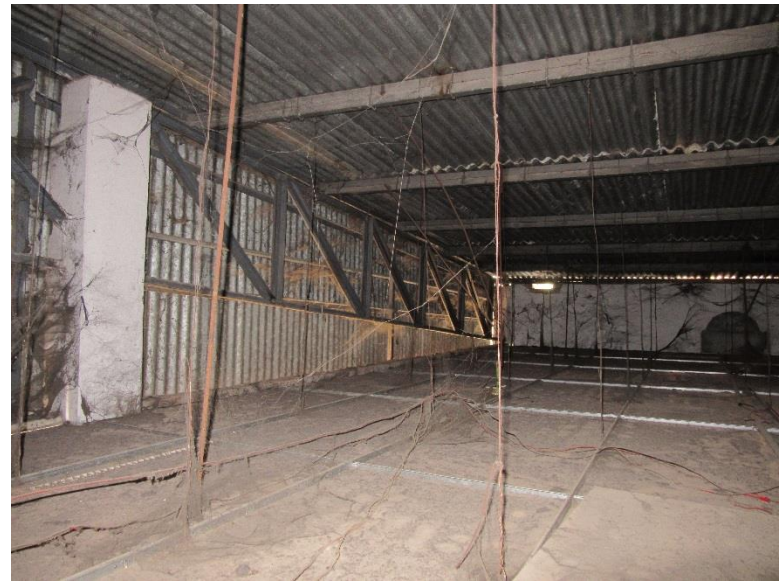
# **Possible lack of lateral bracing for the steel roofs of all the sheds**

## Lateral stability system non-apparent:

- No bracing
- No moment frame
- Non-load-bearing brick walls as in-fill on perimeter lines (exception is shed 6 which consists of metal sheet cladding)

Lateral stability system of sheds is non-apparent

| Item No. | Observation | Recommended Action Plan | Recommended Timeline |
|---|---|---|---|
| 9 | Possible lack of lateral bracing for the steel roofs of the shades | The Building Engineer to investigate the lateral longitudinal stability and bracing of all the buildings. Code adequacy to be ensured and eventual alterations to be defined. | 6-months |
| 10 | Possible lack of lateral bracing for the steel roofs of the shades | Make any structural alterations as advised by Factory Engineer. | 6-months |

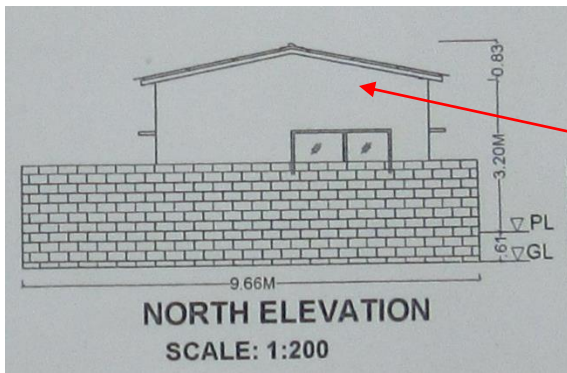
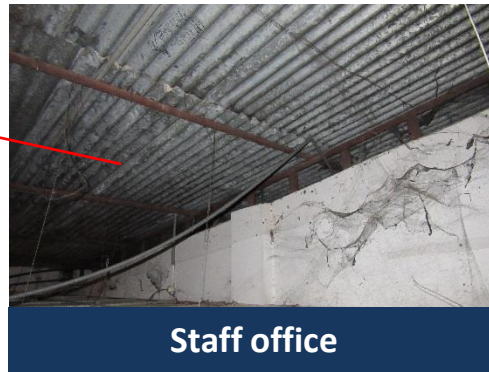
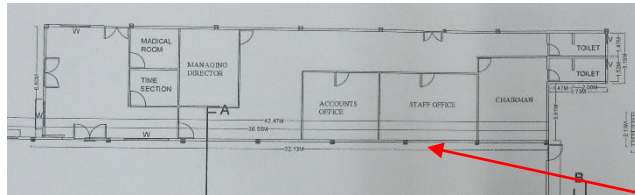
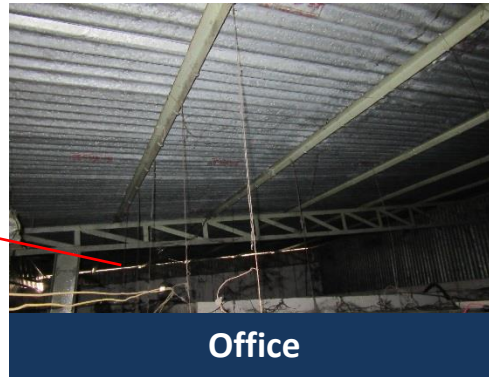
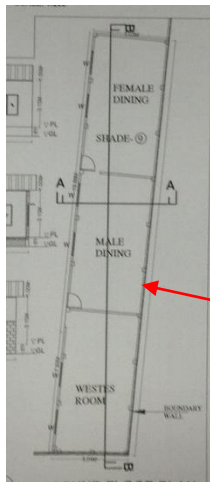
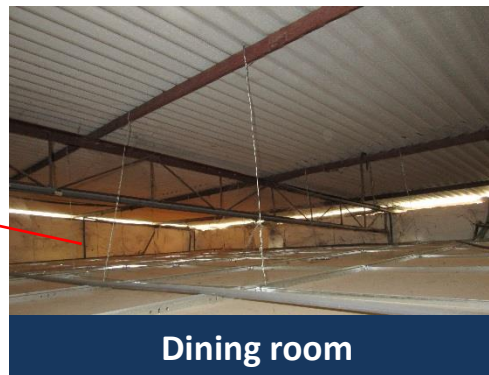
**Discrepancies between  
permit/structural/architectural drawings and as-  
built structure for all the sheds**

- Changes in the overall roof structure → truss/beams (parallel or sloped), height, shape
- Column layout and spans (bigger or smaller spans due to additional or missing column lines)
- Steel and concrete column not according to structural drawings

Discrepancies between permit/structural/architectural drawings and as-built structure

| Item No. | Observation | Recommended Action Plan | Recommended Timeline |
|---|---|---|---|
| 11 | Discrepancies between permit/structural/architectural drawings and as-built structure | Building engineer to survey as constructed building. Updated drawings to be prepared showing the correct as constructed layouts, roof structures and shed 11 (Office building). | 6-months |

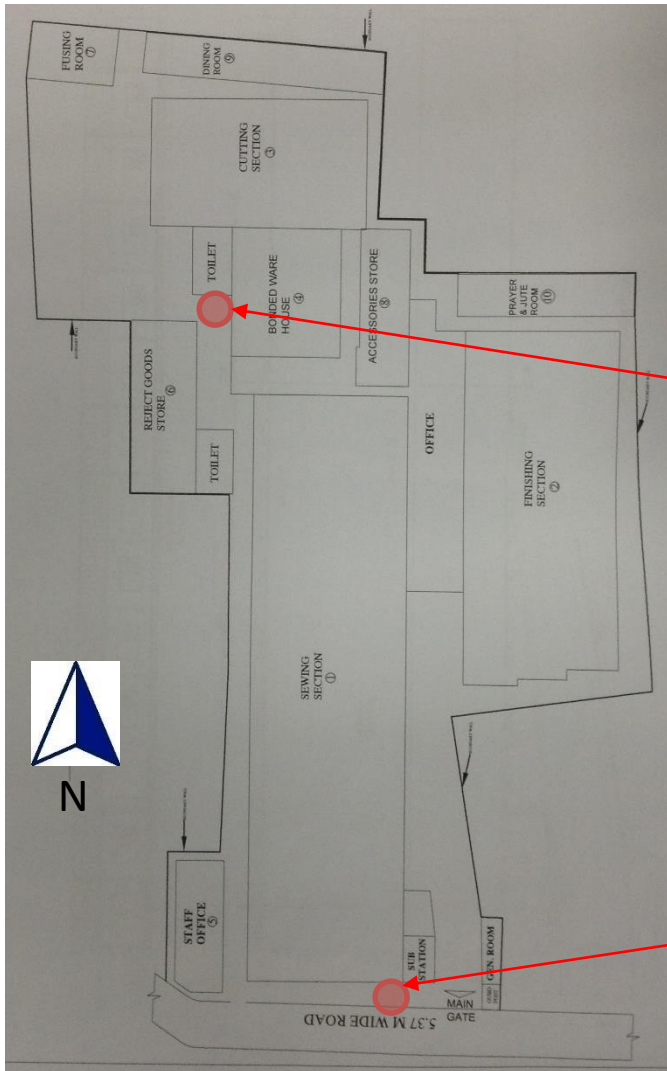
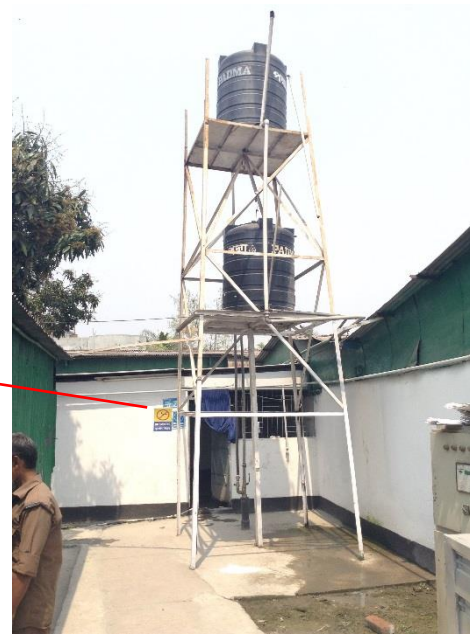
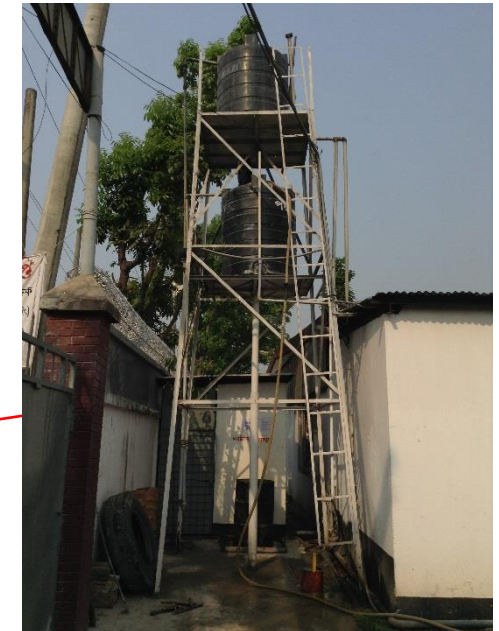
# Apparently non-engineered Water towers

Water towers in two locations appear to be non-engineered.

| Item No. | Observation | Recommended Action Plan | Recommended Timeline |
|---|---|---|---|
| 12 | Apparently non-engineered Water towers | Building engineer to survey and investigate the structures of the water towers. Adequacy for code vertical and wind loads to be ensured | 6-months |
| 13 | Apparently non-engineered Water towers | Perform any structural alterations as advised by Factory Engineer. | 6-months |

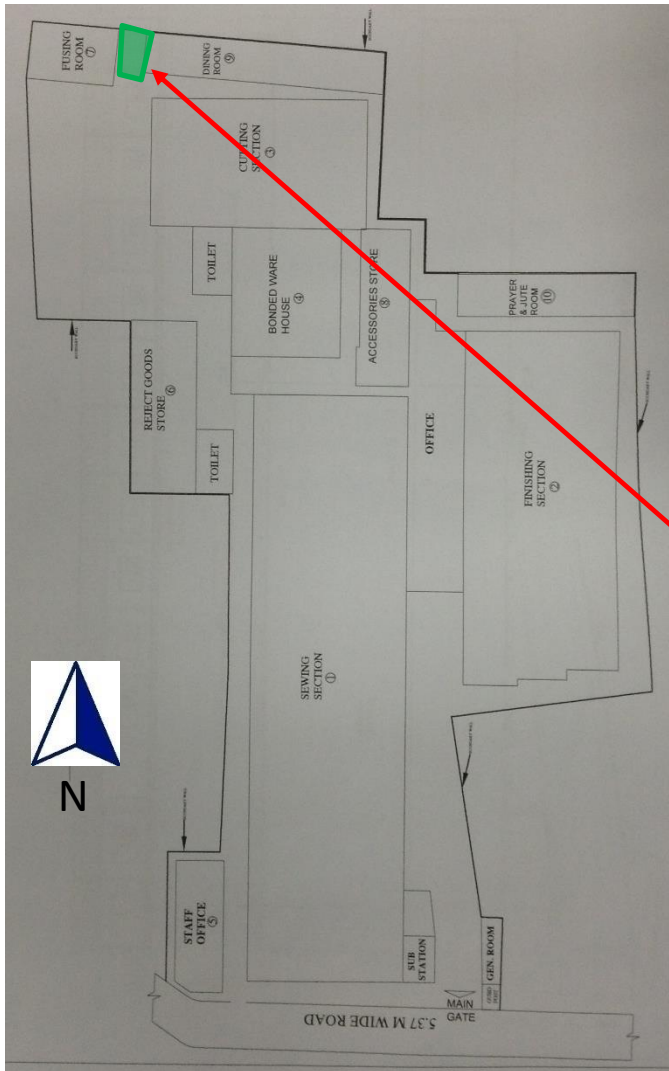
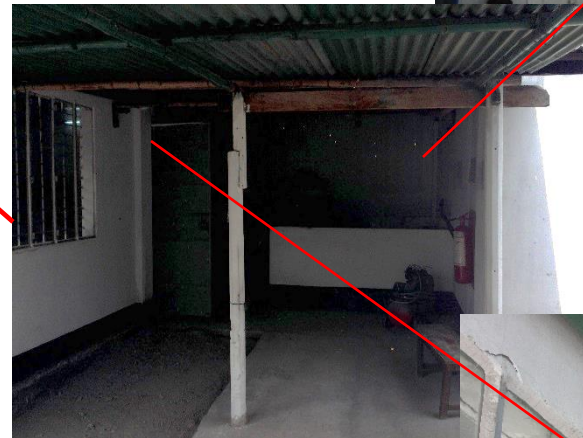
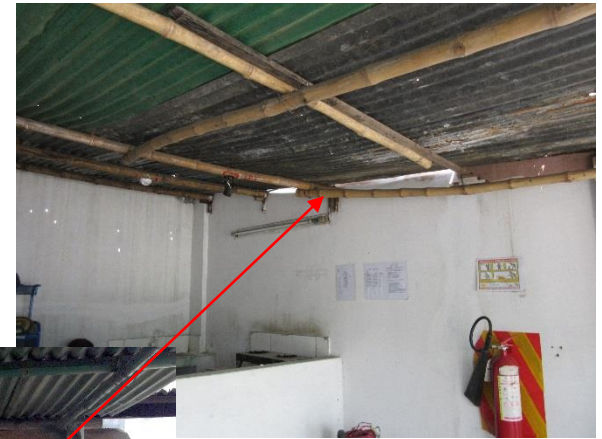
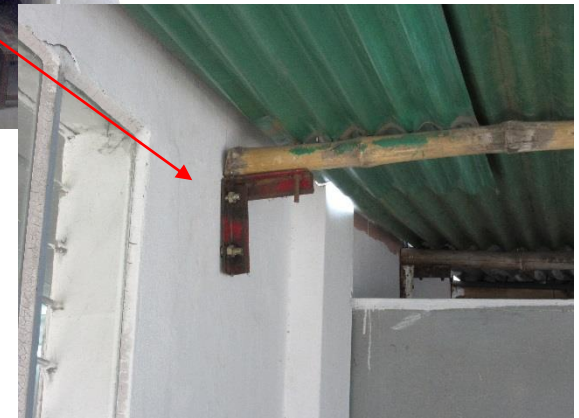
# **Apparently non-engineered lightweight roof between Shed 7 & 9**

Bamboo decking between Shed 7 and Shed 9 appears to be non-engineered

| Item No. | Observation | Recommended Action Plan | Recommended Timeline |
|---|---|---|---|
| 14 | Apparently non-engineered lightweight roof between Shed 7 and Shed 9 | Lightweight bamboo roof is to be reconstructed/upgraded to ensure adequacy for code vertical and wind loads by the Building Engineer. | 6-months |
| 15 | Apparently non-engineered lightweight roof between Shed 7 and Shed 9 | Perform any structural alterations as advised by Factory Engineer. | 6-months |
