MNR Sweaters Ltd.

Beraiderchala, Sreepur, Gazipur-1740, Bangladesh.

28th March 2015

Observations

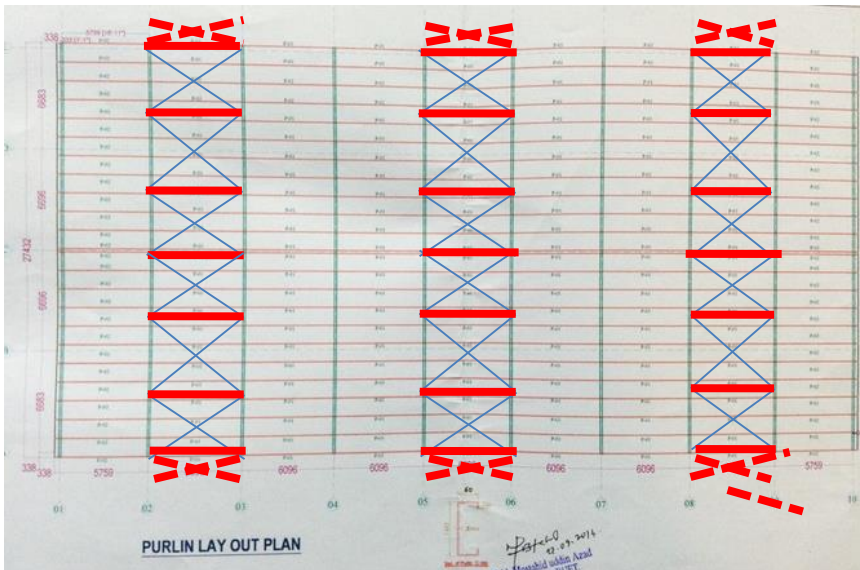
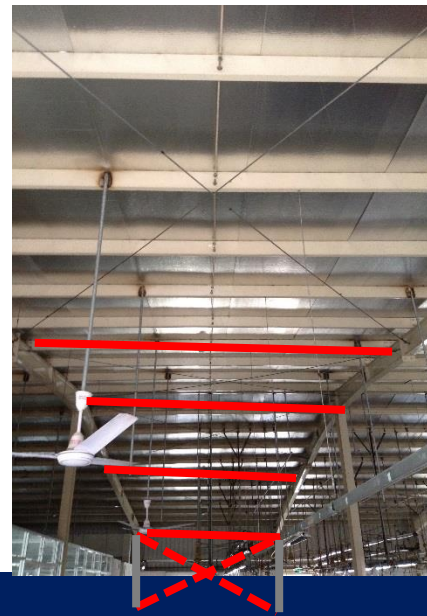
Non-engineered connections and lack of bracing

Lack of roof bracing struts and vertical bracing

Item No.	Observation	Recommended Action Plan	Recommended Timeline
1	Buildings 1 & 2 - Non-engineered connections and lack of bracing	Building Engineer to check design of connection joints.	6-weeks
2	Buildings 1 & 2 - Non-engineered connections and lack of bracing	Building Engineer to check roof bracing and vertical bracing for adequacy to resist Code vertical and horizontal loads.	6-weeks
3	Buildings 1 & 2 - Non-engineered connections and lack of bracing	Carry out any remedial works arising from engineering checks.	6-months
4	Building 1 - Corrosion in 1st floor beams	Building Engineer to identify steel elements where corrosion is evident.	6-weeks
5	Building 1 - Corrosion in 1st floor beams	Building Engineer to specify remedial paint works to corroded elements, including preparation, primer and top coat(s).	6-weeks
6	Building 1 - Corrosion in 1st floor beams	Carry out remedial works to corroded elements.	6-months

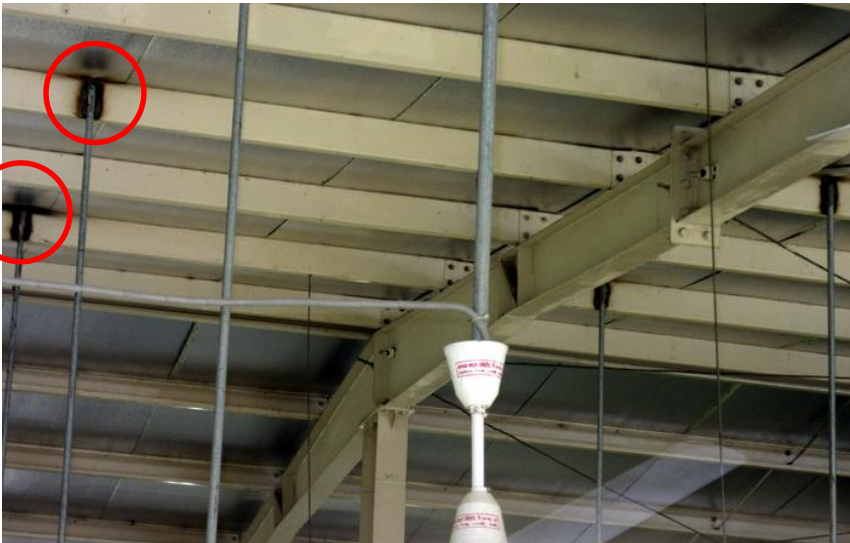
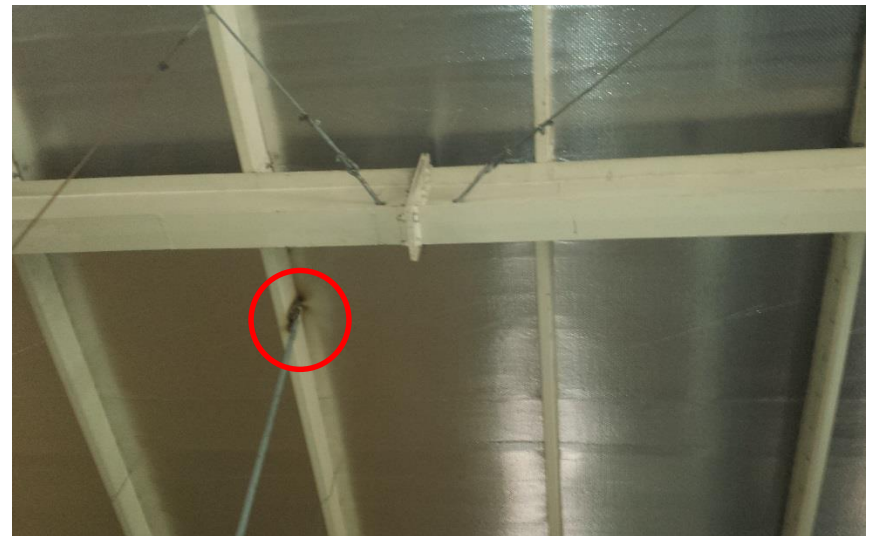
Lack of roof bracing struts and non-engineered hangers (welded to purlins)

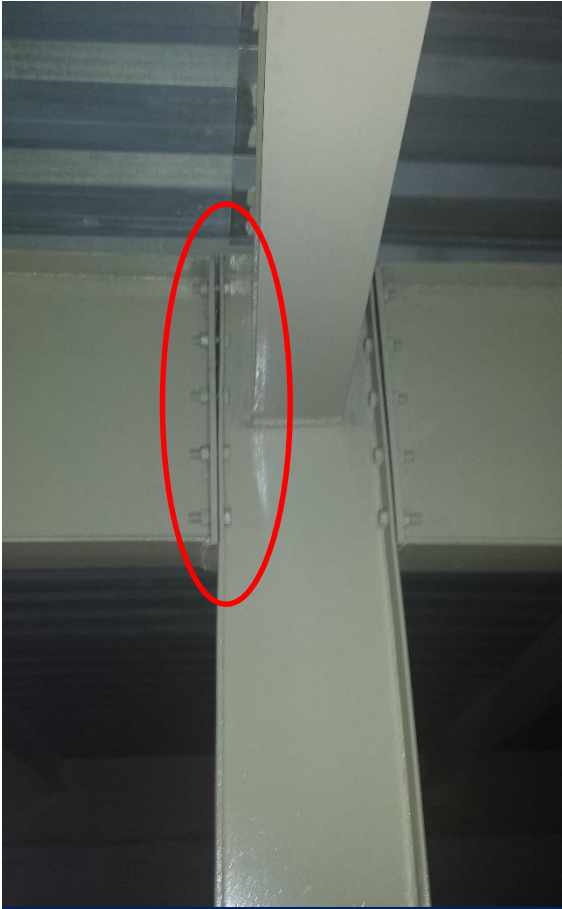
**Building 1 – 1st Floor main beam/column connections
– gaps between endplates**

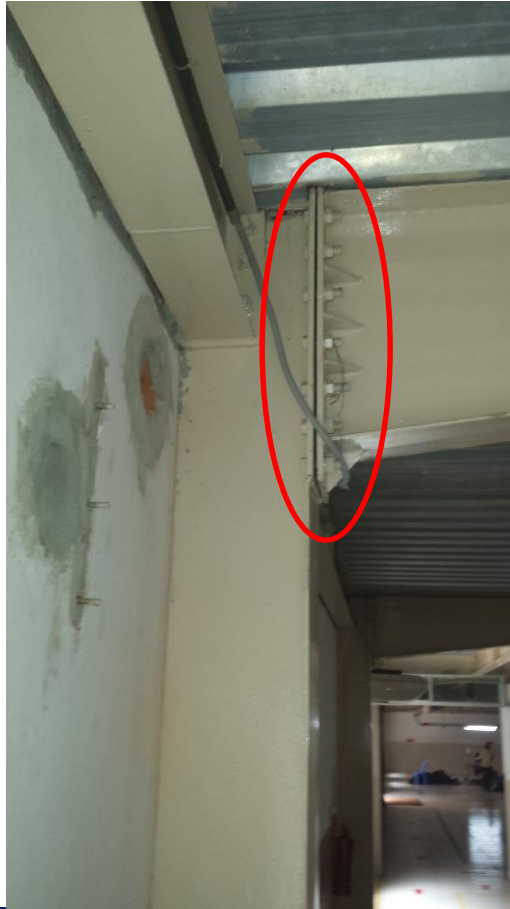
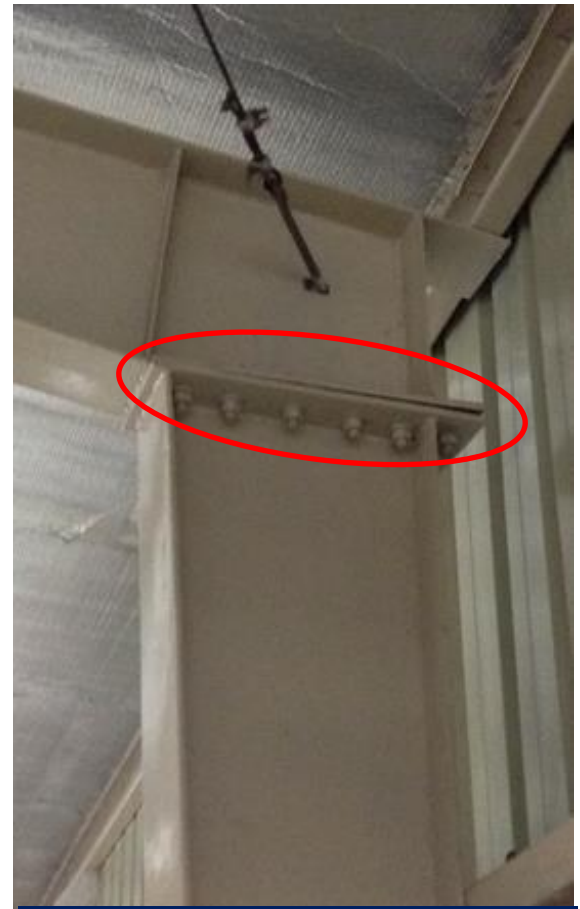
**Building 2 – Roof
beam/column connection –
gap between endplates**

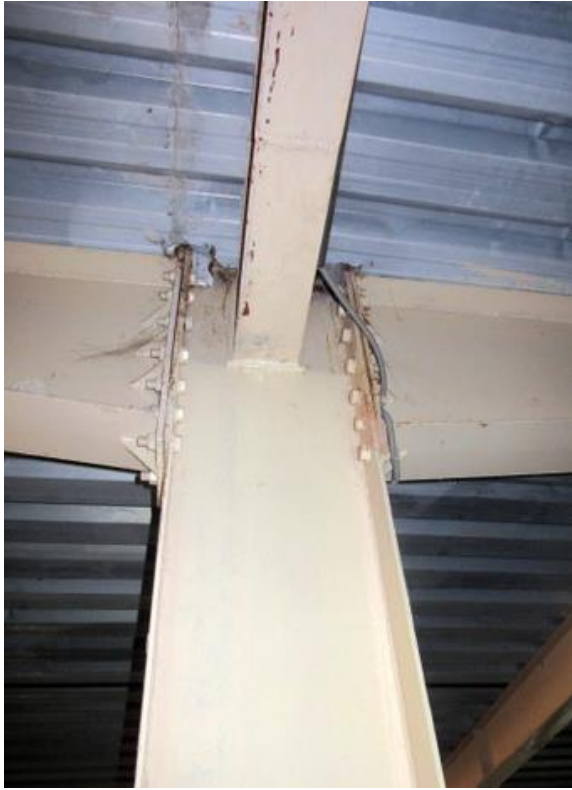
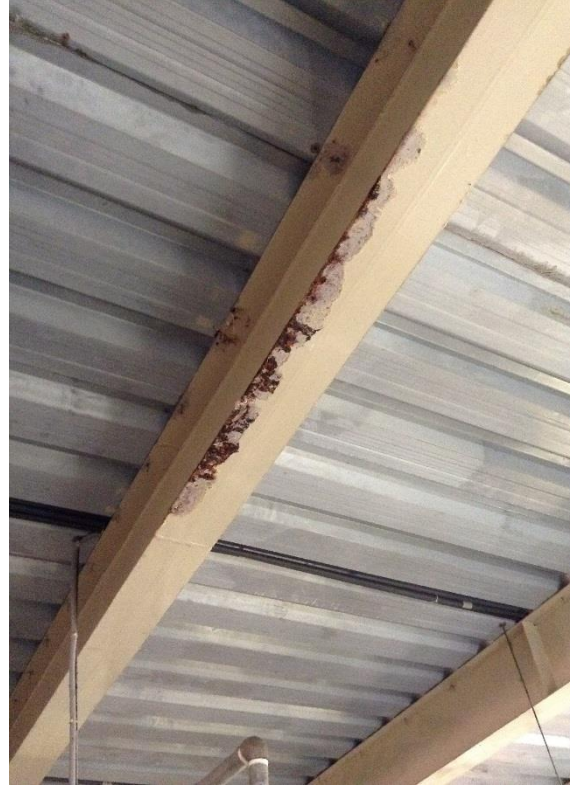
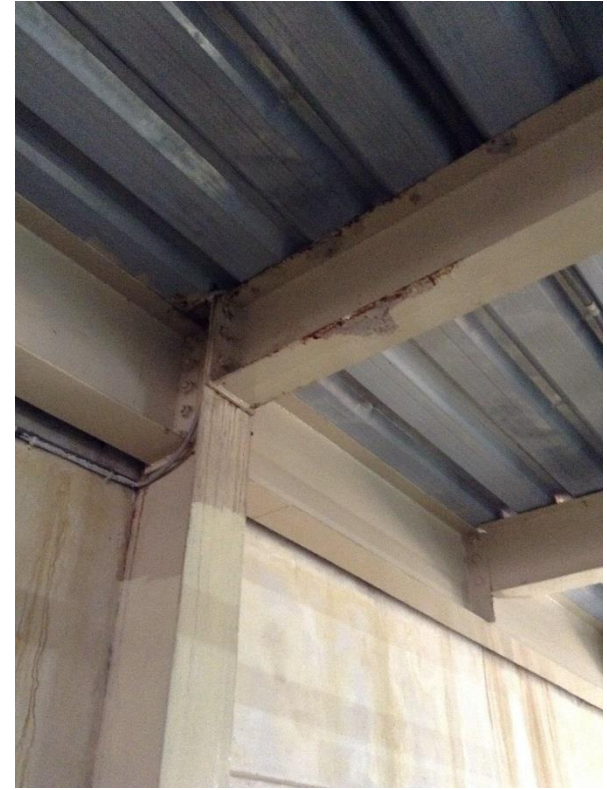
Building 1 - corrosion in 1st floor beams
