# Time Sweater Limited

Survey Date: 13<sup>th</sup> April 2015

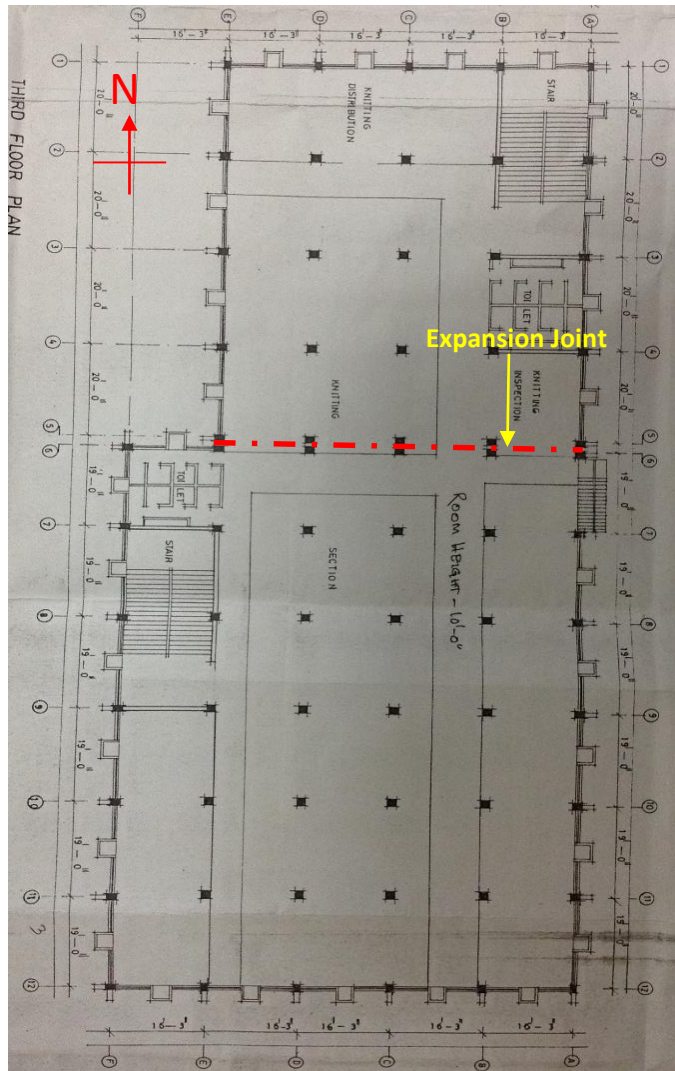
## High Column Stress:

Columns at Ground and First floor levels throughout the building appear to be stressed to levels that are in excess of recommended values.

Columns in areas under water tanks and under toilets appear to be very highly stressed.

Immediate actions are required as noted in the Priority Actions section of this report to reduce the column stresses

| Item No. | Observation | Recommended Action Plan | Recommended Timeline |
|---|---|---|---|
| 1 | High Column stress<br>Water tanks at Roof Level | Empty Water tanks on roof. Provide isolated small plastic water tanks distributed in the roof area as directed by the Factory Engineer. | Immediate - Now |
| 2 | High Column stress<br>Water tanks at Roof Level | Remove dead and live loading on all floors as noted on next page. | Immediate - Now |
| 3 | High Column stress<br>Water tanks at Roof Level | Factory Engineer to review design, loads and columns stresses in all areas. | Immediate - Now |
| 4 | High Column stress<br>Water tanks at Roof Level | Factory Engineer to determine reinforcement in ground level columns immediately | Immediate - Now |
| 5 | High Column stress<br>Water tanks at Roof Level | Verify insitu concrete strengths by taking a minimum of 4 no. 100mm diameter cores from columns at ground floor | Immediate - Now |
| 6 | High Column stress<br>Water tanks at Roof Level | A Detail Engineering Assessment of Factory to be commenced, see attached Scope | Immediate - Now |
| 7 | High Column stress<br>Water tanks at Roof Level | Produce and actively manage a loading plan for all floor plates within the factory giving consideration to floor capacity and column capacity. | 6-weeks |
| 8 | High Column stress<br>Water tanks at Roof Level | Detail Engineering Assessment to be completed | 6-weeks |

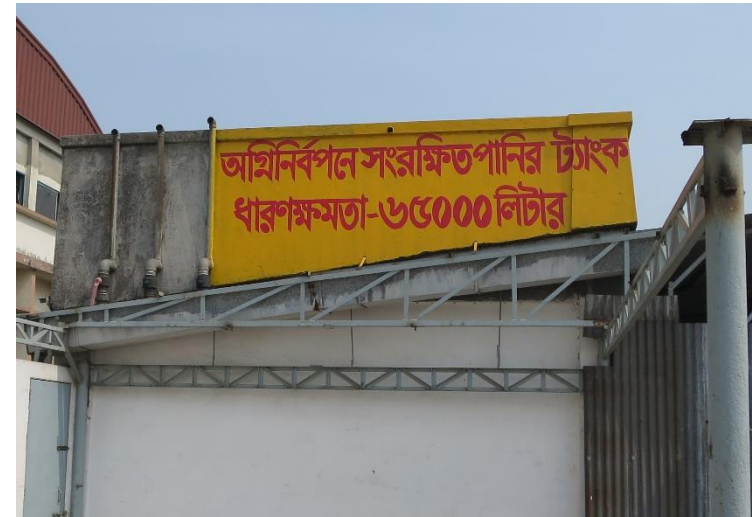
65,000 Litre R.C Water tank (1)

## Water tanks at Roof Level

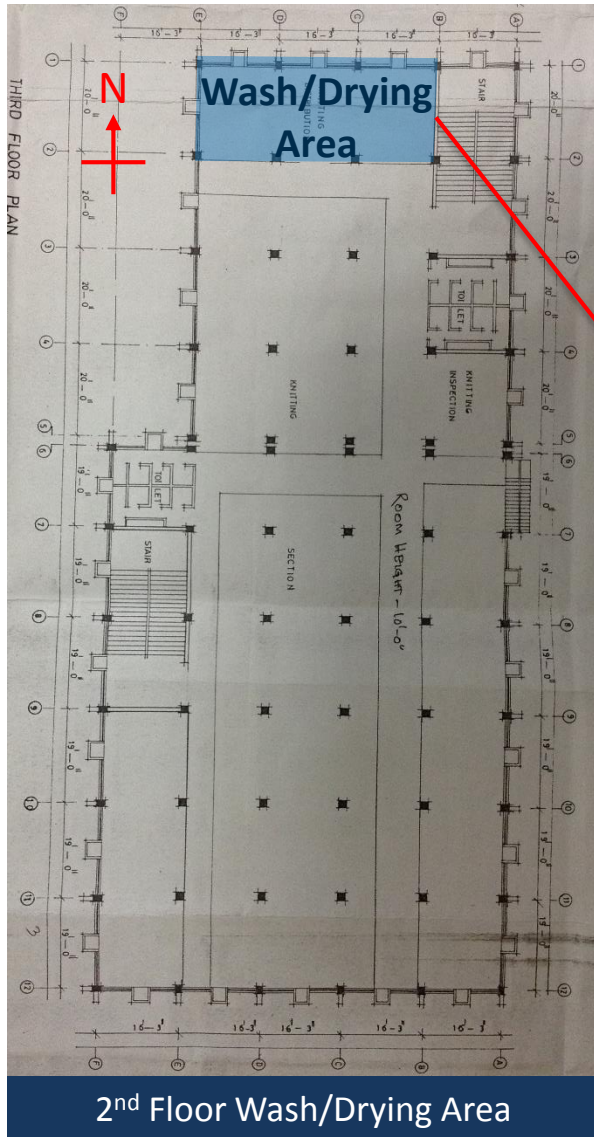
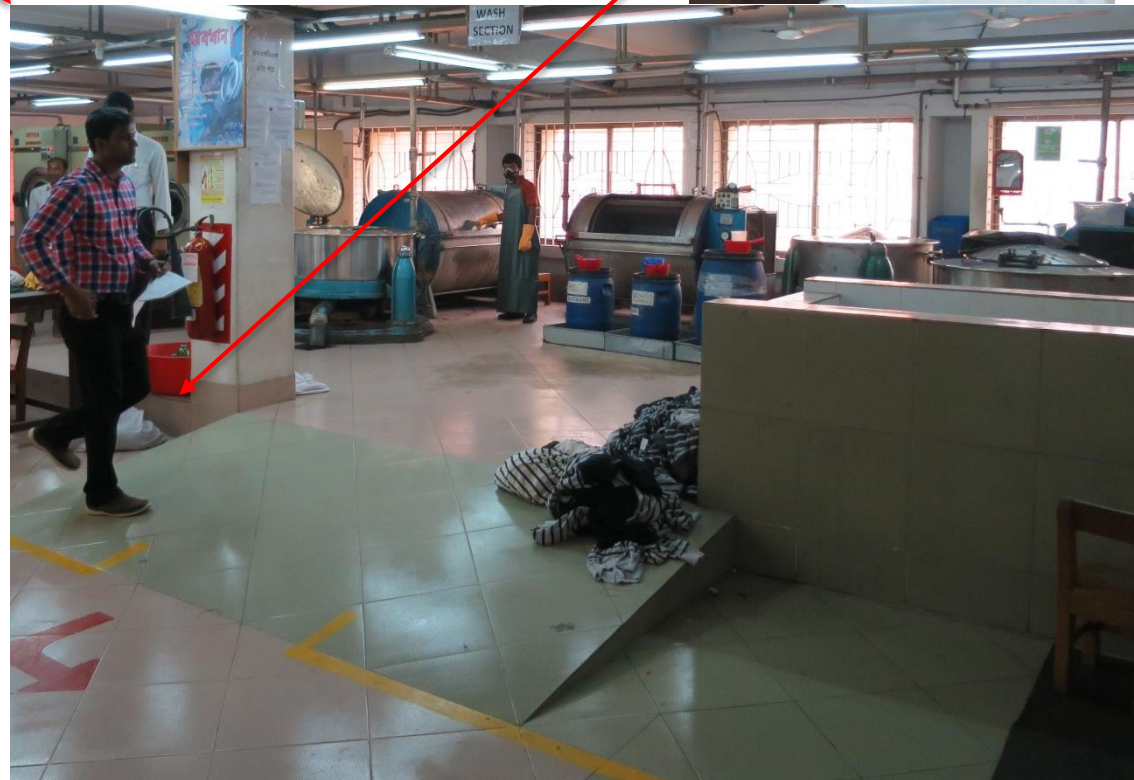
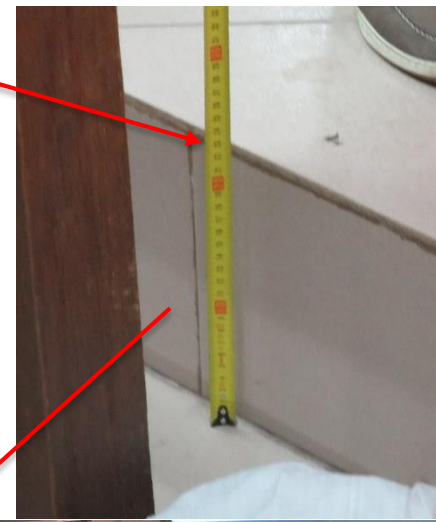
## **Washing and drying Area on 2<sup>nd</sup> Floor**

230mm solid build-up

| Item No. | Observation | Recommended Action Plan | Recommended Timeline |
|---|---|---|---|
| 9 | Raised Floor at Washing and drying Area on 2nd Floor | As part of the Detailed Engineering assessment (see Item1) Factory Engineer to verify that the 2nd floor slab and beams can safely carry the superimposed dead load resulting from raised floor build-up (circa 230mm) along with all other dead and imposed loads. | 6-weeks |
| 10 | Raised Floor at Washing and drying Area on 2nd Floor | Carry out any remedial actions as directed by the Factory Engineer. | 6-weeks |

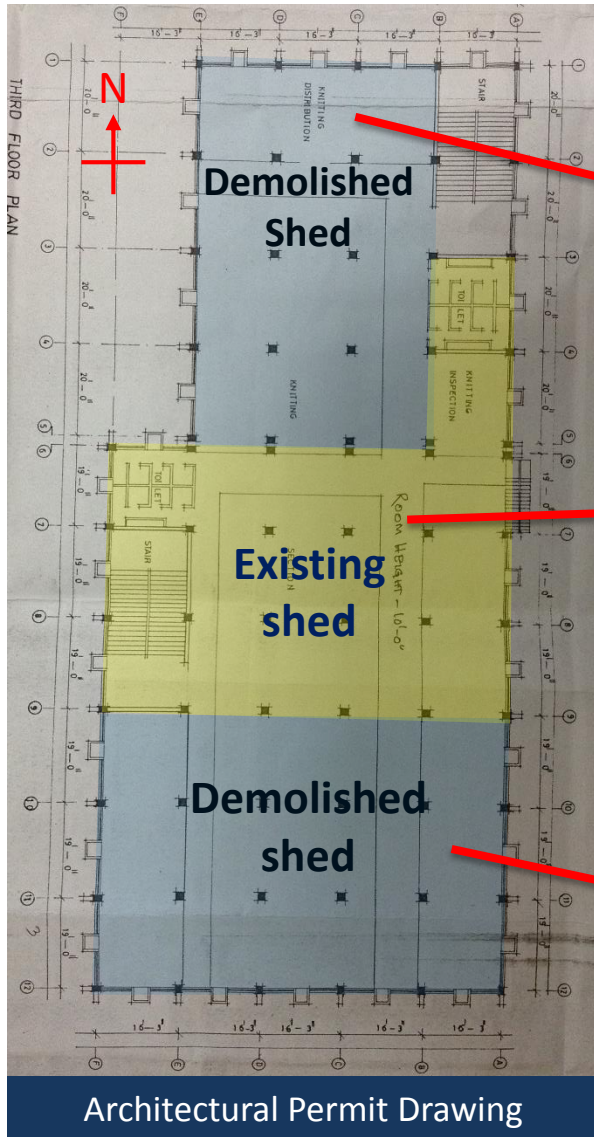
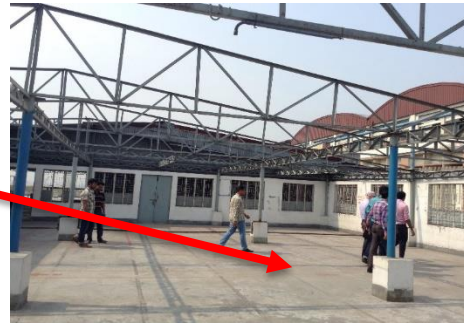
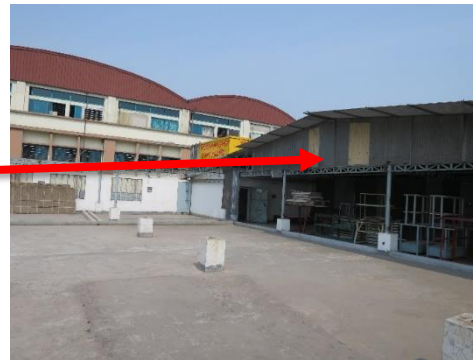
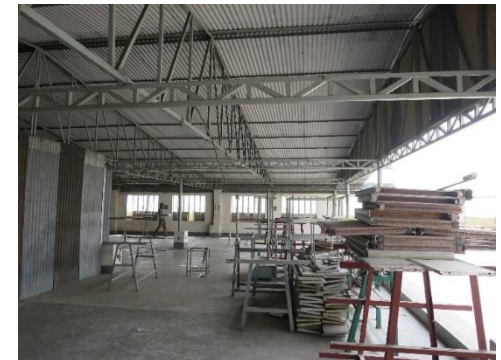
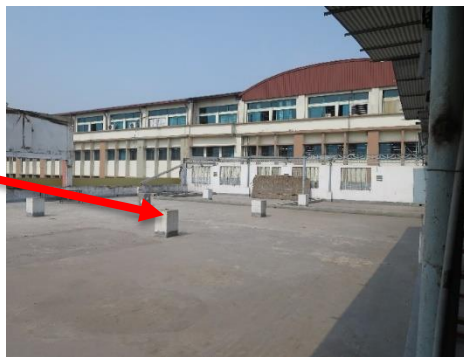
## Shed at roof level is partially demolished

| Item No. | Observation | Recommended Action Plan | Recommended Timeline |
|---|---|---|---|
| 11 | Removal of partially demolished construction at roof level | Factory Engineer to ensure all remaining walls and steel roof construction at roof level are demolished and removed. | 6-weeks |

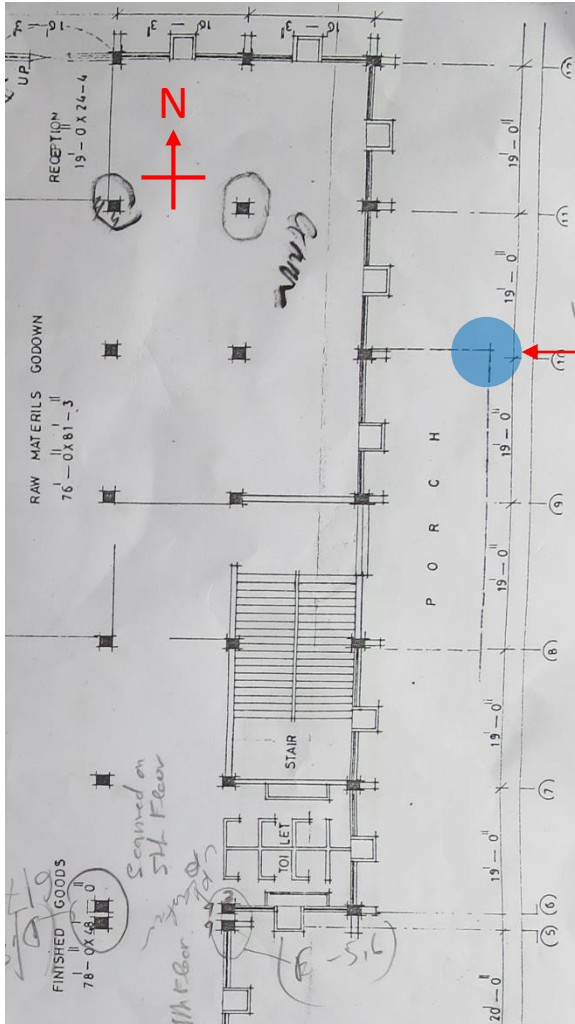
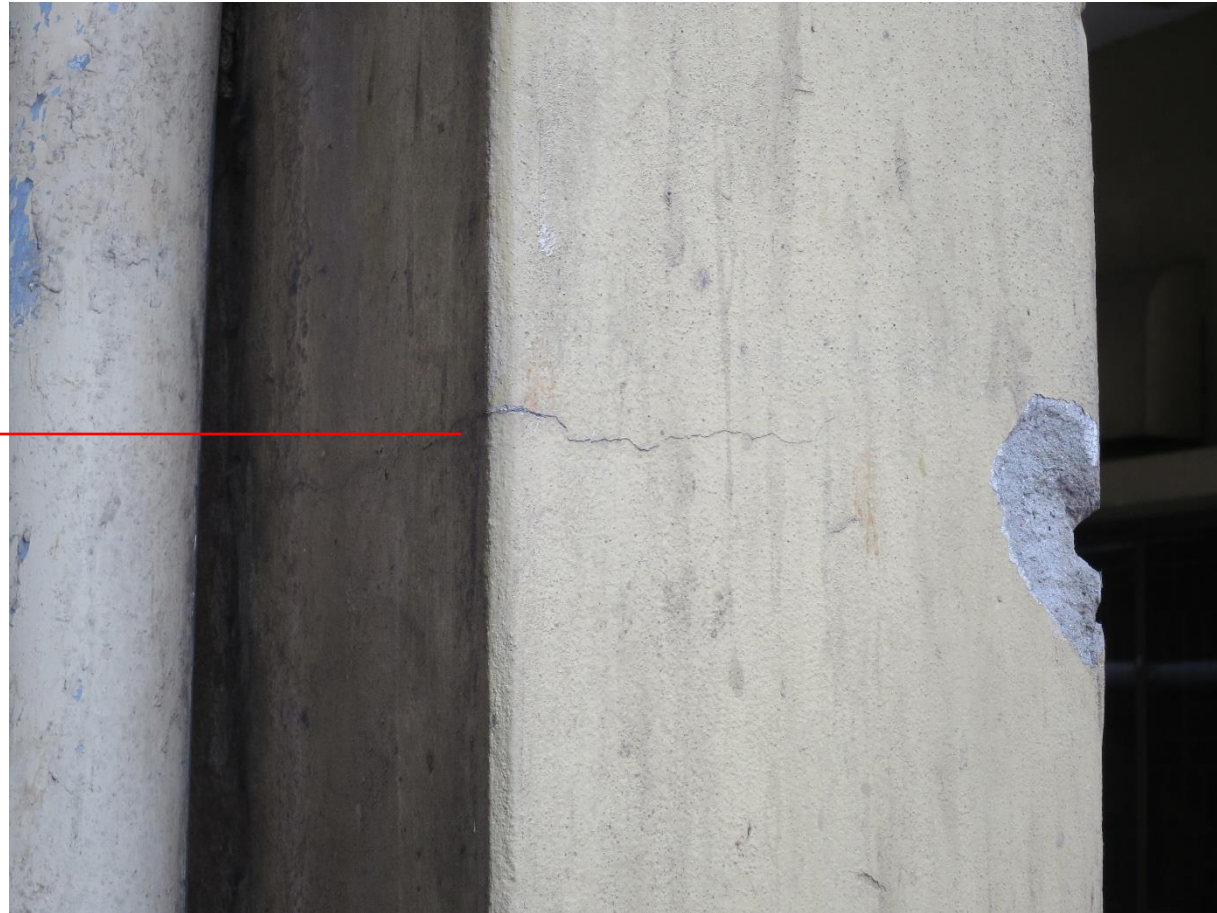
## Cracked Column at Porch (G-10)

| Item No. | Observation | Recommended Action Plan | Recommended Timeline |
|---|---|---|---|
| 12 | Cracked Column at Porch (G-10) on Ground Floor | As part of the Detailed Engineering Assessment (see Item 1) Factory Engineer to assess structural capacity of existing cracked column under Porch (G-10) and recommend replace/repair as necessary, if required. | 6-weeks |
| 13 | Cracked Column at Porch (G-10) on Ground Floor | Carry out any remedial actions as directed by the Factory Engineer. | 6-weeks |

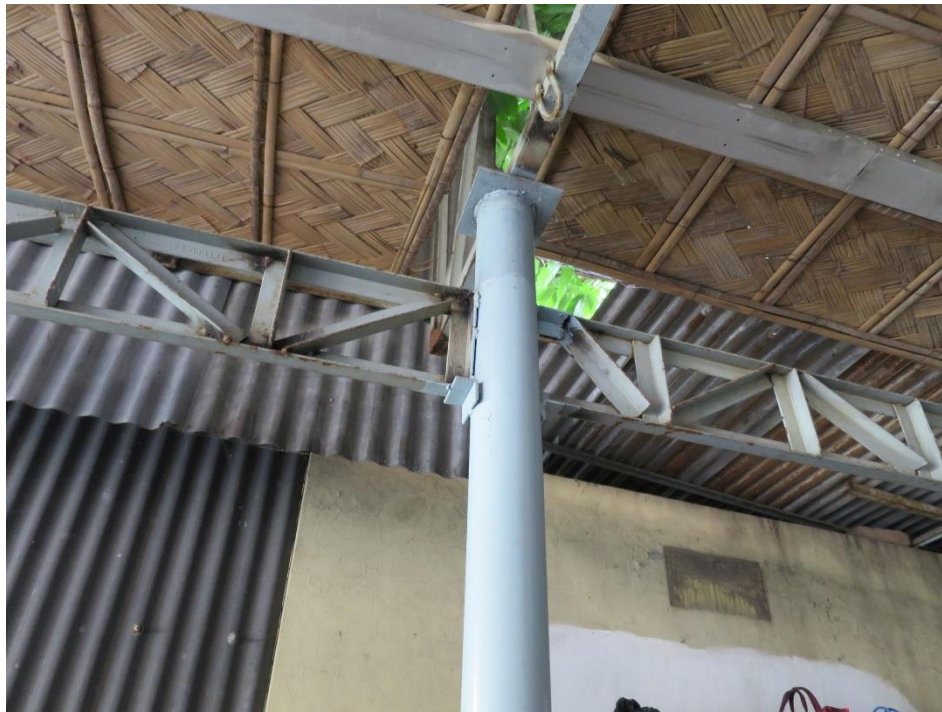
Dining Shed

# **Apparently non engineered roof structures to Dining and Boiler House Buildings**

| Item No. | Observation | Recommended Action Plan | Recommended Timeline |
|---|---|---|---|
| 14 | Apparently Non-Engineered Steel Sheds (Dining and Boiler House Buildings) | Factory Engineer to review design and construction of apparently non-engineered steel sheds in Dining and Boiler House buildings. | 6-months |
| 15 | Apparently Non-Engineered Steel Sheds (Dining and Boiler House Buildings) | Carry out any remedial works as directed by the Factory Engineer. | 6-months |
