# Ratul Fabrics Ltd. Ratul Accessories Ltd.

Zohar Sanda, Ashulia, Savar, Dhaka region

12 April 2015

# Observations

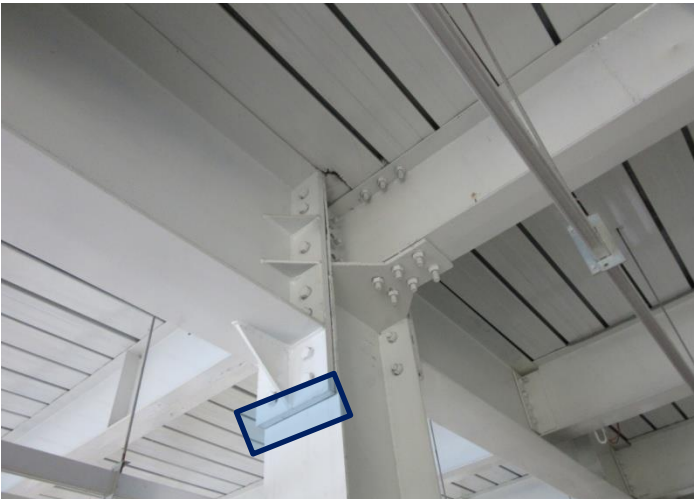
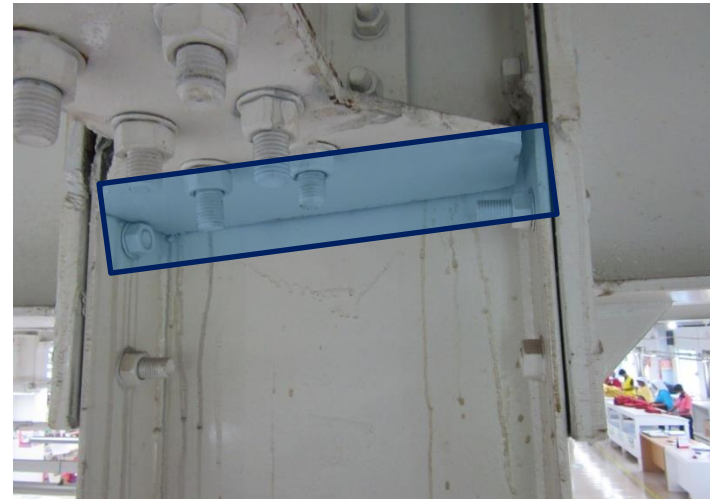
# Apparently non-engineered structural details and connections

Some of the connections between different steel members were non-welded

Item No.	Observation	Recommended Action Plan	Recommended Timeline
1	Building 1 (B1) - Apparently non-engineered structural details and connections	Building Engineer to survey the connection details in the as built structure.	6-months
2	Building 1 (B1) - Apparently non-engineered structural details and connections	Code adequacy to be ensured.	6-months
3	Building 1 (B1) - Apparently non-engineered structural details and connections	Complete any structural alterations as advised by Building Engineer. Omissions to be eliminated.	6-months
4	Building 1 (B1) - Apparently non-engineered canopy	Building Engineer to survey and investigate the canopy structure and to ensure adequacy for code vertical and horizontal loads including wind up-lift.	6-months
5	Building 1 (B1) - Apparently non-engineered canopy	Connections to the main structure to be defined.	6-months
6	Building 1 (B1) - Apparently non-engineered canopy	Complete any structural alterations as advised by Building Engineer.	6-months

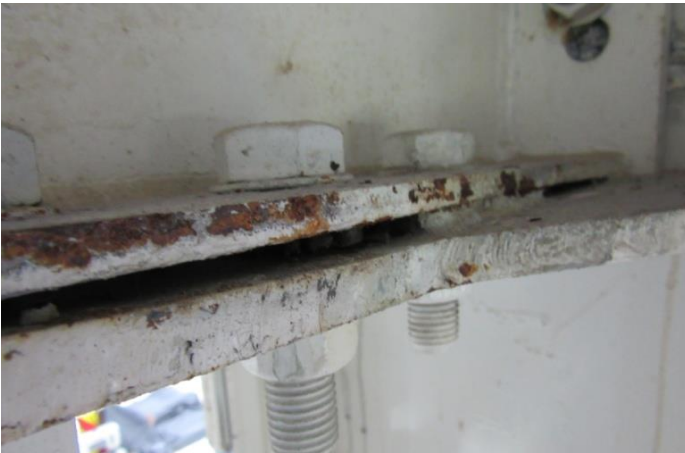
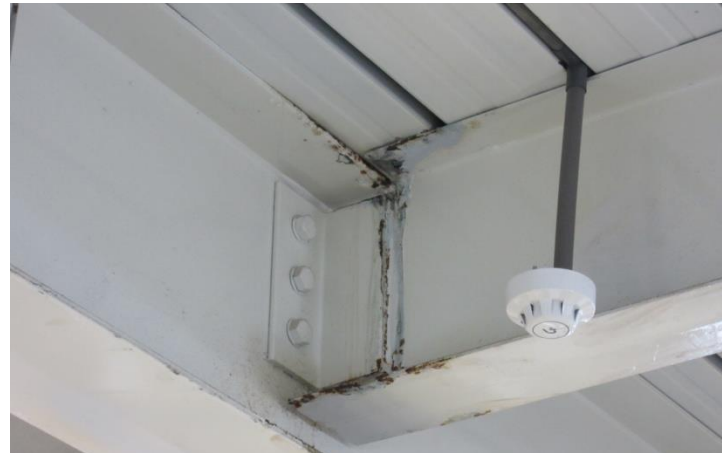
Rusting observed in some of the steel elements as well as not a full contact on the connections plates.

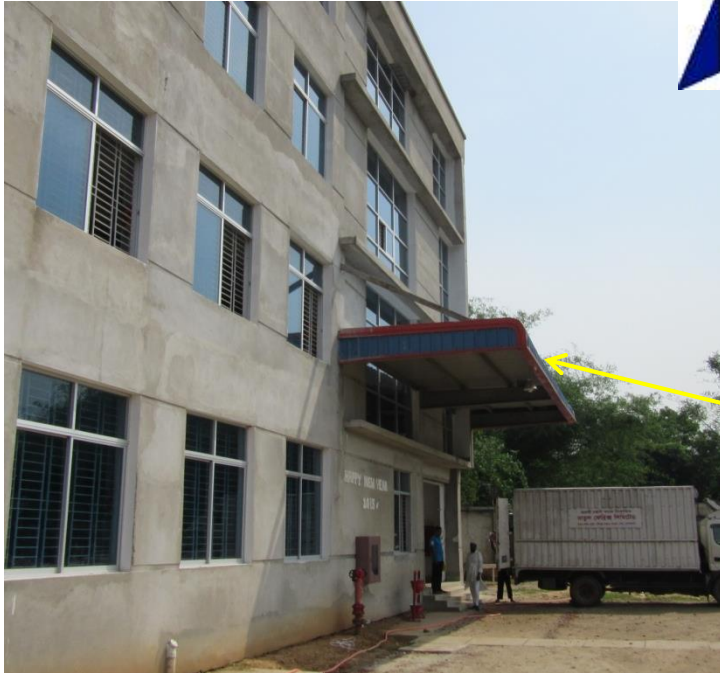
# Apparently non-engineered canopy

Apparently non-engineered canopy

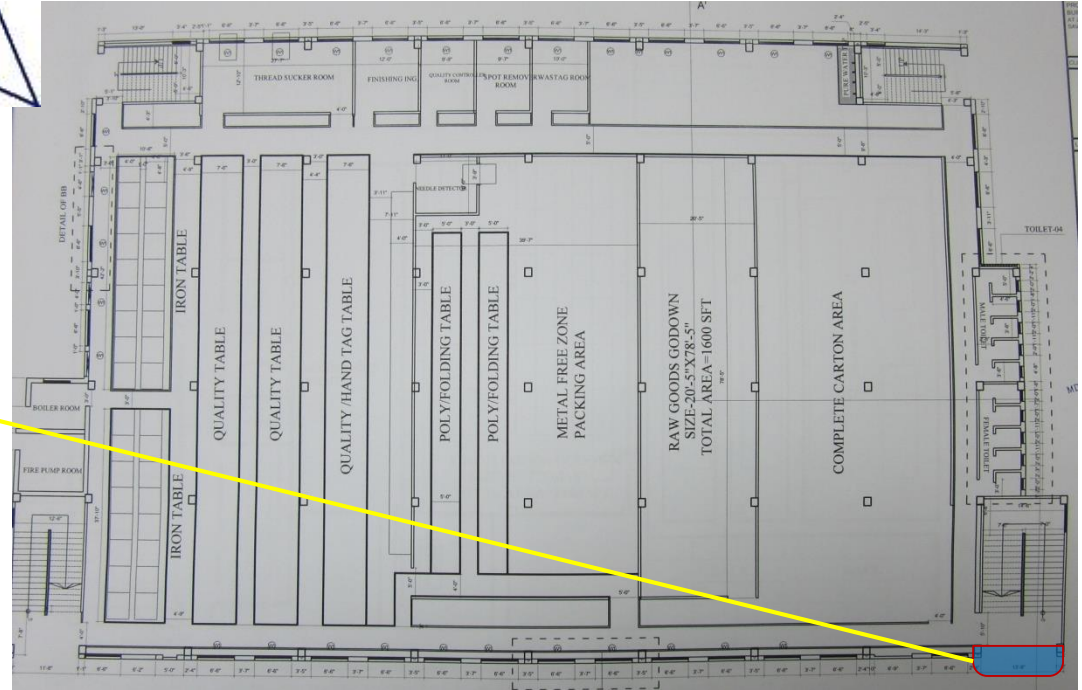
Ground floor layout plan without showing any canopy in the drawings

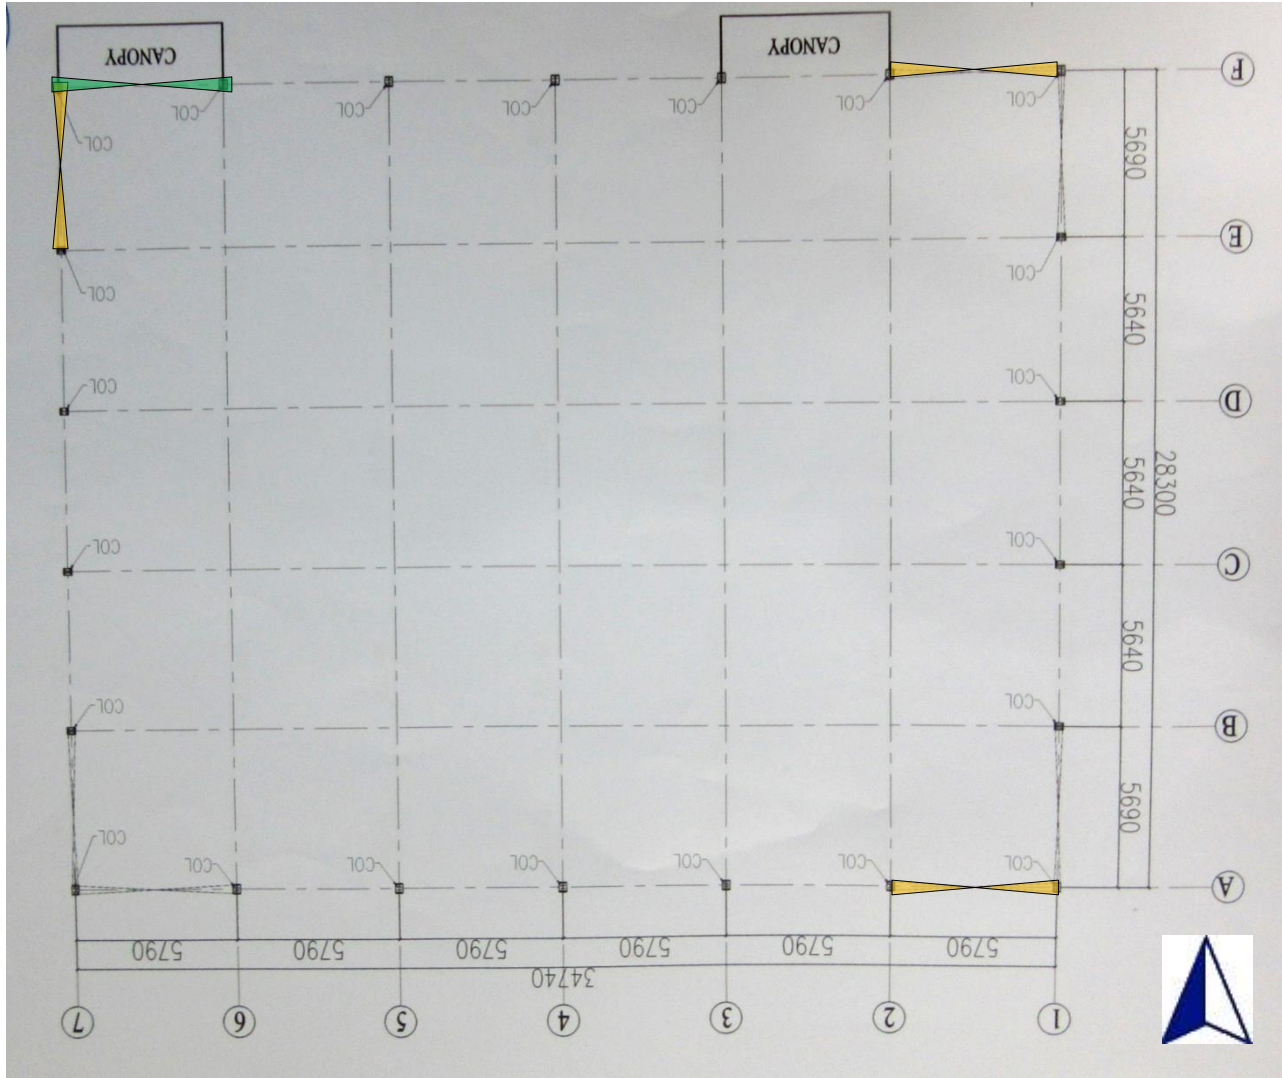
# Non apparent lateral stability system

Observed missing bracing on-site (as per drawing)

Logically should have bracing present in drawings and on site

Apparently irregular lateral stability system due to missing bracings

7	Building 2 (B2) - No-apparent lateral stability system	Building Engineer is to investigate the lateral stability of the building. Code adequacy to be ensured.	6-weeks
8	Building 2 (B2) - No-apparent lateral stability system	Eventual remedial works to be defined.	6-weeks
9	Building 2 (B2) - No-apparent lateral stability system	Make any structural alterations as advised by Building Engineer.	6-months

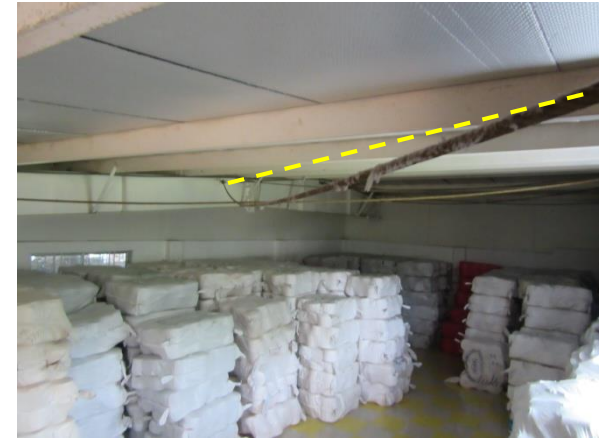
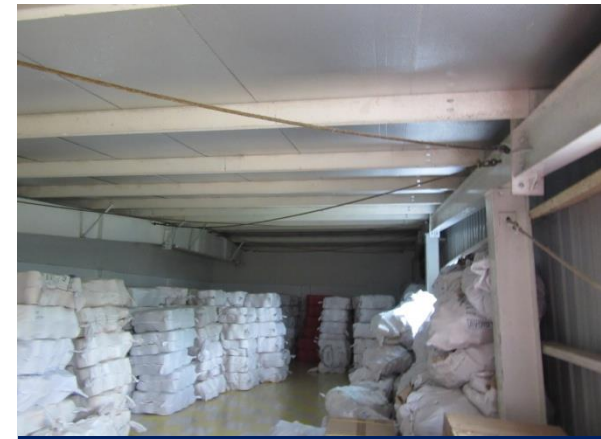
# Apparently loosely tied bracing

Apparently some of the bracing are tied very loosely

Item No.	Observation	Recommended Action Plan	Recommended Timeline
10	Building 2 (B2) - Apparently loosely tied bracing	Building Engineer to survey the bracing in whole the building and to ensured code adequacy	6-months
11	Building 2 (B2) - Apparently loosely tied bracing	Carry out any structural alterations as advised by Building Engineer.	6-months
12	Building 2 (B2) - Apparently non-engineered structural details and connections	Building Engineer to survey the connection details in the as built structure.	6-months
13	Building 2 (B2) - Apparently non-engineered structural details and connections	Code adequacy to be ensured.	6-months
14	Building 2 (B2) - Apparently non-engineered structural details and connections	Complete any structural alterations as advised by Building Engineer. Omissions to be eliminated.	6-months

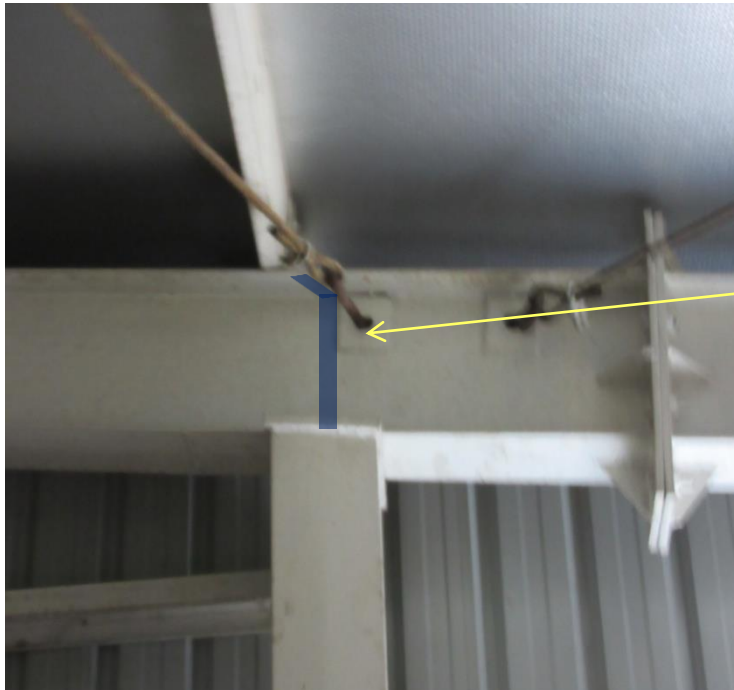
Missing steel rib for the transfer of the vertical load to the column

Apparently some of the perimeter members lacked the highlighted ribs to transfer vertical effort to the facade frame

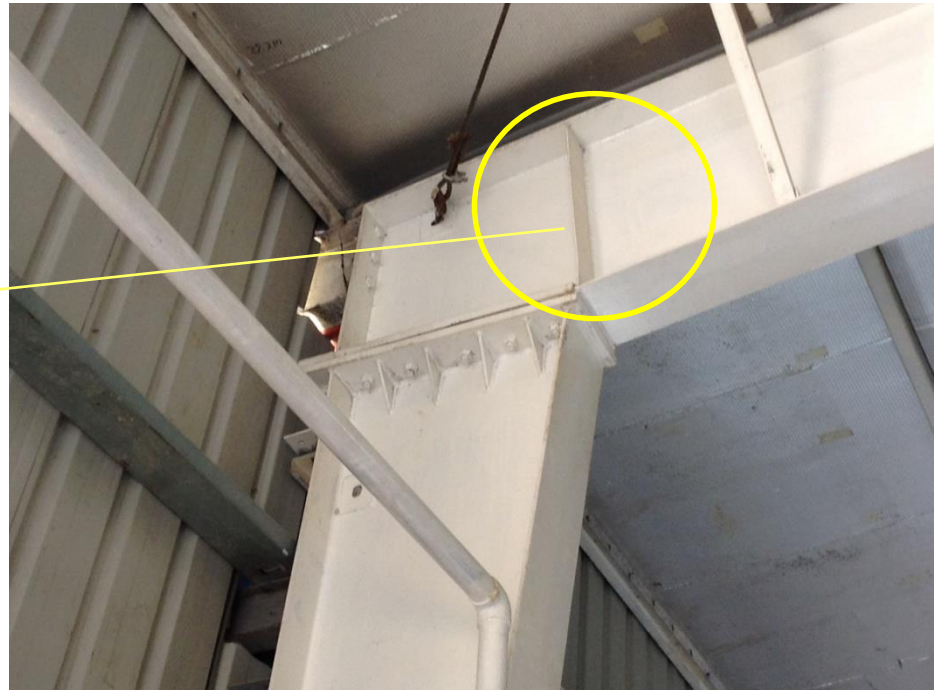
Steel member with rib to transfer vertical load to supporting column

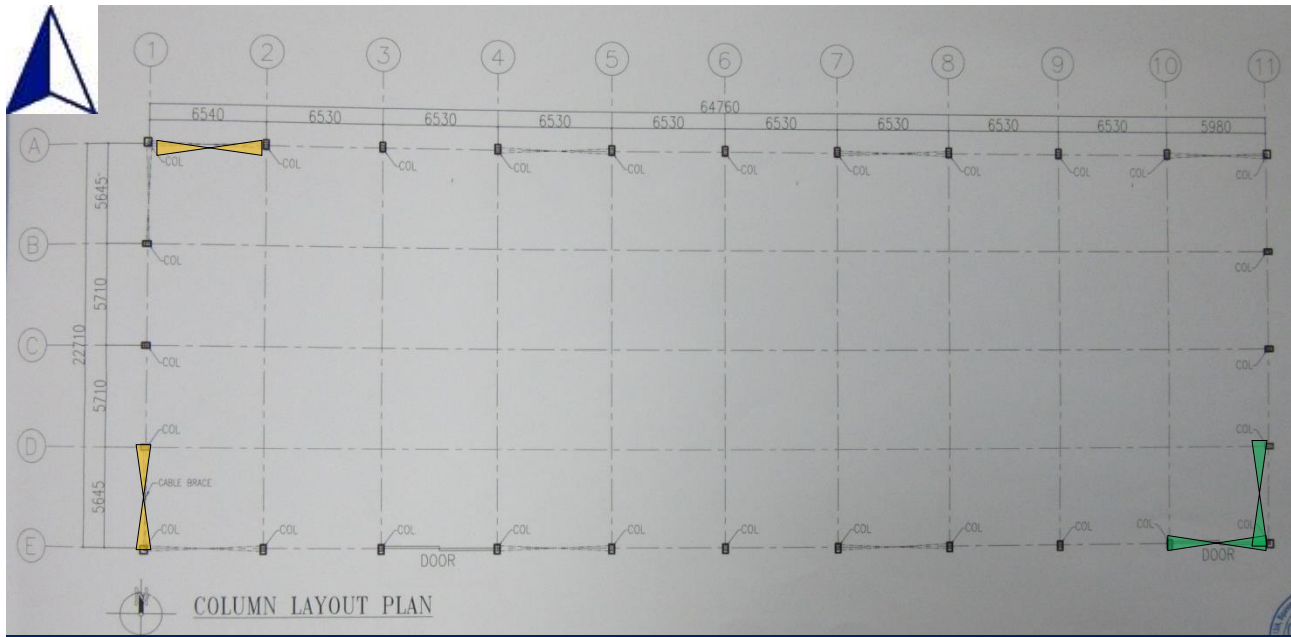
# Non apparent lateral stability system

Observed missing bracing on-site (as per drawing)

Logically should have bracing present in drawings and on site

Apparently irregular lateral stability system due to missing bracings

Item No.	Observation	Recommended Action Plan	Recommended Timeline
15	Building 5 (B5) - No-apparent lateral stability system	Building Engineer is to investigate the lateral stability of the building. Code adequacy to be ensured.	6-weeks
16	Building 5 (B5) - No-apparent lateral stability system	Eventual remedial works to be defined.	6-weeks
17	Building 5 (B5) - No-apparent lateral stability system	Make any structural alterations as advised by Building Engineer.	6-months
18	Building 5 (B5) - Apparently loosely tied bracing	Building Engineer to survey the bracing in whole the building and to ensured code adequacy	6-months
19	Building 5 (B5) - Apparently loosely tied bracing	Carry out any structural alterations as advised by Building Engineer.	6-months

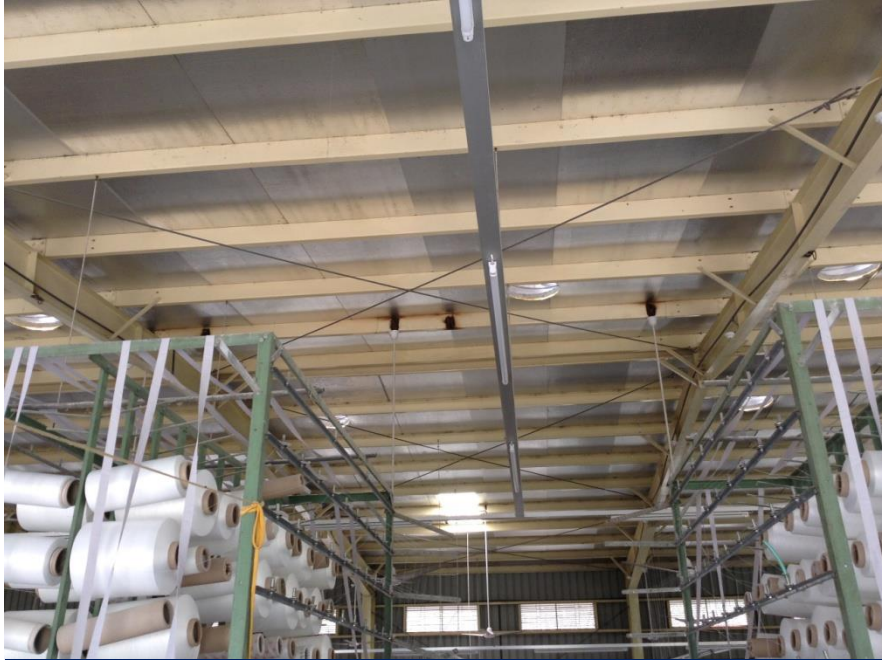
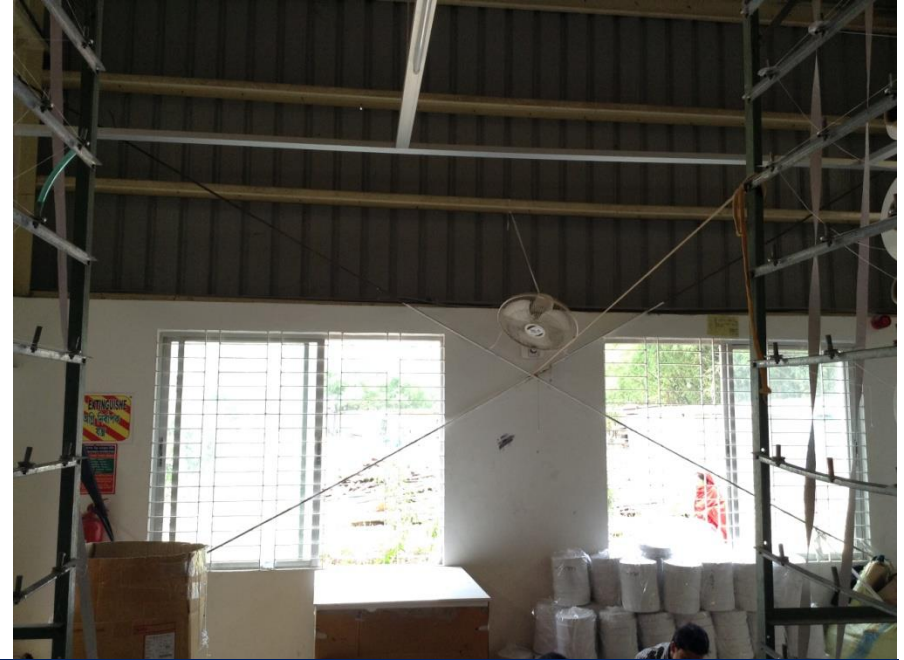
# Apparently loosely tied bracing

Most of the bracing are apparently not sufficiently tight
