# Radisson Garments Ltd.

Plot # B-84, BSCIC, Tongi, Gazipur-1710

4th April 2015

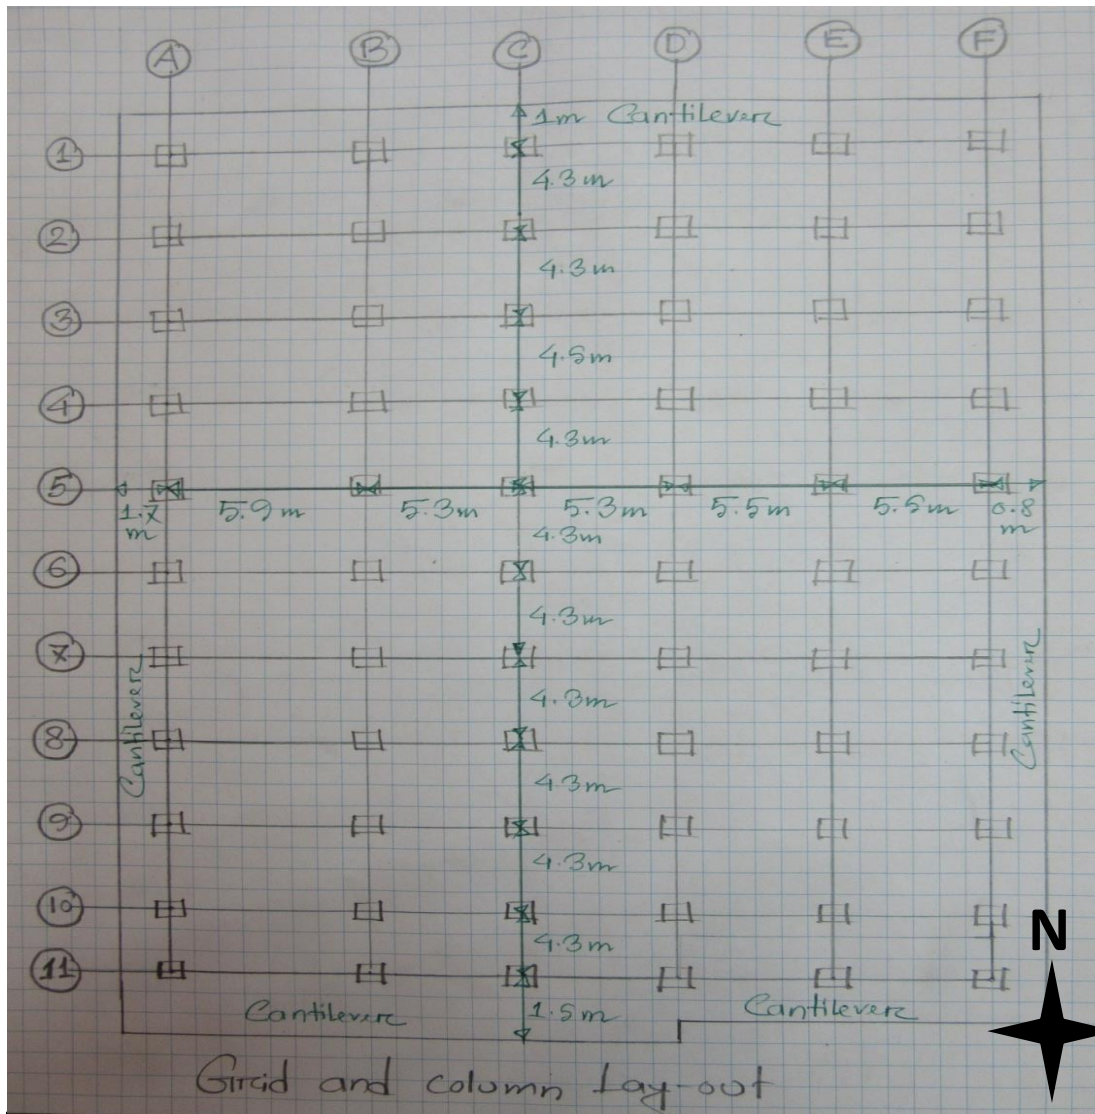
# Apparently high stress levels in the columns

Cursory calculations indicate that the columns at the Ground Floor are highly stressed.

Item No.	Observation	Recommended Action Plan	Recommended Timeline
1	Apparently high stress levels in the columns	Building Engineer to review design, loads and column stresses in all columns.	<b>Immediate - Now</b>
2	Apparently high stress levels in the columns	Verify in-situ concrete stresses by 100mm dia. cores from 4 min. columns in each building.	<b>Immediate - Now</b>
3	Apparently high stress levels in the columns	A Detail Engineering Assessment to be commenced, see attached Scope.	<b>Immediate - Now</b>
4	Apparently high stress levels in the columns	Live load to be limited to 1.5kPa at all levels, pending outcome of Detail Engineering Assessment	<b>Immediate - Now</b>
5	Apparently high stress levels in the columns	Detail Engineering Assessment to be completed	<b>6-weeks</b>
6	Apparently high stress levels in the columns	Produce and actively manage a loading plan for all floor plates within the Buildings, giving consideration to floor capacity and column capacity.	<b>6-weeks</b>

7	Apparently high stress levels in the columns	Actions identified in the Detail Engineering Assessment to be implemented.	<b>6-months</b>
8	Apparently high stress levels in the columns	Continue to implement the load management plan.	<b>6-months</b>

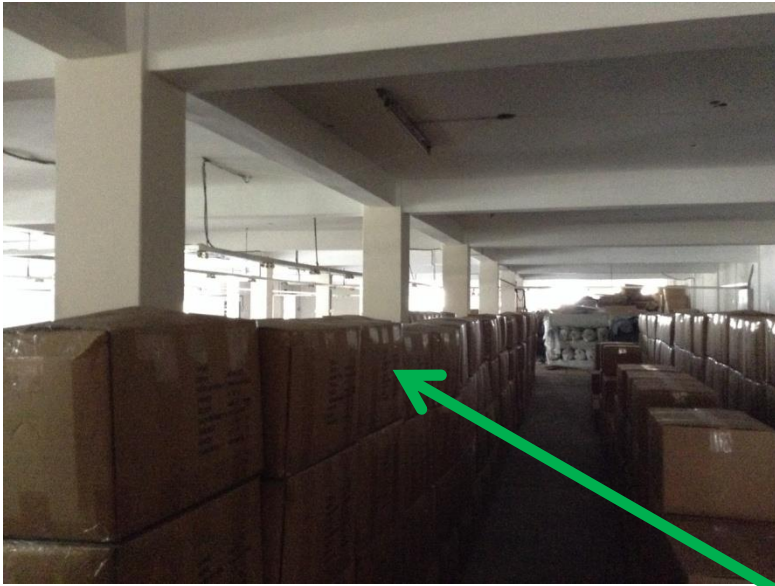
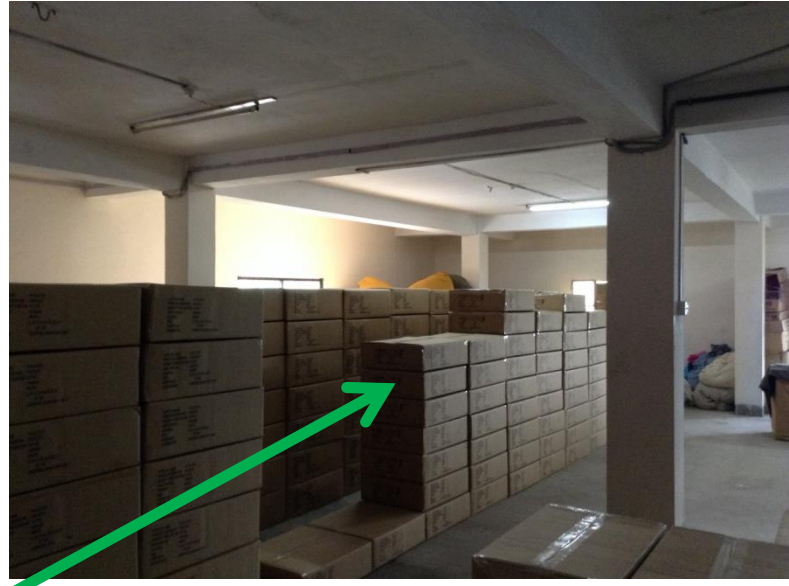
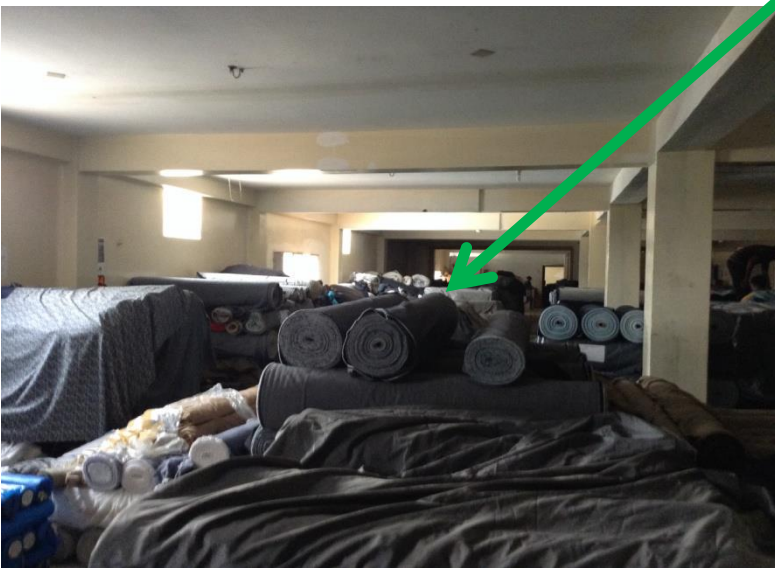
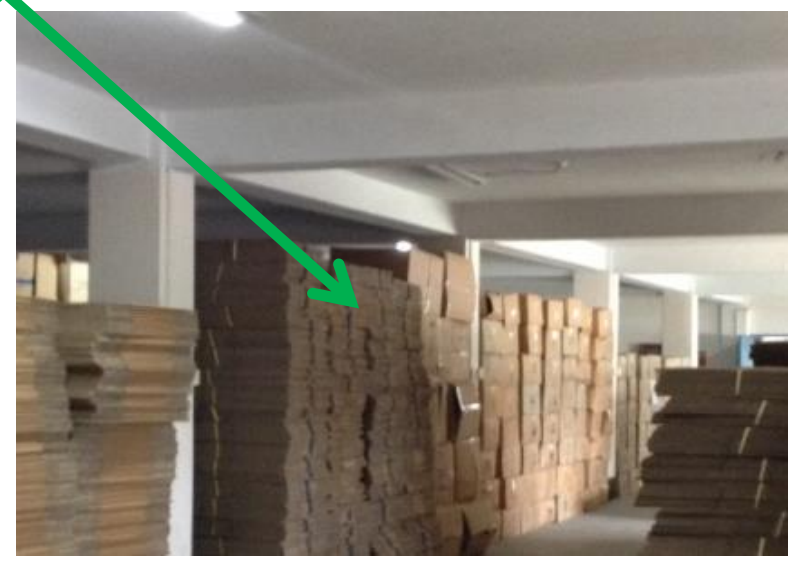
# Heavily-loaded areas

Loading of finished goods on 2<sup>nd</sup> and 1<sup>st</sup> floor level

Item No.	Observation	Recommended Action Plan	Recommended Timeline
9	Heavily-loaded areas	Pending the outcome of the Detail Engineering Assessment (see Item 1), live load to be limited to 1,5 kPa at all levels.	<b>Immediate - Now</b>
10	Heavily-loaded areas	As part of the Detail Engineering Assessment (see Item 1), Building Engineer to confirm design loading of slabs and incorporate it into the loading plan for all floor plates within the Building.	<b>6-weeks</b>
11	Heavily-loaded areas	Continue to implement the load management plan	<b>6-months</b>
12	Apparently small sized load transfer structure.	As part of the Detail Engineering Assessment (see Item 1), Building Engineer to carry out a design check to the load transfer structure on all the floors.	<b>6-weeks</b>
13	Apparently small sized load transfer structure.	Reconstruct or repair load transfer structure as necessary to ensure code adequacy.	<b>6-months</b>

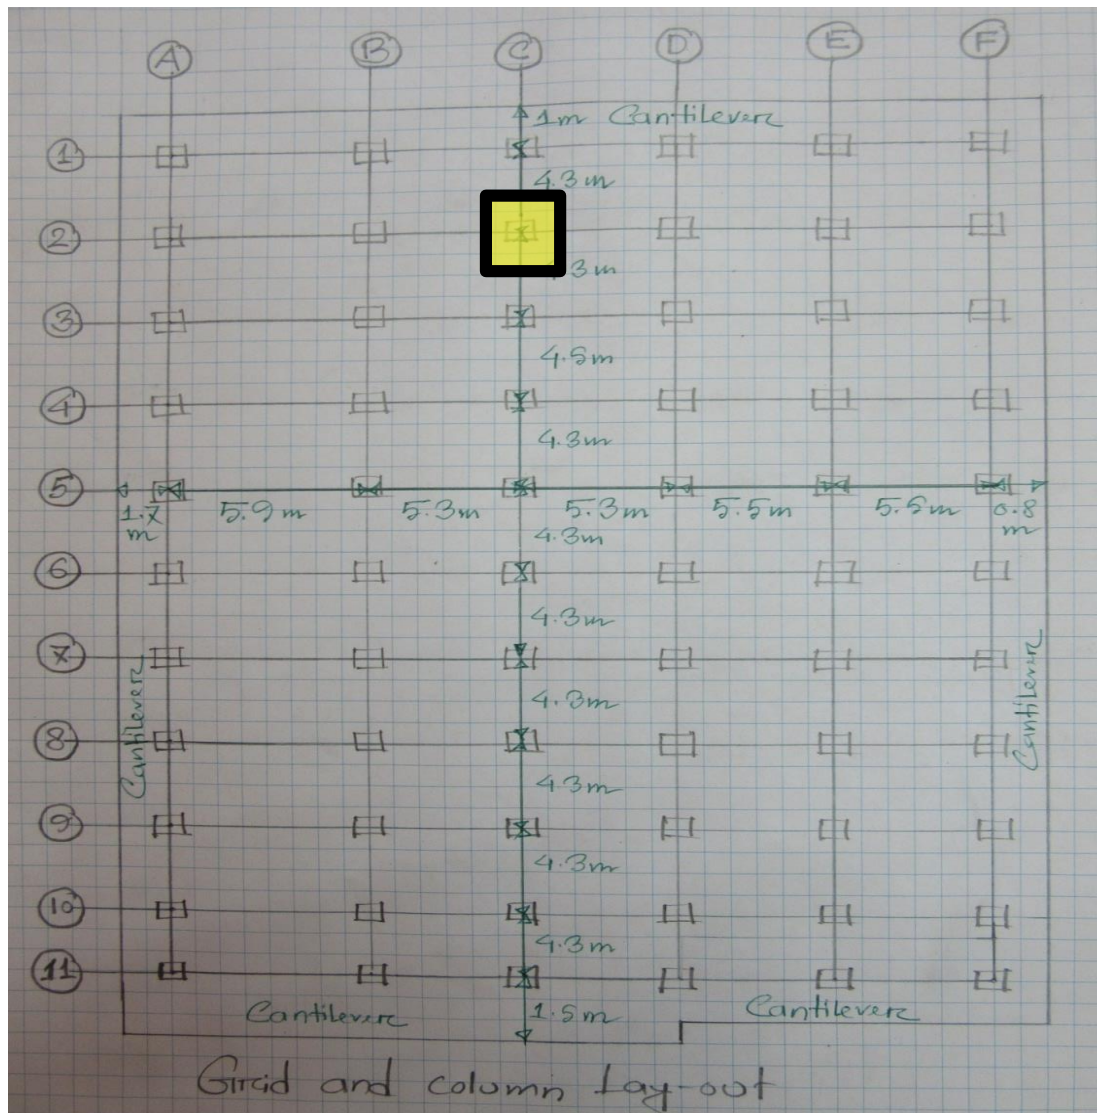
# Apparently small sized load transfer structure

The indicated column is present in the upper floors but absent on Ground, First and Second floors. Instead there are apparently small sized load transfer structure which is not indicate in the Design documentation. In the original design documentation the column is present all the floors.

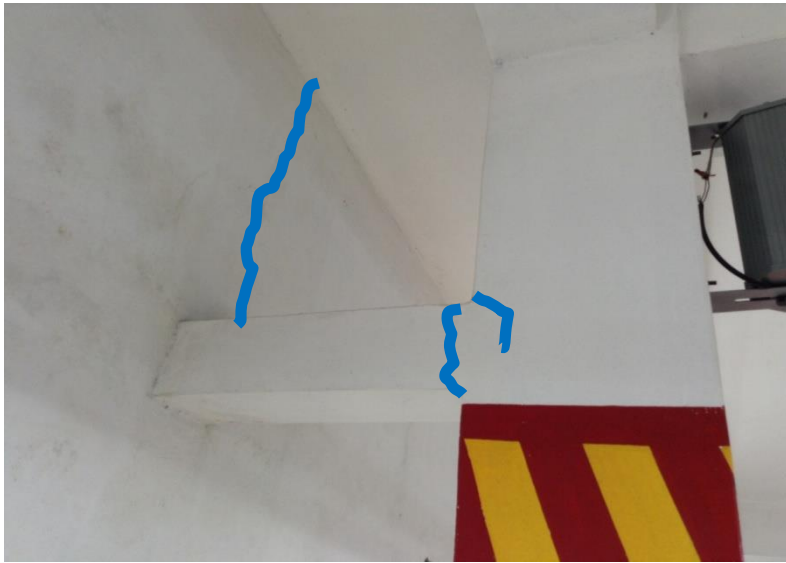
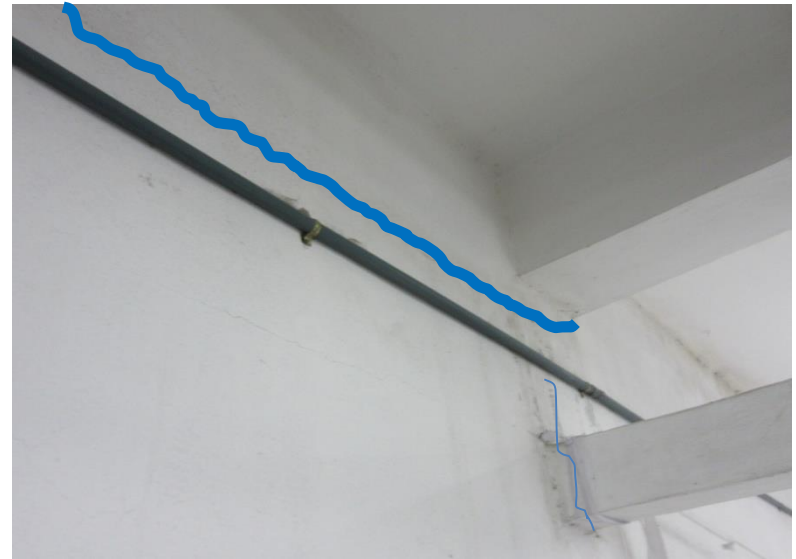
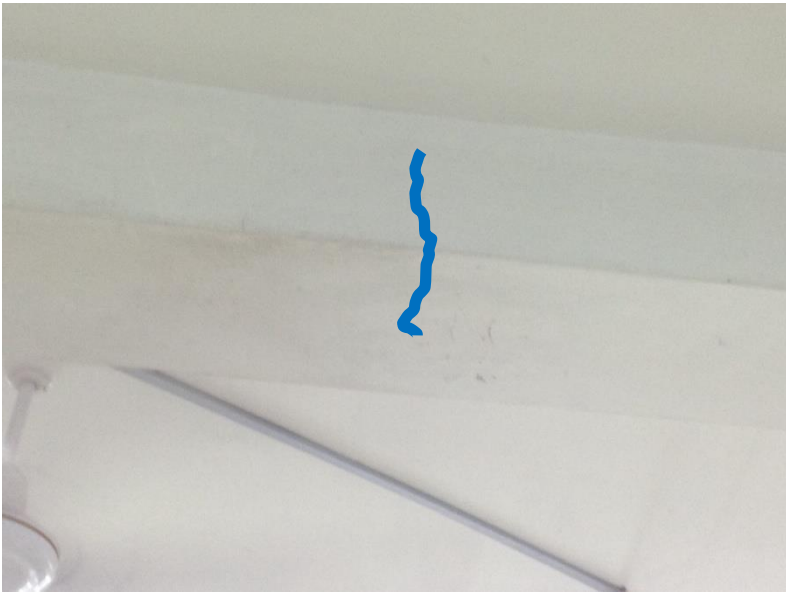
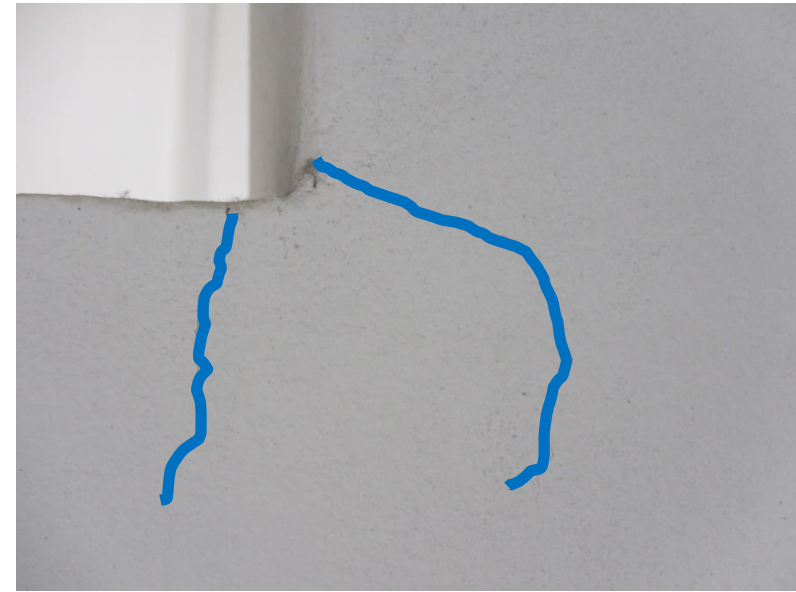
# Cracks in the structural elements

Cracks in different structural elements

14	Cracks in the structural elements	As part of the Detail Engineering Assessment (see Item 1), Building Engineer to investigate the reasons for the crack formation.	<b>6-weeks</b>
15	Cracks in the structural elements	Define the necessary remedial works.	<b>6-weeks</b>
16	Cracks in the structural elements	Monitor cracks to beams, slabs, columns and facades. Engage a Building Engineer to investigate if cracks are only in the internal plastering.	<b>6-months</b>
17	Cracks in the structural elements	Building Engineer to advise on load reduction and repair and strengthening of the structure if required.	<b>6-months</b>

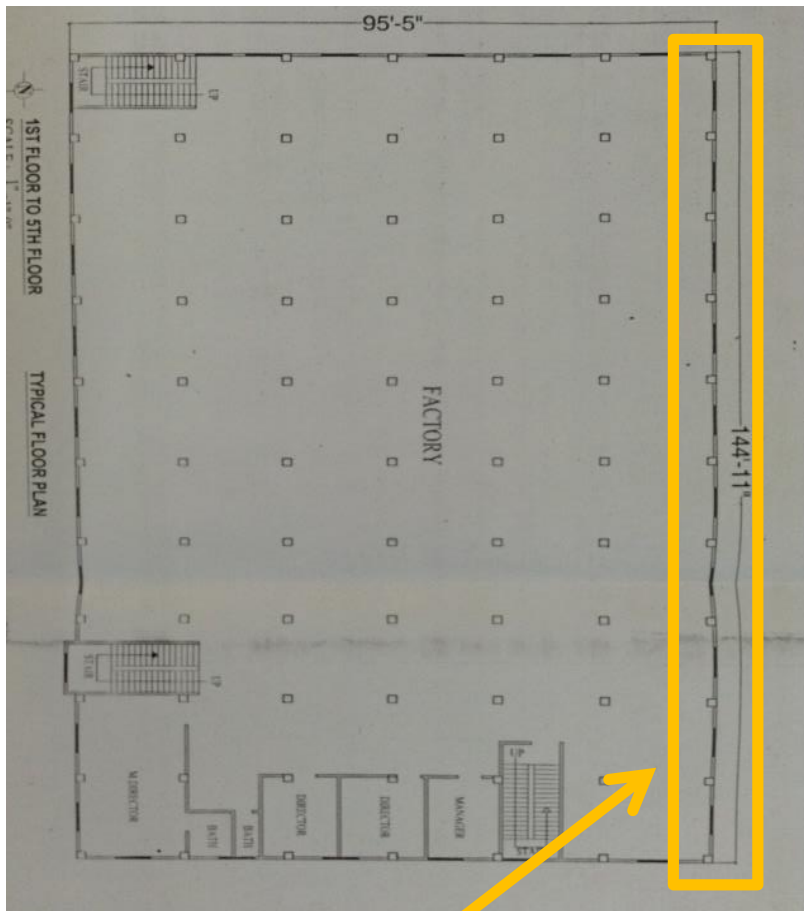
This row of columns shown in the permit drawings is absent in the as-built structure

Item No.	Observation	Recommended Action Plan	Recommended Timeline
18	Discrepancies between permit drawing, design drawings and as-built structure	As part of the Detail Engineering Assessment (see Item 1), Building Engineer to survey the as-built structure, including as-built floor finish thickness.	6-weeks
19	Discrepancies between permit drawing, design drawings and as-built structure	Building Engineer to produce accurate as-built drawings.	6-months
20	Non-permitted additional rooftop structures	As part of the Detail Engineering Assessment (see Item 1), Building Engineer to assess the additional rooftop structures in terms of their own engineering robustness and stability, and also their effect on the supporting structures.	6-weeks
21	Non-permitted additional rooftop structures	Repair or remove the additional rooftop structures as directed by the Building Engineer.	6-months
22	Non-permitted additional rooftop structures	Carry out any structural works as required to the supporting structures.	6-months

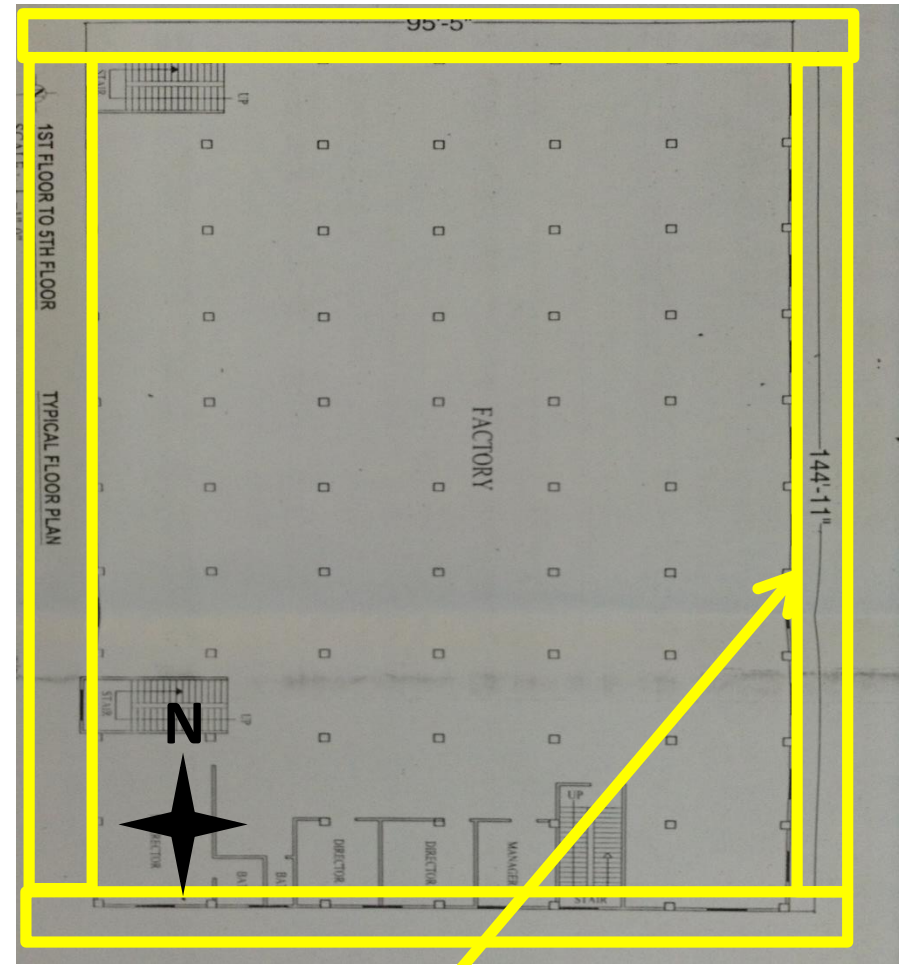
Cantilevers at four sides (5<sup>th</sup> & 4<sup>th</sup> floor) and at north and east sides (3<sup>rd</sup>, 2<sup>nd</sup> and 1<sup>st</sup> floor) are not shown in the permit drawings

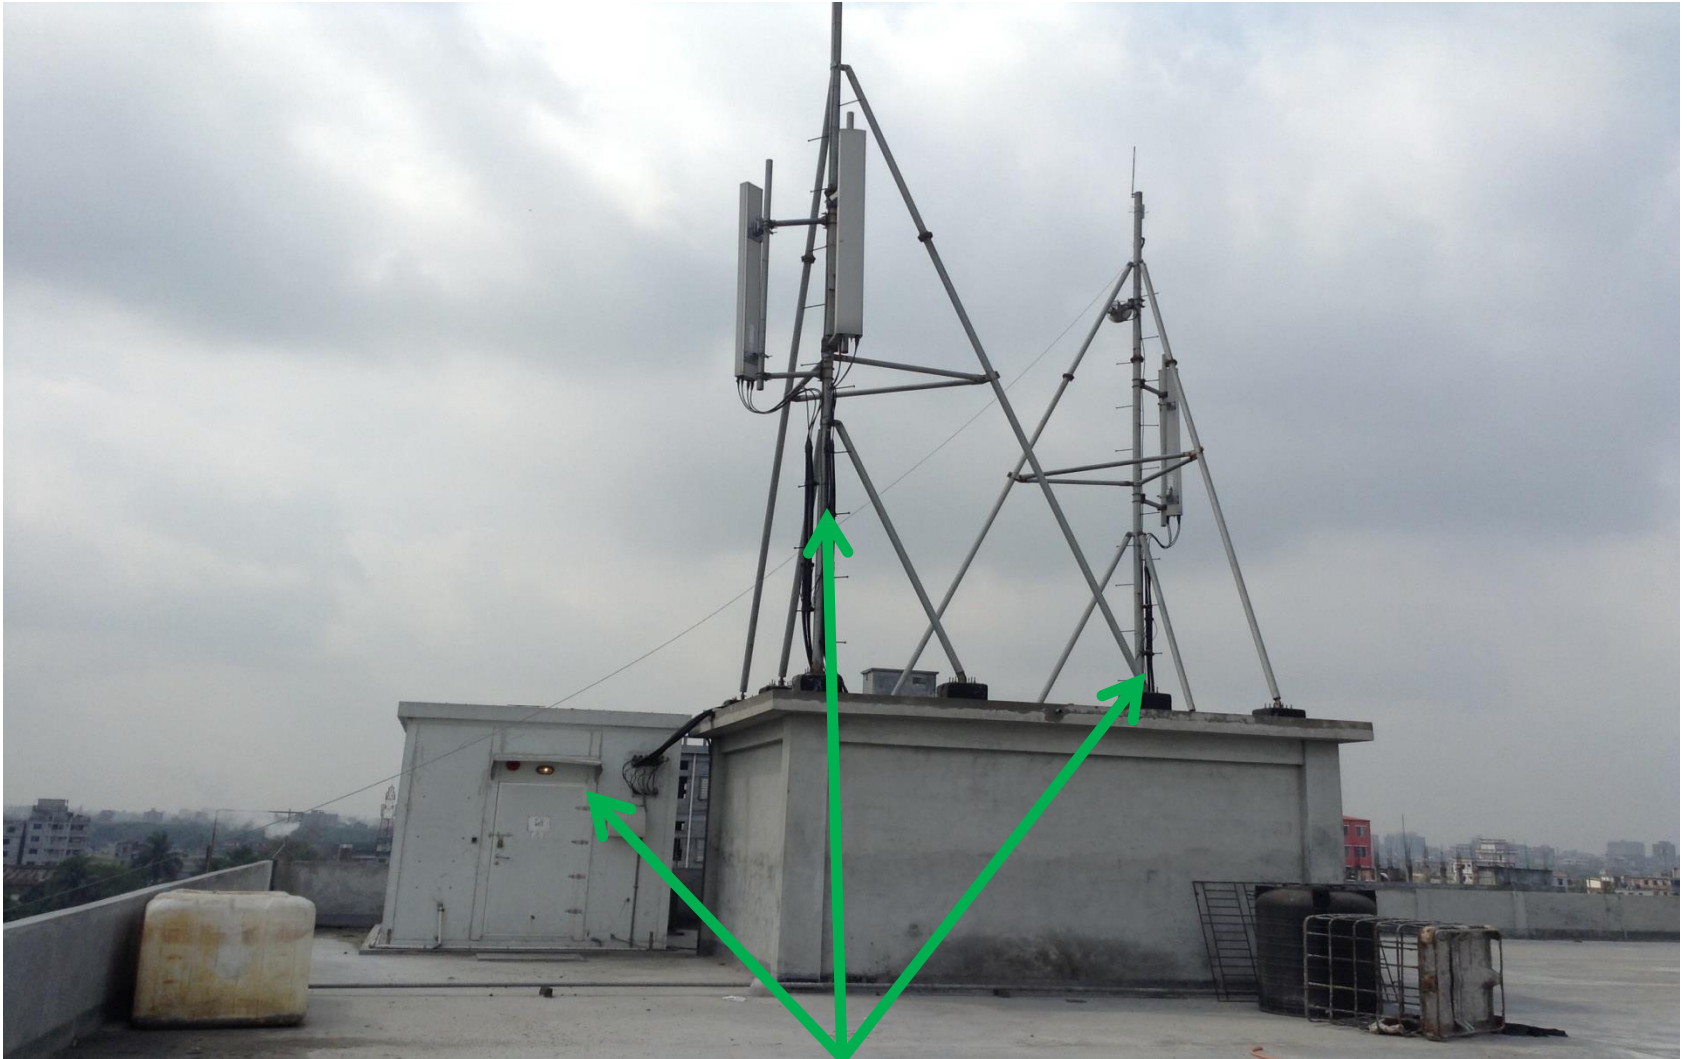
**Additional rooftop structure for mobile transmission tower was not shown in the permit drawings.**

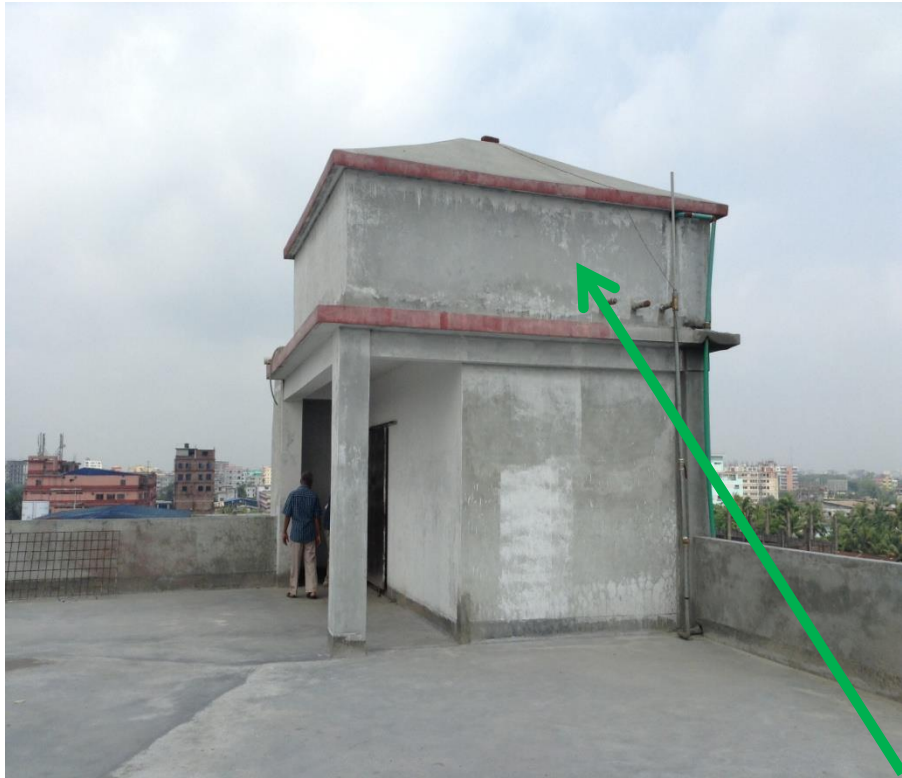
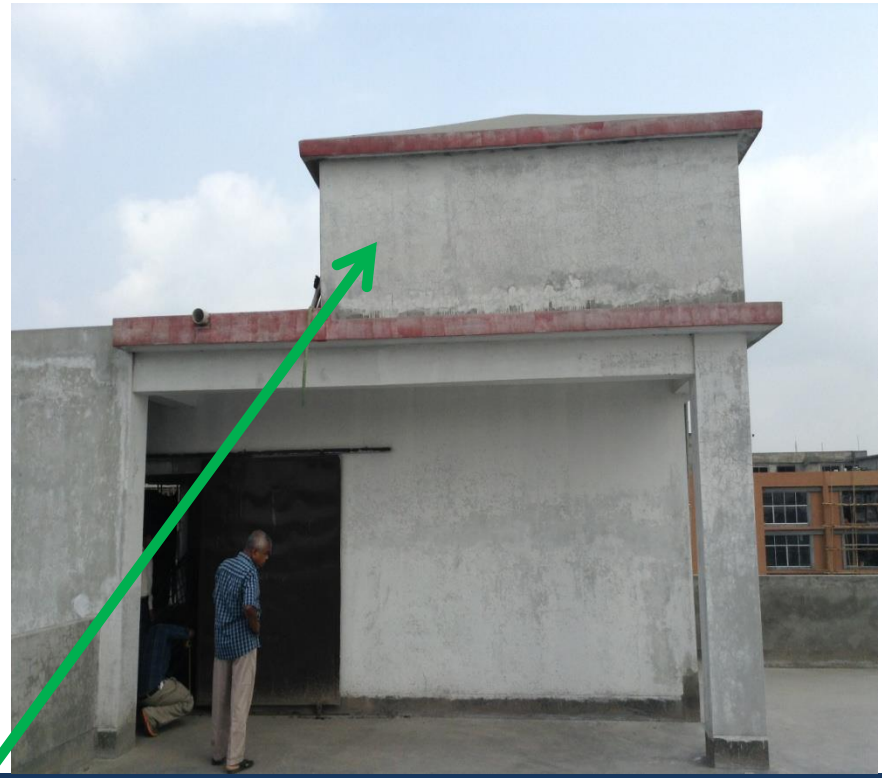
**Additional rooftop structure for RC water tank was not shown in the permit drawings.**
