# **FIRE SAFETY INSPECTION REPORT**

## **LATEST GARMENTS LTD**

**ACCORD**  
on Fire and Building Safety in Bangladesh

May 20, 2014

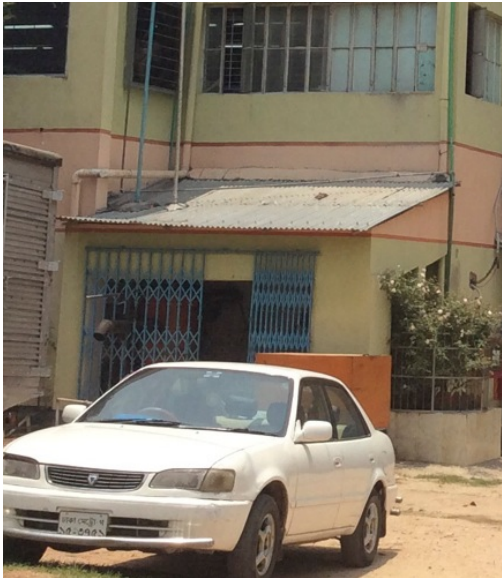
| No. | Category | Finding | Recommendation | Remediation Timeframe |
|---|---|---|---|---|
| F-1 | Fire Rated Construction | The boiler room on the ground floor is not separated by fire-rated construction due to a non-rated roof with an unprotected window above it. | Separate the boiler room by a minimum 2-hr fire-rated construction. Seal and/or protect all openings to maintain the required fire separations | Within 3 months |

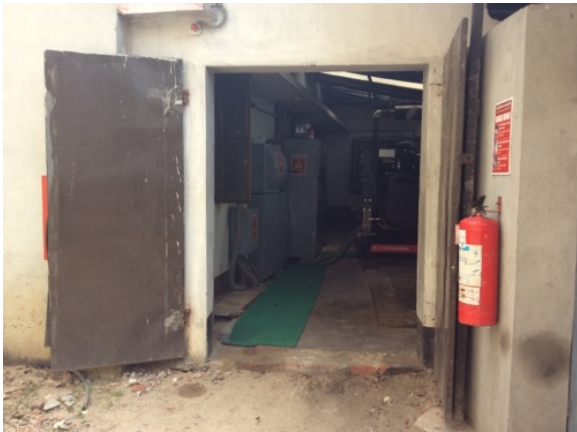
| No. | Category | Finding | Recommendation | Remediation Timeframe |
|---|---|---|---|---|
| F-2 | Fire Rated Construction | The generator room in the utility building is open to the egress path from the South stair due to a non-rated door. | Separate the generator room by a minimum 2-hr fire-rated construction. Seal and/or protect all openings to maintain the required fire separations | Within 3 months |

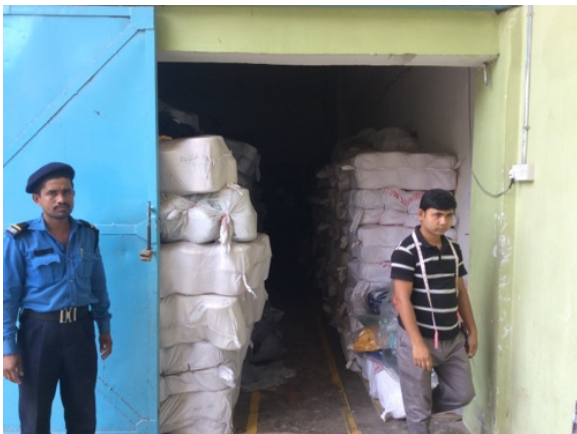
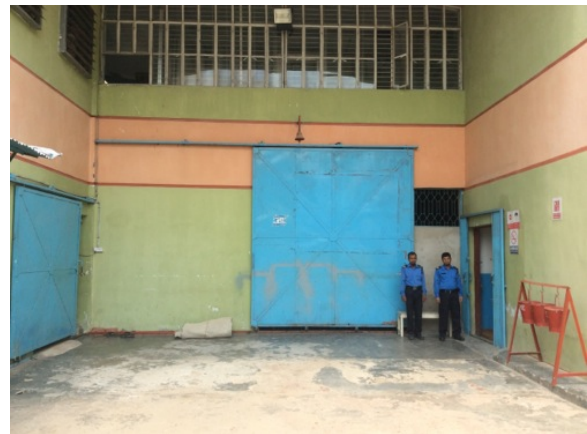
| F-3 | Fire Rated Construction | The warehouse is open to the North stair discharge due to a non-rated door. | Provide dedicated storage rooms separated by minimum 1-hr fire-rated construction. | Within 3 months |

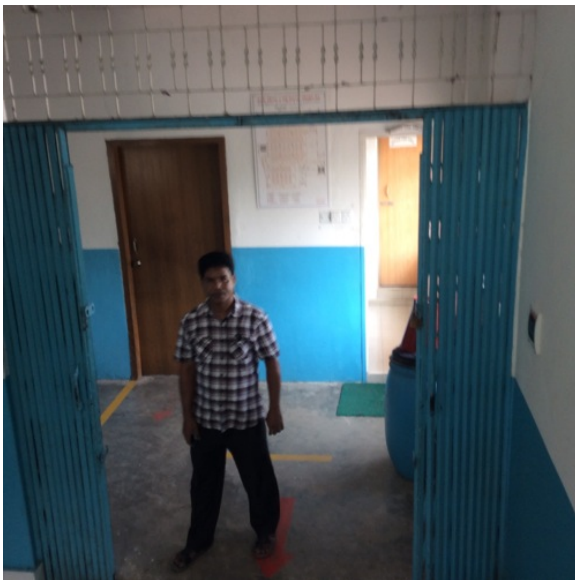
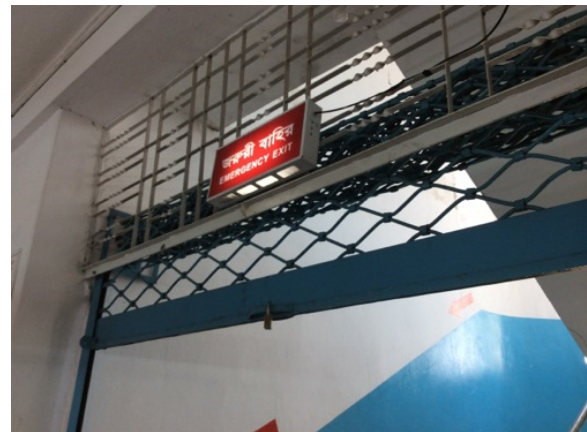
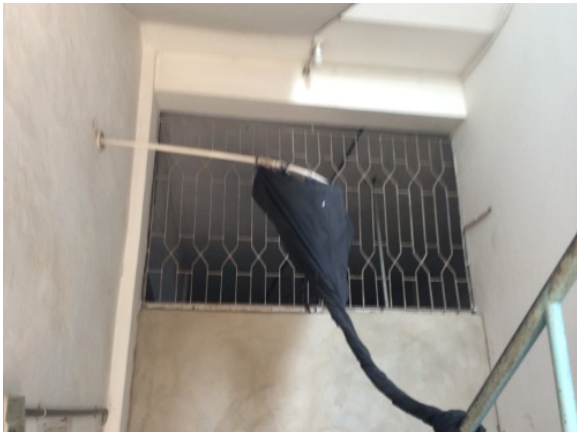
| F-4 | Fire Rated Construction | The exit stairs are not separated from work areas and other spaces on each floor by fire-rated construction. Non-rated doors and vent openings are present on each floor. | Provide minimum 1.5-hr fire rated doors and seal all unprotected openings to separate the exit stairs from work areas and other building spaces on all floor levels. Ensure that the fire doors are self-closing and positive latching and that they are provided with fire exit (panic) hardware where serving production floors. | Within 3 months |

If fire doors are required to be held open for functional reasons, provide automatic-closing devices tied to the fire alarm system.

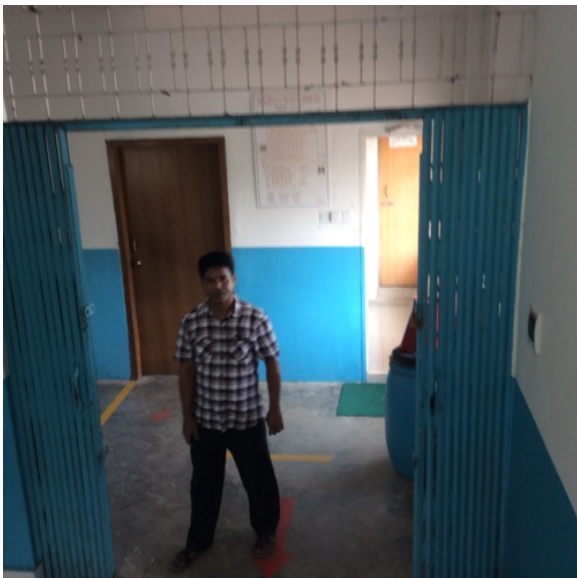
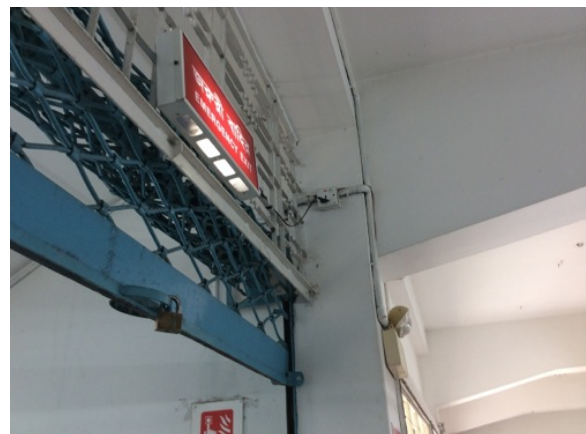
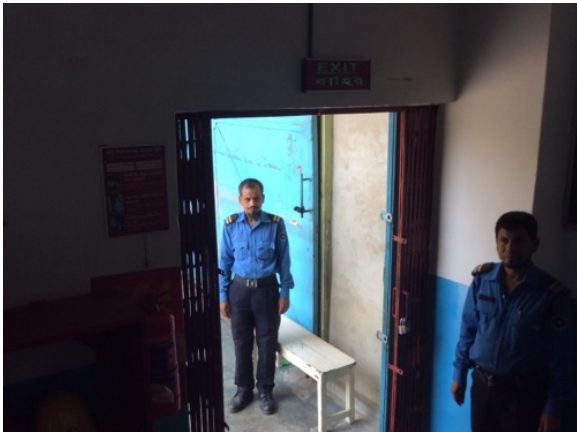
| F-5 | Egress | Egress doors and gates with locking features are provided at all exit stair openings and discharge. | Remove locking features from all egress doors and gates. If locks are required for security reasons, utilize special door locking features complying with NFPA 101. | Immediate |

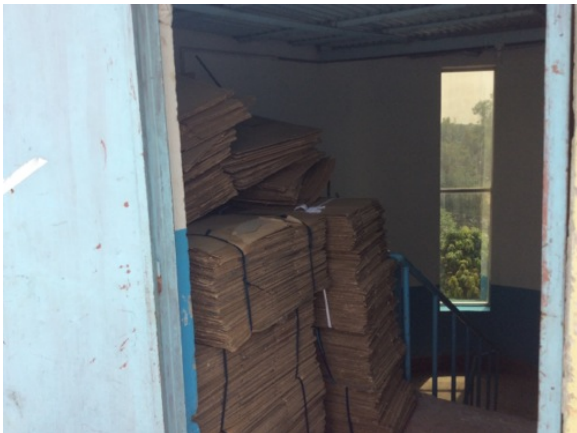
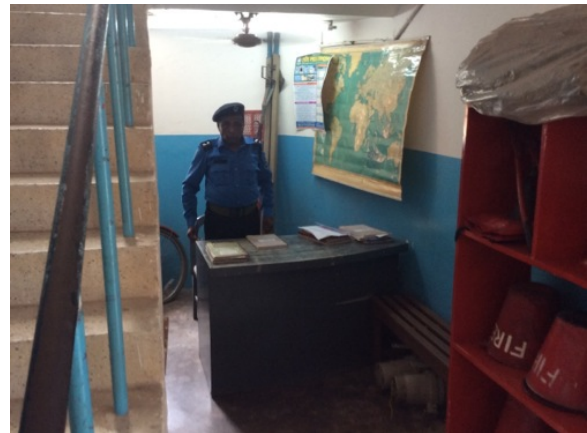
| F-6 | Egress | Storage was located in the exit stair. Piled cardboard was observed at the top of the North stair. A security desk was observed at the bottom of the North stair. | Remove all storage from exit stairs and egress paths. | Immediate |

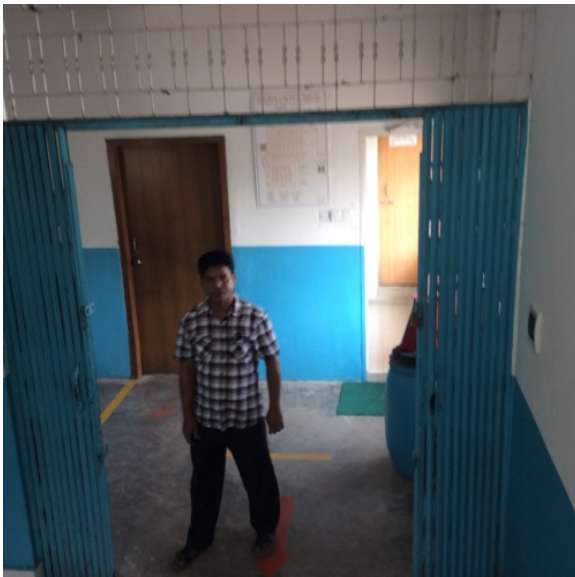
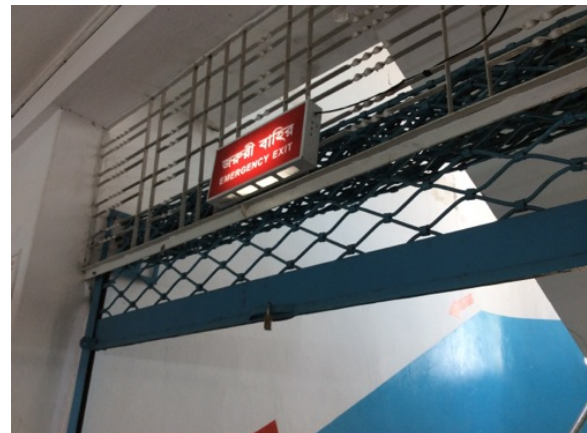
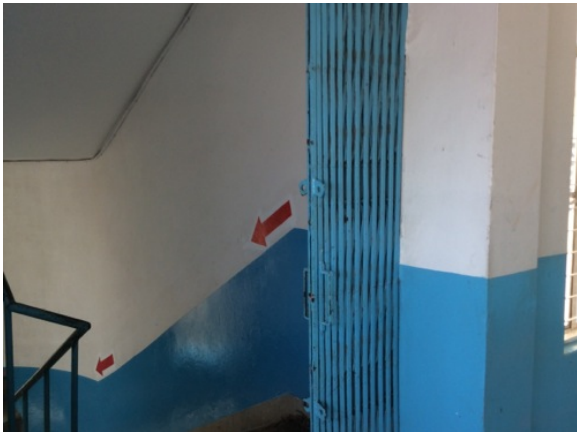
| F-8 | Egress | Coiling gates, sliding gates or sliding doors are provided at all exit stair openings and discharge. | Replace all gates and sliding doors along the means of egress with side-hinged, swinging egress doors.<br><br>If locks are required for security reasons, utilize special door locking features complying with NFPA 101. | Within 1 month |

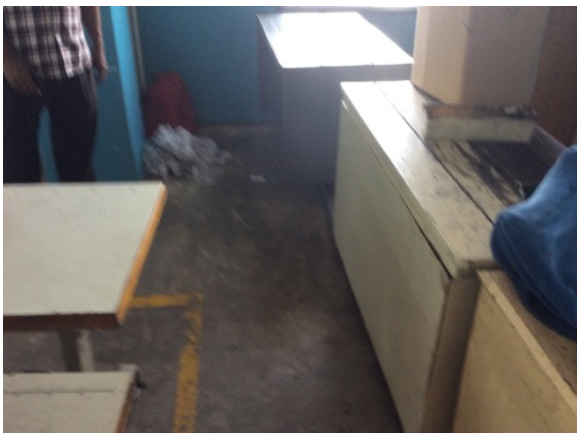
| F-9 | Egress | An egress aisle on the 2nd floor is restricted to 22 inches by a desk. | Provide minimum aisle widths of 36-in. | Within 3 months |

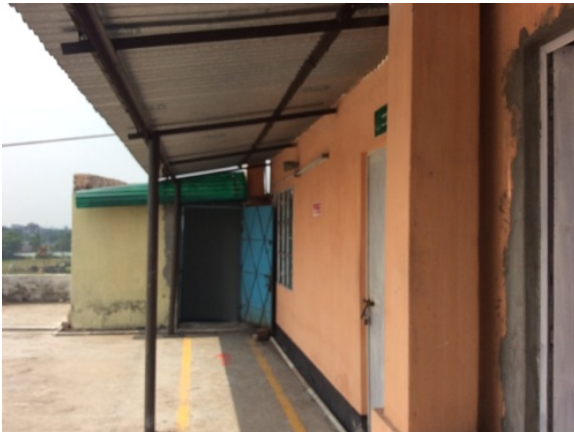
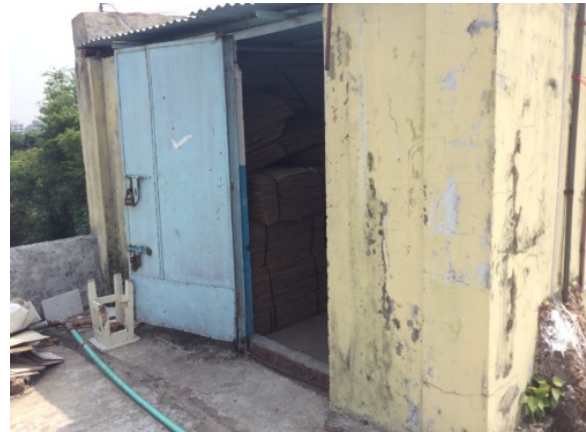
| F-10 | Egress | Doors to both stairs from the occupied roof (serving 250 occupants) swing against the direction of egress. | Modify the egress door to swing in the direction of egress travel. | Within 3 months |

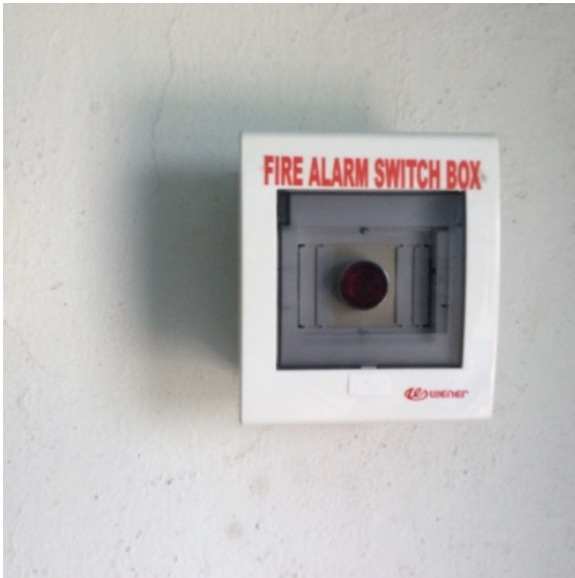
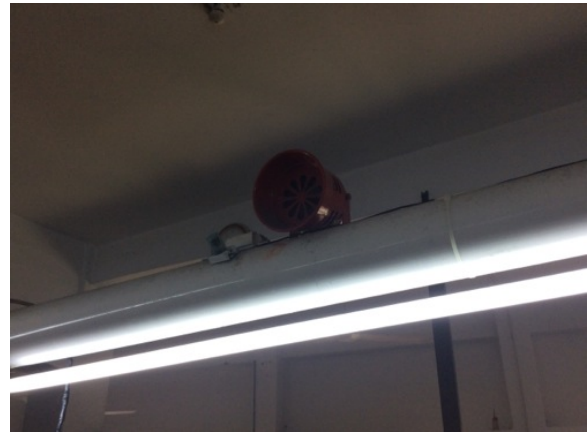
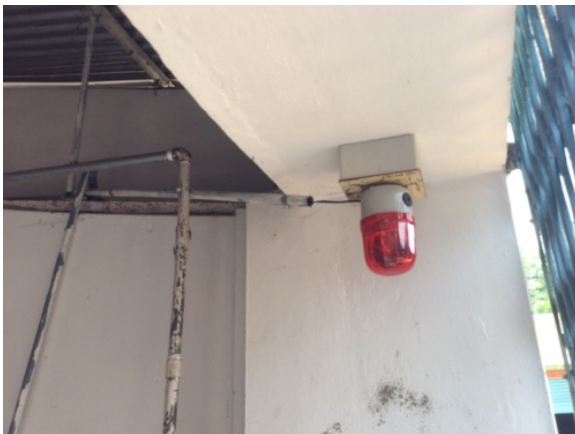
| F-12 | Fire Protection | The fire alarm system is antiquated, not a listed system, and does not provide alarm and notification features consistent with acceptable standards. | Replace the fire alarm system with a new, listed addressable fire alarm system in accordance with NFPA 72. | Design within 4 months, install within 9 months |

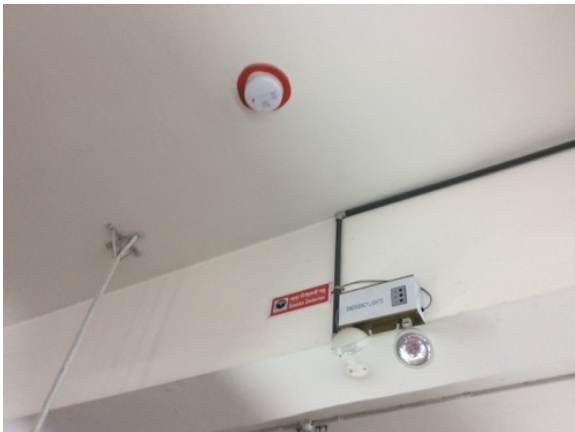
| F-14 | Fire Protection | The building is equipped with single-station smoke alarms. Smoke alarm activation sounds only a local alarm and does not provide automatic fire alarm notification of occupants. | Remove single-station smoke alarms. Provide automatic smoke detection throughout the building in accordance with NFPA 72. | Within 6 months |

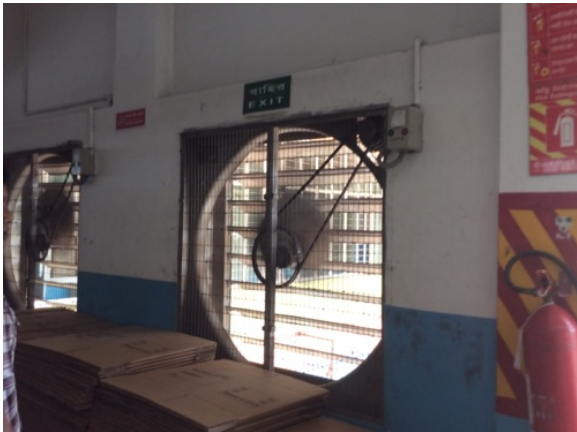
| F-15 | Egress Lighting | An exit sign was posted over a ventilation fan on the 1st floor where no exit was located. | Remove misleading exit sign. | Immediate |

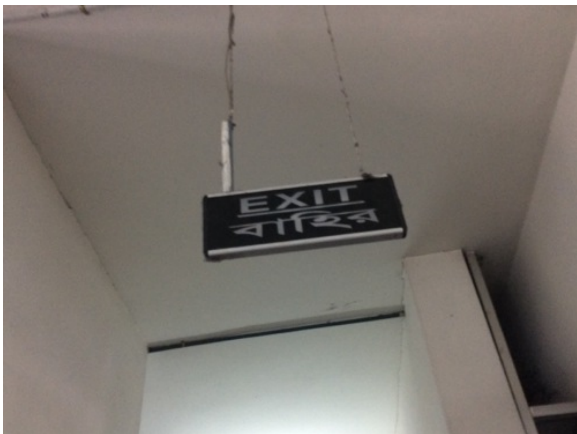
| F-16 | Egress Lighting | Exit signage was observed to not be lit on 1st floor. | Regularly inspect all exit signage and replace/install lights as needed to illuminate signs. | Within 1 month |

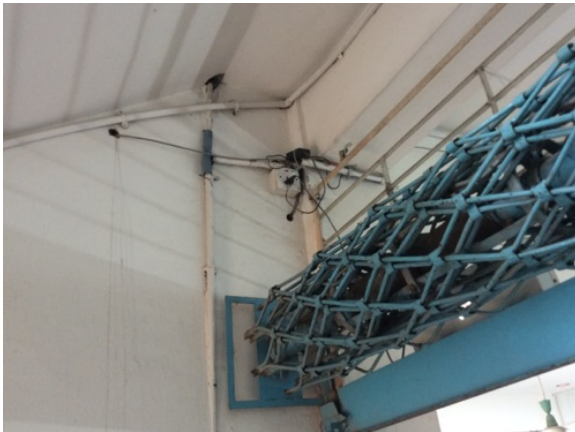
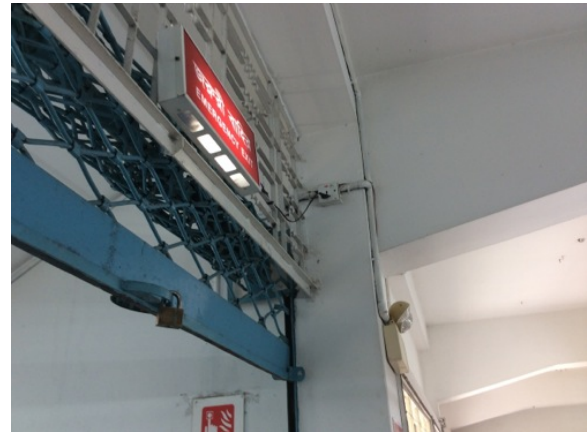
| F-17 | Egress Lighting | Manual on-off switch is provided for multiple exit signage units. | Remove manual on/off switches from exit signage units to prevent them from being switched off. | Within 1 month |

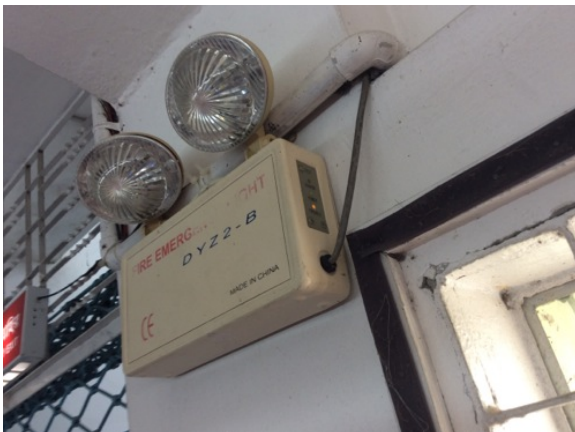
| F-18 | Egress Lighting | Emergency lighting on 2nd floor near the South stair did not function in test mode, and was observed to have a failure indicator lit. | Regularly test the emergency lighting system on each floor and replace/repair lights as needed. | Within 1 month |
