# Regency Garments Ltd (Unit 1)

Plot # 60-62, Sector # 1, CEPZ, Chittagong, Bangladesh  
(22.291652N 91.773435E)

21 April 2015

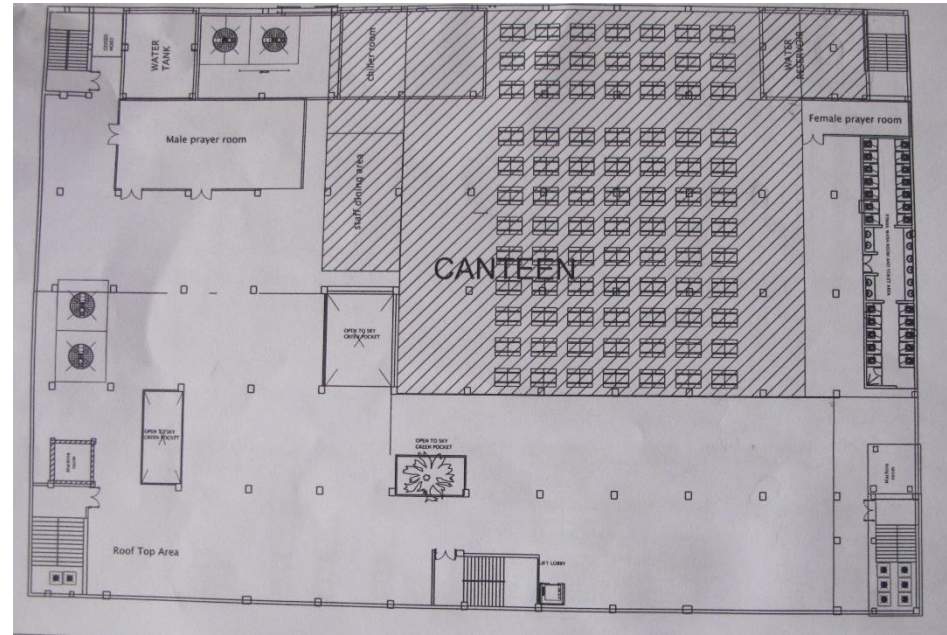
## Architectural drawing showing proposed new canteen and ancillary accommodation

Proposed additional Canteen and ancillary accommodation shown on architectural layout but no account taken for this on structural drawings  
Proposed construction is RC stub columns, steel columns and lightweight steel roof.  
Brickwork infill around perimeter of canteen and other accommodation (all brickwork observed on site is solid 250mm thk walls). Toilets shown with undetermined floor build-up

Item No.	Observation	Recommended Action Plan	Recommended Timeline
1	Undocumented proposed Canteen and ancillary accommodation on Roof Undocumented proposed Canteen and ancillary accommodation on Roof	Building engineer to review proposed additional structures and loading and assess capacity of the existing structure to support the loads.	6-months
2	Undocumented proposed Canteen and ancillary accommodation on Roof Undocumented proposed Canteen and ancillary accommodation on Roof	Document the additional structures fully including calculations and updated as-built drawings	6-months
3	Inaccuracies in 'as-built' structural drawings	Building engineer to collect information and produce accurate and complete as-built documentation at soonest opportunity.	6-months
4	Undocumented Mezzanine floor structures between Ground and 1st Floors	Structural engineer to assess the existing steel and composite structure and confirm its capacity to support the applied loading, particularly the foundation support structure.	6-months

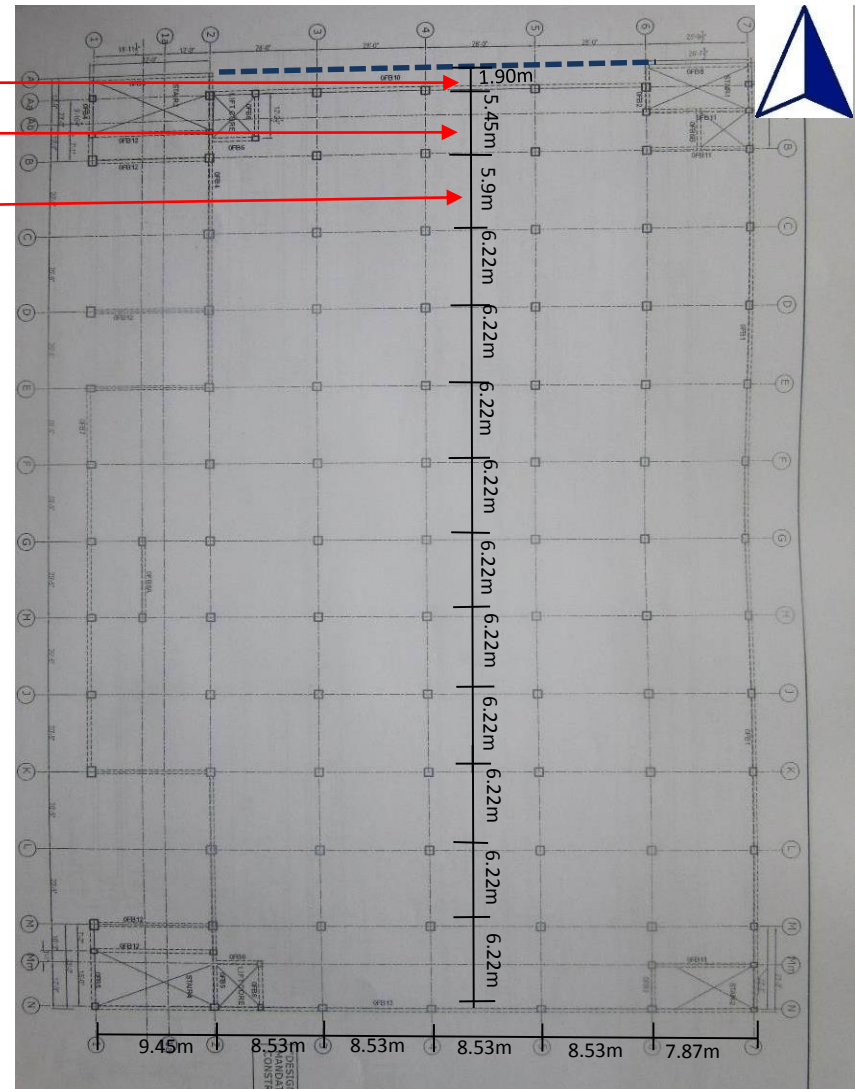
As-built Structural Drawing showing measured dimensions

Cantilever not shown  
on Structural drawings

Dimensions of these  
two bays incorrect on  
structural drawings

As-built structural drawings do not show 1.9m cantilever on N side of the building, and two end bay dimensions are incorrect

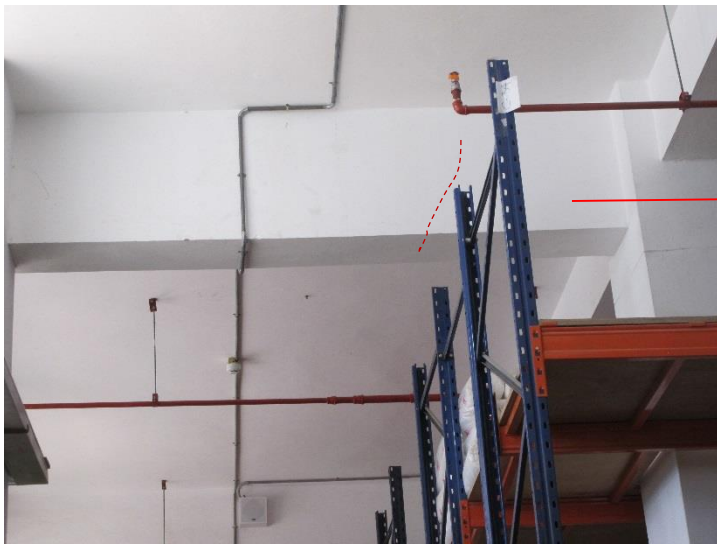
Hairline crack in beam

5	Undocumented Mezzanine floor structures between Ground and 1st Floors	Document the additional structures fully including calculations and updated as-built drawings .	6-months
6	Cracking of brickwork panel adjacent to loading bay	Repair cracks in brickwork panel and monitor for further cracking.	6-months
7	Cracking of brickwork panel adjacent to loading bay	Structural engineer to review if further cracking occurs	6-months

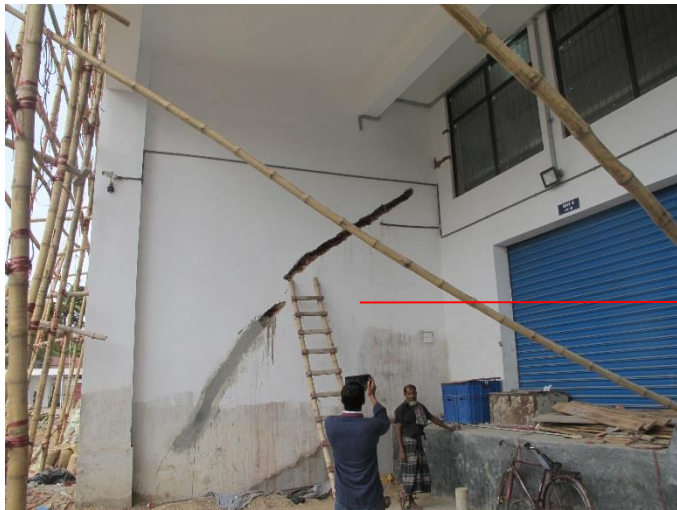
Line of brick facade

Large crack in brick wall panel

Diagonal crack in brick wall panel, suggest some subsidence in area of loading bay

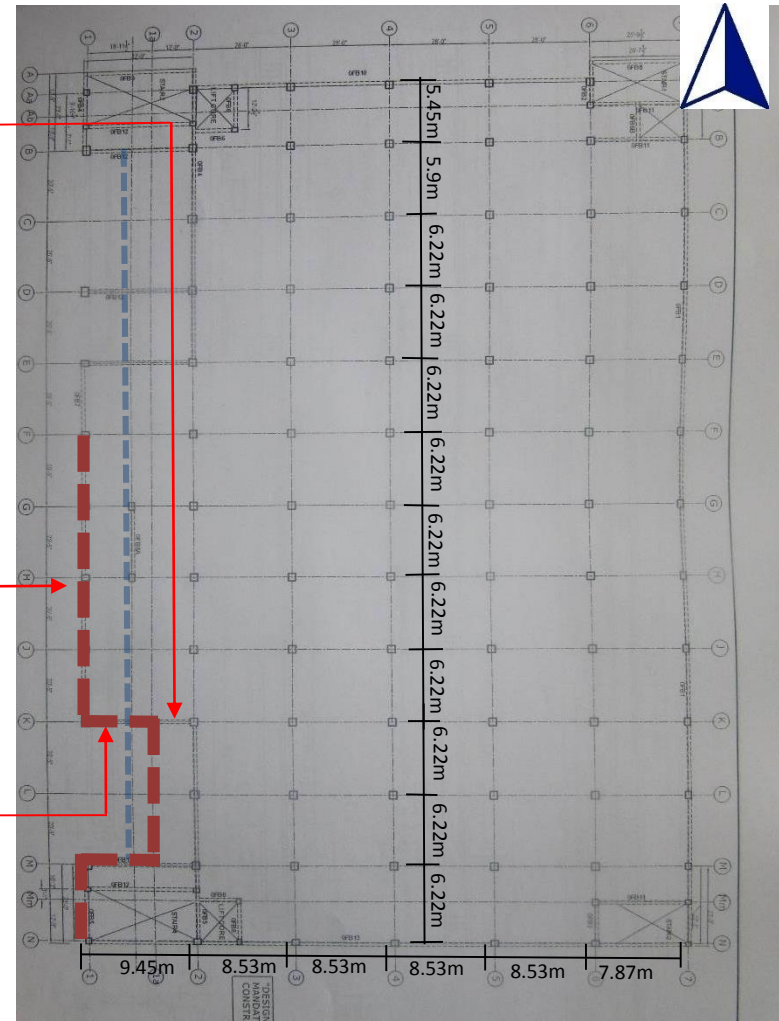
Area adjacent to loading bay where cracking occurred
