# Ratool Apparels Ltd.

Ansar Road , Vangnahati , Sreepur Paurosova , Gazipur 1740

18 April 2015

# Observations

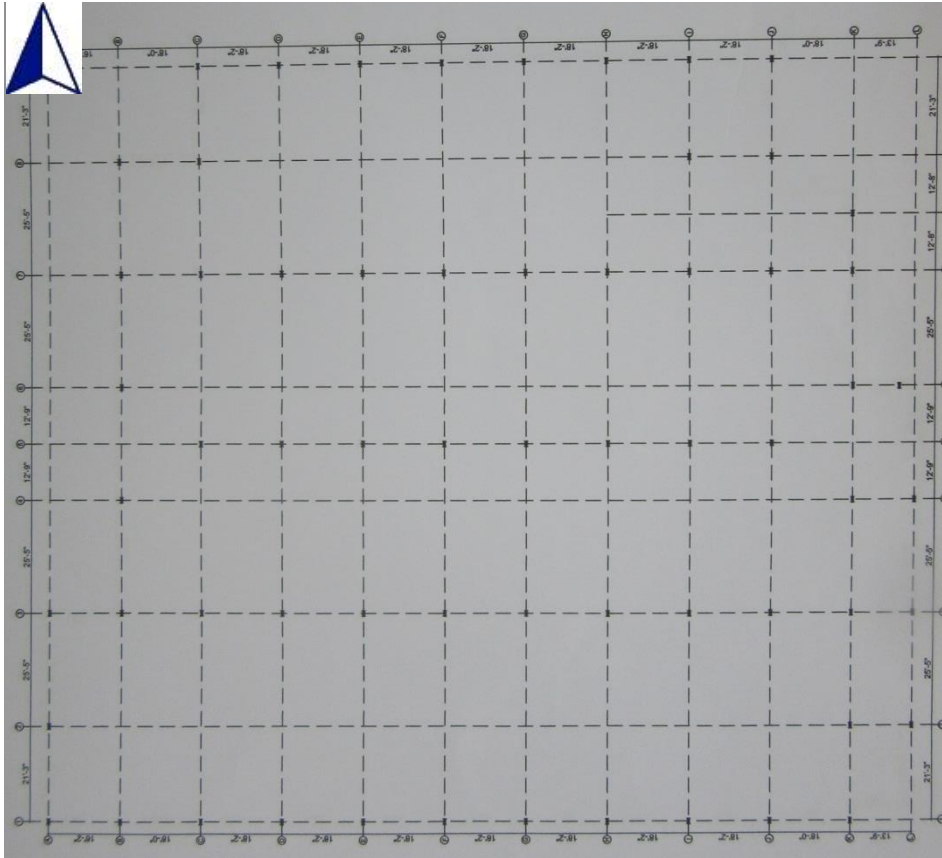
### Industrial shed-01

Neither vertical or horizontal bracing were observed in the design or at during the survey as constructed structure.

| Item No. | Observation | Recommended Action Plan | Recommended Timeline |
|---|---|---|---|
| 1 | No-apparent lateral stability system (missing bracing) | Building Engineer to investigate the lateral stability of the buildings. Code adequacy to be ensured. | 6-months |
| 2 | No-apparent lateral stability system (missing bracing) | Eventual remedial works to be defined. | 6-months |
| 3 | No-apparent lateral stability system (missing bracing) | Make any structural alterations as advised by Building Engineer. | 6-months |

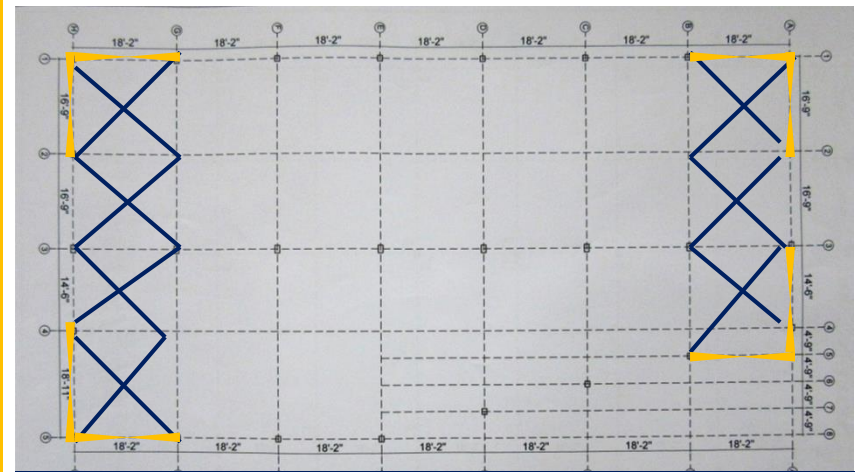
### Industrial shed-02

Non apparent lateral stability system. Possible vertical and horizontal bracing could look like the indicated drawings which were not observed on site.

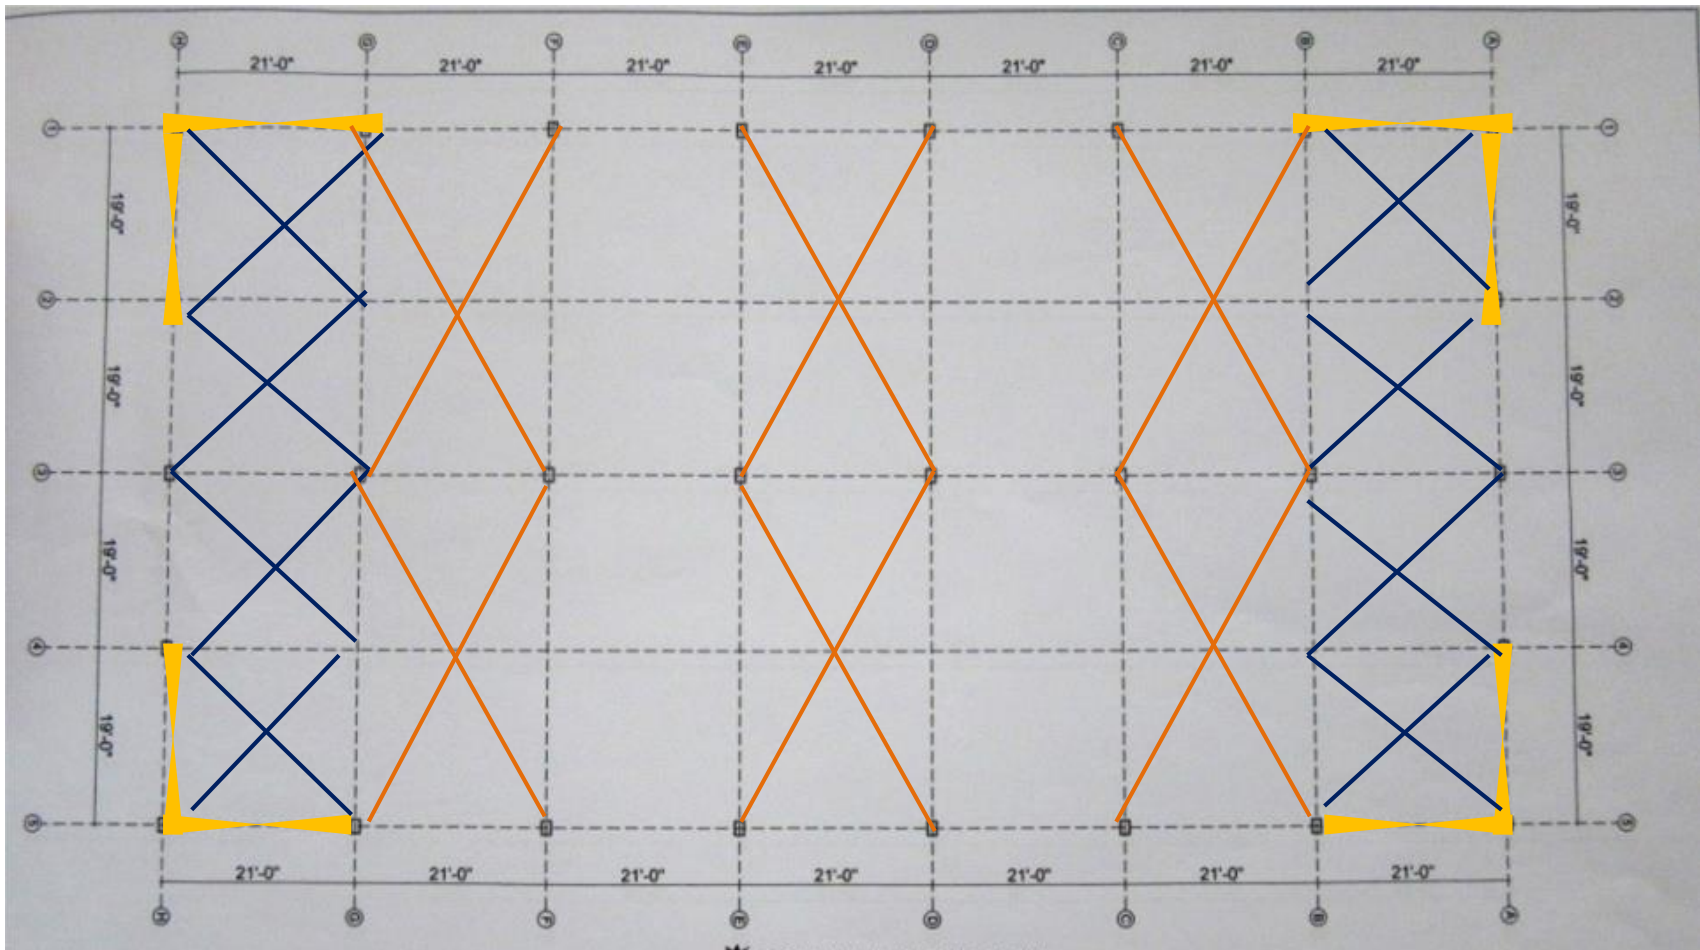
Observed bracing is not on the expected position.

Observed bracing

Apparent logical position of bracing

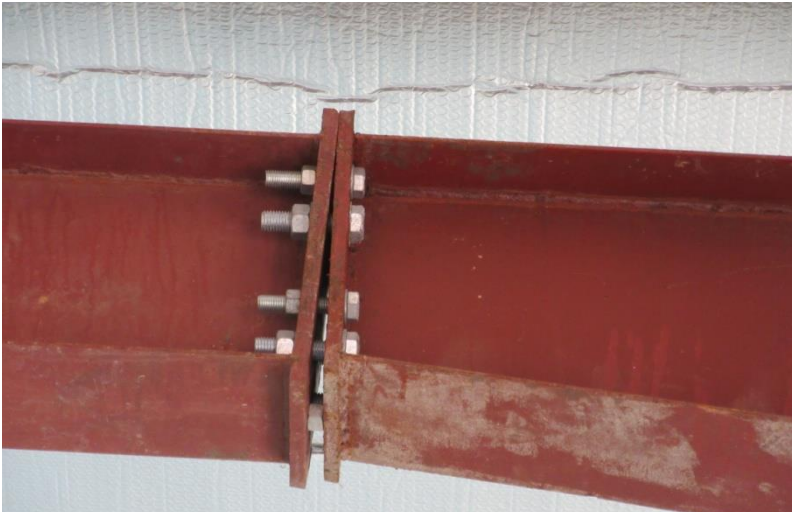
Apparently not a full contact of the connection plates.

| Item No. | Observation | Recommended Action Plan | Recommended Timeline |
|---|---|---|---|
| 4 | Apparently non-engineered structural details and connections (not a full connection of the plates, missing vertical plates; missing bolts) | Building Engineer to survey the connection details in the as built structure. | 6-months |
| 5 | Apparently non-engineered structural details and connections (not a full connection of the plates, missing vertical plates; missing bolts) | Code adequacy to be ensured. | 6-months |
| 6 | Apparently non-engineered structural details and connections (not a full connection of the plates, missing vertical plates; missing bolts) | Complete any structural alterations as advised by Building Engineer. Omissions to be eliminated. | 6-months |

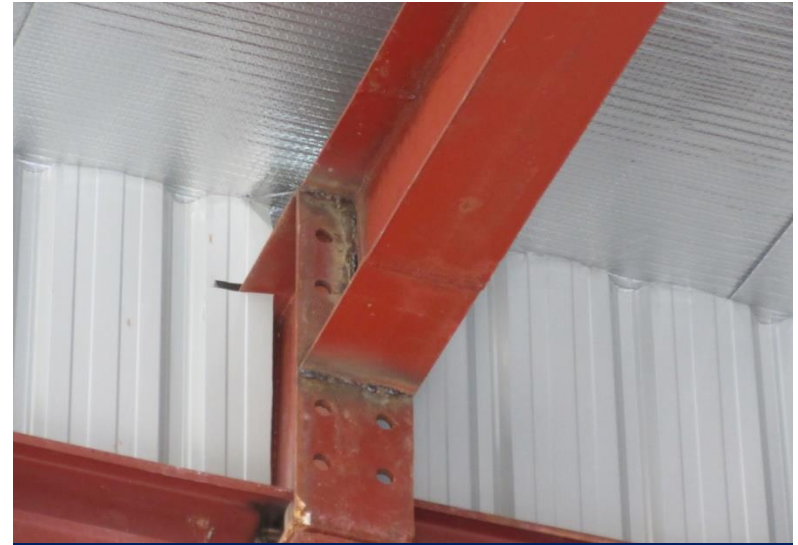
Missing bolts.

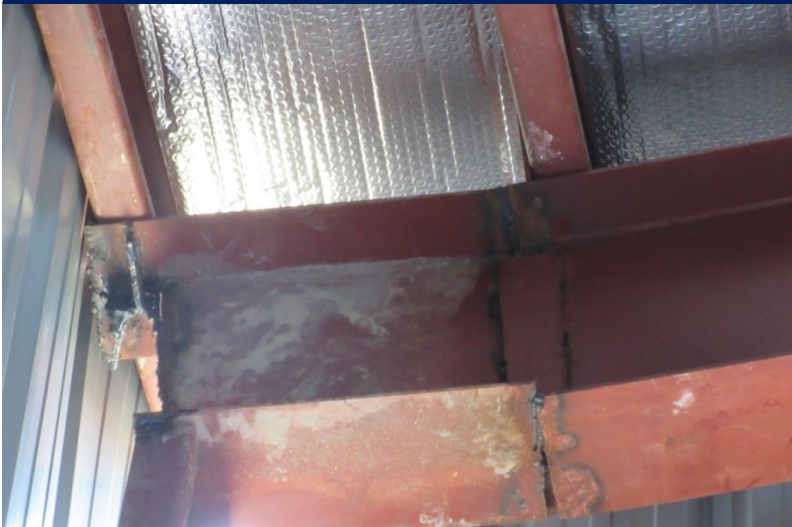
Non-engineered joint.

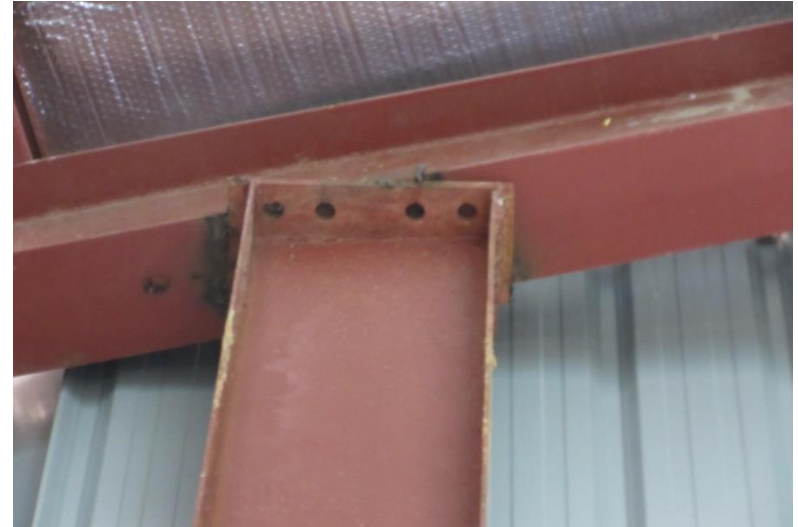
Missing bolts.

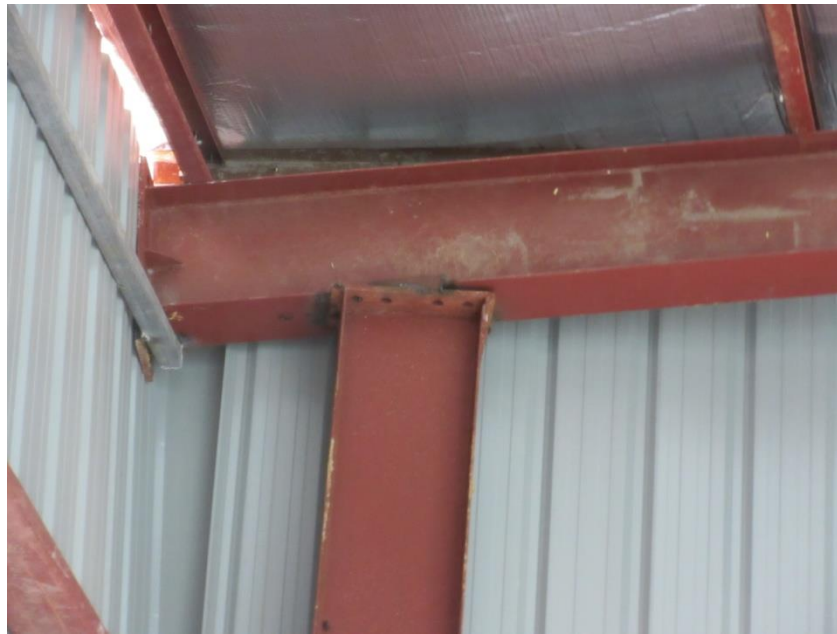
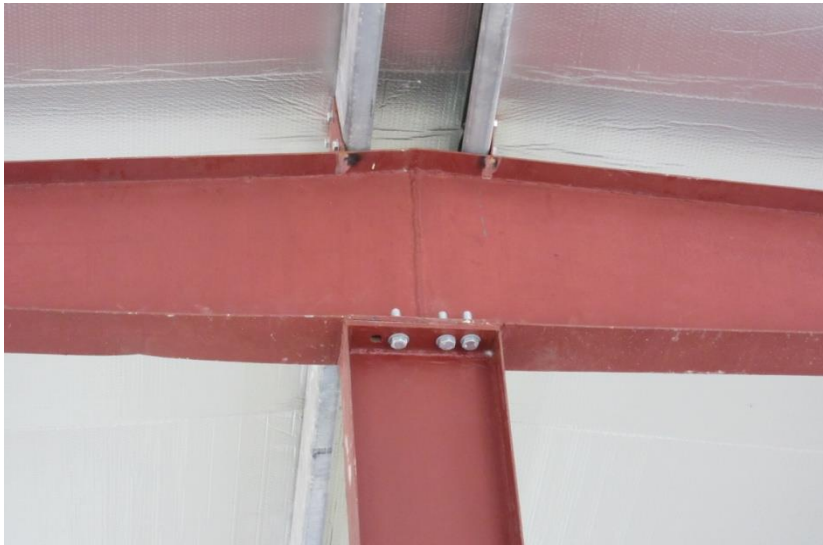
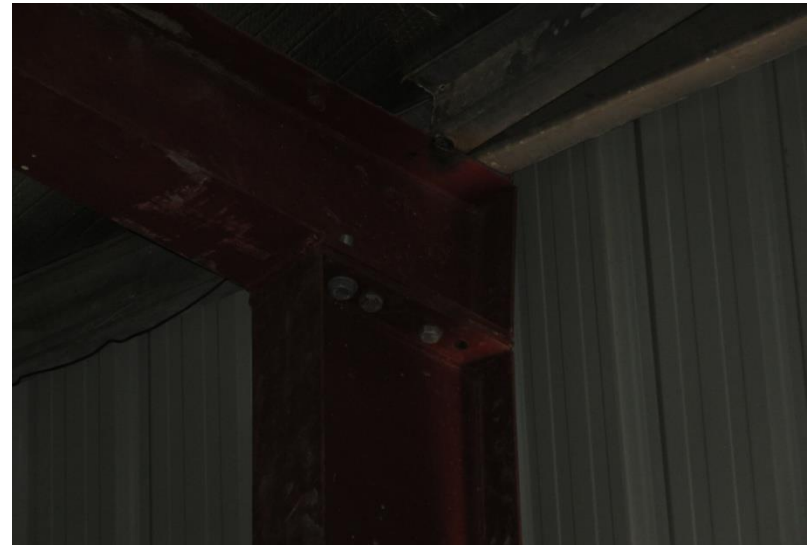
Non apparent transfer of vertical effort to columns due to the absence of steel rib.

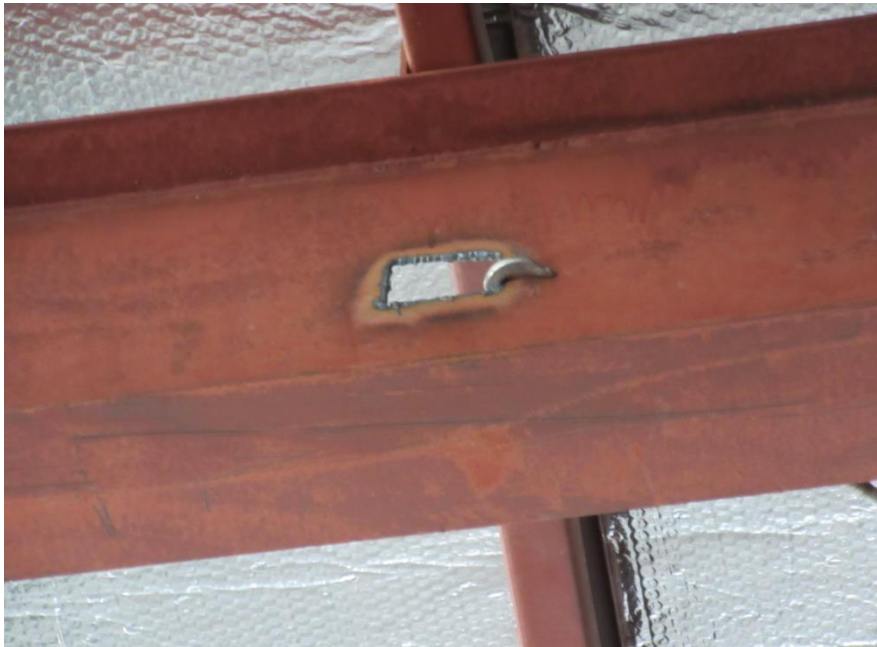
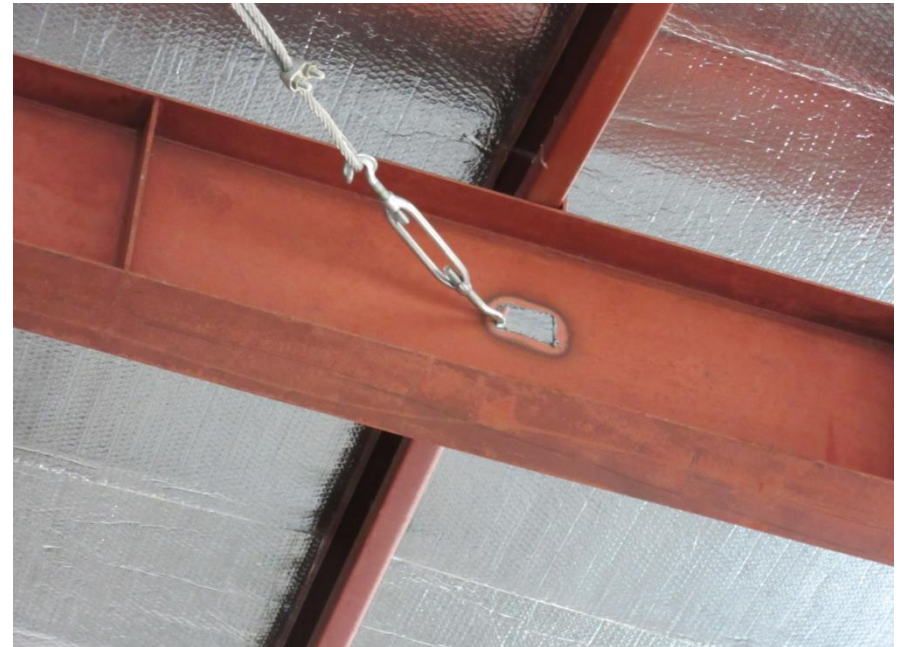
The connection of the bracing to the main steel element appears to be non-engineered.

| Item No. | Observation | Recommended Action Plan | Recommended Timeline |
|---|---|---|---|
| 7 | Apparently non-engineered bracing connection | Building Engineer to survey the bracing connection details in the as built structure. | 6-months |
| 8 | Apparently non-engineered bracing connection | Code adequacy to be ensured. | 6-months |
| 9 | Apparently non-engineered bracing connection | Complete any structural alterations as advised by Building Engineer. | 6-months |
