# Apex Textile Printing Mills Ltd

Chandora, Kaliakoir, Gazipur, Dhaka  
(+24.043819N, 90.260622E)

14 December 2013

# Building Observations

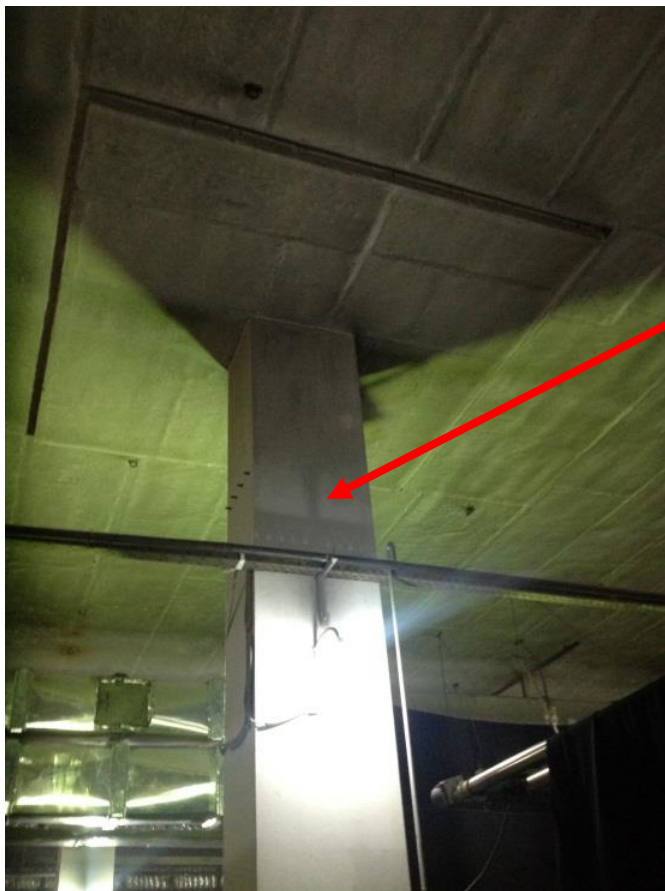
**Columns appear to be stressed in excess of  
normal design limits**

Cursory calculations indicate that column size appears to be smaller than required by code for the applied dead and live load, assuming typical concrete strength and reinforcement content.

Building Engineer to perform detailed calculations, concrete tests and verify reinforcement content to prove column size and (if required) :

- Reduce loads by preparation of allowable floor loading plans
- Carry out strengthening works

| Item No. | Observation | Recommended Action Plan | Recommended Timeline |
|---|---|---|---|
| 1 | Verify the structural adequacy of columns at all levels based on as built dimensions, material properties and verified reinforcement content | Factory Engineer to review design, loads and columns stresses in area identified above. | 6-weeks |
| 2 | Verify the structural adequacy of columns at all levels based on as built dimensions, material properties and verified reinforcement content | Verify insitu concrete stresses either by cores or existing cylinder strength data for 6 columns. | 6-weeks |
| 3 | Verify the structural adequacy of columns at all levels based on as built dimensions, material properties and verified reinforcement content | Verify that reinforcement content in columns at 4 locations at ground floor is per the design drawings. | 6-weeks |
| 4 | Verify the structural adequacy of columns at all levels based on as built dimensions, material properties and verified reinforcement content | Produce and actively manage Allowable Floor Loading plans for all floor plates within the factory giving consideration to floor capacity and column capacity. | 6-months |

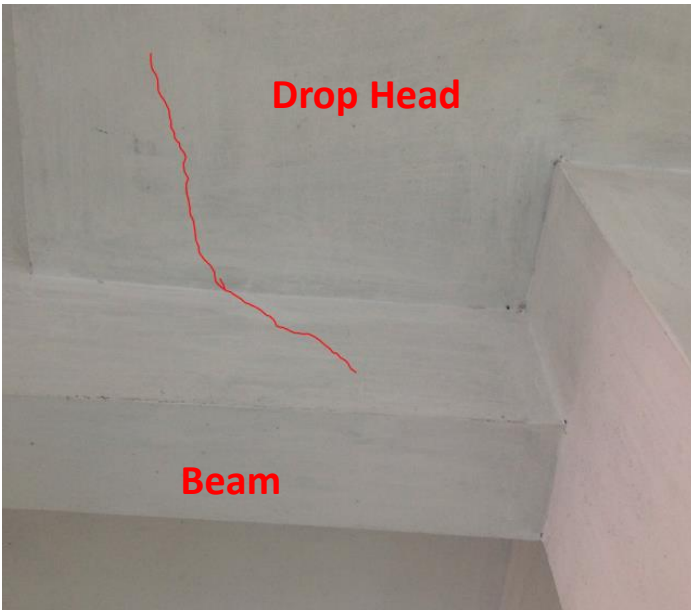
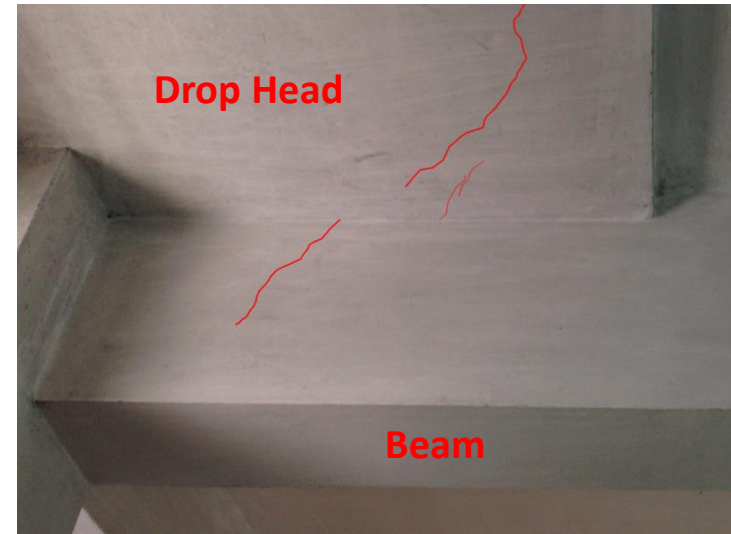
**Crack in beam and drop head –  
u/side 6<sup>th</sup> floor**

**Cracking pattern to concrete  
beams and drop heads on the  
underside of 6<sup>th</sup> floor slab**

| Item No. | Observation | Recommended Action Plan | Recommended Timeline |
|---|---|---|---|
| 6 | Cracking to underside of concrete beams, slabs, drop heads and partitions. | Sections of plaster finish to beams/slab to be removed to investigate if cracks penetrate the building structure. | 6-weeks |
| 8 | Cracking to underside of concrete beams, slabs, drop heads and partitions. | Building Engineer to carry out design check on beams/slab to confirm that these cracks are non-structural. | 6-months |
| 9 | Cracking to underside of concrete beams, slabs, drop heads and partitions. | Building Engineer to issue details of repair works to be completed | 6-months |

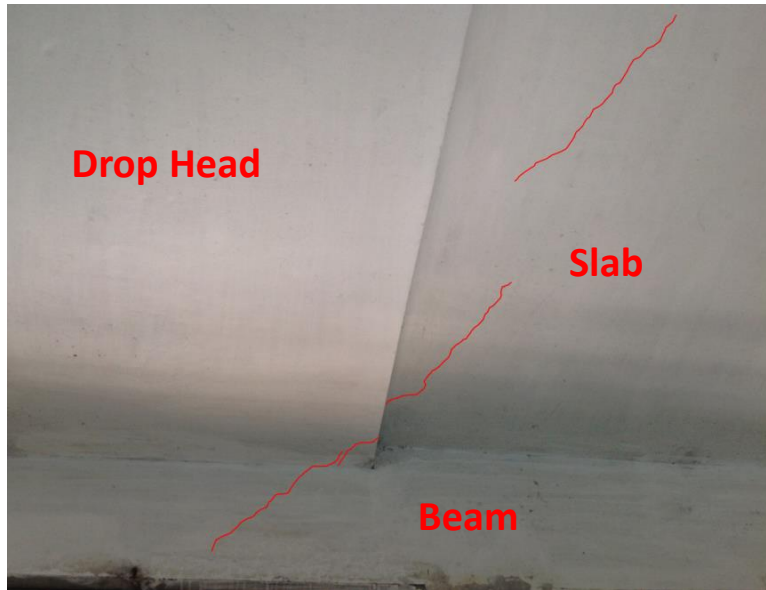
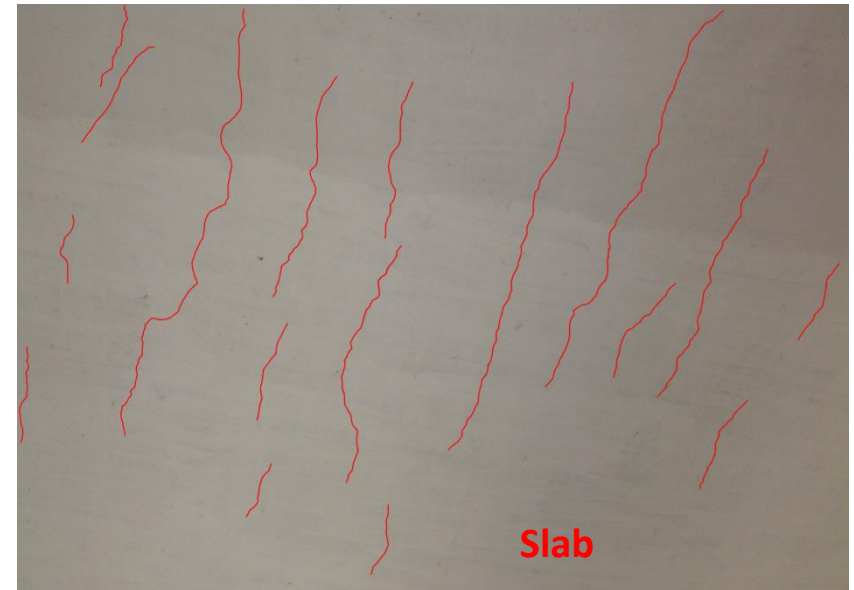
**Crack in beams, slabs and drop heads at area highlighted in yellow – u/side 6<sup>th</sup> floor**

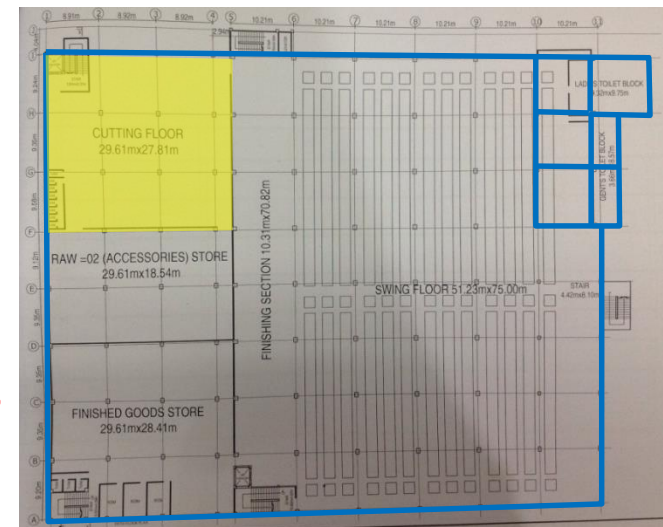
**5<sup>th</sup> floor**

**Cracks in beams/slabs/drop heads**

**Crack in slab at the movement joint at area highlighted in yellow – u/side 6<sup>th</sup> floor**

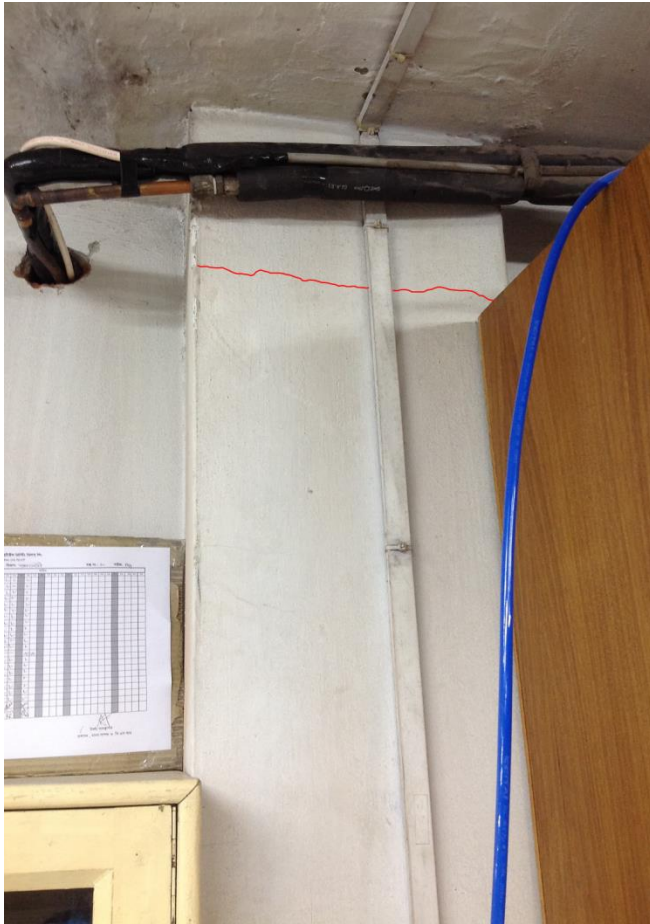
**Horizontal crack in column –  
Ground Floor Mezzanine**

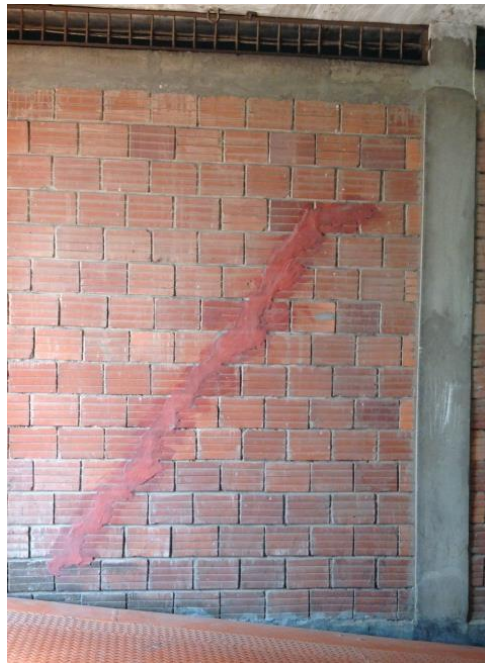
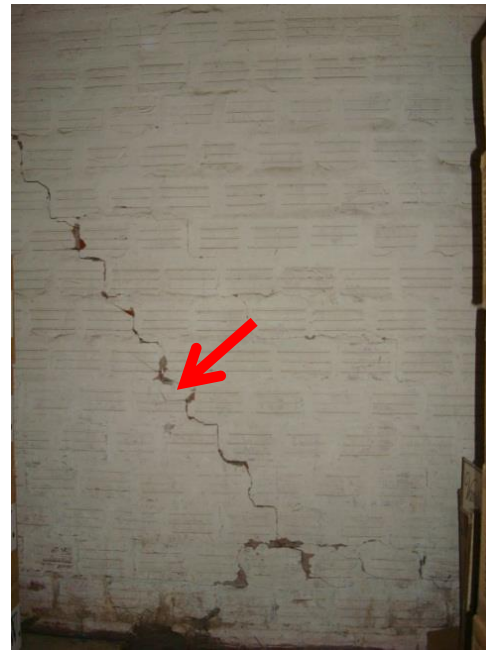
**Crack in partition – 2nd floor**

| Item No. | Observation | Recommended Action Plan | Recommended Timeline |
|---|---|---|---|
| 7 | Cracking to underside of concrete beams, slabs, drop heads and partitions. | Cracks in brick wall to be reviewed to identify the cause and confirm that it is non structural | 6-weeks |

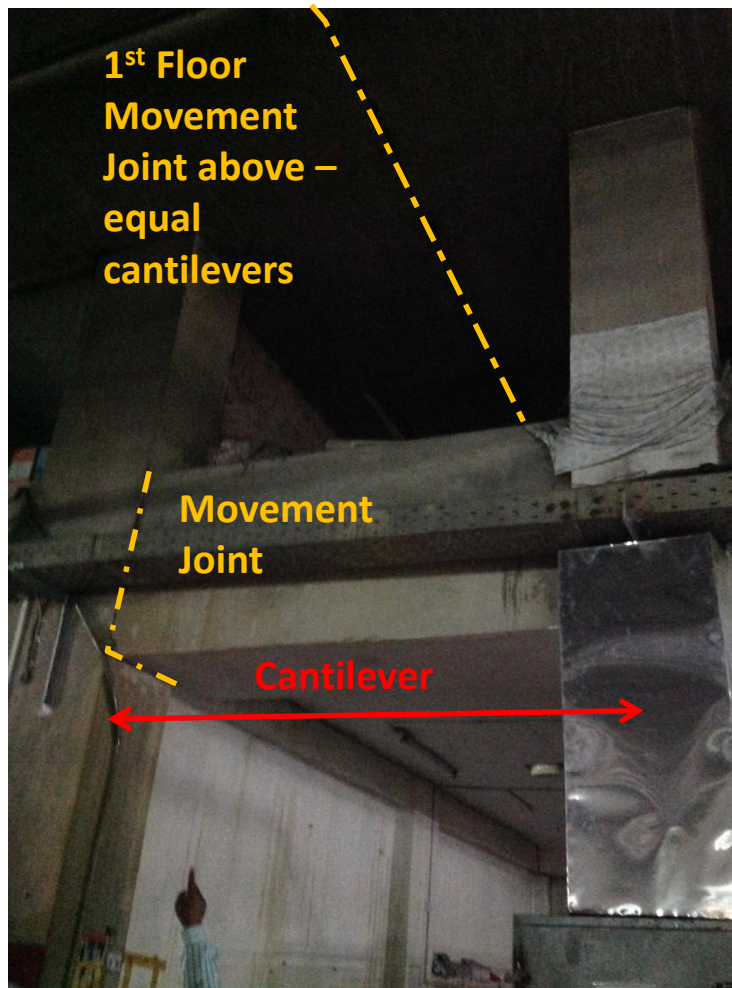
Ground Floor

# **Stepped floor slab alignment at movement joint – capacity of cantilever floor slab to be checked**

| Item No. | Observation | Recommended Action Plan | Recommended Timeline |
|---|---|---|---|
| 10 | Stepped floor slab alignment at movement joint – capacity of cantilever floor slab and mezzanine beam to be checked. | Building Engineer to review typical floor plate design at the south east side of the movement joint and carry out design check calculations to confirm that slab is adequately designed for the increase cantilever span. | 6-weeks |
| 11 | Stepped floor slab alignment at movement joint – capacity of cantilever floor slab and mezzanine beam to be checked. | If required the load capacity of the floor plate may be reduced locally - Refer to Item 1; requirement for Allowable Floor Loading Plans | 6-weeks |
| 12 | Stepped floor slab alignment at movement joint – capacity of cantilever floor slab and mezzanine beam to be checked. | Design check required to confirm that north/south ground floor mezzanine beam is structurally adequate adjacent to movement joint. | 6-weeks |

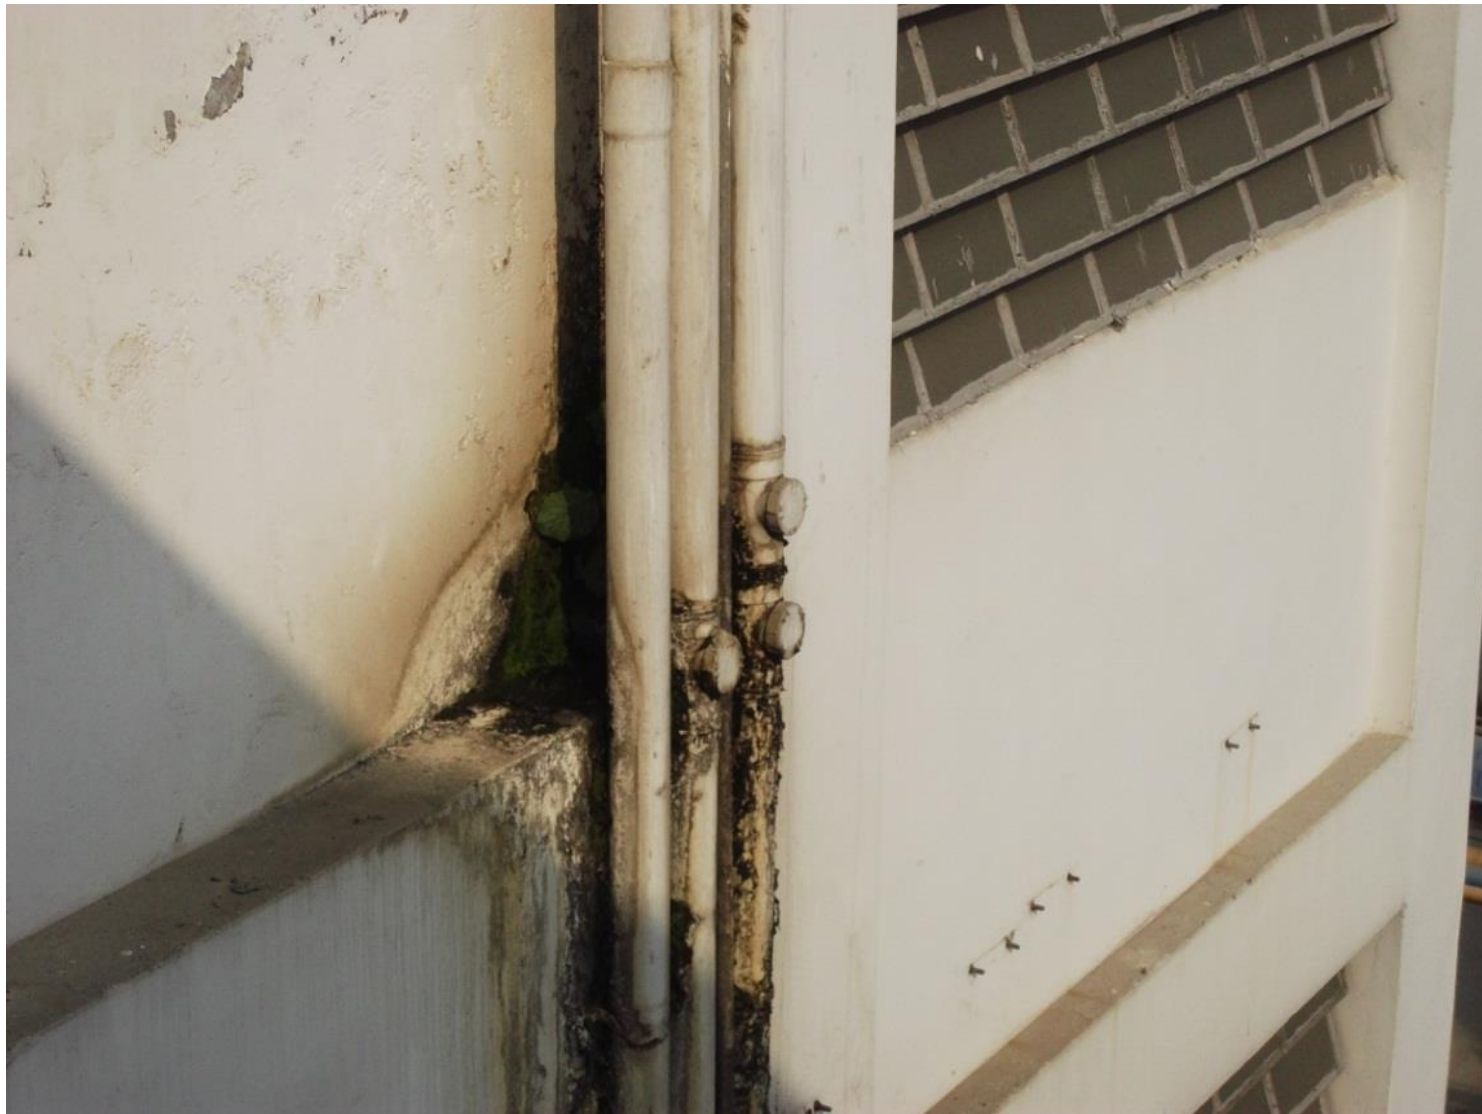
**South Elevation – Maintenance Required**

**Water causing damage in the  
façade**

| Item No. | Observation | Recommended Action Plan | Recommended Timeline |
|---|---|---|---|
| 13 | Water causing damage to building facade | Engineer to inspect area of water damaged structure and identify remedial works – if required. | 6-weeks |
| 14 | Water causing damage to building facade | Building owner to ensure that rainwater downpipes are maintained. | 6-weeks |
| 15 | Water causing damage to building facade | Rainwater downpipes to be maintained on an on-going basis | 6-months |
