MM Knitwear Ltd

Gazipur
(24.013868N, 90.321500E)

14 December 2013

Building Observations

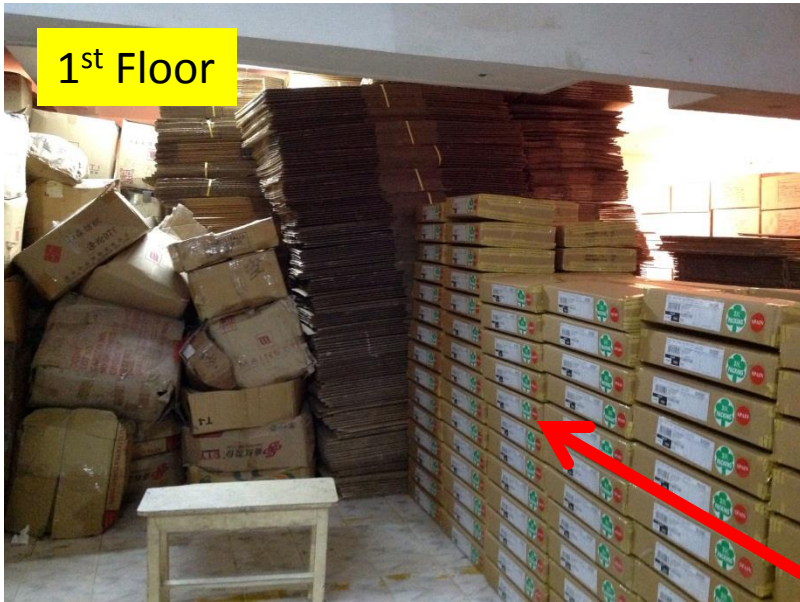
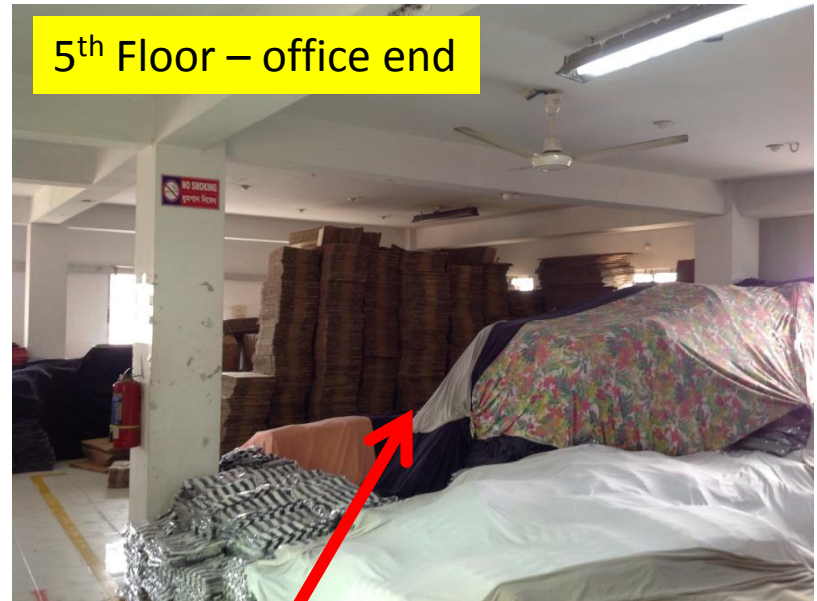
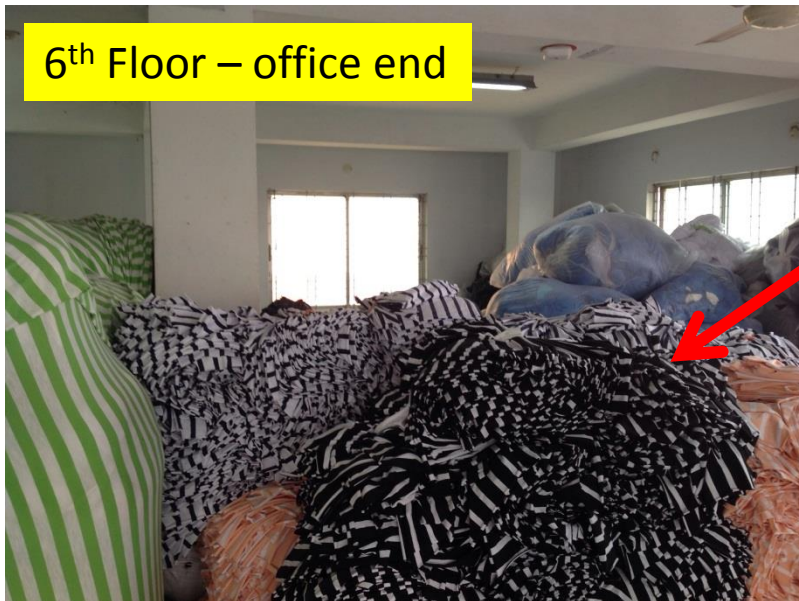
Limit density of loading in storage areas

Uncontrolled loading

Plan and height restrictions to be introduced to prevent future overloading. (Loading plans in line with design loads from engineer)

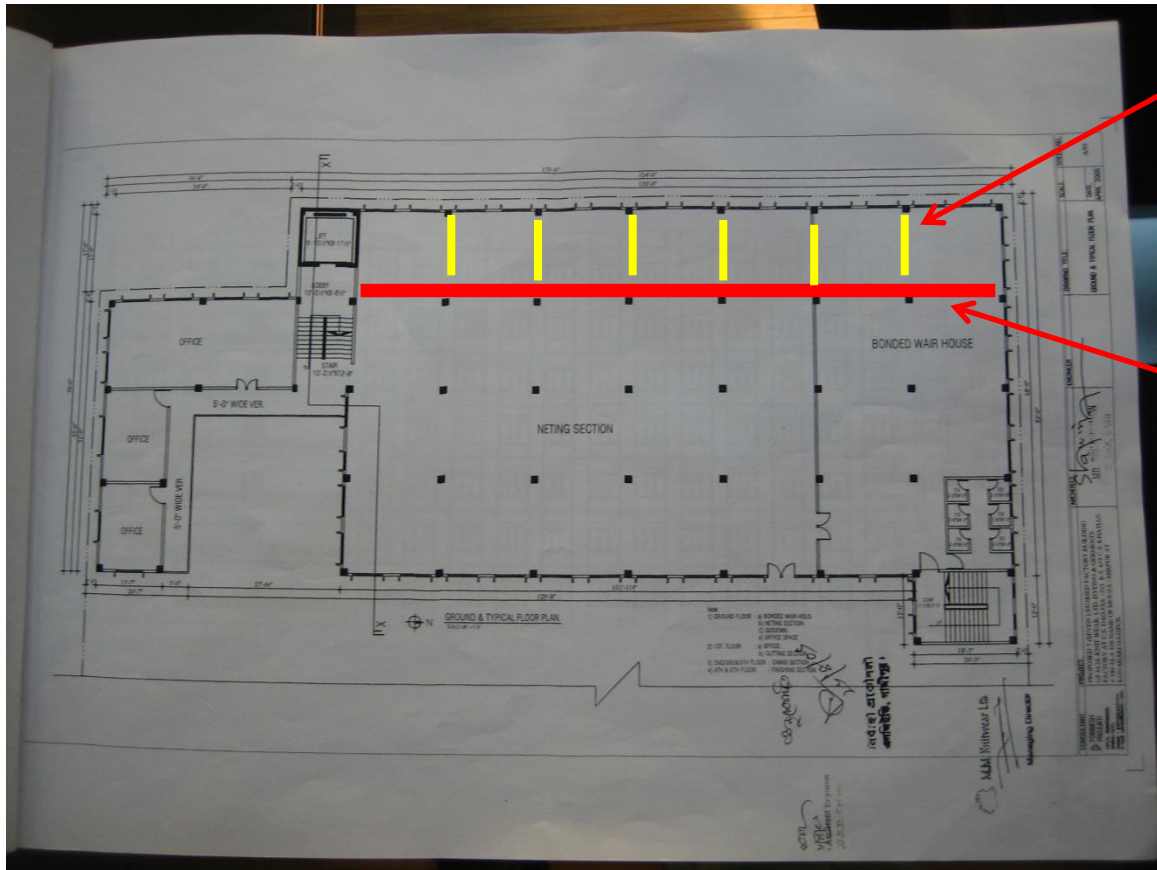
Drawings do not match constructed building

Beams here to underside of Level 1, 2 and 3

Beams here to all levels (original edge of building in Phase 1)

Structural engineering drawings do not match constructed building

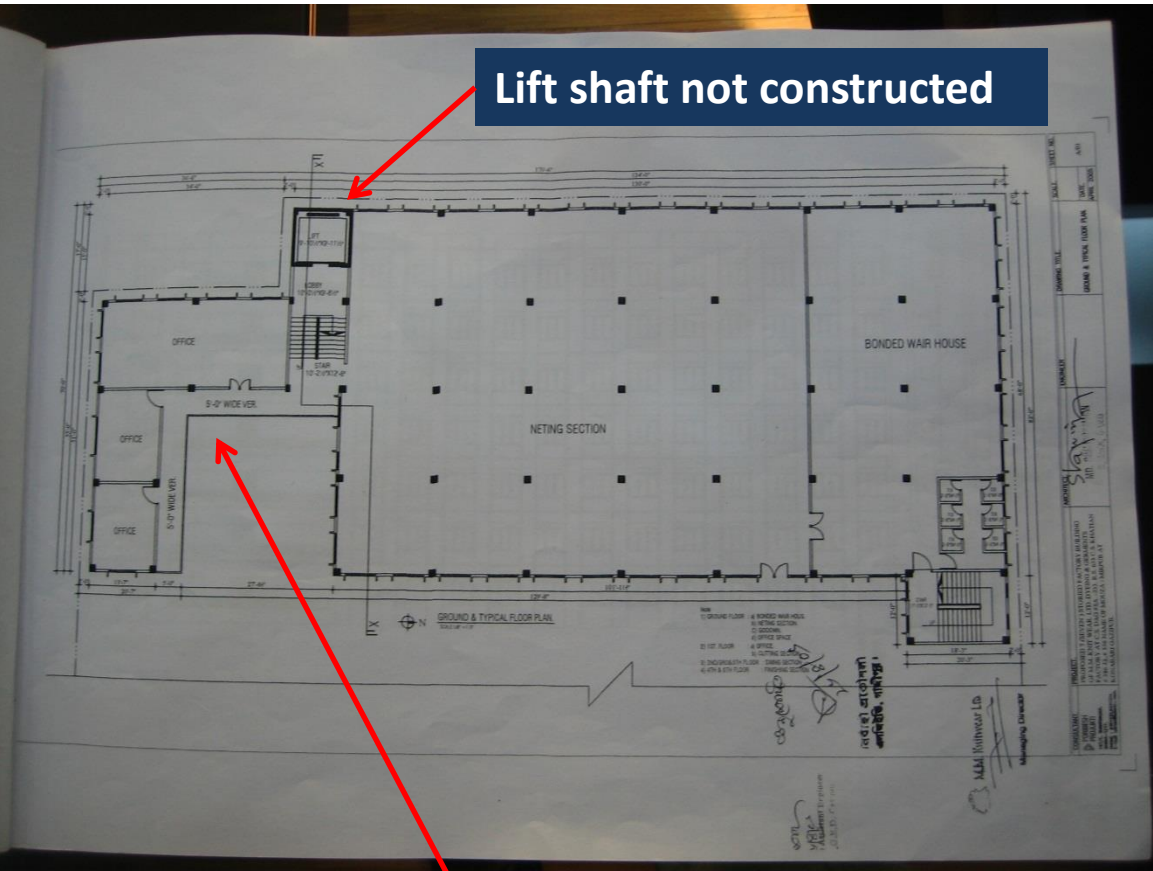
Drawings do not match as built

Lift shaft not constructed

Balcony walkway closed in over upper levels

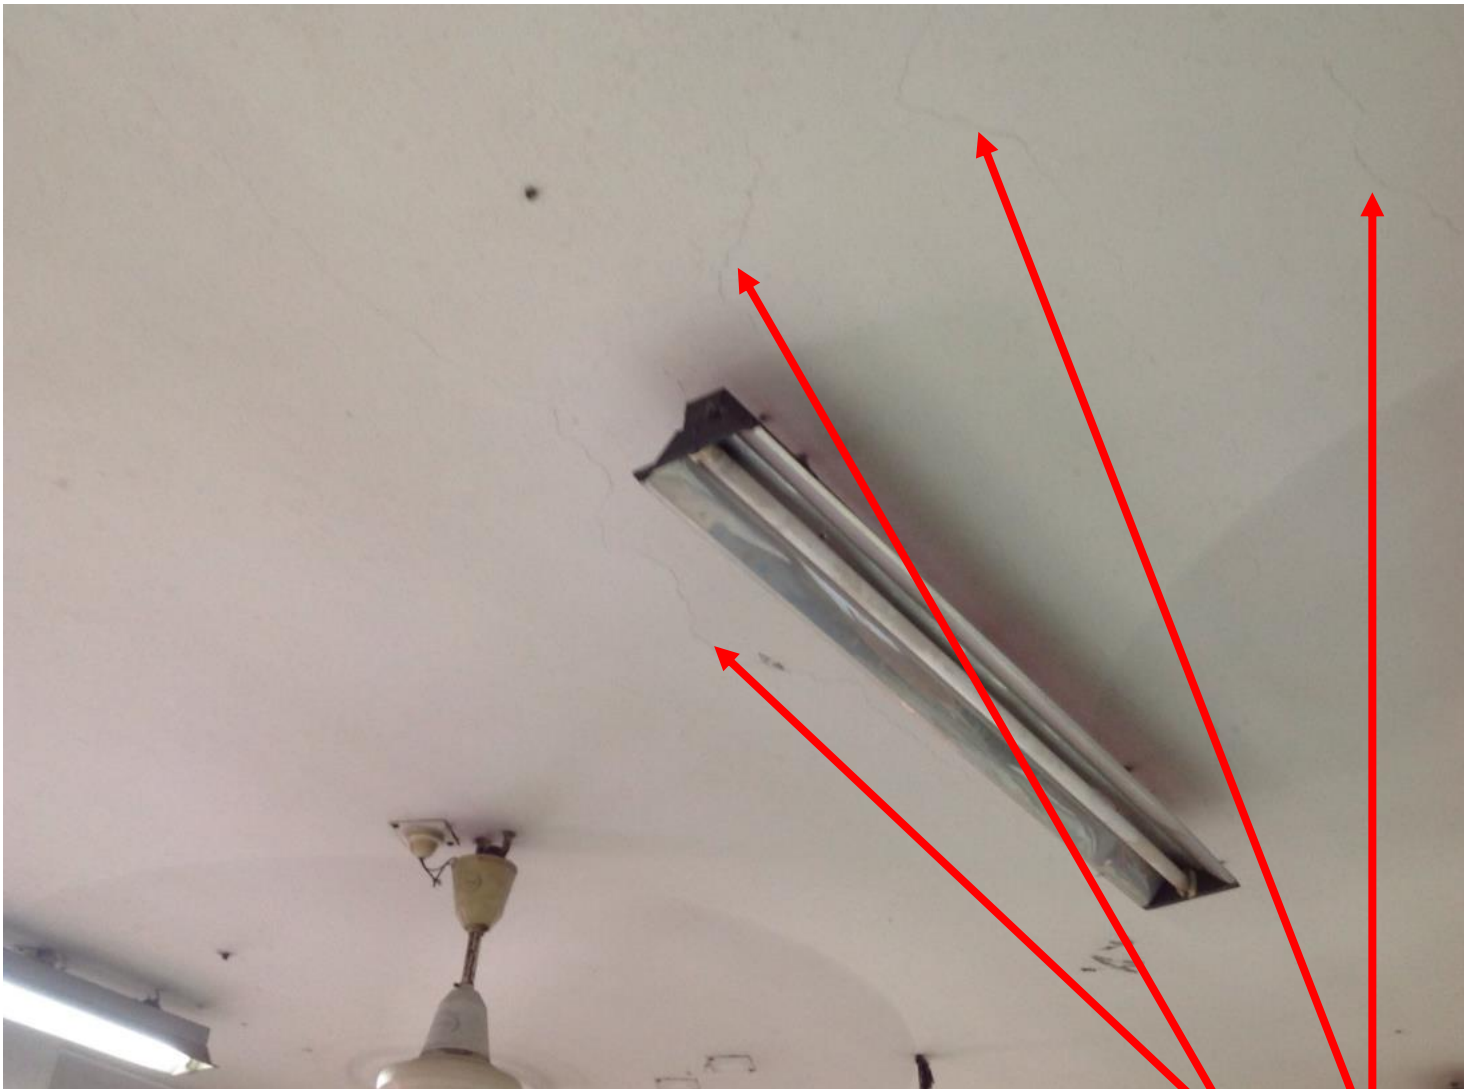
Minor cracking to underside of Level 3 flat slab

Minor cracking to underside of slab

Minor cracking to underside of Level 3 slab

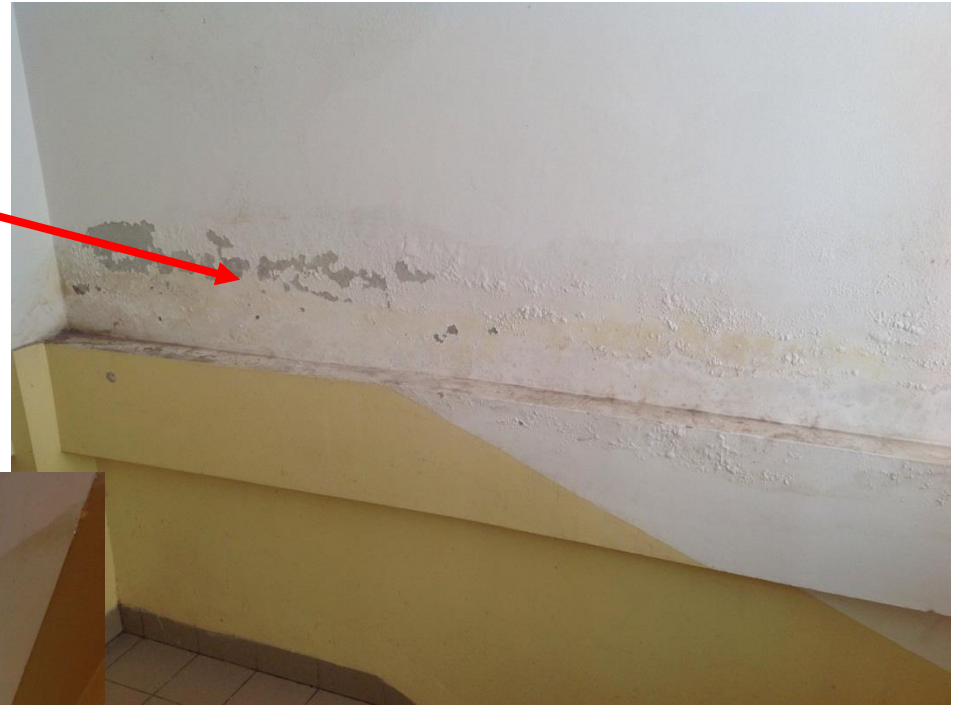
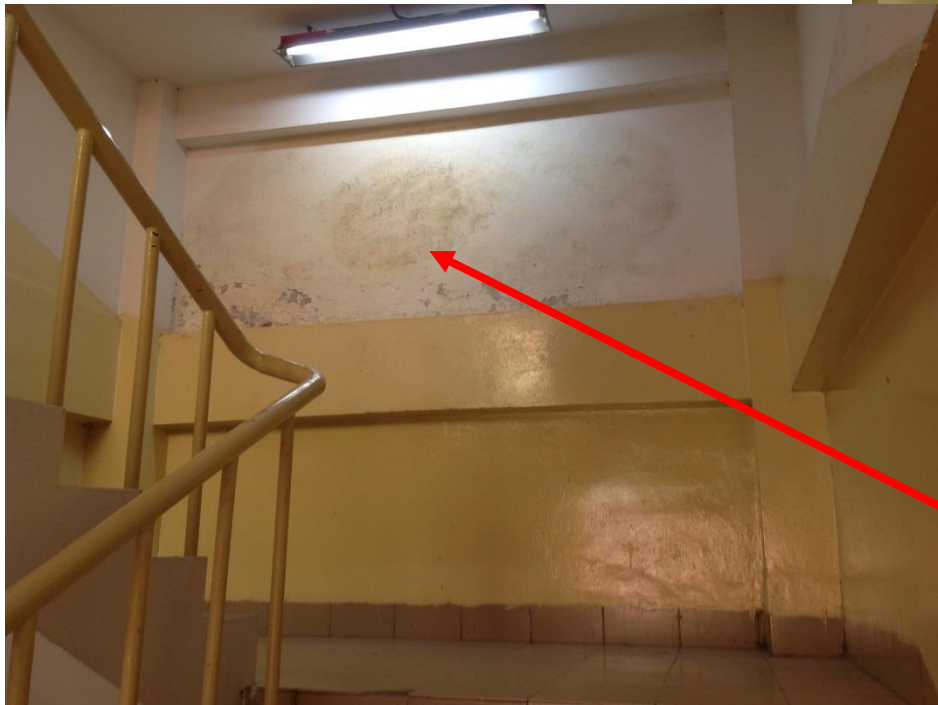
Water causing damage and risk of corrosion

Water from now uncovered roof slab behind causing damage to wall

Water from toilet area behind causing damage to wall

Item No.	Observation	Recommended Action Plan	Recommended Timeline
8	Building 1:Water damage and risk of corrosion from roof slab	Engineer to inspect water damaged structure including the exterior and propose a suitable repair. Roof drainage system/water proofing to be installed	6-months
9	Building 2: Load management – design loads from engineer	Design check all columns, beams and slabs. Create loading plans and heights to match actual structural code capacity.	6-weeks
10	Building 3:Drawings do not match the as built condition Assess double storey height columns at ground floor for stability	Design check all columns, beams and slabs. Produce As-Built drawings showing actual conditions.	6-weeks

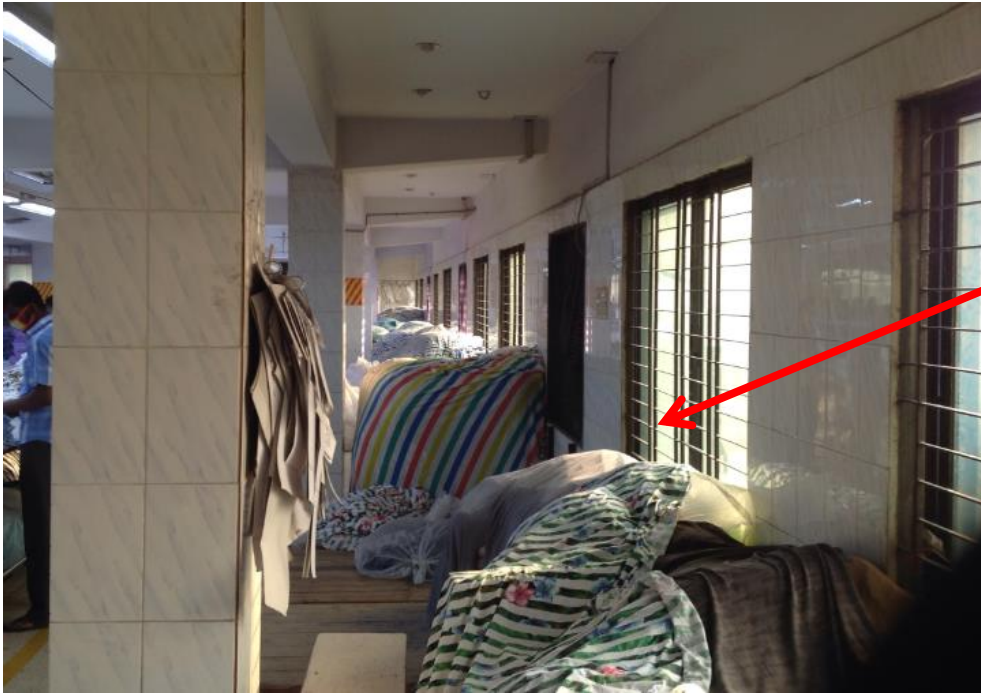
Limit density of loading in storage areas

Uncontrolled loading on cantilever

Plan and height restrictions to be introduced to prevent future overloading. (Loading plans in line with design loads from engineer)

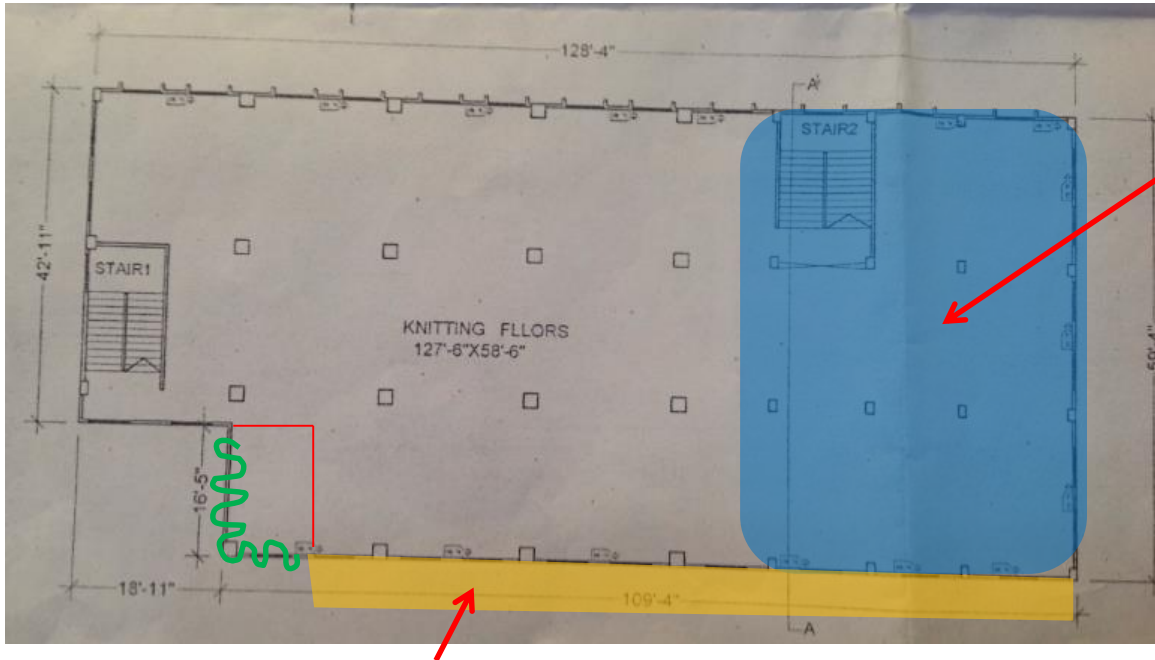
Building 3 - Generally

Drawings do not match constructed building

Columns in this area do not correspond with drawings (location or size)

Cantilever along this edge (Level Roof to Level 3) does not correspond with drawing. Also extended building edge to additional row of columns at Level 2 not shown

No structural engineering drawings available

Drawings do not match as built

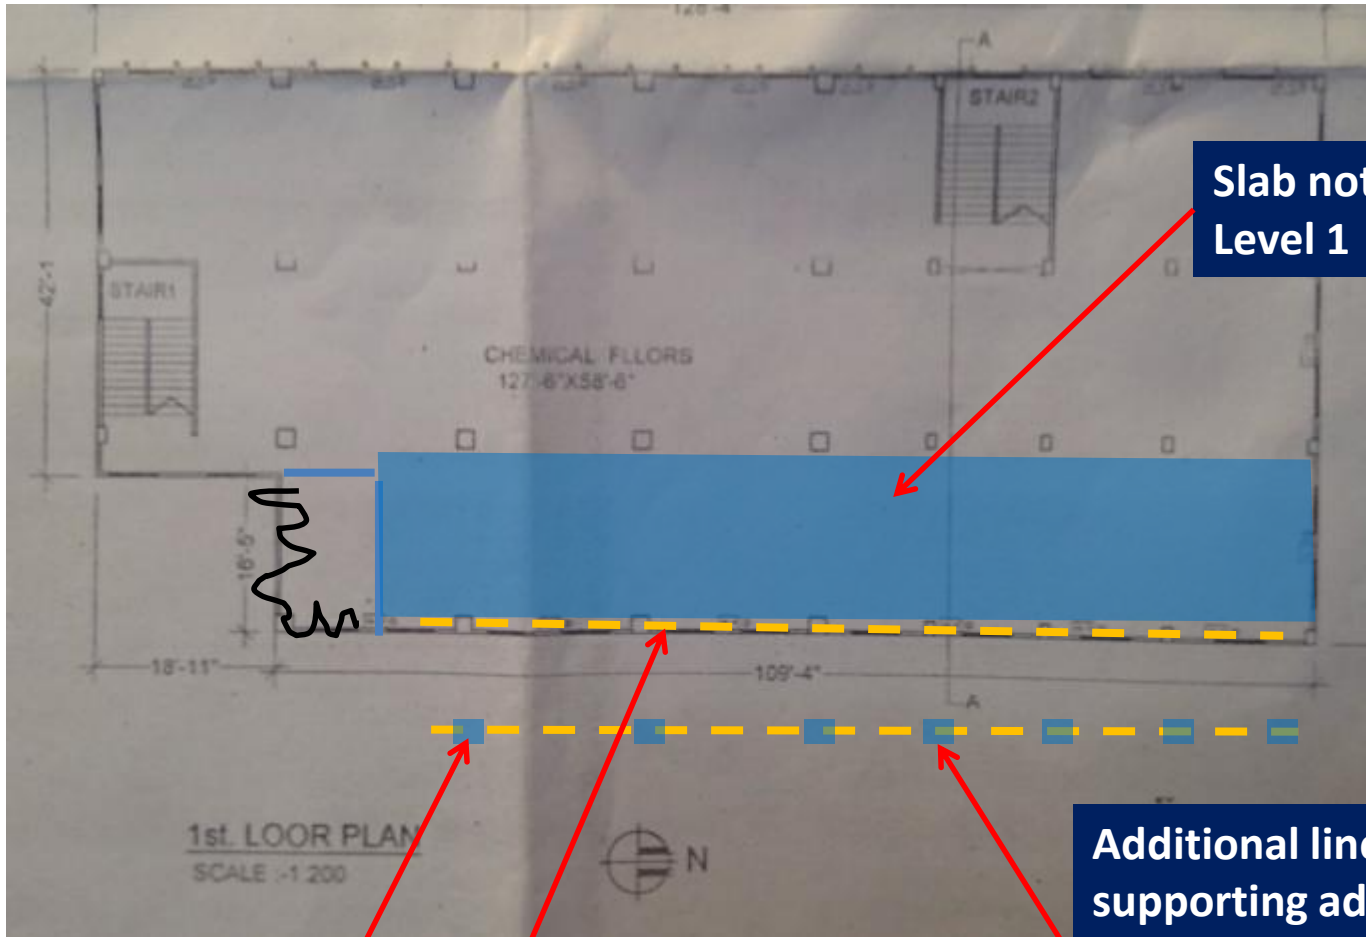
Slab not present here at Level 1

Additional line of columns supporting additional area of slab at Level 2 beyond cantilever area shown generally

Concern with restraint of columns at Level 1 – engineering check required

Drawings do not match as built

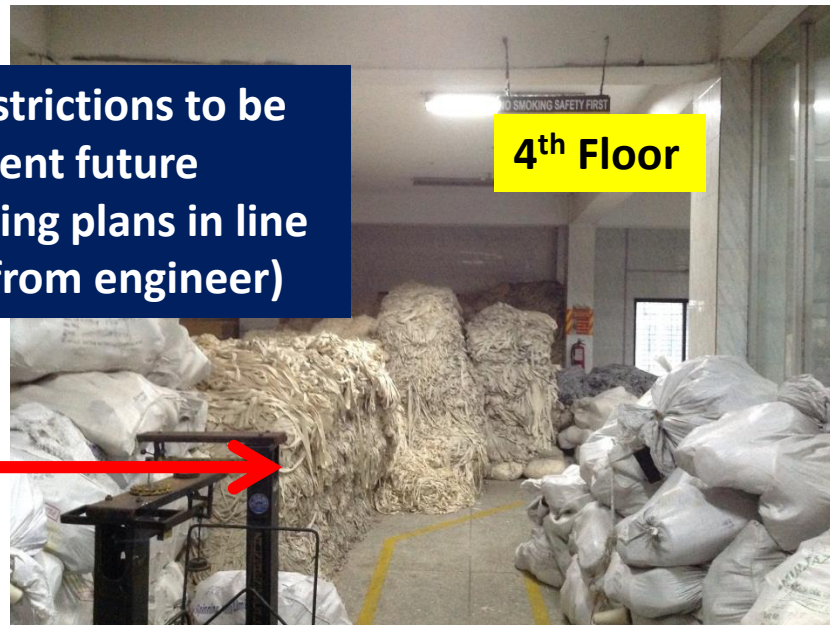
4th Floor

Limit density of loading in storage areas

Uncontrolled loading

Plan and height restrictions to be introduced to prevent future overloading. (Loading plans in line with design loads from engineer)

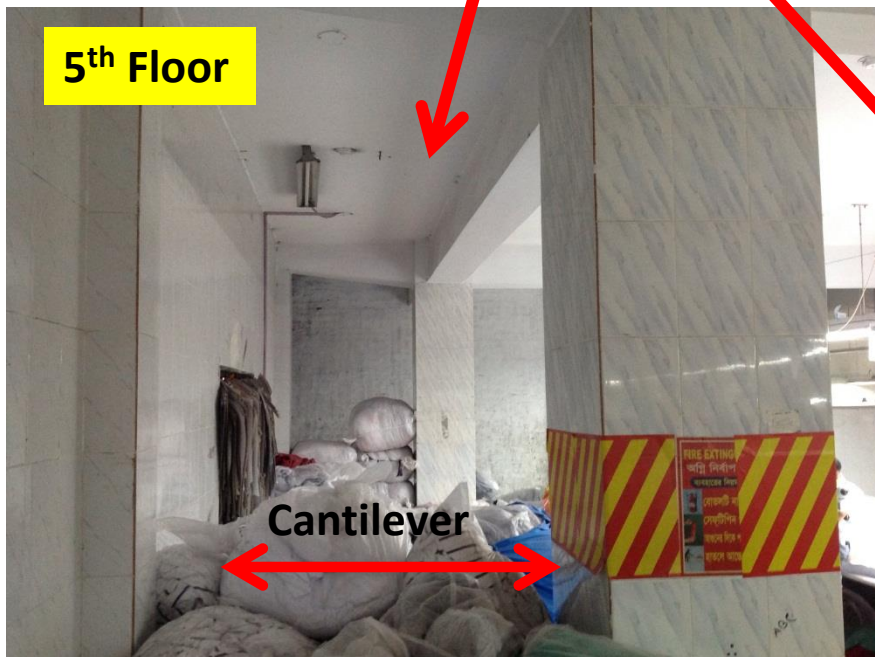
5th Floor

Cantilever

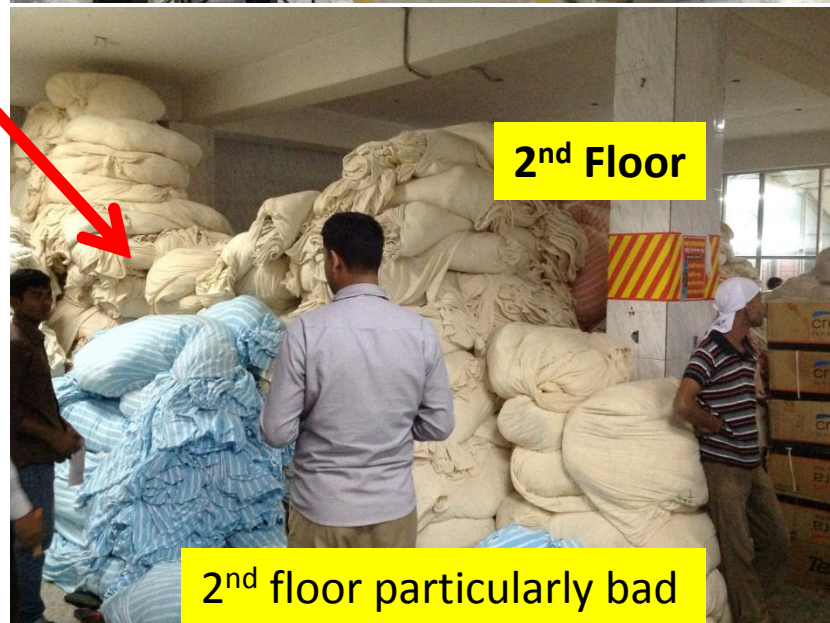
2nd Floor

2nd floor particularly bad

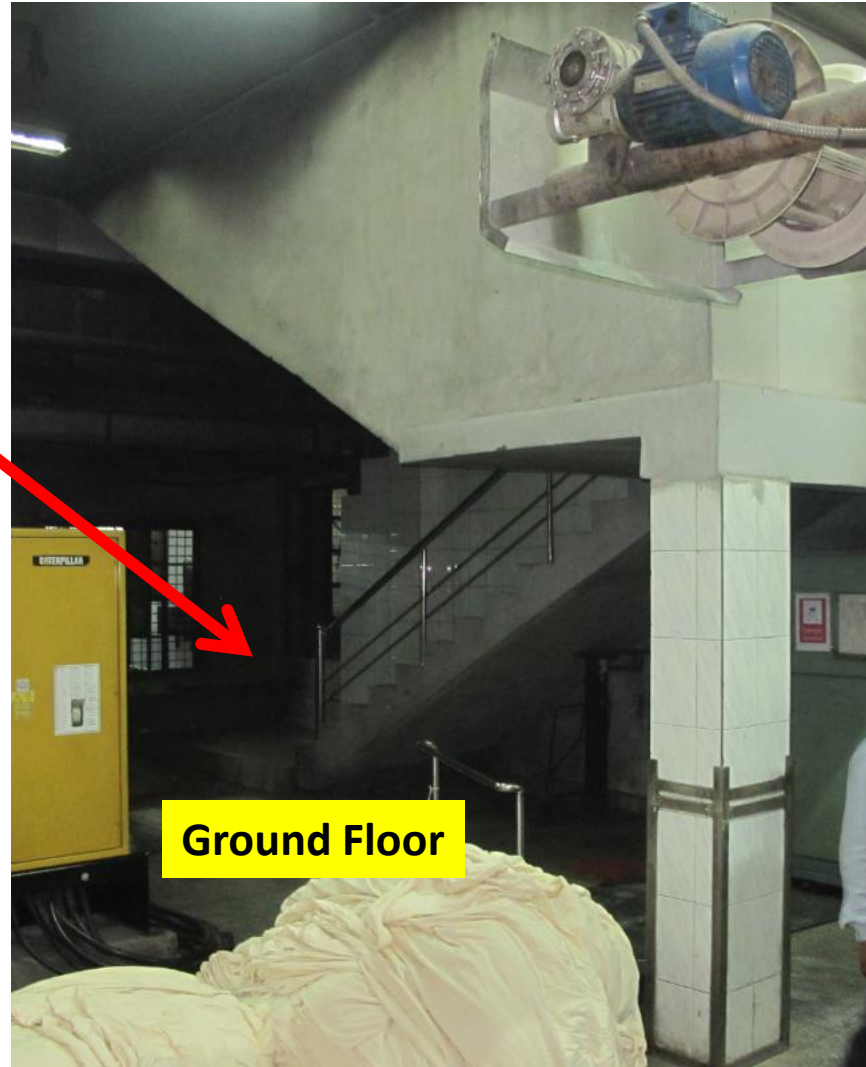
Non-Structural Issue
Escape stairs require exit through ground floor
of Building 3 to outside

Escape stair discharges at ground level with long unprotected exit path to outside the building

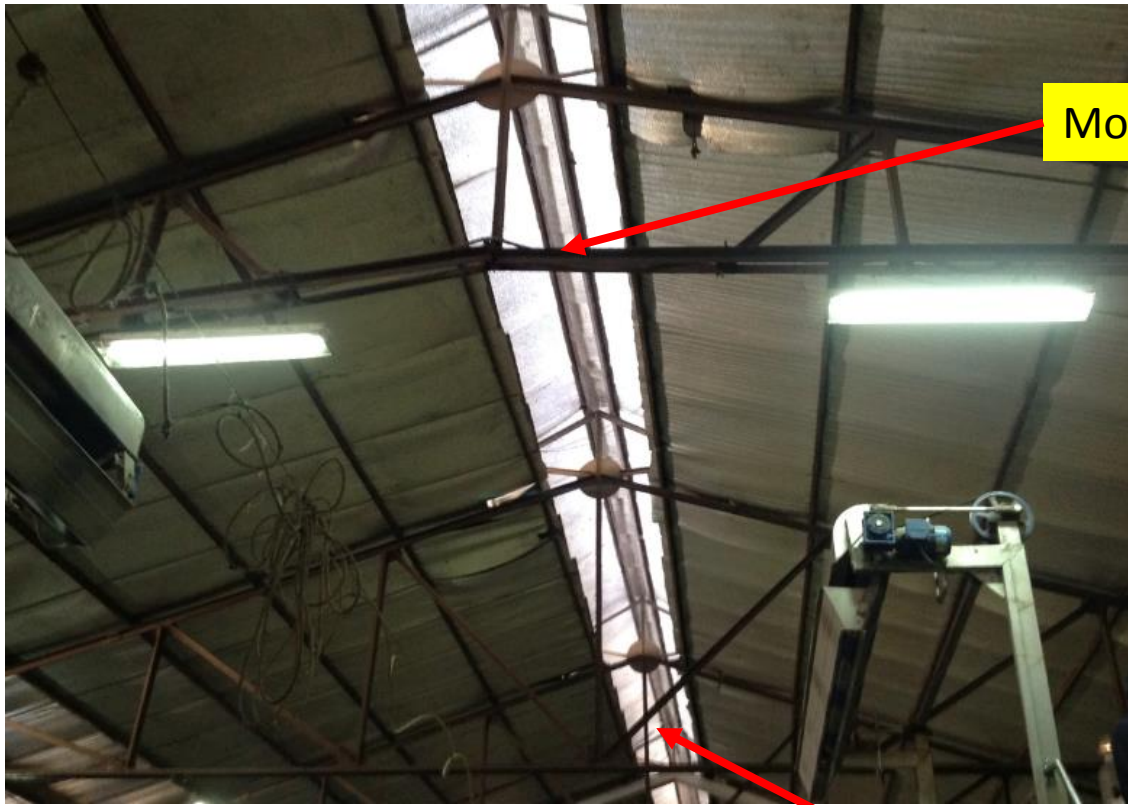
Lateral stability of roof and modifications generally

Modified truss

Generally engineer to check lateral stability of shed roof structures to ground and acceptability of roof modifications throughout

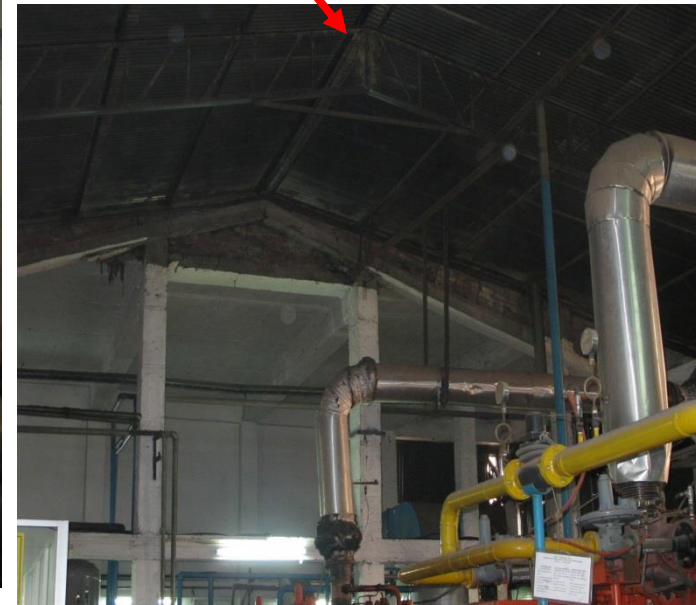
Un-modified truss

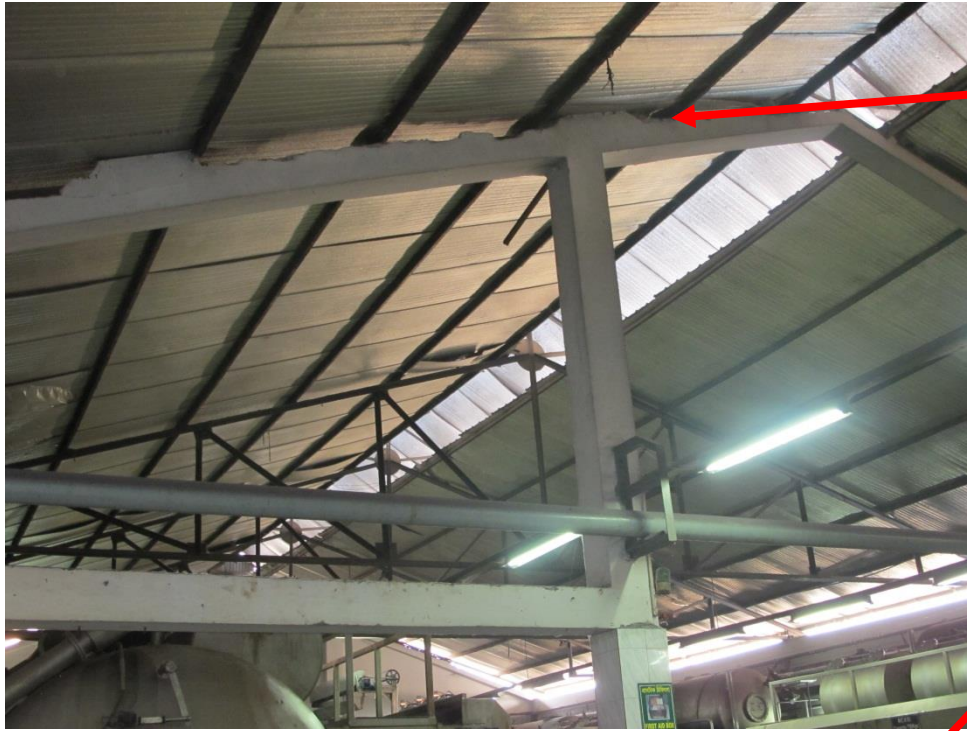
Lateral stability of Sheds and Modifications

Support to roof purlins on damaged RC beam

Generally engineer to check lateral stability of shed roof structures and acceptability of supports throughout

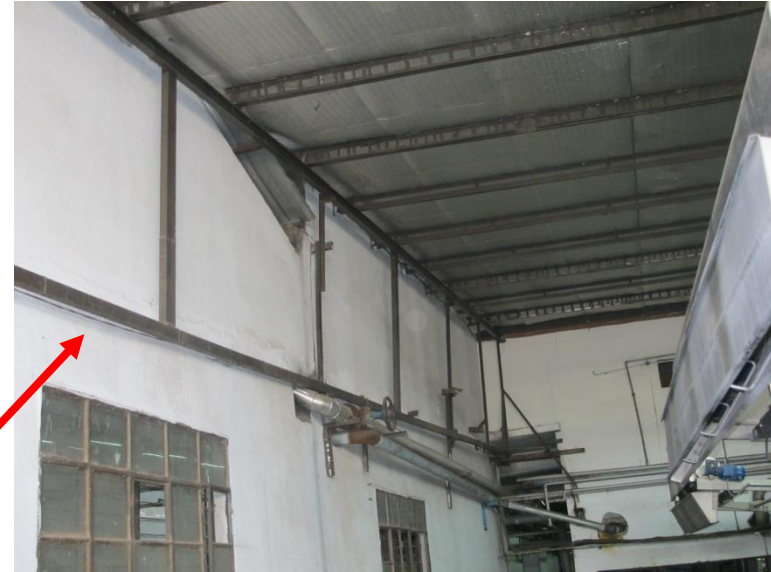
Support to steel roof with wall brackets

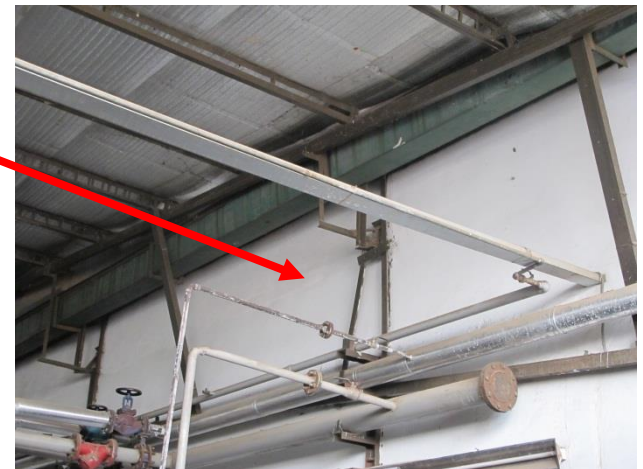
Stability of Shed roofs

Item No.	Observation	Recommended Action Plan	Recommended Timeline
18	<p style="text-align: center;">Sheds:</p> Check the structural capacity of modified roof elements (trusses/purlins) and lateral stability of the roof to ground level	Design check modified trusses and purlins and check lateral stability of the roof down to ground level.	6-weeks
