# ELECTRICAL SAFETY INSPECTION REPORT

INTERFAB SHIRT MANUFACTURING LTD (UNIT-2)

STOFFATEX FASHIONS LTD

**Inspected on:** July 28, 2019

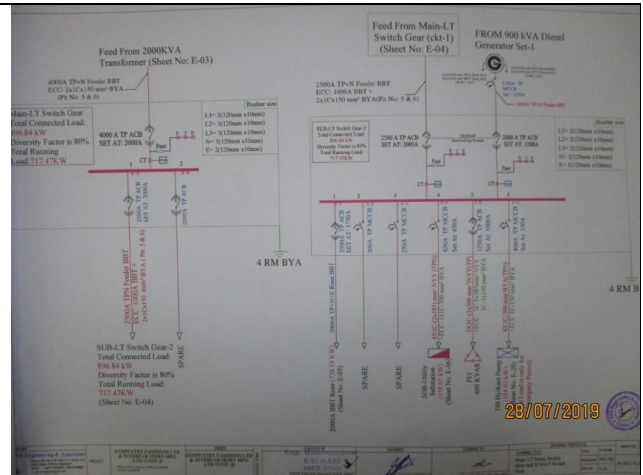
| <b>FINDING NO:</b> | <b>E - 1</b> |

| <b>FINDING:</b><br>SLD is not amended properly (busbar dimension, connecting busbar rating from main bus to MCCB and load details missing). | |

| <b>RECOMMENDATION:</b><br>Draw as built electrical SLD mentioning all required information by qualified engineer and get it reviewed by Accord. Electrical SLD must be updated properly when electrical system is modified. | |
| <b>PRIORITY:</b> | <b>P2</b> |
| <b>REMEDIATION TIME FRAME:</b> | <b>3 MONTHS</b> |

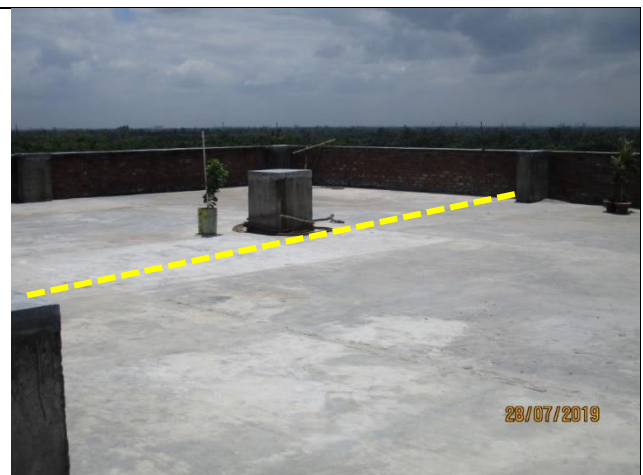
| <b>FINDING NO:</b> | <b>E - 2</b> |

| <b>FINDING:</b><br>Installed LPS needs modification. Cross run conductor is not installed as mentioned in LPS drawing. | |

| <b>RECOMMENDATION:</b><br>Install cross run conductor as per standard. | |
| <b>PRIORITY:</b> | <b>P2</b> |
| <b>REMEDIATION TIME FRAME:</b> | <b>1 MONTH</b> |

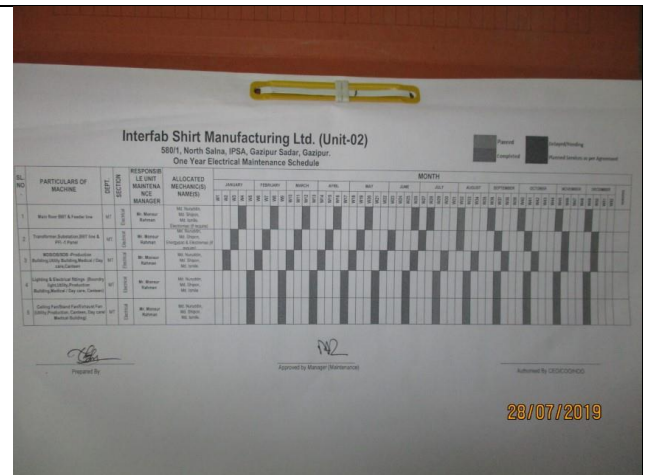
| <b>FINDING NO:</b> | <b>E - 3</b> |

| <b>FINDING:</b><br>Programmed schedule for periodical inspection & testing of electrical equipment is not adequate. | |

| <b>RECOMMENDATION:</b><br>An electrical maintenance program shall be prepared which will include inspections and testing of the electrical systems (preventive and proactive). | |
| <b>PRIORITY:</b> | <b>P3</b> |
| <b>REMEDIATION TIME FRAME:</b> | <b>1 MONTH</b> |

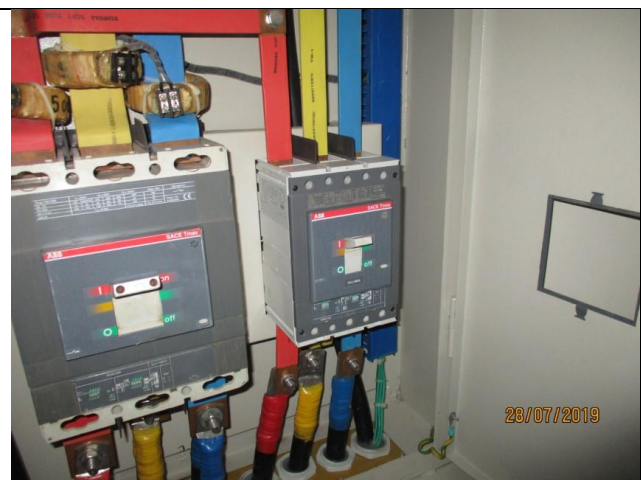
| <b>FINDING NO:</b> | <b>E - 4</b> |

| <b>FINDING:</b><br>MCCBs are not adjusted per load demand (connecting busbar size is lower than CB rating). | |

| <b>RECOMMENDATION:</b><br>All the MCCBs must be adjusted per connected load current; if adjustment is not possible, replacement will be the only way. | |
| <b>PRIORITY:</b> | <b>P2</b> |
| <b>REMEDIATION TIME FRAME:</b> | <b>2 MONTHS</b> |
