# **FIRE SAFETY INSPECTION REPORT**

## **BLUE PLANET KNIT WEAR LTD. BARMI-MAONA ROAD**

March 29, 2014

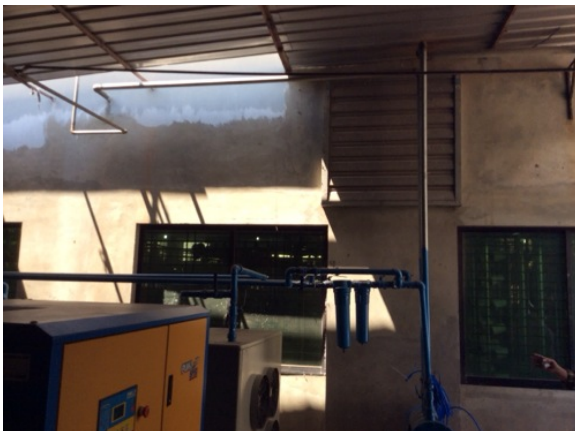
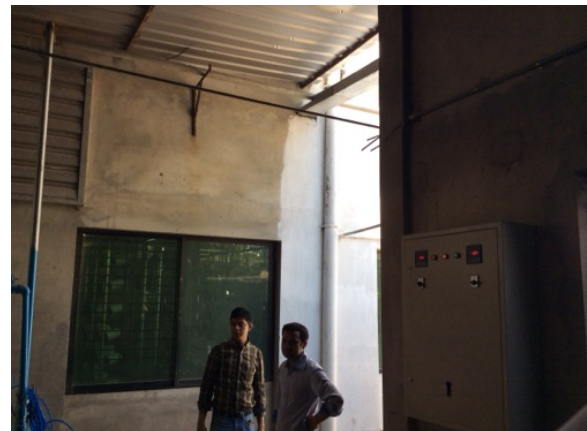
| No. | Category | Finding | Recommendation | Remediation Timeframe |
|---|---|---|---|---|
| F-1 | Fire Rated Construction | The boiler room was not separated by fire-rated construction (openings, non-rated doors, penetrations).<br><br>Ground floor. | Separate the boiler room by a minimum 2-hr fire-rated construction. Seal and/or protected all openings to maintain the required fire separations | Within 3 months |

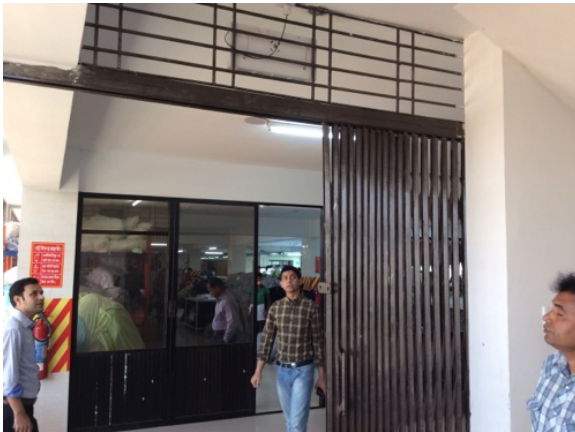
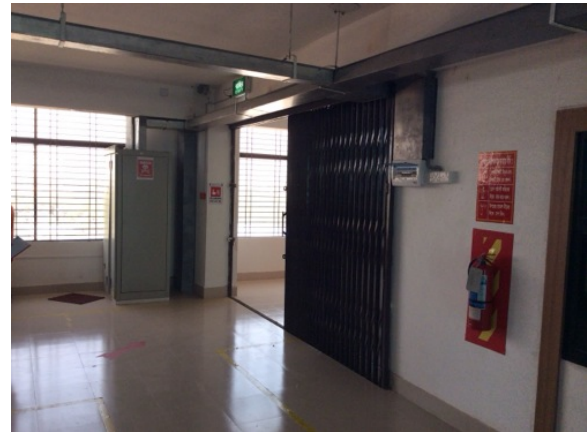
| F-2 | Fire Rated Construction | The exit stairs are not separated from work areas, and other spaces on each floor by fire-rated construction. | Provide minimum 1.5-hr fire rated doors and seal all unprotected openings to separate the exit stairs from work areas and other building spaces on all floor levels. Ensure that the fire doors are self-closing and positive latching and that they are provided with fire exit (panic) hardware where serving production floors.<br><br>If fire doors are required to be held open for functional reasons, provide automatic-closing devices tied to the fire alarm system. | Within 3 months |

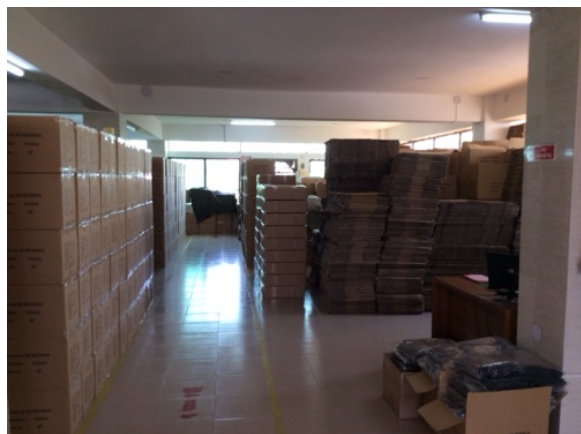
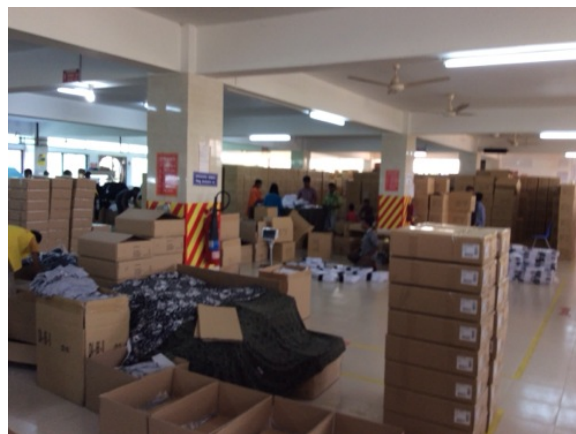
| F-3 | Fire Rated Construction | <p>Areas used for combustible storage are not separated by fire-rated construction.</p> <p>Fabric store on second floor.</p> | <p>Provide dedicated storage rooms separated by minimum 1-hr fire-rated construction.</p> <p>Where separate storage rooms are not feasible, provide defined storage areas and limit the storage arrangement as follows:</p> <ul style="list-style-type: none"> <li>- Maximum height of 2.4m and maximum area of 23m<sup>2</sup></li> <li>- If sprinkler protected: maximum height of 3.66m and maximum area of 93m<sup>2</sup></li> </ul> <p>Separate areas of unenclosed combustible storage by a minimum clear distance of 3m.</p> | Within 3 months |

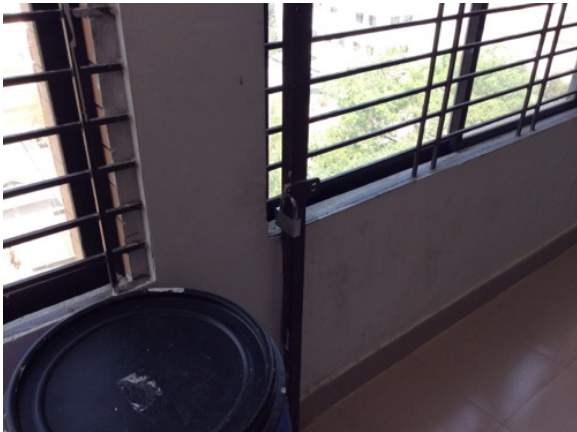
| F-4 | Egress | <p>Egress doors / gates with locking features are provided at building exits, and exit stairs.</p> <p>Pad locks on doors were unlocked and open at time of inspection.</p> | <p>Remove locking features from all egress doors / gates.</p> <p>If locks are required for security reasons, utilize special door locking features complying with NFPA 101.</p> | Immediate |

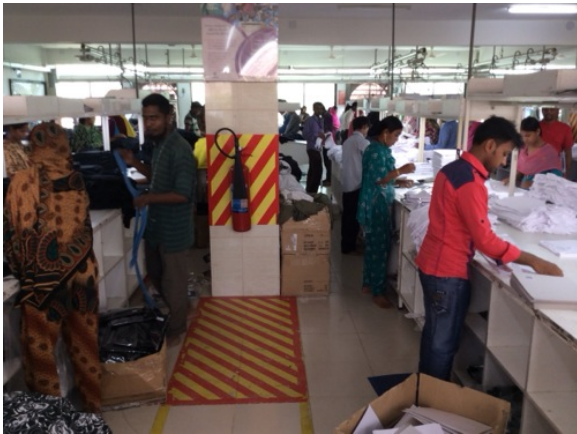
| F-5 | Egress | The width of egress aisles is less than 36-in.<br><br>On second floor. | Provide minimum aisle widths of 36-in. | Within 3 months |

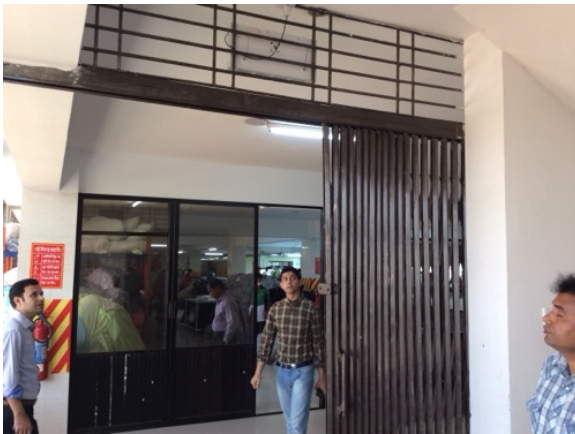
| F-6 | Egress | Collapsible gates / sliding doors are provided at building exits, and exit stairs.<br><br>Sliding gates at all egress stairs. | Replace all gates / sliding doors along the means of egress with side-hinged, swinging egress doors.<br><br>If locks are required for security reasons, utilize special door locking features complying with NFPA 101. | Within 3 months |

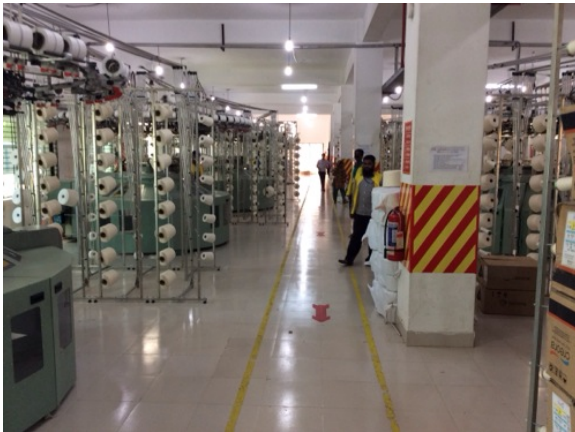
| F-7 | Egress | Common path of egress travel exceeds 30 m.<br><br>Knitting area on ground floor. | Reconfigure the egress arrangement to reduce the maximum common path of travel to not more than 30 m. | Within 3 months |

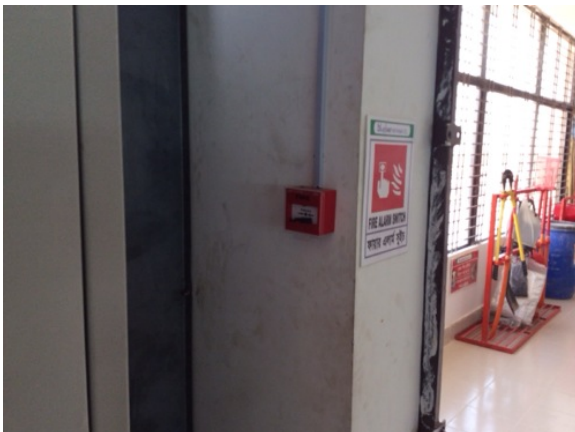
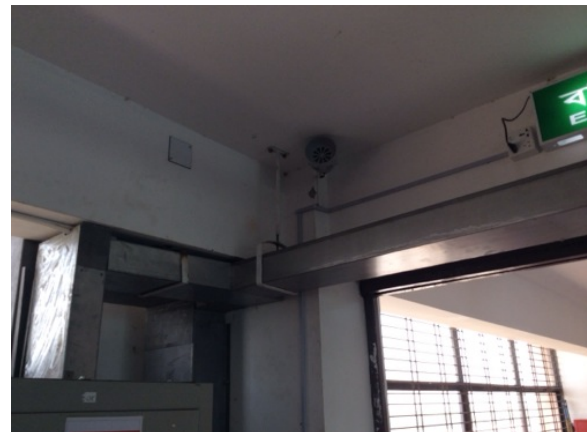
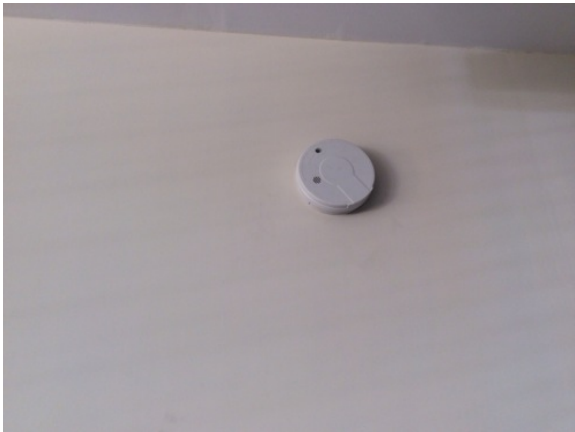
| F-8 | Fire Protection | The fire alarm system is antiquated, not a listed system, and does not provide alarm and notification features consistent with acceptable standards. | Replace the fire alarm system with a new, listed addressable fire alarm system in accordance with NFPA 72. | Design within 4 months, install within 9 months |

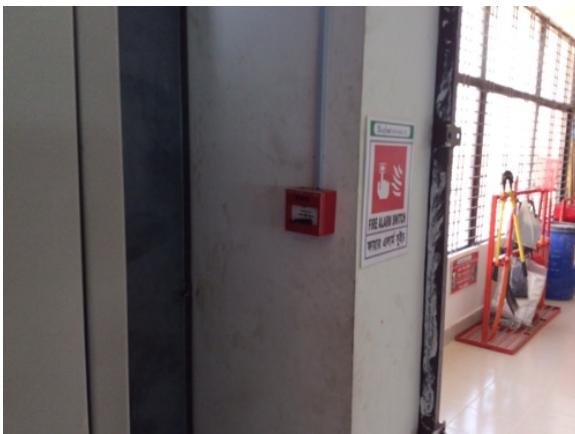
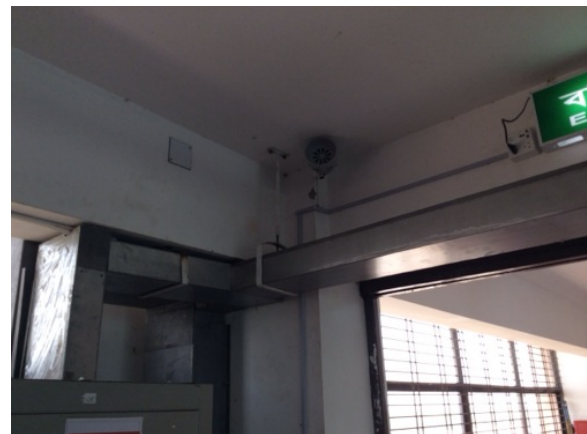
| F-9 | Fire Protection | Activation of the fire alarm system by a manual fire alarm station provides automatic occupant notification only on the floor of alarm and not throughout the building.<br><br>Each floor had single horn activated by a single manual activation switch. | Configure the fire alarm system to initiate automatic occupant notification on all floor levels to facilitate whole-building evacuation upon any manual fire alarm station activation. | Within 1 months |

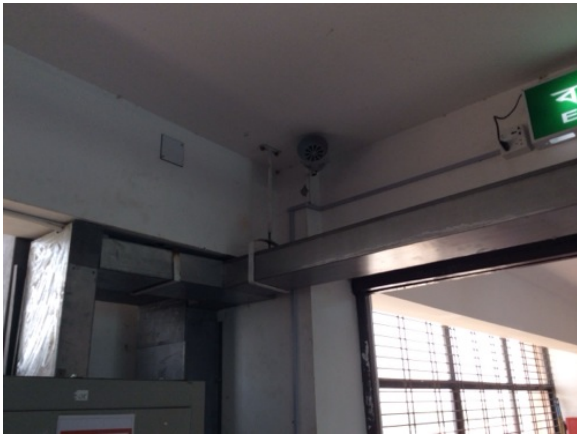
| F-11 | Fire Protection | The fire alarm system does not appear to provide adequate audible notification coverage.<br><br>All floors had only one horn and no light. | Provide additional notification appliances such that the fire alarm system is audible throughout the building in accordance with NFPA 72. | Within 6 months |

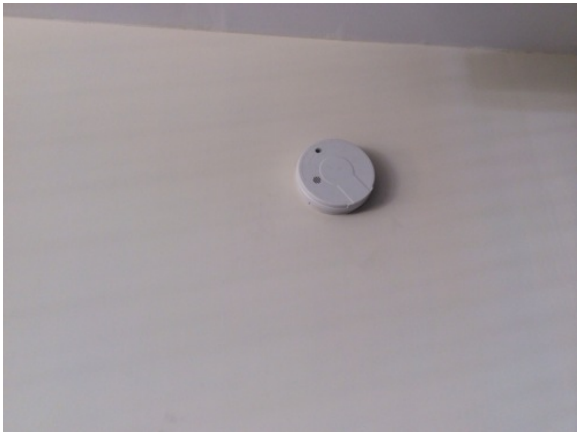
| F-12 | Fire Protection | The building is equipped with single-station smoke alarms. Smoke alarm activation sounds only a local alarm and does not provide automatic fire alarm notification of occupants. | Replace the single-station smoke alarms with automatic smoke detectors tied into the fire alarm system. Configure the fire alarm system to initiate occupant notification upon activation of any two smoke detectors in addition to the manual fire alarm stations. | Within 6 months |

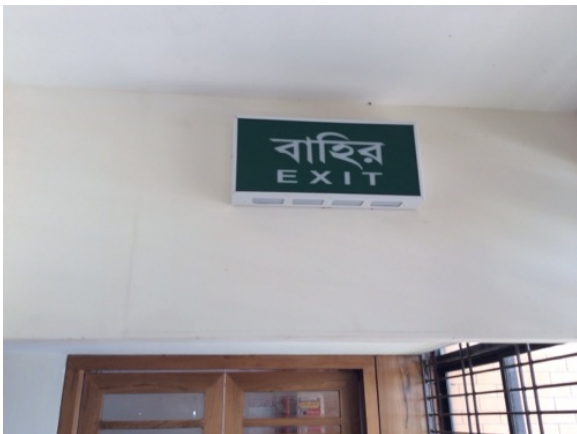
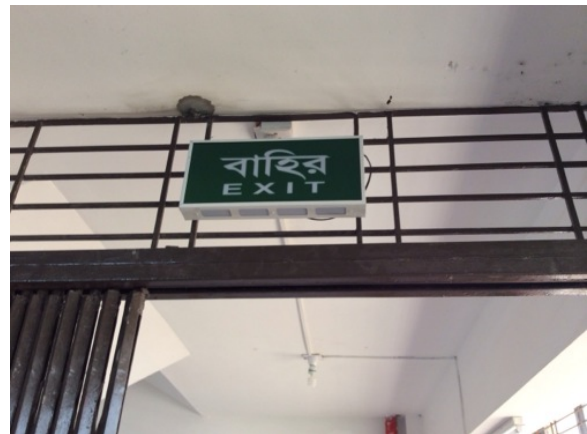
| F-13 | Egress Lighting | Exit signage not illuminated (burned out, broken, etc.).<br><br>On sixth floor in office and fourth floor. | Regularly inspect all exit signage and replace/install lights as needed to illuminate signs. | Within 1 month |

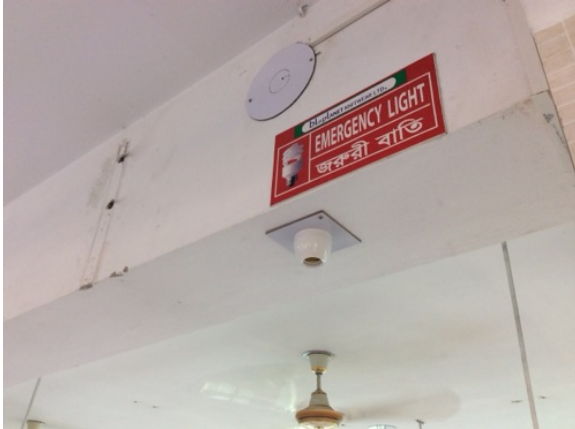
| F-14 | Egress Lighting | Emergency lighting did not function in test mode (burned out, broken, etc.).<br><br>Third, first and ground floors. | Regularly test the emergency lighting system on each floor and replace/repair lights as needed. | Within 1 month |
