# 4 Stitch Knit Composite Ltd.

West Shaildubi, Ward No: 05, Kashimpur, Gazipur – 1346, Bangladesh.

21<sup>st</sup> July 2019

# Observations

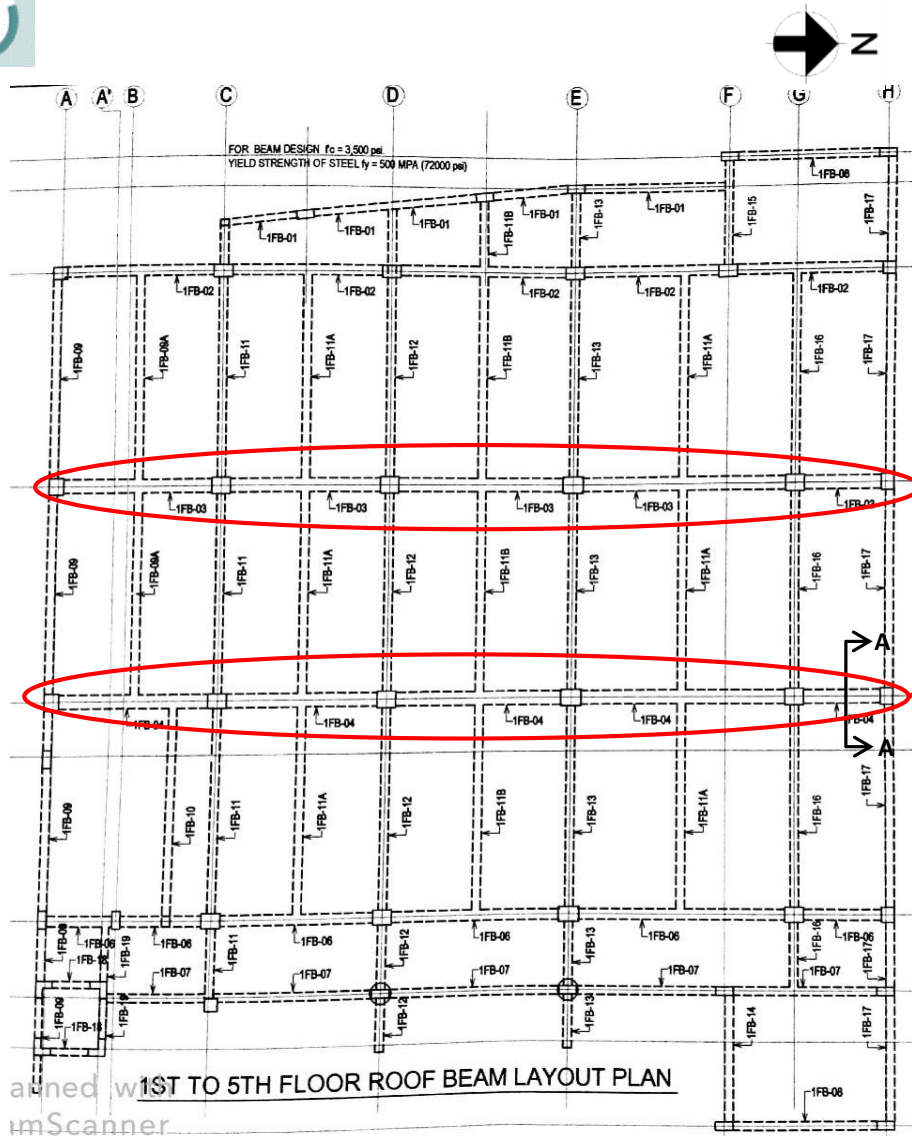
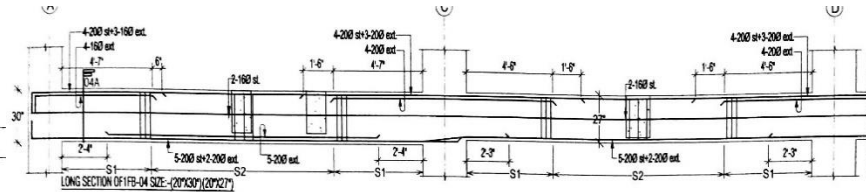
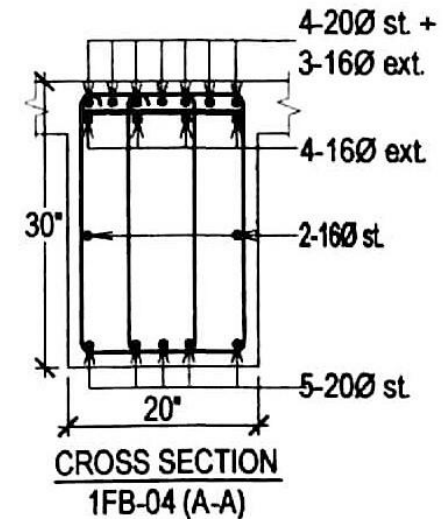
Beam width of FB-03 & FB-04 was supposed to be 20 inches as per provided as-built drawings. During inspection, beam width of FB-03 & FB-04 on 1<sup>st</sup> to 3<sup>rd</sup> floor roof was found 18 inches.

| Item No. | Observation | Recommended Action Plan | Recommended Timeline |
|---|---|---|---|
| 1 | Discrepancies between provided drawing and on-site condition (Main Building) | Building engineer to survey the building and update as-built drawings reflecting the as constructed condition. | 6-weeks |

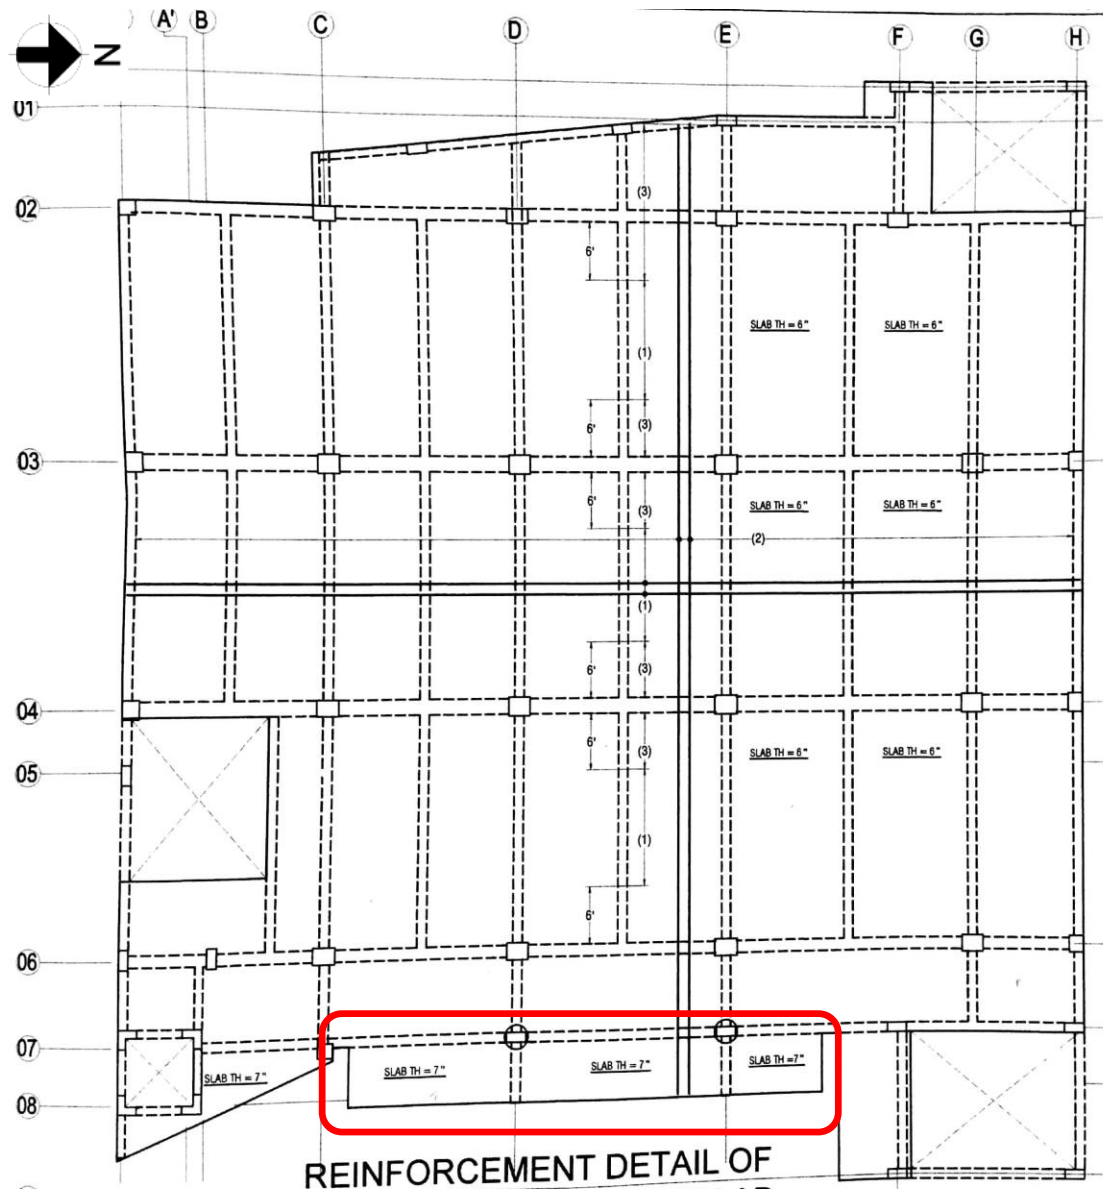
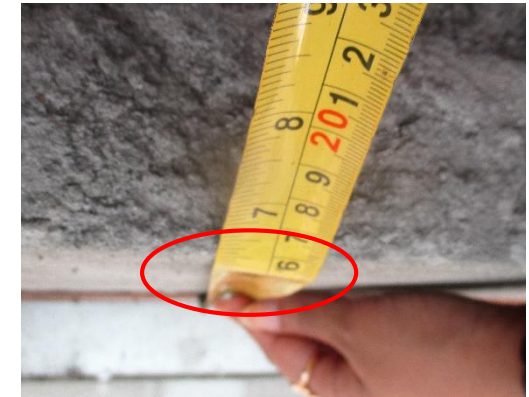
6 inches cantilever slab

Slab thickness of 1<sup>st</sup> to 3<sup>rd</sup> floor slab in the cantilever portion (Marked in Layout) was found to be 6 inches whereas slab thickness in that portion was supposed to be 7 inches as per provided slab layout.

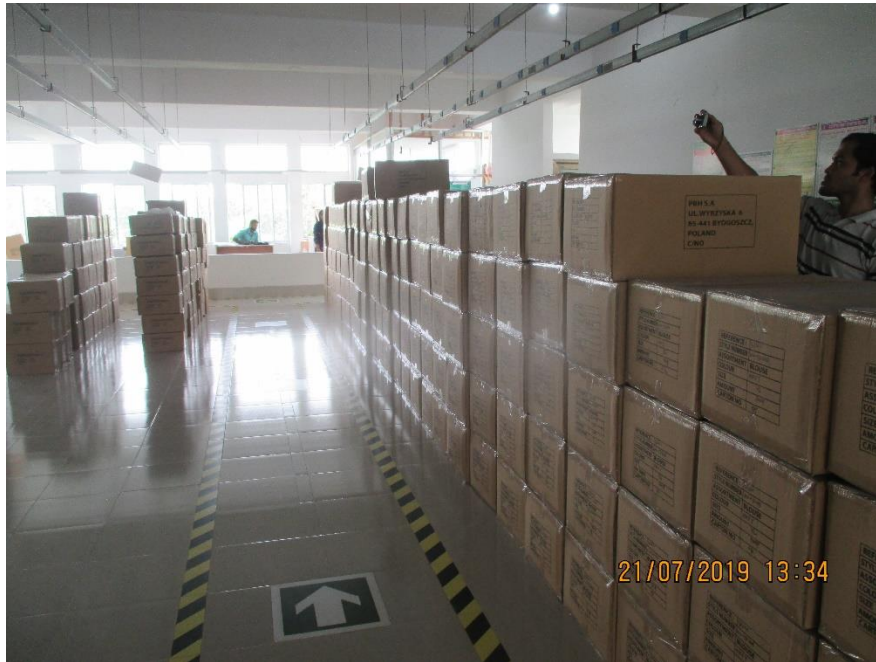
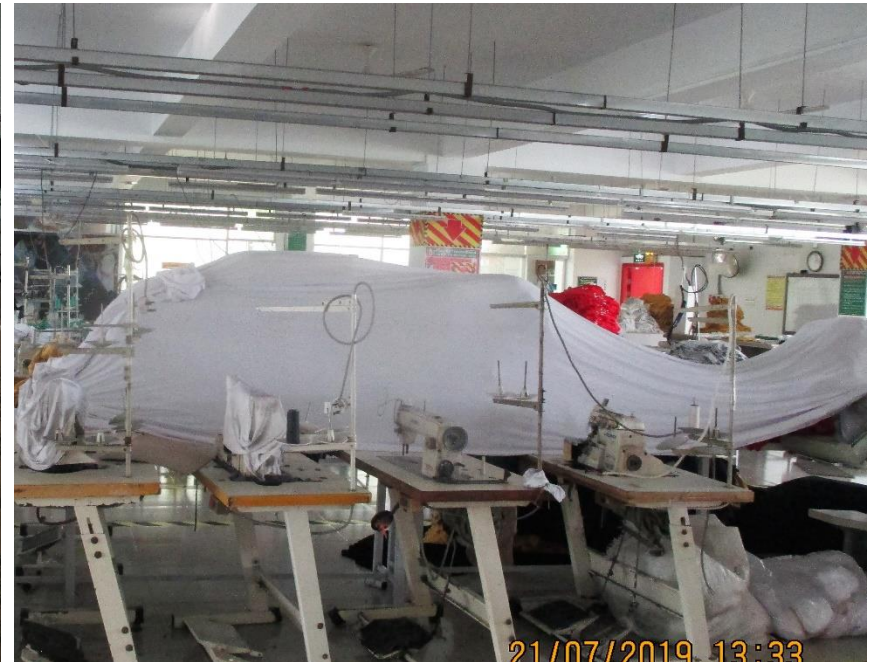
No load management programs were visible. Load plan has been prepared but not posted on floors. Factory is required to implement load management program as per produced load plans for all floors of the buildings and make sure that the workers understand the loading requirements. Also, provide load height marking in storage areas.

| Item No. | Observation | Recommended Action Plan | Recommended Timeline |
|---|---|---|---|
| 2 | Implement floor load management program. (Main Building) | Factory is required to implement load management program (signage, load restriction height marking) as per floor load plan. | 6-weeks |
| 3 | Implement floor load management program. (Main Building) | Continue to implement load plan. | 6-months |

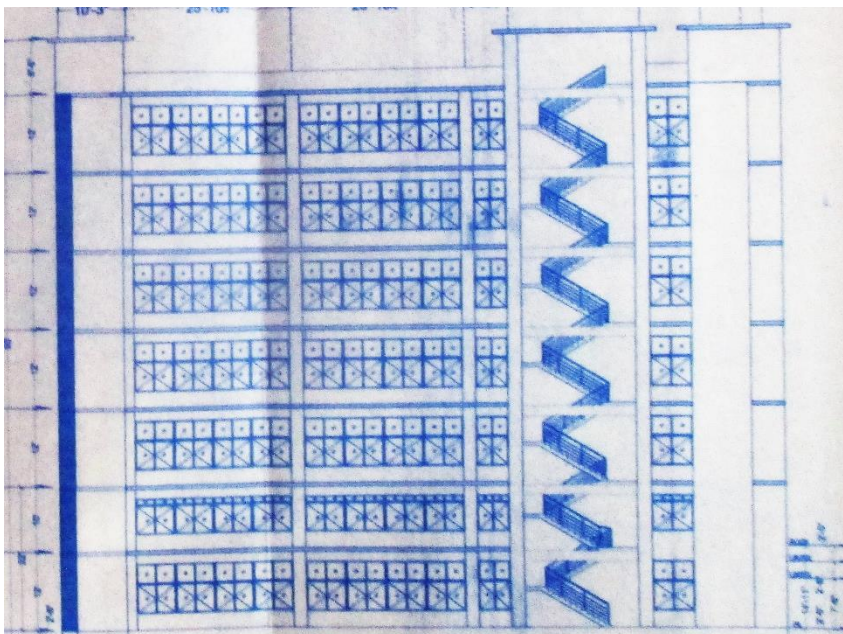
LGED Permit drawing showed 6-storied with mezzanine

This building is permitted for 6 storied with a mezzanine (G+M+5) on the ground floor from LGED. Currently the building is 3 storied with a mezzanine. Factory has a future plan to complete construction up to 6 storeys. Proposed drawings were available during inspection. Factory engineer is required to carry out a Detail Engineering Assessment considering BNBC standard prior to any extension work.

| Item No. | Observation | Recommended Action Plan | Recommended Timeline |
|---|---|---|---|
| 4 | Possible vertical extension. (Main Building) | In case of extension, detailed engineering assessment to be carried out following BNBC requirement. | 6-weeks |

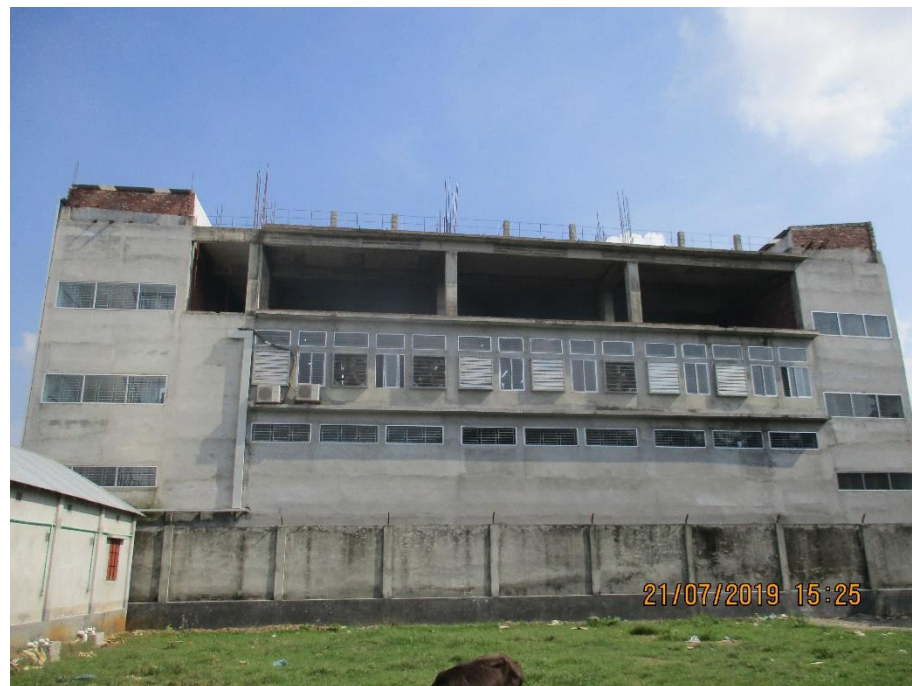
3-storied Main Building with a mezzanine

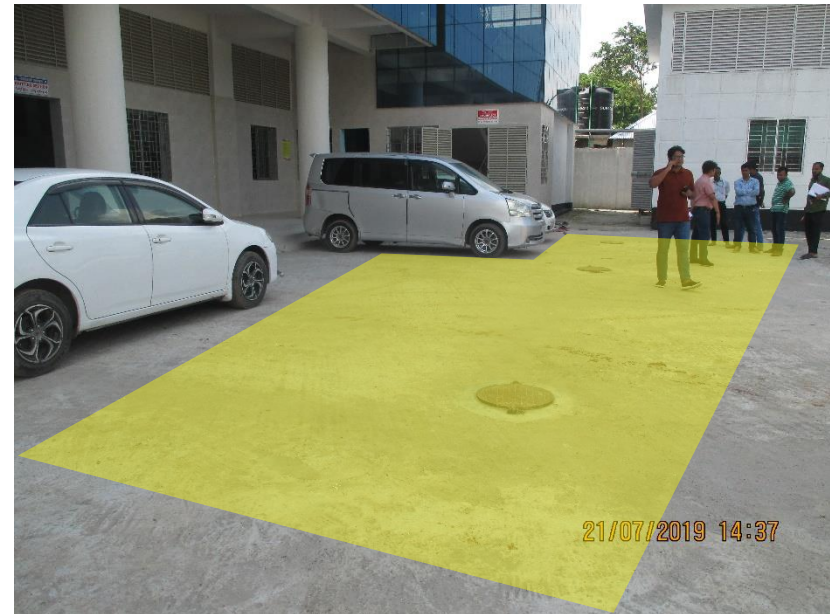
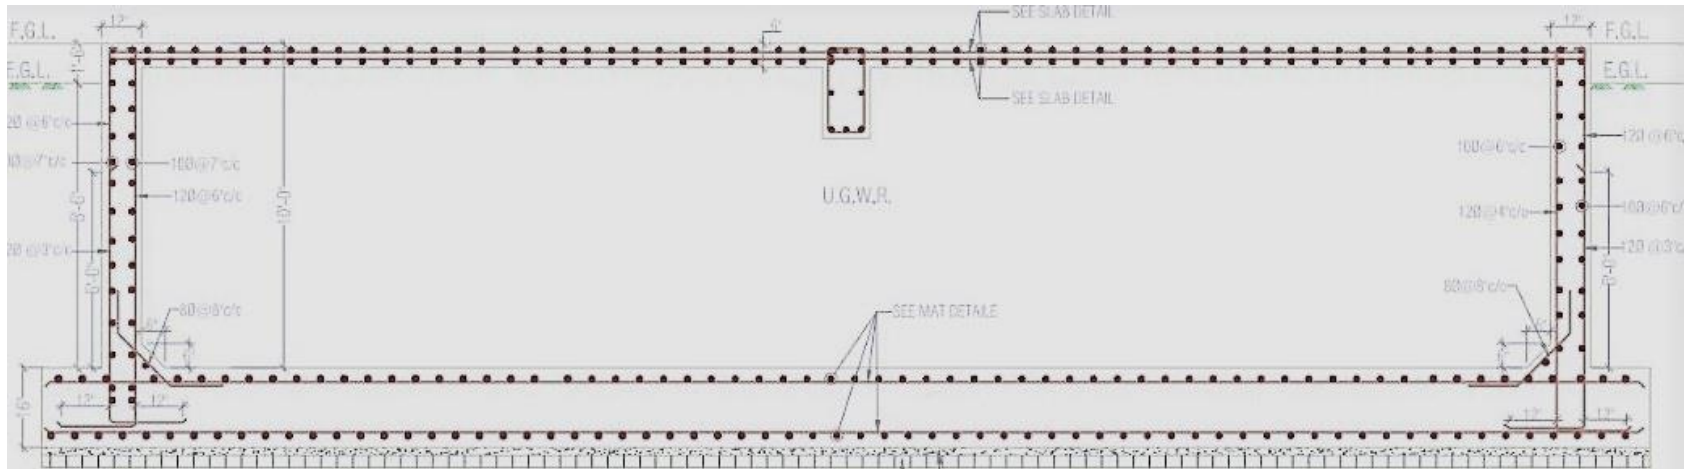
Underground Water Reservoir is situated beneath the vehicle parking and loading-unloading zone. Top slab thickness is 6 inches as per provided water reservoir drawing. Therefore, factory is required to check for adequacy of the top slab of water reservoir.

| Item No. | Observation | Recommended Action Plan | Recommended Timeline |
|---|---|---|---|
| 5 | Slab adequacy check of underground water reservoir. (Main Building) | Building Engineer to check the adequacy of top slab of underground water reservoir for the applied load. | 6-weeks |
| 6 | Slab adequacy check of underground water reservoir. (Main Building) | Implement remediation work if required. | 6-months |

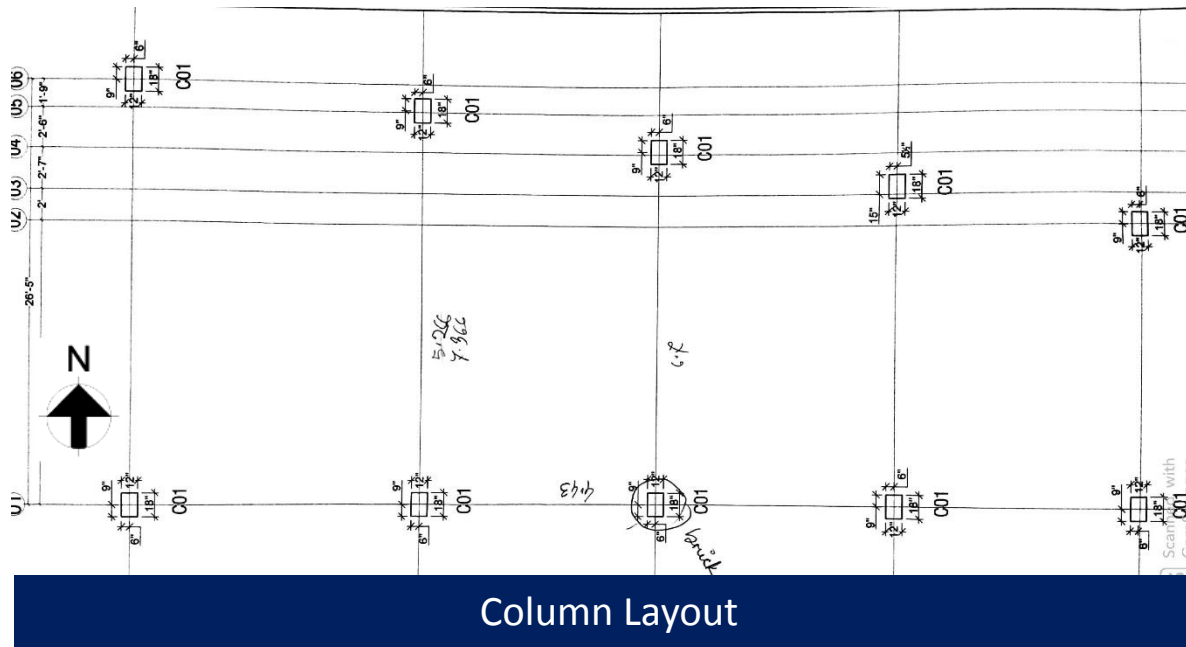
6-16 mm rebars were found in C1 type columns in stead of 8-16 mm rebars as mentioned in provided as-built structural drawing. Factory is required to update as-built drawings representing actual on-site condition.

| Item No. | Observation | Recommended Action Plan | Recommended Timeline |
|---|---|---|---|
| 7 | Discrepancies between provided drawing and on-site condition. (Utility Building) | Building engineer to survey the building and update as-built drawings reflecting the as constructed condition. | 6-weeks |

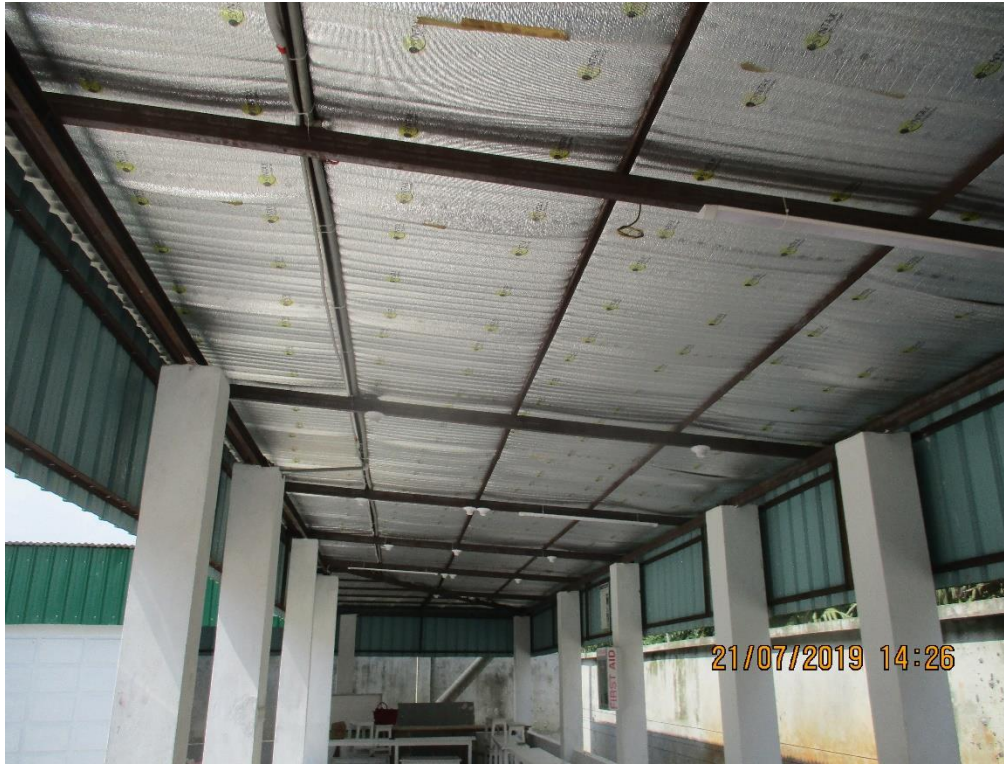
Light weight roof supported on RC column

Dining Shed is apparently non-engineered shed. Poor connection between support and rafter. Building engineer to check the stability of the lightweight roof structure against lateral loading and if inadequate then replace the structure with an engineered one. Also, prepare as-built drawings for the structure.

| Item No. | Observation | Recommended Action Plan | Recommended Timeline |
|---|---|---|---|
| 8 | Apparently non-engineered shed. (Dining Shed) | Prepare an “as constructed” drawings which reflect the actual site dimensions with complete structural information. | 6-weeks |
| 9 | Apparently non-engineered shed. (Dining Shed) | Building engineer to check the capacity of the lightweight steel roof against lateral loading. | 6-weeks |
| 10 | Apparently non-engineered shed. (Dining Shed) | Carry out remedial works resulting from engineering assessment if necessary. | 6-months |

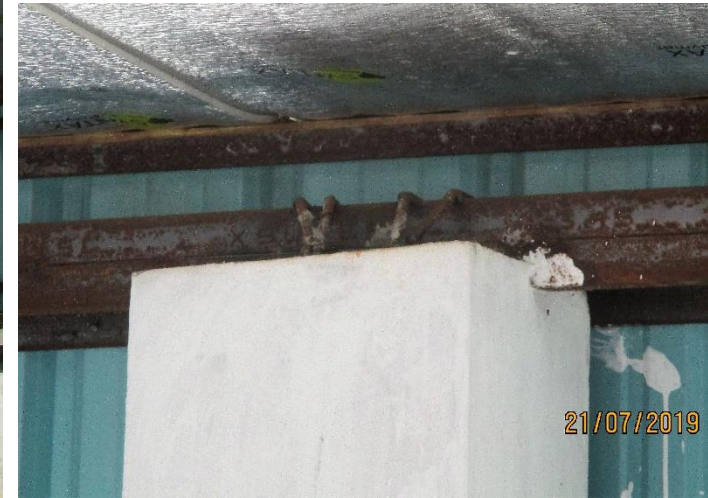
Non-engineered connection
