# Target Denim & Casual Wear Ltd.

Islampur Road, Kodda, Nadun, Gazipur

27<sup>th</sup> January and 4<sup>th</sup> February 2019

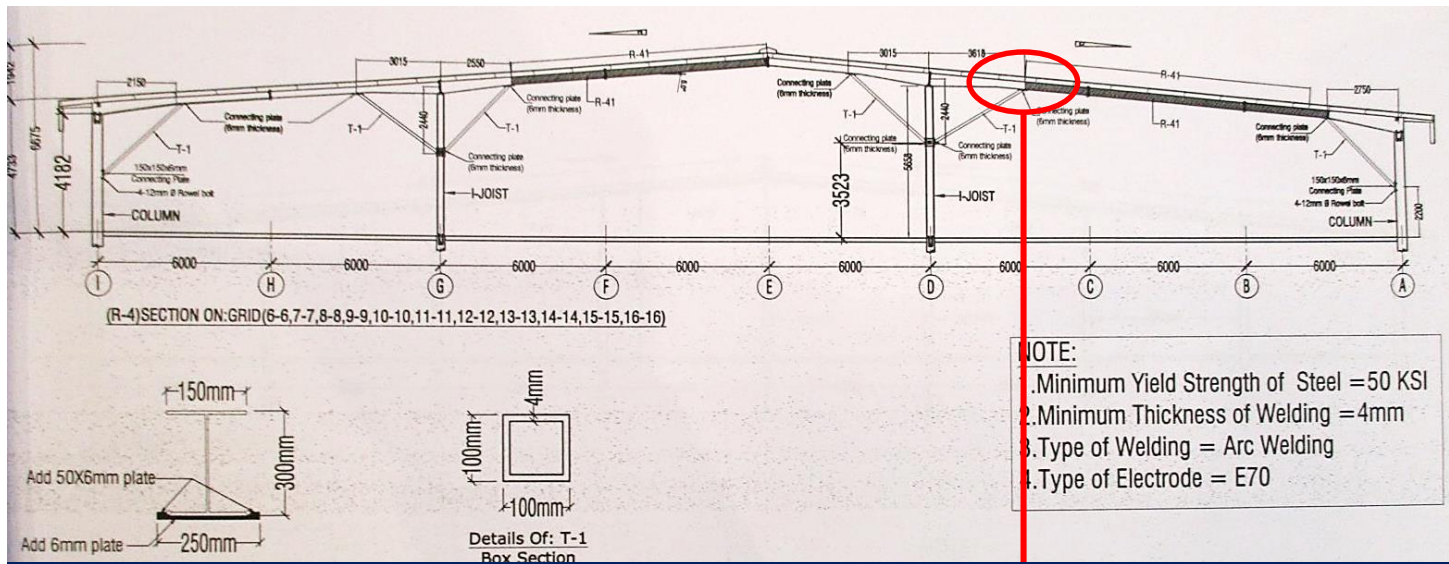
Retrofitting drawing.

As per retrofitting drawings bottom flange of rafter was required to retrofit up to the knee bracing. But bottom flanges were not retrofitted up-to the mentioned point.

| Item No. | Observation | Recommended Action Plan | Recommended Timeline |
|---|---|---|---|
| 1 | Improper retrofitting works<br>Shed-1 (Finishing) | The factory is required to implement the further retrofitting works as per retrofitting drawings. | 6-weeks |

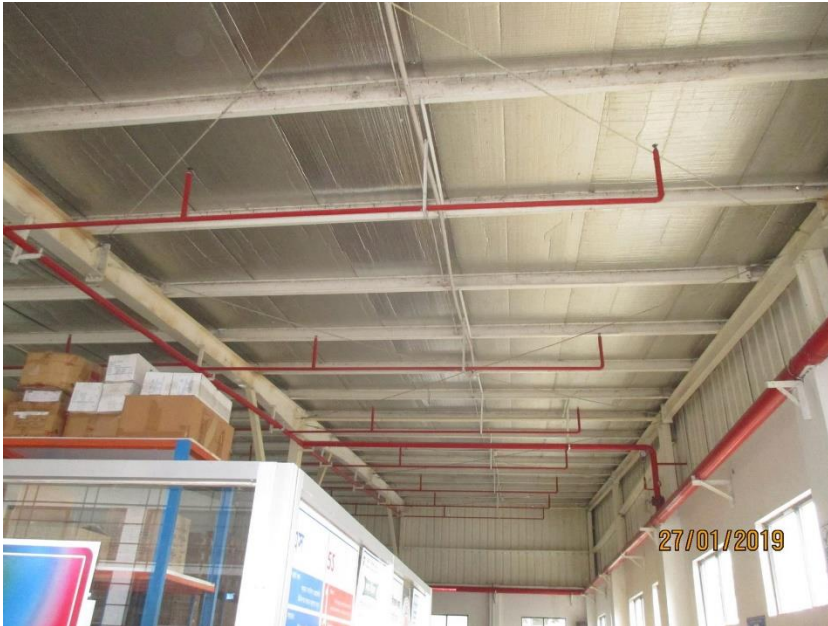
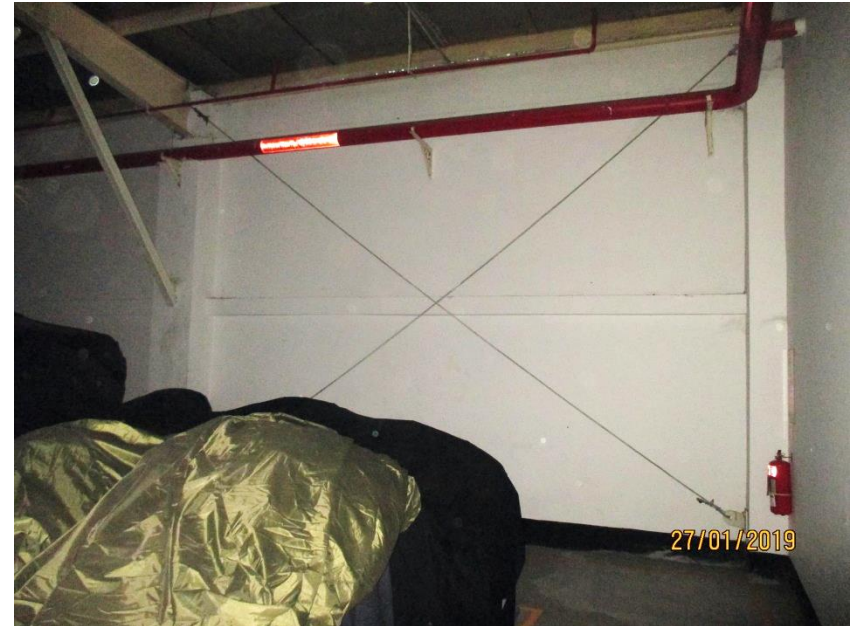
Horizontal & Vertical bracing found loose. The bracings are required to be tighten.

| Item No. | Observation | Recommended Action Plan | Recommended Timeline |
|---|---|---|---|
| 2 | Loose bracings and gap in connections<br>Shed-1 (Finishing) | The factory is required to tighten the loose bracings. | 6-weeks |
| 3 | Loose bracings and gap in connections<br>Shed-1 (Finishing) | Fill the gaps in connections as per the engineers suggestion. | 6-weeks |

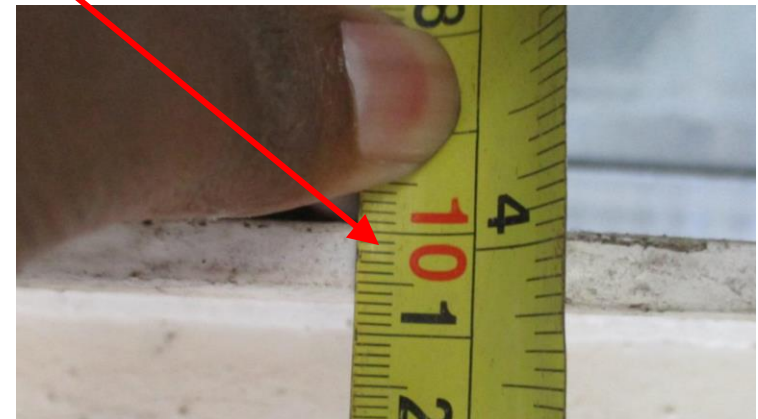
Flange thickness rafter was found 6mm instead of 8mm

| Item No. | Observation | Recommended Action Plan | Recommended Timeline |
|---|---|---|---|
| 4 | Mismatch in as-built drawings.<br>Shed-2 (Sewing and Cutting Shed) | Factory Engineer is required to survey the structure and develop as-built drawings to as-constructed status. | 6-weeks |
| 5 | Mismatch in as-built drawings.<br>Shed-2 (Sewing and Cutting Shed) | Factory Engineer to check the adequacy of rafter/beams based on as-built conditions. | 6-weeks |

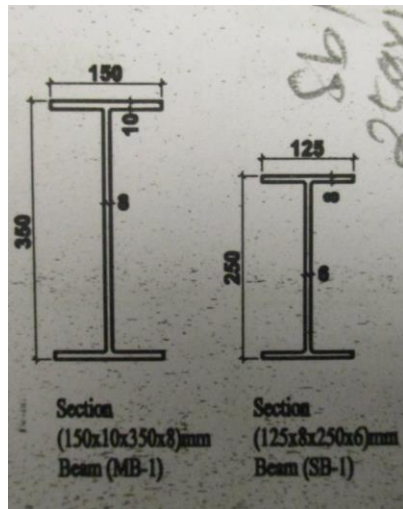
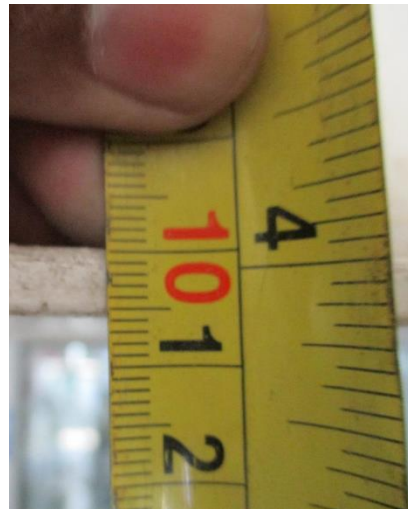
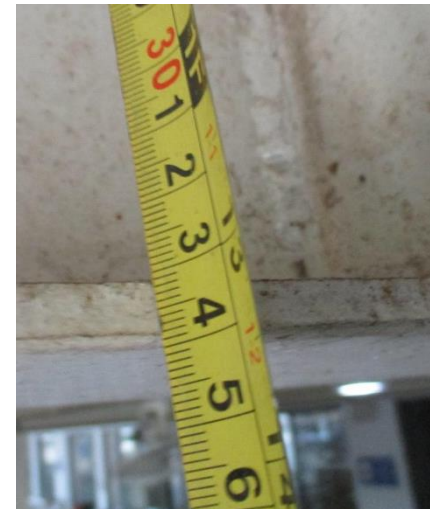
Flange thickness of mezzanine floor main beam and sub-beam was found 6mm instead of 100mm and 8mm respectively.

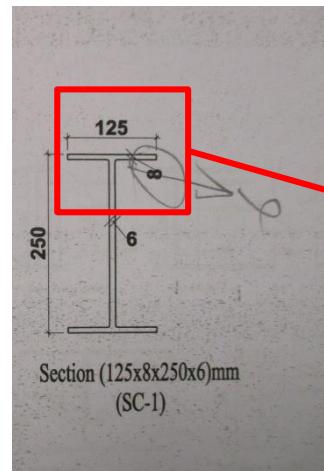
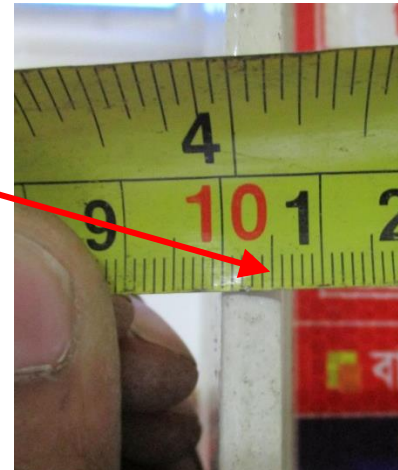
Flange thickness of mezzanine floor column was found 6mm instead of 8mm

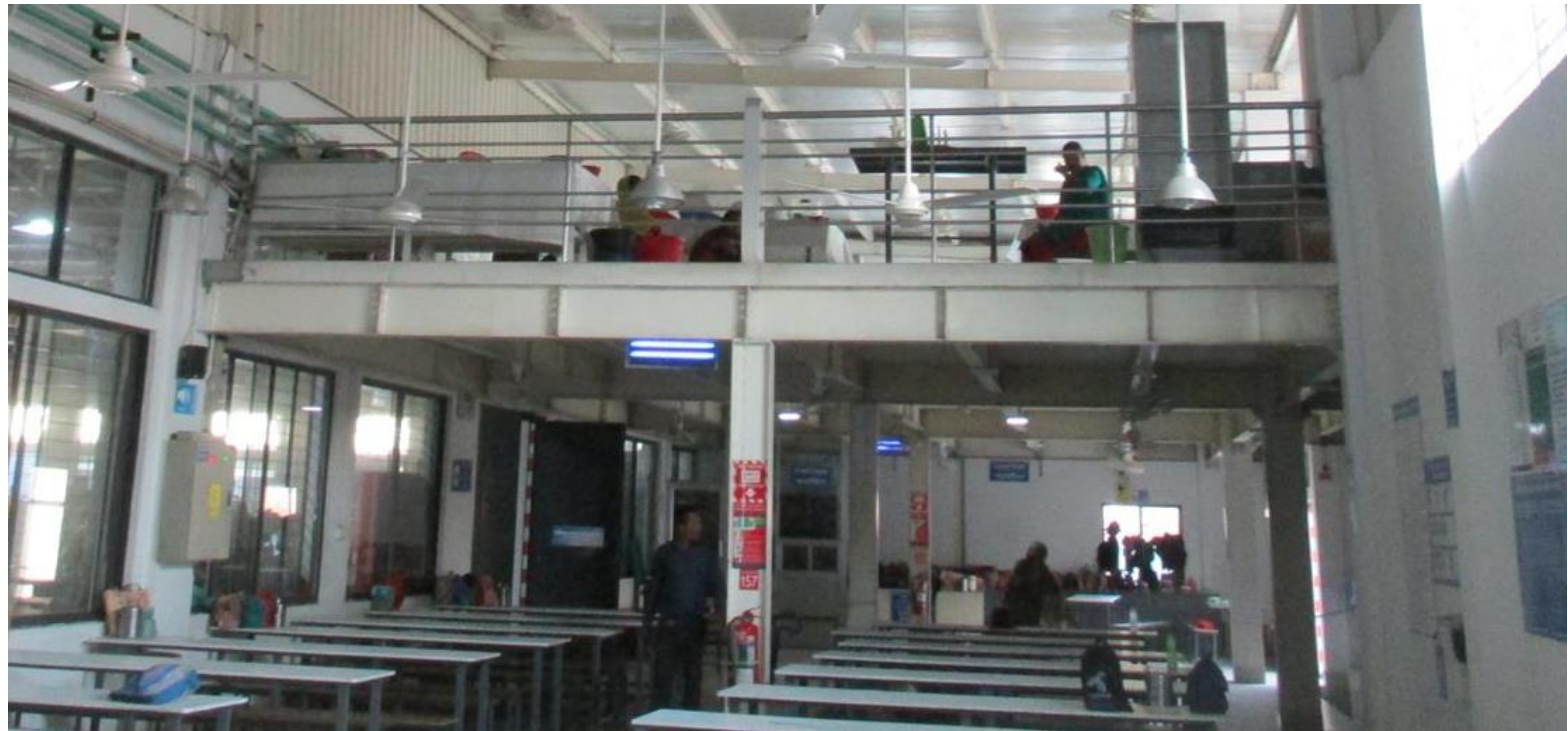
The factory engineer to prepare floor live loading plan for the mezzanine floor considering live loading requirement of BNBC-2006. Also, implement the load management program.

| Item No. | Observation | Recommended Action Plan | Recommended Timeline |
|---|---|---|---|
| 7 | Floor loading plan to be updated<br>Shed-2 (Sewing and Cutting Shed) | Prepared loading plan is required to be updated following minimum live loading requirement of BNBC-2006. | 6-weeks |
| 8 | Floor loading plan to be updated<br>Shed-2 (Sewing and Cutting Shed) | Implement floor loading plan. | 6-months |

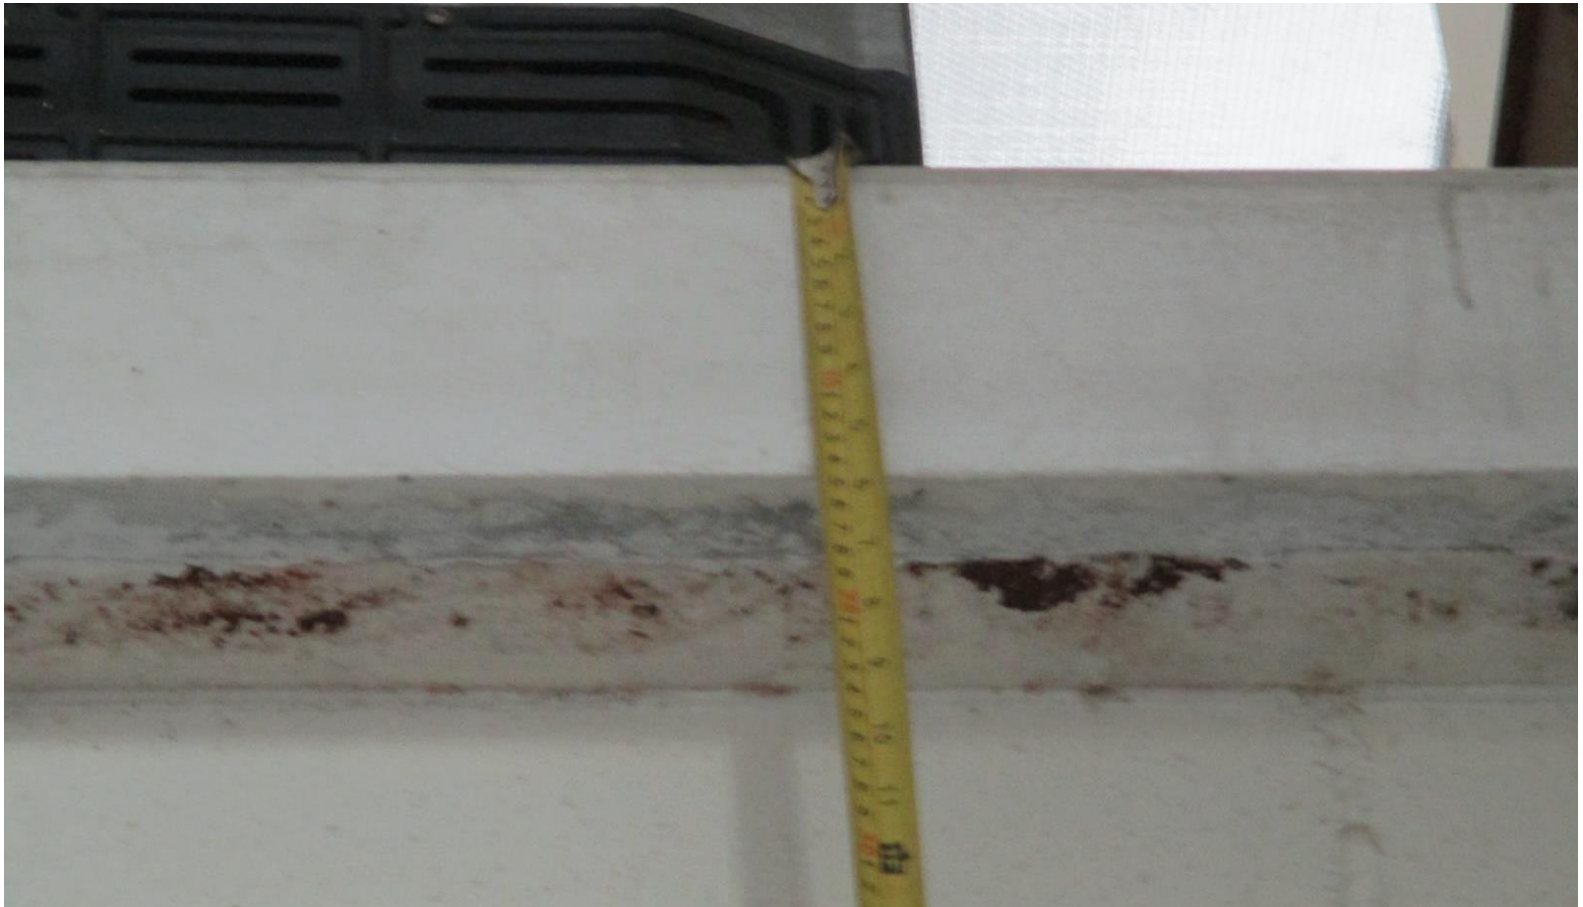
Corrosion in steel members at mezzanine floor main beam was observed. The factory is required to apply corrosion resistance coating on the steel member.

| Item No. | Observation | Recommended Action Plan | Recommended Timeline |
|---|---|---|---|
| 9 | Corrosion in steel members<br>Shed-2 (Sewing and Cutting Shed) | Factory is required to take necessary measures to repair the corrosion of steel members and prevent the reasons of corrosion. | 6-weeks |

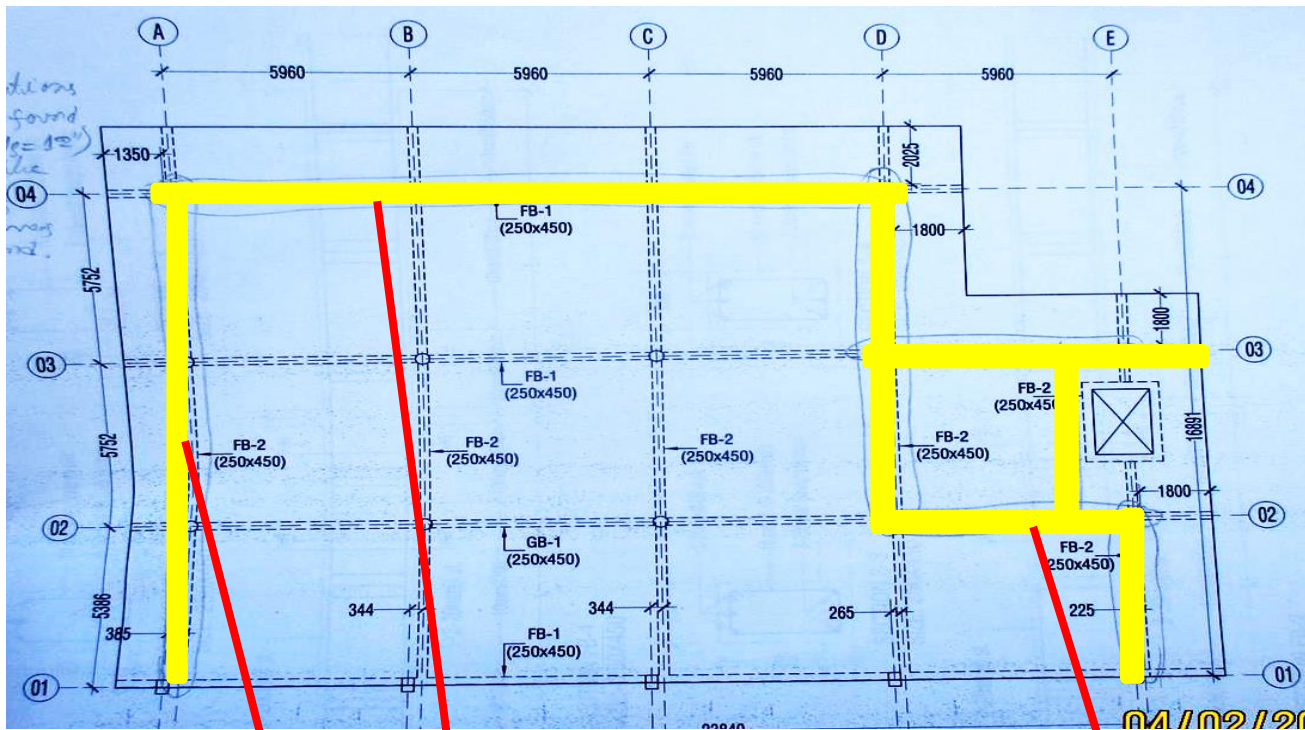
Inverted beam was only found at roof level only at marked locations. Beam was not found rest of the location as shown in as built drawing

| Item No. | Observation | Recommended Action Plan | Recommended Timeline |
|---|---|---|---|
| 11 | Mismatch in as-built drawings.<br>Building-1 (Office Building) | Factory Engineer is required to survey the structure and develop as-built drawings to as-constructed status. | 6-weeks |
| 12 | Mismatch in as-built drawings.<br>Building-1 (Office Building) | Factory Engineer to check the adequacy of rafter/beams based on as-built conditions. | 6-weeks |

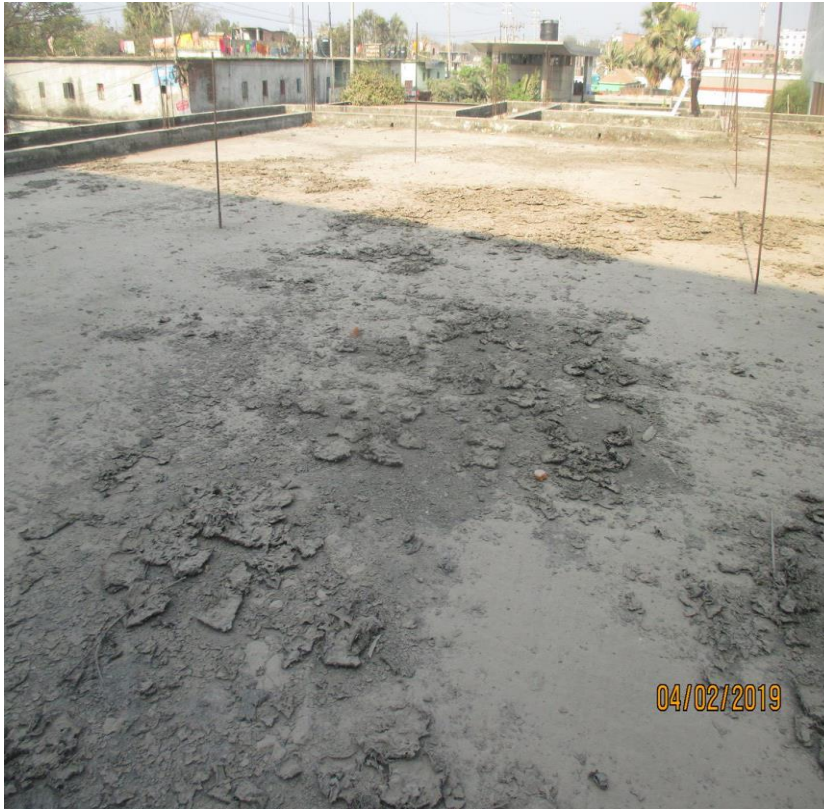
Signage of water ponding was found at roof level

| Item No. | Observation | Recommended Action Plan | Recommended Timeline |
|---|---|---|---|
| 14 | Lack of water proofing membrane and exposed rebar on roof.<br>Building-1 (Office Building) | Provide water proofing membrane on roof and provide corrosion resistance coating on exposed rebar. | 6-months |

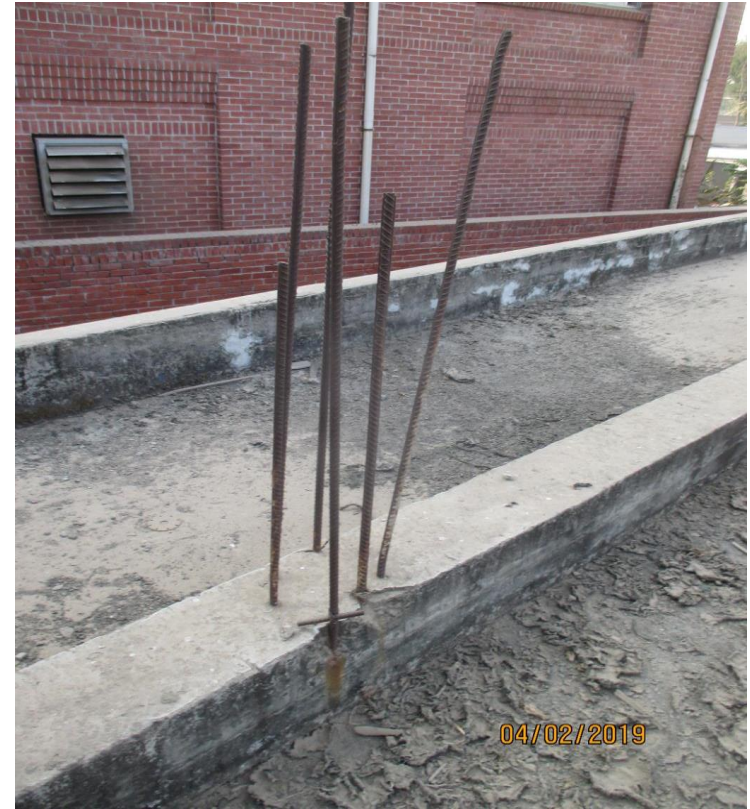
Column re-bar was found exposed at roof level

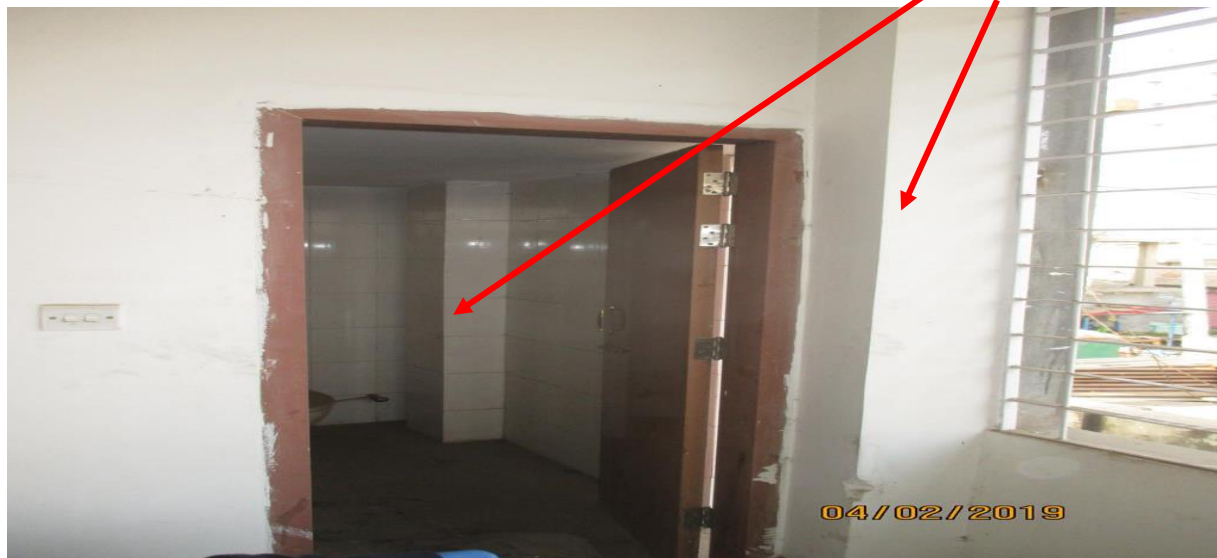
Column at grid A/2 & A/1 has been shown circular in column schedule. During inspection, this two column was found rectangle with size of 300mmX300mm

| Item No. | Observation | Recommended Action Plan | Recommended Timeline |
|---|---|---|---|
| 15 | Mismatch in as-built drawings.<br>Building-2<br>(Security/Gatehouse Building) | Factory Engineer is required to survey the structure and develop as-built drawings to as-constructed status. | 6-weeks |
| 16 | Mismatch in as-built drawings.<br>Building-2<br>(Security/Gatehouse Building) | Factory Engineer to check the adequacy of rafter/beams based on as-built conditions. | 6-weeks |

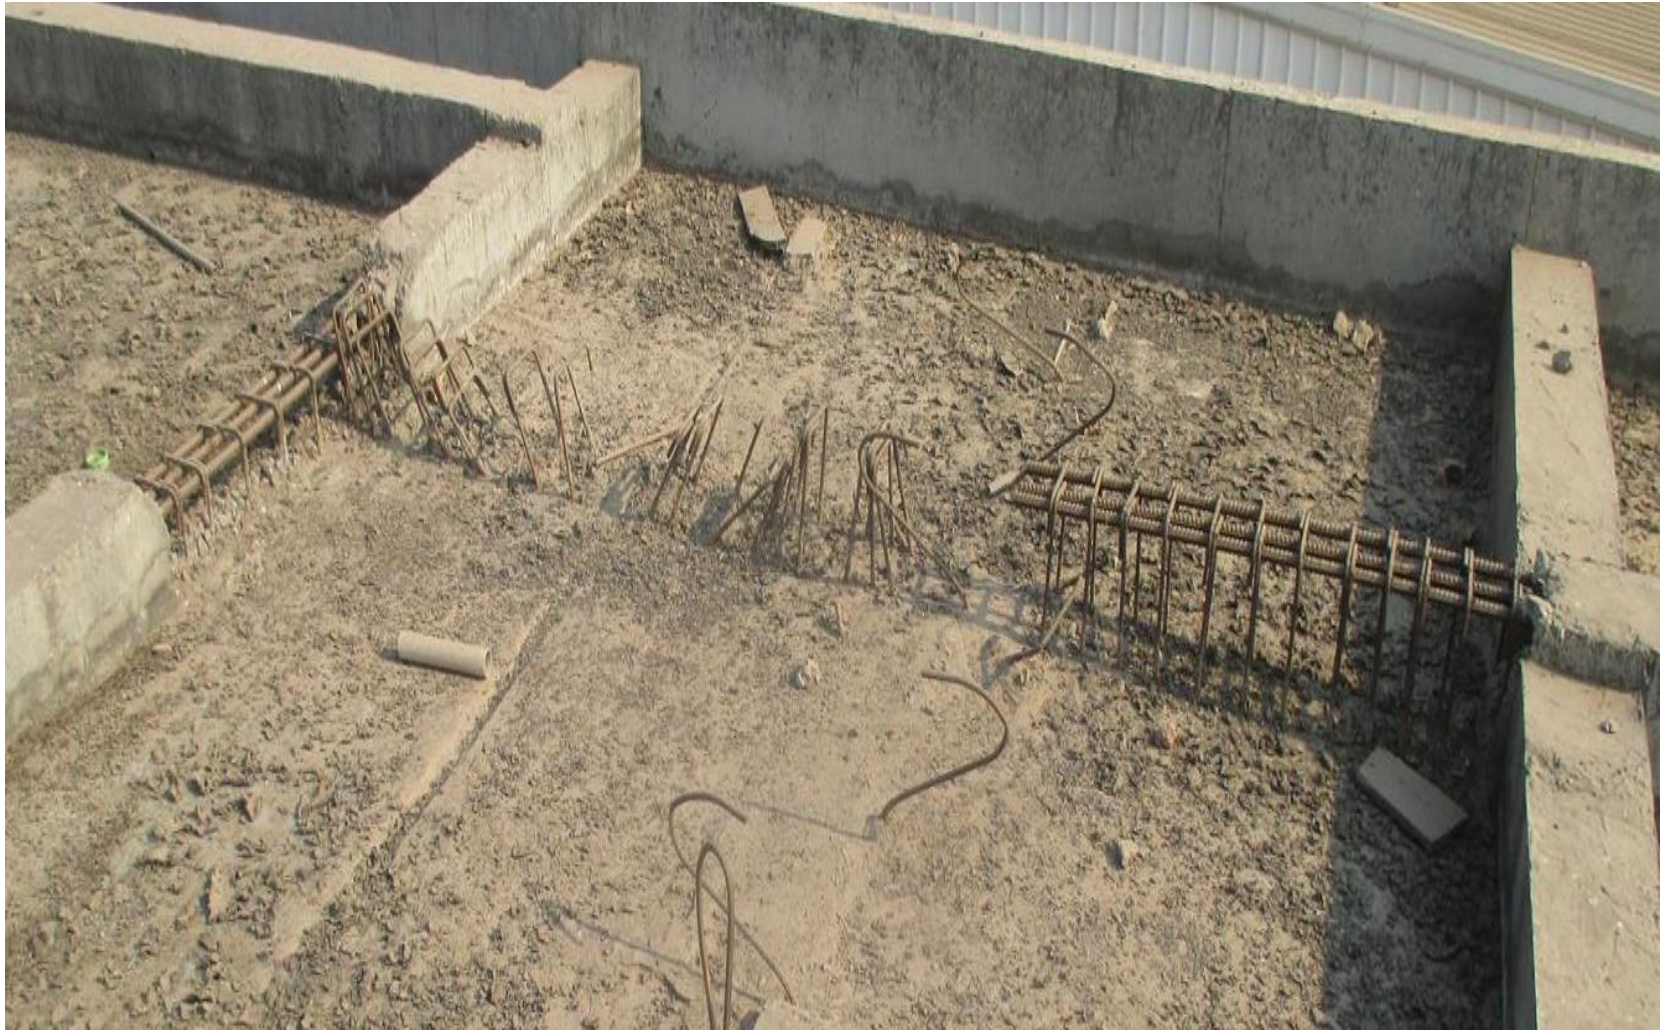
The roof floor beam was found partially casted and the rebars were exposed to air

| Item No. | Observation | Recommended Action Plan | Recommended Timeline |
|---|---|---|---|
| 18 | The roof floor beam was found partially casted and the rebars were exposed to air.<br>Building-2<br>(Security/Gatehouse Building) | Factory Engineer is required to cast the roof beam. | 6-weeks |

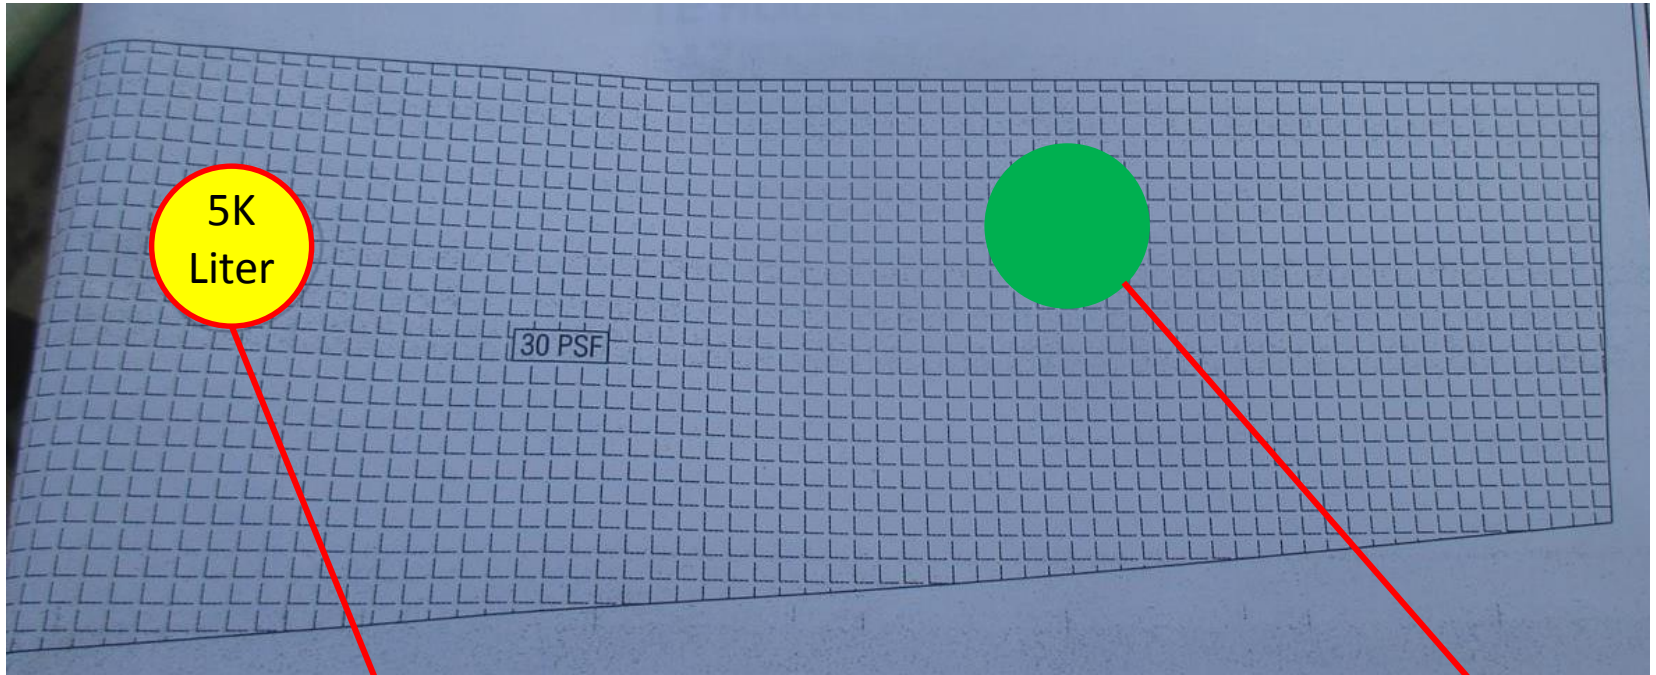
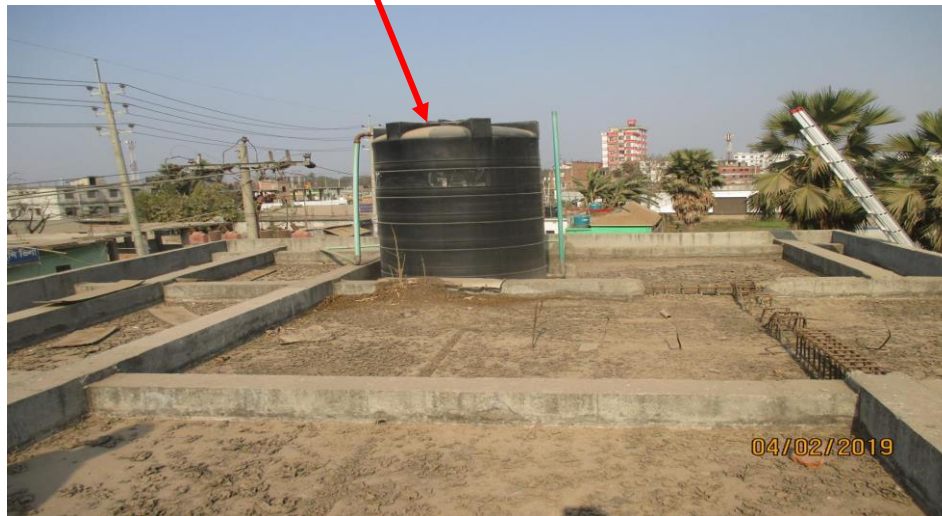
5K liter water tank was found at roof which has not been placed as per layout. Water tank was found at marked location.

Water tank was not found at this location

| Item No. | Observation | Recommended Action Plan | Recommended Timeline |
|---|---|---|---|
| 19 | Floor loading plan to be updated.<br>Building-2<br>(Security/Gatehouse Building) | The loading plan to be revised as per the requirement of BNBC-2006. | 6-weeks |
| 20 | Floor loading plan to be updated.<br>Building-2<br>(Security/Gatehouse Building) | Implement the floor loading plan. | 6-months |

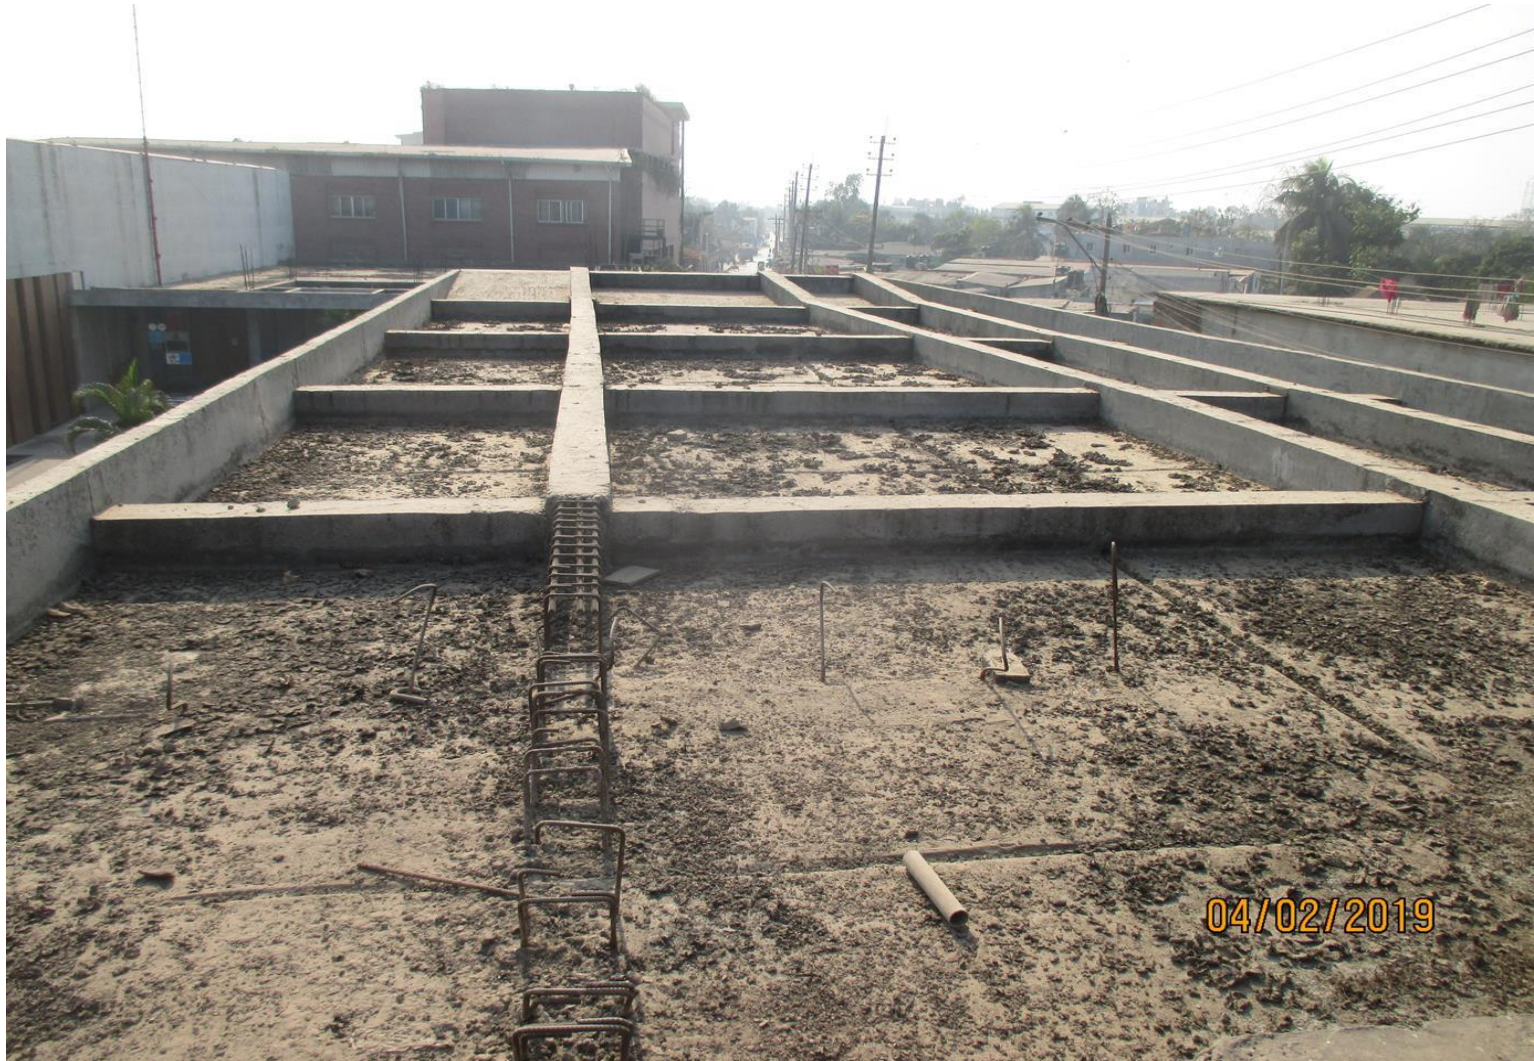
Signage of water ponding was found at roof level.

| Item No. | Observation | Recommended Action Plan | Recommended Timeline |
|---|---|---|---|
| 21 | Water ponding/intrusion signs in the roof<br>Building-2<br>(Security/Gatehouse Building) | Factory is required to take necessary measures to prevent water intrusion and repair damaged area. | 6-weeks |

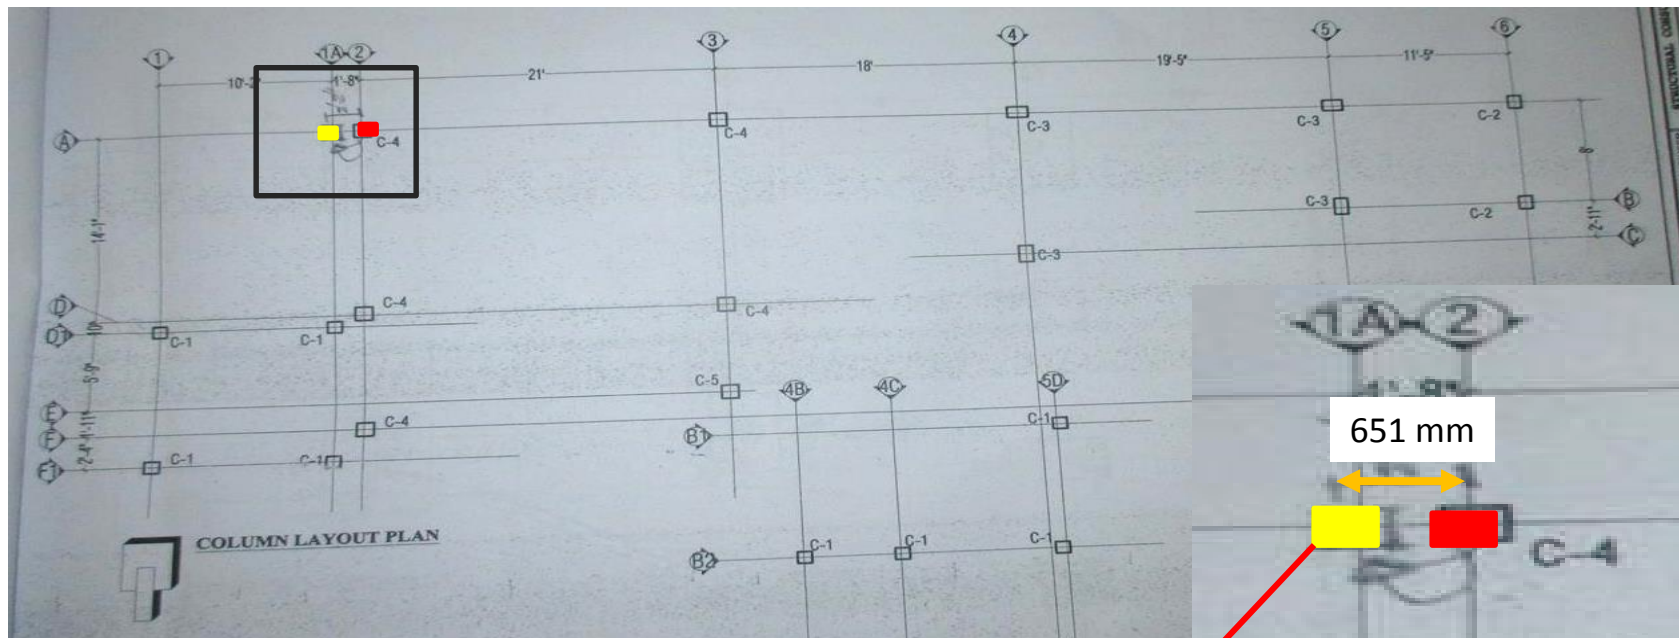
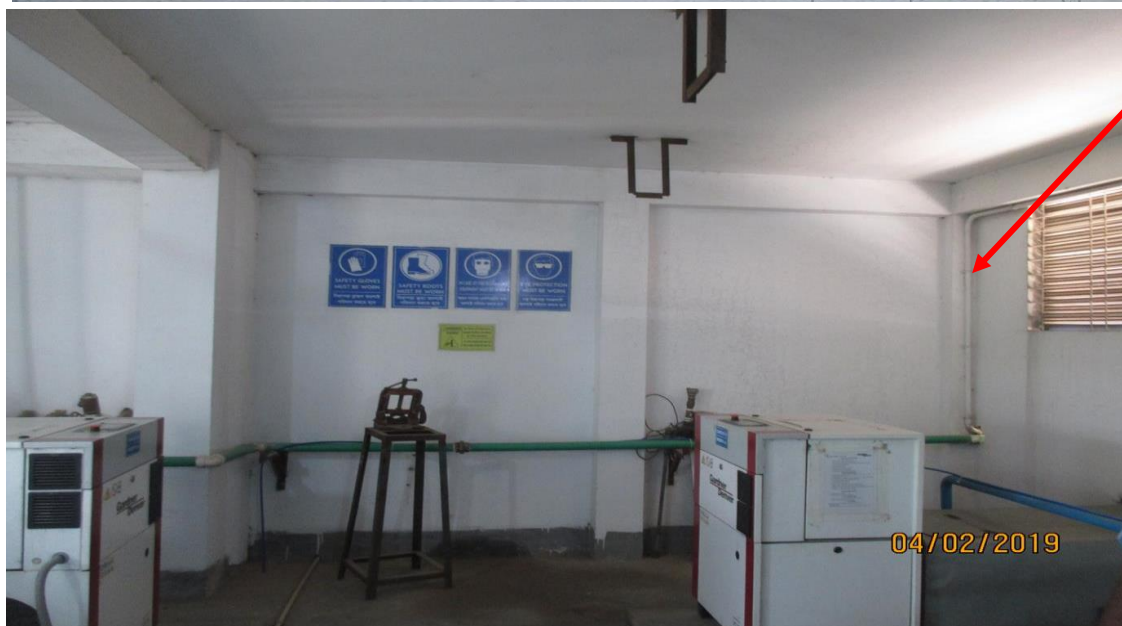
Column Layout plan does not match with actual site condition. Column was found at yellow marked location instead of red marked location

| Item No. | Observation | Recommended Action Plan | Recommended Timeline |
|---|---|---|---|
| 22 | Mismatch in as-built drawings.<br>Building-3 (Utility Building) | Factory Engineer is required to survey the structure and develop as-built drawings to as-constructed status. | 6-weeks |
| 23 | Mismatch in as-built drawings.<br>Building-3 (Utility Building) | Factory Engineer to check the adequacy of column/beam based on as-built conditions. | 6-weeks |

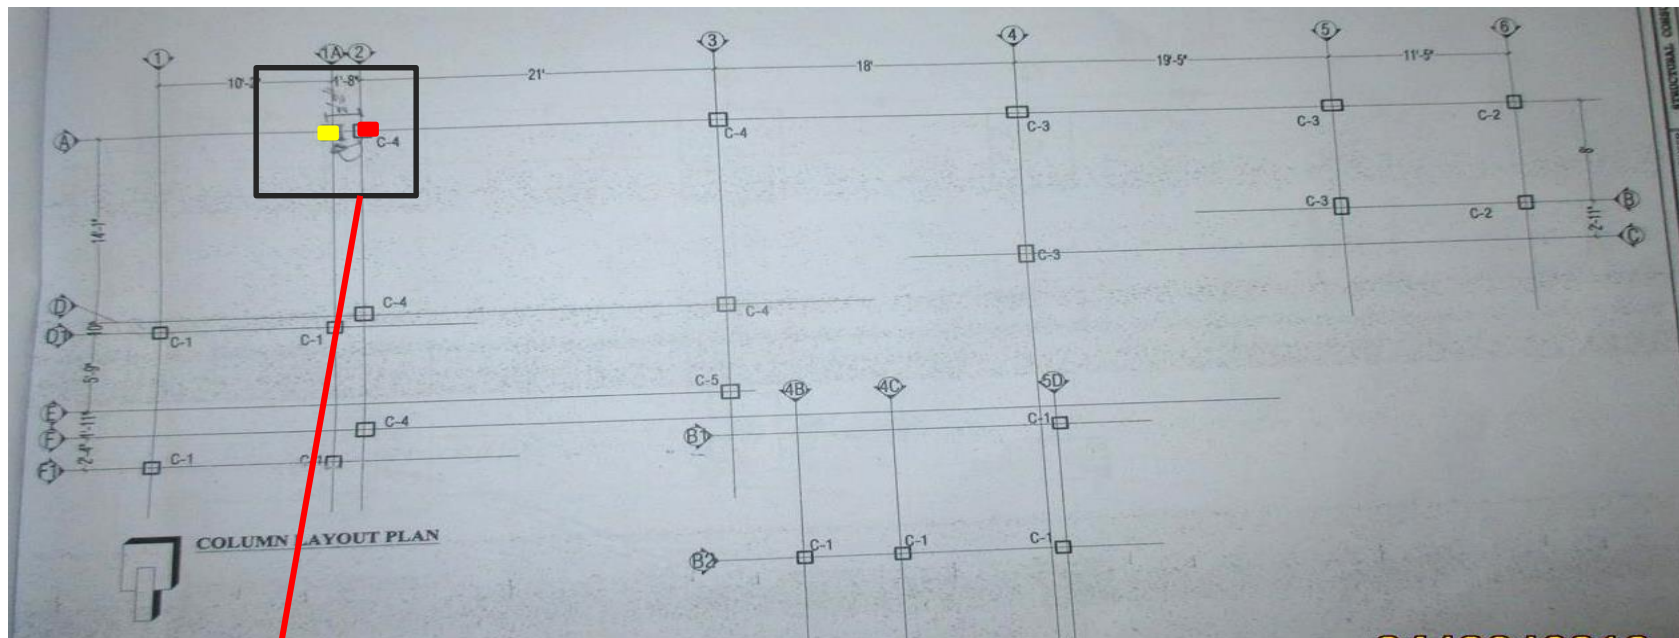
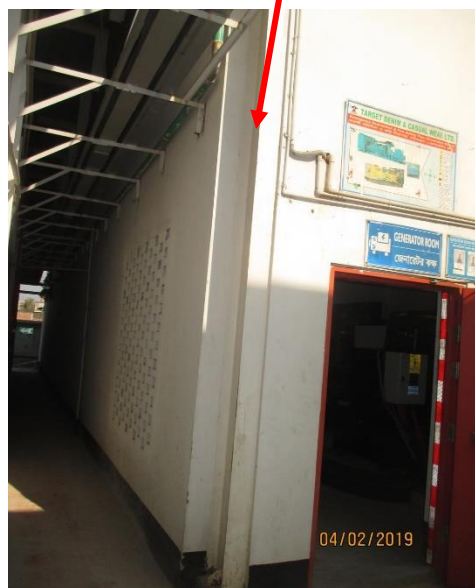
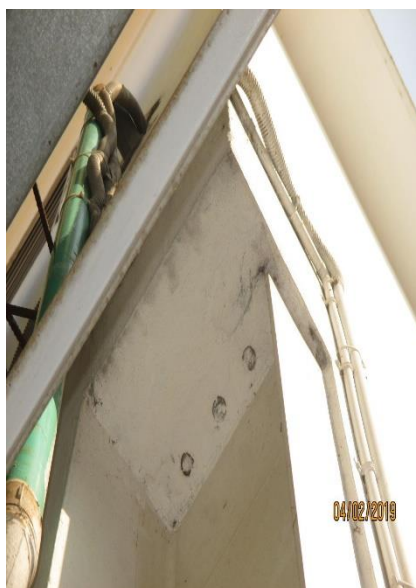
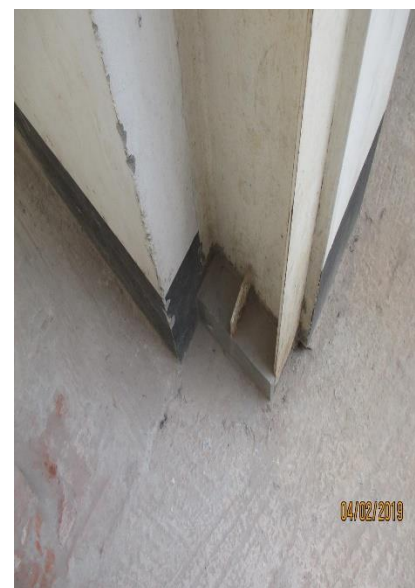
Steel column was found at ground floor at marked location. RCC column was found started above the steel column at 1<sup>st</sup> floor

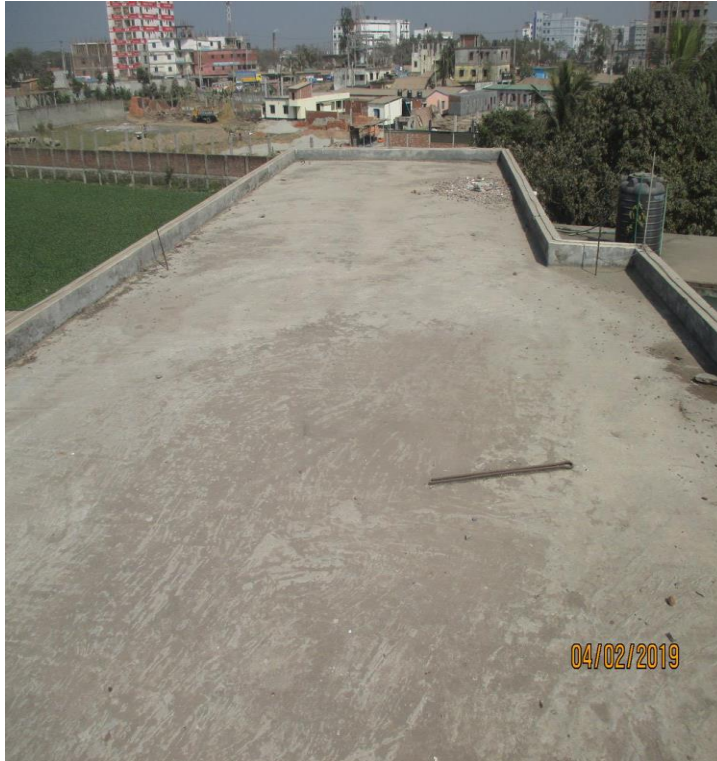
Signage of water ponding was found at roof level

| Item No. | Observation | Recommended Action Plan | Recommended Timeline |
|---|---|---|---|
| 25 | Lack of water proofing membrane and exposed rebar on roof.<br>Building-3 (Utility Building) | Provide water proofing membrane on roof and provide corrosion resistance coating on exposed rebar. | 6-months |

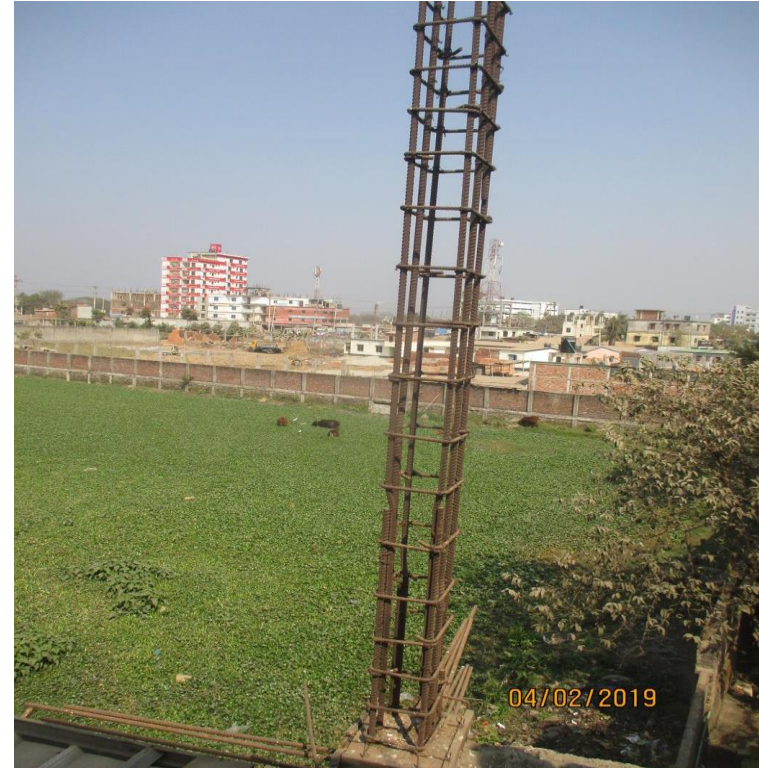
Column re-bar was found exposed at roof level

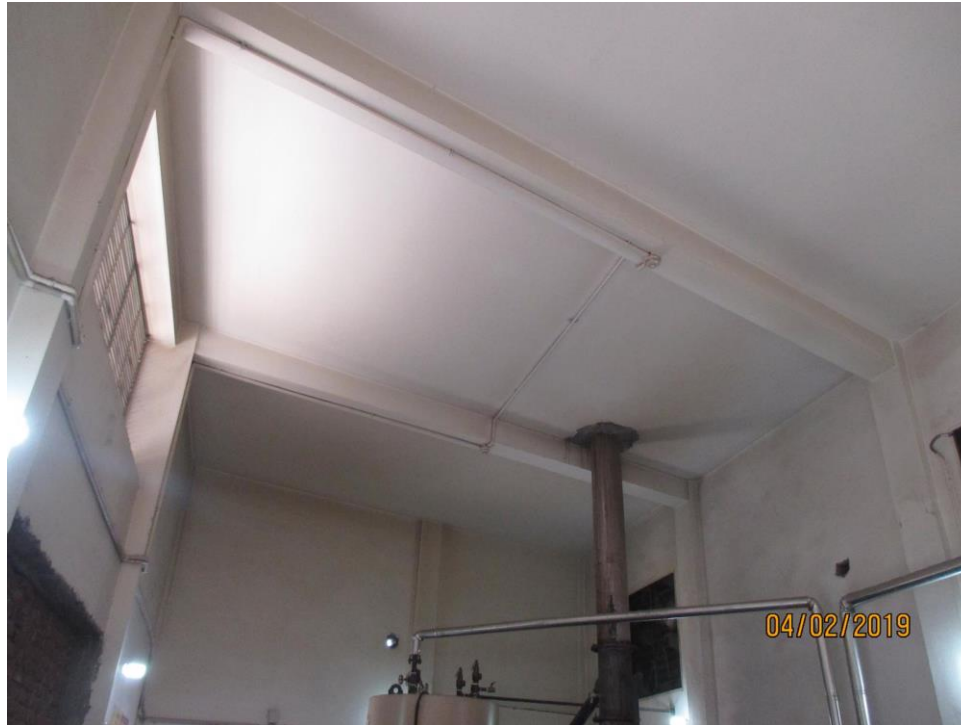
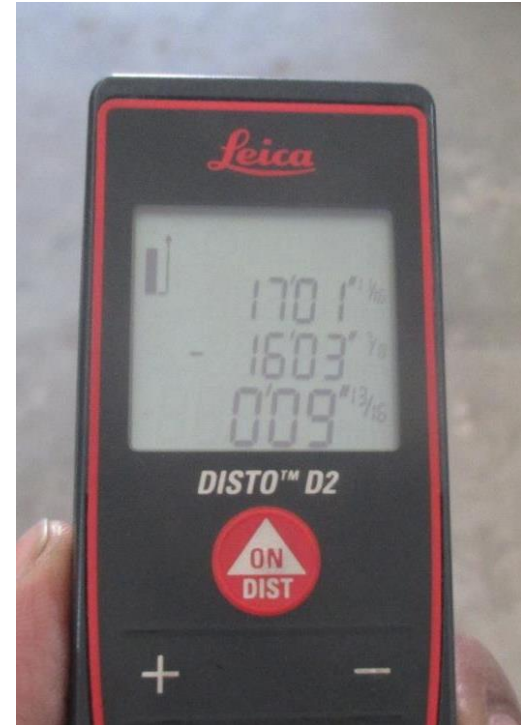
Beam size does not match with actual site condition. Down stand depth was found 9" instead of 13" at grid 3/(C1-H) & 2/(C1-H). (considering slab thickness 5")

| Item No. | Observation | Recommended Action Plan | Recommended Timeline |
|---|---|---|---|
| 26 | Mismatch in as-built drawings.<br>Building-4 (Boiler Building) | Factory Engineer is required to survey the structure and develop as-built drawings to as-constructed status. | 6-weeks |
