# LOGOS Apparels Ltd.(New buildings)

TELIRCHALA, MOUCHAK, KALIAKOIR, GAZIPUR  
(24.016202, 90.305371)

29<sup>th</sup> January 2019 & 5<sup>th</sup> February 2019

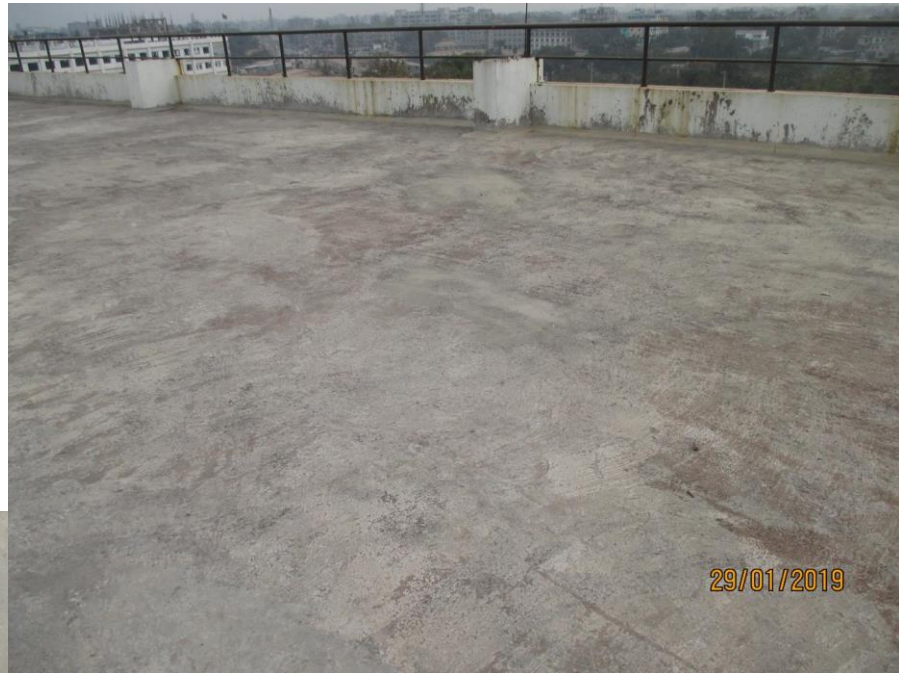
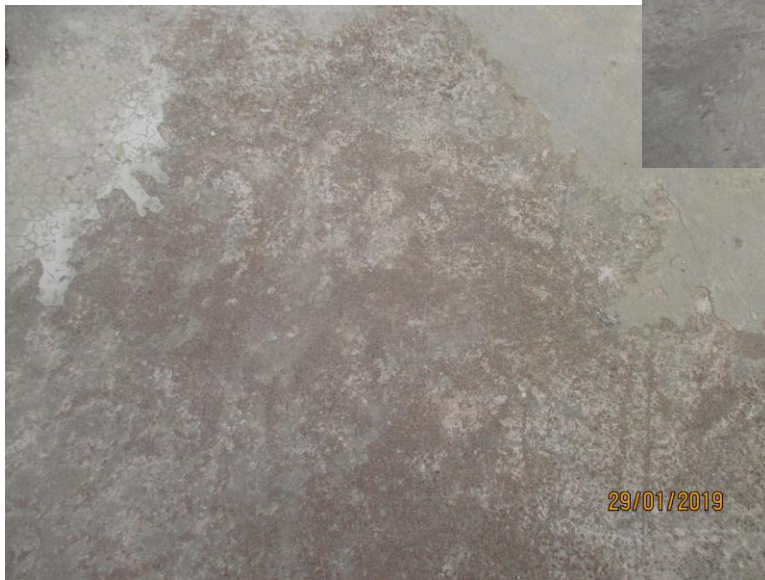
**Lack of water proofing membrane at roof**

Roof slab constructed with brick aggregate. Water proofing membrane is required to be applied with proper slope.

| Item No. | Observation | Recommended Action Plan | Recommended Timeline |
|---|---|---|---|
| 1 | Lack of water proofing membrane at roof (Building#2) | Apply suitable waterproofing material suggested by the factory engineer. | 6-months |

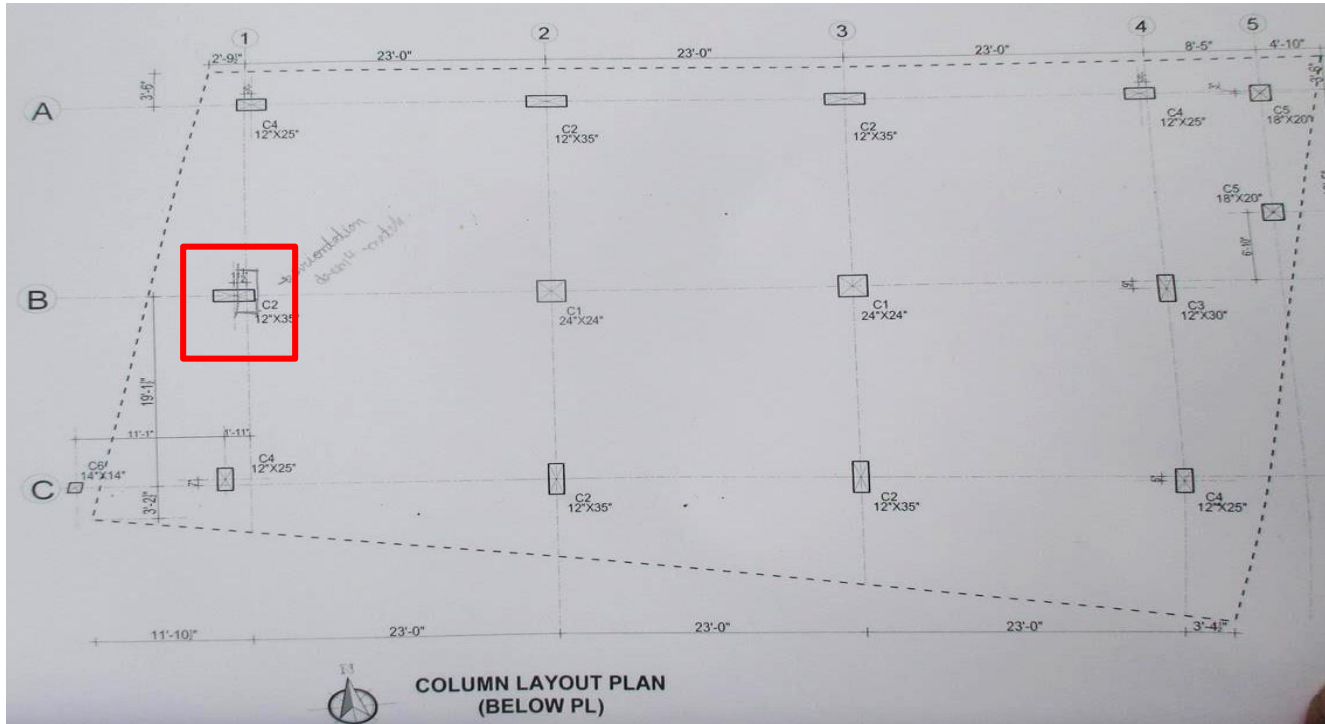
Orientation of column layout at grid- B/1 does not match with actual site condition

| Item No. | Observation | Recommended Action Plan | Recommended Timeline |
|---|---|---|---|
| 2 | Discrepancies between provided drawing and as-built condition (Building#2) | Factory Engineer to survey the structure and update the full set of architectural and structural “as-constructed” drawings. | 6-weeks |

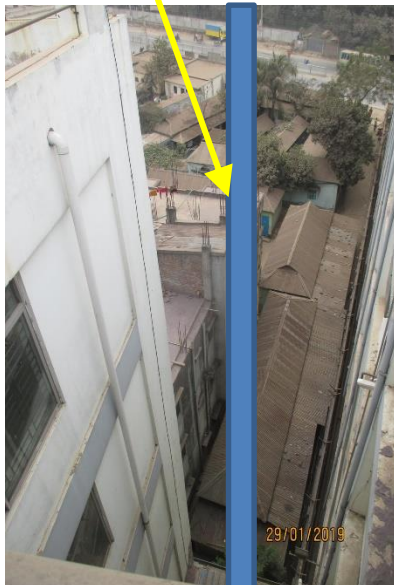
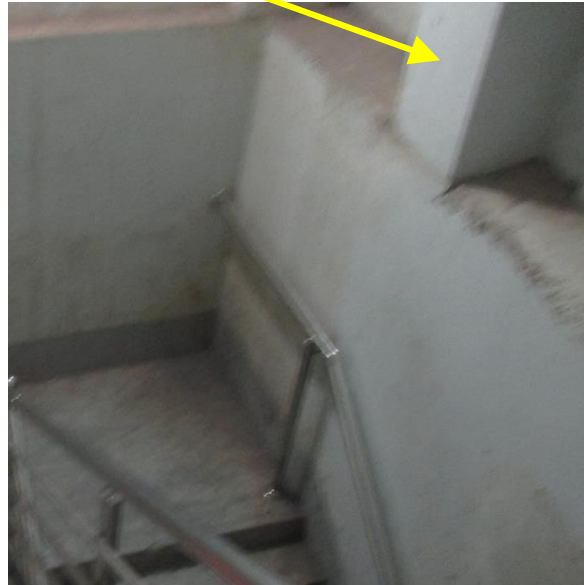
C6 column was found at basement level only but shown up to roof level in as-built drawing.

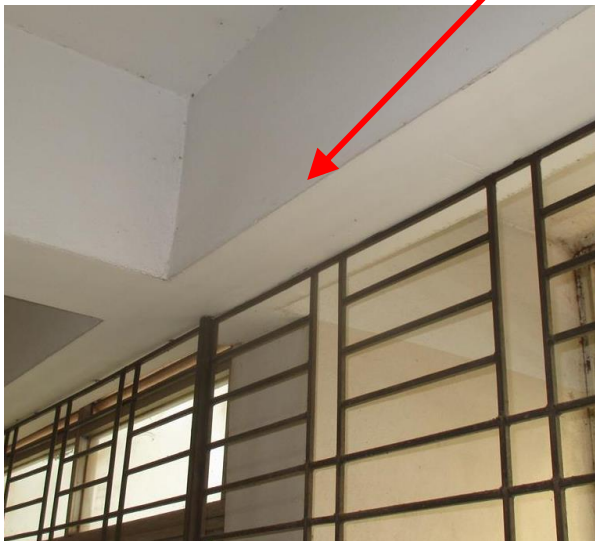
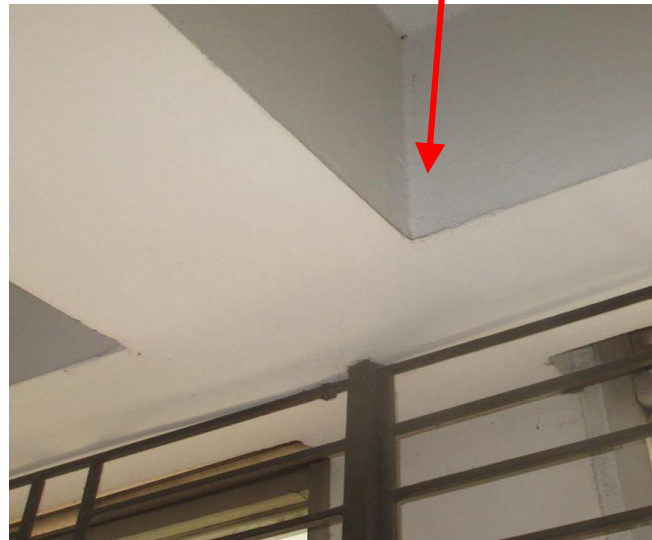
Eccentric connection at beam-column joint (marked Locations)

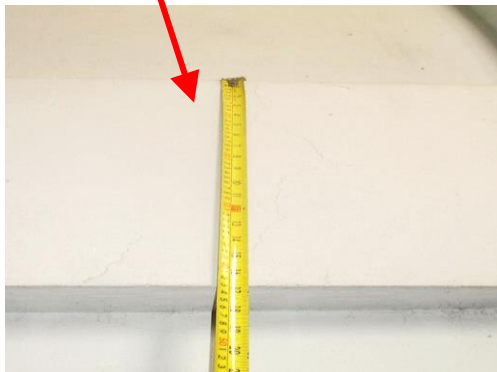
Full Depth  
found 400 mm  
instead of 600  
mm

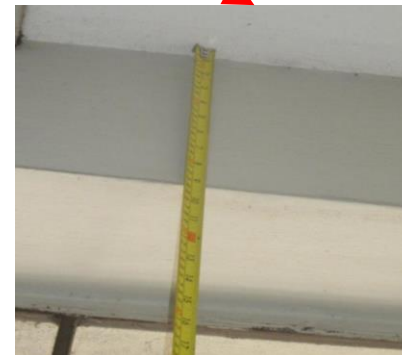
Down stand  
depth of Beam  
was found  
250mm.

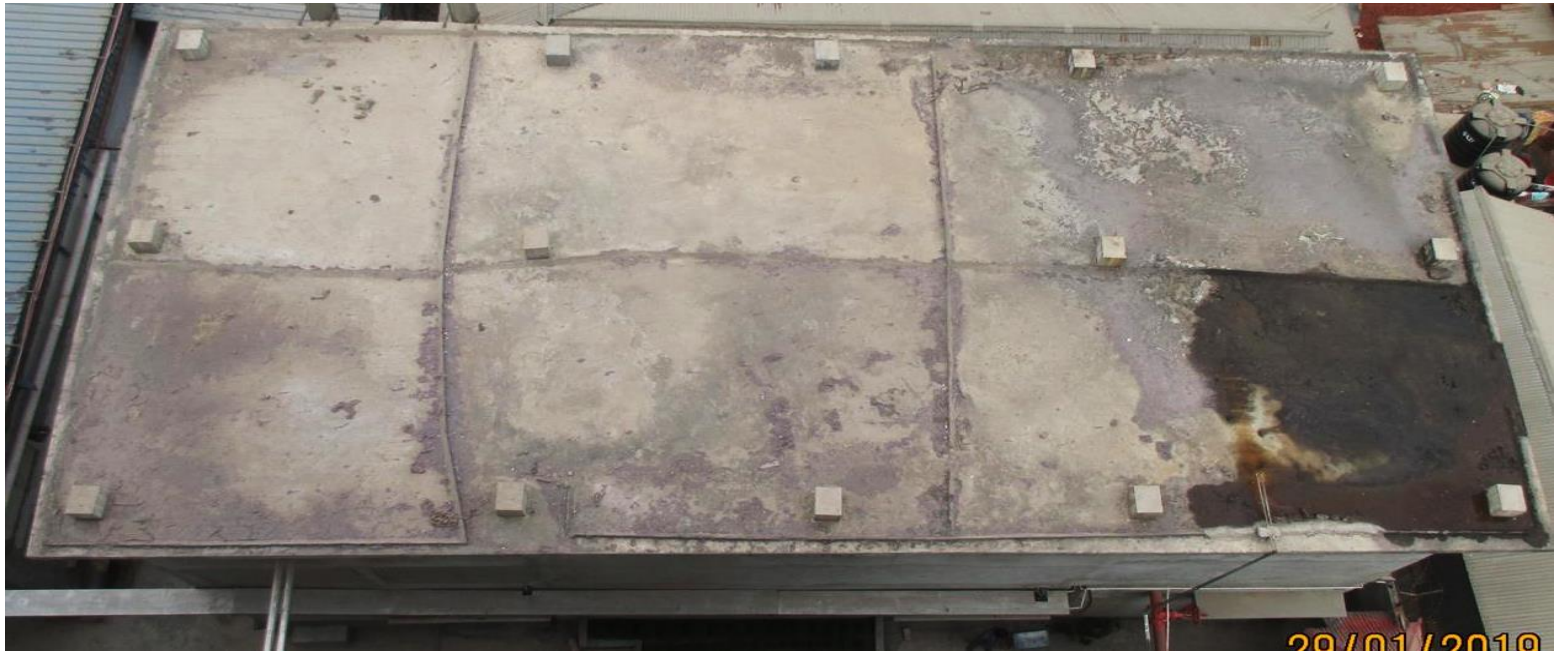
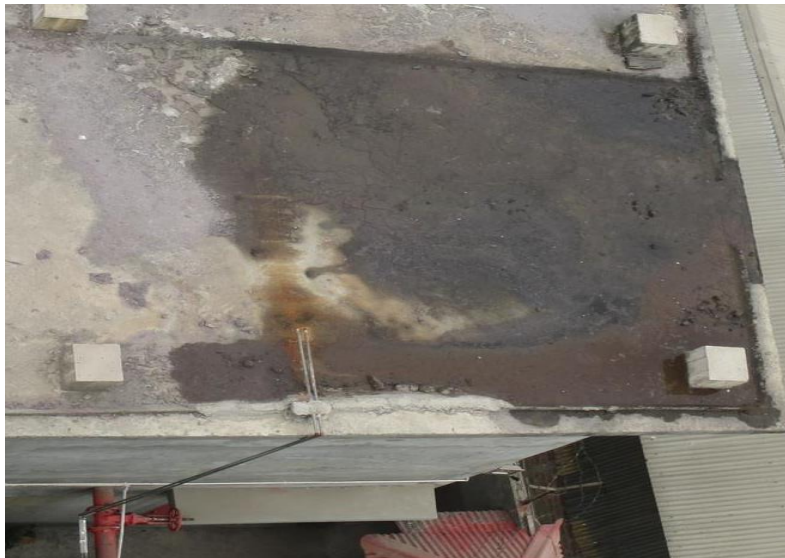
# Water ponding and dampness at roof

Water ponding and dampness  
at roof of the pump house.  
Water proofing to be applied  
by maintaining proper slope.

| Item No. | Observation | Recommended Action Plan | Recommended Timeline |
|---|---|---|---|
| 7 | Water ponding and dampness found at roof (Building#3) | Factory Engineer to investigate the cause of water ponding & dampness at roof and suggest appropriate remedial measures. | 6-months |

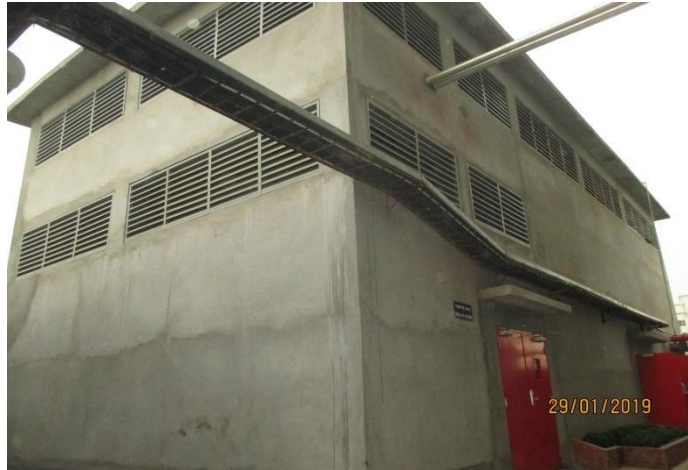
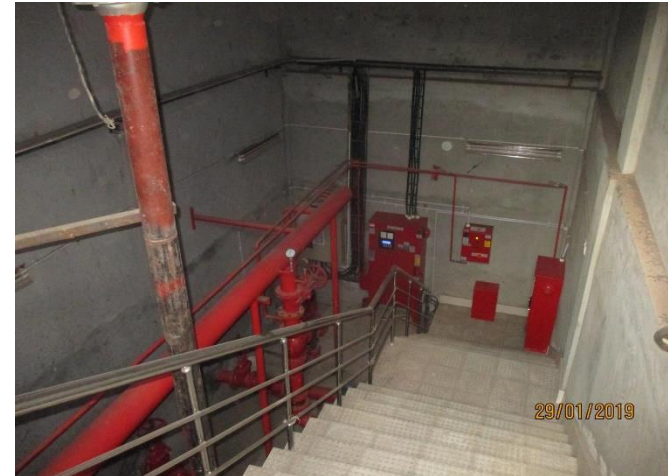
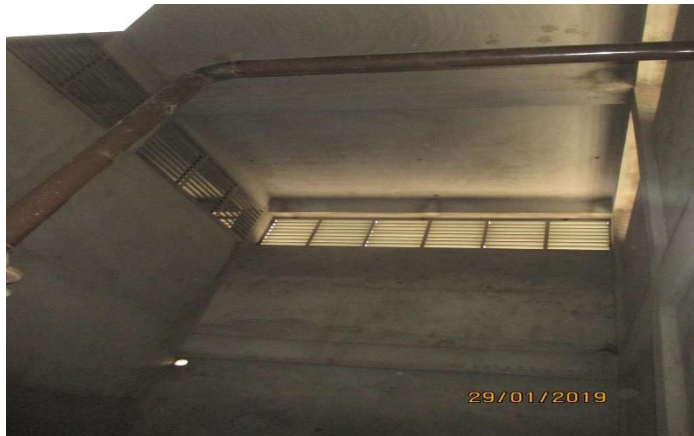
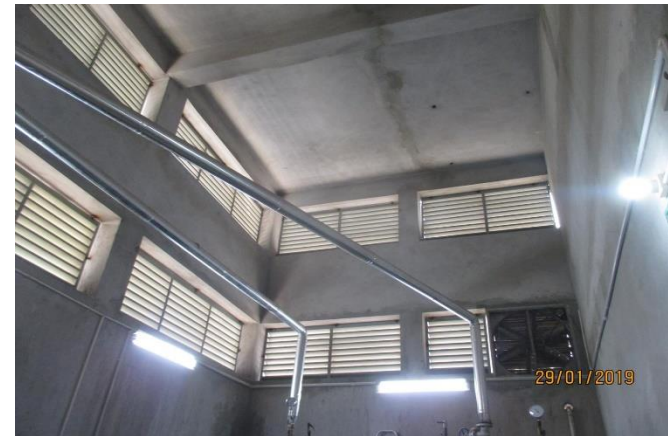
Full set of as-built drawings was not available at site. Factory engineer is required to survey and prepare all necessary as-built drawing.

| Item No. | Observation | Recommended Action Plan | Recommended Timeline |
|---|---|---|---|
| 8 | Lack of As-built drawings (Building#3) | Factory Engineer to survey the structure and update the full set of architectural and structural “as-constructed” drawings. | 6-weeks |

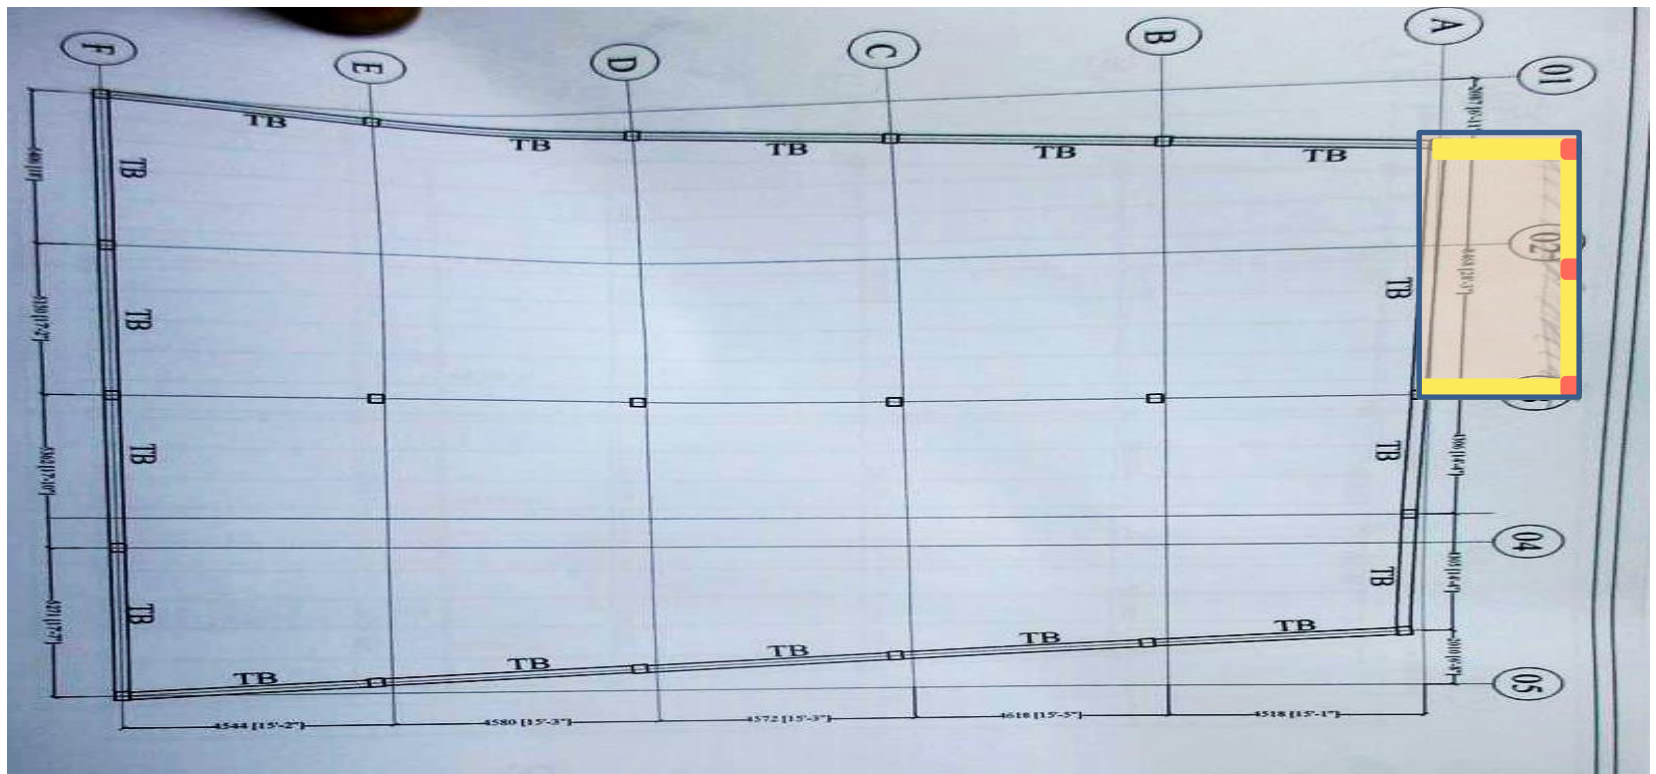
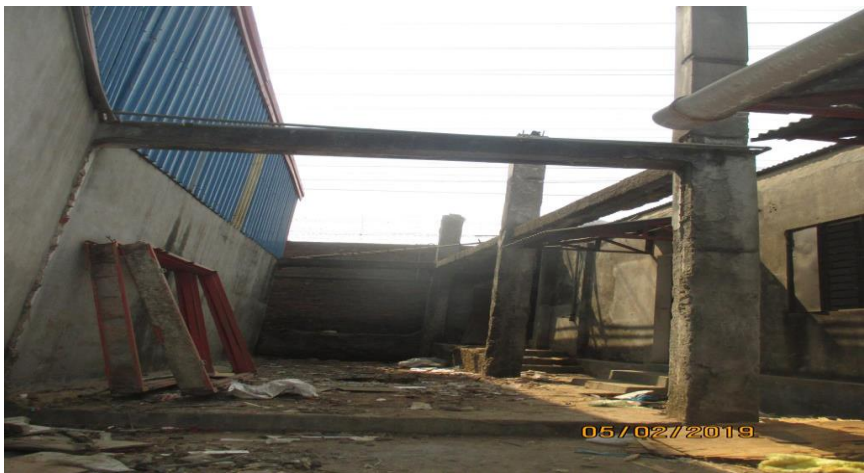
Extended shaded portion is not shown in as-built drawing.

| Item No. | Observation | Recommended Action Plan | Recommended Timeline |
|---|---|---|---|
| 11 | Discrepancies between provided drawing and as-built condition (Shed#1) | Factory Engineer to survey the structure and update the full set of architectural and structural “as-constructed” drawings. | 6-weeks |

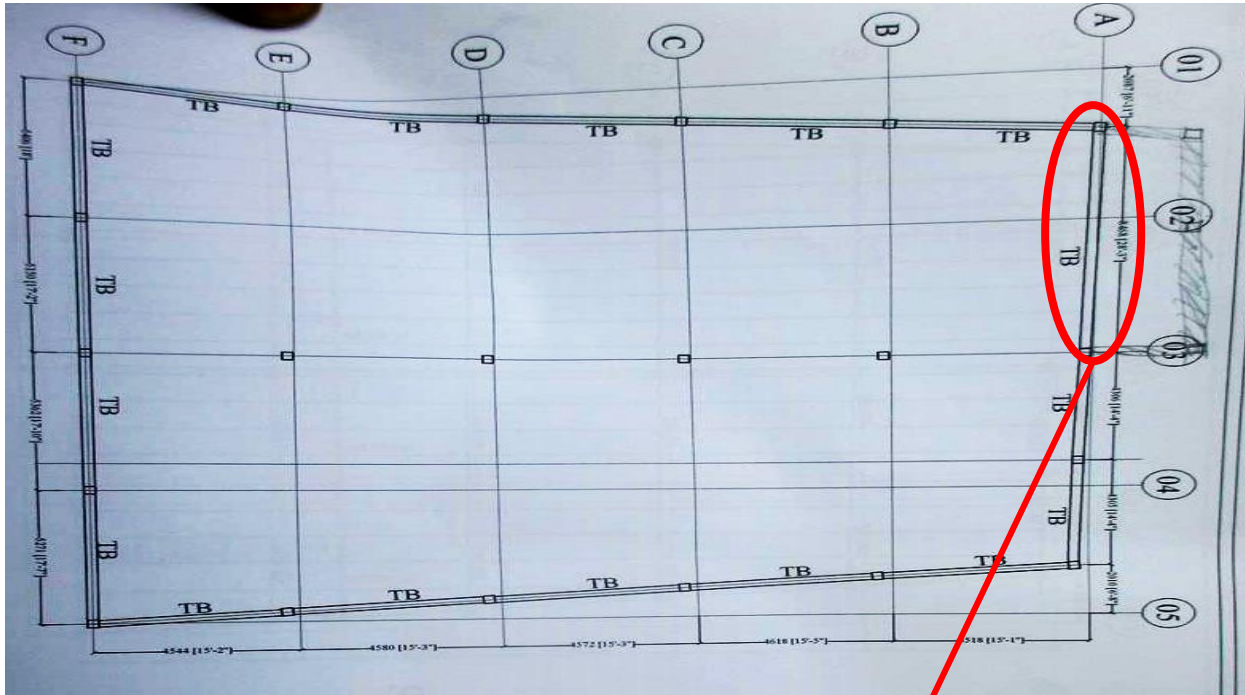
Tie beam was not found at marked location. But tie beam has been shown in as-built drawing.

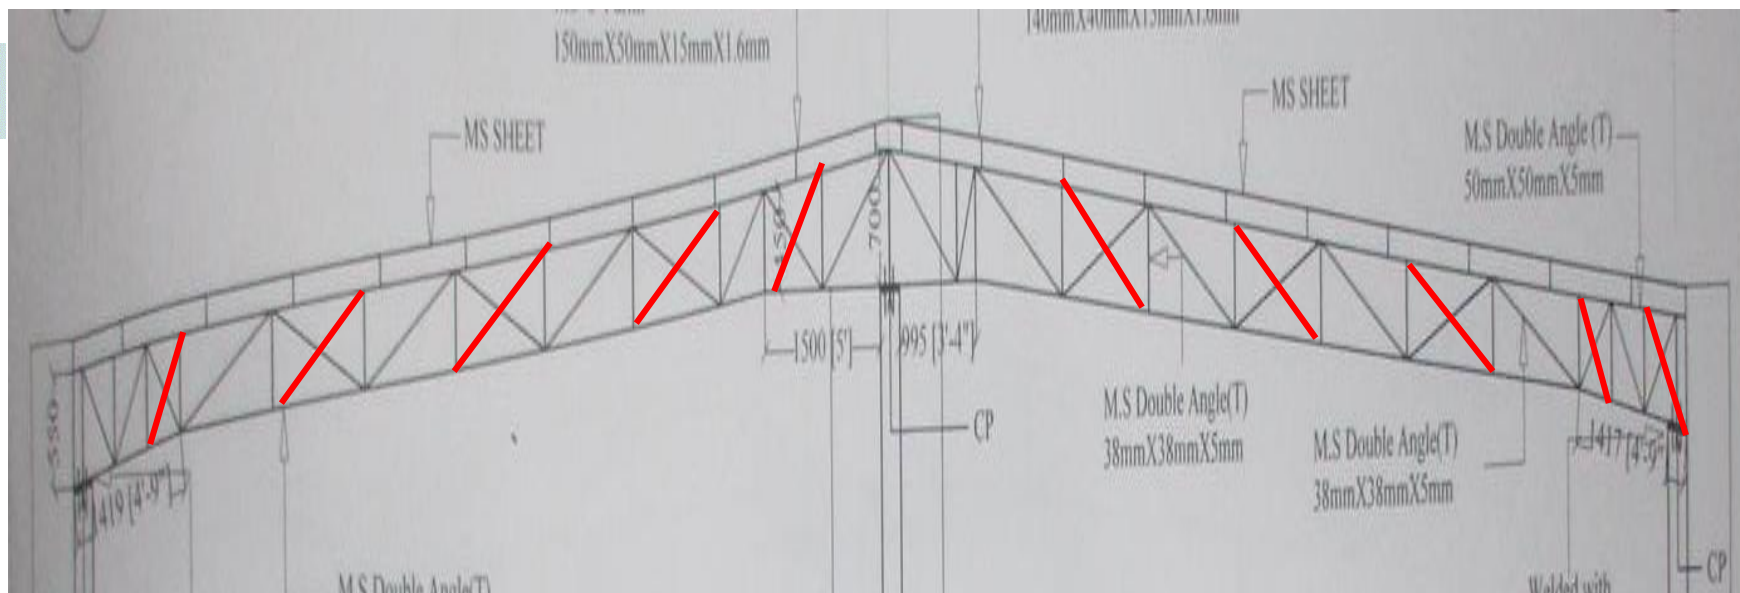
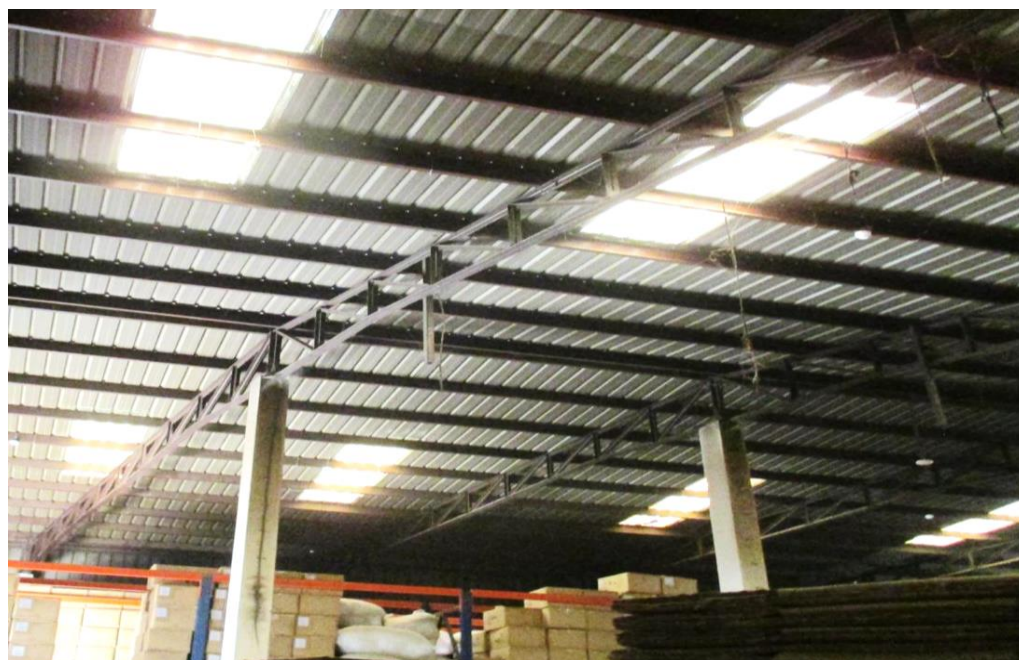
Arrangement and number of the truss member do not match with actual site condition. Total number of vertical member was found 10 nos in each side instead of 13 nos. Diagonal members were found in the pattern shown in red mark.

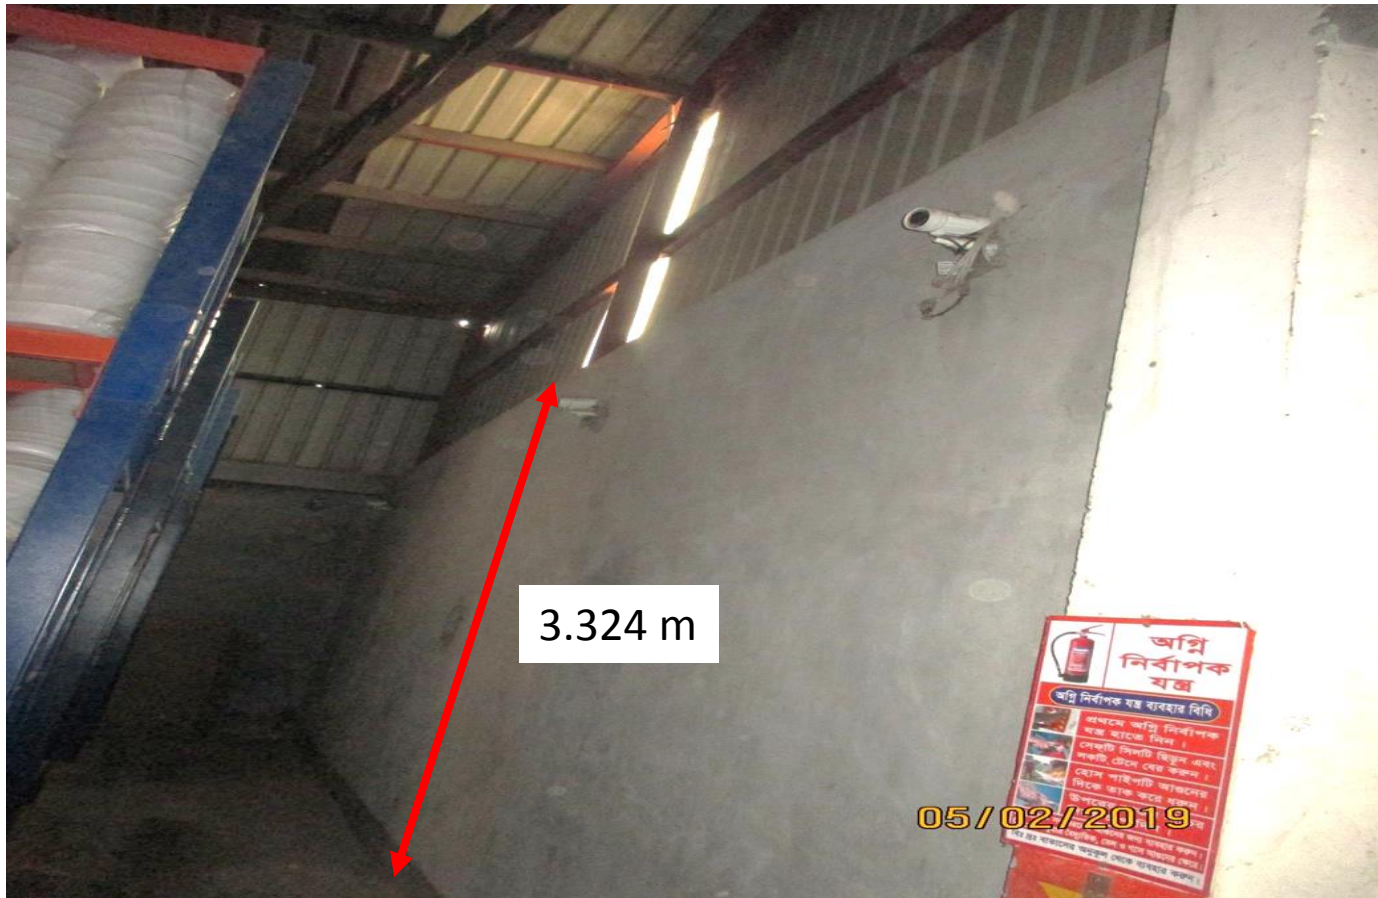
# Wall with no head restraint

3.324m Height; 250mm masonry wall with no head restraint. Factory engineer is required to check the capacity of the free standing masonry wall.

| Item No. | Observation | Recommended Action Plan | Recommended Timeline |
|---|---|---|---|
| 14 | Wall with no head restraint (Shed#1) | Factory engineer to check the stability of the free sanding wall. | 6-weeks |
| 15 | Wall with no head restraint (Shed#1) | Apply suitable remedial actions suggested by the factory engineer. | 6-months |

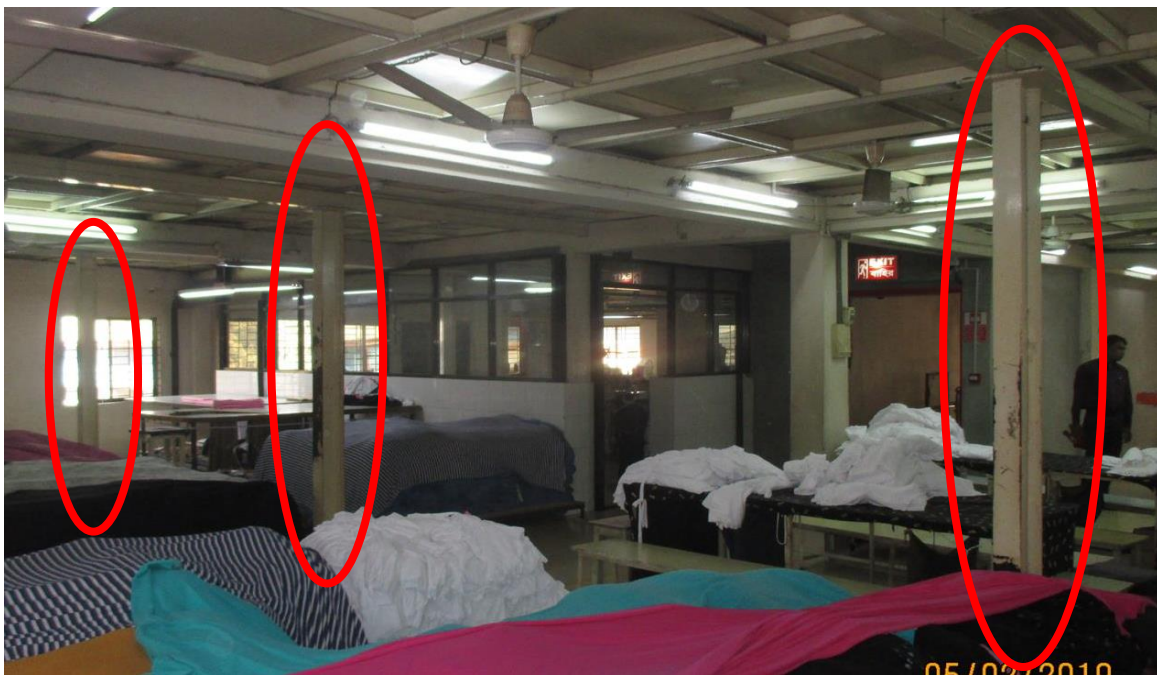
**Three steel column constructed on 1st floor slab**

Three steel column started from 1st floor to 2nd floor level. No adequacy check of slab was found. Factory engineer is required to check adequacy of the slab to bear load from steel column.

| Item No. | Observation | Recommended Action Plan | Recommended Timeline |
|---|---|---|---|
| 16 | Three steel column constructed on 1st floor slab (Shed#2) | Factory engineer to verify the capacity of the slab to carry the loading from columns. | 6-weeks |
| 17 | Three steel column constructed on 1st floor slab (Shed#2) | Complete remedial works as per the recommendation of engineering assessment. | 6-months |

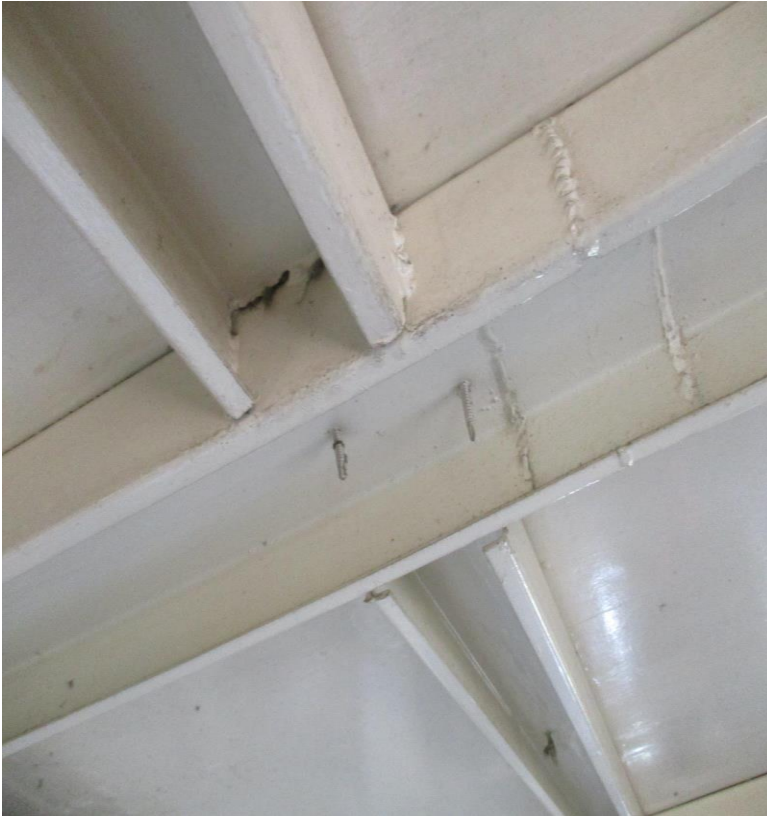
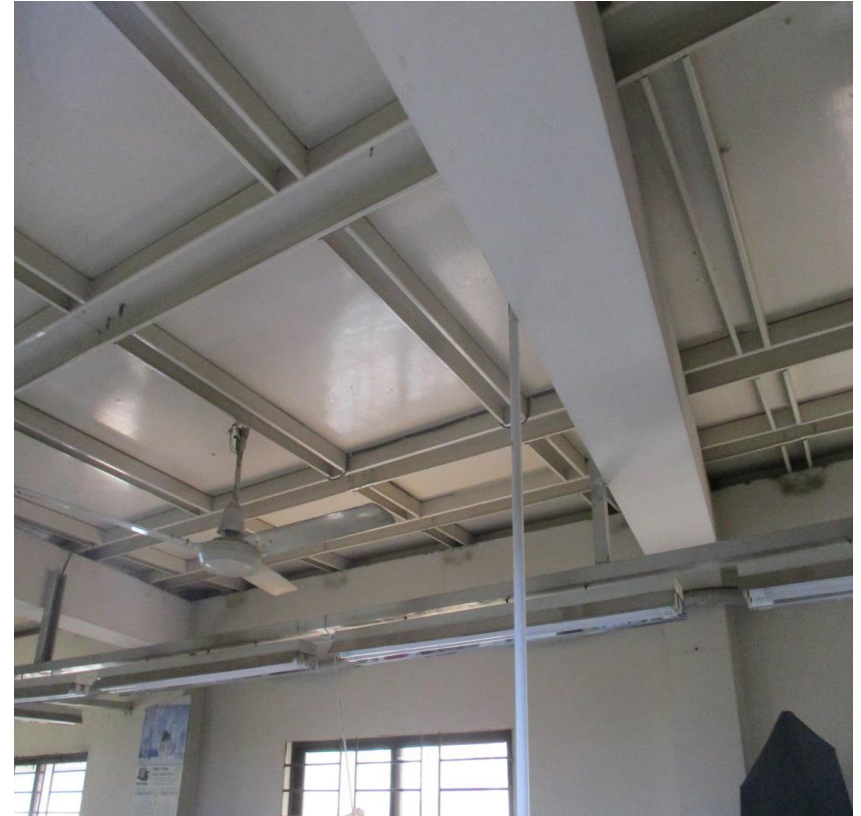
No anchorage/shear connector was found between mezzanine floor and supporting beam framing system.

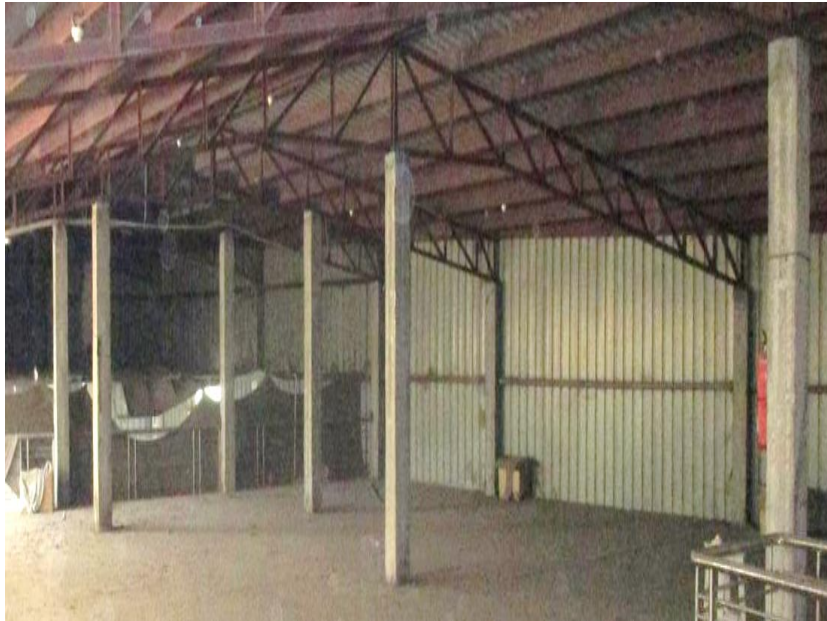
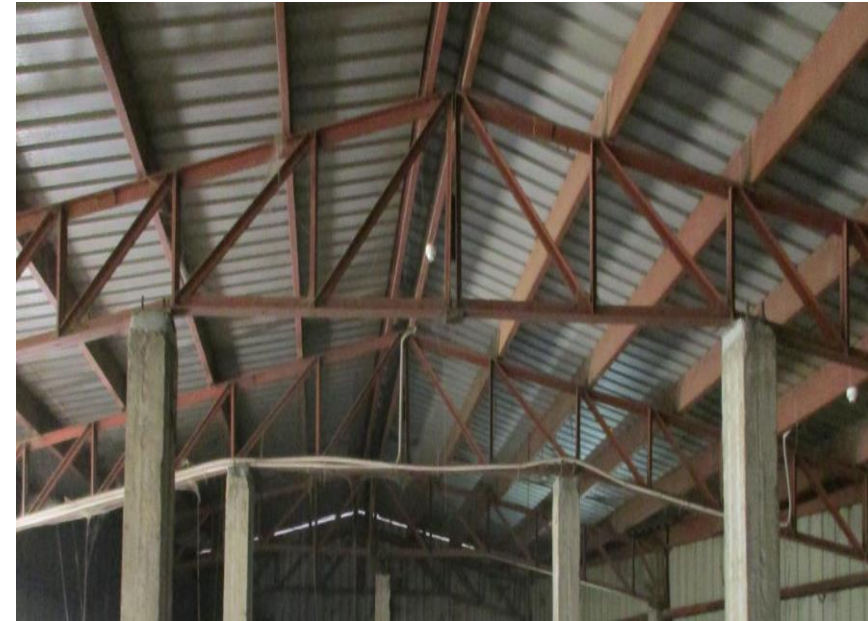
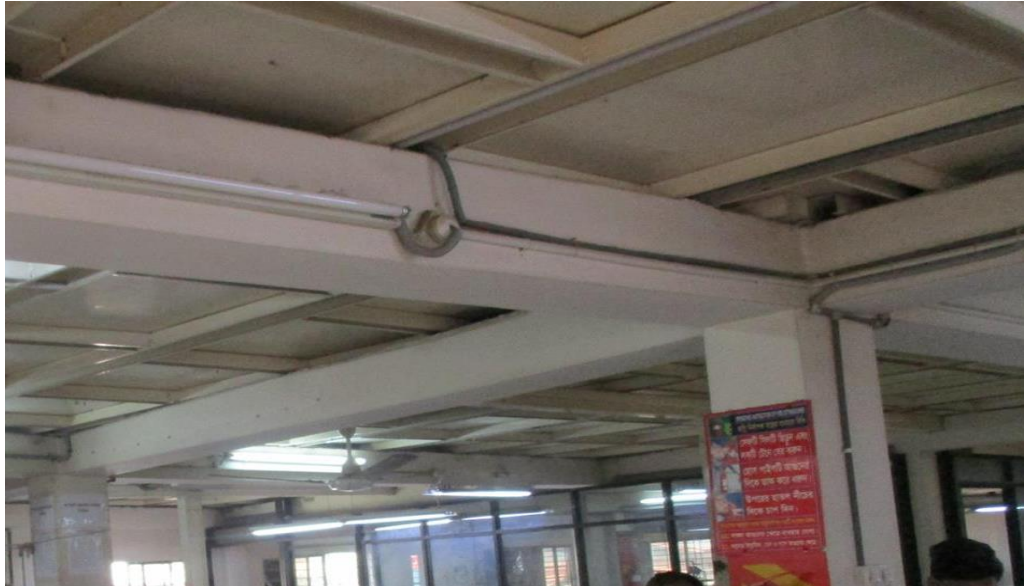
**Lateral stability of the structure to be verified**

The building is vertically irregular, suspended deck slab is not rigidly connected with main framing system and there is no roof bracing. Factory Engineer is required to check the lateral stability of the structure.

| Item No. | Observation | Recommended Action Plan | Recommended Timeline |
|---|---|---|---|
| 19 | Lateral stability of the structure to be verified (Shed#2) | An engineering assessment is required to be carried out considering lateral loading. | 6-weeks |
| 20 | Lateral stability of the structure to be verified (Shed#2) | Complete remedial works as per the recommendation of engineering assessment. | 6-months |

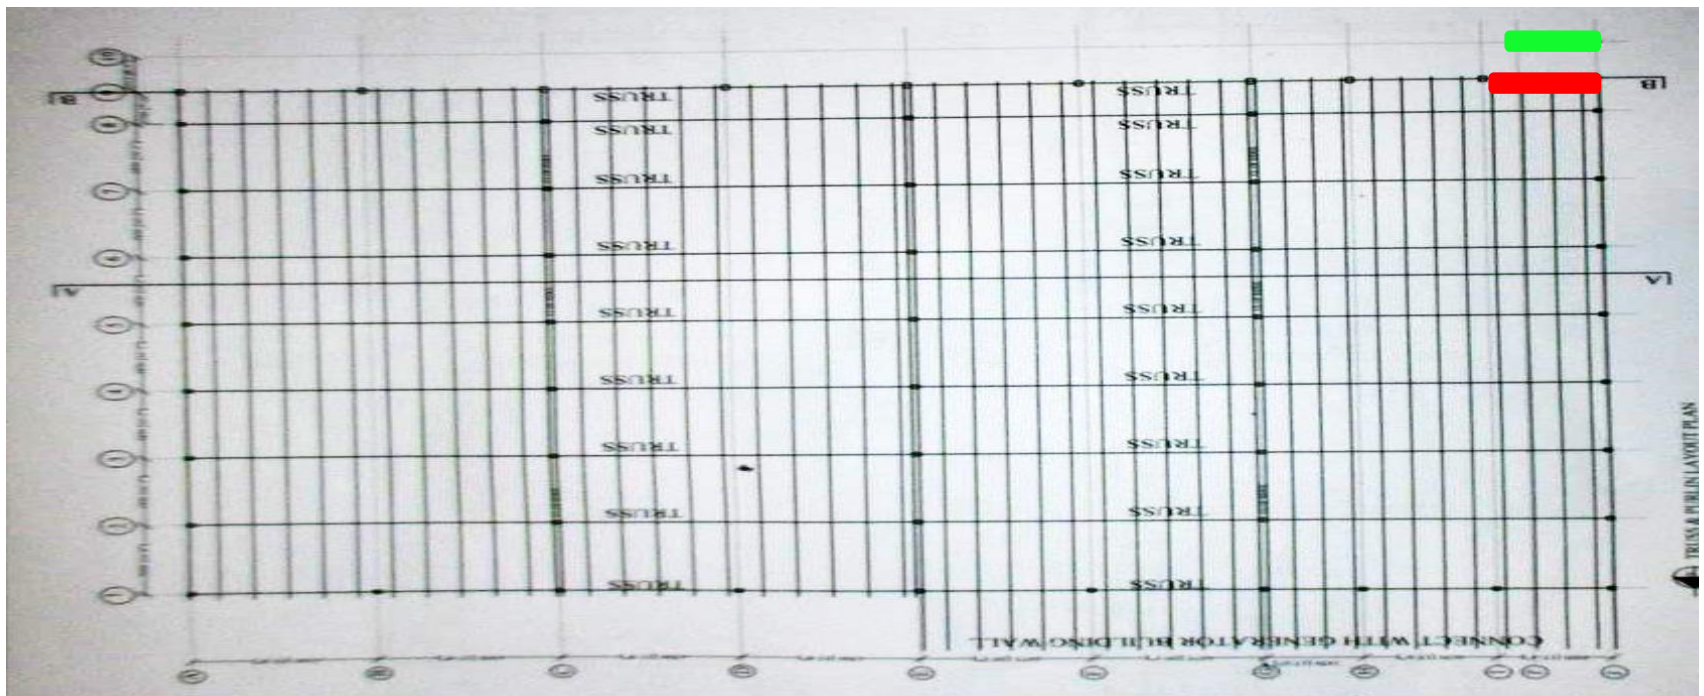
Truss layout plan; Additional truss found at grid 10 instead of Grid-9 at marked location. Truss was found at green marked location instead of red marked location.

| Item No. | Observation | Recommended Action Plan | Recommended Timeline |
|---|---|---|---|
| 21 | Discrepancies between provided drawing and as-built condition (Shed#3) | Factory Engineer to survey the structure and update the full set of architectural and structural “as-constructed” drawings. | 6-weeks |

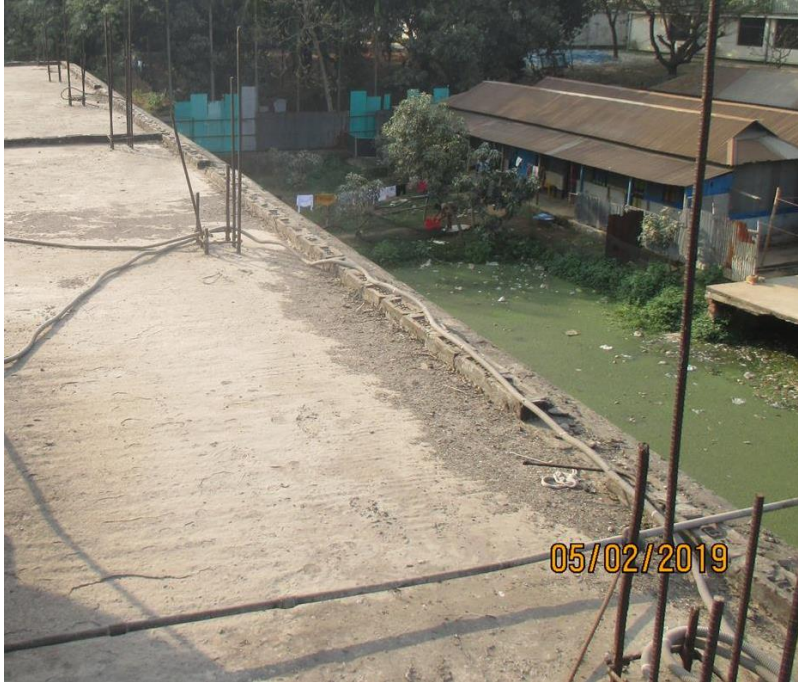
**Exposed re-bar found at roof level**

Exposed re-bar was found at roof level. Factory is required to take necessary measure to prevent corrosion in exposed re-bar

| Item No. | Observation | Recommended Action Plan | Recommended Timeline |
|---|---|---|---|
| 24 | Exposed re-bar found at roof level (Generator Building) | All exposed reinforcement to be protected from corrosion which may cause degradation of the concrete. | 6-weeks |
