INITIAL STRUCTURAL INTEGRITY ASSESSMENT REPORT (SIAR)

Factory Name: **Kenpark Bangladesh (PVT), Ltd.**
Address: **Sector 8, Plot 31-42 Export Processing Zone KEPZ,
Chittagong Chittagong Chittagong Bangladesh**
Assessor: **Emkay Enterprises LTD**
Date: **26 Feb 2014**

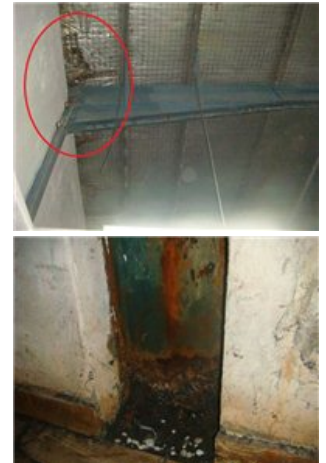
Question:	Have all areas of needed maintenance, including areas with efflorescence, dampness, standing water on rooftops, and corrosion been addressed.
Priority Level:	Medium
Non-Compliance Level:	2
Description:	Building-1: Dampness was observed in the roof insulation; Building-1: Severe corrosion in the base plate was found.
Source of Findings:	Photograph: Dampness and corrosion., Visual Assessment: Site Visit 26 Feb, 2014 Onsite observation
Suggested Plan of Action:	Under guidance from a qualified structural engineer, address all areas of needed maintenance by correcting the identified issues. Remove the rust and then take proper step to resist the propagation.
Suggested Deadline Date:	25 Sep 2014
Standard:	Alliance Standard Part 8 Section 8.26 Durability and Maintenance

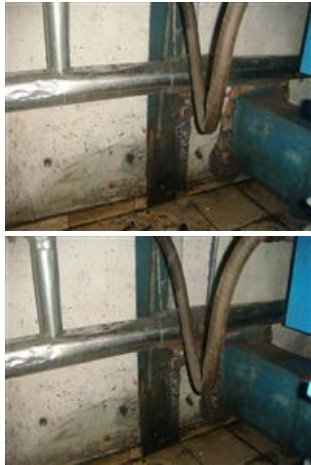
Date:	
Standard:	Alliance Standards Part 7 Building Materials Section 7.2 Masonry-chip aggregate concrete (MCAC).
Question:	Are structural steel members free of corrosion, physical damage or other types of deterioration?
Priority Level:	Medium
Non-Compliance Level:	2
Description:	Building-1: Severe corrosion was observed in the base plate and steel column and appears to be propagating from bottom to top. This reduces the thickness of the base plate and column.
Source of Findings:	Photograph: Corroded base plate and columns, Visual Assessment: Site Visit 26 Feb, 2014 Physical inspection
Suggested Plan of Action:	Under guidance from a qualified structural engineer, address all areas of needed maintenance by correcting the identified issues.
Suggested Deadline Date:	25 Sep 2014
Standard:	Alliance Standard Part 8 Section 8.26
