# ISLAM GARMENTS LTD. (UNIT-2)-Extension

ZARUN, KONABARI, GAZIPUR  
(23.994929, 90.326208)

28<sup>th</sup> April 2019

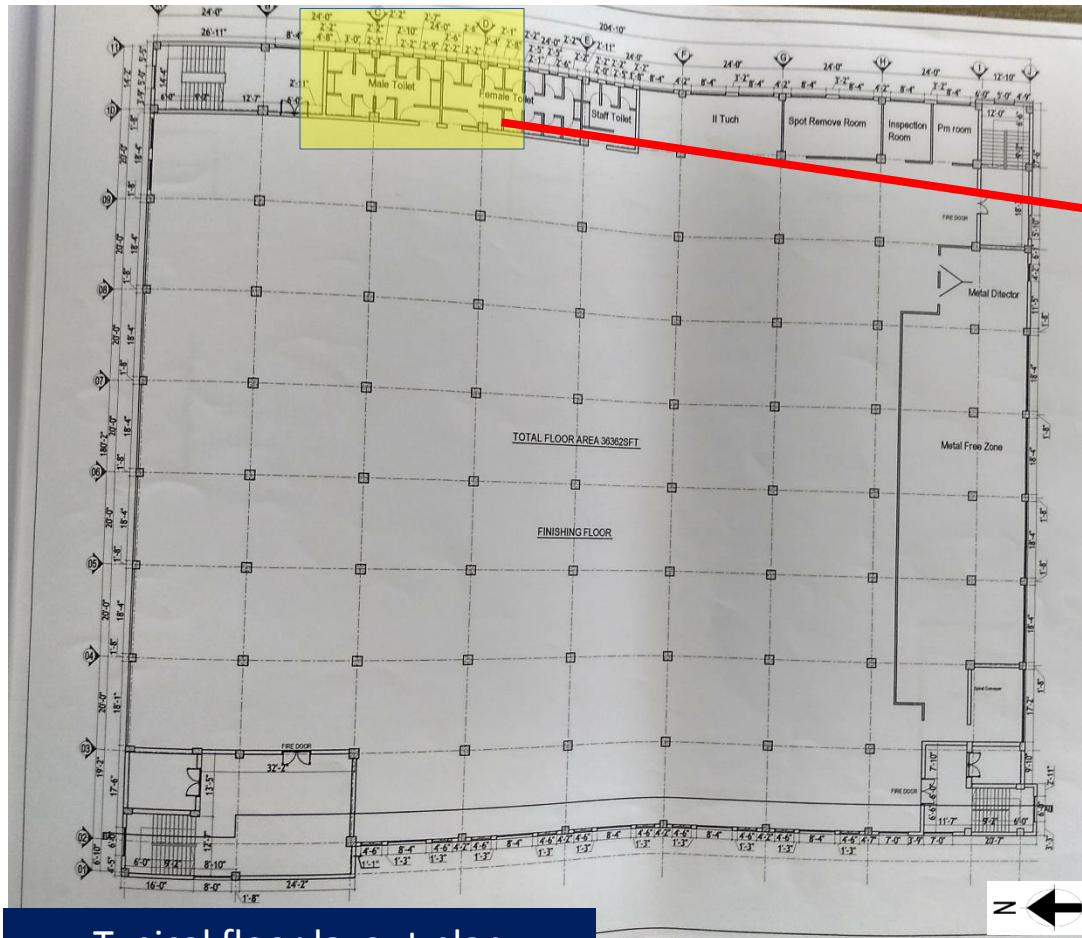
Typical floor layout plan

Cursory calculation indicates that columns appear to be stressed marginally above normal design limits considering floor built up loads (Toilet zone), 3kPa live loads on typical floor and assuming minimum concrete strength. Building Engineer to review design, loads and columns stresses.

| Item No. | Observation | Recommended Action Plan | Recommended Timeline |
|---|---|---|---|
| 1 | Column stresses marginally exceeds the normal design limit | Factory Engineer to review design, loads and column stresses. | 6-weeks |
| 2 | Column stresses marginally exceeds the normal design limit | Verify in-situ concrete strength by taken min. 4 nos. 100mm dia. core samples from lower tier or credible cylinder test data. | 6-weeks |
| 3 | Column stresses marginally exceeds the normal design limit | Produce and actively manage a loading plan for all floor plates within the factory, considering floor, column and foundation capacity. | 6-months |
| 4 | Column stresses marginally exceeds the normal design limit | Carry out remedial works where necessary. | 6-months |

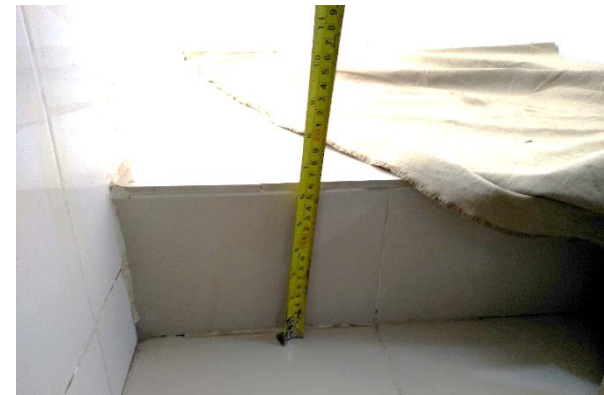
Build up (350~375 mm)

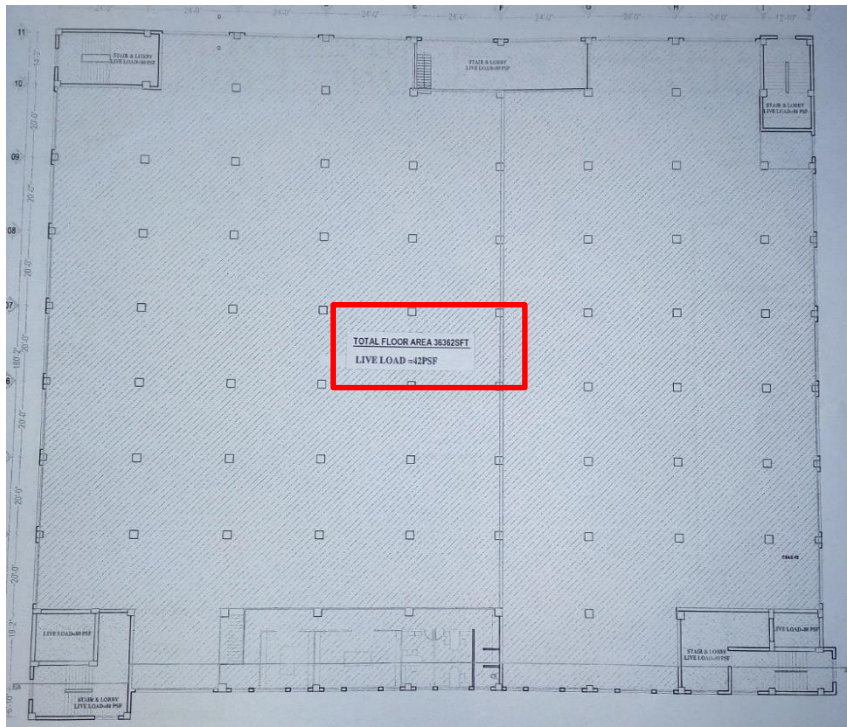
Floor load plan

The construction of the building was completed in December 2018. Therefore, as per BNBC standard load plan of the building is required to be considered minimum 3 kPa. But the load plan provided by the factory considers 2 kPa. Factory is required to revise the load plan considering BNBC standard and implement the load plan accordingly.

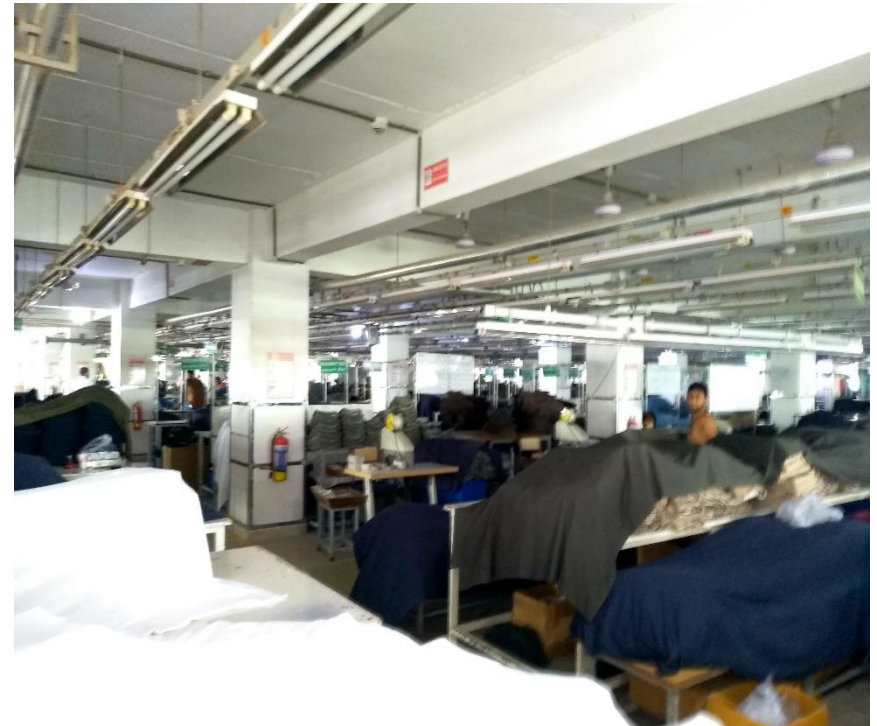
Floor loading condition (Within 3 kPa)

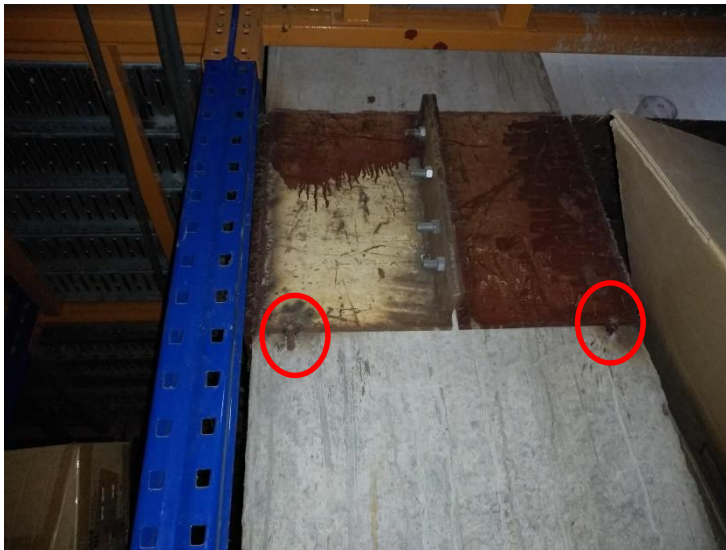
Steel plate with inadequate anchorage

Mezzanine floors are supported by steel box surrounded with RC column. Apparently inadequate connection was observed between steel box and RC column. Factory engineer is required to check the adequacy of the connection against vertical loading.

| Item No. | Observation | Recommended Action Plan | Recommended Timeline |
|---|---|---|---|
| 5 | Mezzanine steel beam connection with RC column | Factory engineer is required to check the adequacy of the connection against vertical loading. | 6-weeks |
| 6 | Mezzanine steel beam connection with RC column | Prepare as-built documentation for both mezzanine. | 6-weeks |
| 7 | Mezzanine steel beam connection with RC column | Implement remediation work if required. | 6-months |

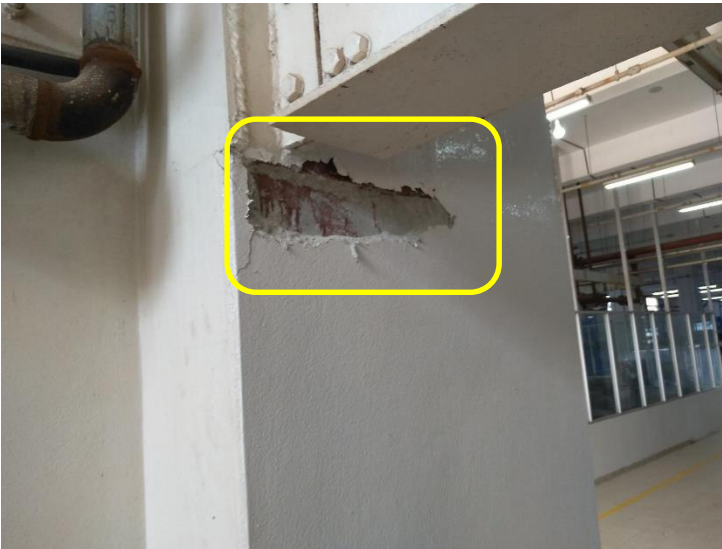
Steel plate without anchorage

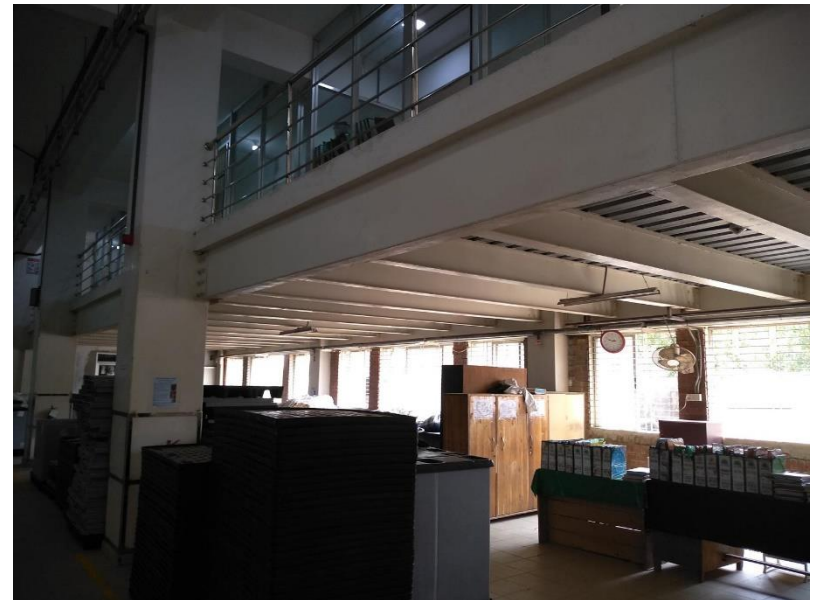
Mezzanine Steel frame connected with RC column of factory building

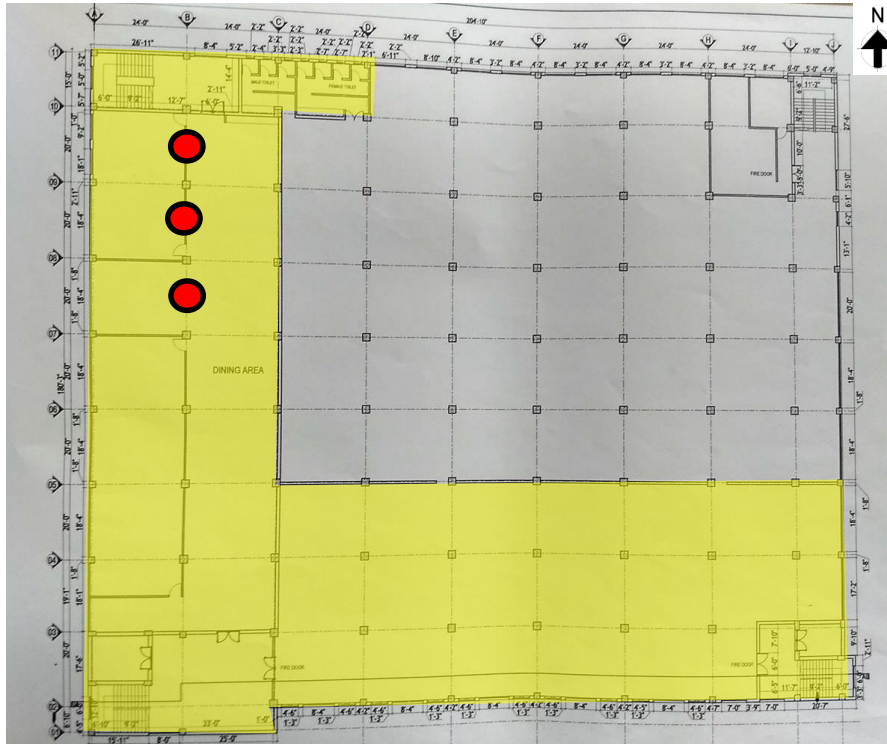
Existing roof Layout

Three nos. of over head plastic water tank (10000 liters capacity) were found at existing roof. Factory engineer is required to check the adequacy of slab and beam .

| Item No. | Observation | Recommended Action Plan | Recommended Timeline |
|---|---|---|---|
| 8 | Heavy water tank on roof | Building engineer is required to check for the adequacy of slab. | 6-weeks |
| 9 | Heavy water tank on roof | Verify that supporting structures have adequate capacity to support heavy loading such as plastic water tank. | 6-weeks |
| 10 | Heavy water tank on roof | Remedial works/replacement to be carried out if required. | 6-months |

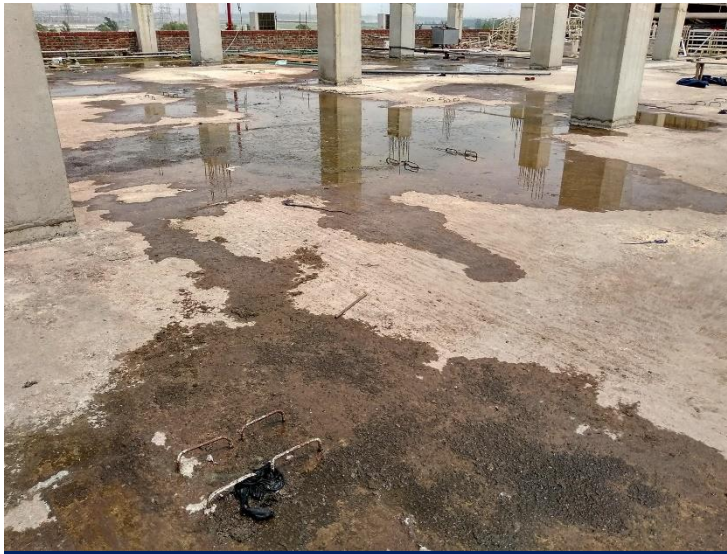
Lack of water proofing layer

Sign of water Clogging was observed on roof. Besides no water proofing layer was found during inspection. Also, proper drainage system was not installed.

| Item No. | Observation | Recommended Action Plan | Recommended Timeline |
|---|---|---|---|
| 11 | Insufficient drainage system on existing roof | Factory is required to improve the water drainage system to avoid water clogging in future. | 6-weeks |

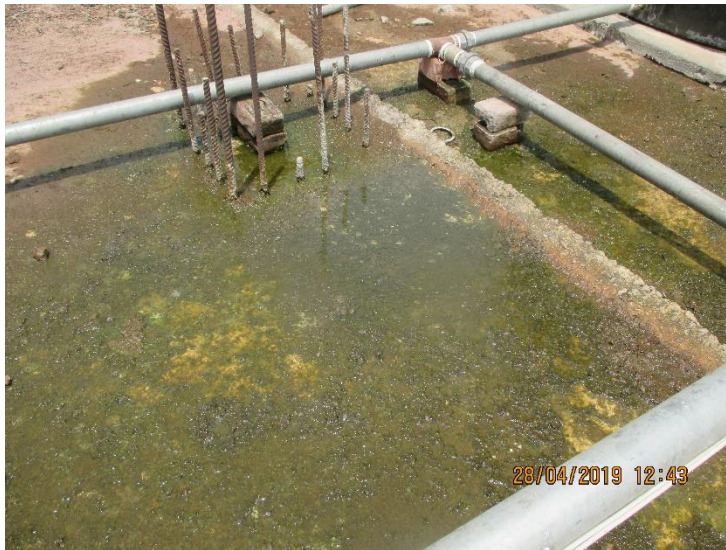
Sign of water clogging

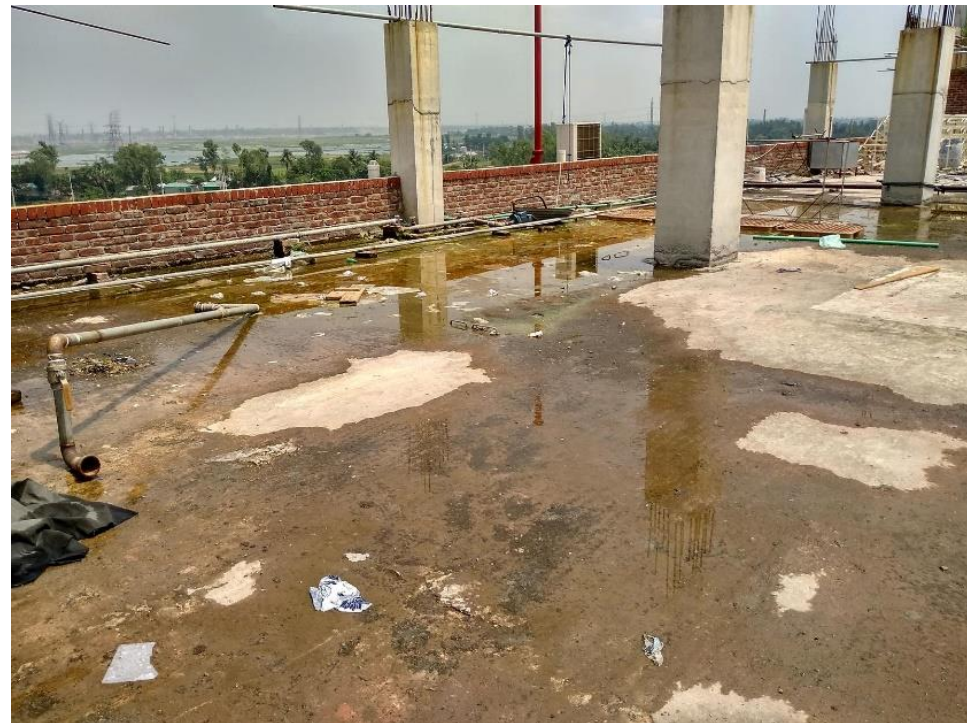
Improper roof drainage system

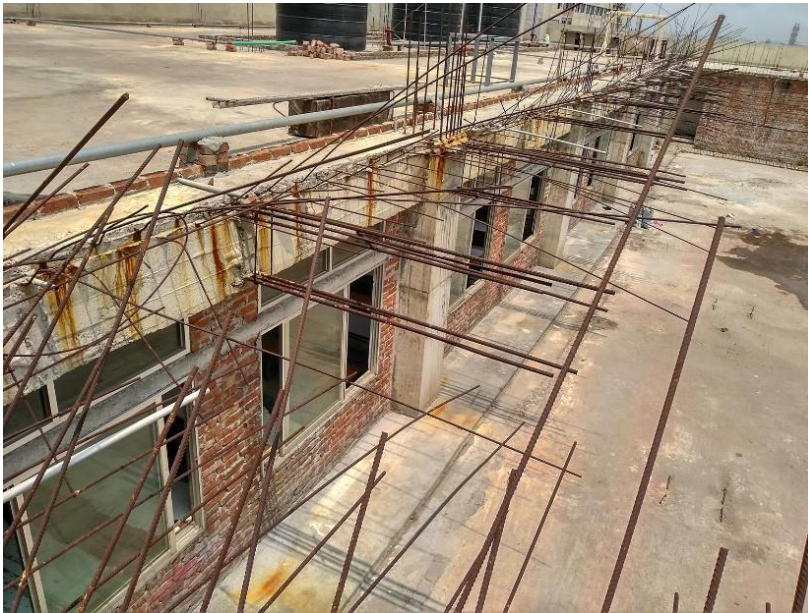
Corrosion was observed on all exposed reinforcement on roof top columns, beams and slabs. Factory must provide adequate protection to the structural elements from corrosion.

Exposed rebar at Beam & Slab

| Item No. | Observation | Recommended Action Plan | Recommended Timeline |
|---|---|---|---|
| 12 | Corroded and exposed rebar at roof | All exposed reinforcement is to be protected from corrosion which may cause degradation of the concrete. | 6-weeks |

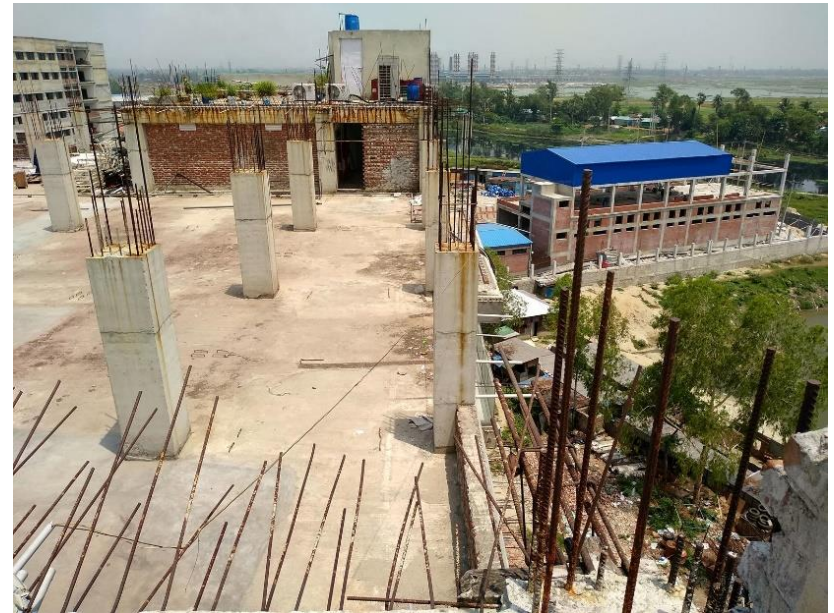
Exposed rebar at Column

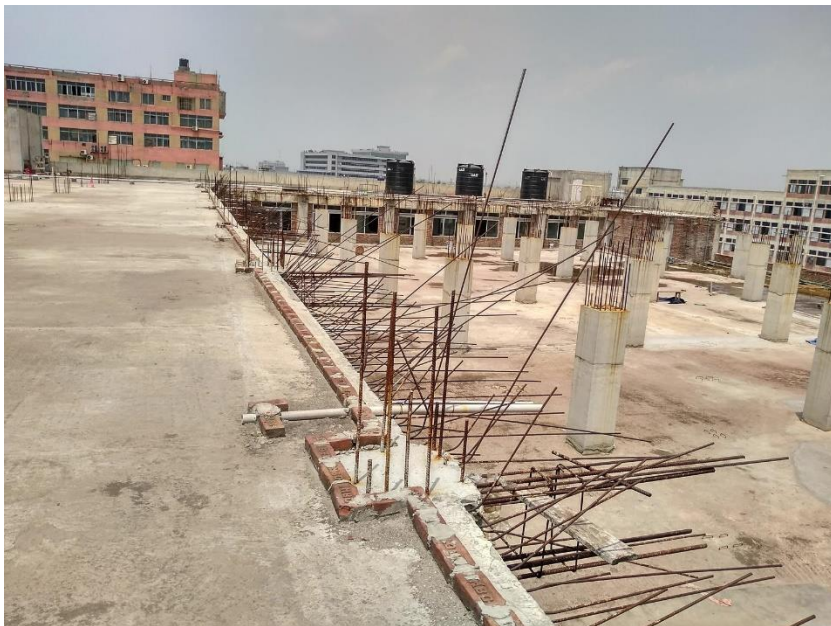
Column & Slab reinforcements are exposed on roof and South side of structures. Extension work may be carried out in the existing structure. Factory engineer is required to carry out a Detail Engineering Assessment considering BNBC provision prior to any further extension work.

Expose rebar at roof

| Item No. | Observation | Recommended Action Plan | Recommended Timeline |
|---|---|---|---|
| 13 | Possible vertical and horizontal extension | Any extensions or modifications of the existing building, a Detail Engineering Assessment by a structural Engineer needs to be carryout in compliance with the BNBC provision. | 6-months |
| 14 | Possible vertical and horizontal extension | Carry out remedial works from outcome of Detail Engineering Assessment where necessary before further construction. | 6-months |

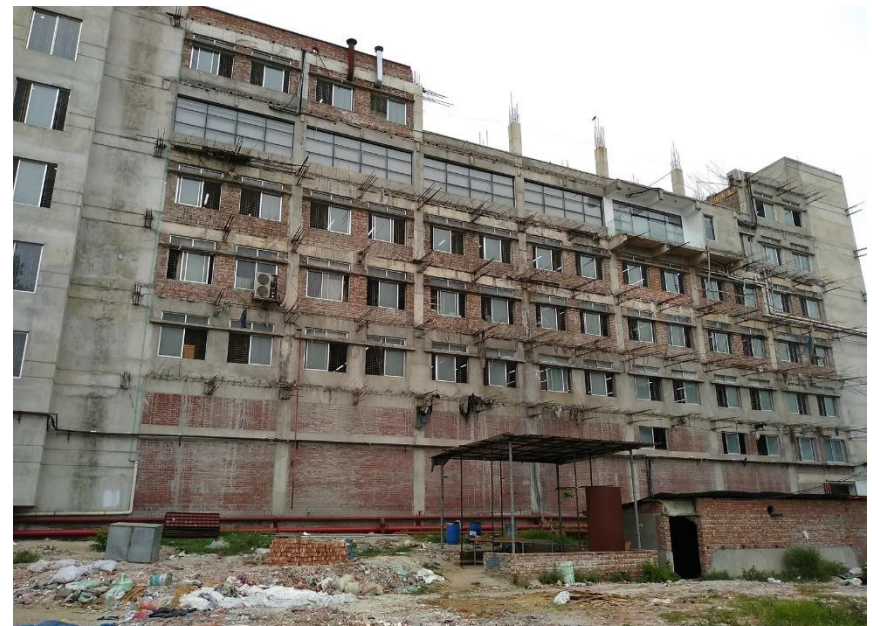
Expose rebar at South
