# Artistic Design Ltd.(Extension)

232-233 East Narashingapur, Ashulia, Savar, Dhaka, Bangladesh.

18<sup>th</sup> August 2019

# Discrepancies in between as built drawing and actual site condition

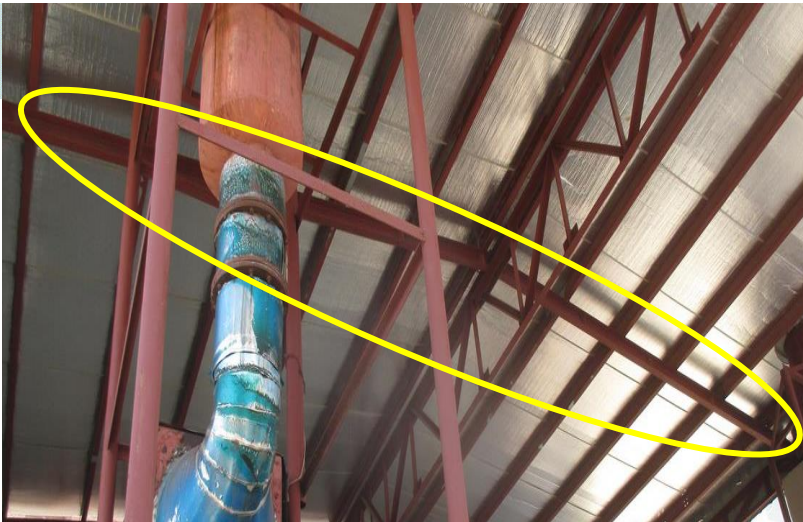
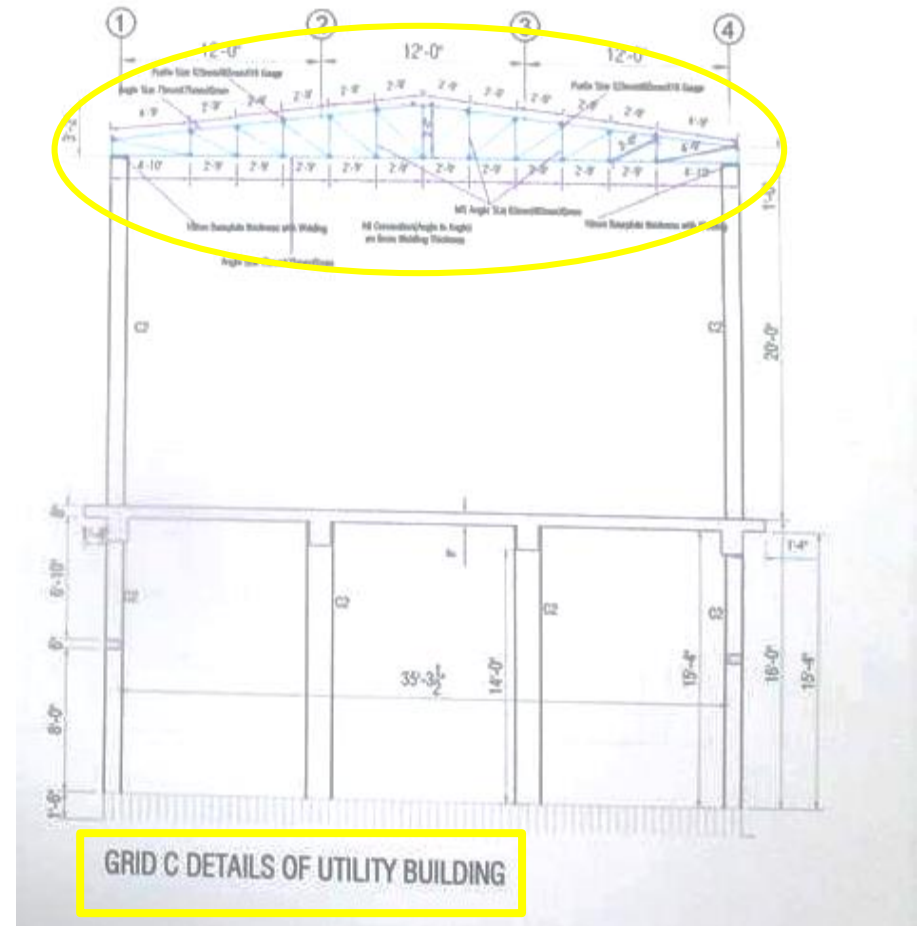
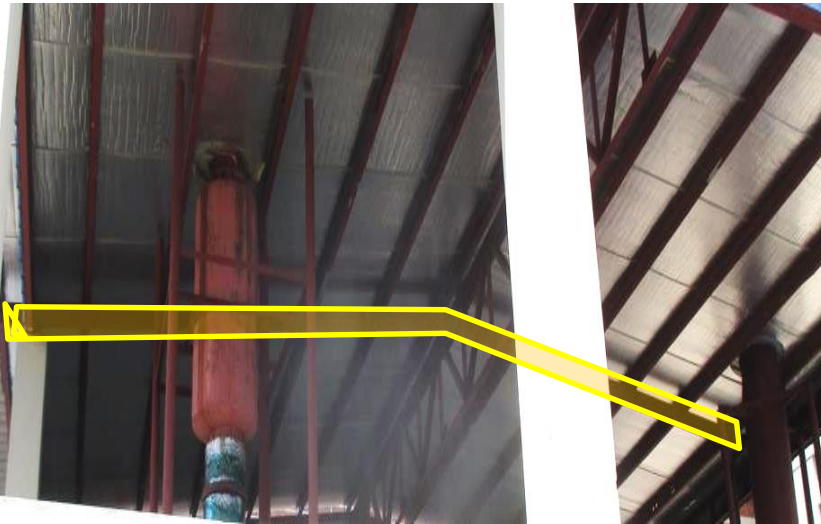
Truss shown along grid-C in drawing. But at on site channel section was found at that location.

| Item No. | Observation | Recommended Action Plan | Recommended Timeline |
|---|---|---|---|
| 2 | Discrepancies in between as-built drawing and actual site condition.(Utility Building) | Install the truss as per as-built drawing or review the design of roof truss system as per site condition. | 6-weeks |

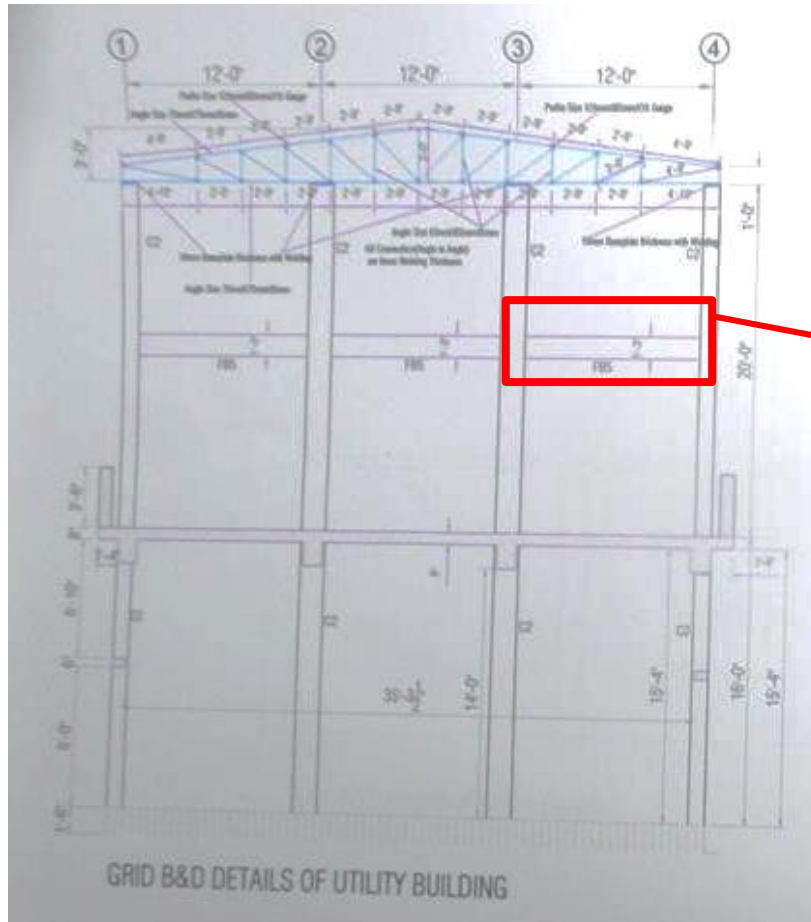
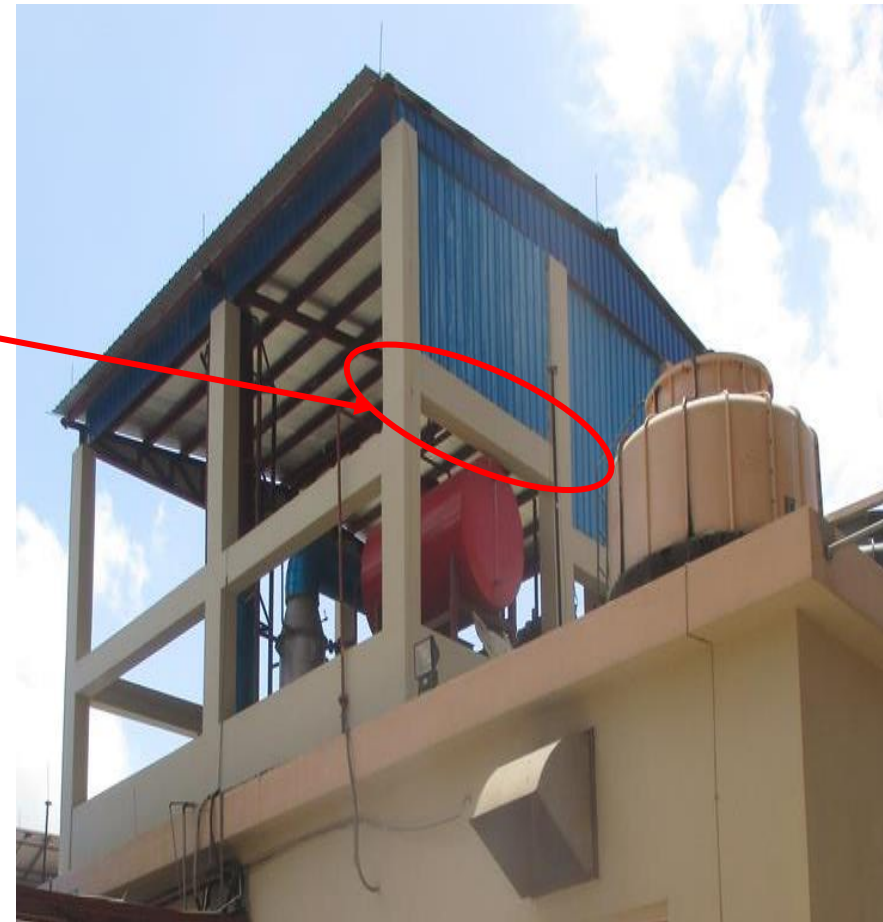
Sectional elevation

Beam position at site

Arrangement of tie beam was found mismatch with site condition at roof level. The marked beam was found elevated from the regular height as shown in drawing

| Item No. | Observation | Recommended Action Plan | Recommended Timeline |
|---|---|---|---|
| 1 | Discrepancies in between as-built drawing and actual site condition.(Utility Building) | Factory Engineer is required to survey the structure and develop as-built drawings which reflect the on-site condition. | 6-weeks |

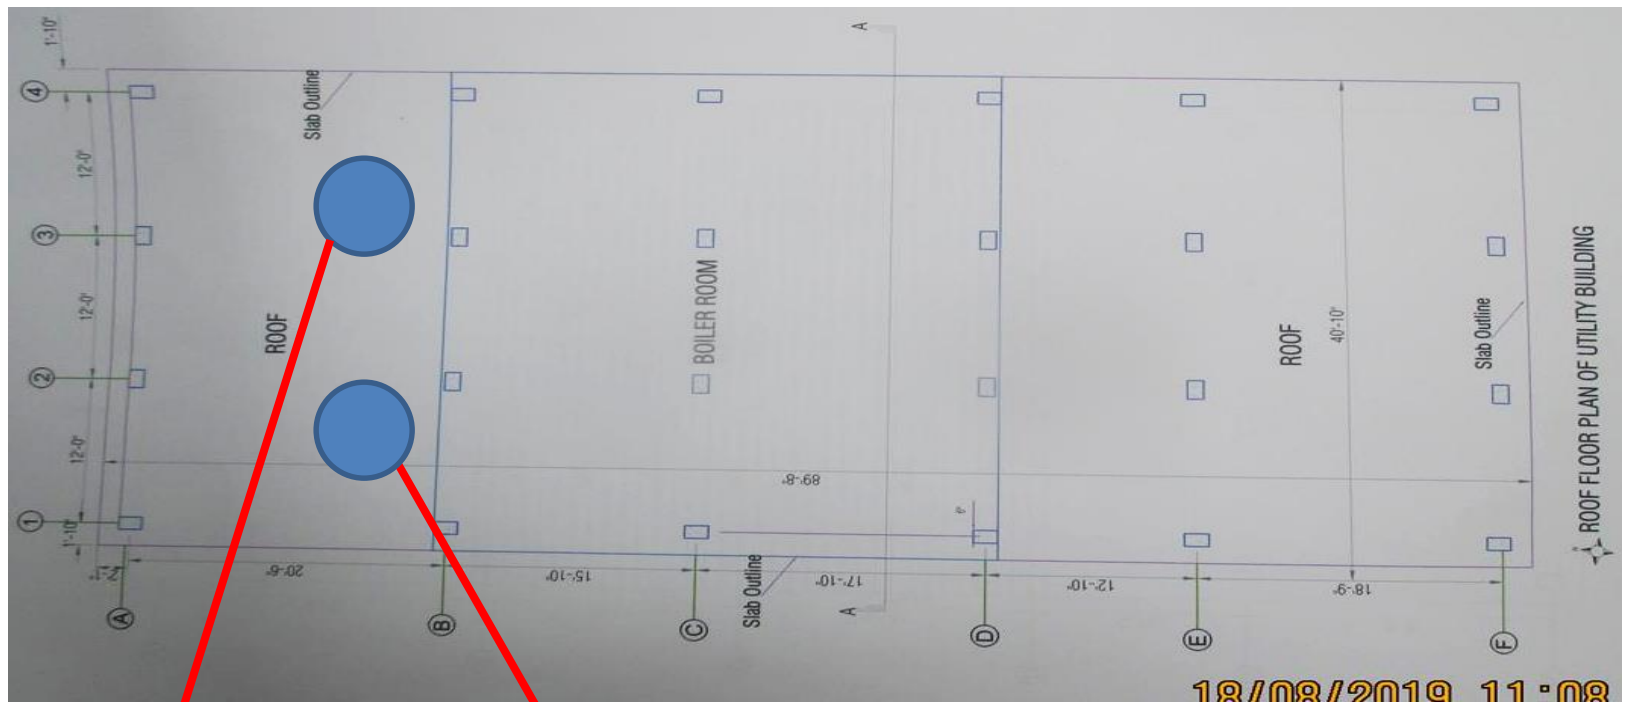
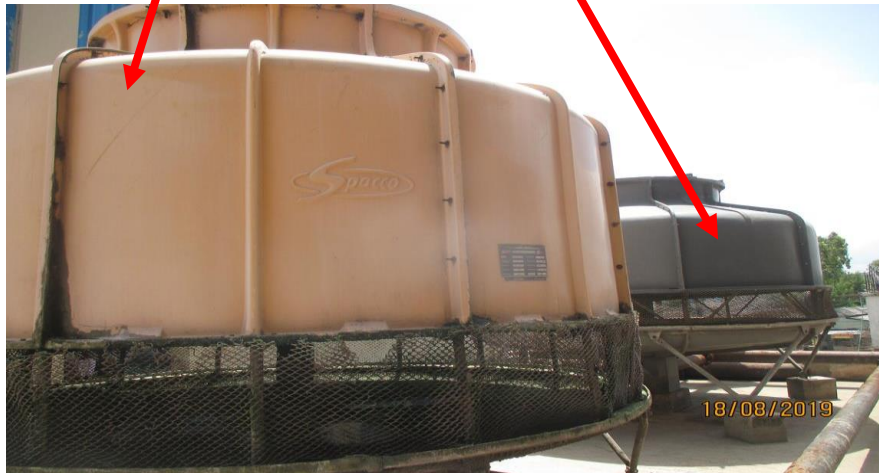
Roof floor layout

Undocumented cooler/chiller was found at roof top of utility building. The cooler/chiller has not been shown in as-built drawing.

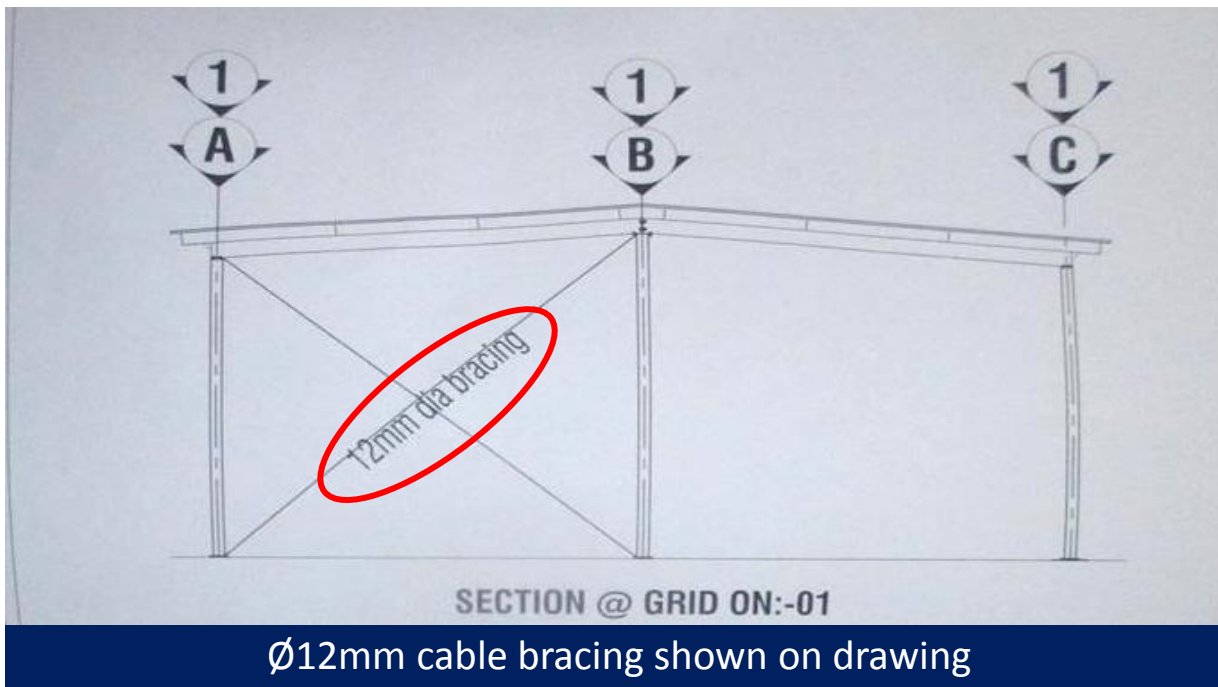
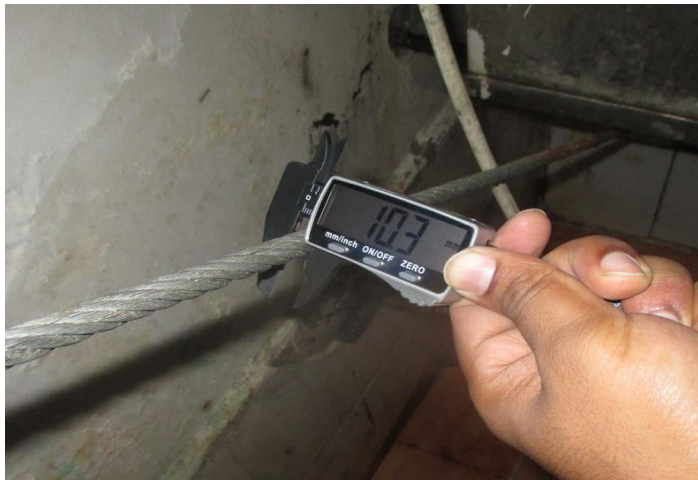
cable bracing was found Ø10mm instead of Ø12mm.

| Item No. | Observation | Recommended Action Plan | Recommended Timeline |
|---|---|---|---|
| 4 | Discrepancies in between as-built drawing and actual site condition.(Dinning shed) | Building engineer is required to check the bracing system and deemed to upgrade the bracings. | 6-weeks |

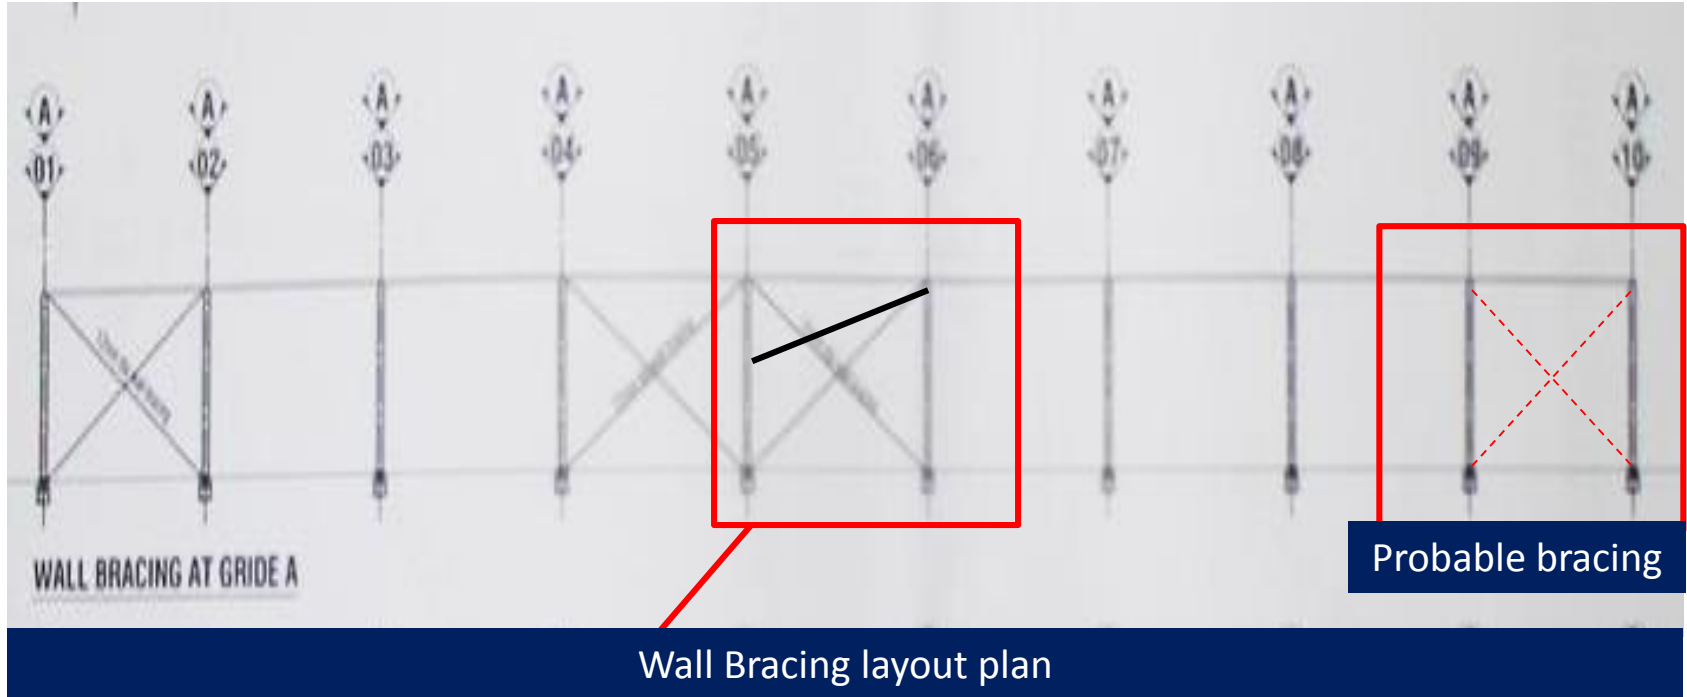
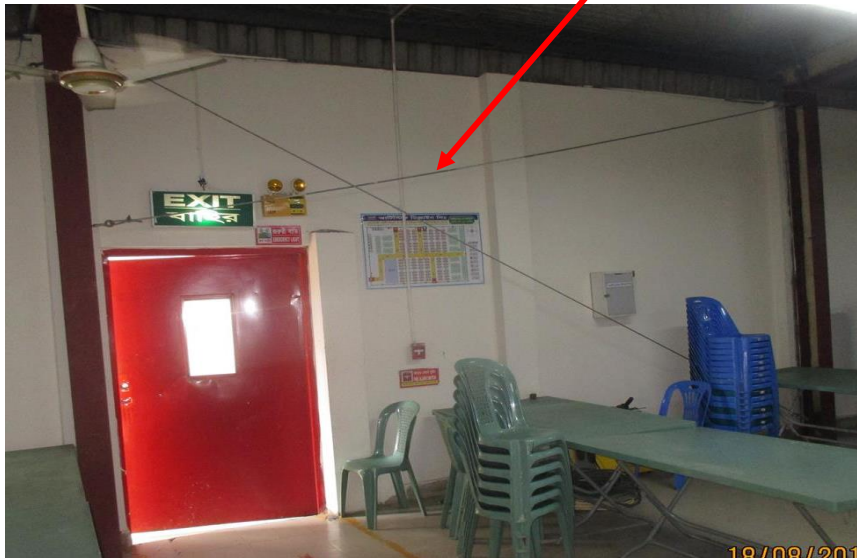
Installation of wall bracing in as-built drawing does not match with actual site condition. Due to door opening bracing arrangement has been changed. Also asymmetric bracing system observed. Factory engineer is required to survey the actual site condition and prepare as constructed as built drawing.

| Item No. | Observation | Recommended Action Plan | Recommended Timeline |
|---|---|---|---|
| 3 | Discrepancies in between as-built drawing and actual site condition.(Dinning shed) | Factory Engineer is required to survey the structure and develop as-built drawings which reflect the on-site condition. | 6-weeks |

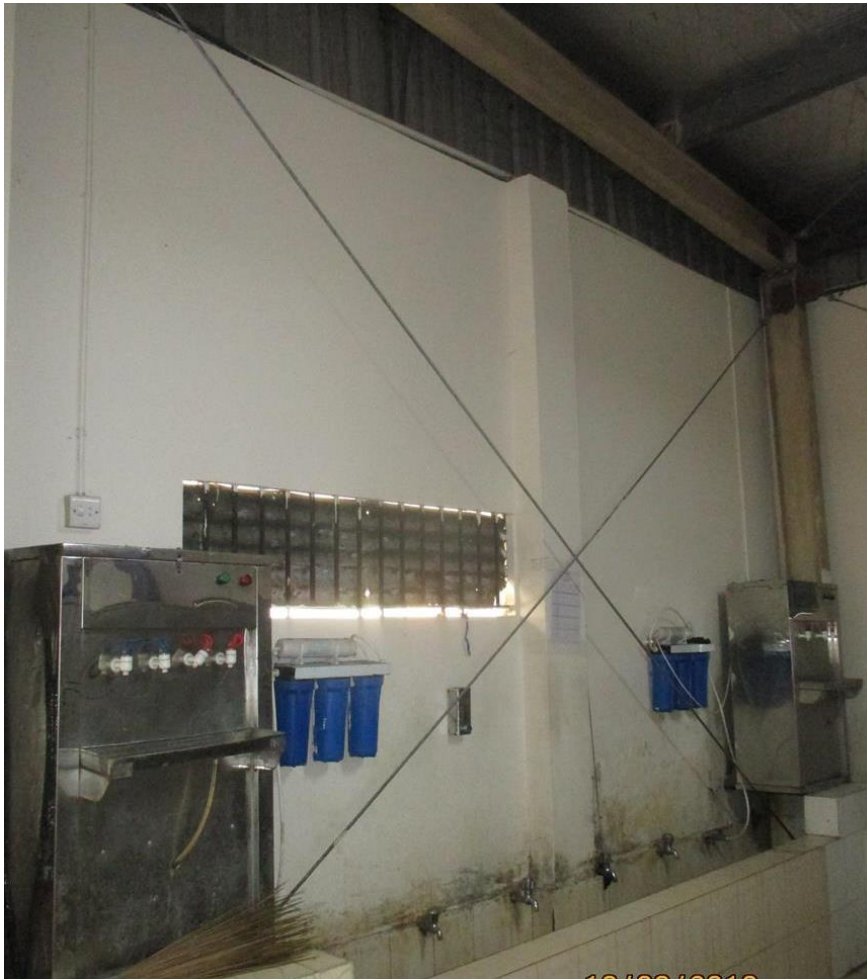
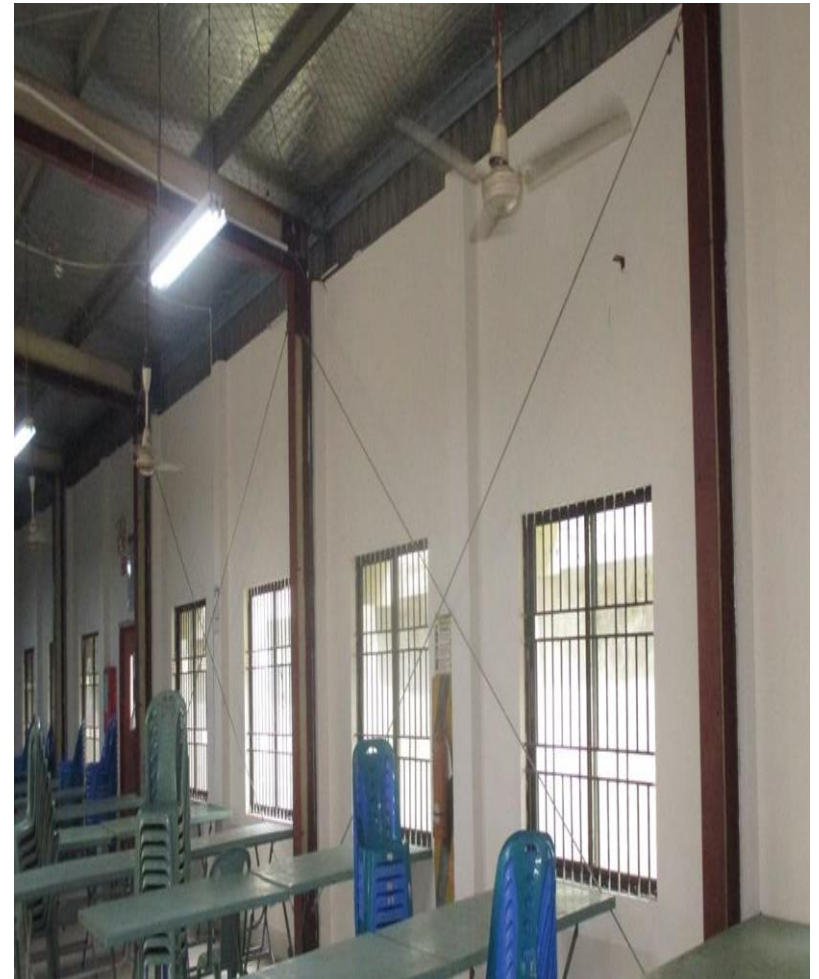
Bracing was found loose on site.

| Item No. | Observation | Recommended Action Plan | Recommended Timeline |
|---|---|---|---|
| 5 | Loose cable bracing(Dinning shed) | Factory is required to tighten the loose bracings. | 6-weeks |

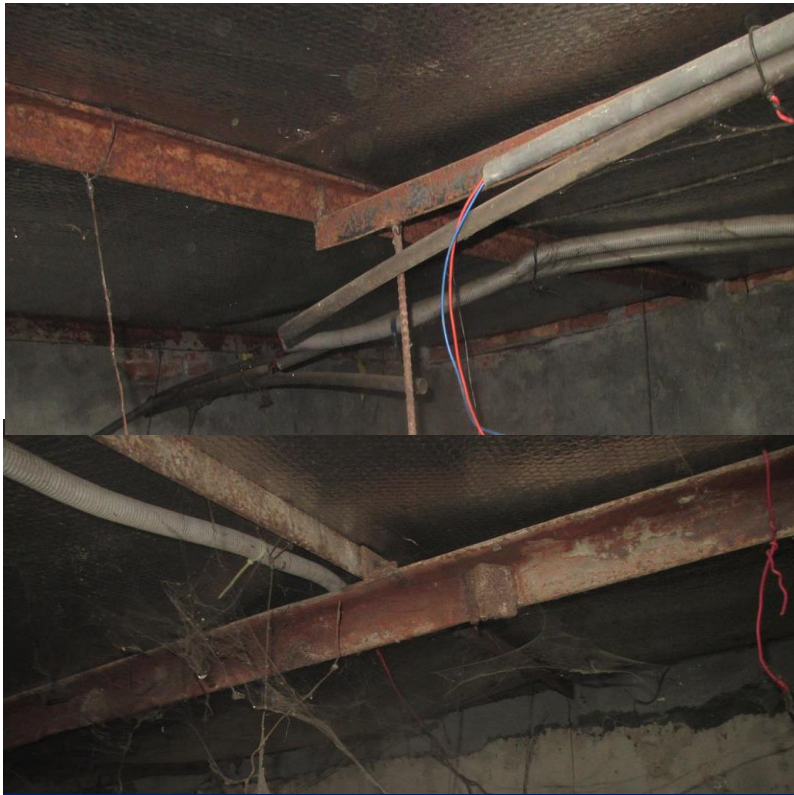
Non-engineered roof shed

Roof truss shown in as-built drawing, but onsite truss wasn't found. Non-engineered steel roof shed supported by masonry structure. Inadequate connection of shed with brick wall. No definite arrangement of angle members. Factory engineer is required to survey the site condition and prepare as-built drawing. Factory engineer is also required to check the adequacy of the roof shed against lateral loading.

| Item No. | Observation | Recommended Action Plan | Recommended Timeline |
|---|---|---|---|
| 6 | Lack of as-built documentation(Medical & Childcare) | Factory Engineer to survey the structure and update the full set of architectural and structural “as-constructed” drawings. | 6-weeks |
| 7 | Lack of as-built documentation(Medical & Childcare) | Building engineer is required to check the lateral stability system of the existing structure. | 6-weeks |

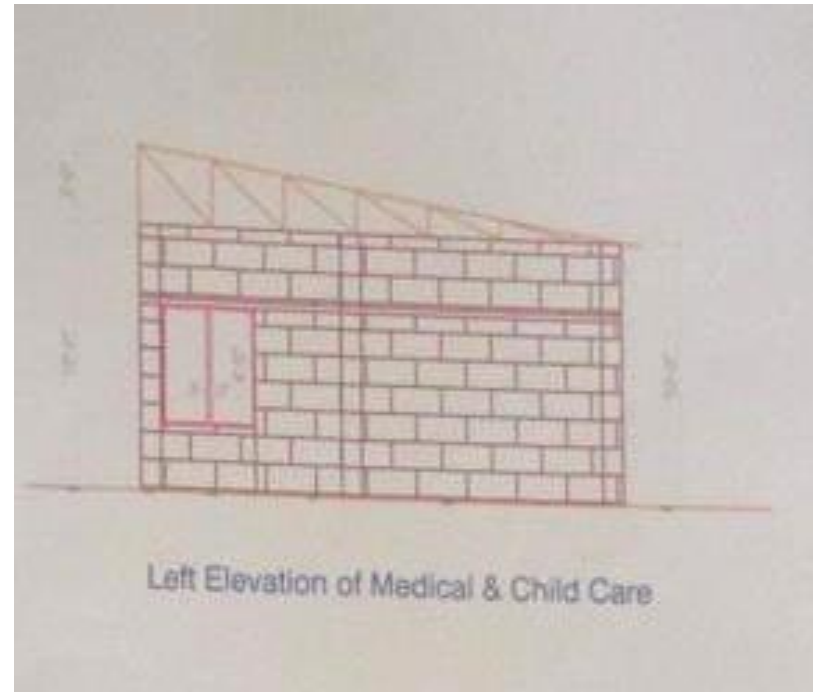
Truss has been shown as-built drawing

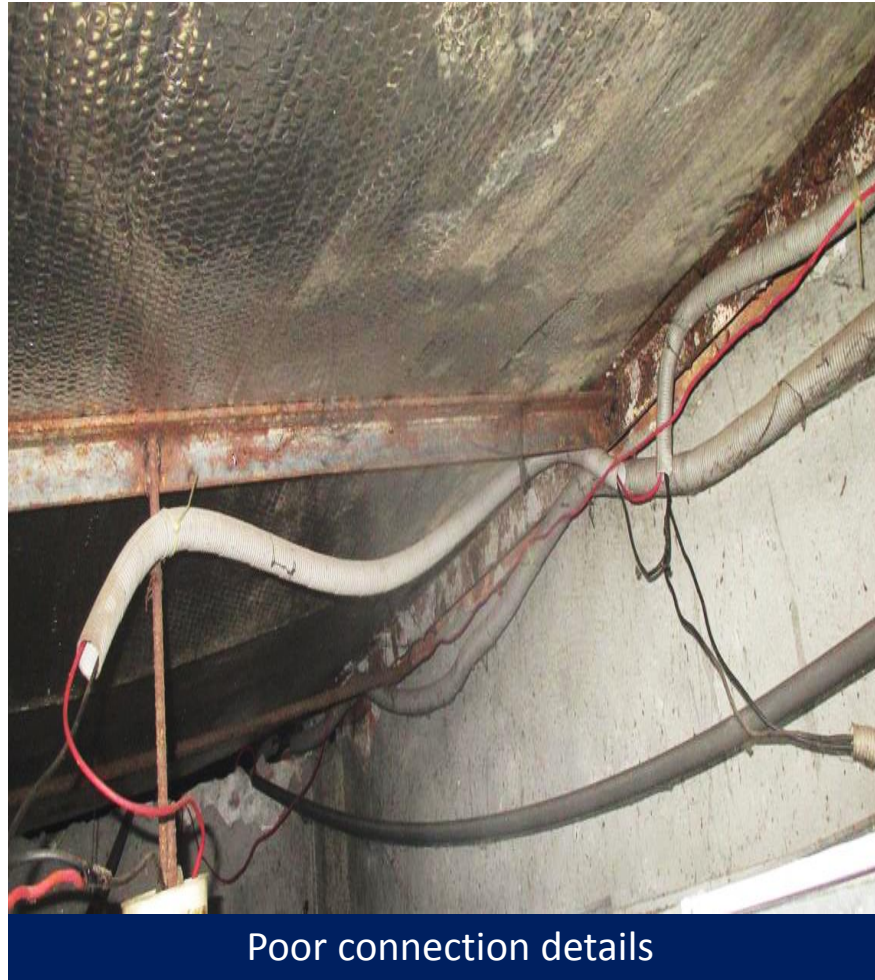
Poor connection details

| Item No. | Observation | Recommended Action Plan | Recommended Timeline |
|---|---|---|---|
| 8 | Lack of as-built documentation(Medical & Childcare) | Complete remedial works as per the recommendation of engineering assessment. | 6-months |
