# MUAZUDDIN KNIT FASHION (NEW)

B-31, East Chandura, Shaipur, Kaliakoir, Gazipur  
(24.033288N, 90.272368E)  
16th March 2017

# Observation

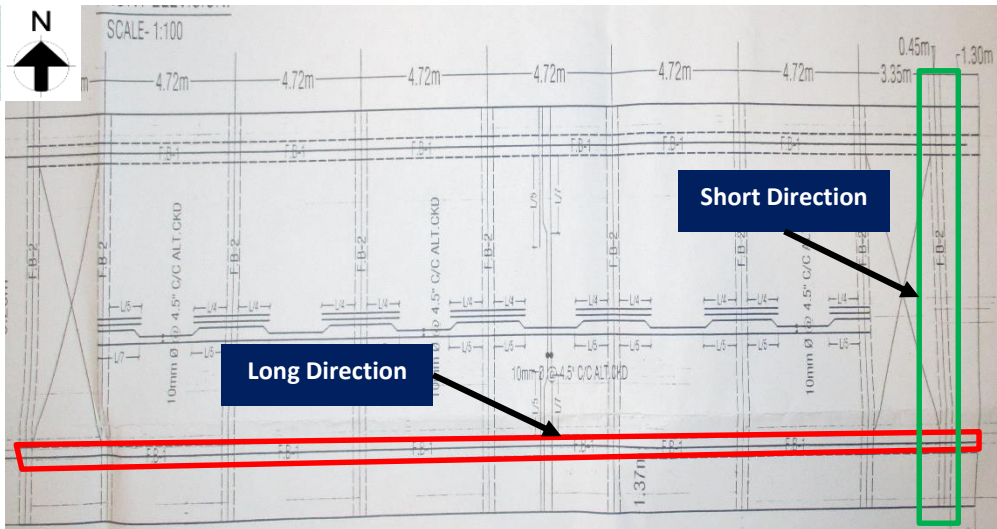
Beam Layout

Depth of beam found from under slab was 9inch instead of 14inch and width was found 10 inch instead of 18 inch for long direction beam. However, no information was found regarding the short direction beams in provided drawing.

| Item No. | Observation | Recommended Action Plan | Recommended Timeline |
|---|---|---|---|
| 1 | Inconsistent and missing documents | Building engineer to survey the whole building and produce as-built document reflecting the as constructed condition. | 6-weeks |

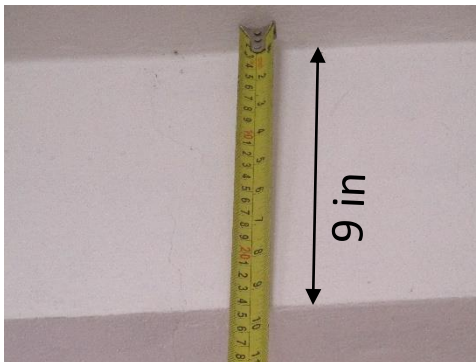
9 inch depth found under slab of long direction beam

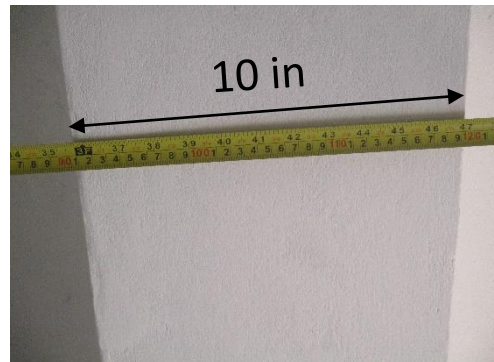
10 inch width found of long direction beam

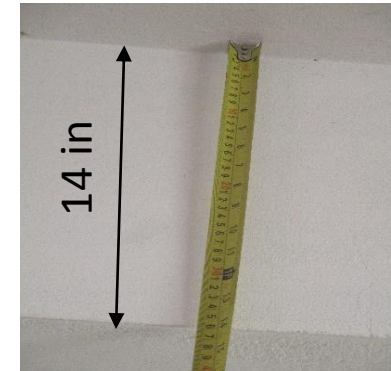
14 inch depth found under slab of short direction beam

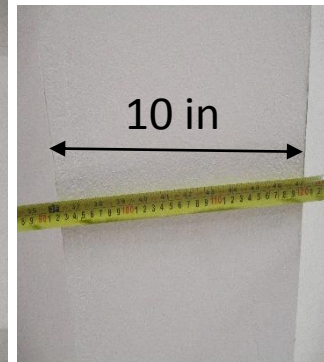
10 inch width found of short direction beam

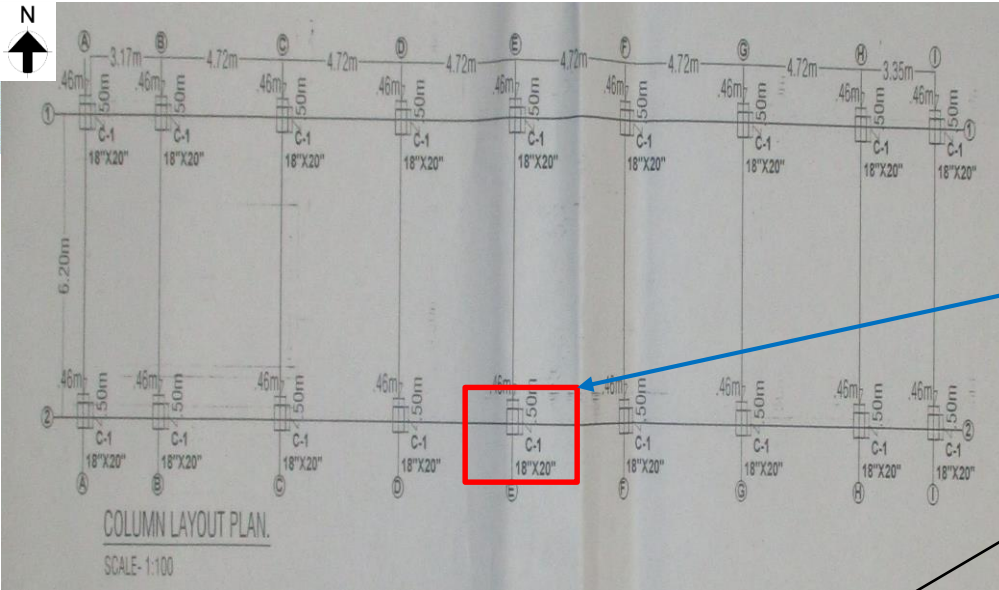
Column Layout

C-1 type column dimension was found 15inch x 20inch with plaster instead of 18inch x 20inch which was in provided drawing.

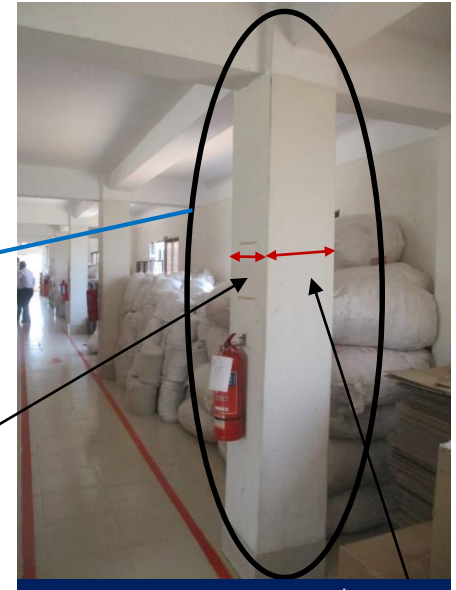
C-1 column type on 3<sup>rd</sup> floor

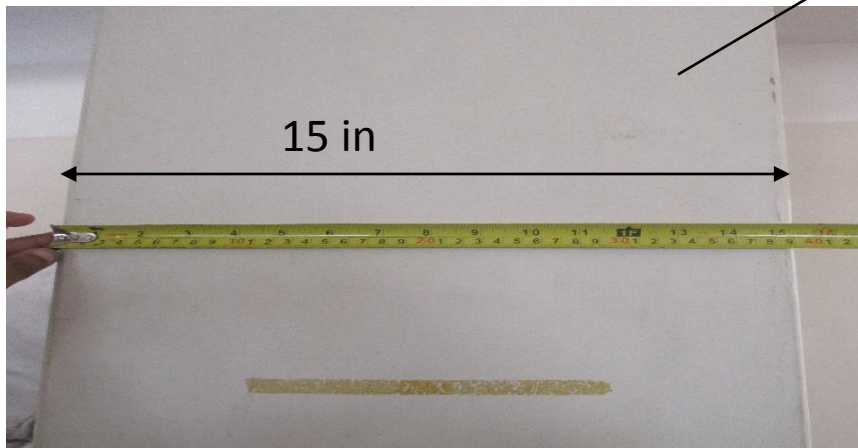
Column dimension was found 15 inch with plaster on short direction

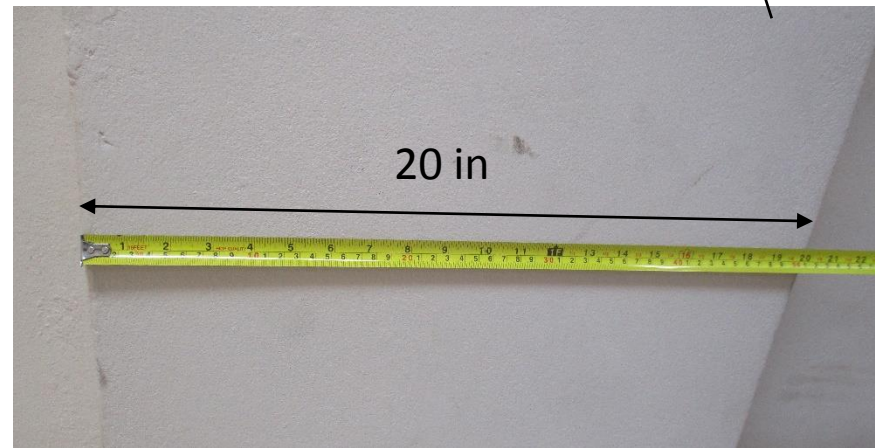
Column dimension was found 20 inch with plaster on long direction

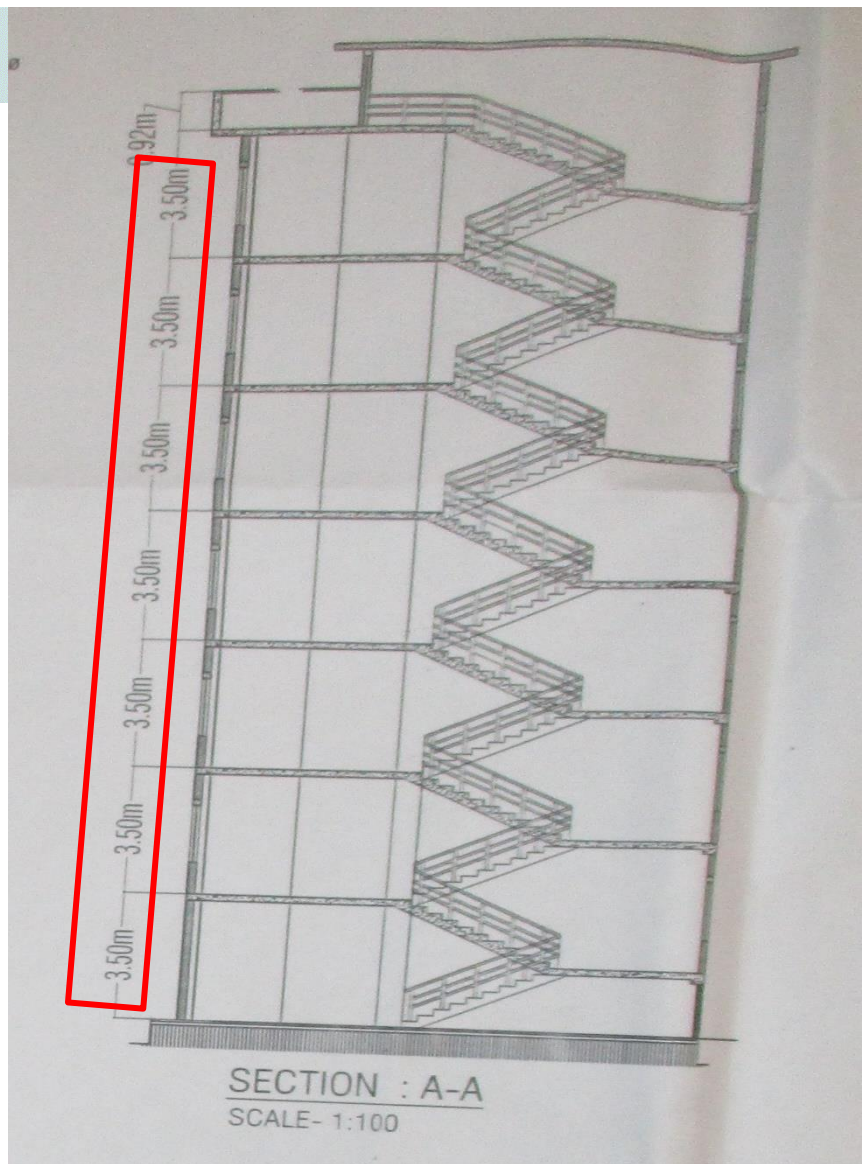
Floor to ceiling height was found 2.8m for typical floor and 4.5m for ground floor whereas in provided drawing, all floor height was mention as 3.5m.

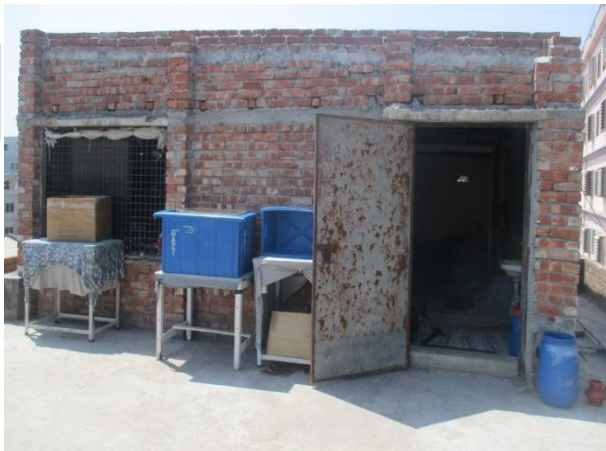
Roof top shed

The support condition of roof top shed was vulnerable and non engineered due to poor detailing.

| Item No. | Observation | Recommended Action Plan | Recommended Timeline |
|---|---|---|---|
| 2 | Lightweight steel structure is appeared to be non engineered | Building engineer to check the adequacy of the lightweight steel roofs under lateral and vertical loading. | 6-weeks |
| 3 | Lightweight steel structure is appeared to be non engineered | Carry out remedial works resulting from engineering assessment if necessary. | 6-months |

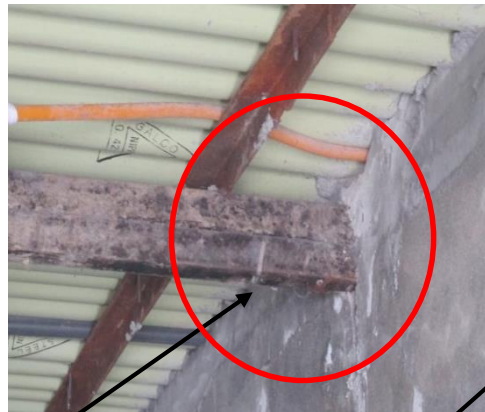
Steel member was supported on brick wall

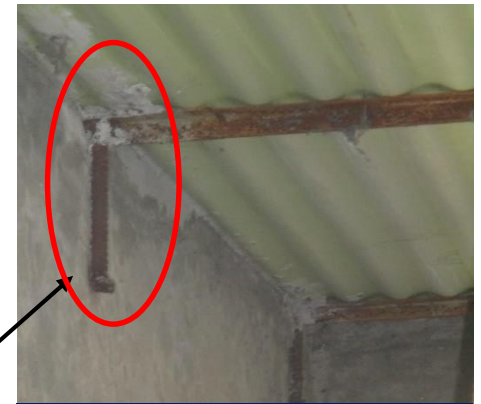
Steel angle was inserted into brick wall and welded with some inserted rod

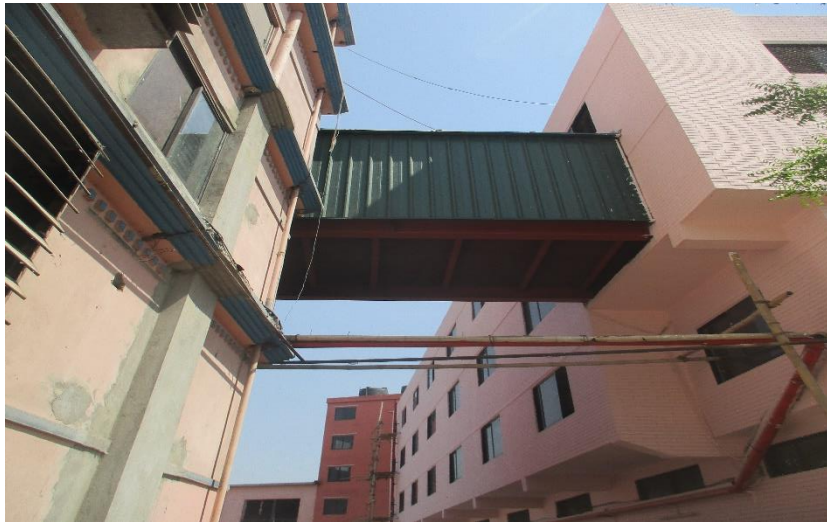
Connecting bridge was found on the north side of the building.

Factory is required to engage a qualified engineer to verify the capacity of the bridge and the connection between the RC beam and Steel beam. Also evaluate the performance of connection bridge in time of relative movement of both buildings.

| Item No. | Observation | Recommended Action Plan | Recommended Timeline |
|---|---|---|---|
| 4 | Presence of bridge between the factory building and adjacent building | The factory engineer is to verify the capacity of beams and columns of the RCC building | 6-weeks |
| 5 | Presence of bridge between the factory building and adjacent building | Check the capacity of connection between bridge and RCC building | 6-weeks |
| 6 | Presence of bridge between the factory building and adjacent building | Carry out remedial works resulting from engineering assessment if necessary. | 6-months |

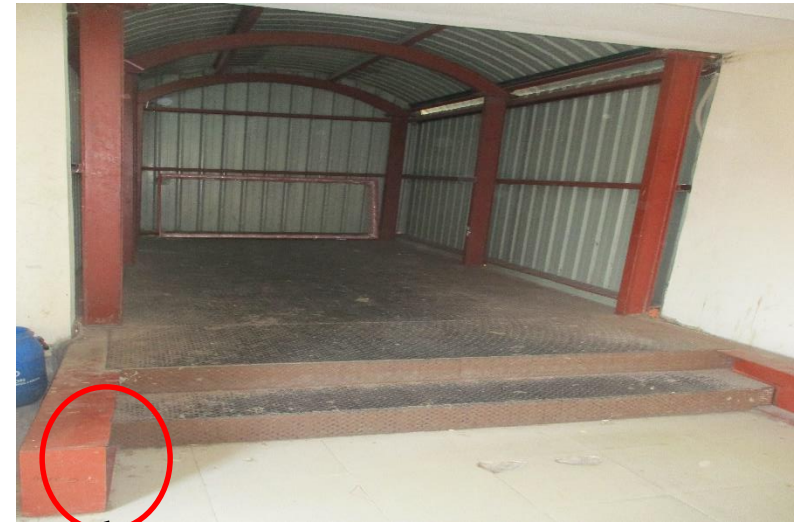
Steel beam and column of the connection bridge

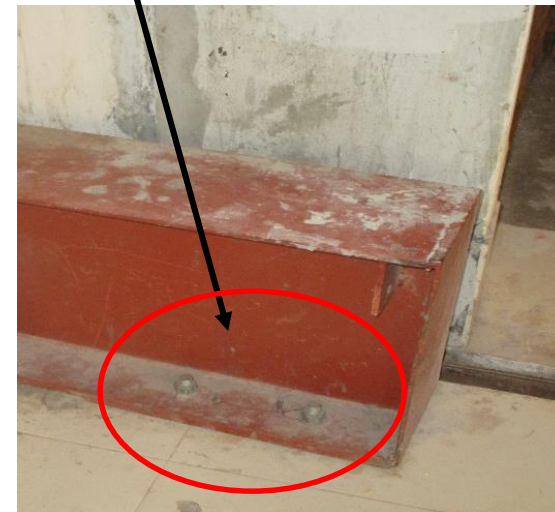
Steel beam was bolted with RC beam of the building

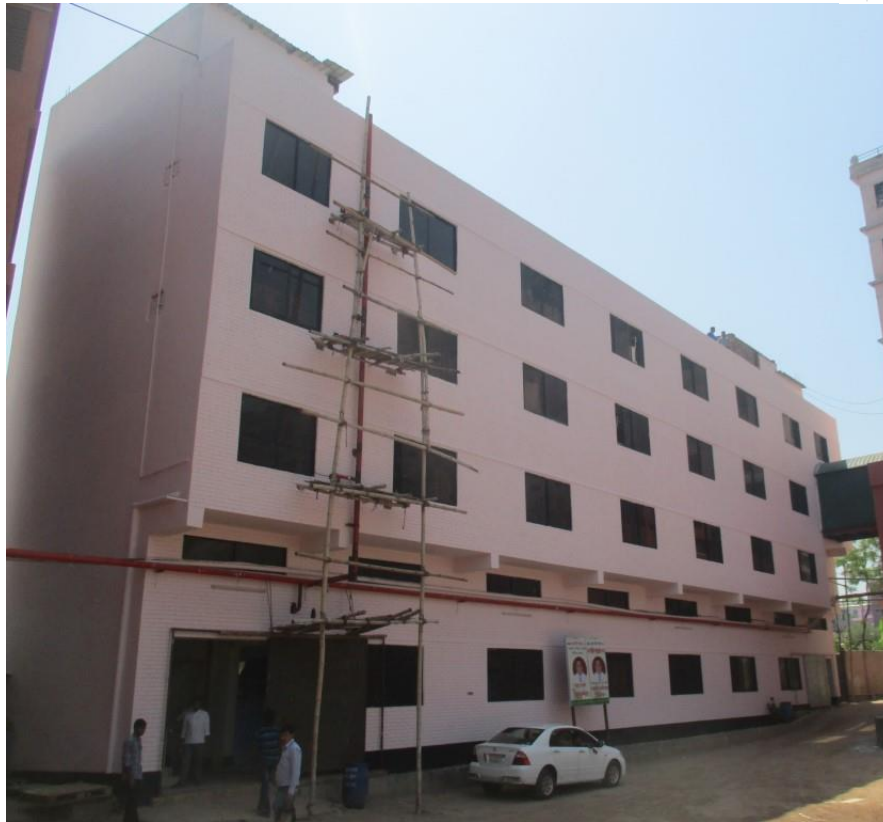
Inspected building

The building height was found 13.5 m, width 8.8m and length was 36.3m. Due to poor aspect ratio and single bay of the building, factory is required to engage a qualified engineer to investigate the stability against the lateral loads.

| Item No. | Observation | Recommended Action Plan | Recommended Timeline |
|---|---|---|---|
| 7 | Overall stability system | An Engineering Assessment of the overall building to be carried out against vertical and lateral loads. | 6-weeks |
| 8 | Overall stability system | Carry out remedial works resulting from engineering assessment if necessary. | 6-months |

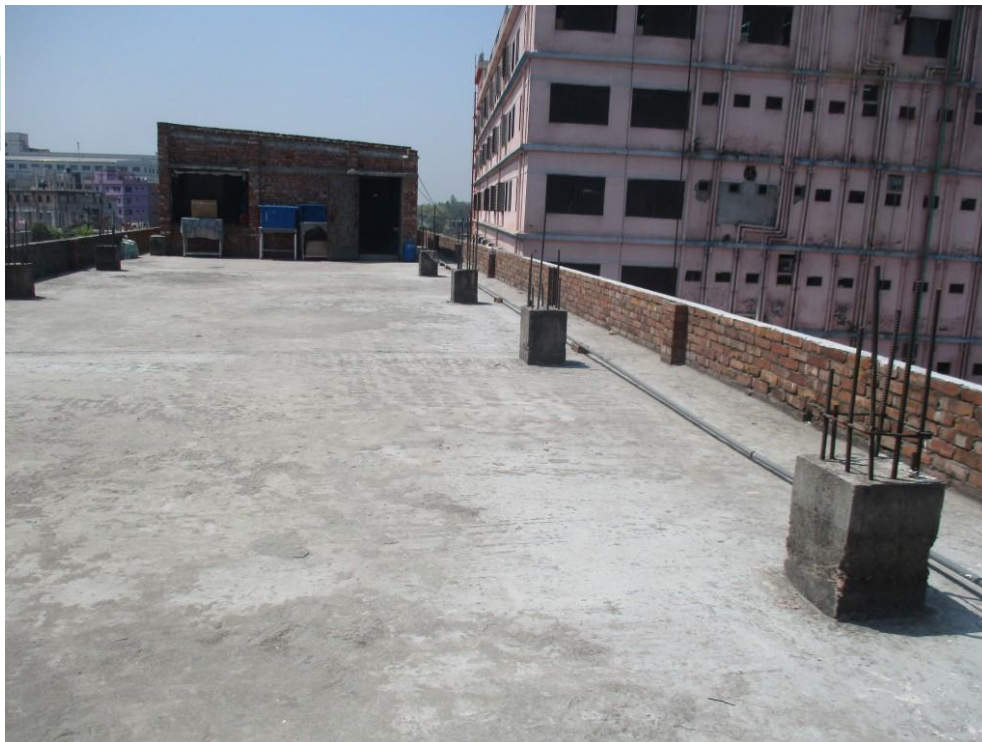
Reinforcement of columns were found exposed on existing roof top

Exposed reinforcement on roof top and building permission for 7 storey indicate further extension of the building. Any future extension may cause a significant increase in column loads which would require to carry out Detail Engineering assessment as per BNBC.

| Item No. | Observation | Recommended Action Plan | Recommended Timeline |
|---|---|---|---|
| 9 | Excessive column stresses in fully completed building (7 storey) | Any extensions or modifications of the existing building needs to be carried out Detail Engineering assessment by a Structural Engineer and in full compliance with the BNBC provision. | 6-months |

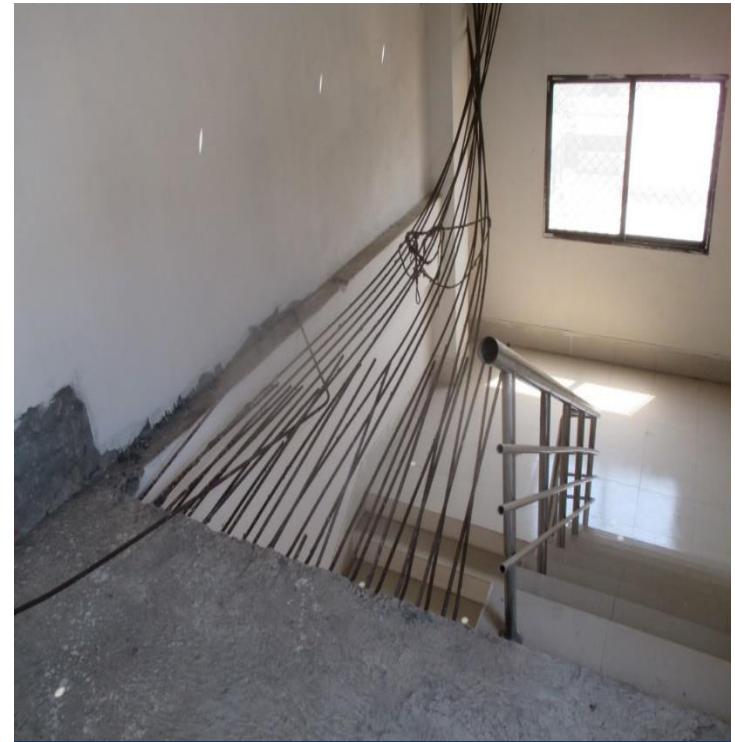
Reinforcement of Stair slab were found exposed
