## Cotton Dyeing & Finishing Mills Ltd

10 May 2014

## Structural Inspection Report

### Observations & Actions

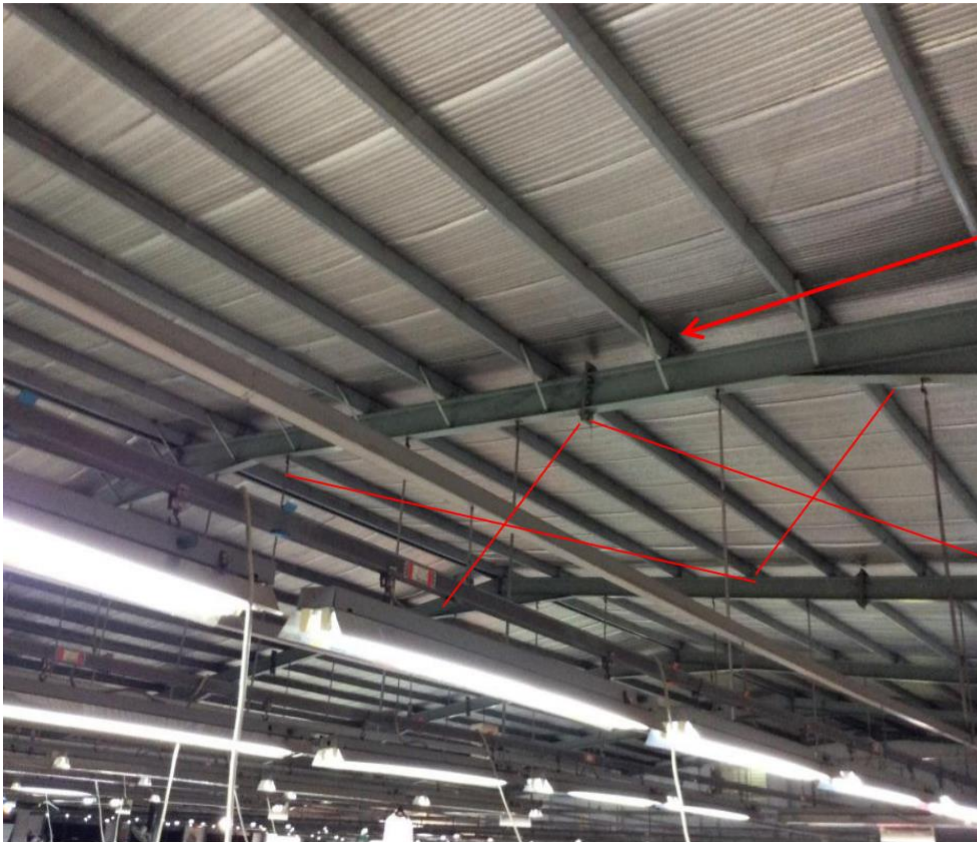
## **Incomplete bracing and inconsistent restraint detail to steel rafter**

**Compression flange restraints for roof rafter steel are provided at a limited number of locations.**

**Roof horizontal bracing for lateral stability of steel roof structure is incomplete. Building Engineer to review horizontal and vertical bracing.**

**Structural steel columns do not correspond with sizes shown on building section drawing.**

**Building Engineer to review and confirm that these are provided in accordance with the design.**

**Building Engineer to review adequacy of steel roof structure.**

- The design of the steel roof should be checked by the Building Engineer and, if required, upgraded to support code vertical and wind loads. Specifically the provision of roof bracing (horizontal and vertical) and compression flange restraints should be reviewed.

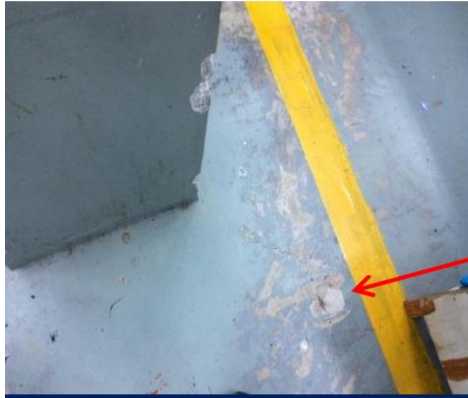
**Cracks in 1<sup>st</sup> floor slab**

**Building Engineer to prepare controlled loading plans, based on floor slab and column capacity, for all floors which will designate allowable storage density and where storage may be placed. Crack repairs to be carried out as necessary.**

- Produce and actively manage a loading plan for all floor plates within the factory giving consideration to floor capacity and column capacity.
- Building Engineer to review typical floor finish cracks at ground and 1<sup>st</sup> floors and confirm that cracking is in finishes only. Where required, remedial works to be carried out.

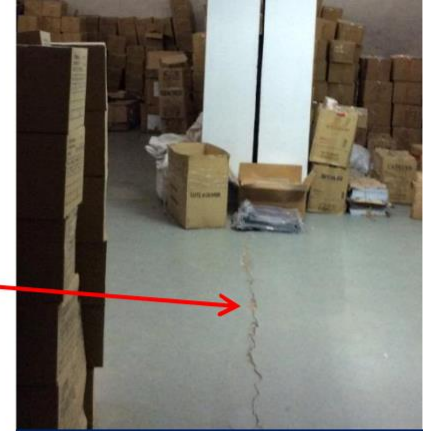
**Cracks in Ground floor slab**

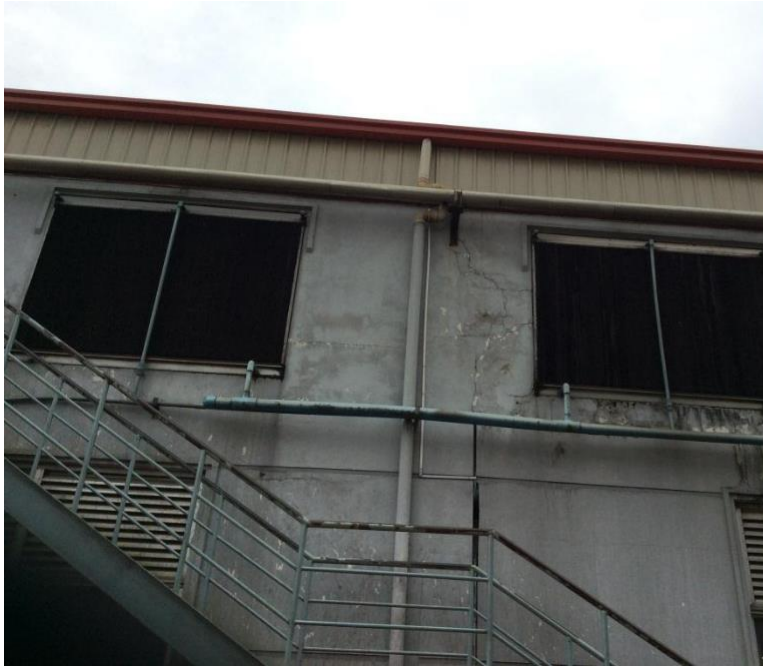
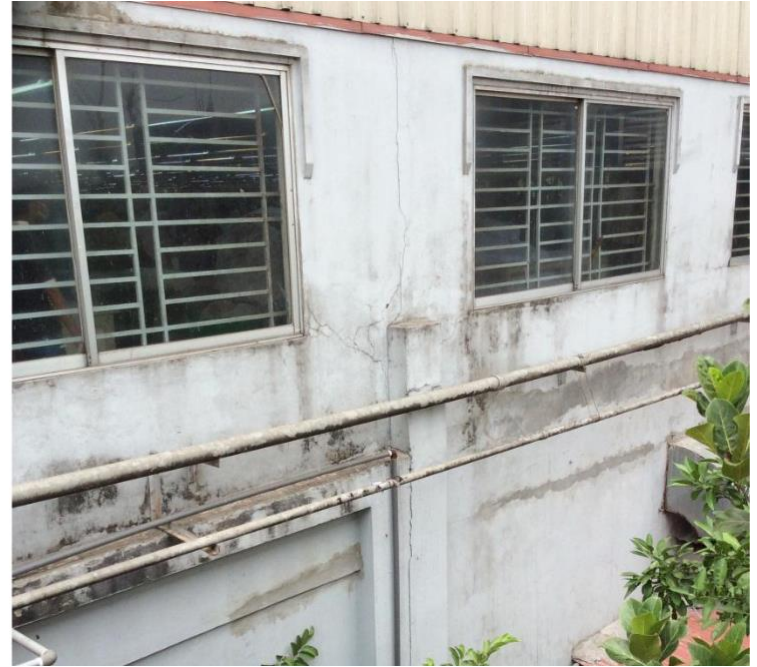
**Façade cracks visible on elevations of the Garments Building.**

**Building Engineer to conduct routine inspection and issue maintenance schedule for façade brick walls**

- Building Engineer to inspect area where cracking has occurred and propose a suitable repair to ensure that rainwater does not penetrate the building fabric.
- Building Engineer to provide a method statement for the on-going maintenance of the external facades.

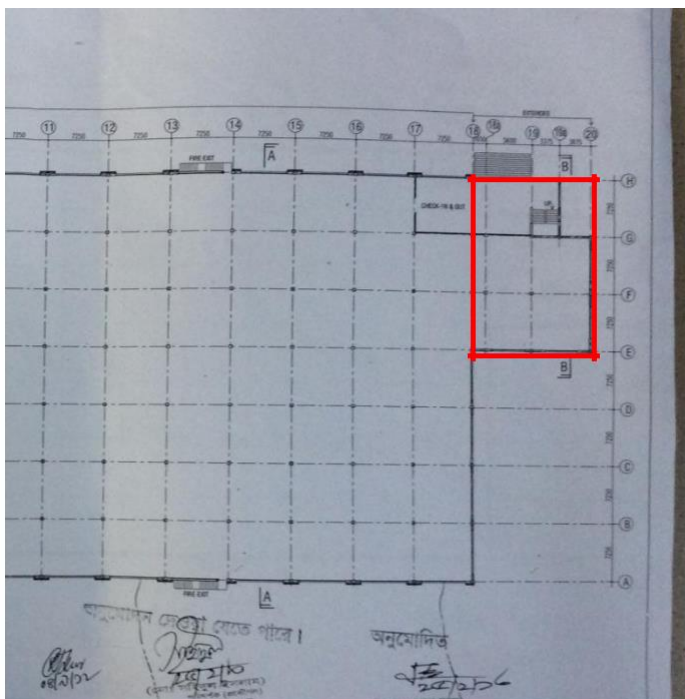
As constructed Eastern extension is rectangular on plan – this differs to layout shown on drawing

Building Engineer to check all drawings and update to match as constructed building.

- Building Engineer to survey as constructed building. Updated drawings to be prepared showing the correct as constructed layout including the steel frame structure.
- Update controlled loading plans for all floors designating allowable storage density and where storage may be placed.

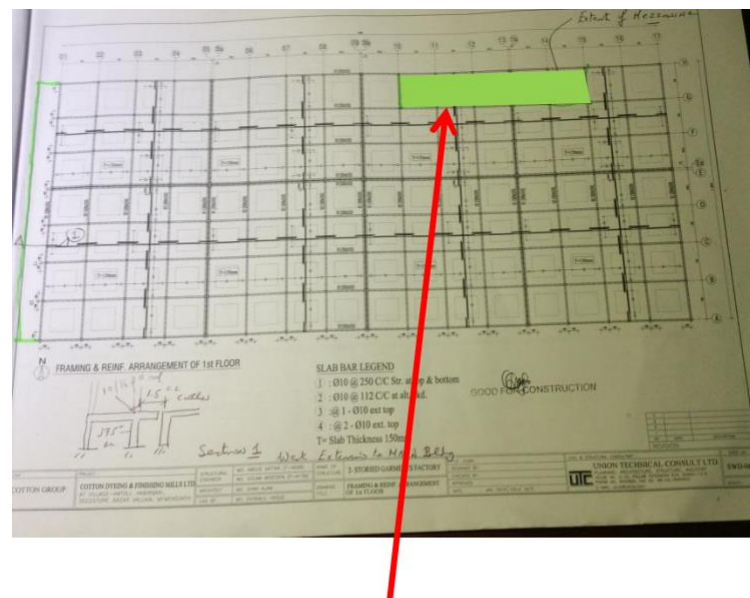
Missing drawings for the Mezzanine floor of the Garments Building

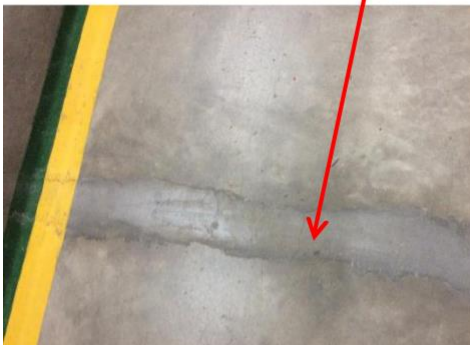
**1<sup>st</sup> floor slab**

**Building Engineer to prepare controlled loading plans, based on floor slab and column capacity, for all floors which will designate allowable storage density and where storage may be placed. Crack repairs to be carried out as necessary.**

- Produce and actively manage a loading plan for all floor plates within the factory giving consideration to floor capacity and column capacity.
- Building Engineer to review typical floor finish cracks and confirm that cracking is in finishes only. Where required, remedial works to be carried out.

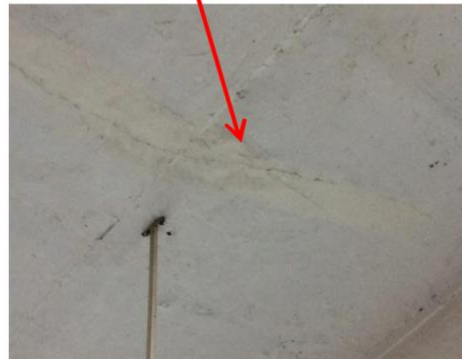
**2<sup>nd</sup> floor slab soffit**

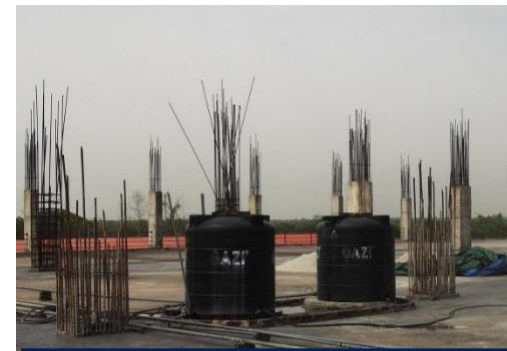
**Water tanks loads**

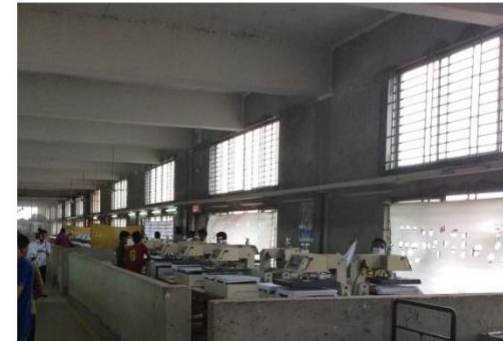
**Equipment loads**

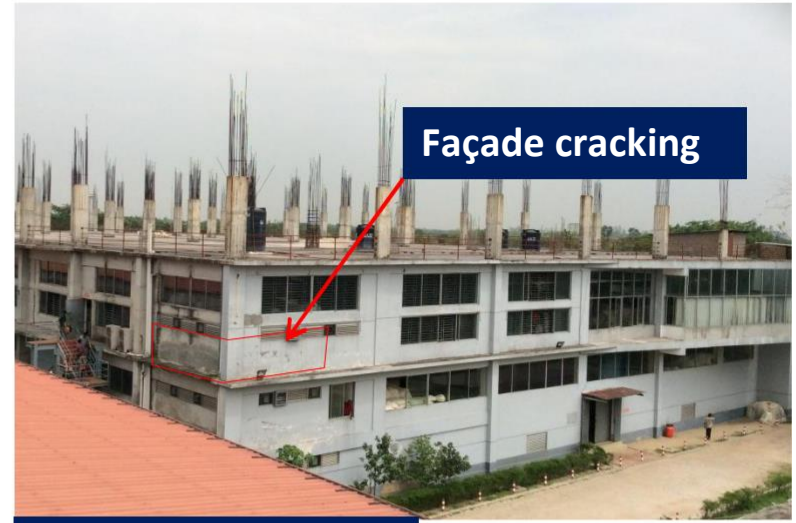
**Façade cracking**

**Building Engineer to investigate reasons for cracking and implement repairs as necessary**

- Building Engineer to inspect area where cracking has occurred and propose a suitable repair to ensure that rainwater does not penetrate the building fabric and cantilever slab.
- Building Engineer to provide a method statement for the on-going maintenance of the external facades.

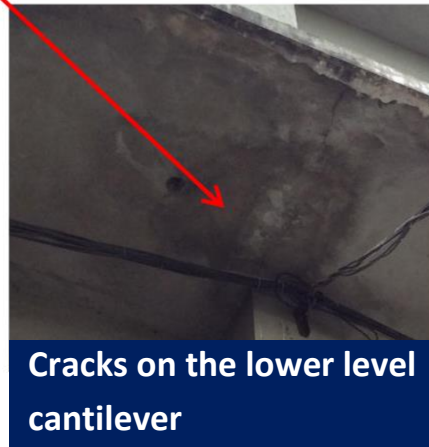
**Cracks on the lower level cantilever**

**Cracks on the upper and lower cantilevers propagating from the column towards the tip of the cantilevers**

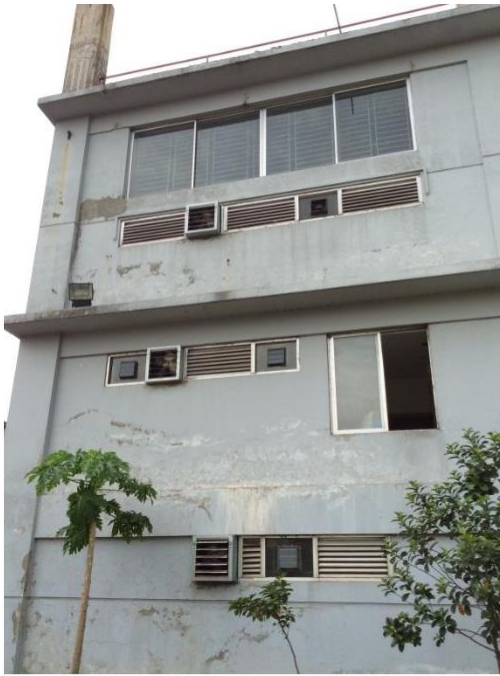
**Façade cracks visible on elevations of the Knitting and Dyeing building.**

**Building Engineer to conduct routine inspection and issue maintenance schedule for façade brick walls**

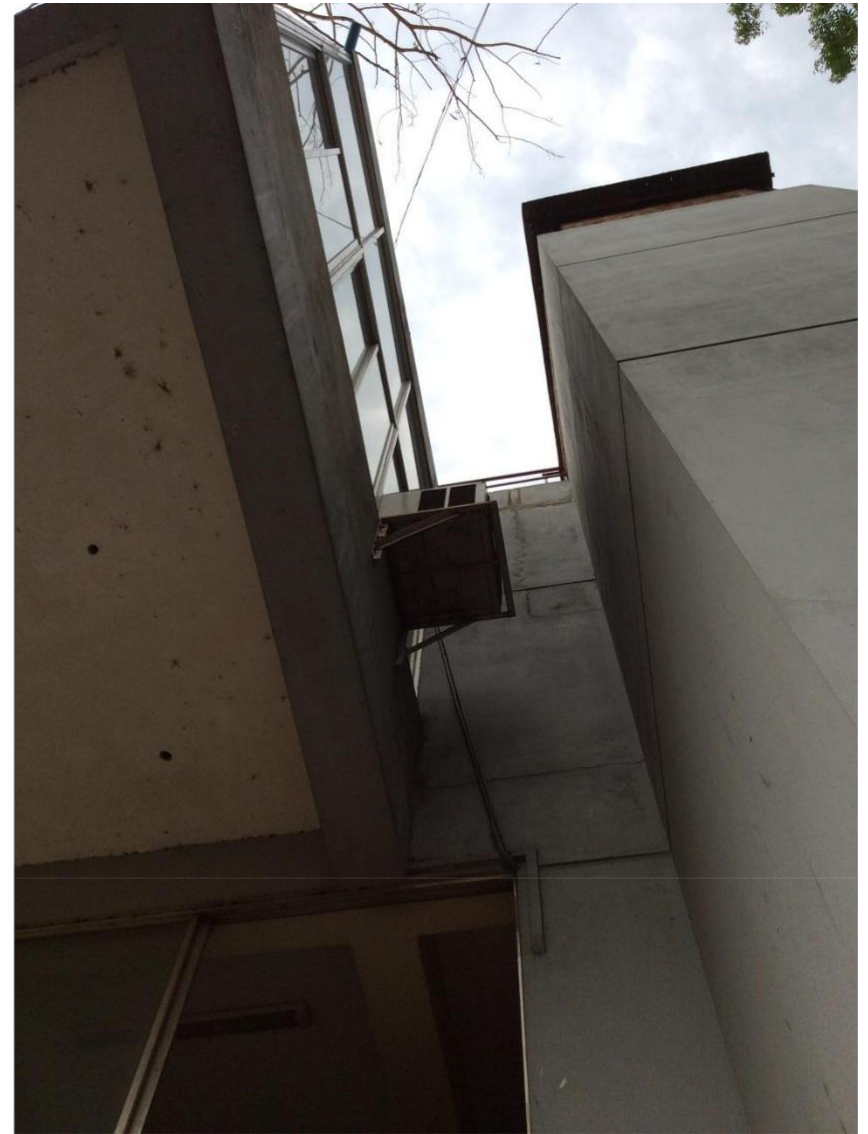
**Cracks on façade brickwork walls**

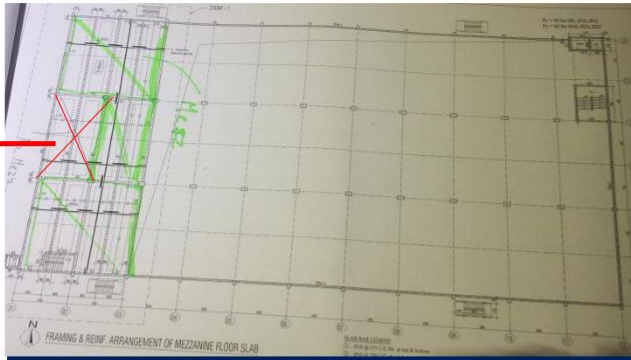
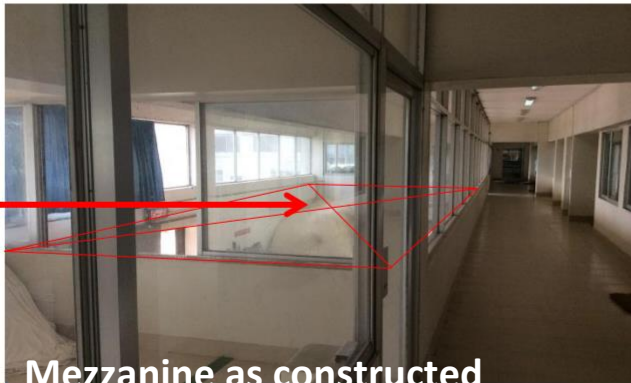
**Mezzanine RC drawing**

**Mezzanine as constructed**

Mezzanine is shown covering 2 full bays at the west end of the building on the RC drawing. As constructed it only covers 1 bay at the middle section of the mezzanine.

**Building Engineer to check all drawings and update as constructed.**

- Building Engineer to survey as constructed building. Updated drawings to be prepared showing the correct as constructed layout.
- Update controlled loading plans for all floors designating allowable storage density and where storage may be placed.

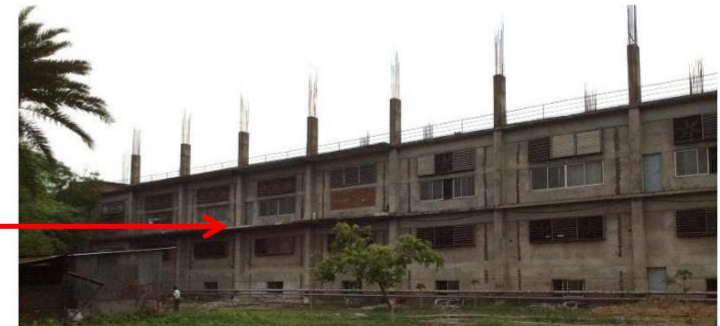
**Cantilever slabs as constructed – not shown on drawings**
