Powertex Fashion Limited (Relocation)

Dr. Panjabali-Dr. Assaduzzaman Industrial Park, Kathora, National University, Gazipur
(23.948446N, 90.363503E)

6th January 2019

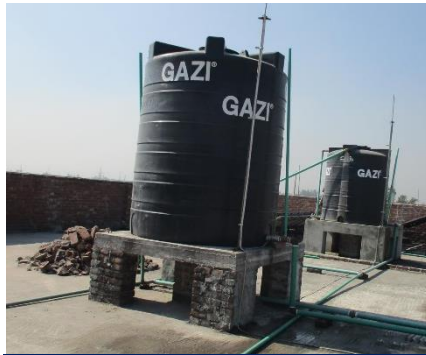
5000 ltr. Water tank

- 1. Remove plastic water tank load from the roof.**
- 2. Maintain live loading below 2 kPa on 1st floor level and keep the mezzanine floor vacant.**
- 3. A Detail Engineering Assessment of Building-1 must commence immediately to the requirements of the scope attached and addressing the concerns as noted.**

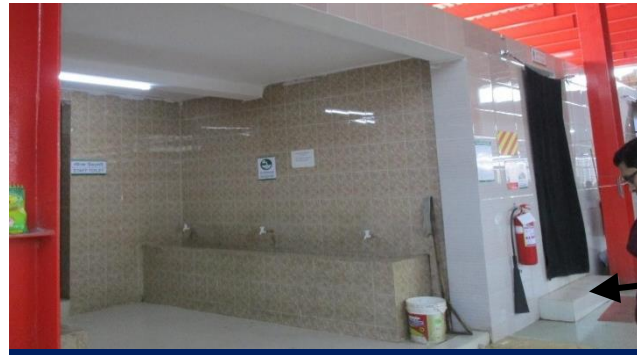
Approximate 450mm floor raised in toilet zone

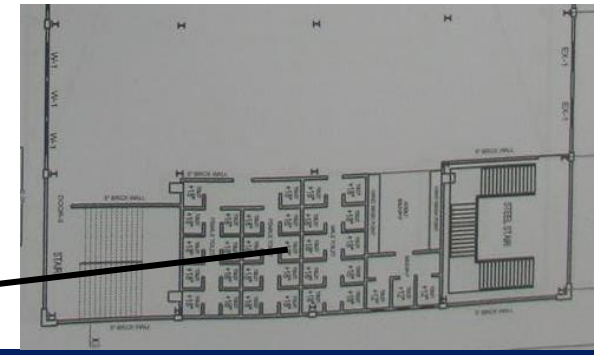
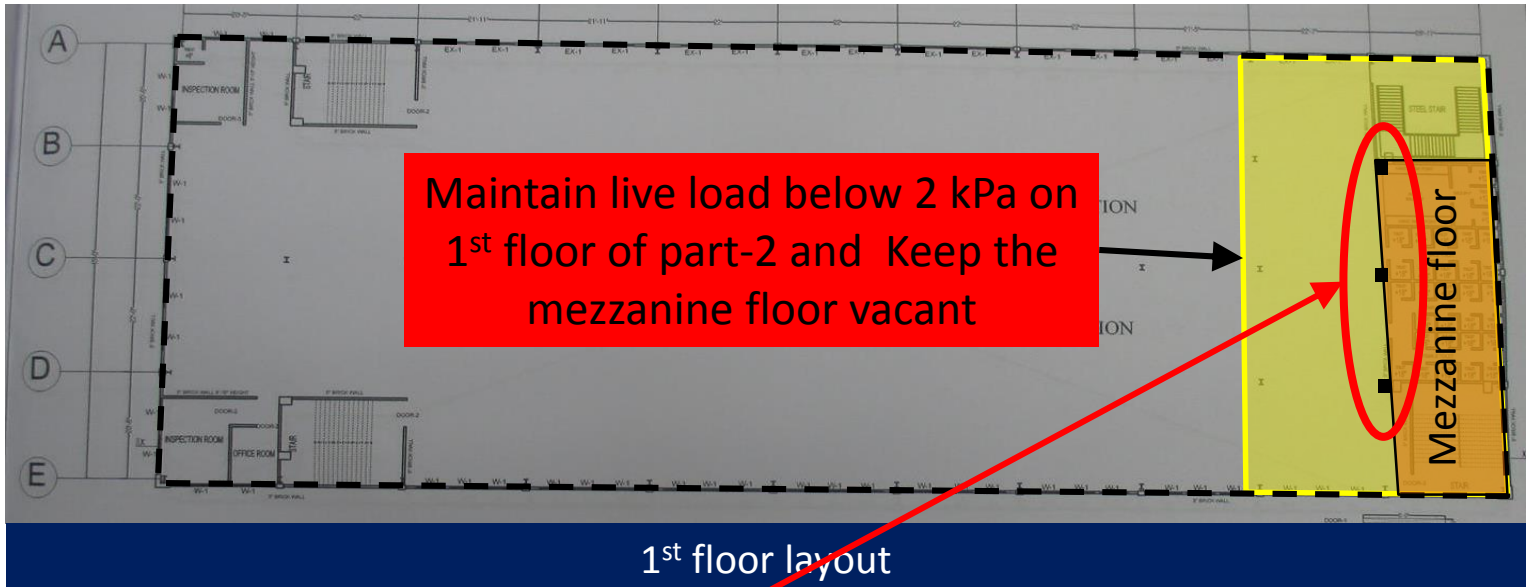
High stress column |

Cursory calculation shows that the stresses of internal columns in mezzanine area exceed the normal design limit at ground level. Immediate actions mentioned in page-4 have to be followed and a Detail Engineering Assessment (DEA) to be commenced immediately based on in-situ material strength.

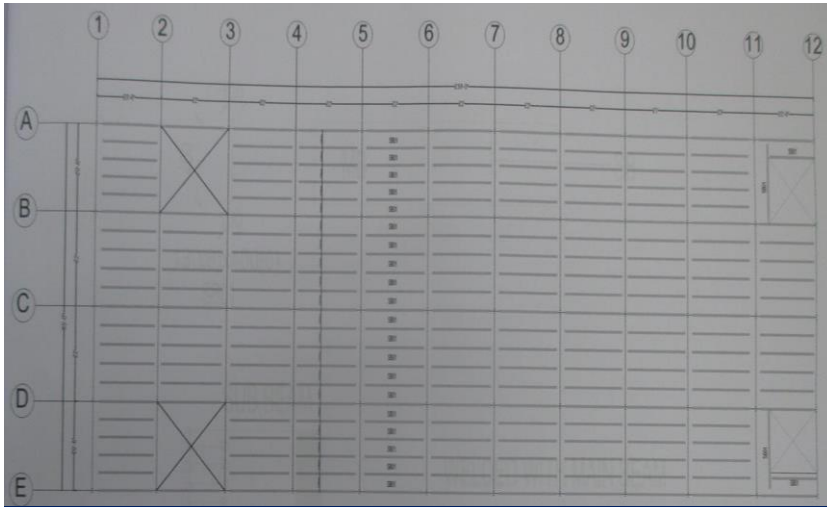
Sub-beam layout

Flange thickness of sub-beam (SB-01) was found 6mm instead of 8mm

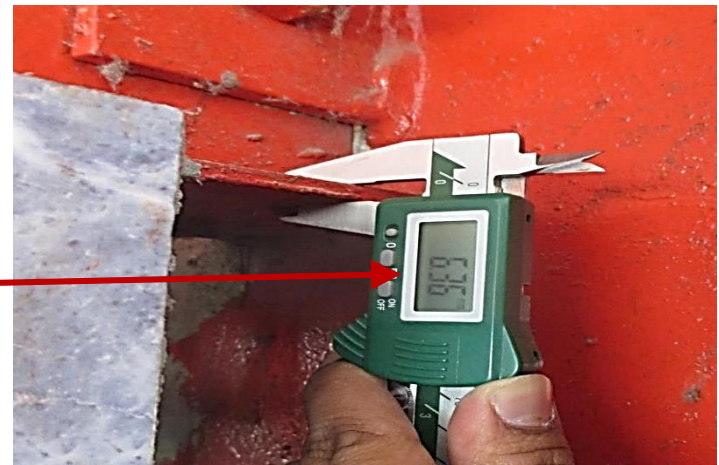
6 mm thick. flange of sub-beam

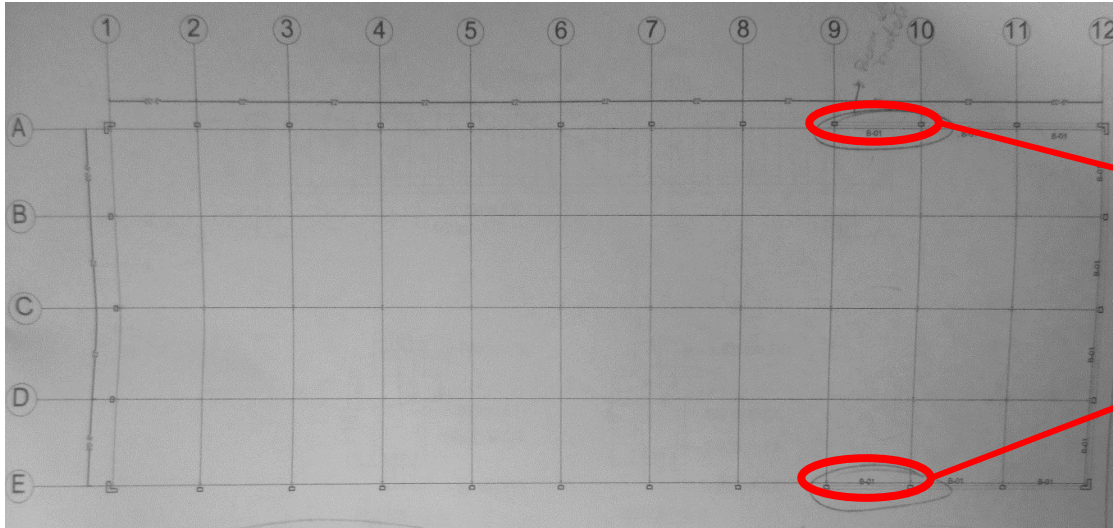
Roof layout

1st floor tie beam at the marked location did not match with as built drawing. Beam depth found 250mm where 450mm was shown in provided drawing.

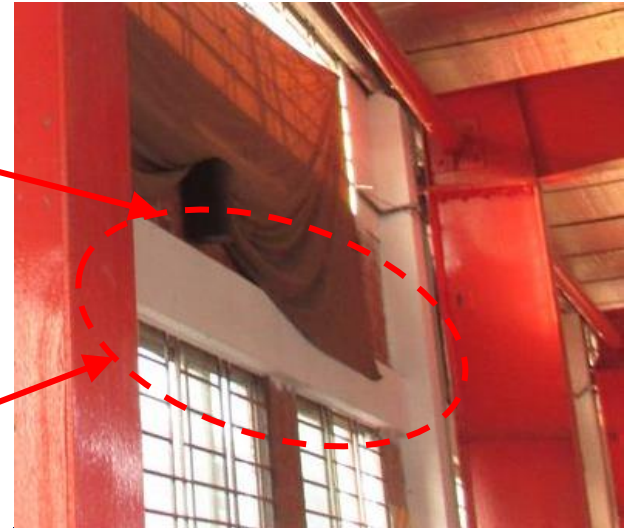
1st floor tie beam layout plan does not match with the on site condition.

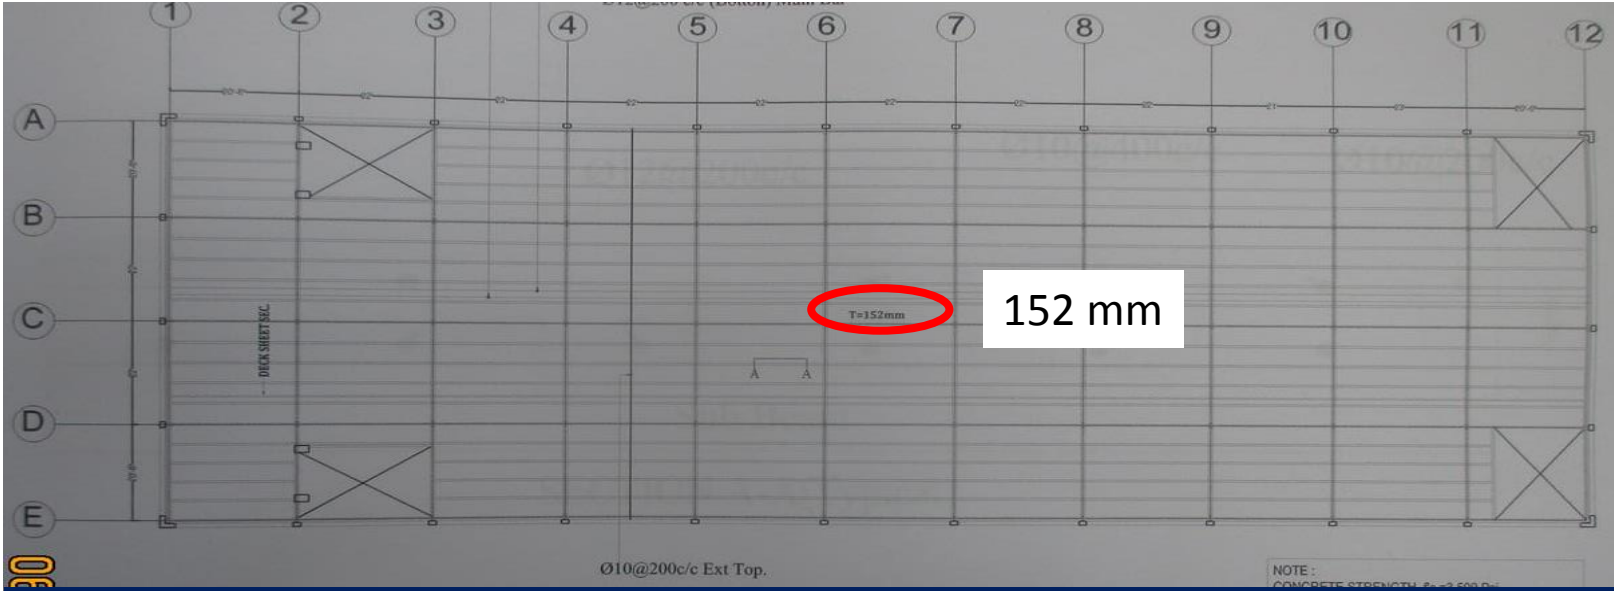
1st floor slab layout

Slab thickness was found 125mm in 1st floor level where 152 mm was shown on provided drawings.

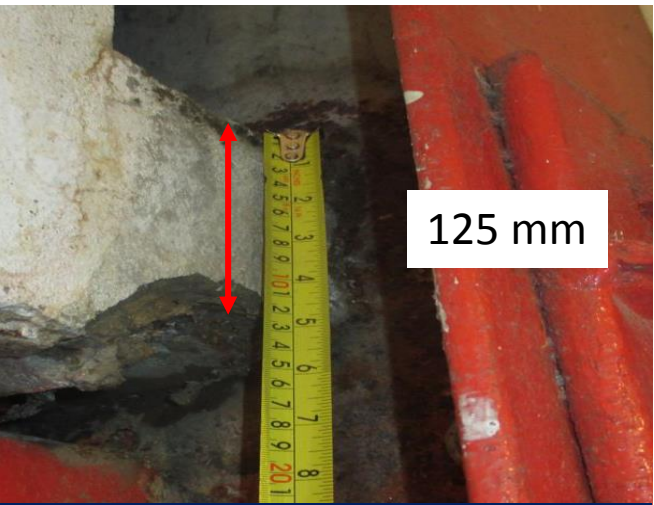
Slab thickness was found 125mm

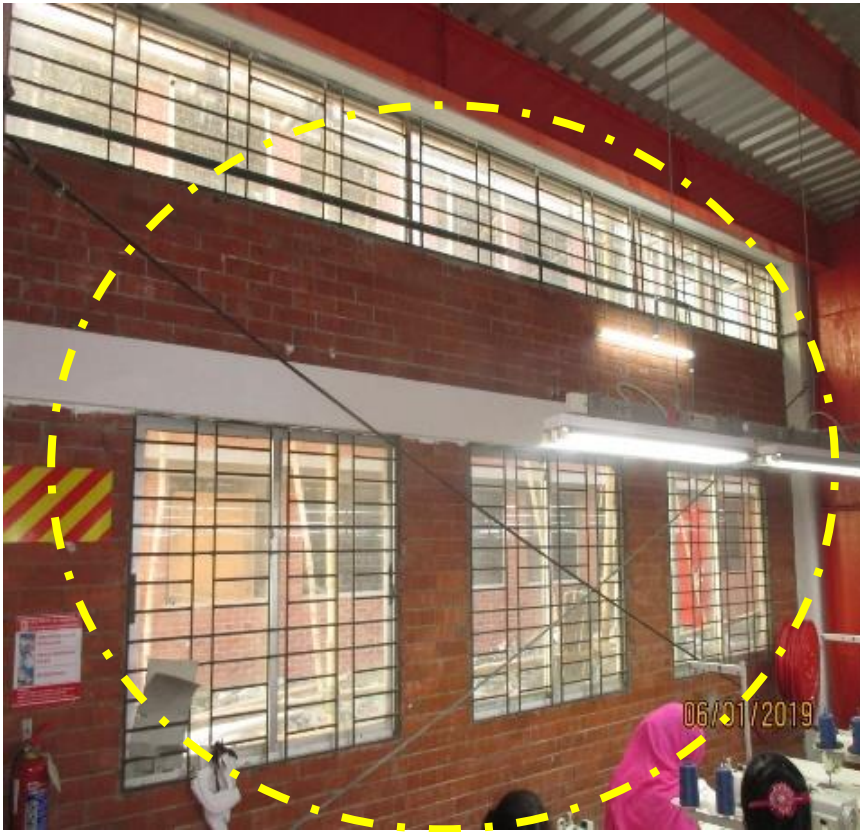
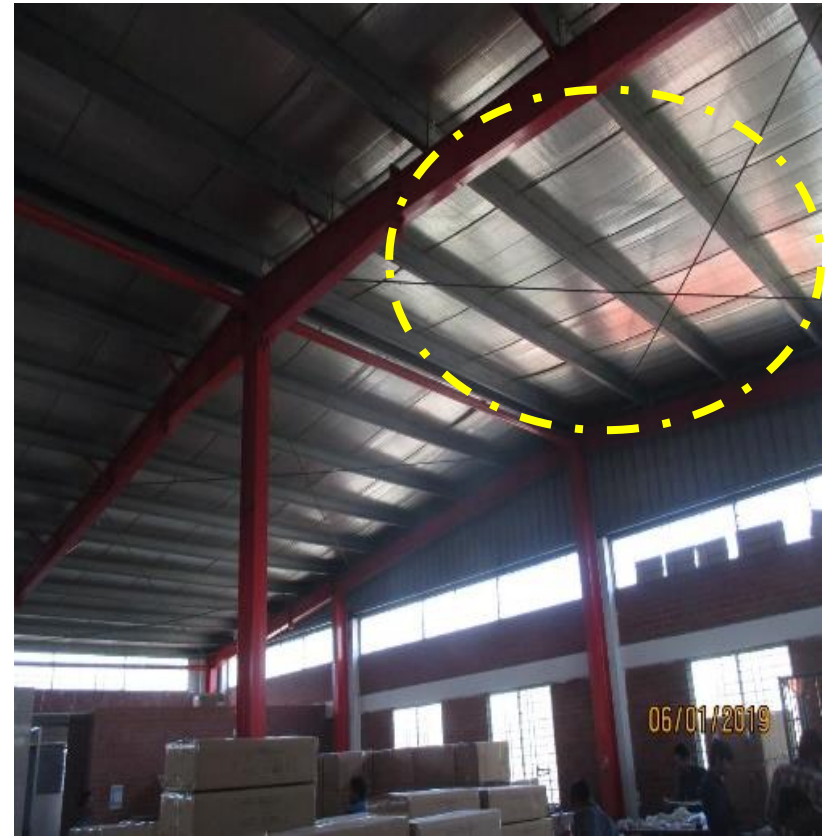
Loose bracing

But horizontal & vertical bracing was found loose on site.

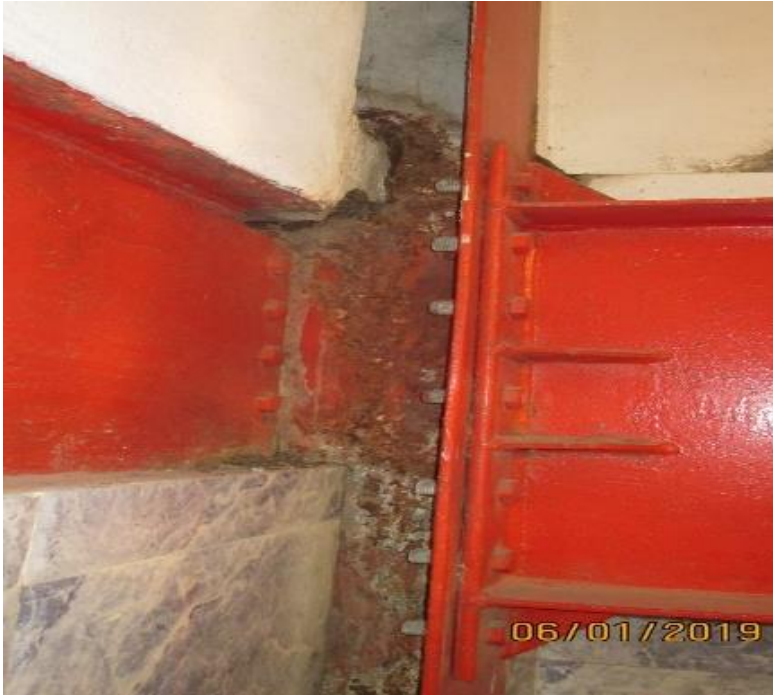
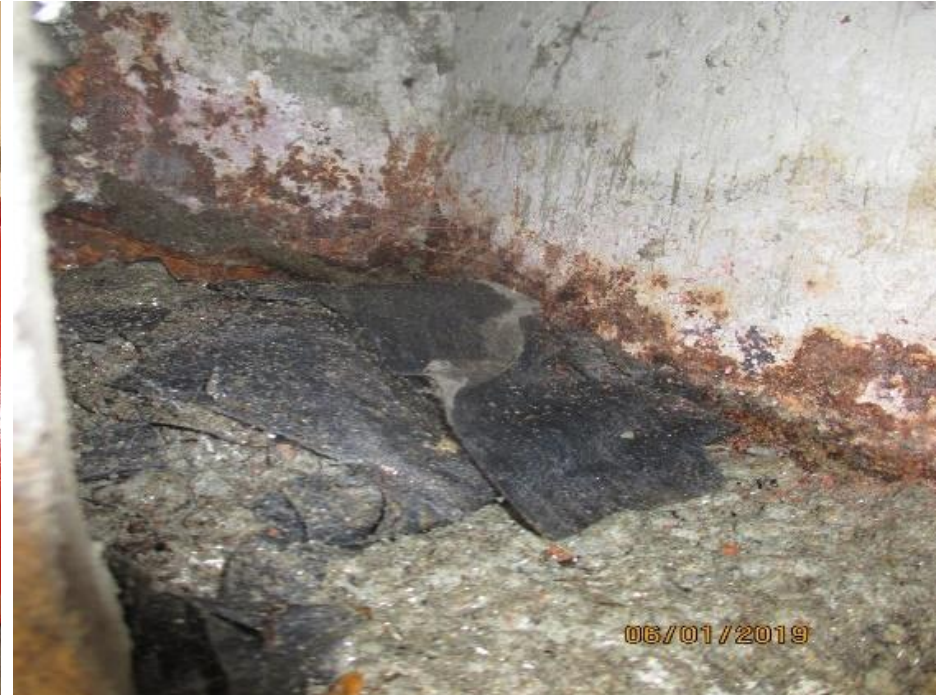
Corrosion in steel members at stair zone.

Corrosion in steel members was observed at stair zone. The extent of corrosion to be investigated by a qualified structural engineer.

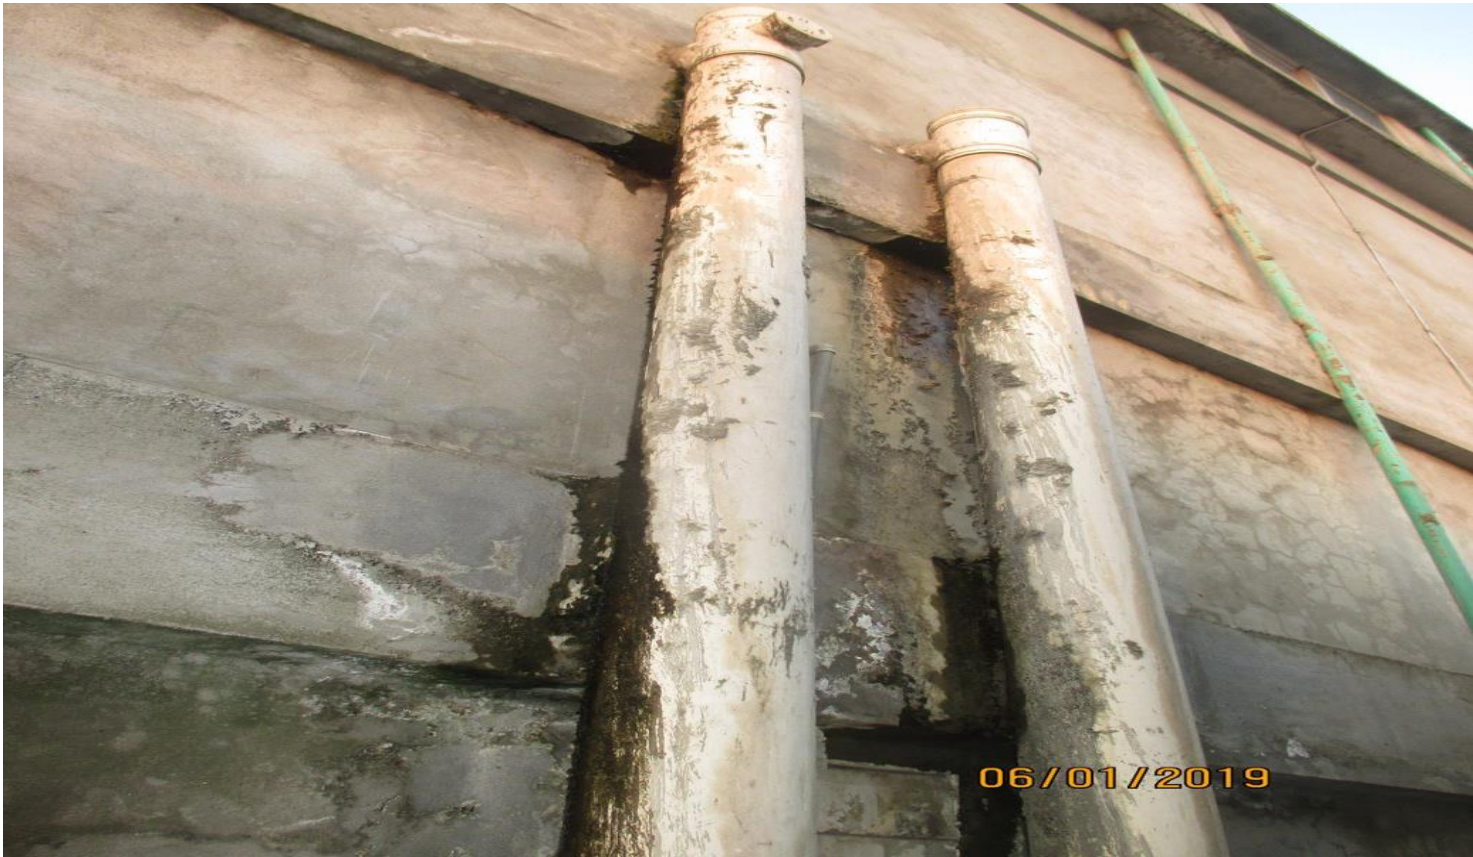
Water intrusion in exterior façade from sanitary pipe.

Water intrusion was observed in exterior façade due to leakage of sanitary pipes. Factory engineer to investigate location of leakage and suggest proper remedial actions.
