# Sublime Greentex Ltd. Executive Intimates Ltd.

Gilarchala, Sreepur, Gazipur  
(24.194254, 90.425146)  
25<sup>th</sup> February 2018

# Observations

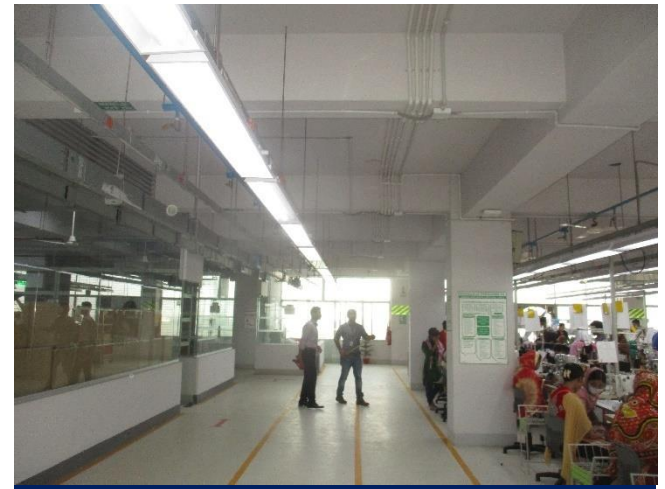
Long span

Cursory calculations indicate that the working stress of the columns at Ground Floor level are above normal design limits.

| Item No. | Observation | Recommended Action Plan | Recommended Timeline |
|---|---|---|---|
| 1 | (Production Building)<br>Column to be stressed above normal design limits | Factory Engineer to review design, loads and columns stresses. | 6-weeks |
| 2 | (Production Building)<br>Column to be stressed above normal design limits | Verify in-situ concrete stresses by 100mm dia. cores from min. 4 no. column from ground floor level. | 6-weeks |

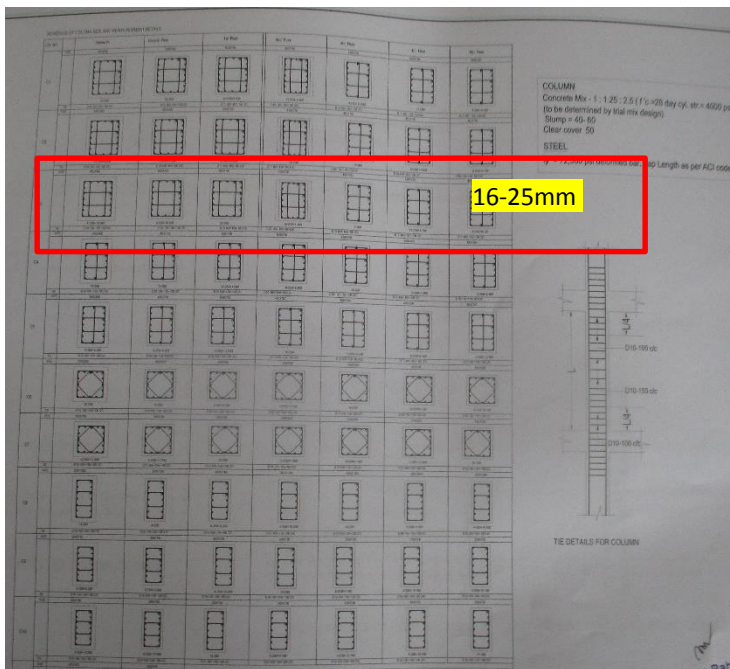
Observed by ferro scan at 3rd Floor

Reinforcement detected by Ferro Scanning internal and external columns in Production Building appears to be different than shown in the structural drawings.

Building engineer to verify number and diameter of rebars at least at two sides by removing plaster and concrete cover of typical columns.

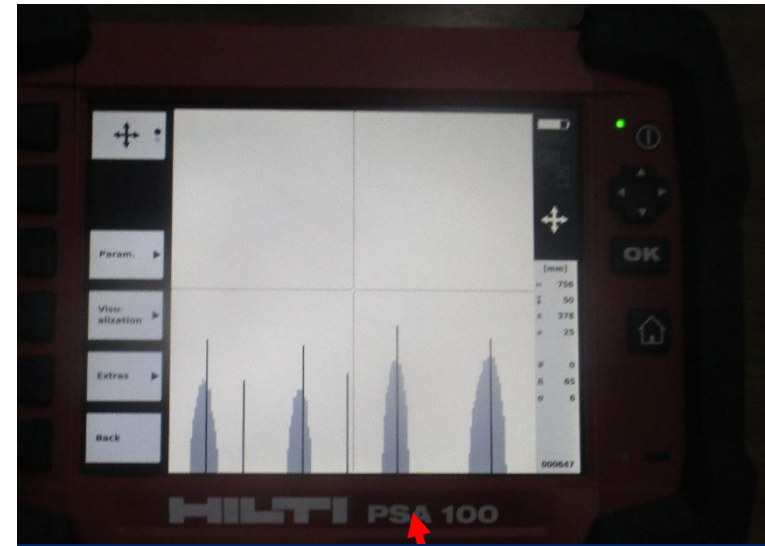
14 rebars (6 rebars on long face)

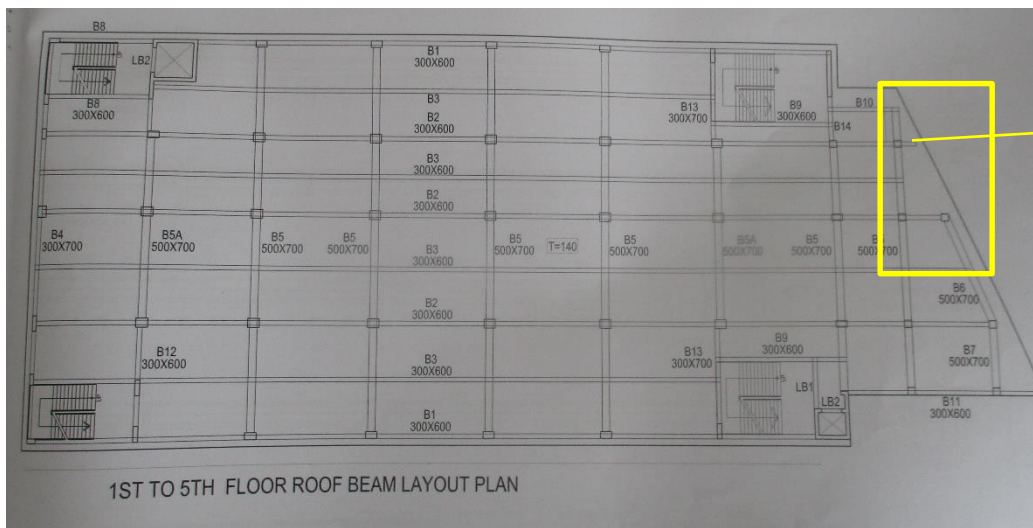
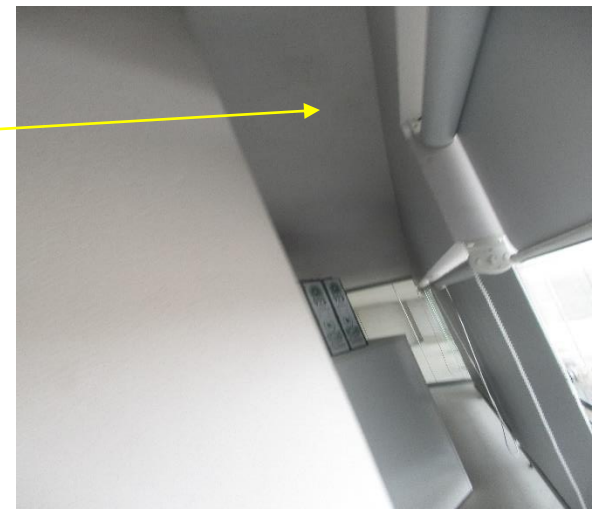
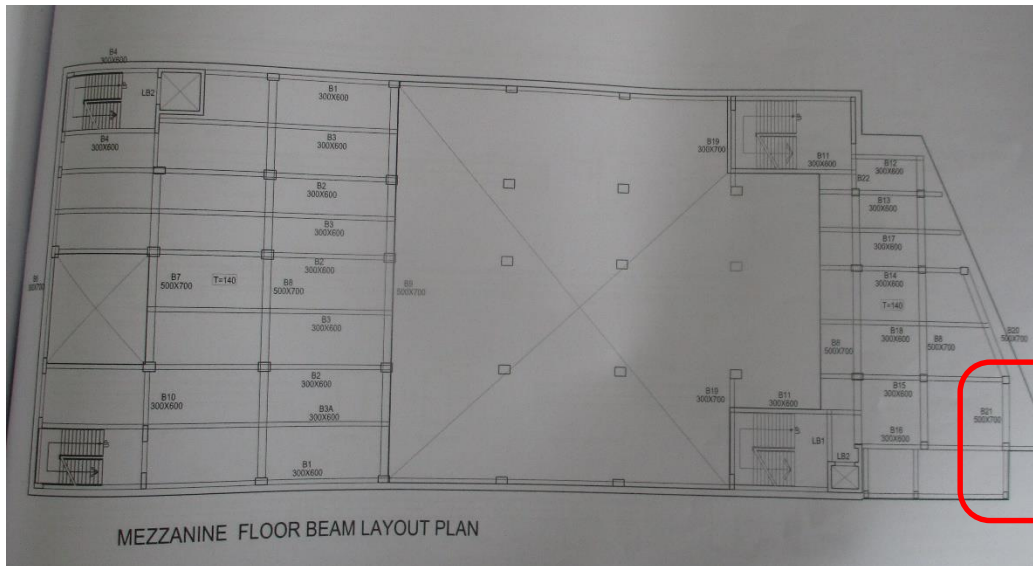
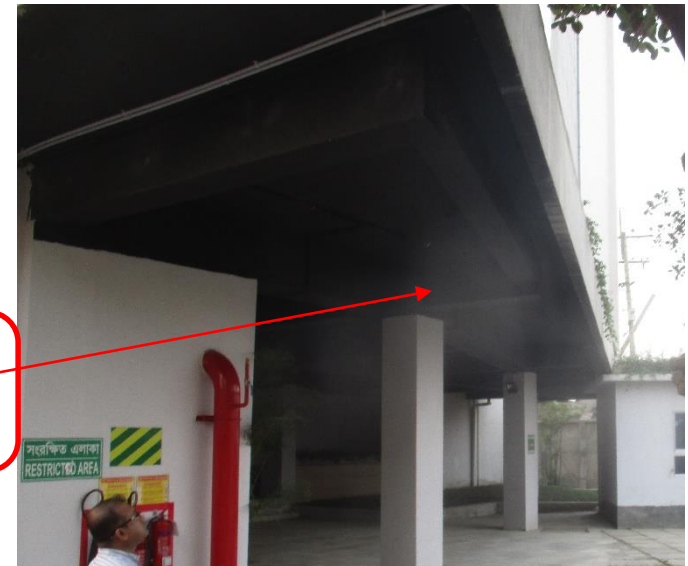
Beam layout does not match with as built condition. Cantilever beams at front are not shown properly on drawings.

| Item No. | Observation | Recommended Action Plan | Recommended Timeline |
|---|---|---|---|
| 6 | (Production Building)<br>Discrepancies between provided drawings and on site condition. | Building Engineer to survey as-built structure and prepare accurate as-built survey information for the building. | 6-weeks |

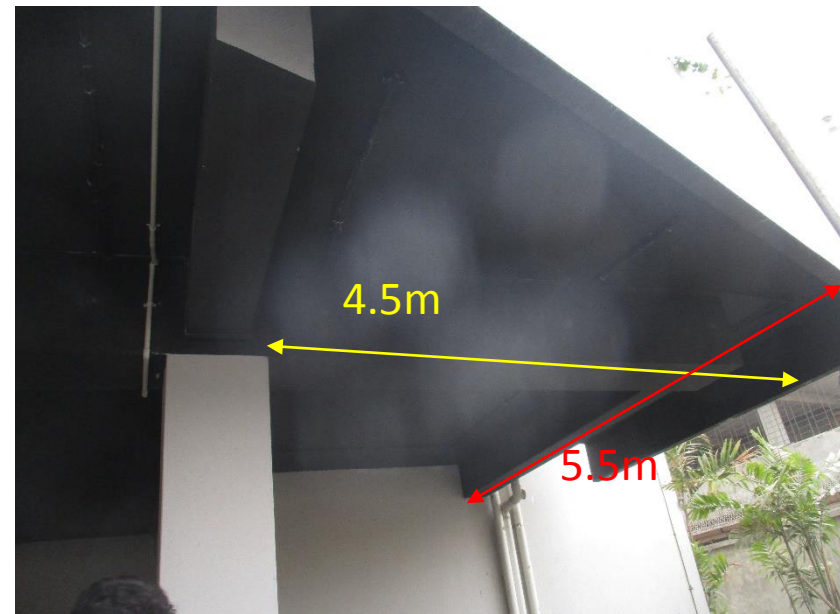
Cantilever at East

Large cantilever beam was observed at the front side of the building. Building Engineer to check structural adequacy of the cantilever and propose any remedial actions if required.

| Item No. | Observation | Recommended Action Plan | Recommended Timeline |
|---|---|---|---|
| 7 | (Production Building)<br>Large floor cantilever at East | Building Engineer to confirm that the cantilever slabs have been designed to take the floor and façade loads applied. | 6-weeks |
| 8 | (Production Building)<br>Large floor cantilever at East | Remedial works to be carried out if required. | 6-months |

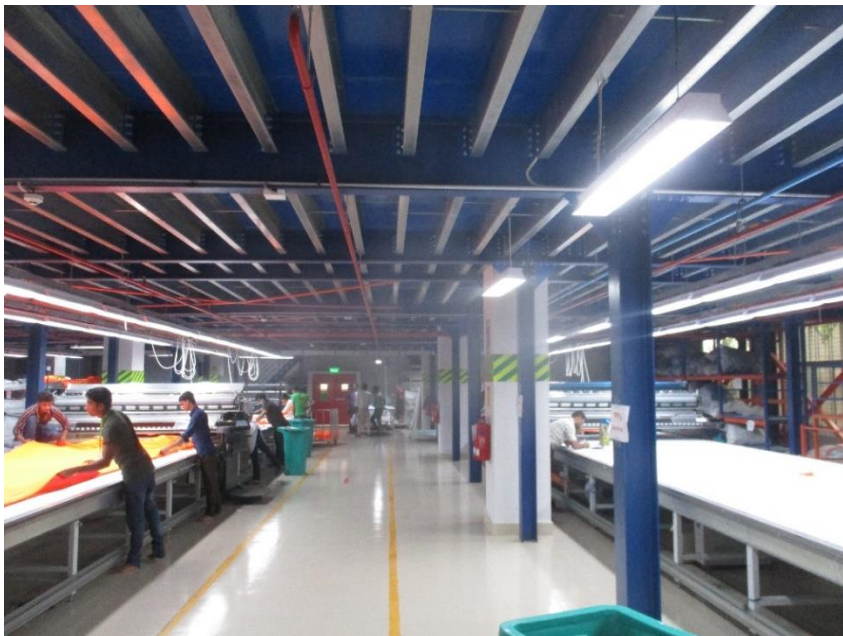
No drawing was available for the steel mezzanine portion at Ground floor. Factory is required to produce as-built drawing reflecting on-site condition. Also, check the adequacy of the steel member and foundation details of the steel structure.

| Item No. | Observation | Recommended Action Plan | Recommended Timeline |
|---|---|---|---|
| 9 | (Production Building)<br>Lack of documents for steel works | Building Engineer to survey as-built structure and prepare accurate as-built survey information for steel part. | 6-weeks |

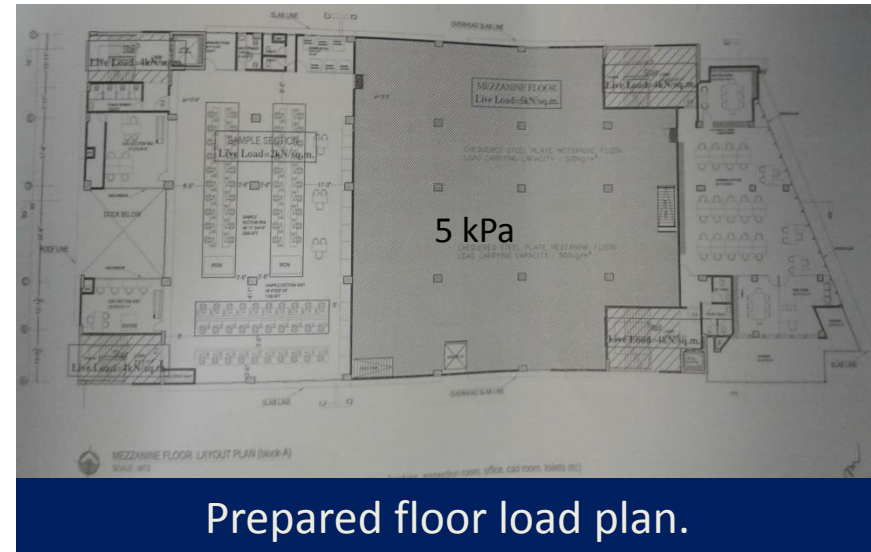
Factory engineer has prepared a load plan considering 5kpa allowable floor loading on steel mezzanine floor. Design report is required if the factory management intends to implement the prepared load plan.

| Item No. | Observation | Recommended Action Plan | Recommended Timeline |
|---|---|---|---|
| 10 | (Production Building)<br>Lack of documents for steel works | Factory Engineer to review design and columns stresses based on the prepared load plan. | 6-weeks |

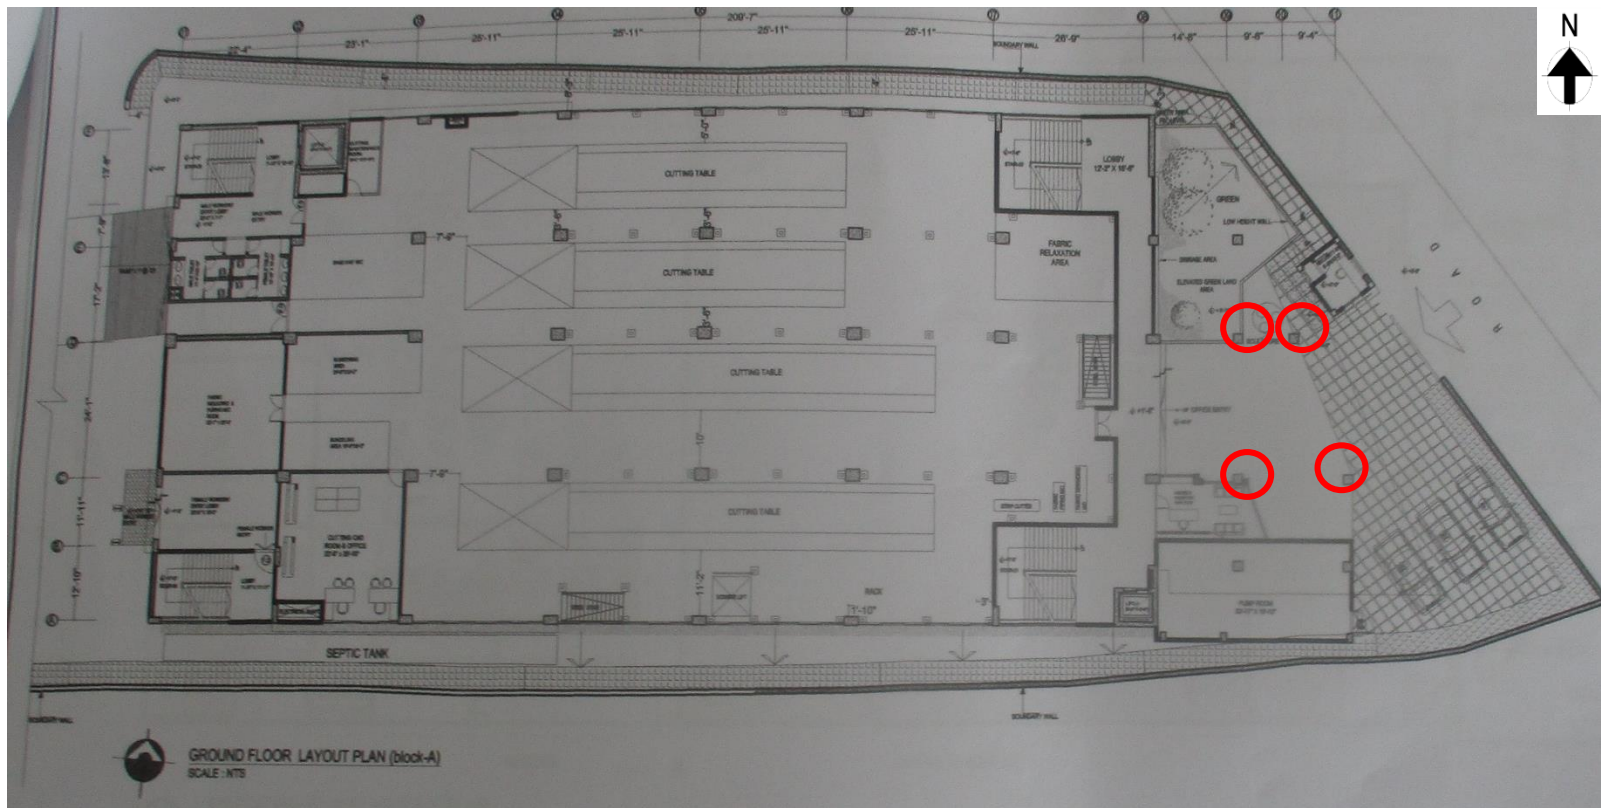
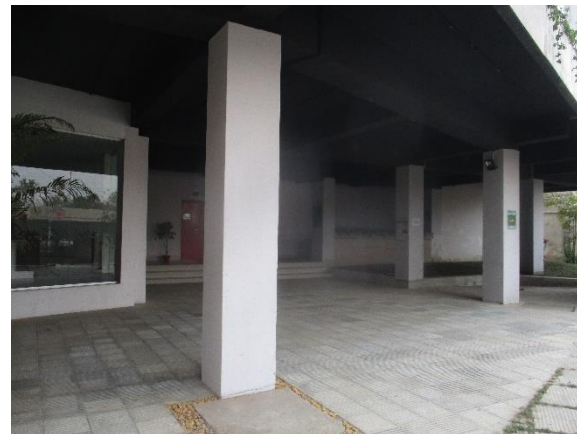
Impact protections are not provided to the columns at front parking area. Columns are susceptible to impact loading from vehicles.

| Item No. | Observation | Recommended Action Plan | Recommended Timeline |
|---|---|---|---|
| 12 | (Production Building)<br>Columns susceptible to vehicle impact | Install a barrier to prevent vehicle impact in columns. | 6-weeks |

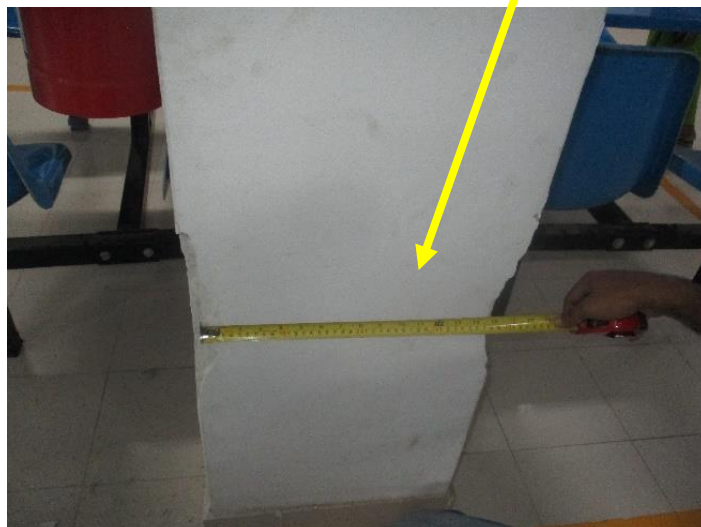
375 mm instead of 450 mm

C-3 type column section was found (375 X 375 mm) instead of (450mmX450mm) along grid B & D. Building engineer to verify sizes of each column and prepare accurate as-built drawings.

| Item No. | Observation | Recommended Action Plan | Recommended Timeline |
|---|---|---|---|
| 13 | (Service Building)<br>Discrepancies between provided drawings and on site condition | Building Engineer to survey as-built structure and prepare accurate as-built survey information for the building. | 6-weeks |

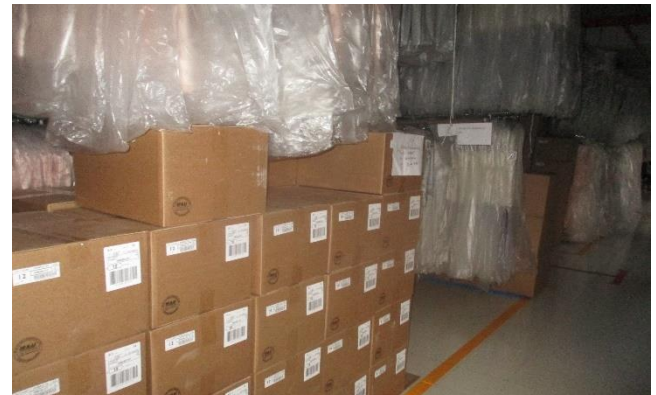
Loading on 1<sup>st</sup> floor (Store)

During inspection no over loading was observed on floor. Factor of safety calculation for internal column was found satisfactory considering 3 kpa allowable floor live loading for existing structure.

Factory engineer has prepared a load plan considering 4kpa allowable floor loading for 1<sup>st</sup> floor. Design report is required to review if the factory management intends to implement the prepared floor load plan (above 3 kPa).

Factory is required to maintain the floor live load below 3 kpa until prepared load plan reviewed by design engineer.

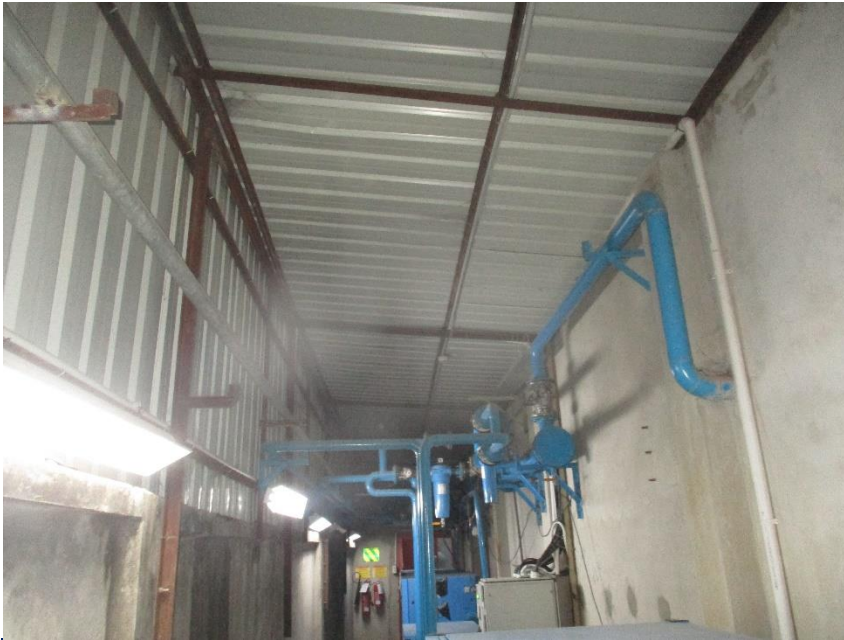
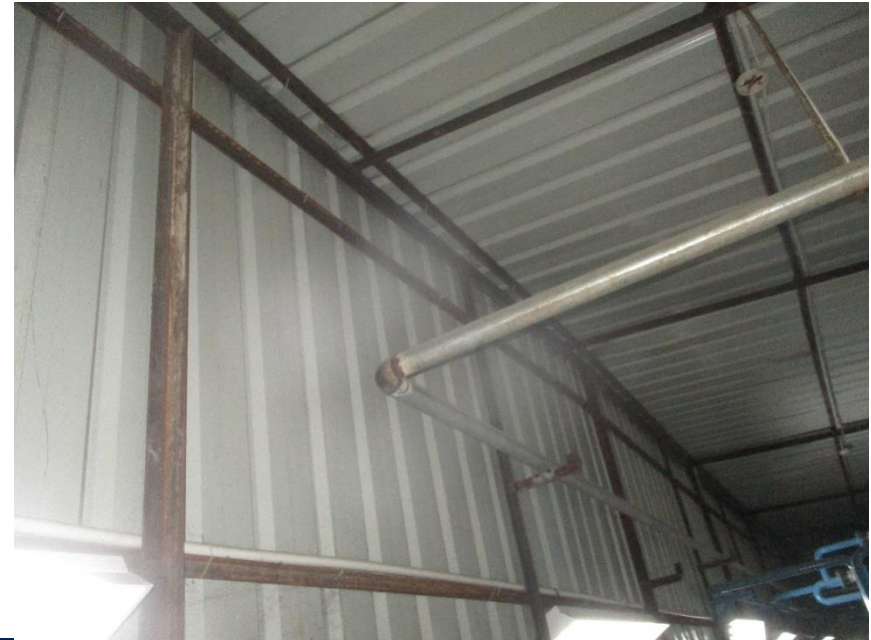
Compressor Shed

Structural drawings were not available for the compressor shed during visit.

| Item No. | Observation | Recommended Action Plan | Recommended Timeline |
|---|---|---|---|
| 17 | (Compressor Shed)<br>Lack of documents for compressor shed | Prepare an “as constructed” drawings which reflect the actual site dimensions with complete structural information. | 6-weeks |
