## **INITIAL ELECTRICAL ASSESSMENT REPORT (EAR)**

Factory Name: **Sun Fashion Wear Ltd.**  
Address: **Allai Ward No: 01 Patiya Chittagong Bangladesh**  
Assessor: **Uttaron Technologies**  
Date: **24 Apr 2018**

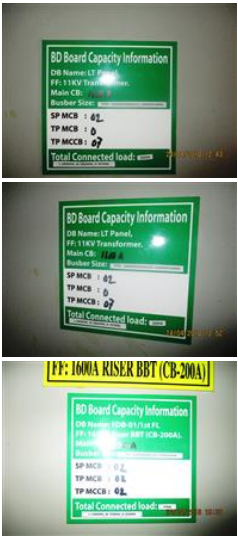
| Description: | Capacity information labels are present in all assessed switchboards and/or distribution boards, but there is no information about the number of spare circuit breakers contained inside. | |
| Source of Findings: | Photograph: Spare circuit breaker number has not been included in the capacity information labels. | |

| Suggested Plan of Action: | Update the capacity information labels with proper number of installed and spare circuit breakers. | |
