Apparel Today Ltd. New

Gohailbari, 1 No. Shimulia Union, P.S: Ashulia, Upazila: Savar, Dist.: Dhaka

23 September 2019

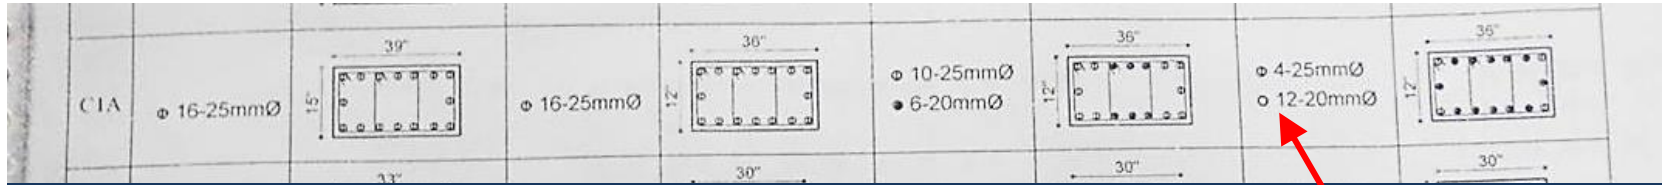
16 rebar shown in C1A Column

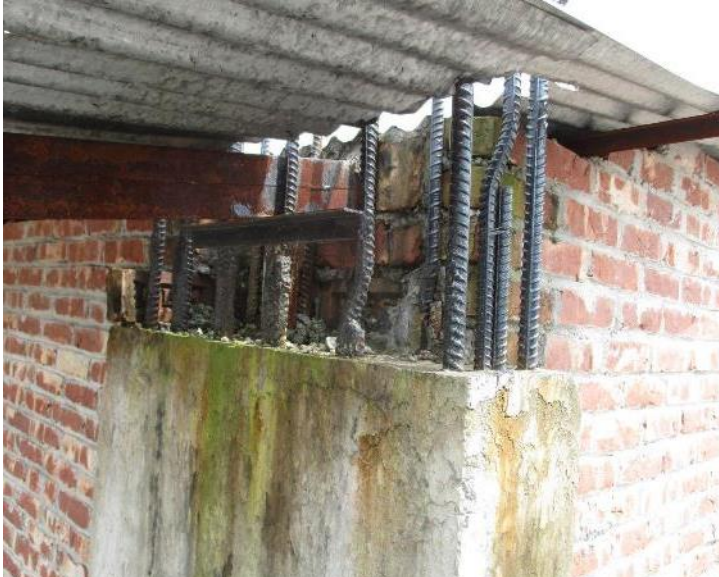
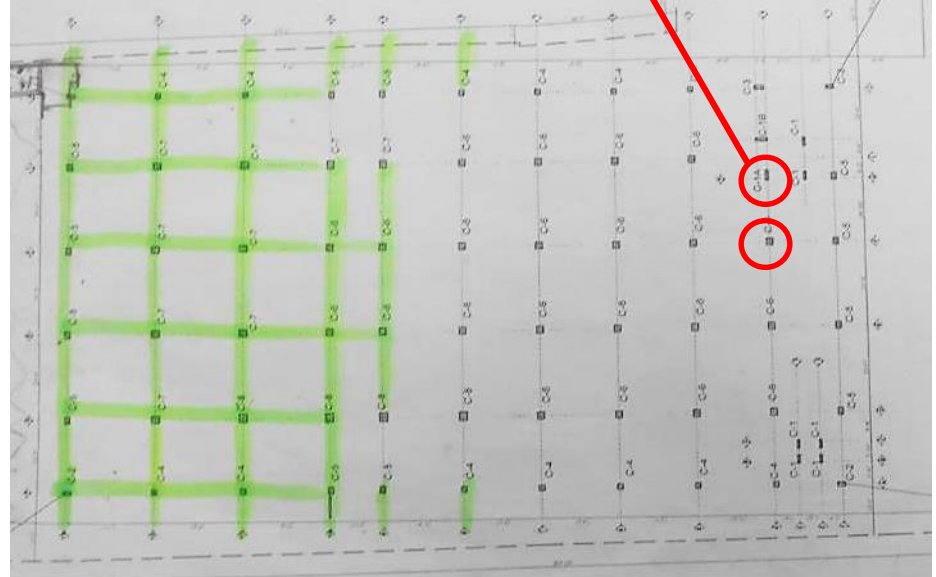
14 rebar observed in C1A column at grid G-4

14 number of rebar was found in C1A column at grid G-4 where 16 rebar has been shown in the structural drawings. Also, in C6 column at grid F-4 rebar diameter was measured 25mm for 5 rebars instead of 12 rebars.

Item No.	Observation	Recommended Action Plan	Recommended Timeline
1	Mismatch in the as-built documents (Main Building)	The factory engineer is required to update the as-built architectural and structural drawings.	6-weeks
2	Floor Load Management Program. (Main Building)	The factory engineer is required to produce floor loading plan for each floor considering floor & column capacity.	6-weeks
3	Floor Load Management Program. (Main Building)	Implement floor load management program.	6-weeks
4	Water ponding on roof. (Main Building)	Develop proper drainage system on roof with adequate slope.	6-months
5	Falling hazard. (Main Building)	The factory is required to install railing or parapet wall on the roof to prevent falling hazard.	6-weeks
6	Future extension of existing building. (Main Building)	Incase of any extensions or modifications of the existing building, Detail Engineering Assessment (DEA) needs to be carryout following BNBC provision.	6-months

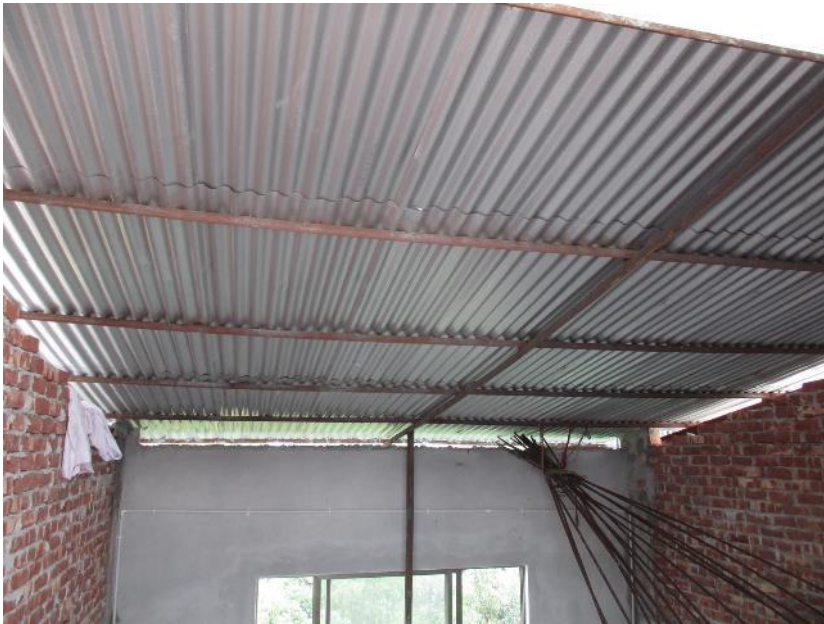
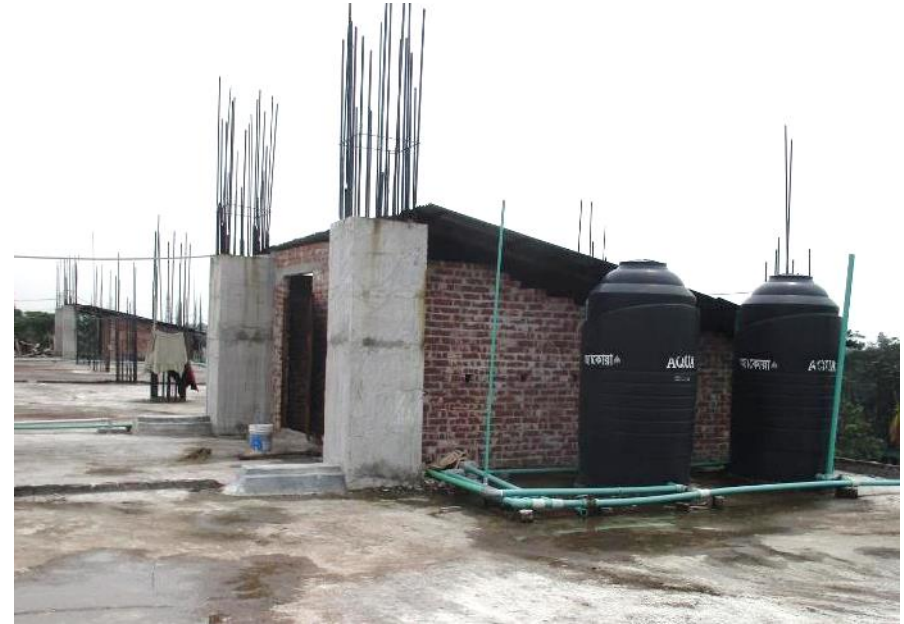
Temporary lightweight staircase roof and the plastic water tanks have not shown in the as-built drawings.

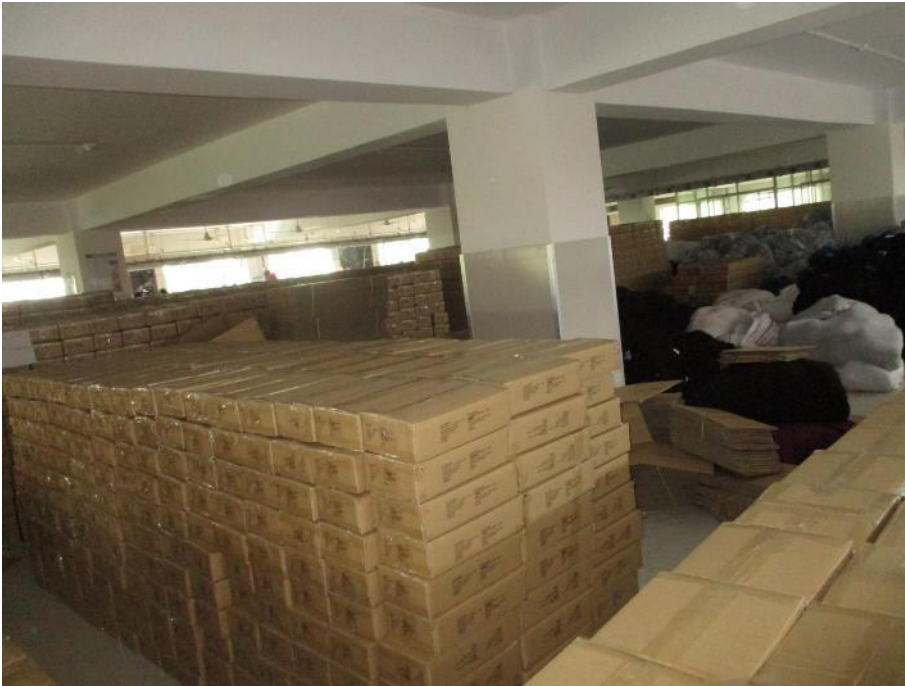
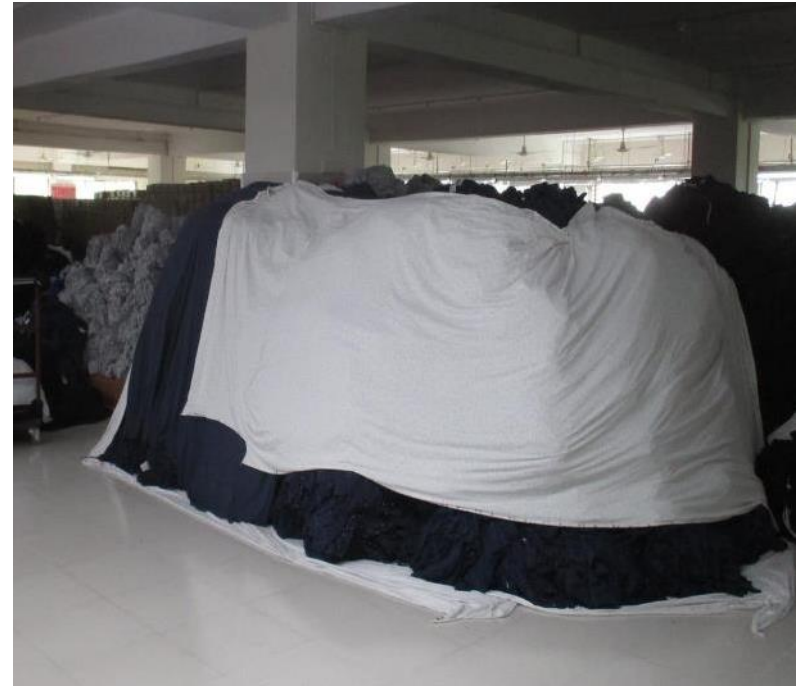
Load plan of the building not produced yet. Also, load management program not implemented. Produce and actively manage a loading plan for all floor plates within the factory considering the floor capacity and column capacity.

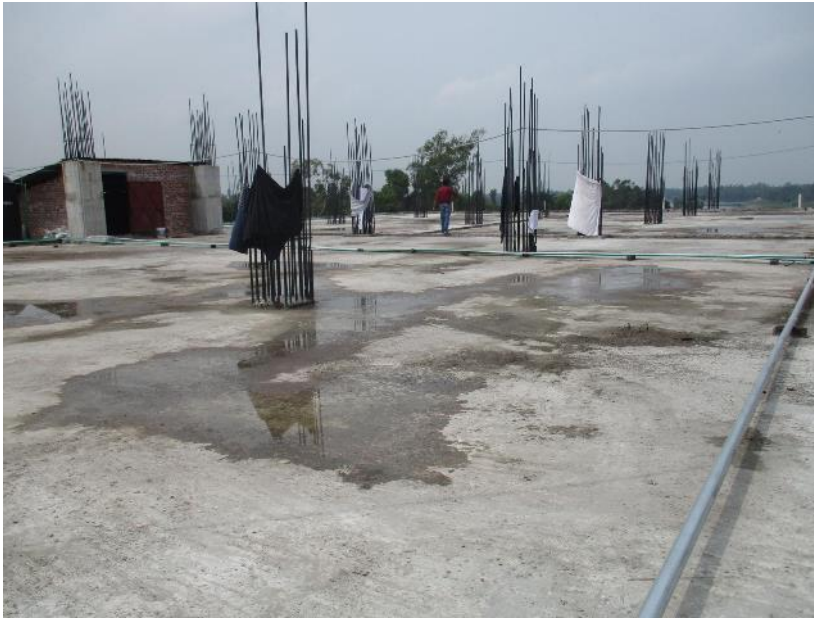
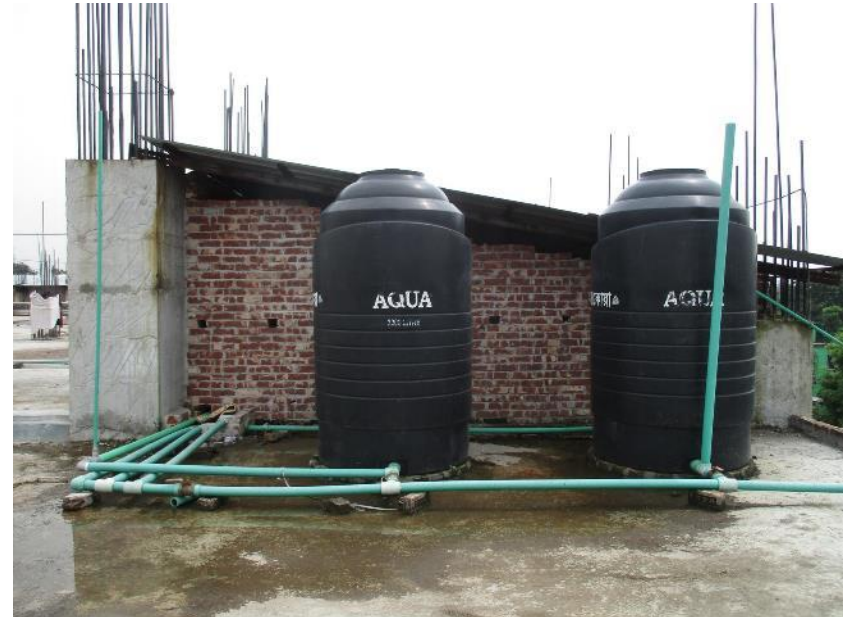
Water ponding was observed on the roof. Building engineer to develop proper drainage system with adequate slope on roof.

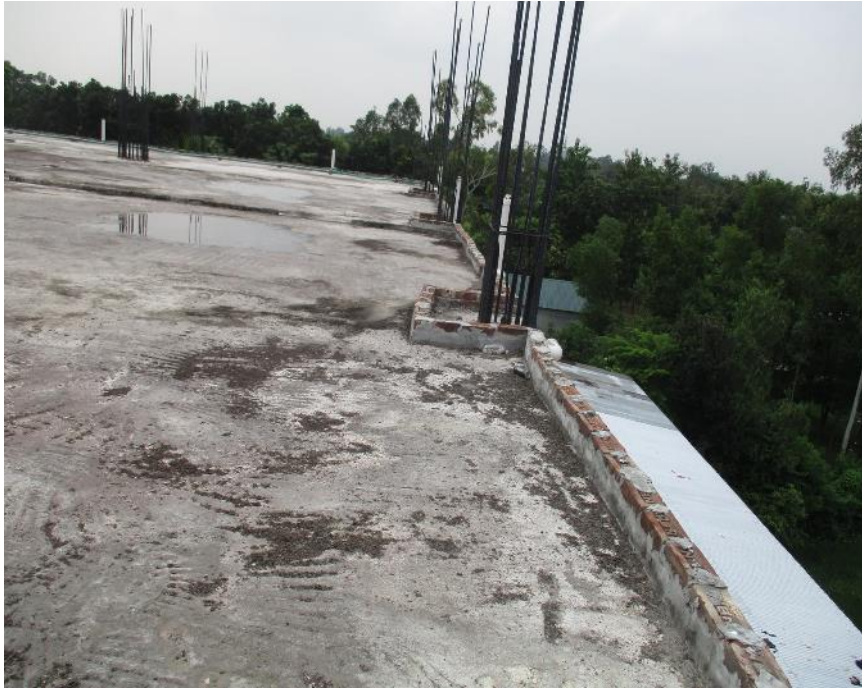
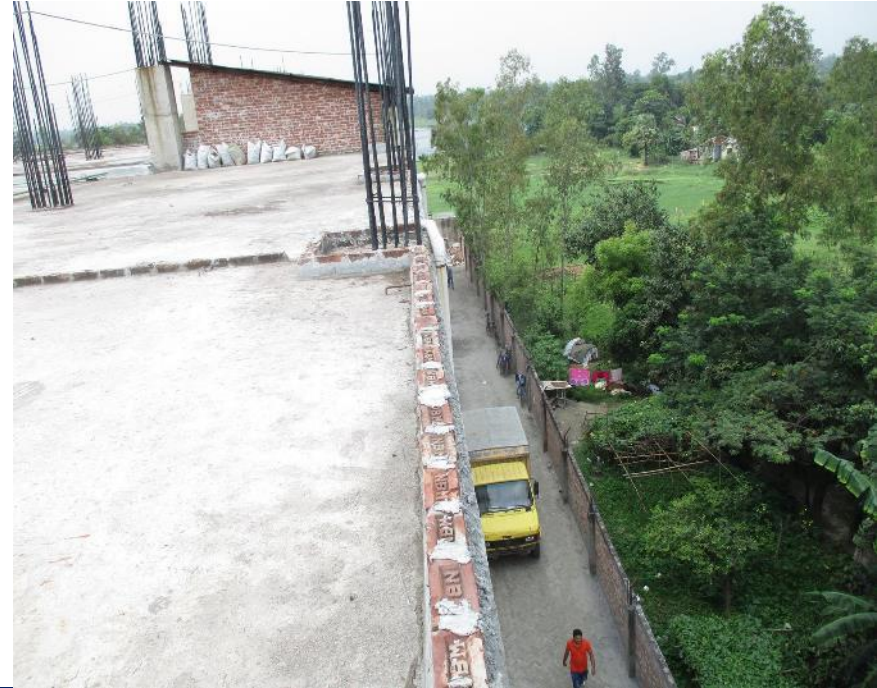
No safety guard or parapet was observed at roof. This area is prone to falling hazard.

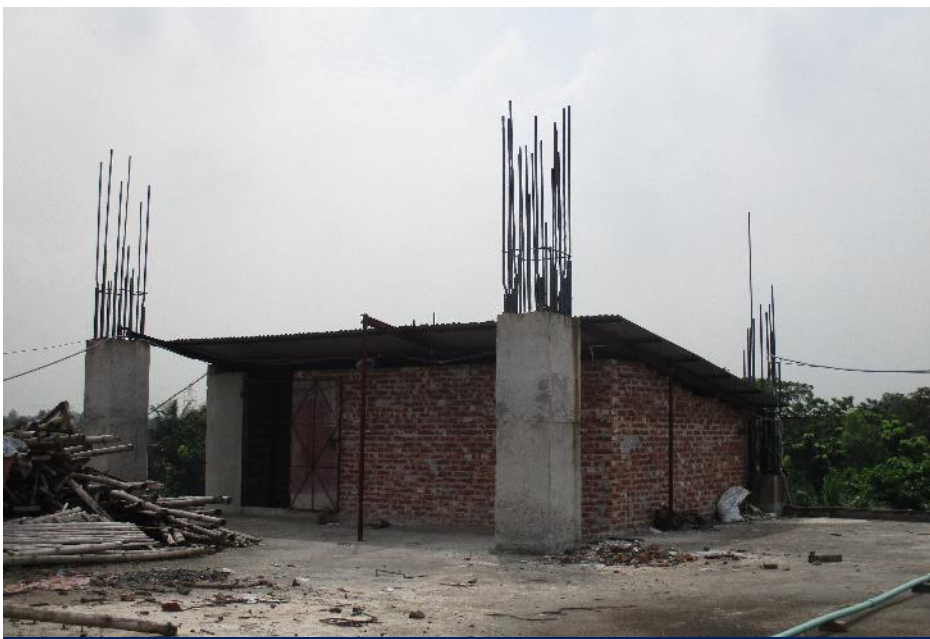
Factory has permit drawings for 6 Storey factory building. Factory has a plan to extend the building vertically up to 6-Storey. The column capacity has been checked for existing condition (3-Storey).

Exposed rebar indicates possibility of vertical extension in future.

For any vertical extension, columns may have higher stresses. A Detail Engineering Assessment (DEA) considering BNBC provision to be completed prior commencement of further construction.

7	Future extension of existing building. (Main Building)	Carry out remedial works from outcome of Detail Engineering Assessment where necessary before commencement of further construction.	6-months

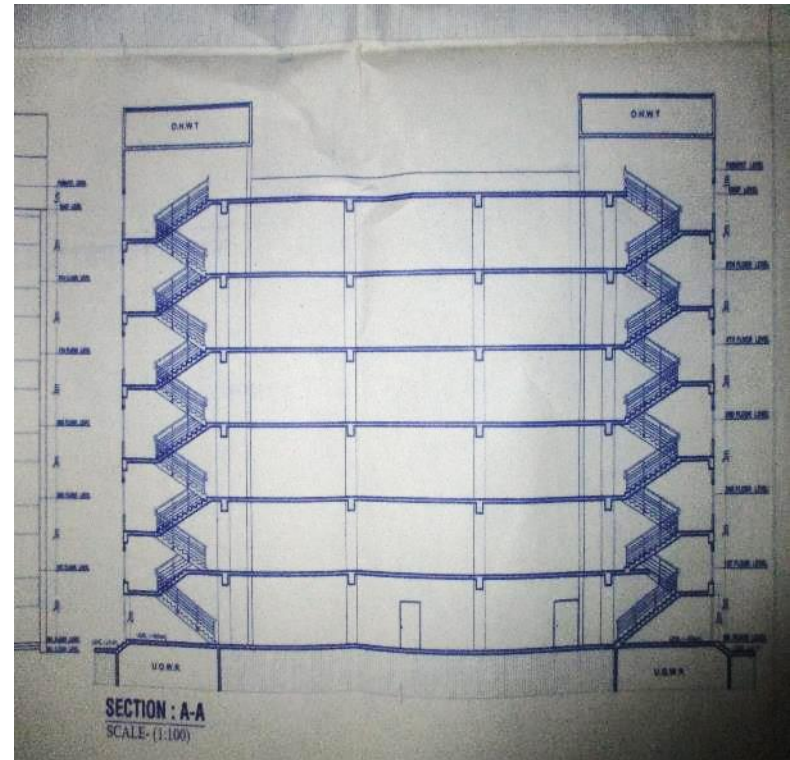
Permit drawing from local authority for 6 Storey factory building.

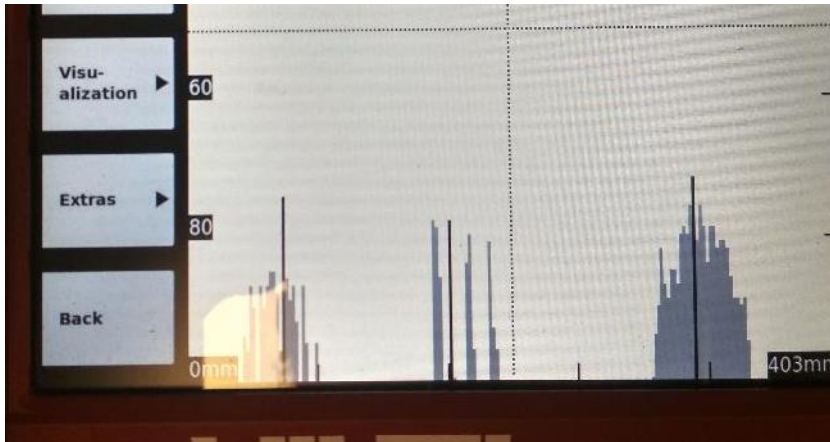
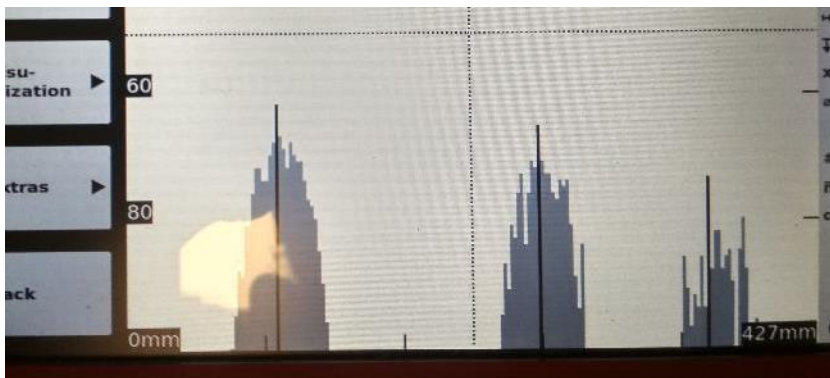
8 rebar was found by ferro-scanning

10 rebar has been shown in the drawing for C2 column at roof level.

8 rebar was found by ferro-scanning where 10 rebar has been shown in the drawing

Item No.	Observation	Recommended Action Plan	Recommended Timeline
8	Discrepancy in the as-built documents. (Utility Building)	Building engineer is required to survey the structure and update the as-built drawings as required.	6-weeks
9	Lack of structural detailing of steel stair. (Utility Building)	The factory engineer is required to check the connections and suggest the proper remedial actions.	6-weeks
10	Lack of structural detailing of steel stair. (Utility Building)	Implement remedial actions suggested by the factory engineer.	6-months
11	As-built documents (Boiler Room)	The factory engineer is required to produce as-built architectural and structural drawings.	6-weeks
12	Lateral stability of steel shed. (Dining and wastage shed)	The factory engineer is required to carry out Engineering Assessment to check the stability of the structure against lateral forces following BNBC.	6-weeks
13	Lateral stability of steel shed. (Dining and wastage shed)	Implement the recommendations of engineering assessment report.	6-months

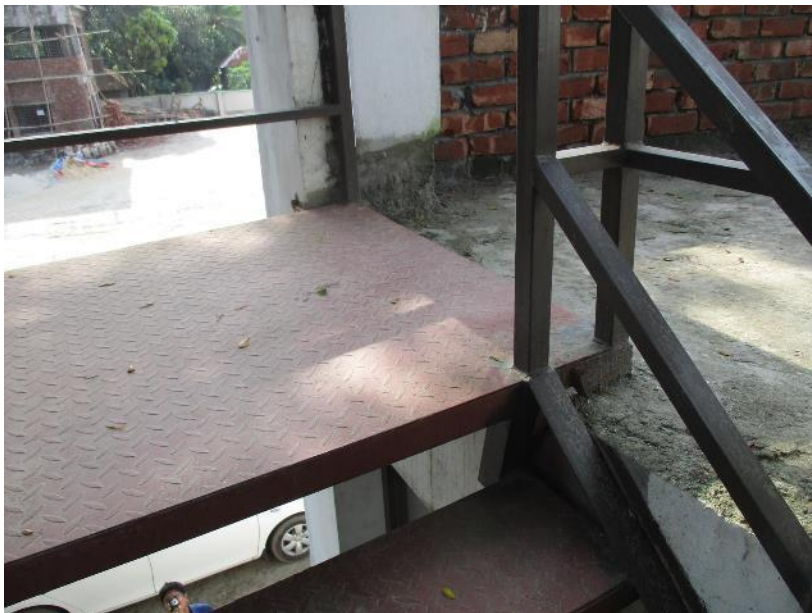
Connection between steel stair and Utility Building

Undocumented steel stair adjacent to utility building was observed on site. Structural details of stair was not available on drawings.

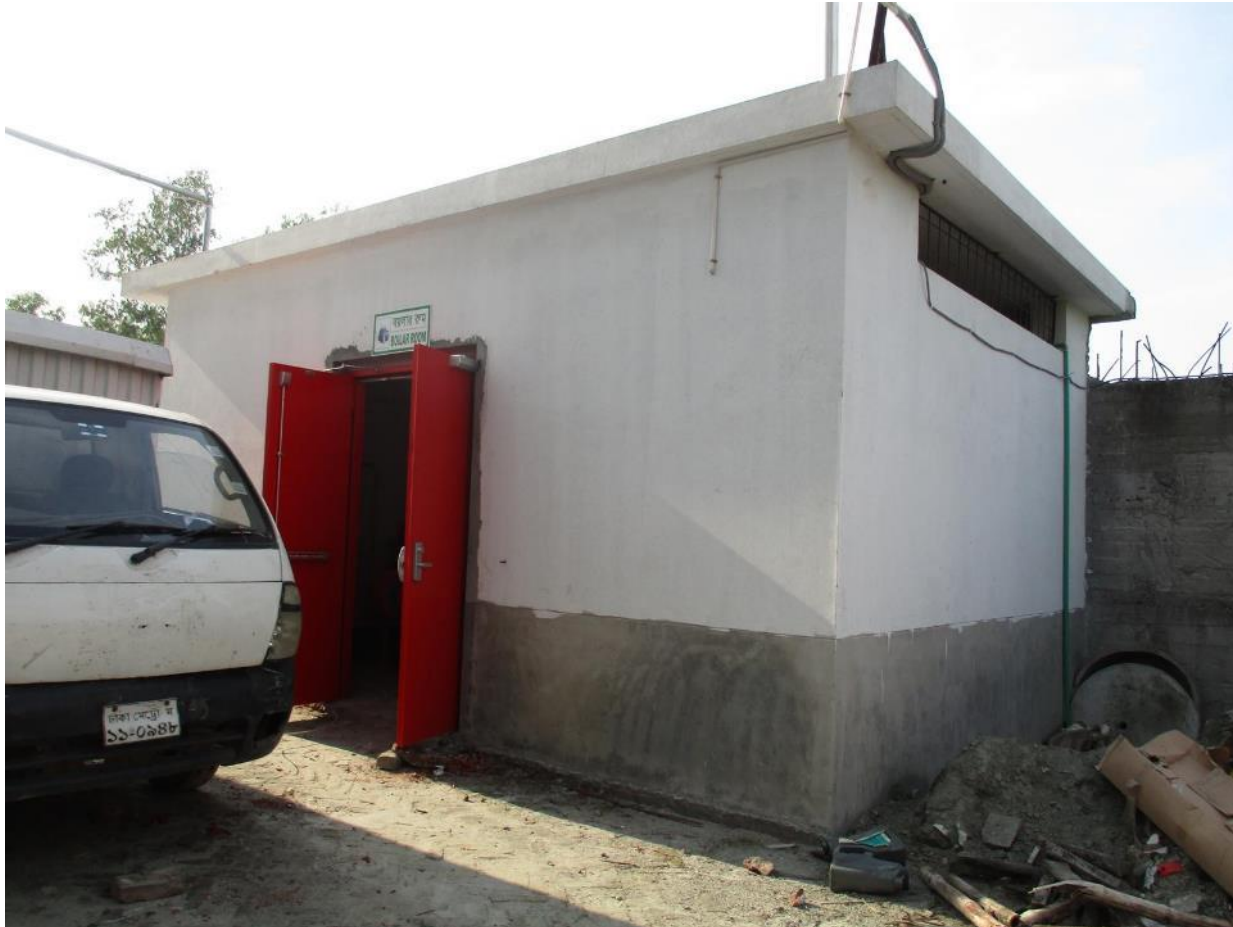
As-built documents wasn't available for the Boiler room. The factory is required to produce full set of as-built drawing for the structure.

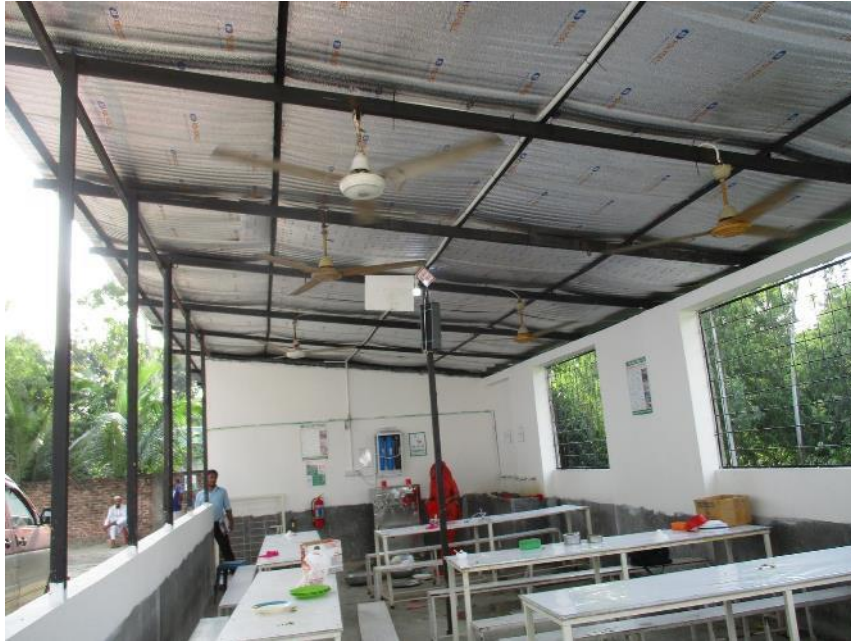
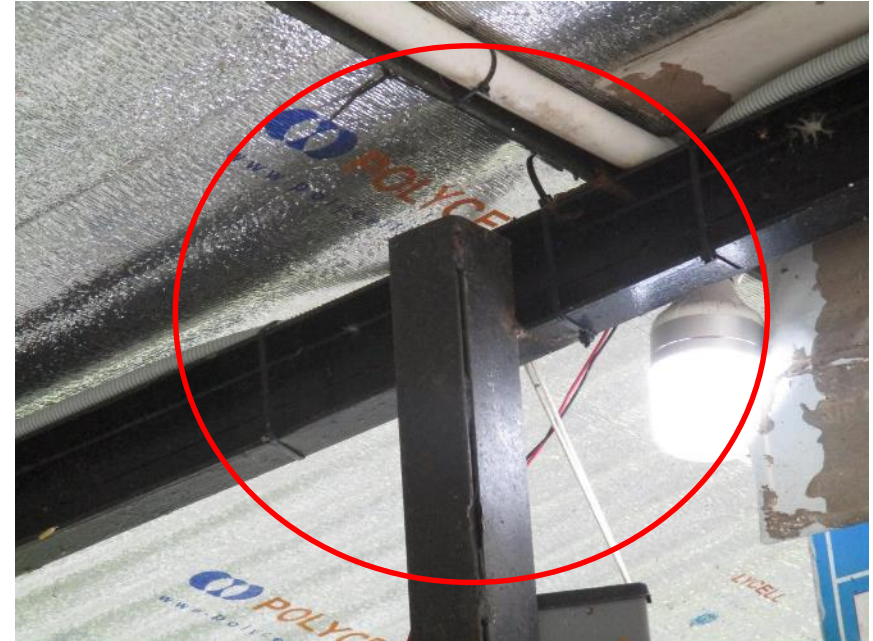
The connections of the shed appear to be non-engineered. The factory is required to check the connections adequacy for uplift forces and lateral stability of the structures for wind loading.
