# Croydon-Kowloon Designs Ltd

Plot# 285-288, Dhaka EPZ (Extension Area), Ganakbari, Ashulia, Savar, Dhaka  
(23.946883N, 90.274114E)

8<sup>th</sup> July 2019

# Observation

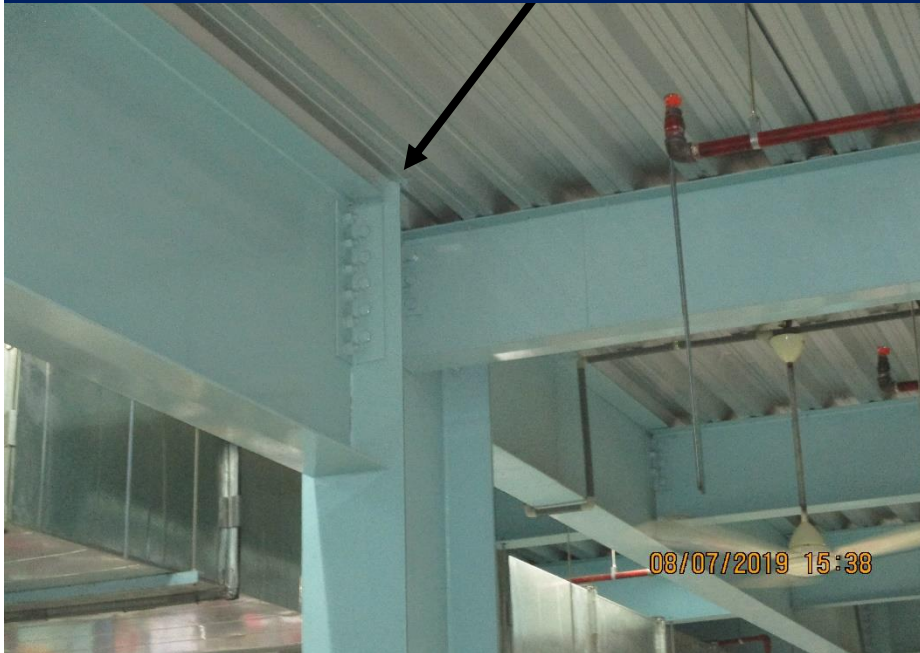
Partially fixed in N-S/ Short Direction

| Item No. | Observation | Recommended Action Plan | Recommended Timeline |
|---|---|---|---|
| 1 | Overall stability of the building (Factory Building) | Factory engineer is required to check stability of the existing structure taking into consideration the adequacy of the connections. | 6-weeks |

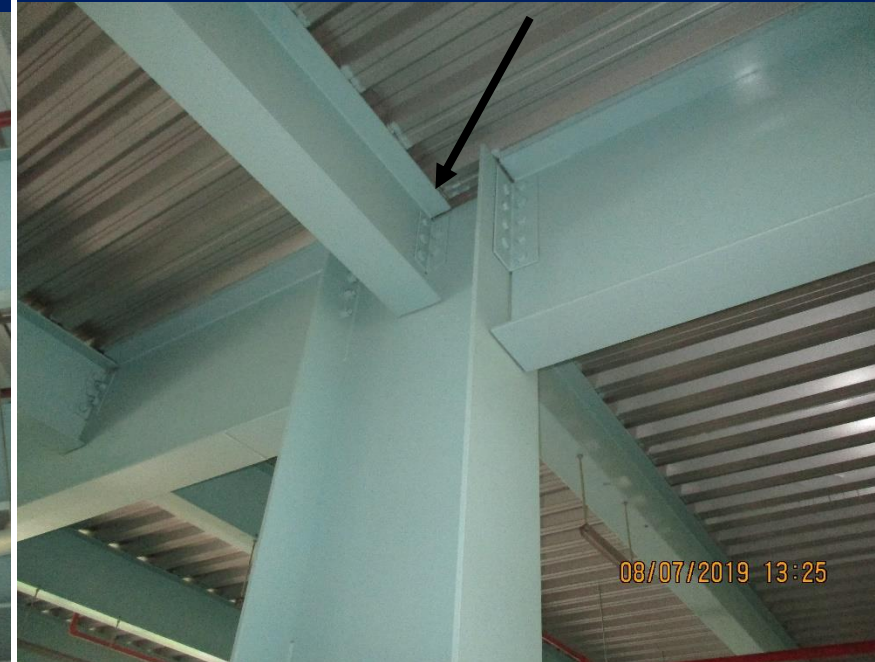
Pin/hinge Connection in E-W/ Long Direction

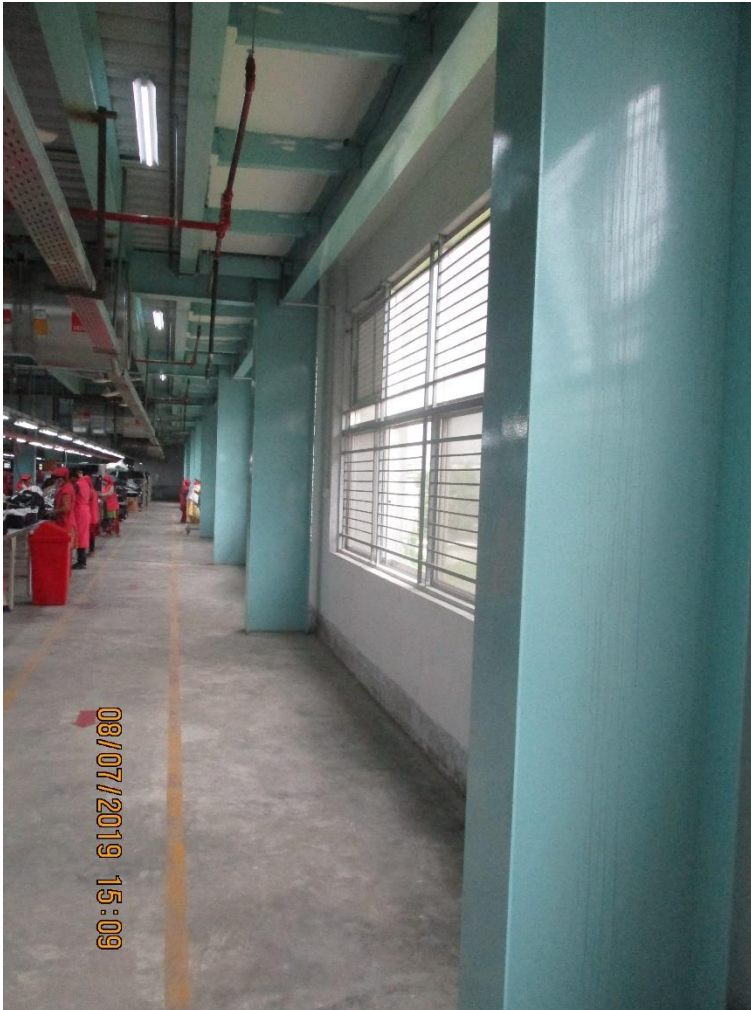
Pin/partially fixed Connection at beams and column joint connected by shear cleat and bolts. Apparently partial moment resisting frame action may govern that may affect the stability.

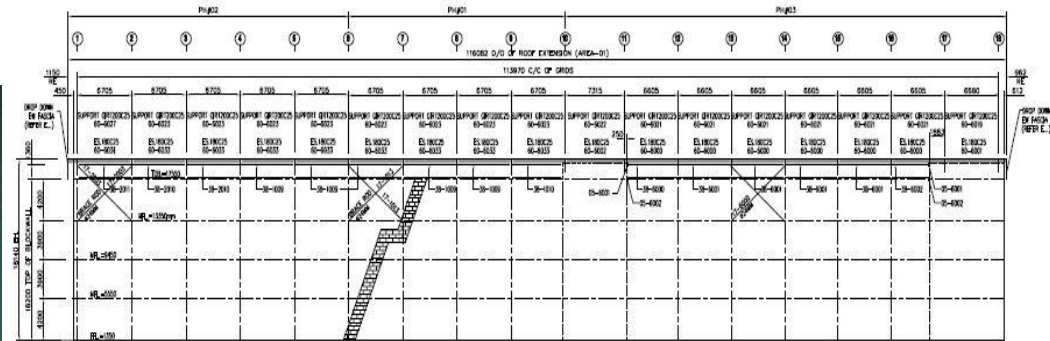
NEAR SIDE WALL FRAMING ELEVATION (GRID LINE A)

No vertical bracing/lateral load resting system in any long direction.

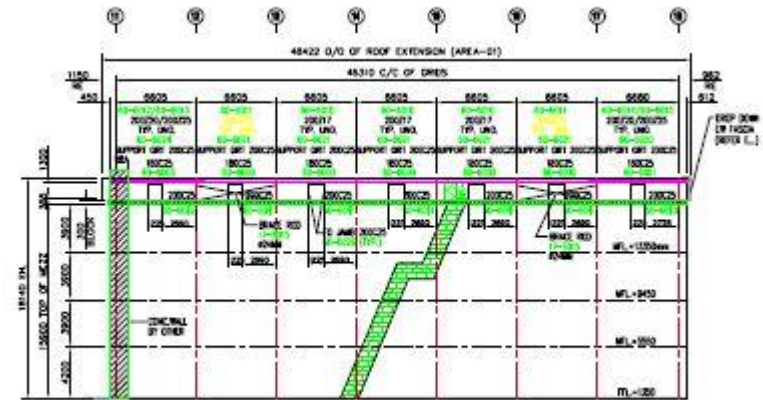
NEAR SIDE WALL FRAMING ELEVATION (GRID LINE F)

Vertical bracing only in 3<sup>rd</sup> floor of portal frame.

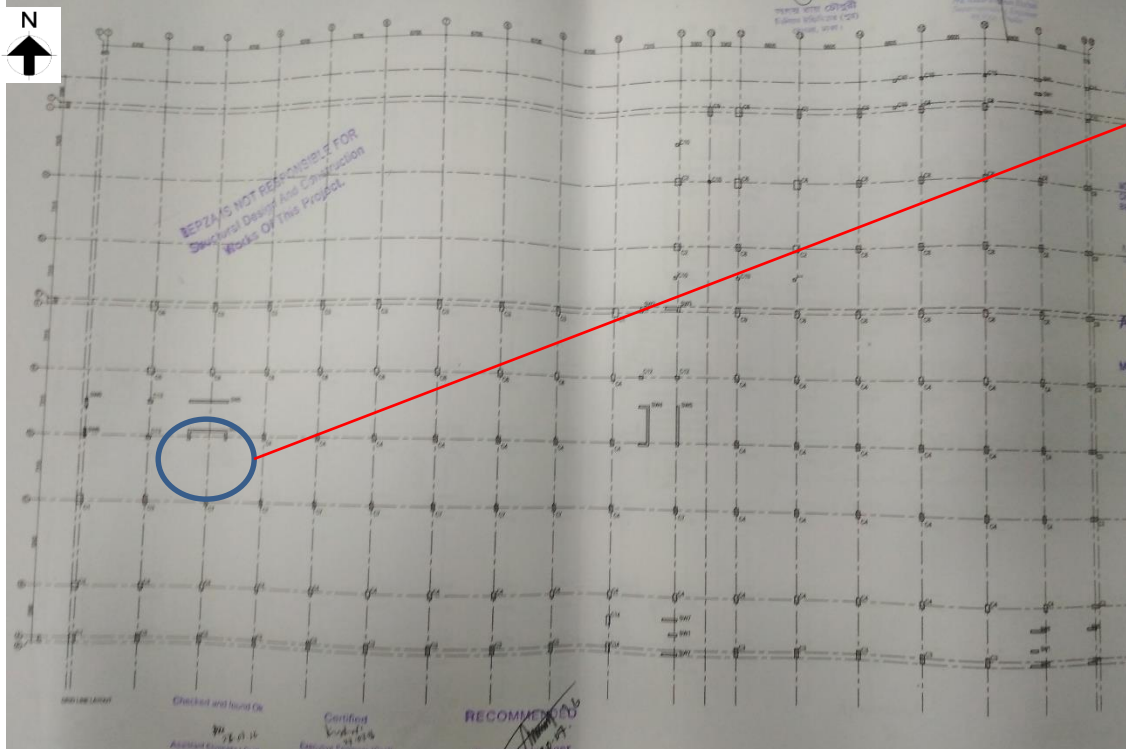
Column and RC wall layout plan

Steel beams in the several grids are connected to the RC walls. Design report was not available to determine the contribution of RC wall and diaphragm action in lateral stability system.

Building engineer is required to check the overall stability system and the connections.

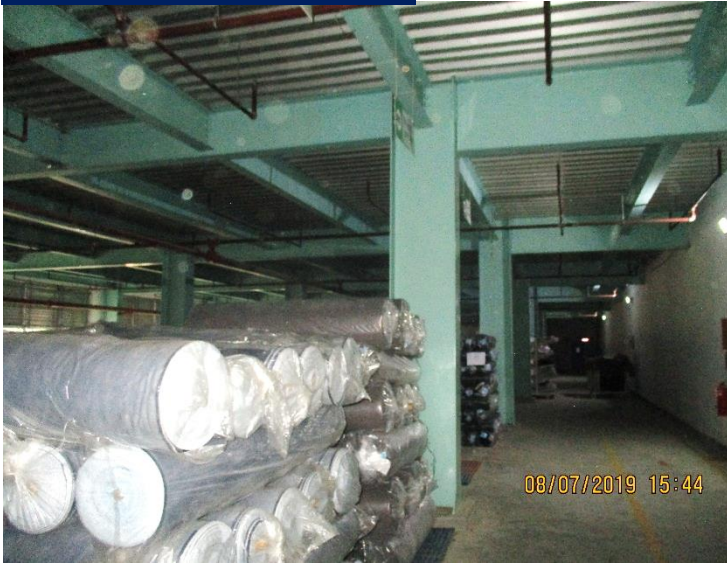
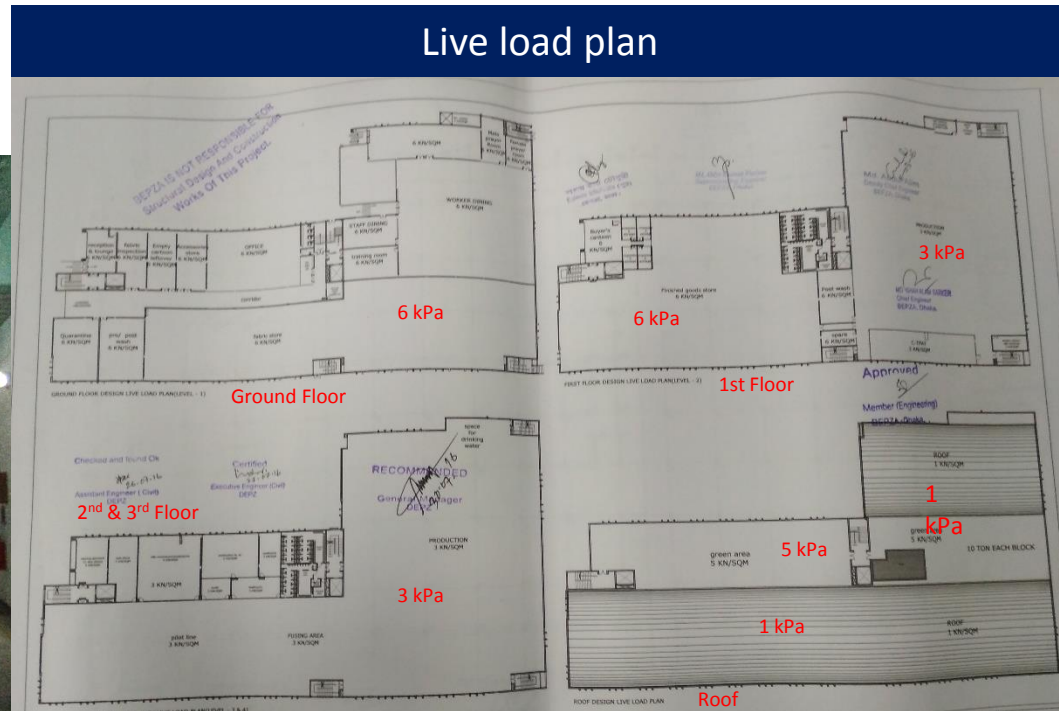
## Ground floor column

During inspection, steel plate test report was not available. Cursory calculation indicates that the working stress of ground floor steel columns (considering  $f_y=248$  Mpa (36 ksi) ) are above the normal design limits. However, calculation indicates that the working stress of ground floor steel columns are satisfactory by considering the  $f_y=345$  MPa (50 ksi). Building engineer is required to carryout plate load test to confirm the steel grade and review the design based on the test report.

| Item No. | Observation | Recommended Action Plan | Recommended Timeline |
|---|---|---|---|
| 3 | Steel plate test for column capacity (Factory Building) | Building engineer is required to perform the steel plate test to confirm the steel grade. | 6-weeks |
| 4 | Steel plate test for column capacity (Factory Building) | Review the design based on the test report. | 6-weeks |
| 5 | Steel plate test for column capacity (Factory Building) | Carry out any repair work according to suggestion of factory engineer | 6-months |

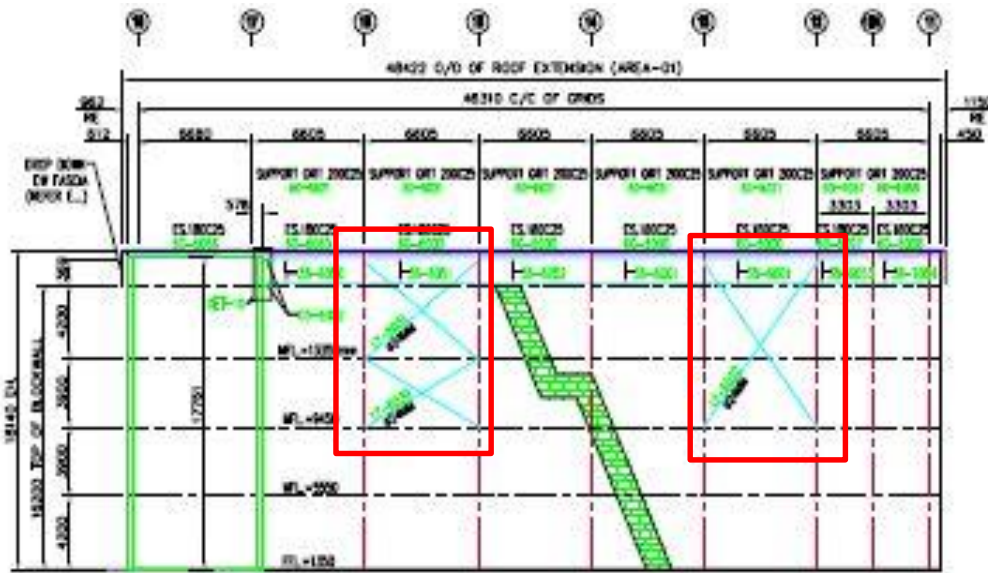
FAR SIDE WALL FRAMING ELEVATION (GRID LINE J)

Wall bracing between in grid J-15~16 & 12~13 does not match with the onsite condition. This bracings were not found on 2<sup>nd</sup> floor.

| Item No. | Observation | Recommended Action Plan | Recommended Timeline |
|---|---|---|---|
| 6 | Wall bracing plan at grid-J (Factory Building) | Review the bracing system as part of Engineering Assessment. | 6-weeks |
| 7 | Wall bracing plan at grid-J (Factory Building) | Update the as-built drawings as per site condition. | 6-weeks |
| 8 | Wall bracing plan at grid-J (Factory Building) | Carryout remedial works where necessary. | 6-months |

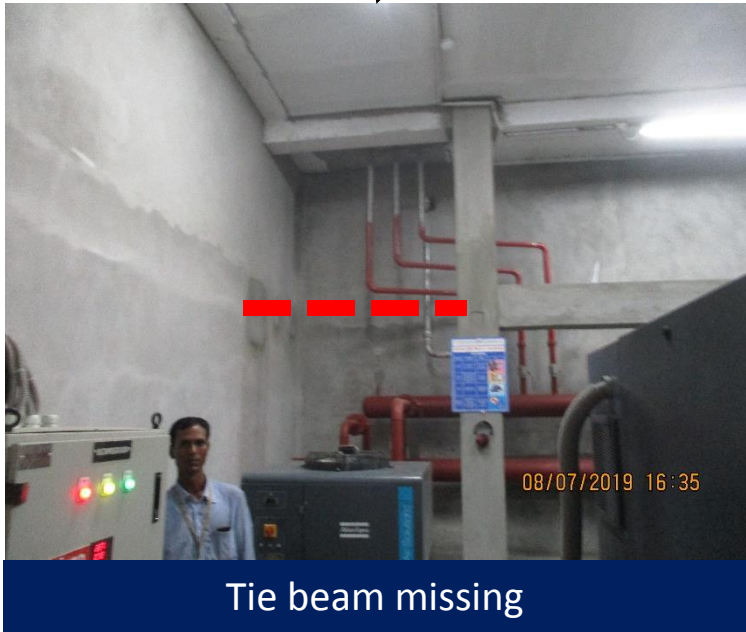
Tie beam missing

| Item No. | Observation | Recommended Action Plan | Recommended Timeline |
|---|---|---|---|
| 10 | Missing floor beam and tie beam (Utility Building) | Install the missing floor and tie beams as part of the remedial scheme. | 6-weeks |

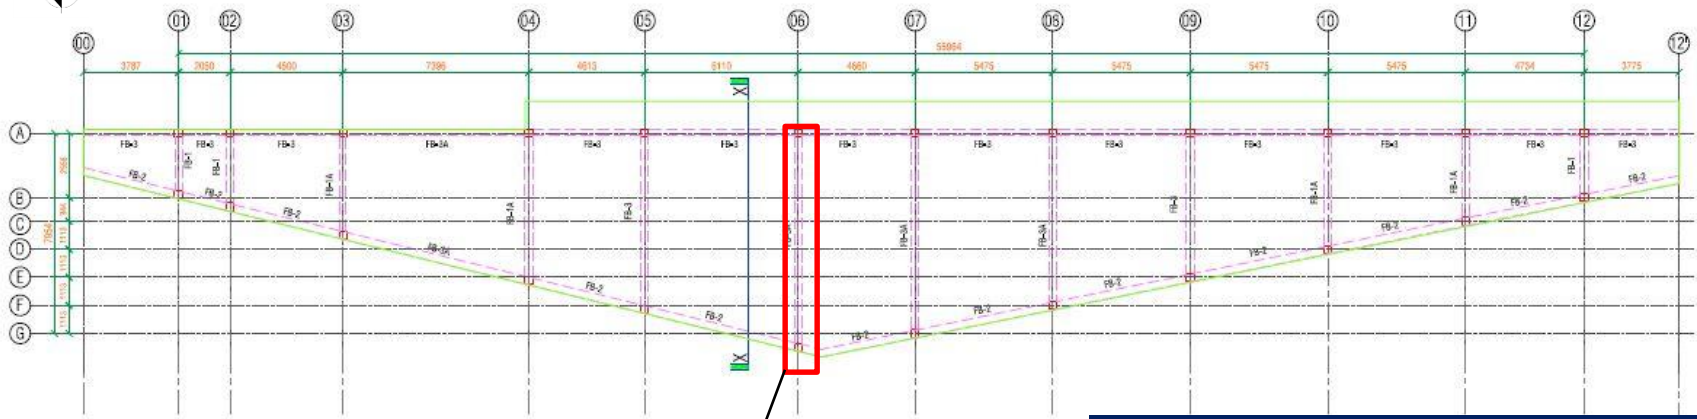
FLOOR BEAM LAYOUT PLAN

The missing beam makes the slab span of 10.2 m X 6.85m .

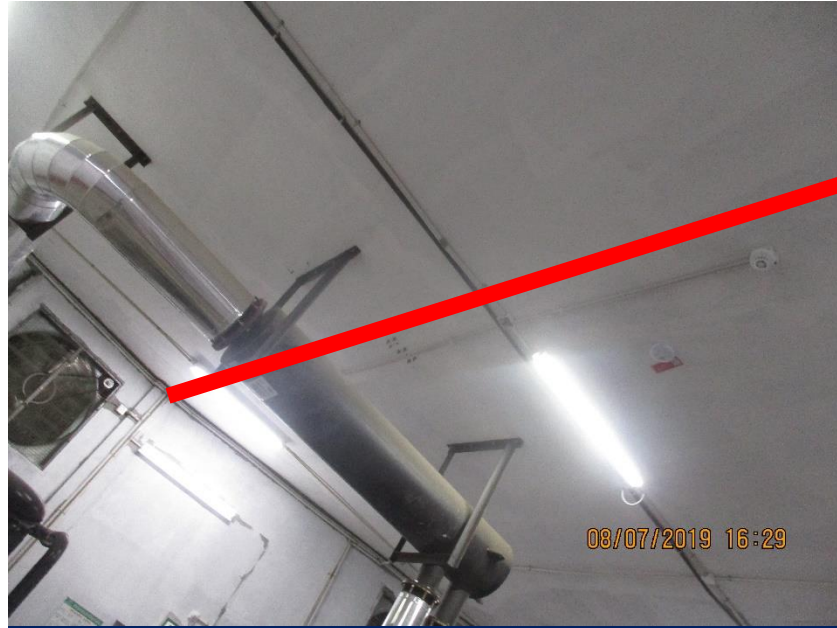
Floor beam missing
