Pacific Casuals Ltd.

Plot: 31-32, Sector: 1, CEPZ, Chattogram
(22.292645, 91.774568)
05th August 2019

Observations

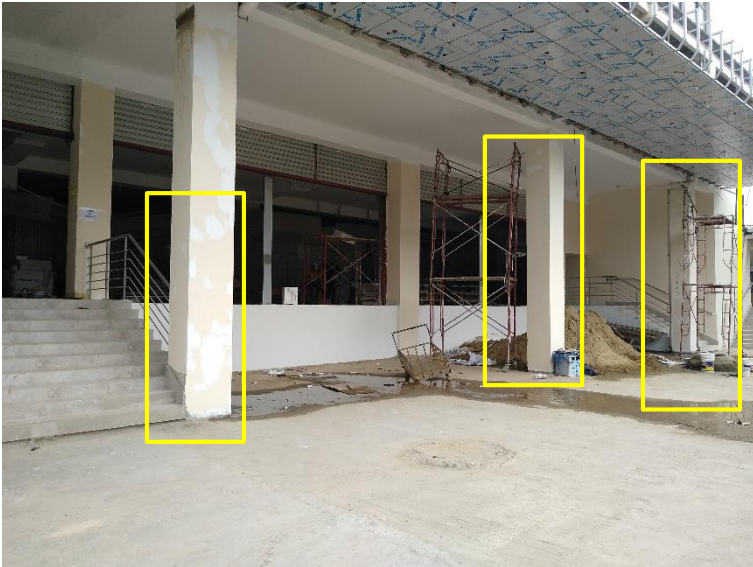
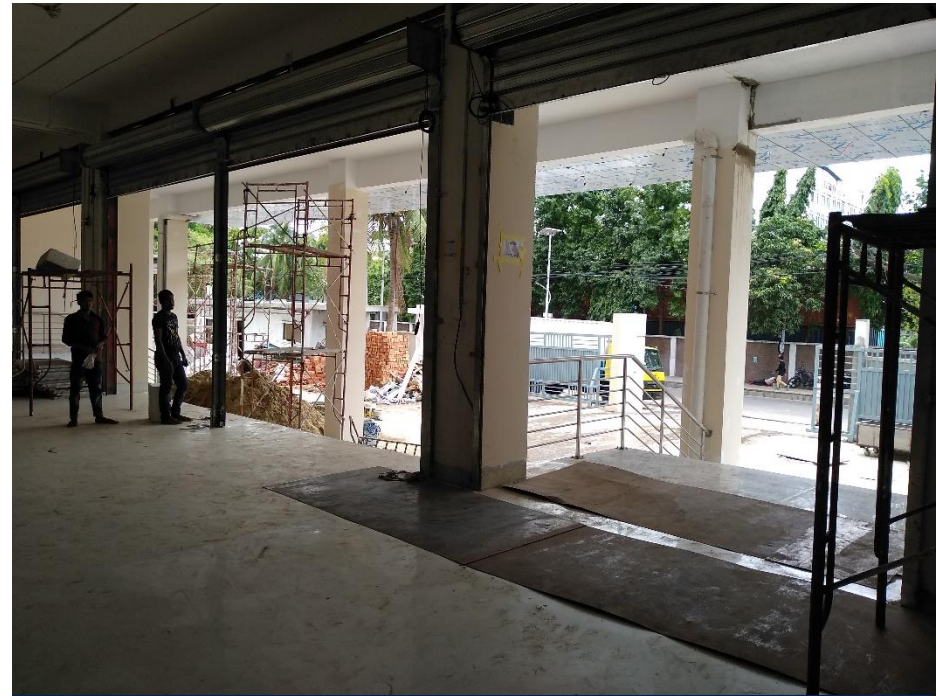
Ground floor column in loading-unloading bay

Columns susceptible to impact loading

Columns at loading bay are susceptible to impact loading from vehicles.

Item No.	Observation	Recommended Action Plan	Recommended Timeline
1	Columns susceptible to impact loading.	Construct and maintain protection to critical column and continue to assess likelihood of vehicle impact to critical elements.	6-weeks
2	Corrosion found on steel member of supporting Structure	The building engineer to investigate the reason & extent of corrosion and suggest proper remedial measure accordingly.	6-weeks
3	Corrosion found on steel member of supporting Structure	Take necessary measures to prevent further corrosion and repair the corroded steel members as per engineer's suggestion.	6-months

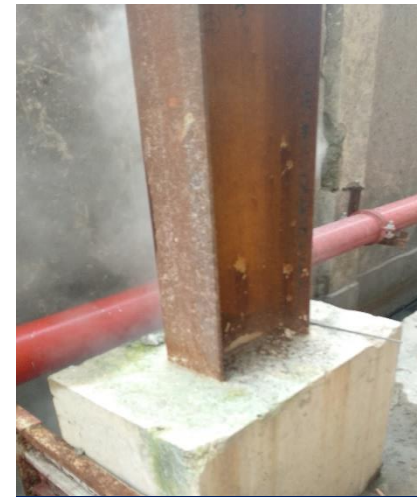
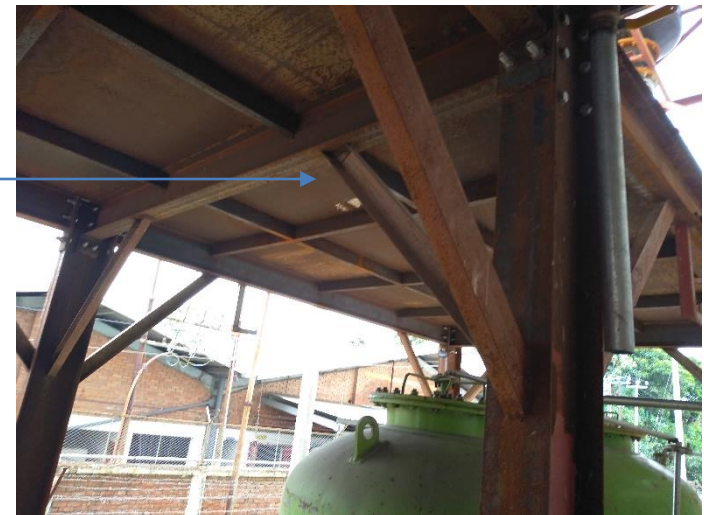
Corrosion found on steel member of supporting Structure

Excessive corrosion was found in steel member of supporting structure at East. The building engineer to investigate the reason & extent of corrosion and suggest proper remedial measure accordingly.

Corrosion at column

Corrosion at I-Joist & bracing
