ARA/Apparel Export Co. Ltd. (10716)

2/C Darussalam rd., Mirpur, Dhaka, Bangladesh

20.MARCH.2014

Identified Priority 1 Concerns

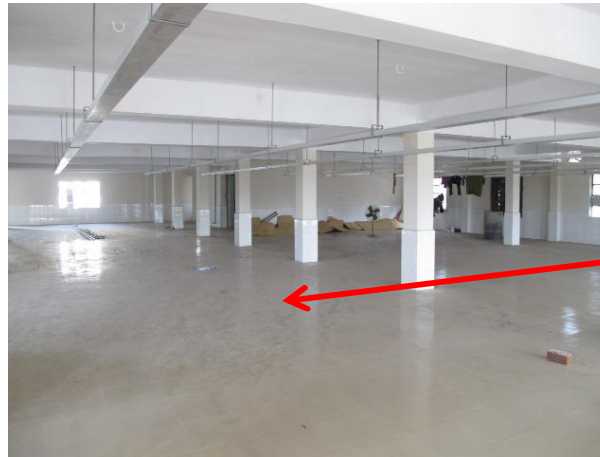
Empty area for 4th and 5th floor.

- **NOTE:** The adequacy of column and foundation capacity are required to investigate further and must be kept empty until a Detailed Engineering Assessment is carried out and any remedial measures resulting are completed.

- Do not operate any production line on 4th to 5th floor prior to structural design review.

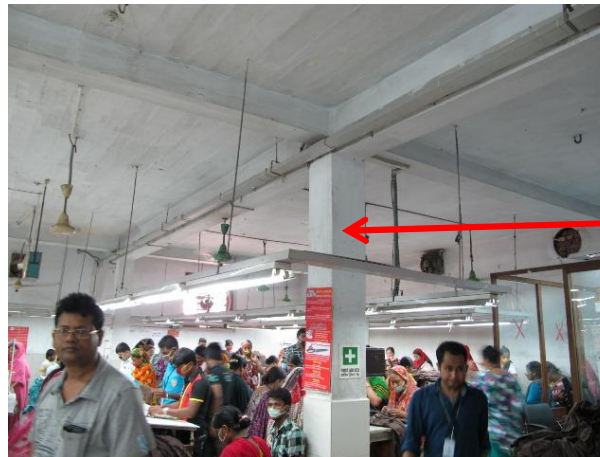
Adequacy of column and foundation capacity are required to be investigated.

Column on ground floor.

- Load run down at the key steel column, it is found that the column has FOS less than 1.25 which is **RED** rating.
- Detail Engineering Assessment of factory to be carried out and in particular column capacity and foundation aspects to be investigated in detail.

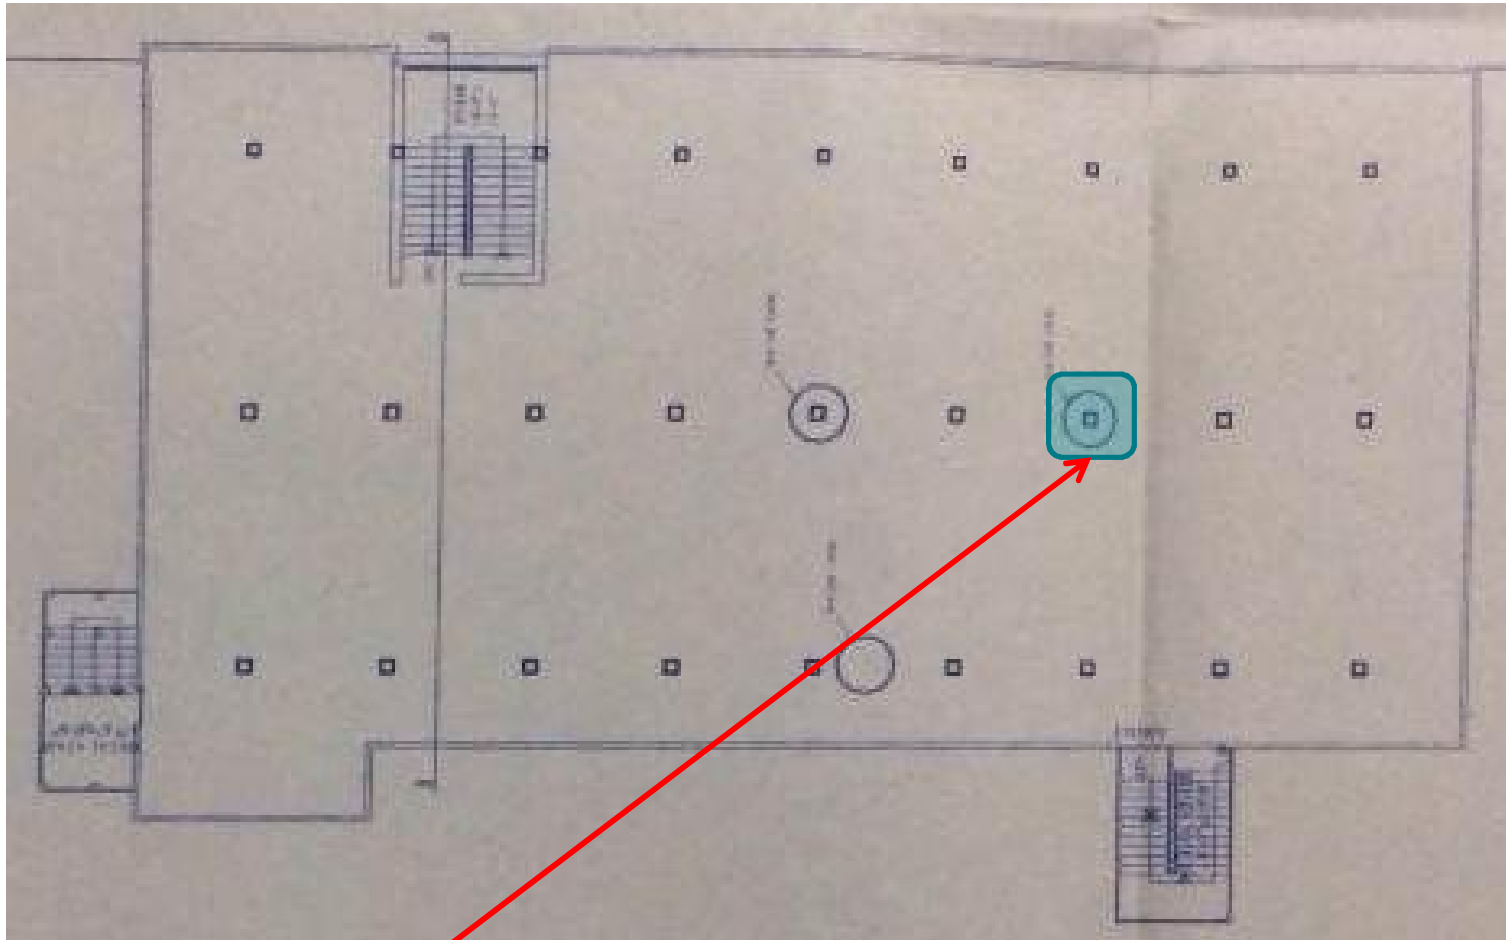
Key Column Check for Building 1:

Load rundown at the key steel column, it is found that the column is within the range of FOS less than 1.25 which is **RED** rating.

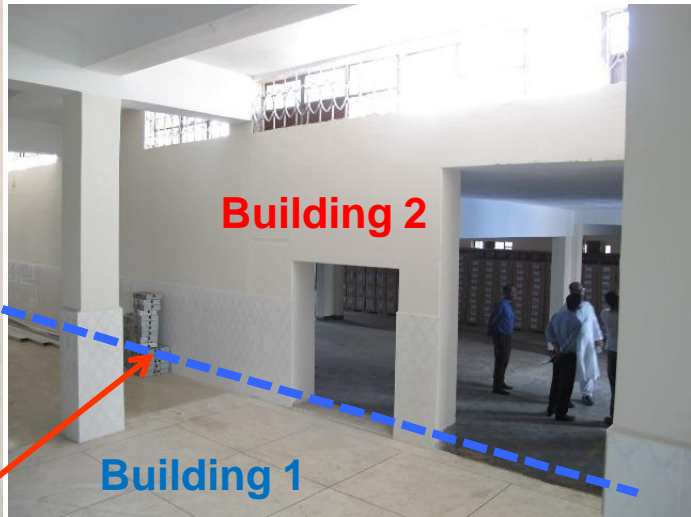
No movement joint properly established
to separate Building 1 and Building 2

----- Movement joint to be established properly

- Building assessment including column and foundation capacity check is required.

- Do not construct any further buildings, connected to the existing factory, without thorough structural design and full building approval.

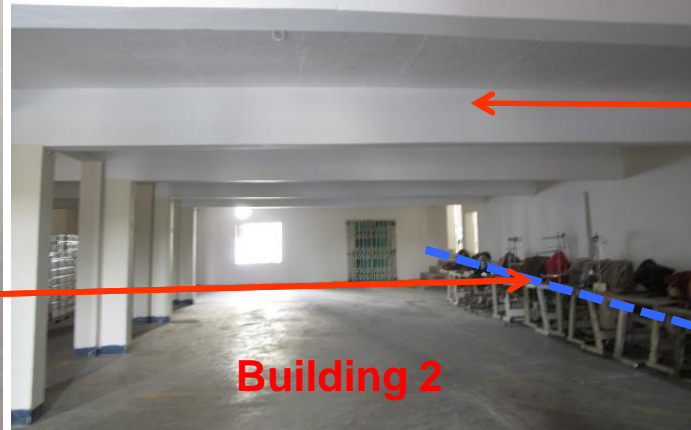
This beam appeared to be supported by column from building 1

No movement joint established properly to separate building 1 and 2. Building assessment including column and foundation capacity check are required.

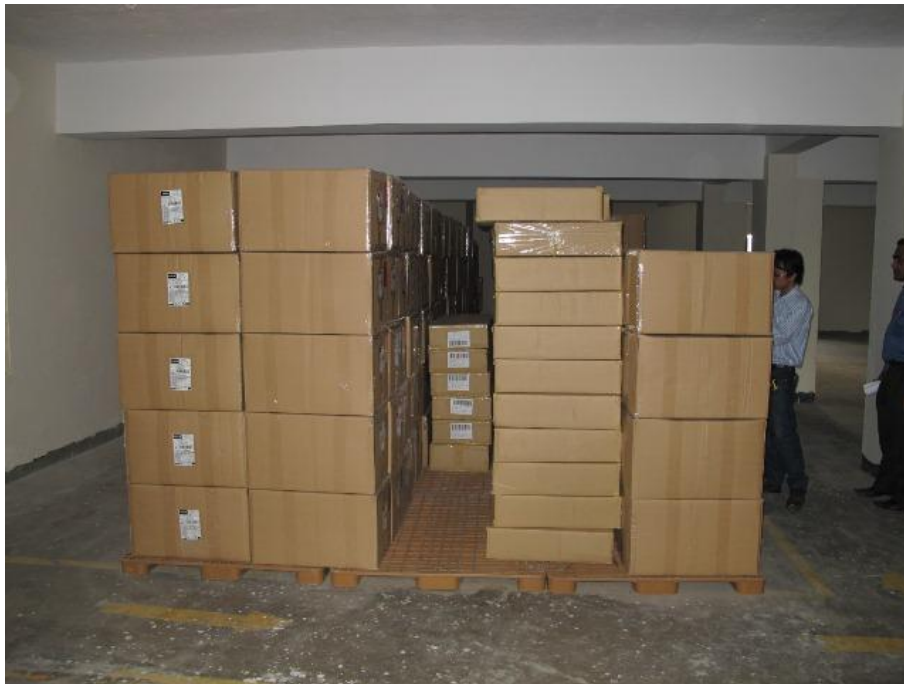
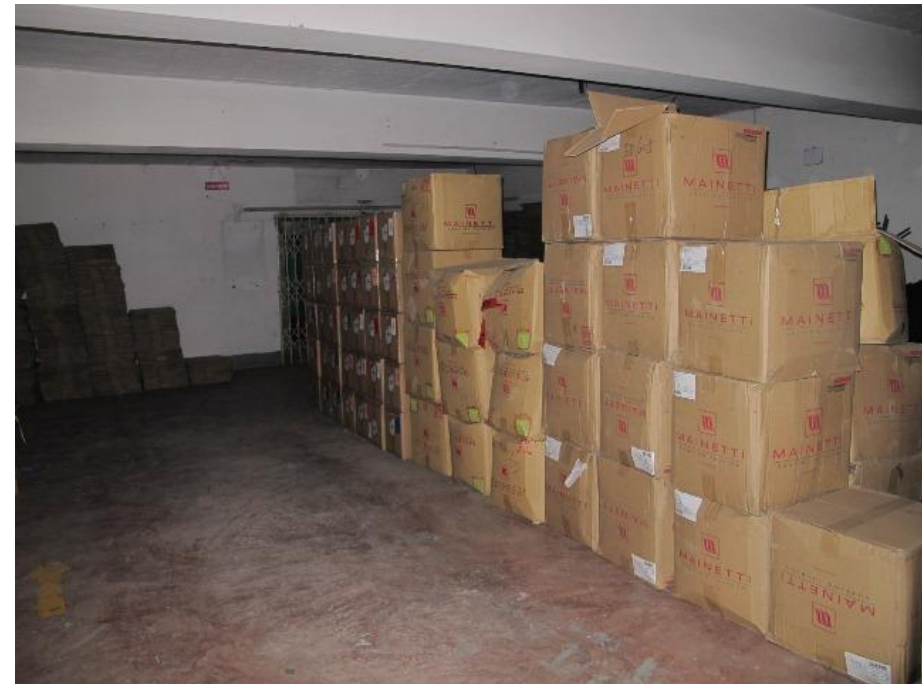
Uncontrolled heavy storage on third floor.
Reduce stacking height of storage to ensure
total load does not exceed 3.0kPa.

- Reduce stacking height of fabric rolls to ensure total load does not exceed 3.0kPa
- Adopt some sort of signage/staff guidance to ensure that the maximum weight of storage is not exceeded .

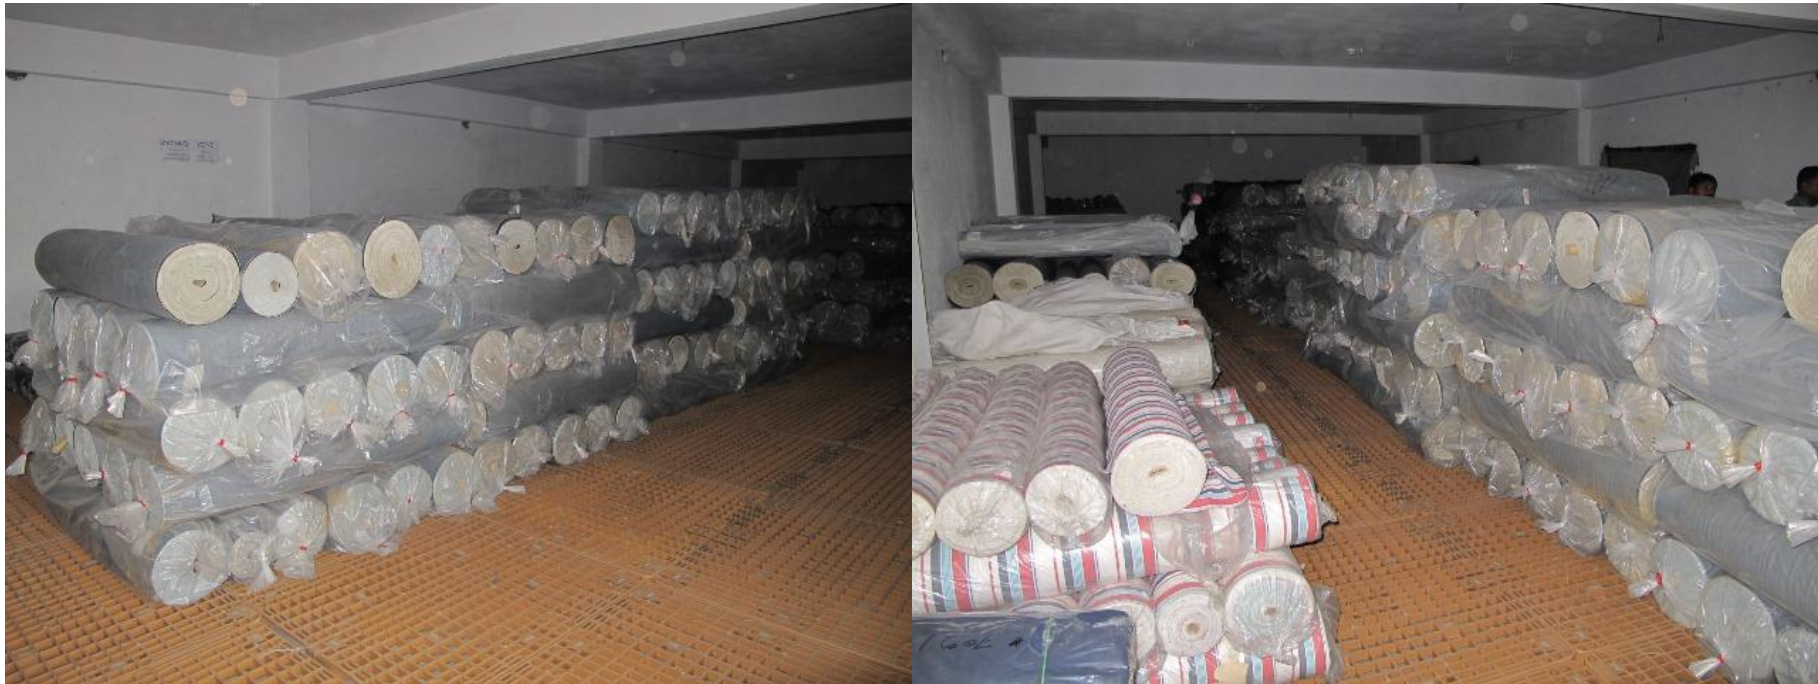
Uncontrolled heavy storage on ground floor.
Reduce stacking height of storage to ensure
total load does not exceed 3.0kPa

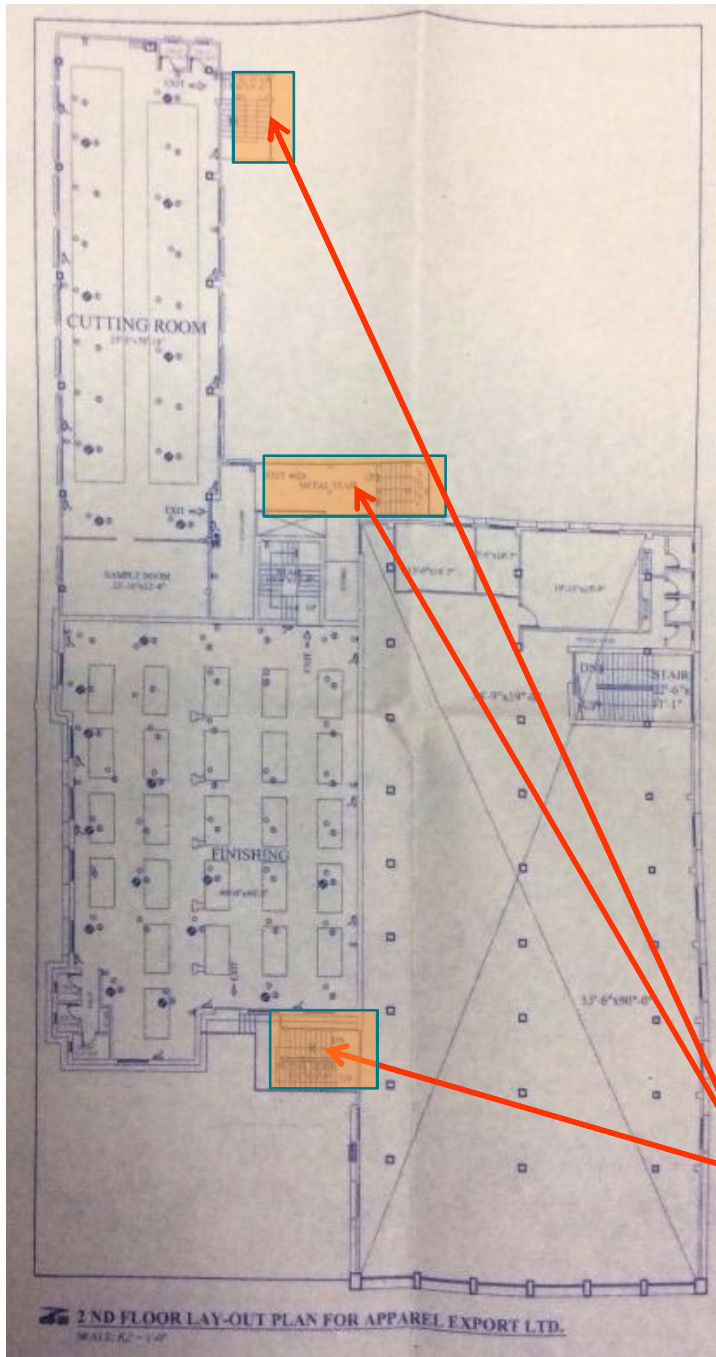
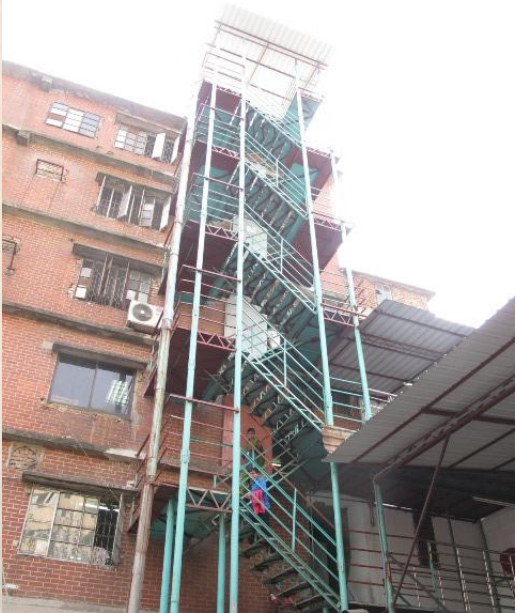
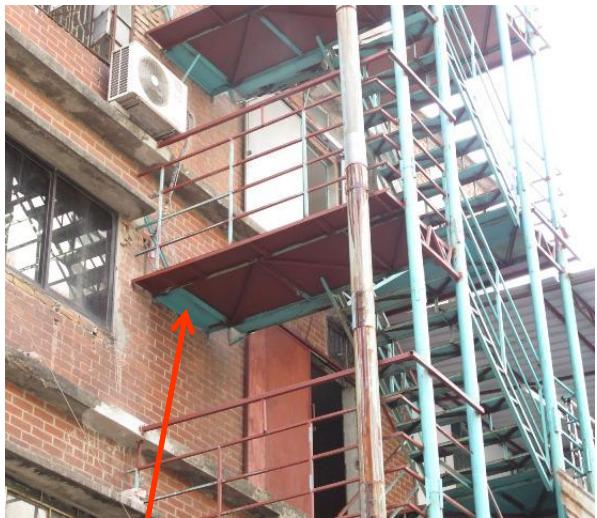
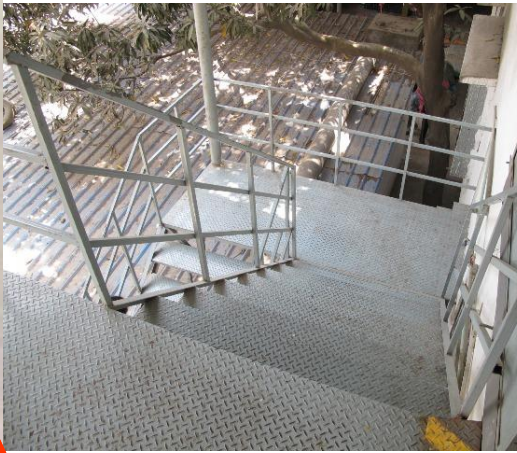
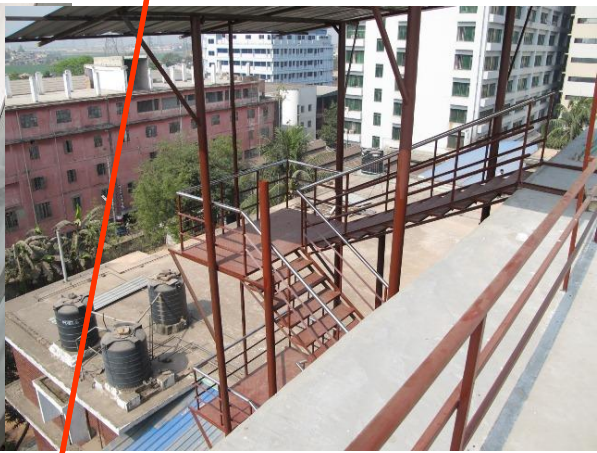
Capacity check for steel escaped staircase, especially at support connections.

- Detail Engineering Assessment to be carried out particularly for steel column capacities including connection.

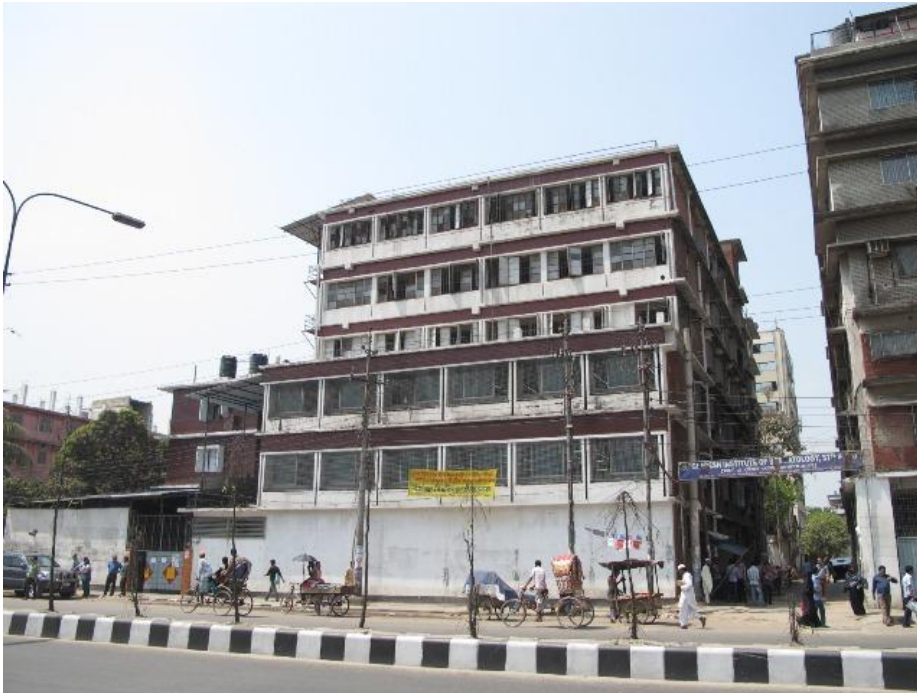
Concerns on the stability system for lateral loading and seismic loading. Façade brickwork with little capacity; lack of moment capacity in connection between columns and beams.

Further Detail Engineering Assessment is required to establish whether such system can resist the lateral load from wind & earthquake.

- Detail engineering assessment to be carried out in particular stability and foundation aspects to be investigated in detail.

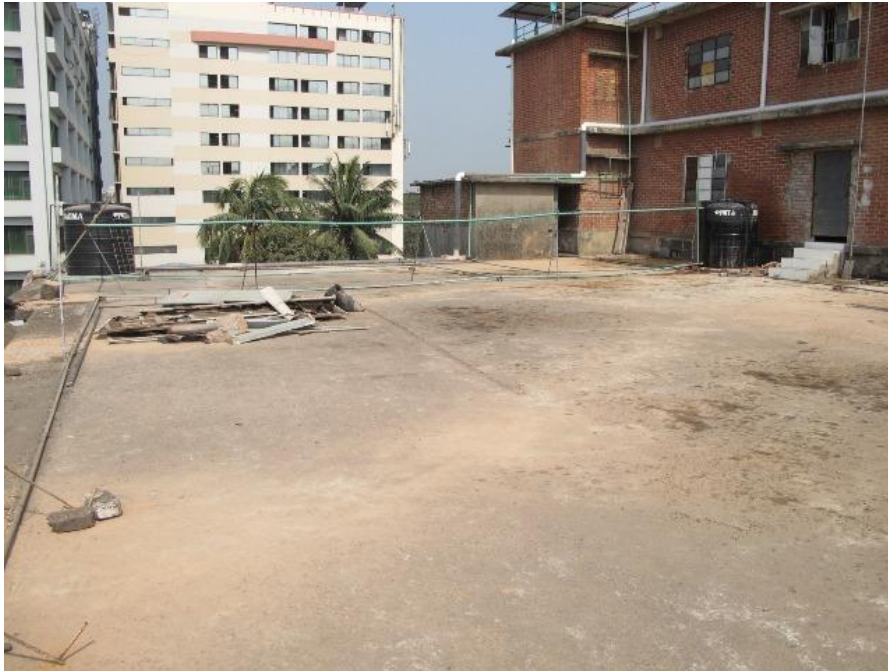
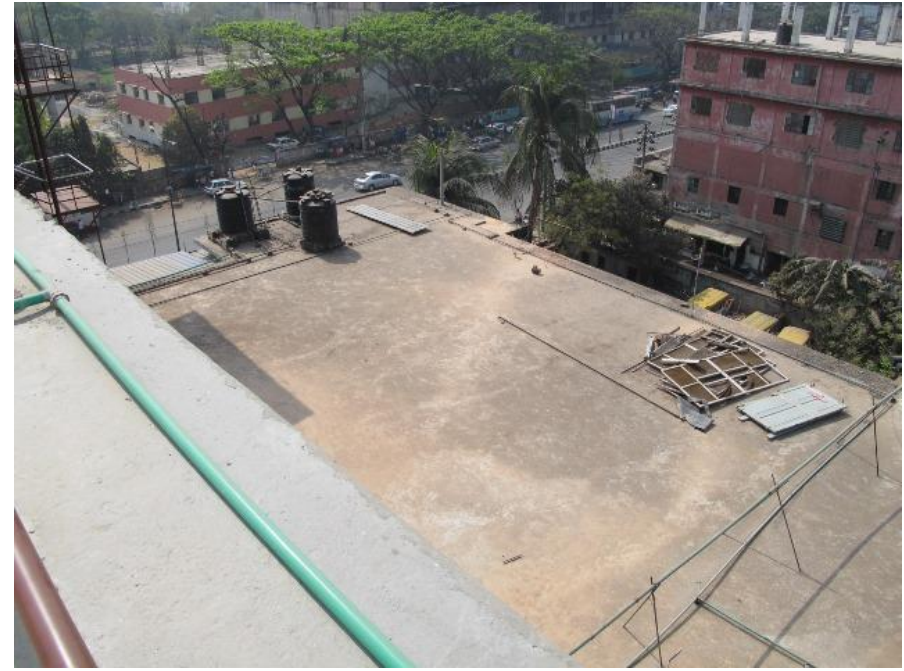
There is no evidence of water ingress on the roof surface, however a waterproofing layer should be applied.

- The existing roof level does not have any waterproofing material, therefore, it should be considered to apply waterproofing measures.

- Ensure that an appropriate layer of waterproofing is applied and its effectiveness is also maintained.
