# Nemrac Design Ltd.

Plot: A-172, BSCIC I/A, Shanshongaon, Fatullah, Narayanganj.

8<sup>th</sup> & 23<sup>rd</sup> December 2019

# Observations

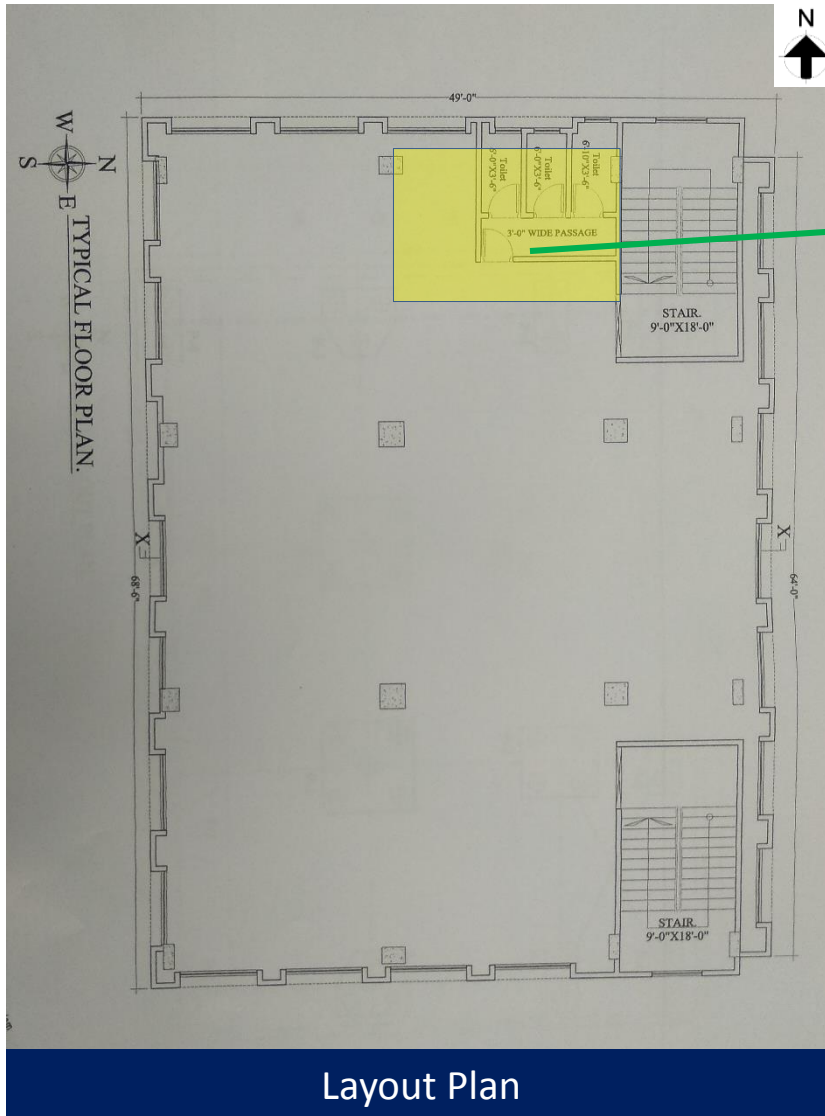
Layout Plan

Cursory calculations indicate that the working stress of the columns at Ground Floor level are above normal design limits.

| Item No. | Observation | Recommended Action Plan | Recommended Timeline |
|---|---|---|---|
| 1 | Column found to be stressed above normal design limits | Factory Engineer to review design, loads and columns stresses. | 6-weeks |
| 2 | Column found to be stressed above normal design limits | Verify in-situ concrete stresses by 100mm dia. cores from min. 4 no. column from ground floor level. | 6-weeks |
| 3 | Column found to be stressed above normal design limits | Produce and actively manage a loading plan for all floor plates considering floor capacity and column capacity. | 6-weeks |

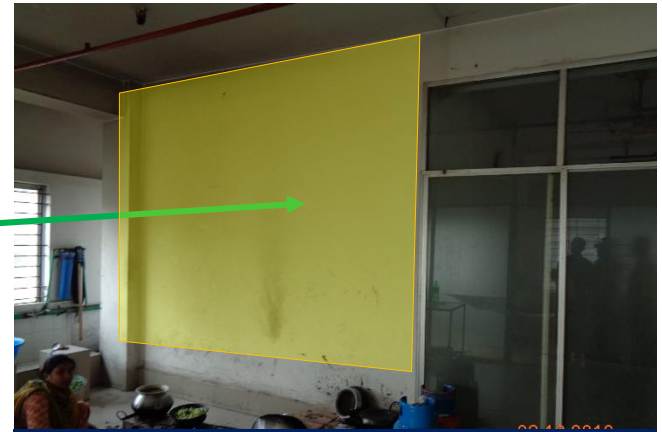
RC water tank at 7<sup>th</sup> floor

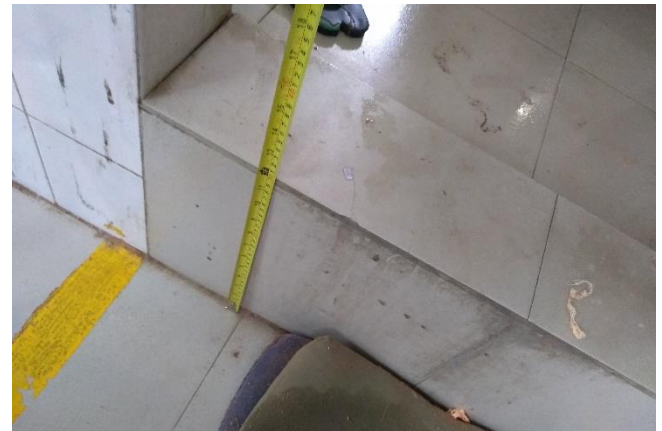
Toilet Build up

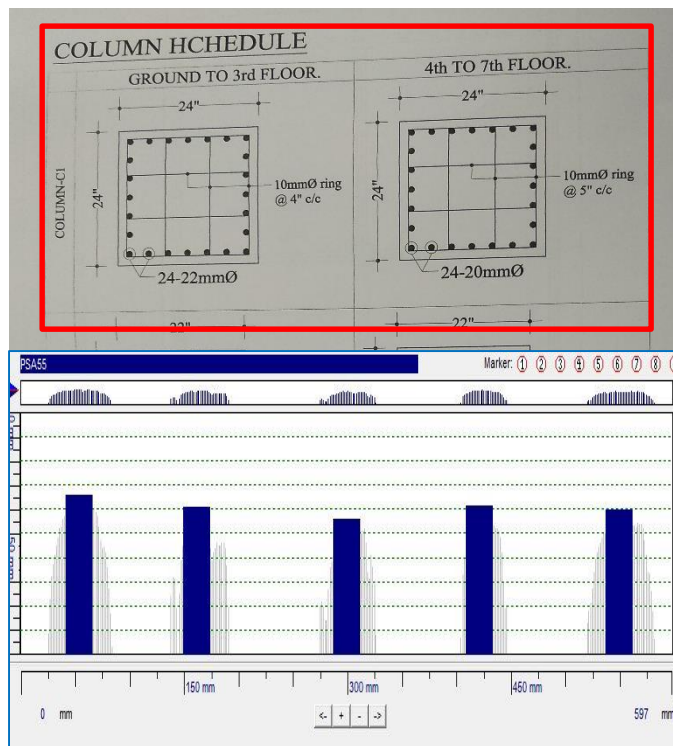
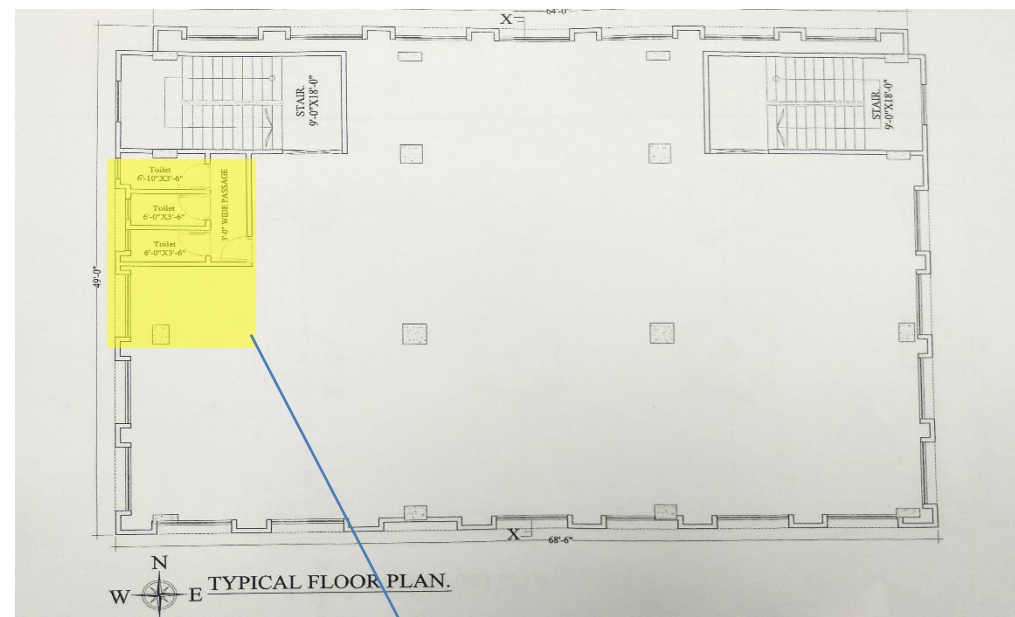
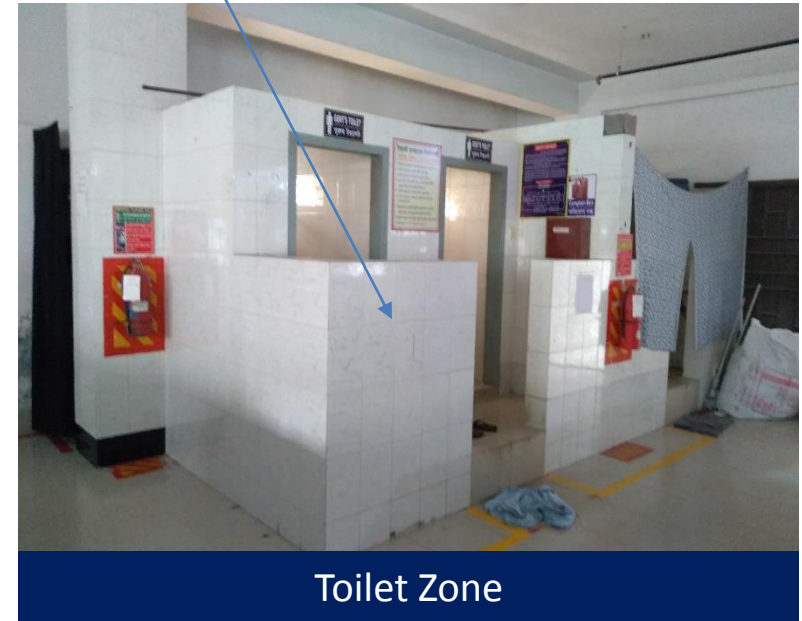
Number of rebar of C8 type column does not match with column schedule. 24 nos of rebar were shown in column schedule whereas 16 nos of rebar were found by ferro scanning. Moreover, architectural drawings did not fully match with as built condition.

| Item No. | Observation | Recommended Action Plan | Recommended Timeline |
|---|---|---|---|
| 6 | Discrepancies between provided drawings and on-site condition | Building Engineer to survey the structure and prepare accurate as-built (both architectural & structural) drawings. | 6-weeks |

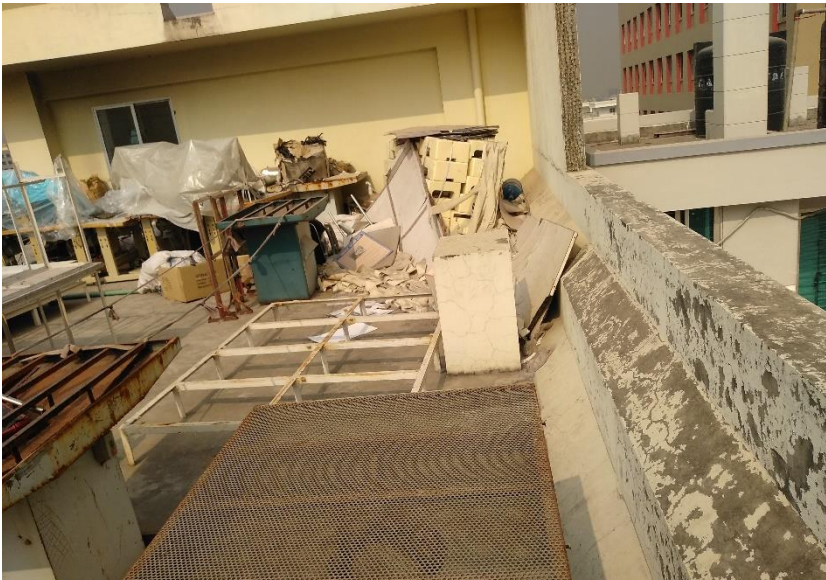
Stacking of idle machine and wastage were found on roof at Building-1. Stacked materials need to be removed from roof.

Stacked wastage materials

| Item No. | Observation | Recommended Action Plan | Recommended Timeline |
|---|---|---|---|
| 7 | Stacking of idle machine and wastage material at roof | All kinds of stacked materials need to be removed. | 6-weeks |
| 8 | Stacking of idle machine and wastage material at roof | Drainage system to be developed on roof. | 6-months |

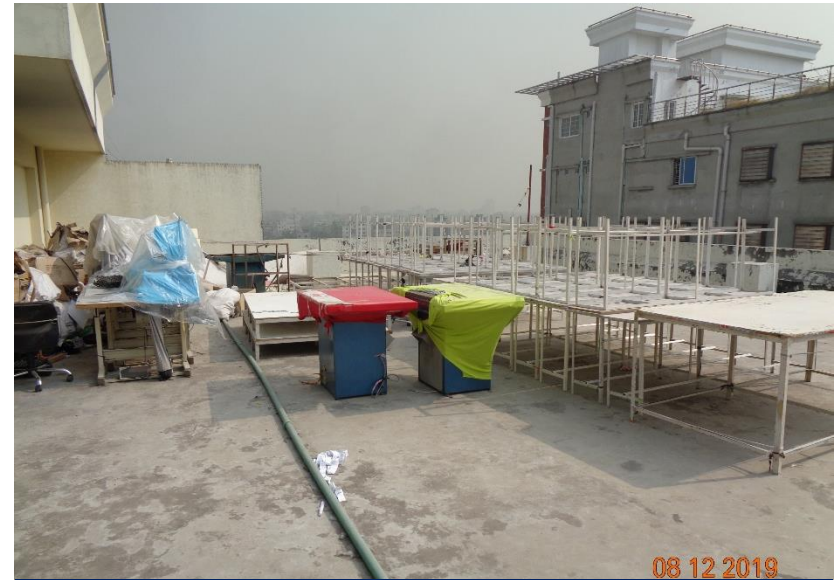
Stacked idle machine

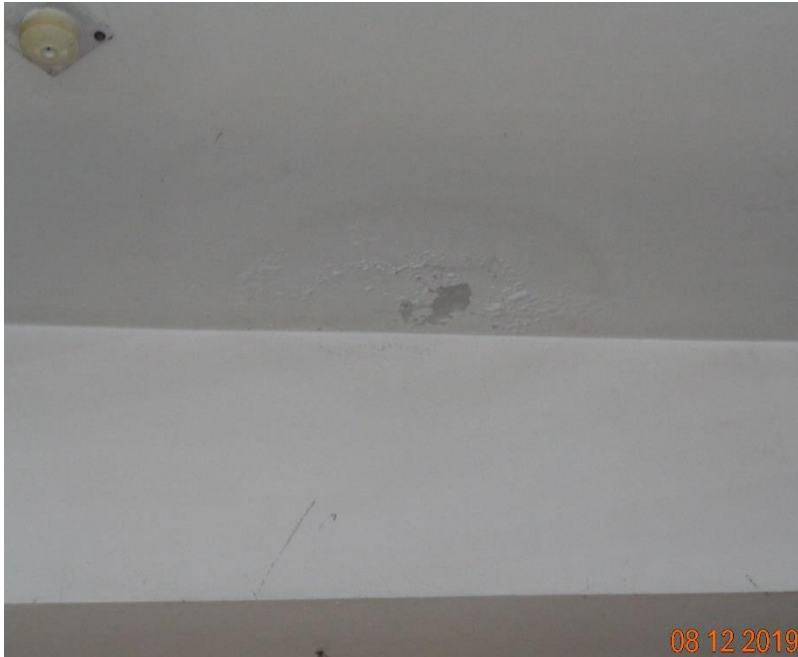
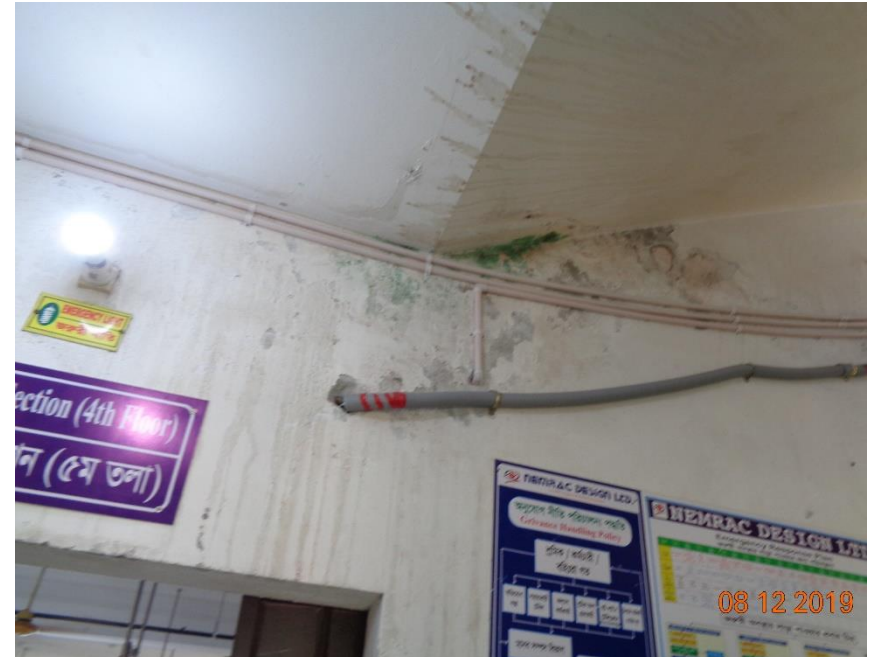
Dampness was observed on the beam, slab and peripheral wall. Water damage also observed on some of walls in the washroom zone.

| Item No. | Observation | Recommended Action Plan | Recommended Timeline |
|---|---|---|---|
| 9 | Water damage at several locations | Investigate the cause of dampness on the beam, slab & wall and suggest suitable remedial method. | 6-weeks |
| 10 | Water damage at several locations | Carry out required measures to remove dampness on beams, slab & walls as per recommendation of factory engineer. | 6-months |

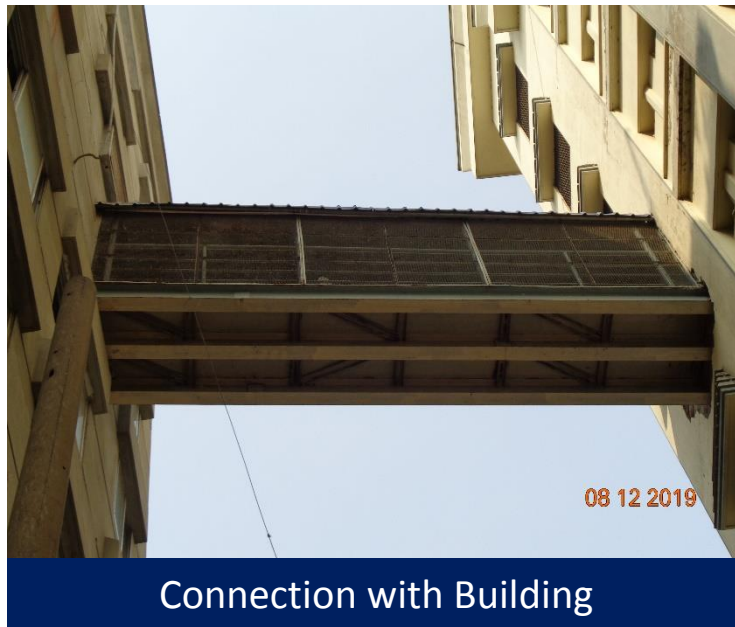
Connecting bridges were found between building-1 and building-2 at level-6. The connection between two buildings is structural. Factory engineer is required to check the adequacy of the connection and prepare as-built drawings.

Connection with Building

| Item No. | Observation | Recommended Action Plan | Recommended Timeline |
|---|---|---|---|
| 11 | Connection bridges between Building-1 and Building-2 | Factory engineer is required to check the adequacy of the connection and prepare as-built drawings for the connecting bridge. | 6-weeks |

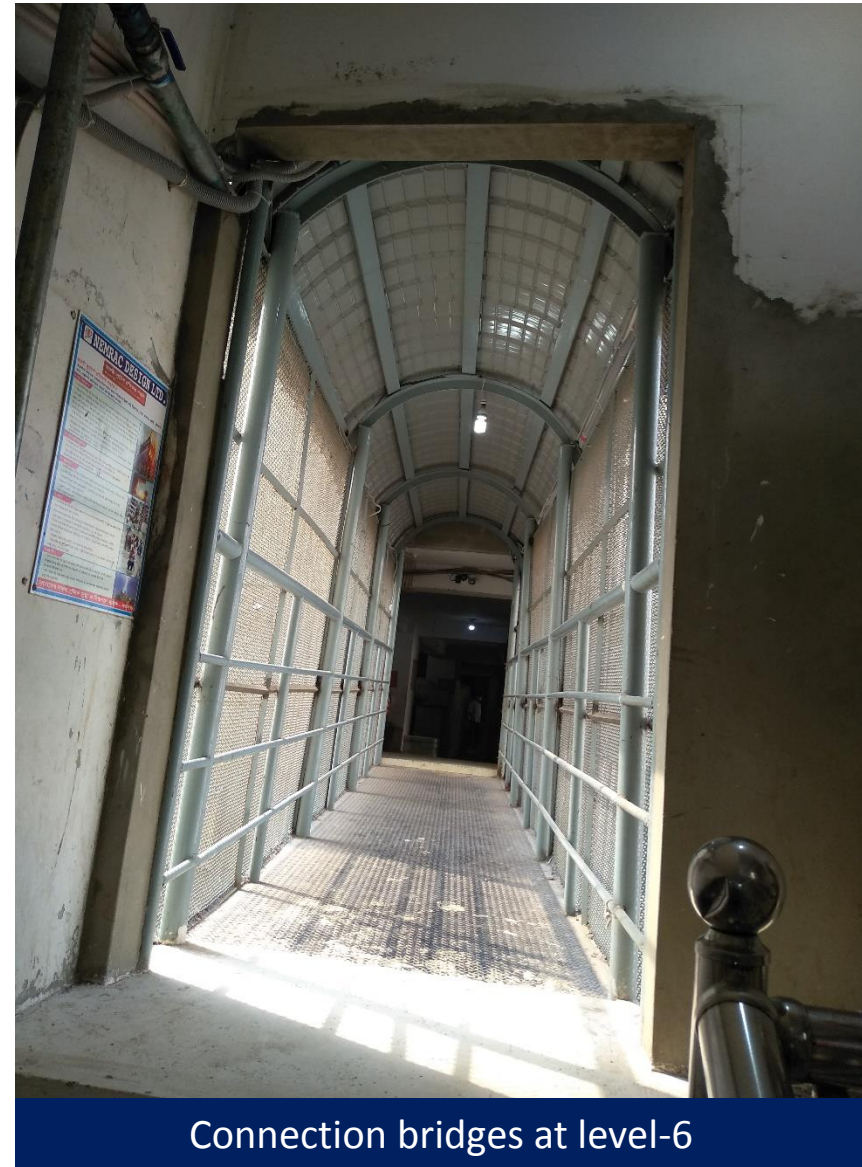
Connection bridges at level-6

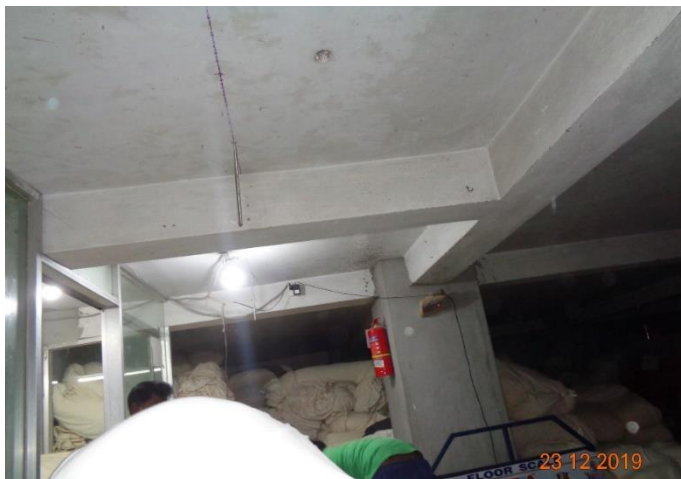
Factory has carried out retrofitting up to first floor of all columns. But no design drawings were available during inspection for retrofitting works.

Retrofitted column

| Item No. | Observation | Recommended Action Plan | Recommended Timeline |
|---|---|---|---|
| 12 | Undocumented retrofitting works and improper connection between beam column joint | Proper retrofitting drawings & design required to be prepared and submitted to Accord for further review. | 6-weeks |

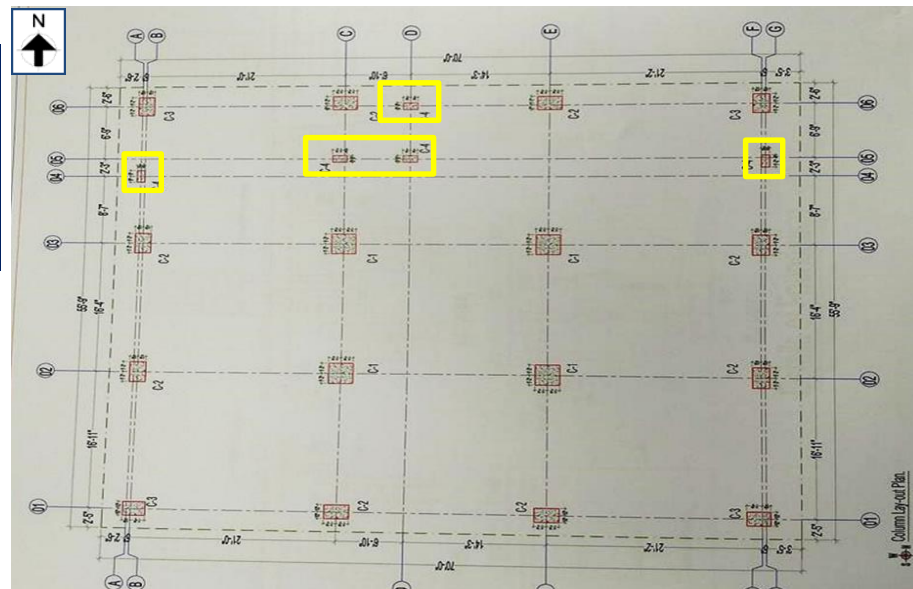
Some new columns have been installed but the connection with existing beam up to 1<sup>st</sup> floor is not monolithic. Factory engineer is required to check the adequacy of the connection and suggest proper remedial measures.

New columns are marked as yellow on drawing

| Item No. | Observation | Recommended Action Plan | Recommended Timeline |
|---|---|---|---|
| 13 | Undocumented retrofitting works and improper connection between beam column joint | Factory engineer is required to check the adequacy of the connection and suggest proper remedial measures. | 6-weeks |

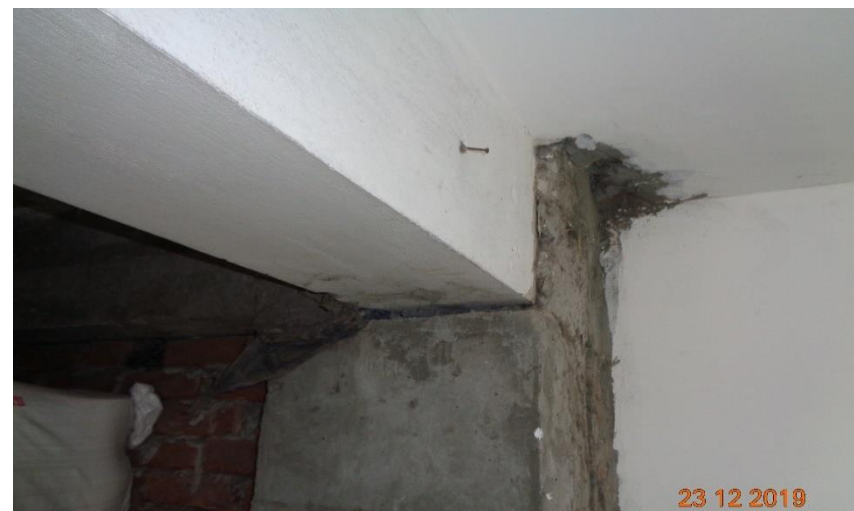
Improper connection with existing beam

| Item No. | Observation | Recommended Action Plan | Recommended Timeline |
|---|---|---|---|
| 14 | Undocumented retrofitting works and improper connection between beam column joint | Carry out remedial works if required. | 6-months |

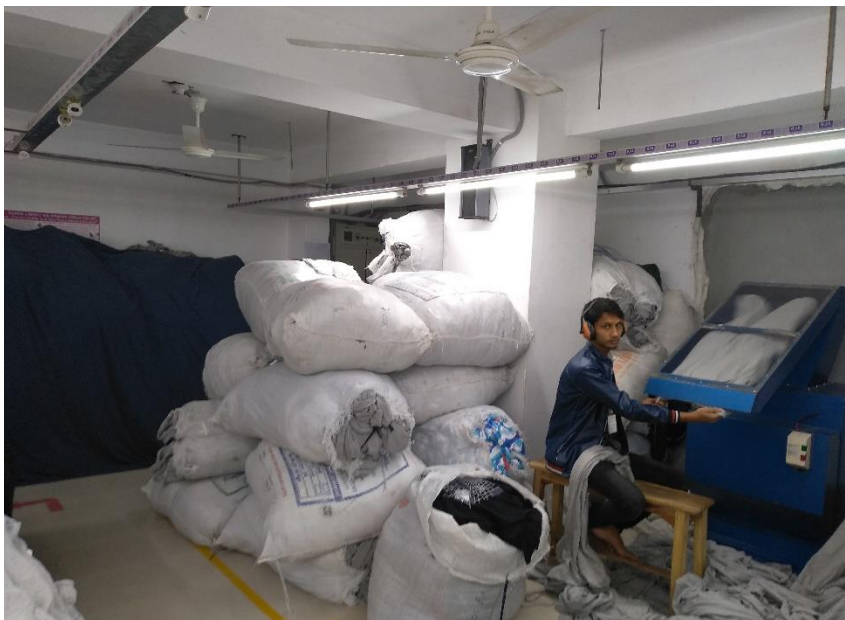
During inspection over loading wasn't found. Factor of Safety calculation for internal & external columns were found satisfactory considering 3kPa allowable floor live loading for the building.

Observed floor loading

| Item No. | Observation | Recommended Action Plan | Recommended Timeline |
|---|---|---|---|
| 15 | Prepared load plan does not comply with BNBC | Implement floor load management program considering 3 kPa floor live load on typical floors. | 6-weeks |
| 16 | Prepared load plan does not comply with BNBC | If the floor loading is considered more than 3 kPa on suspended floors an Engineering Assessment is required to be prepared to review the design of column and floor capacity. | 6-weeks |
