# AKM Knit Wear Ltd

14 Gedda, Karnapara, Ulail, Savar, Dhaka 1340  
(23.82743N, 90.25867E)

23 March 2014, 02 April 2014

# Observations

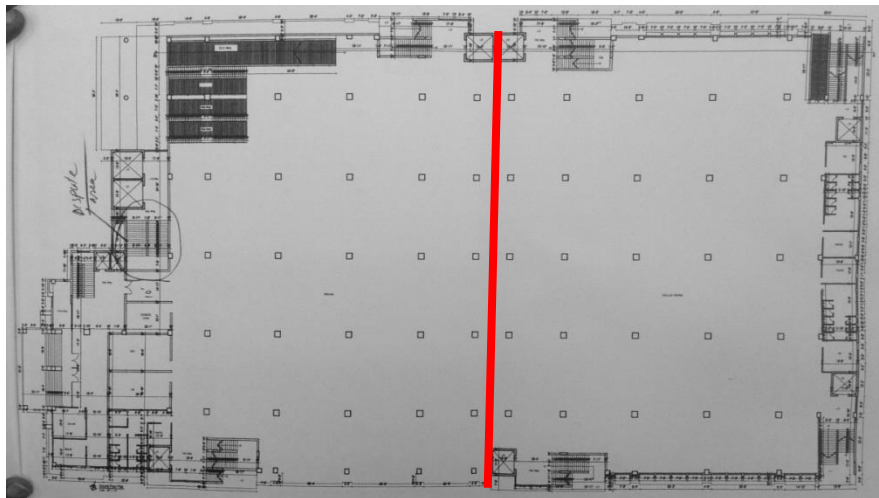
Typical column layout

# **Main Building - Columns appear to be stressed in excess of normal design limits**

Cursory calculations indicate column working stress is in excess of normal design limits.

Engineer to review structural analysis carried out on building to ensure model represents the as constructed building and concrete strengths inputted to model are based on actual cylinder results.

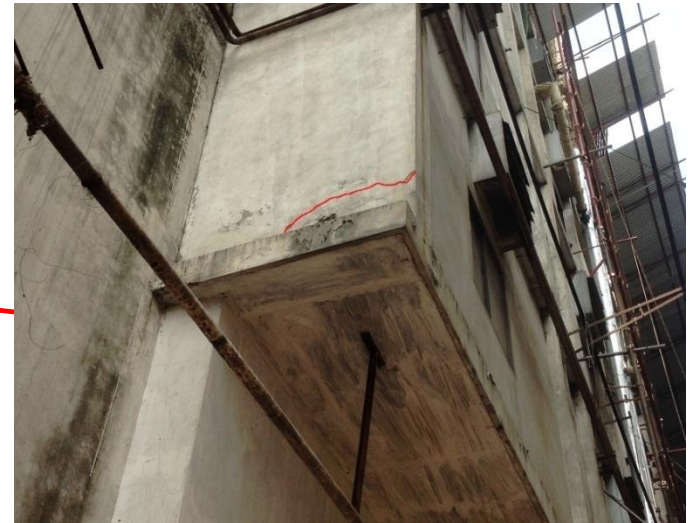
East Side Cantilever Area

Cracking was observed in the façade brick-work over the cantilevers. Building Engineer to monitor.

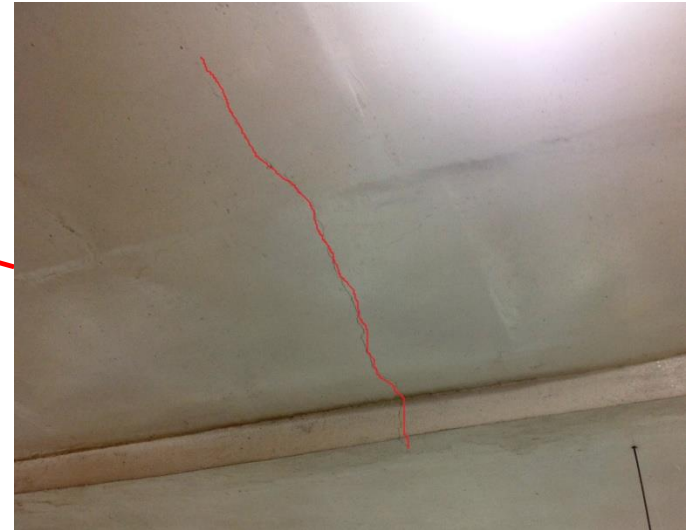
2<sup>nd</sup> Floor At the front of stair case

**There was evidence that the render to drop pad & slab was cracked in a number of locations. Render to be removed to ensure cracks do not extend in to the structure. Building Engineer to monitor.**

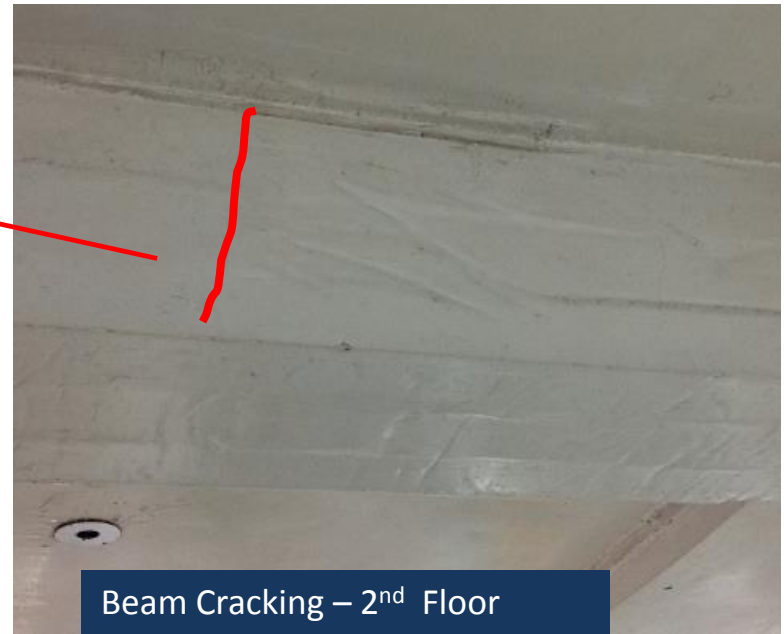
Beam Cracking – 2<sup>nd</sup> Floor

Cracking was observed in a number of beams. Render to be removed to ensure cracks do not extend in to the structure. Building Engineer to monitor.

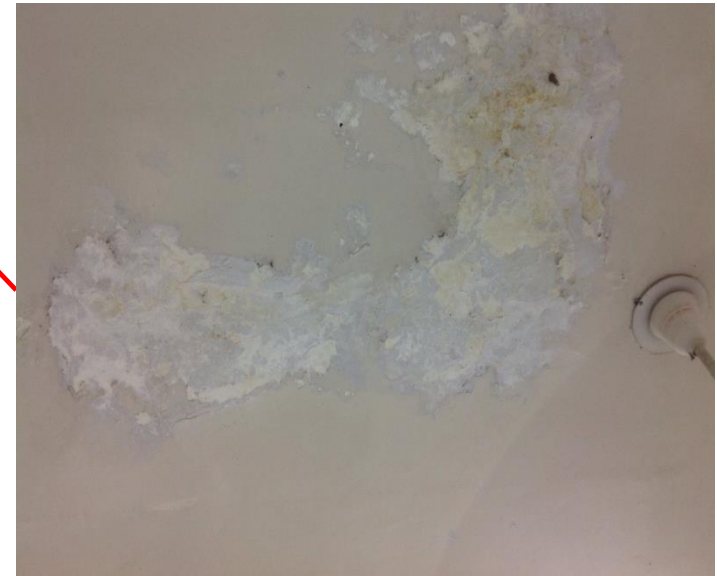
Water ingress to Slab- 2<sup>nd</sup> floor

There was evidence of water ingress into structural elements. Building Engineer to monitor.

8	Water Ingress	Building Engineer to investigate source of water ingress and remedy if necessary with appropriate sealant.	6-weeks
9	Water Ingress	Continue to monitor for water ingress throughout building and implement corrective procedures if necessary.	6-months

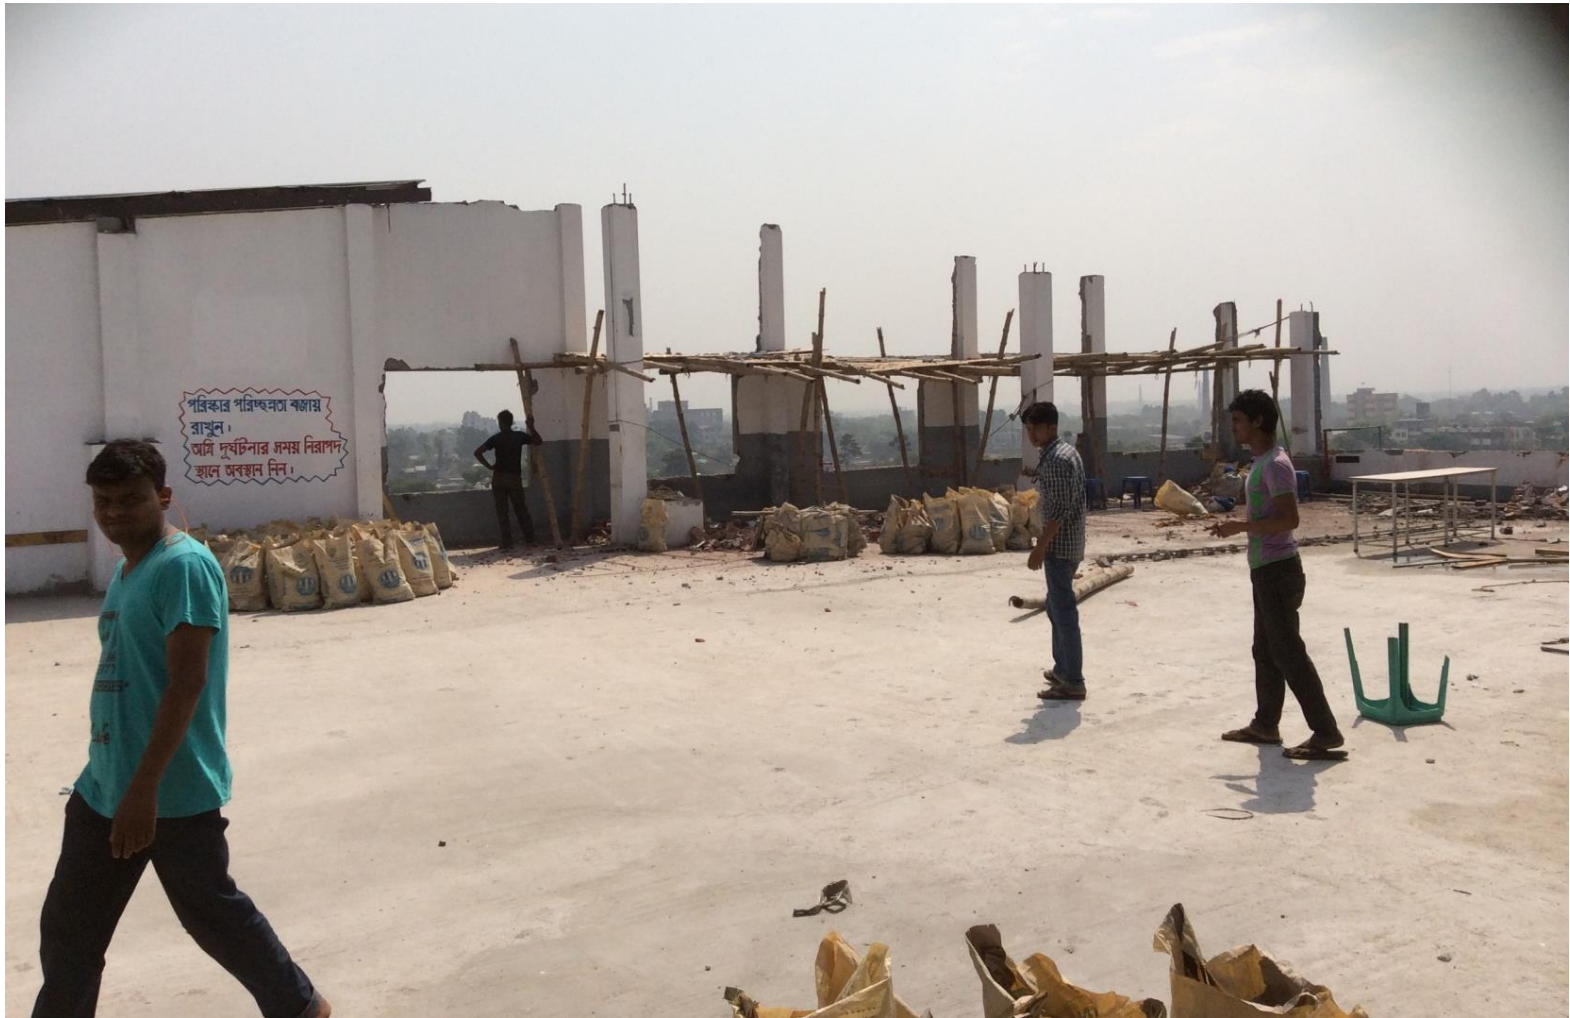
**Note: Roof and façade currently being removed from 6 Storey Accessories building. This is to be replaced with a concrete roof slab.**

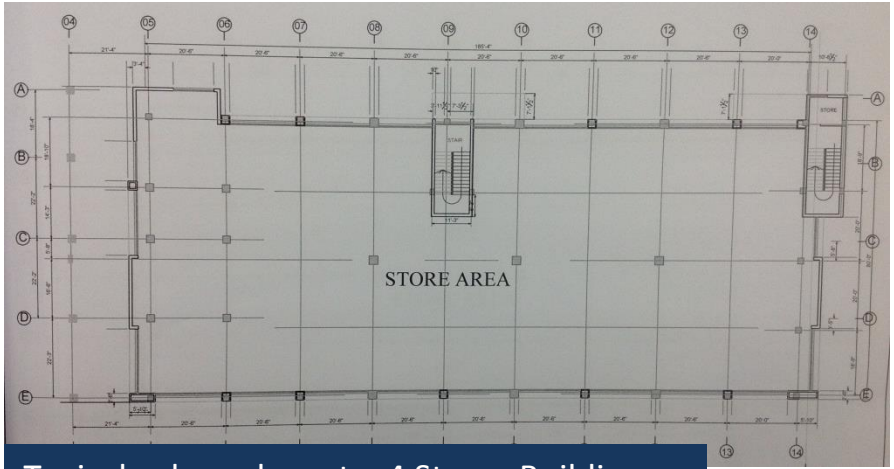
Typical column layout – 4 Storey Building

Cursory calculations indicate column working stress is in excess of normal design limits.

Building Engineer is to perform detailed calculations and concrete tests to prove column size and (if required):

- Reduce loads by vacating floors
- Reinforce columns

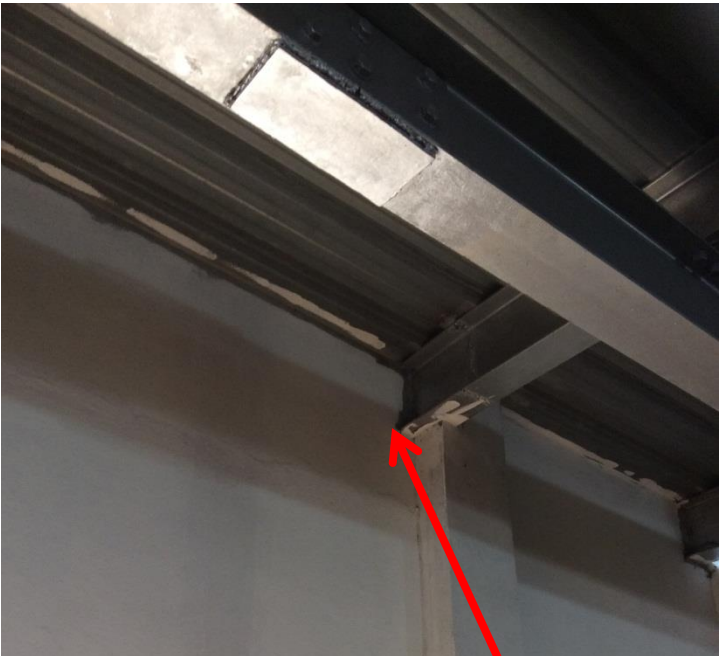
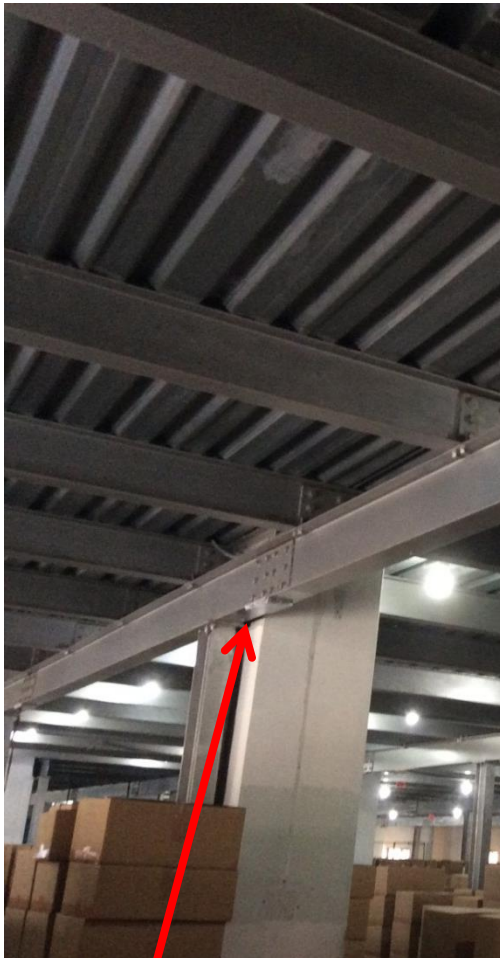
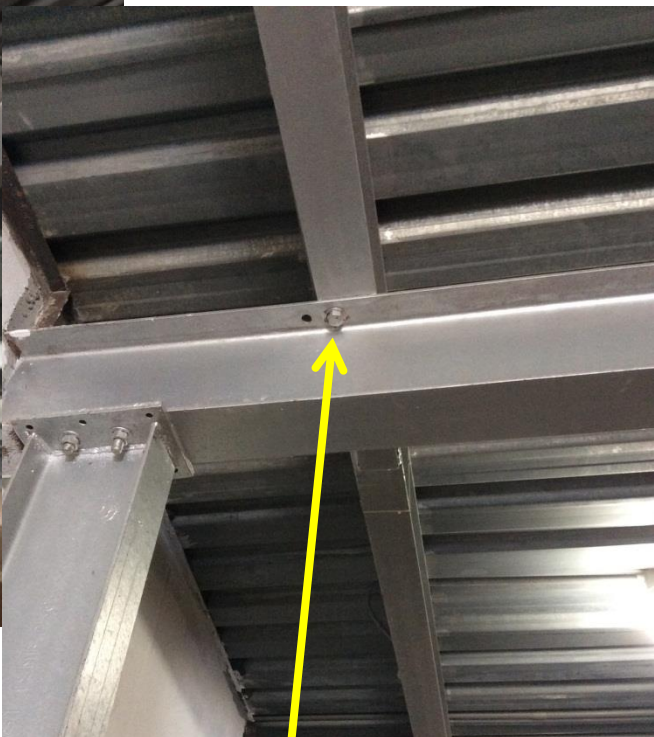
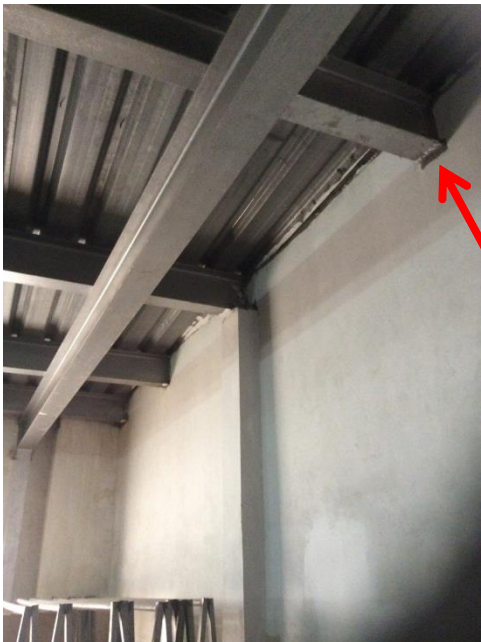
**Note: Steel infill not shown on Permit Drawings.**

**Engineer to confirm steel infill floor connections to façade are sound and how steel floor is connected to the main concrete structure.**

**Engineer to confirm all connections are adequate.**

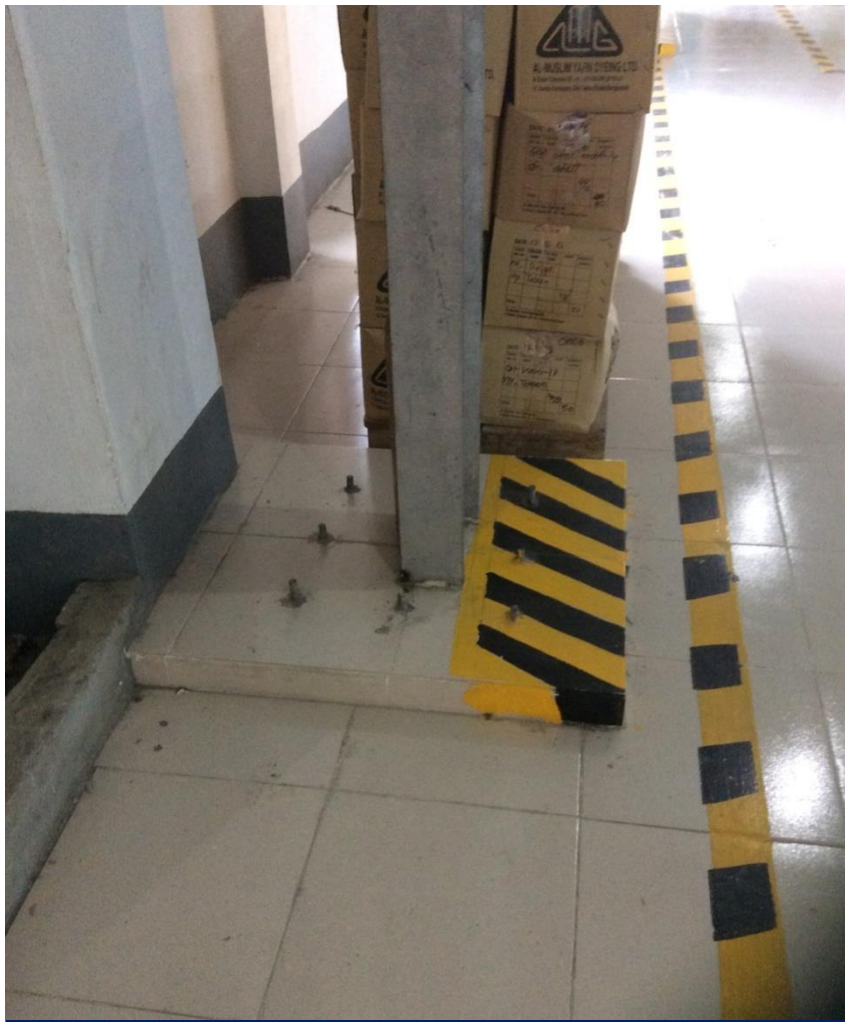
**Steel columns connected to First floor slab. Engineer to confirm capacity of slab to take additional loading.**

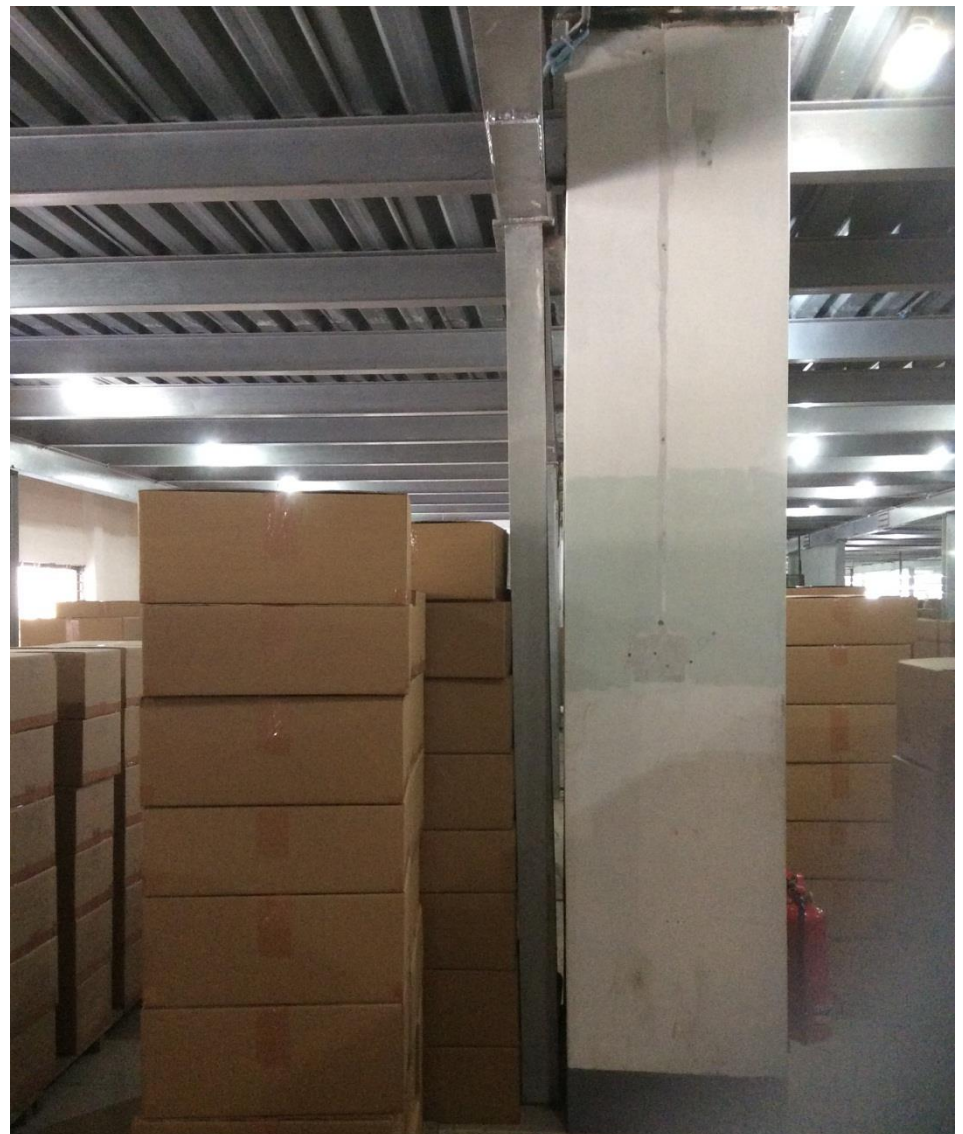
**Steel columns out of plumb. Engineer to confirm Stability of structure.**

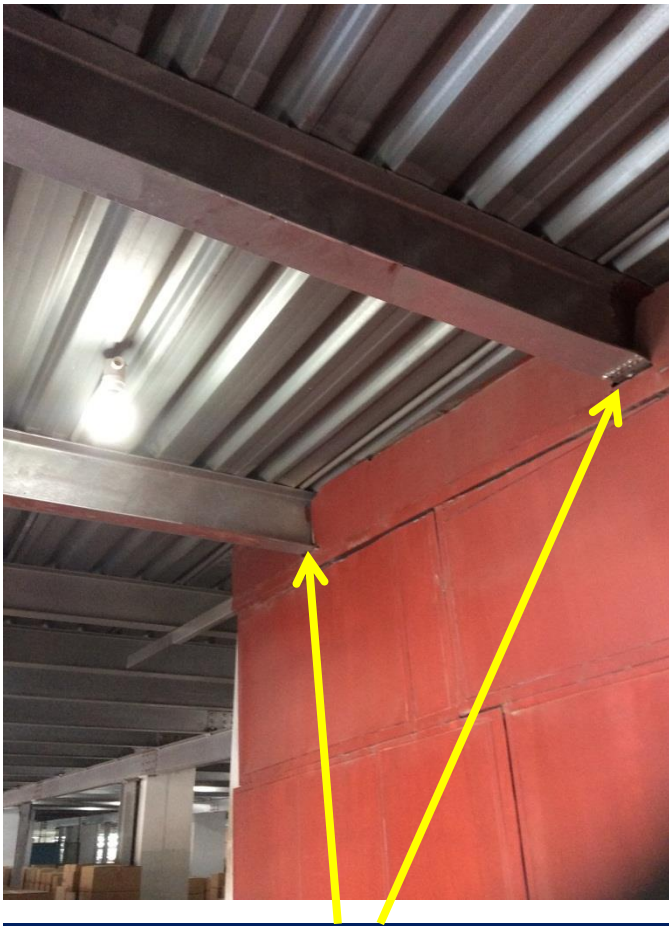
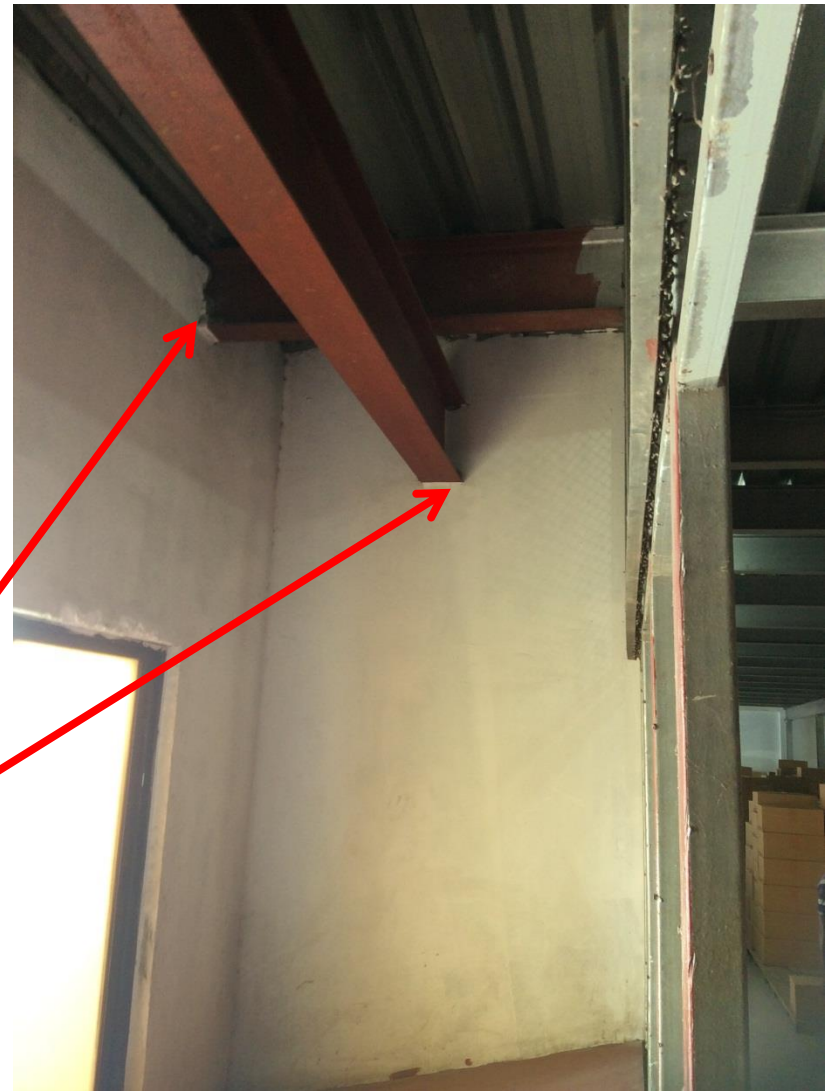
**Building Engineer to confirm how steel beams are supported at walls.**

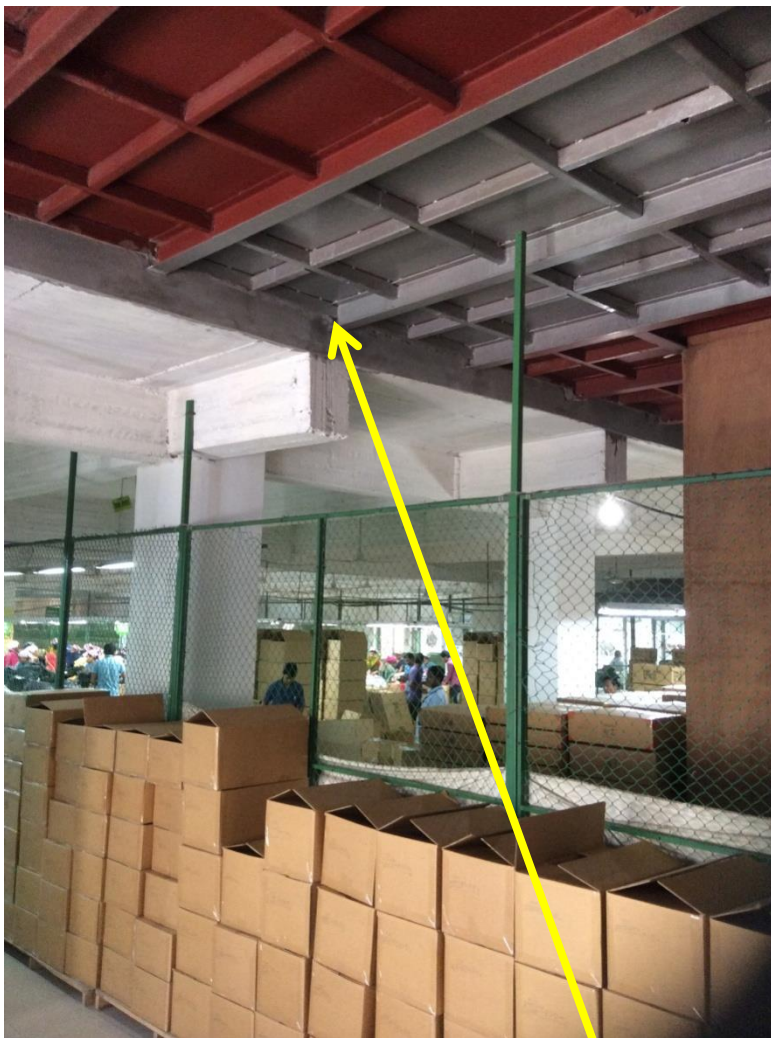
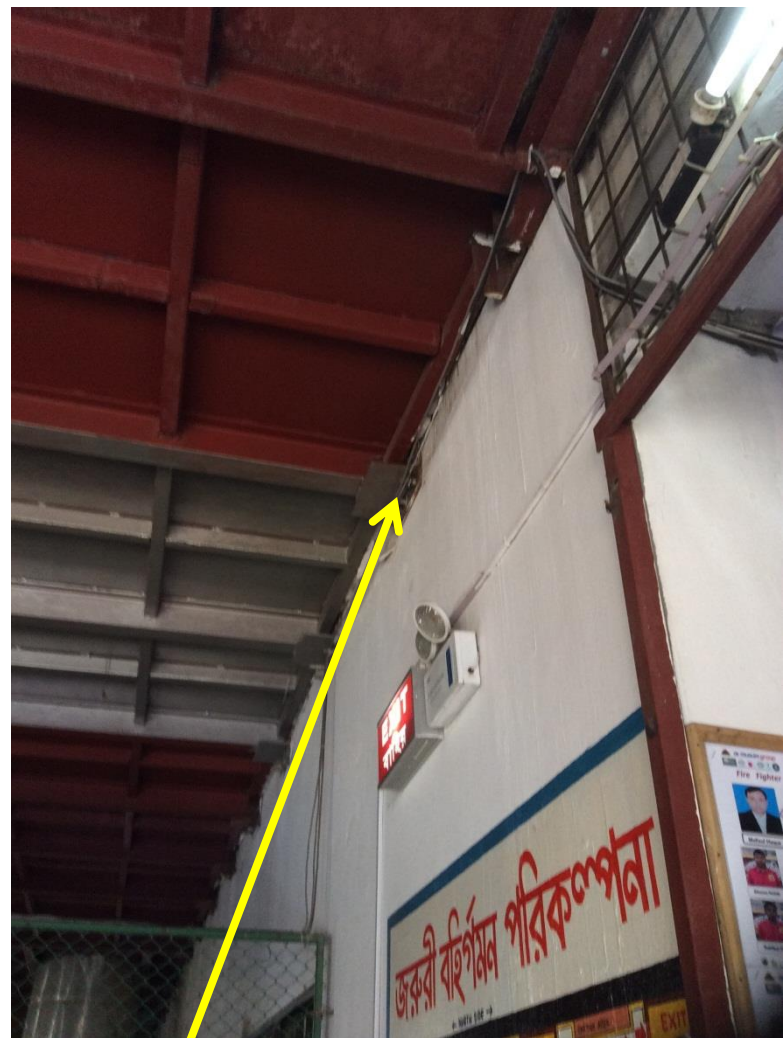
**Building Engineer to confirm adequacy of connection of steel infill slab to concrete structure either side.**

Engineer to confirm connection of steel structure to water tank slab and to check slenderness of column.

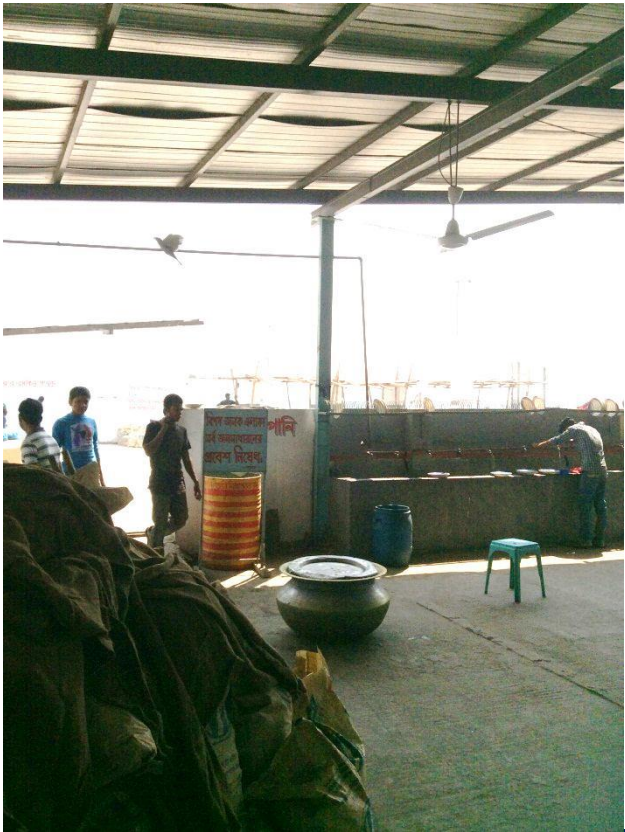
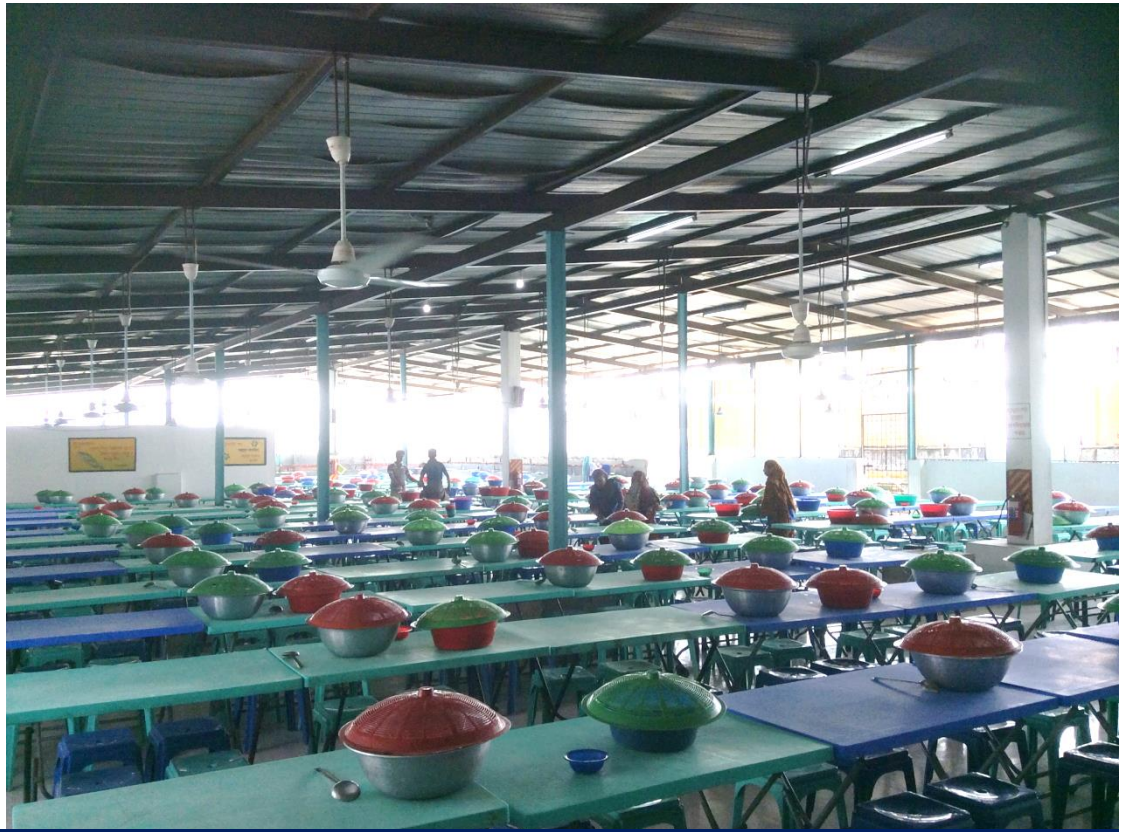
**Accessories Building - Stability of steel  
roof to dining area to be reviewed by  
Building Engineer**

**Roof structure to Dining Area, may be susceptible to wind uplift.  
Building Engineer to review.**

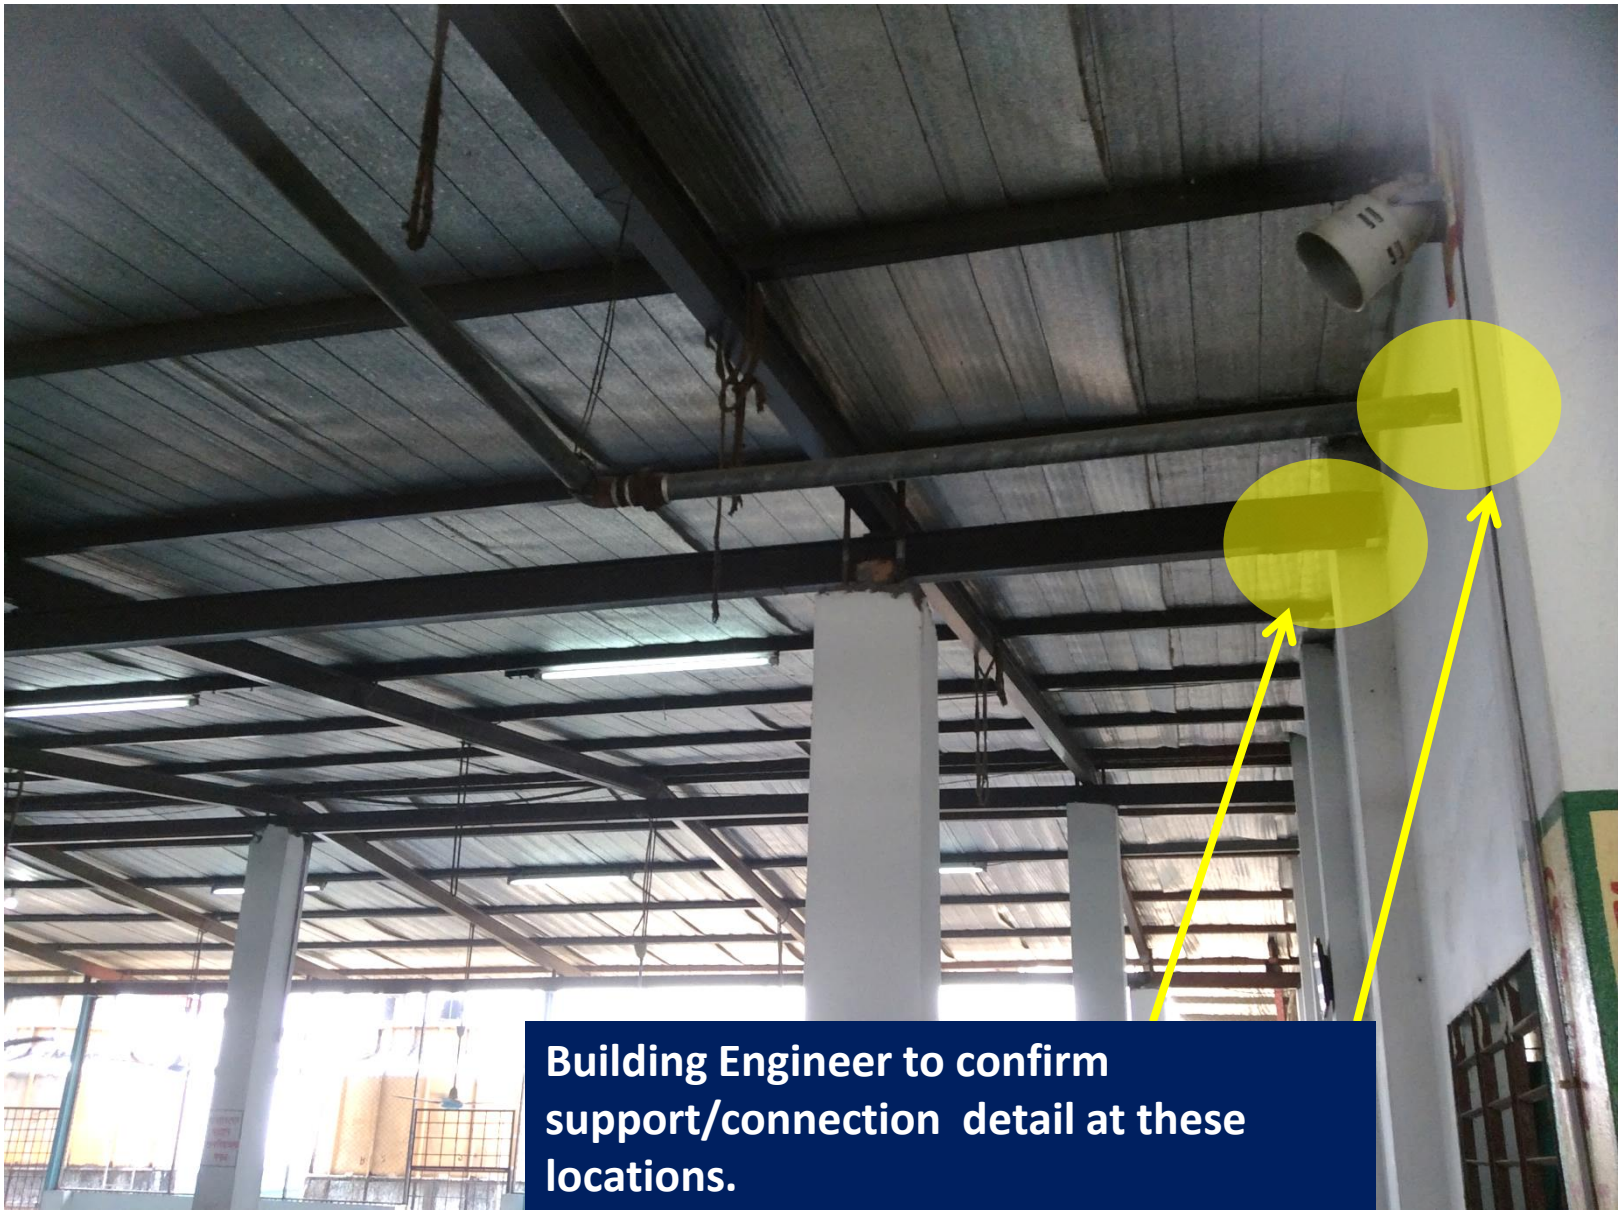
Building Engineer to confirm support/connection detail at these locations.

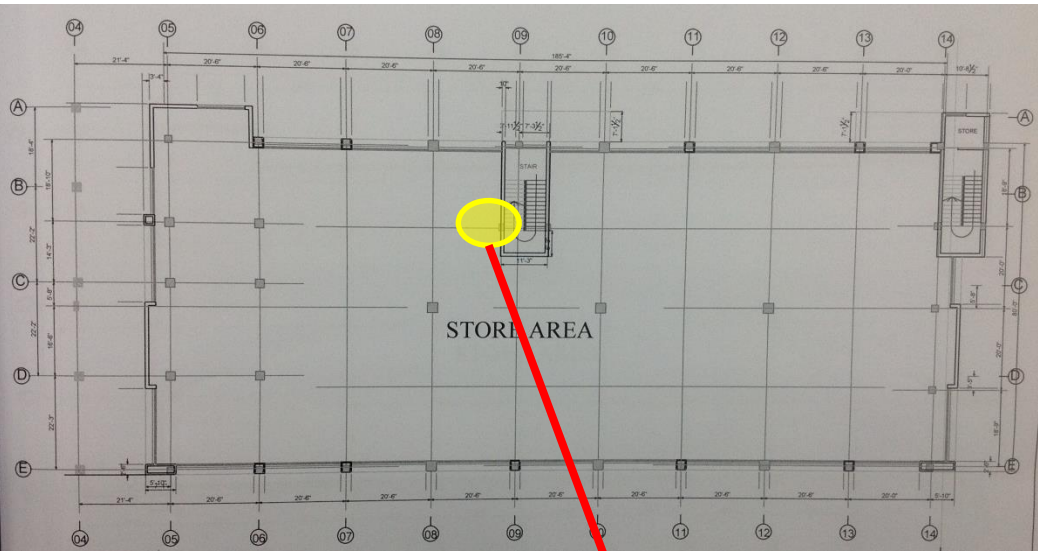
**Building Engineer to confirm connection of R.C. beams**

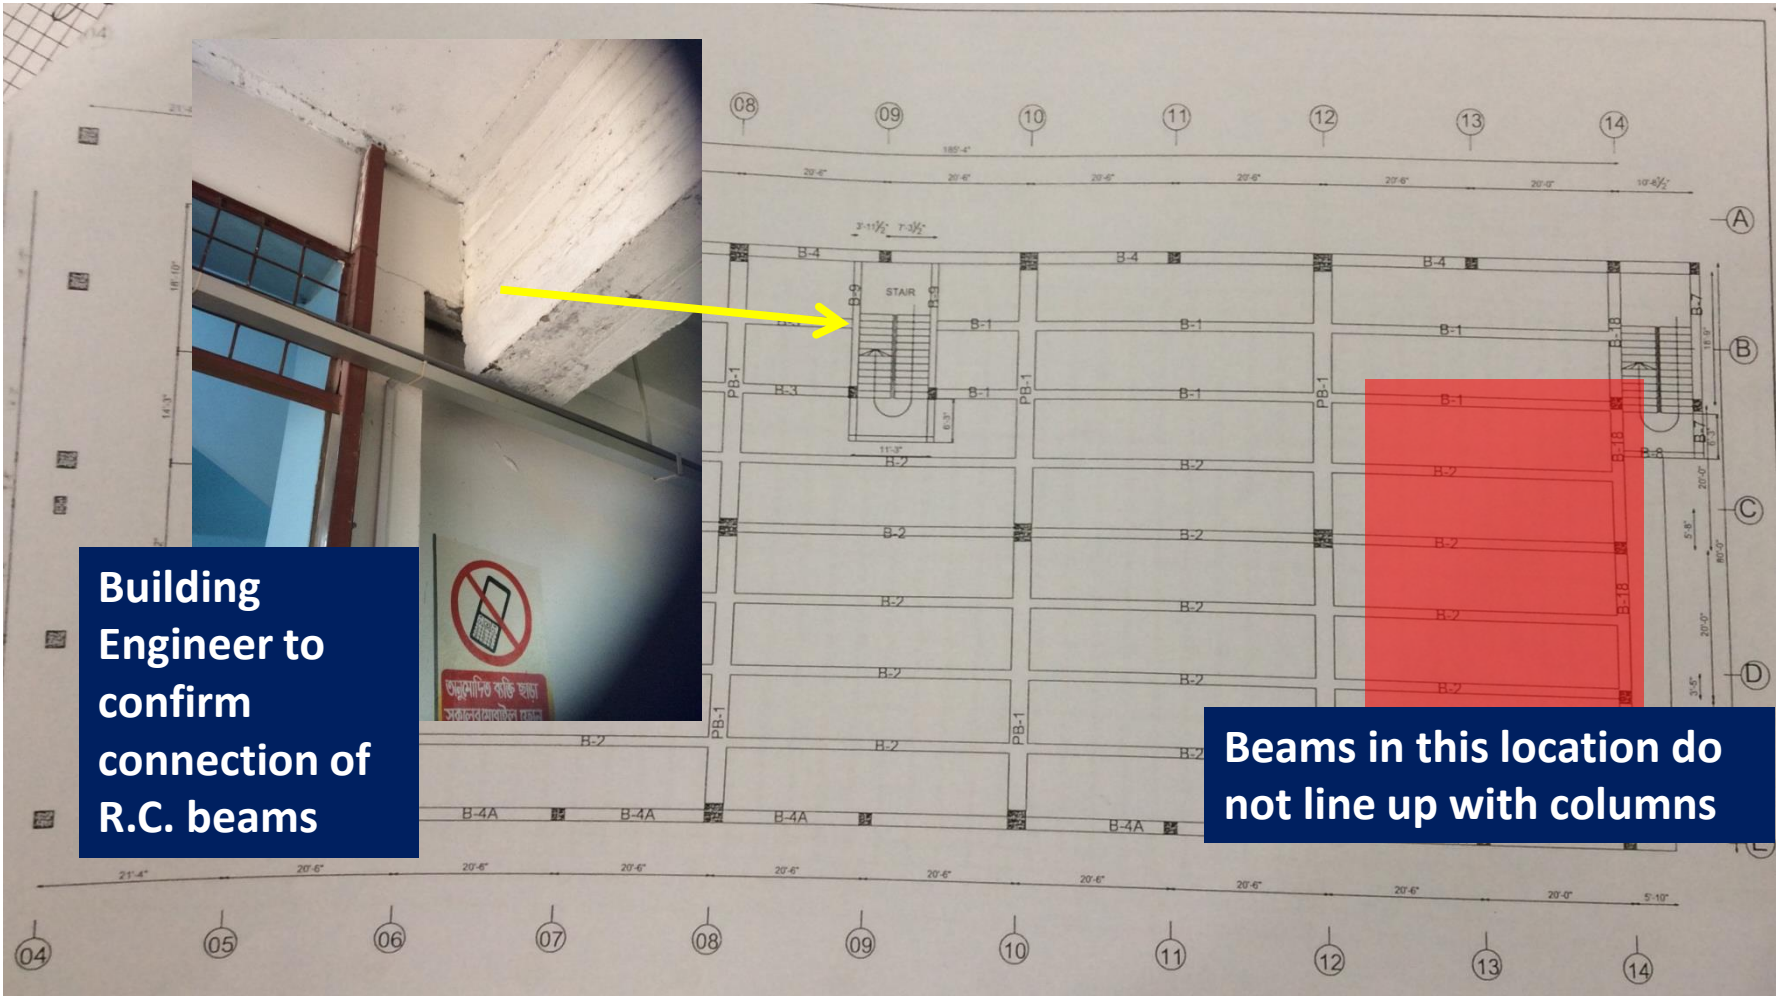
**Building Engineer to confirm connection of R.C. beams**

**Beams in this location do not line up with columns**

**Beam layout does not match as constructed layout. Some beams do not line up with columns. Engineer to confirm that the as built structure matches the design intent for beams and columns.**

14	Beam layout of 4 Storey Utility building	The concrete structure should be reviewed by the Building Engineer to show that the built structure matches the design intent. Particularly a check should be carried out on the beams that are shown on the drawings to be in line with the columns but are not in reality.	6-weeks
15	Beam layout of 4 Storey Utility building	All drawings to be revised to match built structure.	6-months

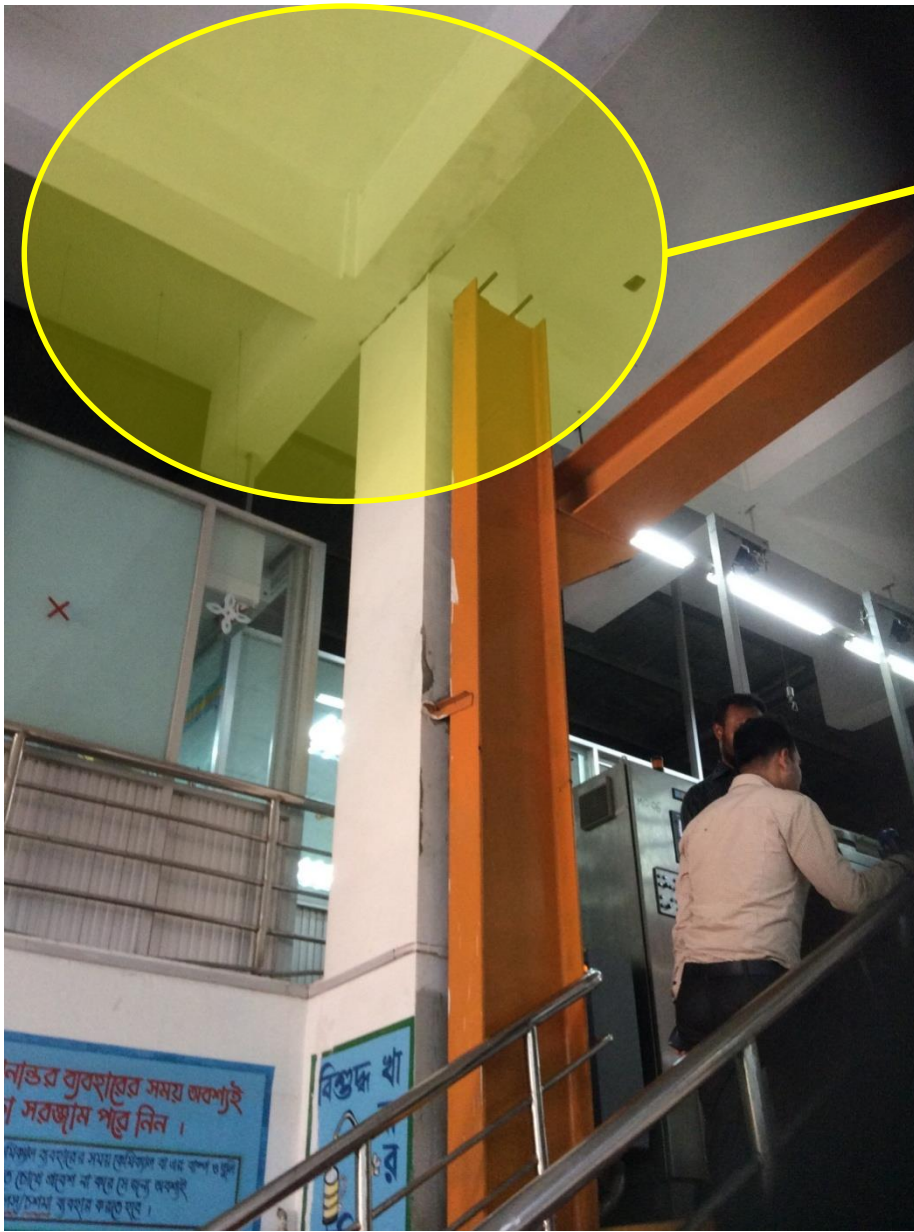
Engineer to confirm that concrete structure matches design intent.

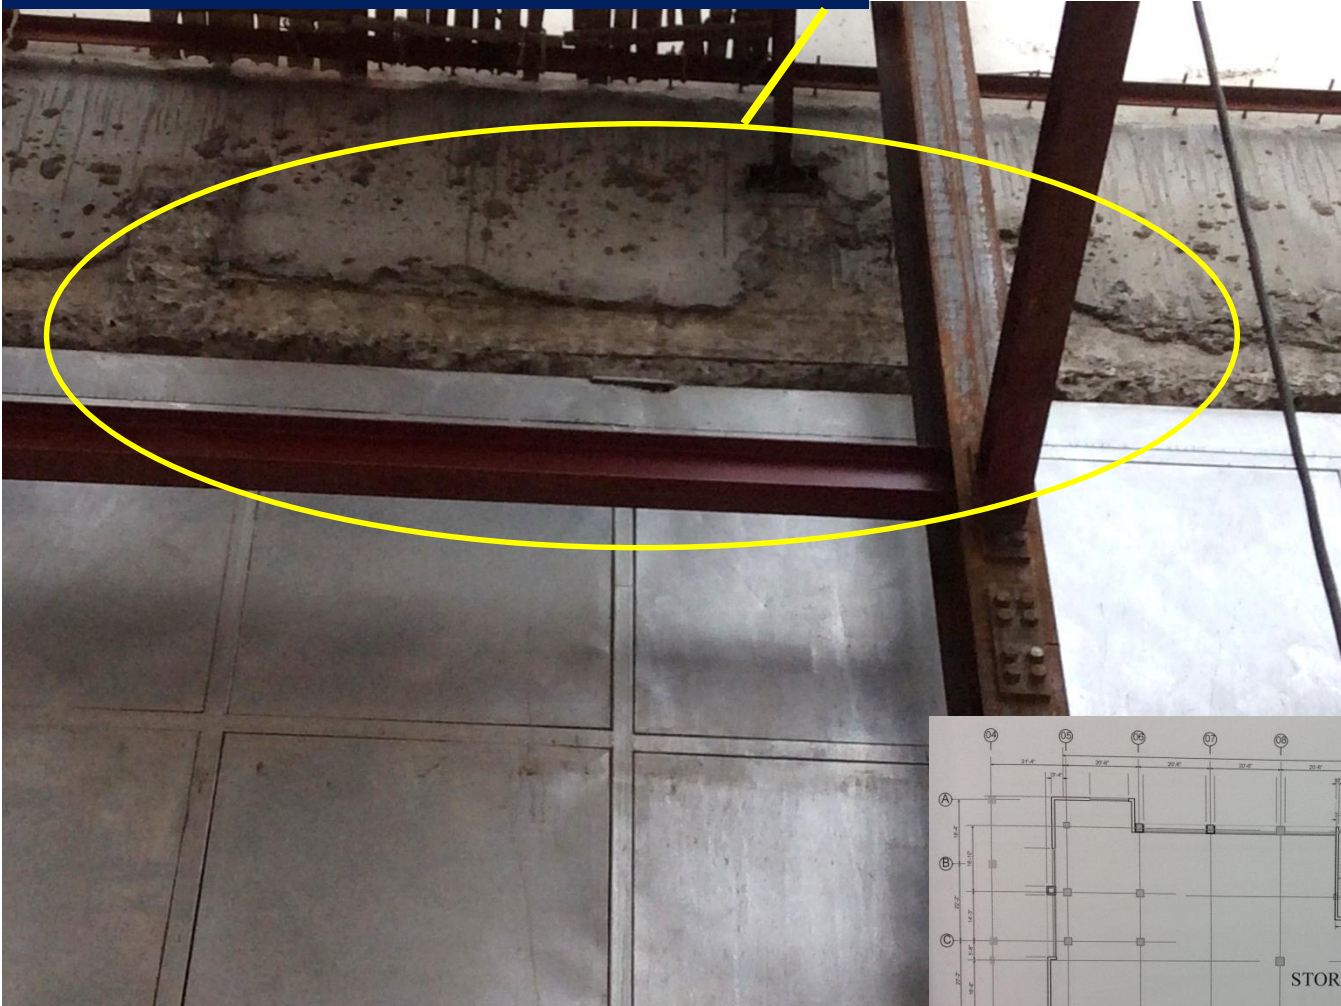
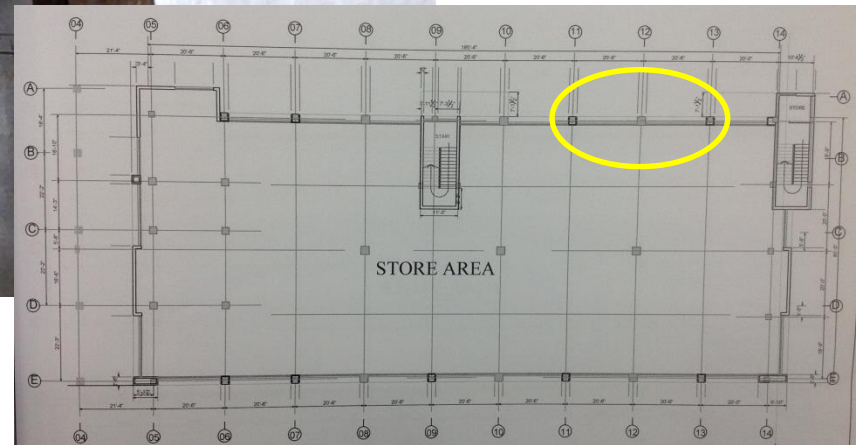
# Utility Building - Exposed Reinforcement

# Exposed reinforcement to be protected

Item No.	Observation	Recommended Action Plan	Recommended Timeline
16	Exposed Reinforcement	Exposed reinforcement should be protected with suitable resin	6-months
17	Management of storage loads	Produce and actively manage a loading plan for all floor plates within the factory giving consideration to floor capacity and column capacity.	6-weeks
18	Management of storage loads	Continue to implement load management plan	6-months
19	Columns at ground floor level of chemical store are susceptible to vehicle impact	Column to be protected from vehicle impact.	6-weeks
20	Stability and connections in steel structures	Building Engineer to provide calculations to prove adequacy of as-built structures. Stability of all steel structures to be reviewed and upgraded where required. All connections in steel structures to be checked and upgraded where required.	6-weeks
21	Stability of lightweight steel canopy adjacent to Utility Building	Lightweight steel canopy should be reviewed by the Building Engineer and, if required, upgraded to support code vertical and wind loads or the area should be vacated and removed.	6-weeks

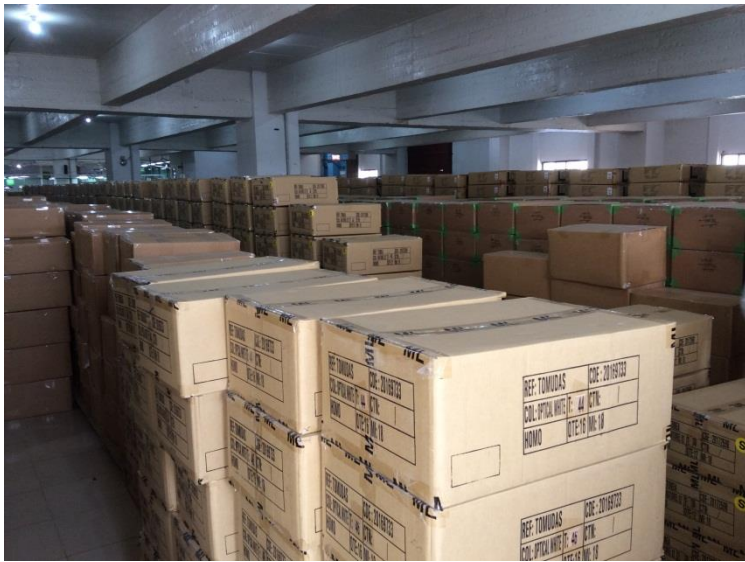
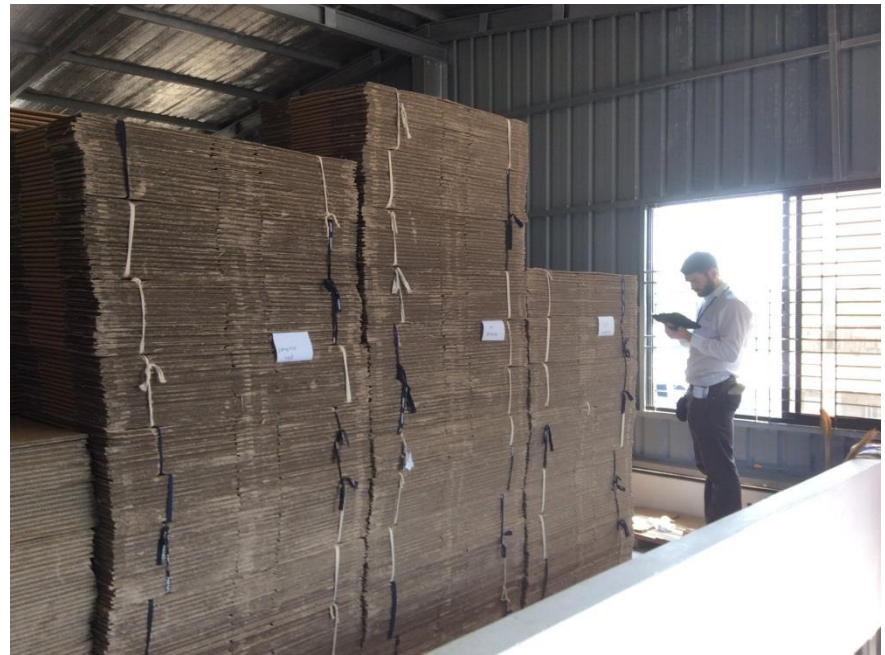
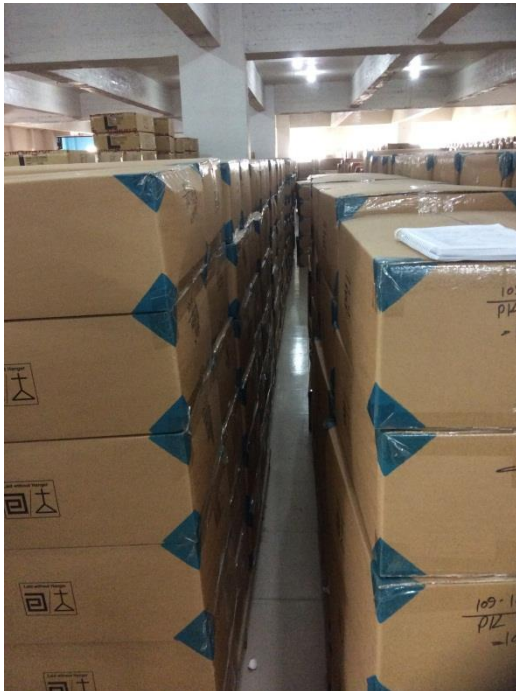
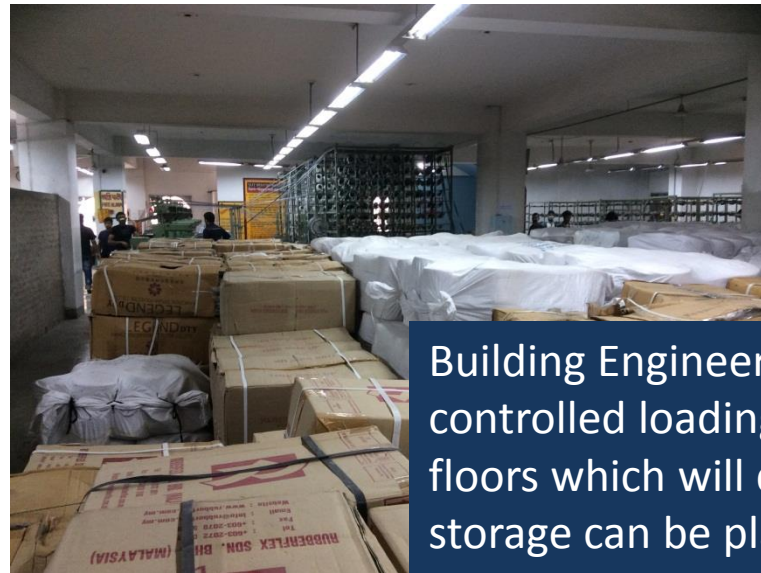
# Accessory & Utility Building - Load Management Plan Required.

Building Engineer to prepare controlled loading plans for all floors which will designate where storage can be placed.

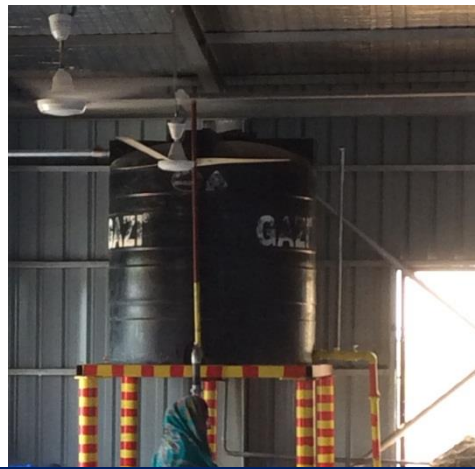
Engineer to review adequacy of structure to carry water tank
