# AKM Knit Wear Ltd

14 Gedda, Karnapara, Ulail, Savar, Dhaka 1340  
(23.82743N, 90.25867E)

23 March 2014, 02 April 2014

# Observations

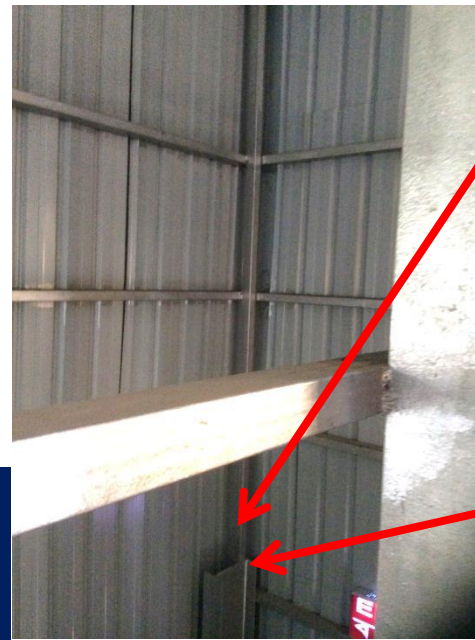
Façade of Chemical Store is tack welded to top of column.

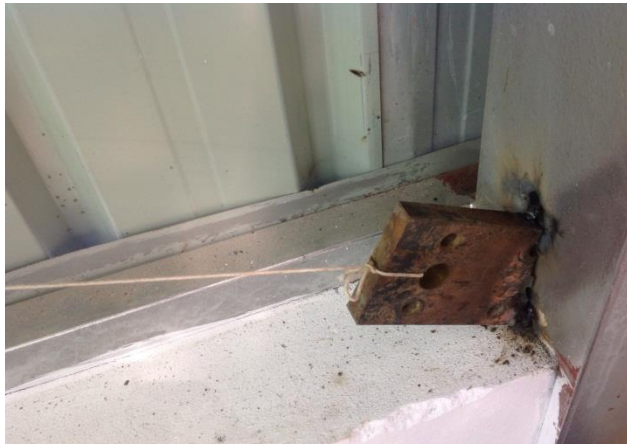
Bracing details not evident in several locations – Engineer to review

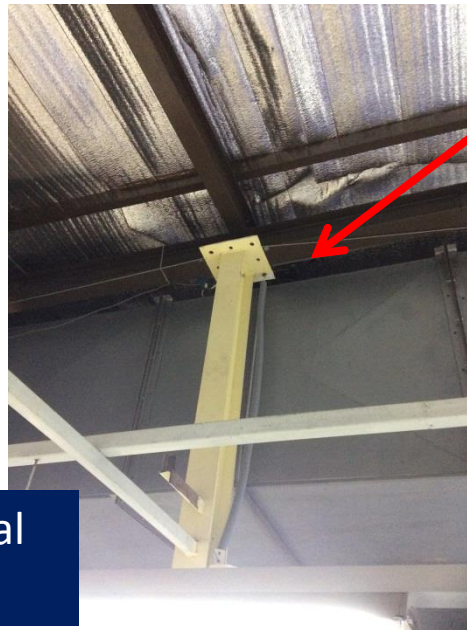
Connection Detail unknown

Engineer to review stability and connection details on all steel structures.

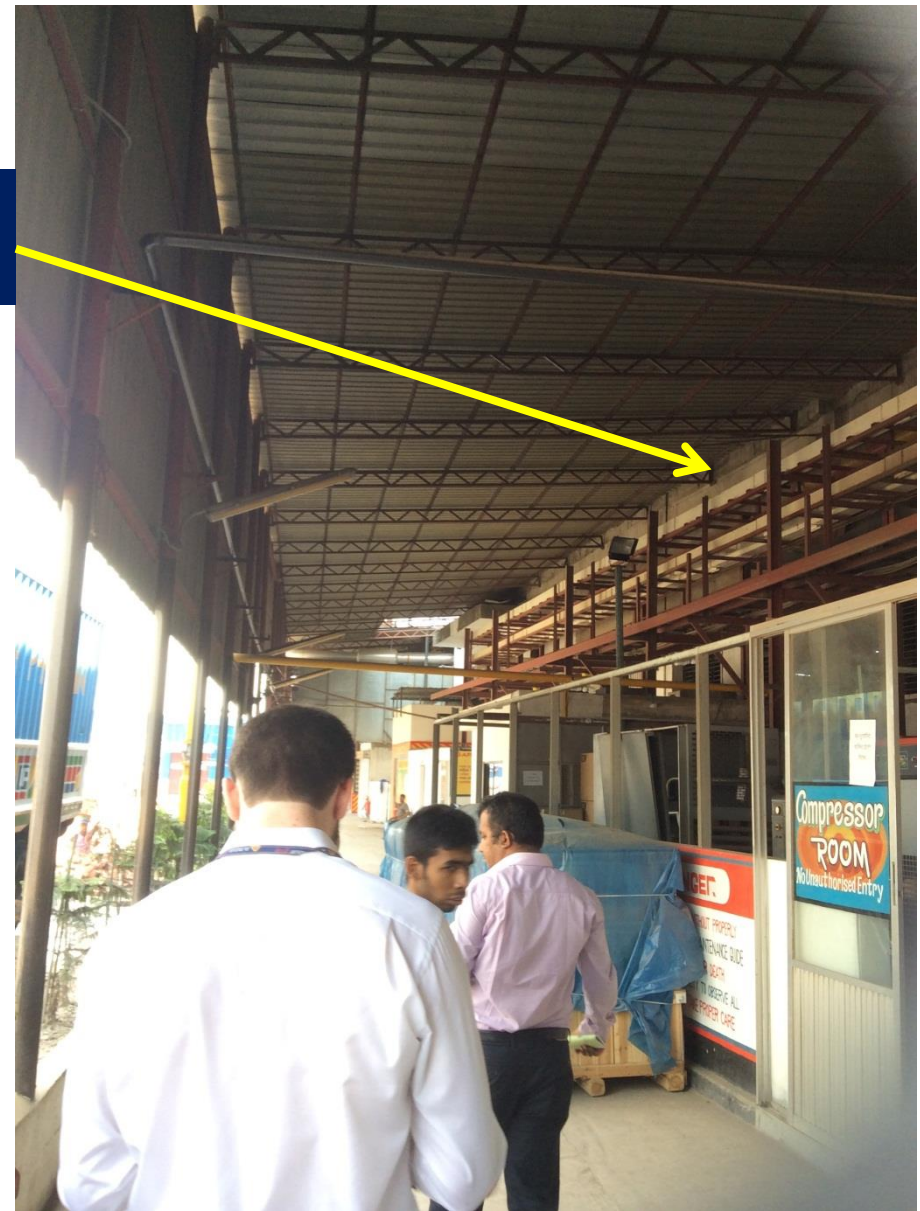
# Lightweight Steel Canopy – Adjacent to Utility Building

Engineer to assess stability and connections of lightweight steel canopy.
