# Panasia Sweaters Ltd

## Panasia Clothing Ltd

Vogra, National University, Gazipur, Dhaka  
(23.98077N, 90.37905E)

22 October 2013

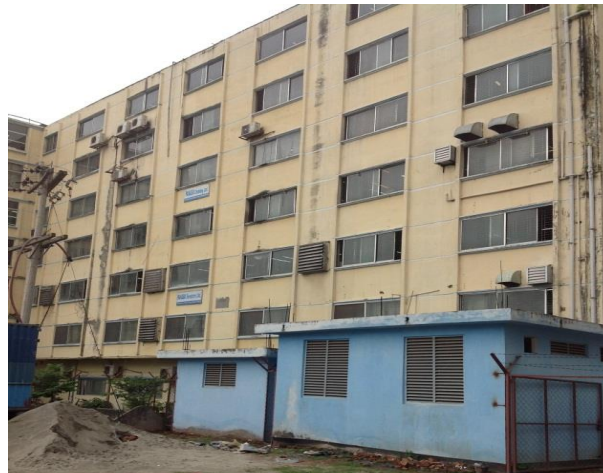
**Stub columns presumably  
to accommodate new Steel  
Roof to 7<sup>th</sup> Floor Level**

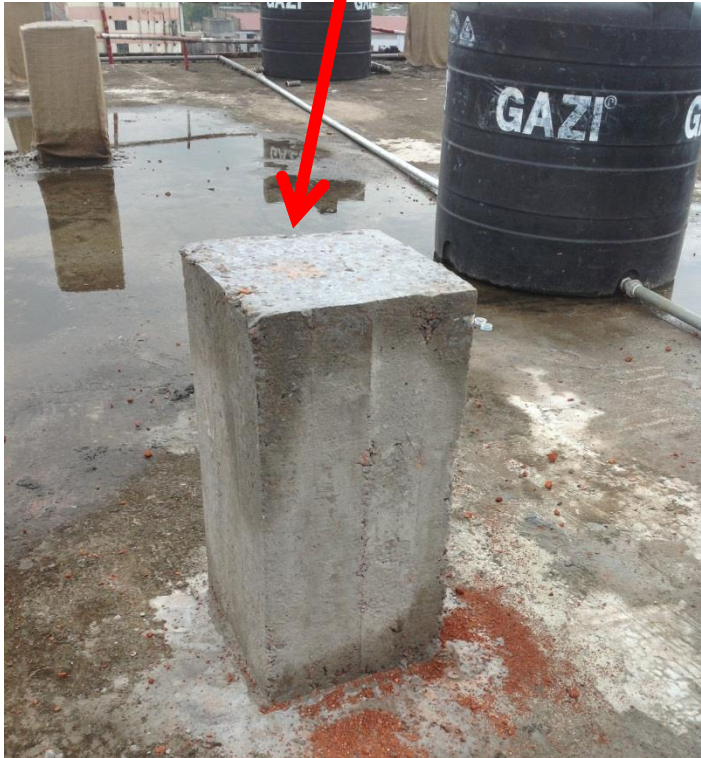
**17 total 2000 litre tanks  
located on roof – in places  
2 per span, located  
midspan.**

| Item No. | Observation | Recommended Action Plan | Recommended Timeline |
|---|---|---|---|
| 2 | Lack of drainage and water tank loading on the roof slab | Get engineer to check whether loading from water tanks in their present locations can be safely carried by 7th Floor slab | 6-months |

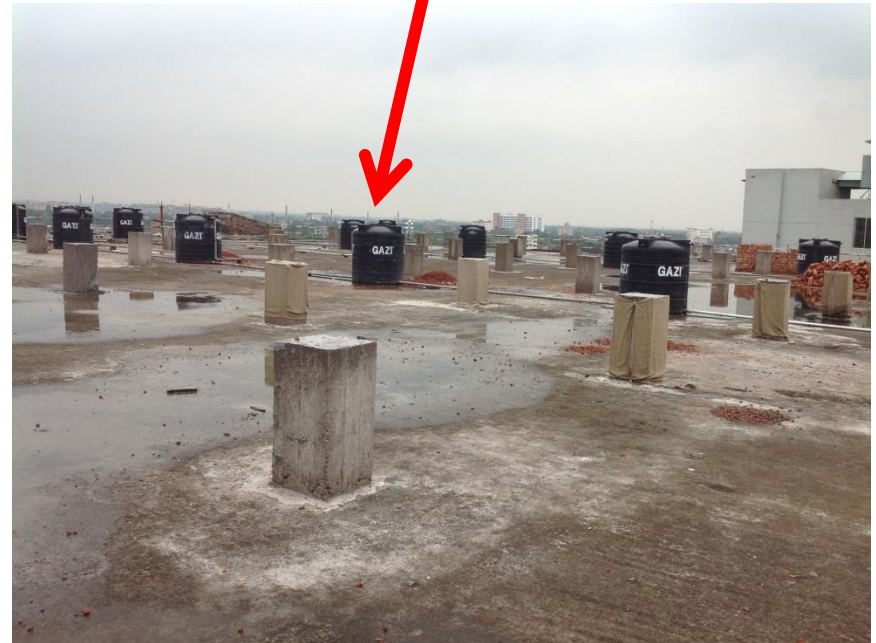
**Lack of drainage and water  
tanks loading of 7<sup>th</sup> Floor Slab**

| Item No. | Observation | Recommended Action Plan | Recommended Timeline |
|---|---|---|---|
| 1 | Lack of drainage and water tank loading on the roof slab | Construct drainage system to remove standing water from roof | 6-months |

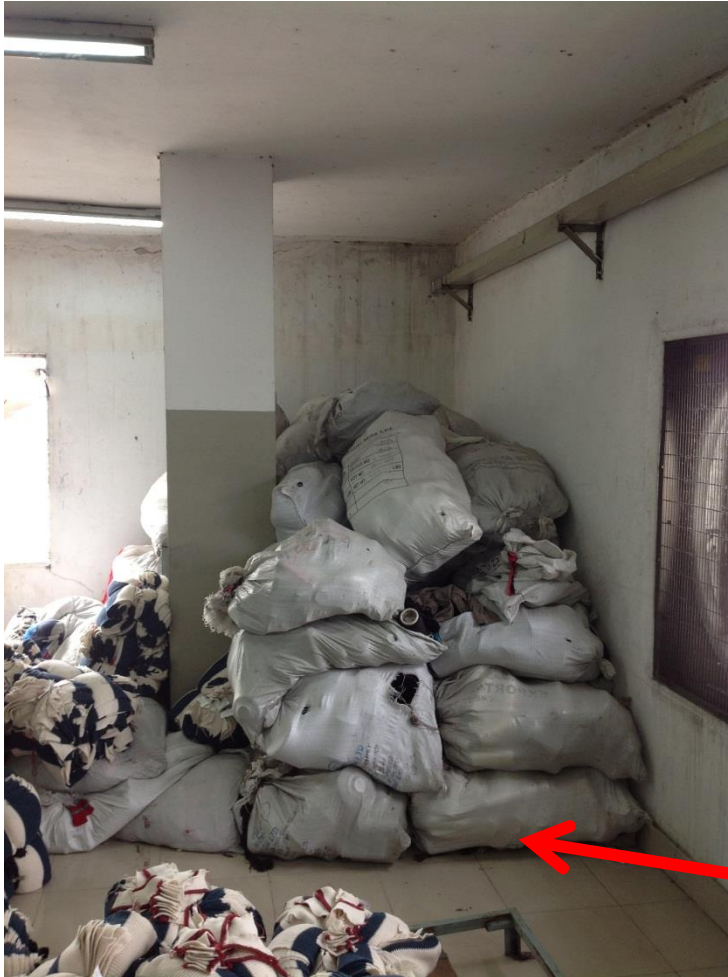
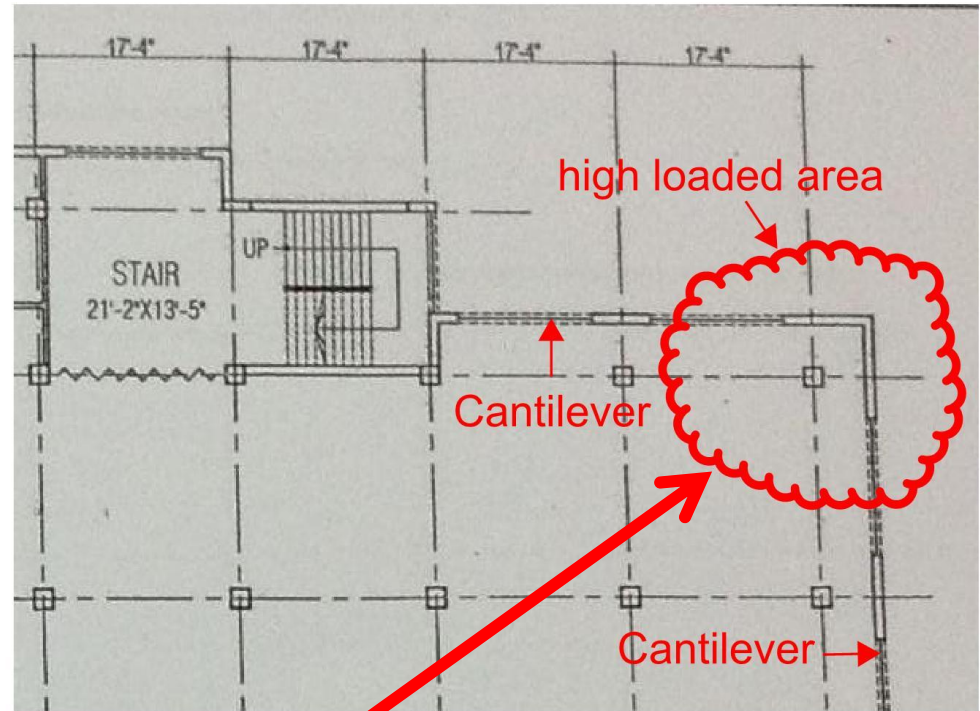
Floor Slab Cantilever subjected to heavy loading. Load needs to be limited to design load by e.g.. limiting stack height

Cantilever Slab at South-West corner of 6<sup>th</sup> Floor. Check loading

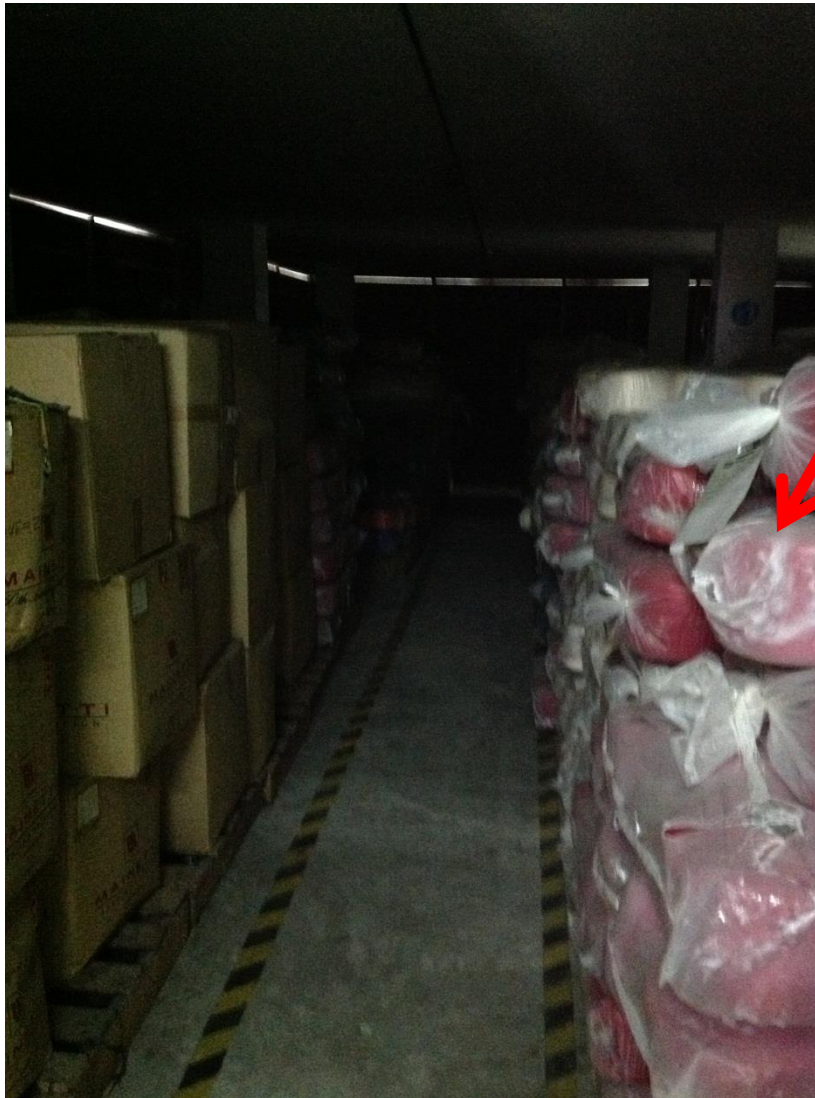
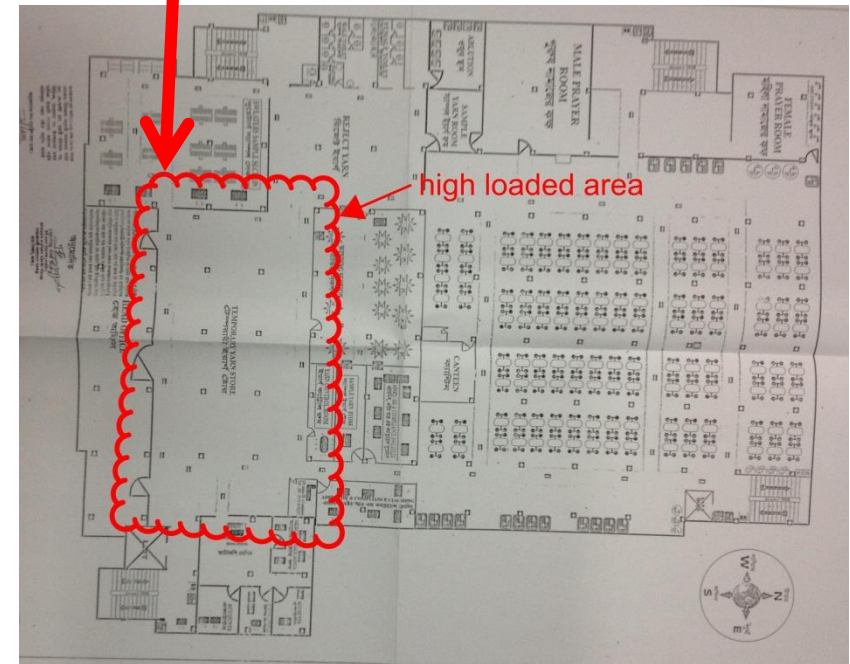
Estimated loading well in excess of documented design load of  $4.25 \text{ kN/m}^2$ . Load needs to be limited to design load by e.g.. limiting stack height or providing  $0.5\text{m}$  wide walkways around  $1.5 \times 1.5 \text{ m}^2$  stacks

**Excessive loading in Temporary Yarn Store on 5<sup>th</sup> Floor**

| Item No. | Observation | Recommended Action Plan | Recommended Timeline |
|---|---|---|---|
| 3 | Heavy storage loading in the Temporary Yarn Store on 5th Floor | Limit loading in this area to maximum permissible design load, by e.g. limiting stack height or providing 0.5m wide walkways around 1.5 x 1.5 m <sup>2</sup> stacks, maximum 2m high | 6-months |
| 4 | Heavy storage loading in the Temporary Yarn Store on 5th Floor | Create controlled loading plans for all floors designating where storage can be placed and can not be placed | 6-months |

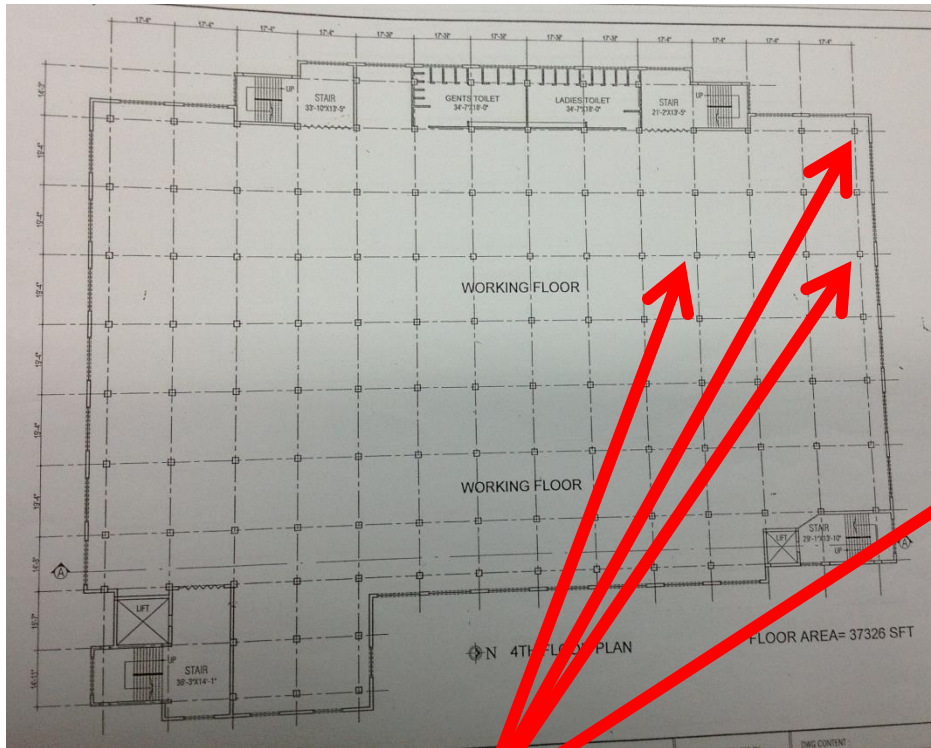
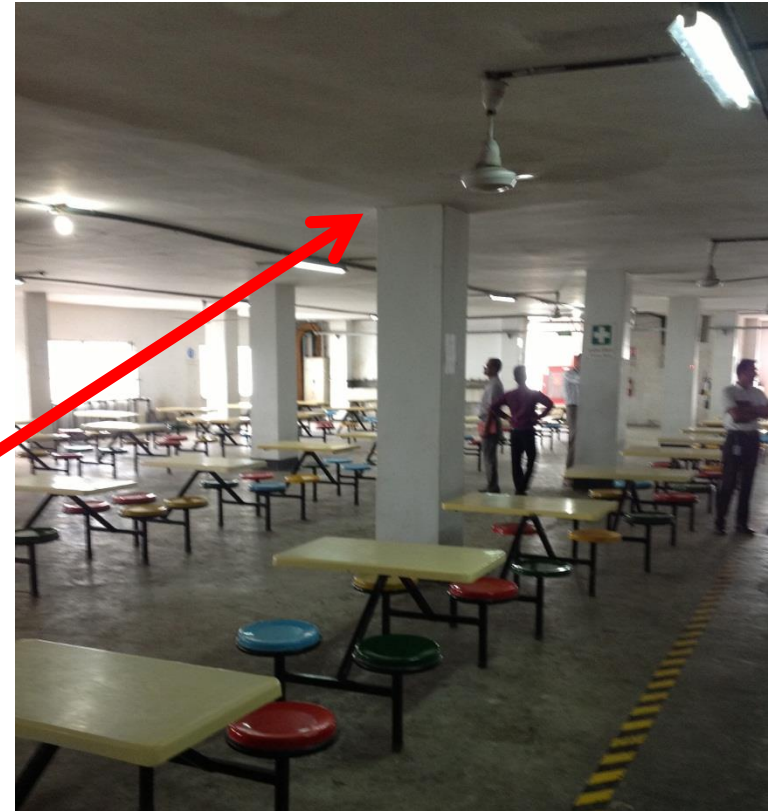
## Punching Shear Stress over Columns

**Cursory Punching shear checks done showing sufficient load carrying capacity for factory design loading as certified ( $4.25 \text{ kN/m}^2$ )**

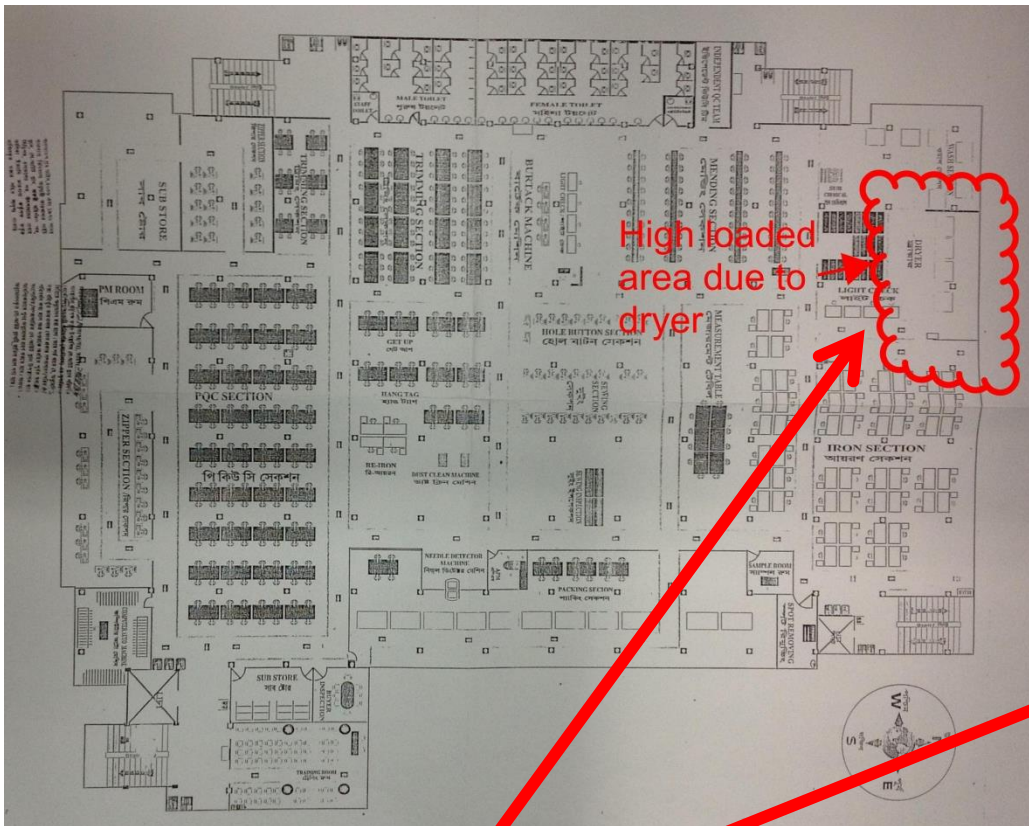
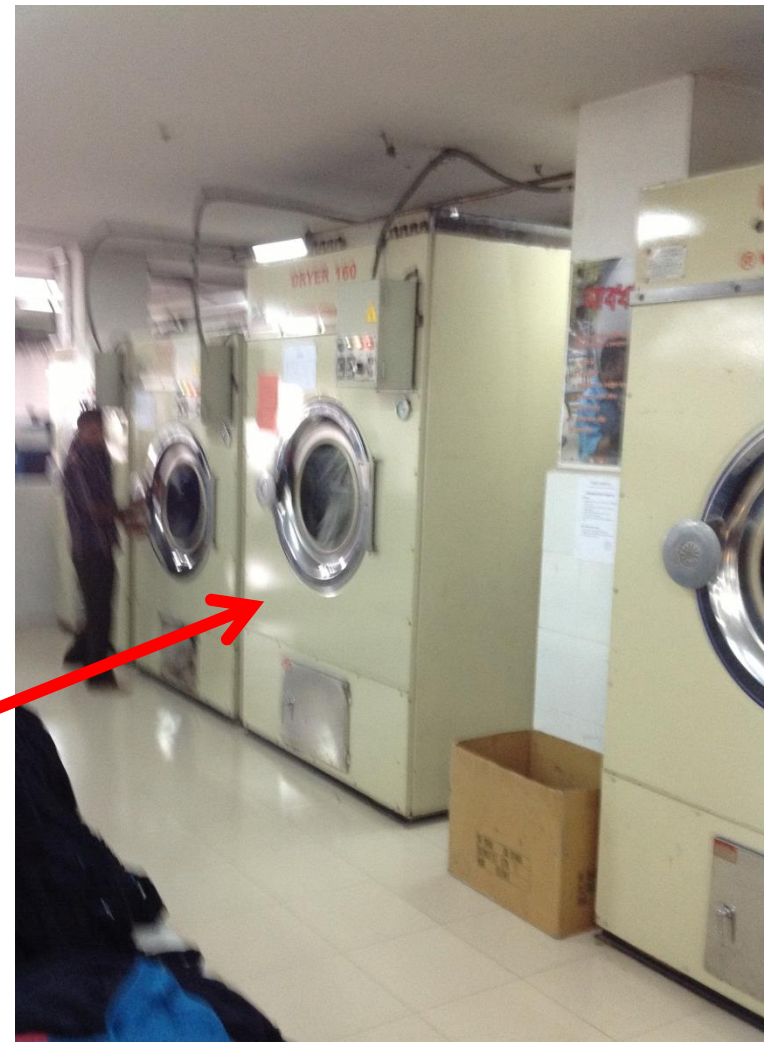
**Washing and Drying area at 1<sup>st</sup> Floor**

**Floor Slab to be checked for additional 150mm floor build-up and Washing & Drying machine loading**

| Item No. | Observation | Recommended Action Plan | Recommended Timeline |
|---|---|---|---|
| 5 | Loading from 150mm floor build-up and Washing & Drying machines in the SW corner of 1st Floor | Calculate loading due to additional floor thickness, and determine machine loadings. Engineer to justify that the existing slab capable of supporting these loads | 6-months |

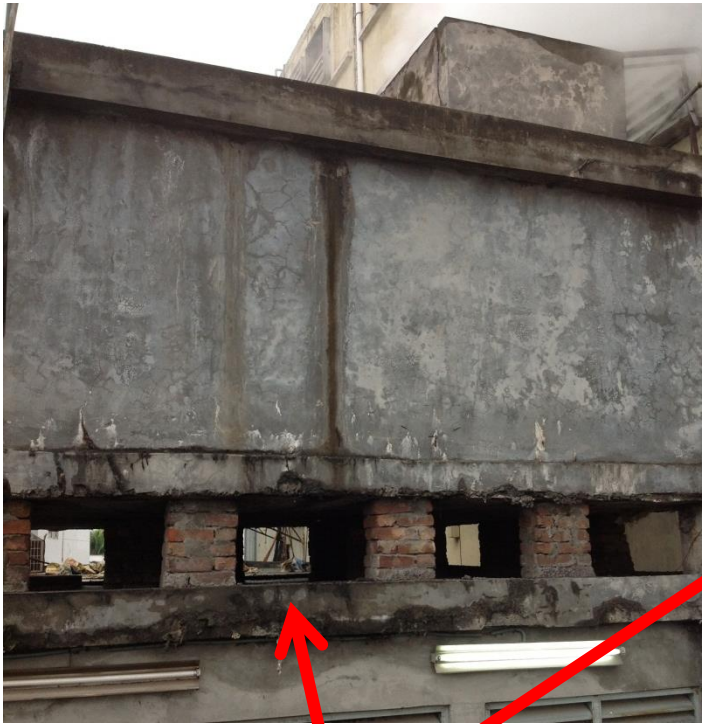
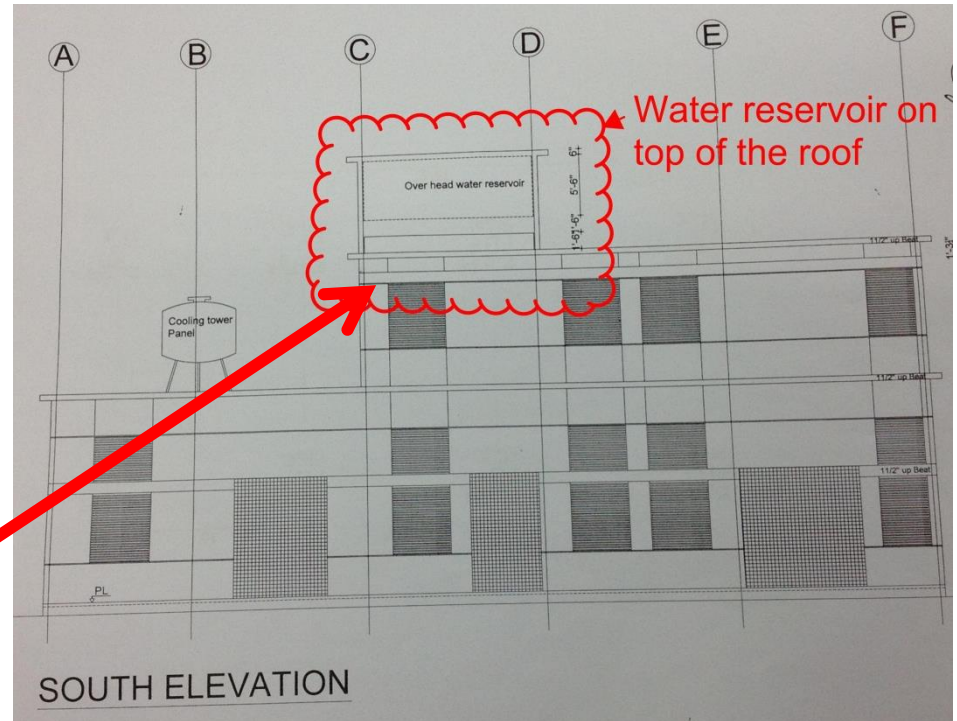
**1<sup>st</sup> Floor roof slab to be checked for safe carrying capacity of point loads from brick piers above**

**Water reservoir supported by brick piers resting on roof slab over Compressor room in Utilities building**

| Item No. | Observation | Recommended Action Plan | Recommended Timeline |
|---|---|---|---|
| 6 | Water reservoir supported by brick piers on roof slab over Compressor room in Utilities building | Check the capacity of the water reservoir slab to determine reason for brick pier supports. Check that 1st Floor roof slab can safely carry point loads from brick piers above | 6-months |
