# Fortis Garments Ltd. Extended Building

Holding No-100/1, Block B, Saheed Mosarraf Hossain Road,  
Purbo Chandora, Sofipur, Kaliakoir, Gazipur.

2<sup>nd</sup> September 2019

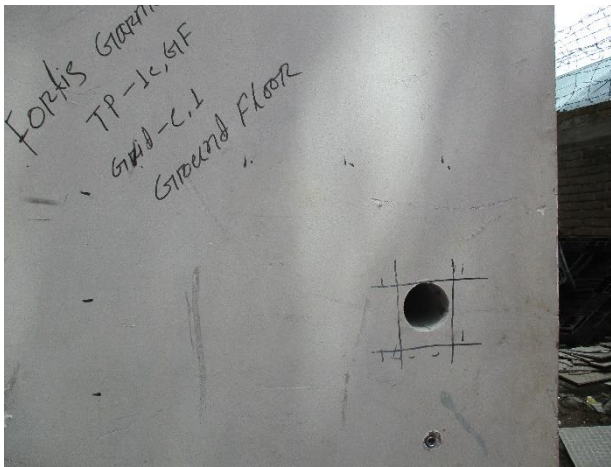
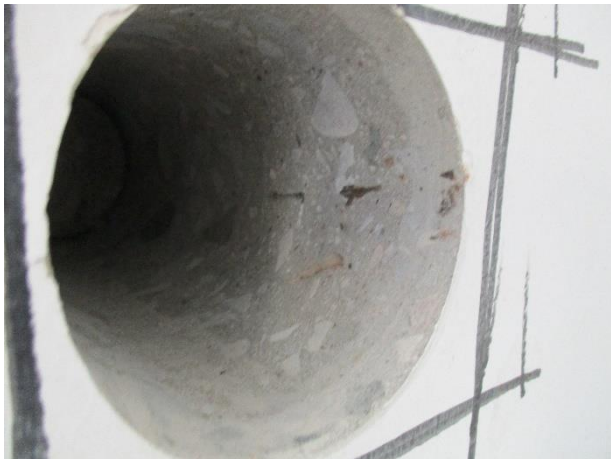
Concrete core cutting from the column of Medical Building

Concrete core samples have been taken from the column and beam of the Medical and Sub-station building. The void of core cutting had not been filled with proper materials. The factory is required to take immediate step to fill the voids.

| Item No. | Observation | Recommended Action Plan | Recommended Timeline |
|---|---|---|---|
| 6 | Concrete core hole remaining unfilled (Medical and Sub-station Building) | Fill the void in the concrete column and beams with appropriate filling material. | Immediate - Now |
| 7 | Concrete core hole remaining unfilled (Medical and Sub-station Building) | The factory engineer is required to produce core location layout drawings for the buildings. | 6-weeks |

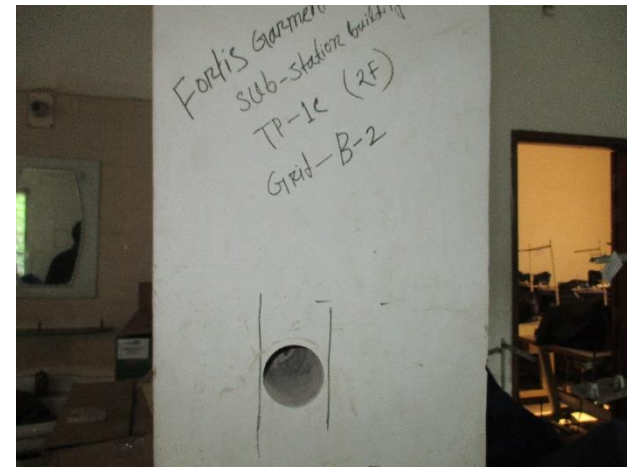
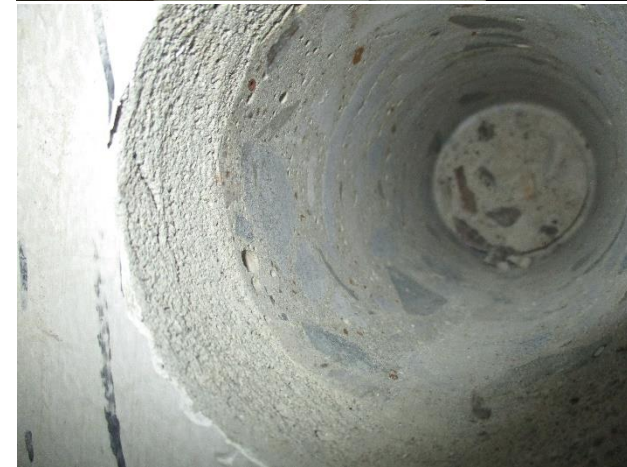
Concrete core cutting from the column of Sub-station Building

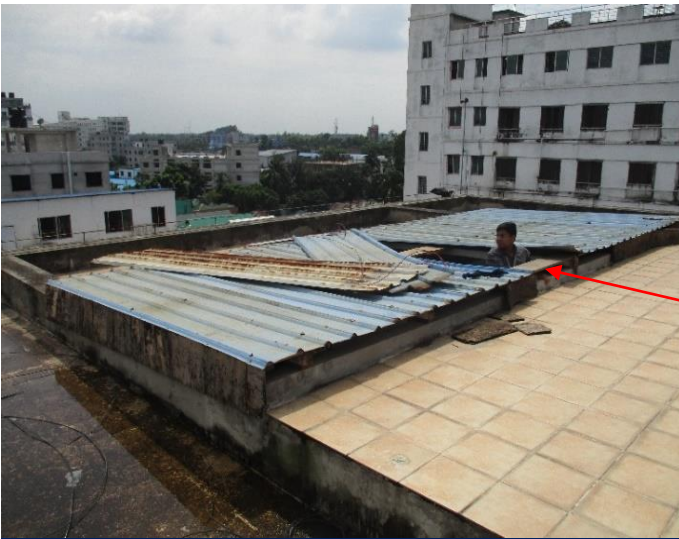
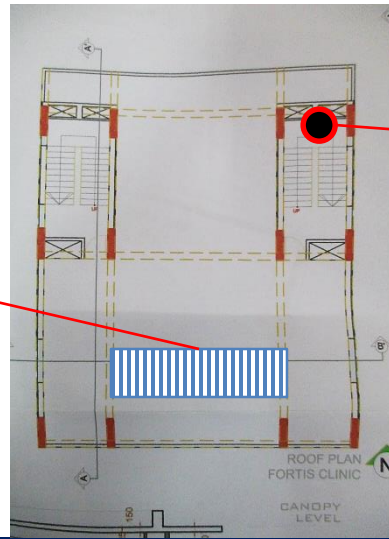
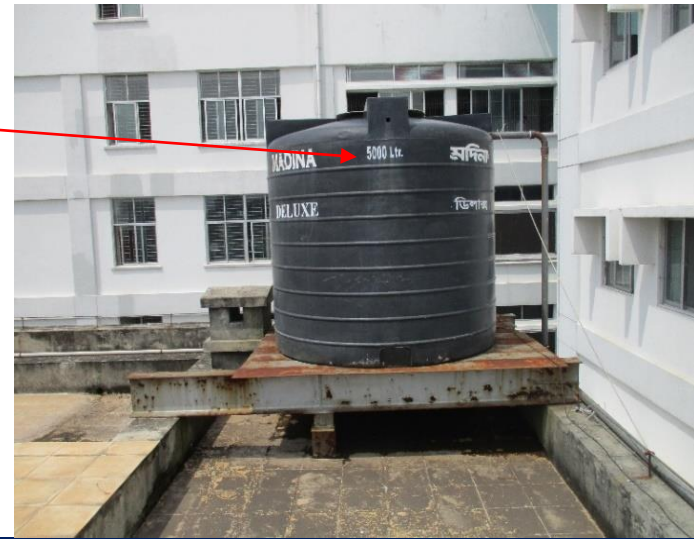
Undocumented lightweight roof and plastic water tank was observed on the roof of Medical Building.

| Item No. | Observation | Recommended Action Plan | Recommended Timeline |
|---|---|---|---|
| 8 | Lack of as-built documents (Medical and Sub-station Building) | The factory engineer is required to survey the structures and produce as-built drawings for the buildings. | 6-weeks |

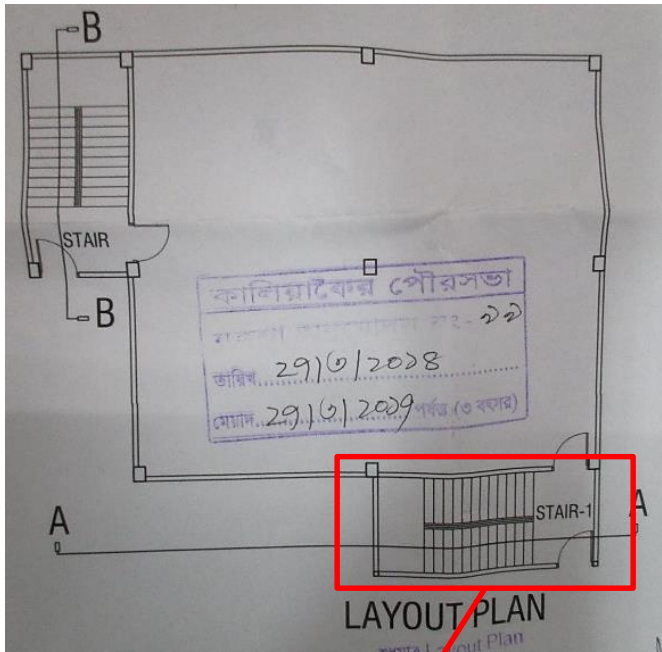
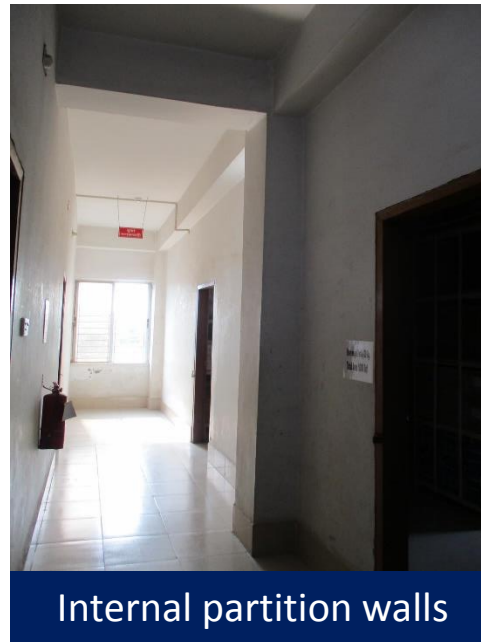
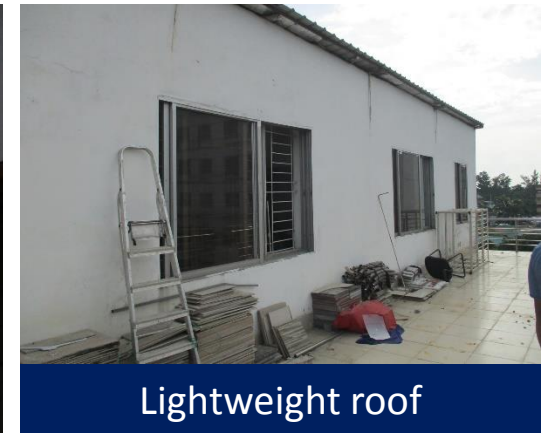
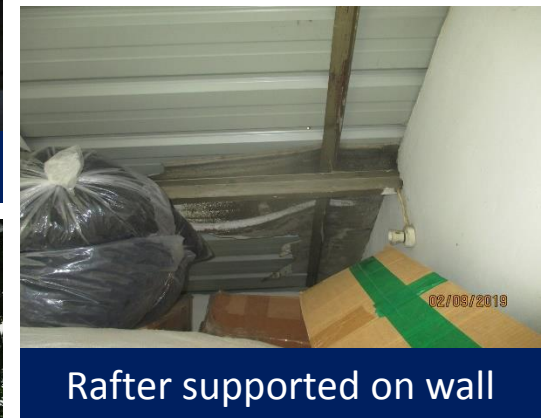
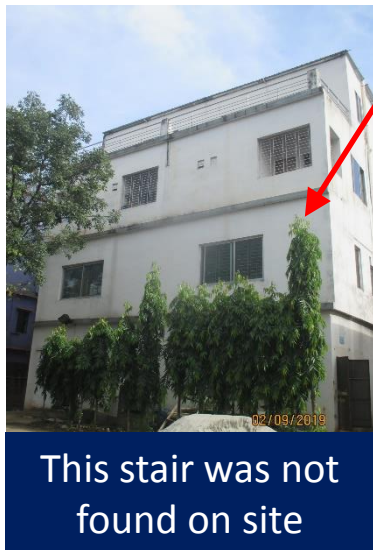
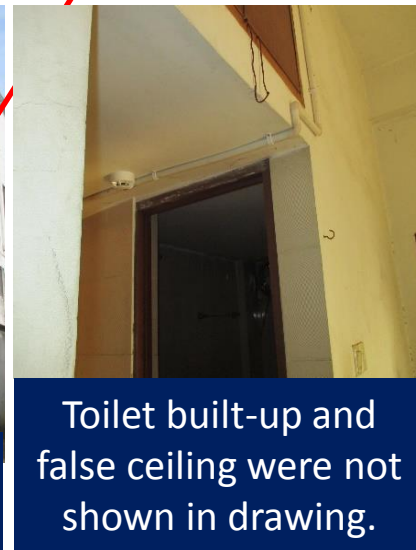
There was no beam layout drawing for the Sub-station Building. Also, discrepancies were found between as-built condition and provided drawings.

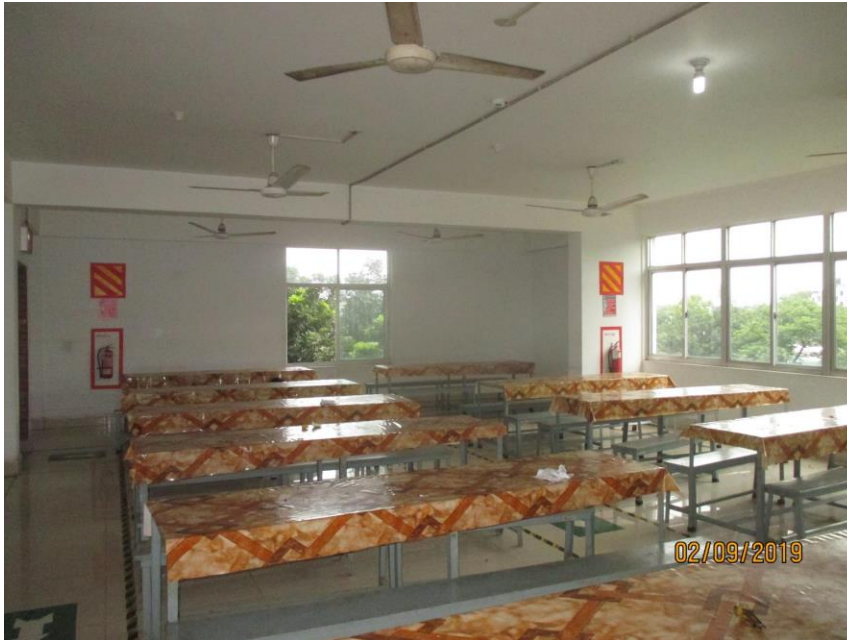
Dining area of the Medical Building.

There was no floor loading plan for the Medical and Sub-station building. During inspection, floor loading more than 3 kPa was observed in the sub-station building. The factory is required to produce floor loading plan for each floor of the buildings.

| Item No. | Observation | Recommended Action Plan | Recommended Timeline |
|---|---|---|---|
| 9 | No floor loading plan (Medical and Sub-station Building) | The factory engineer is required to produce floor loading plan for each floor considering floor, column and foundation capacity. | 6-weeks |
| 10 | No floor loading plan (Medical and Sub-station Building) | Implement the floor loading plan with proper sign and instructions. | 6-months |

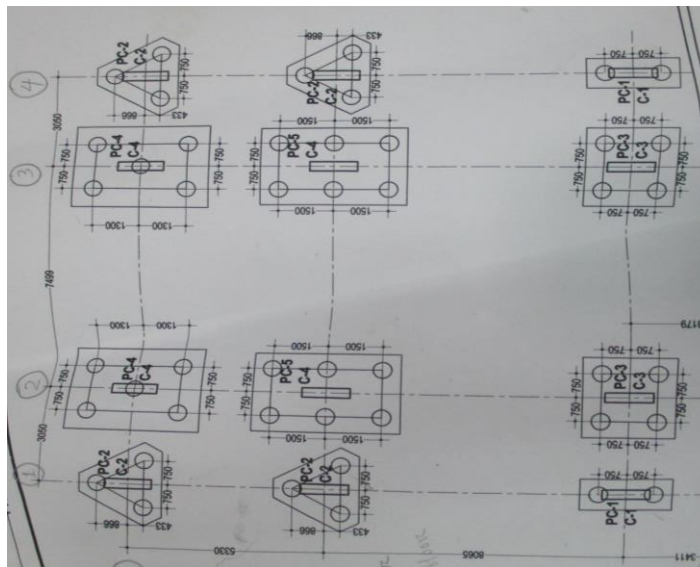
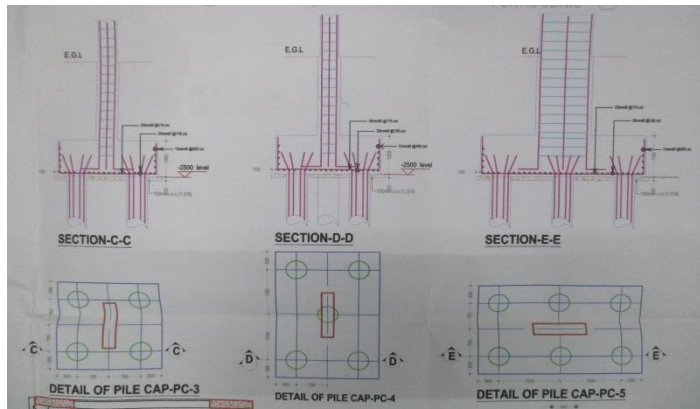
Foundation detail of Medical Building.

The soil investigation report was not available on site. So, the foundation capacity could not be verified. The factory is required to investigate the soil bearing capacity and verify the foundation adequacy accordingly.

| Item No. | Observation | Recommended Action Plan | Recommended Timeline |
|---|---|---|---|
| 11 | No soil investigation report (Medical and Sub-station Building) | The factory is required to investigate the bearing capacity of soil for the buildings. | 6-weeks |
| 12 | No soil investigation report (Medical and Sub-station Building) | Verify the foundation adequacy of the buildings. | 6-weeks |
| 13 | No soil investigation report (Medical and Sub-station Building) | Implement remedial actions, as necessary. | 6-months |

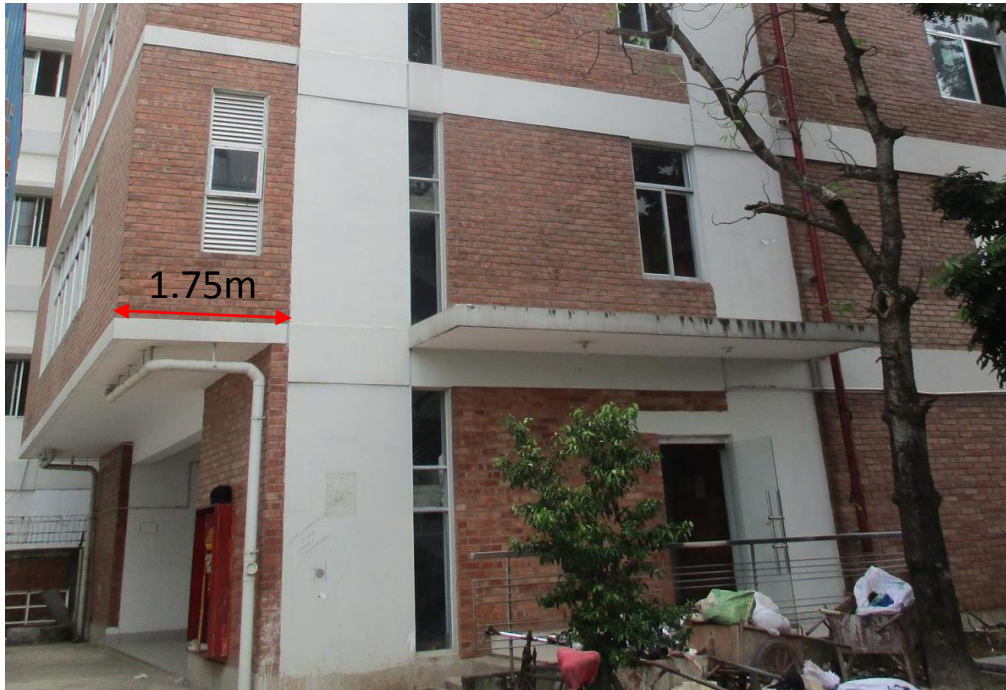
1.75m cantilever slab on north side and 1.33m cantilever slab on east & west side on Medical Building.

Cantilever slab was observed in both Medical and Sub-station Building. The factory is required to check the adequacy of the slab for the imposed loading.

| Item No. | Observation | Recommended Action Plan | Recommended Timeline |
|---|---|---|---|
| 14 | Cantilever slab (Medical and Sub-station Building) | The factory is required to check the adequacy of the cantilever slab. | 6-weeks |
| 15 | Cantilever slab (Medical and Sub-station Building) | Implement remedial actions, as necessary. | 6-months |

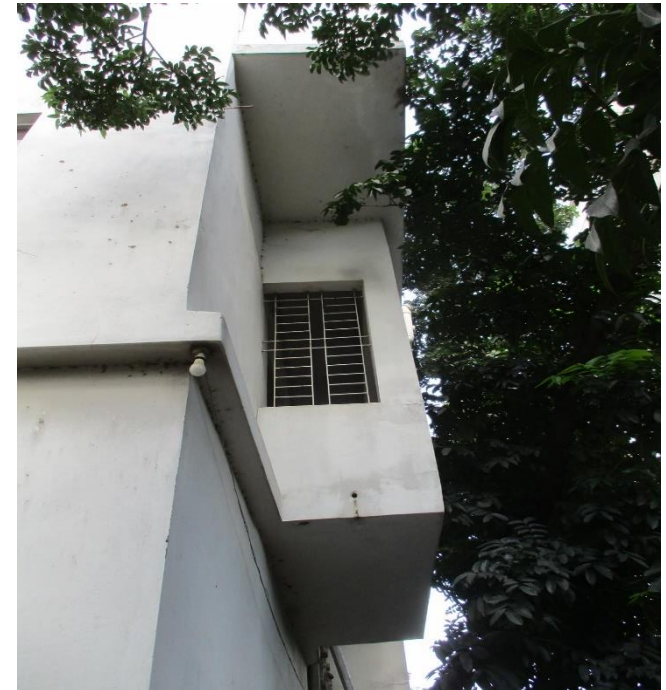
1.2m cantilever slab on south side of Sub-station Building.

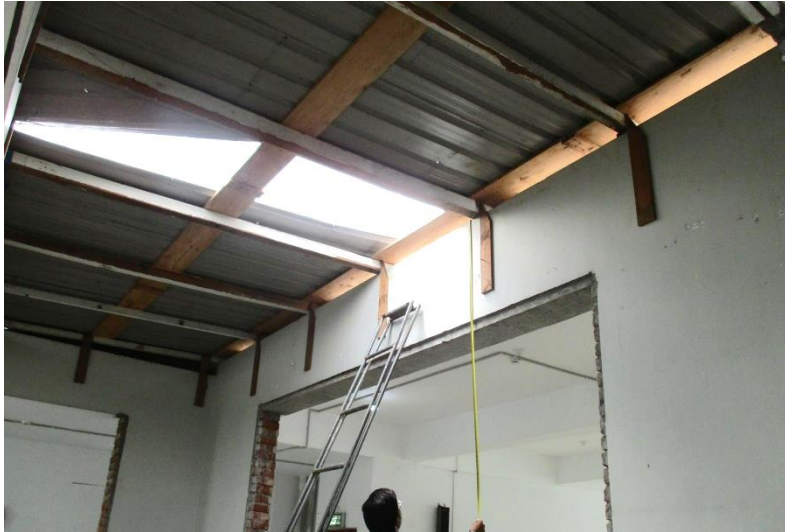
Lightweight roof on Medical Building

The part of roof of Medical building made by wooden frame. And the roof of Sub-station building made by steel angle. Both lightweight roof appears to be non-engineered. The factory engineer is required to investigate and replace the wooden frame with engineered structure (if necessary). Also, check the adequacy steel frame and their connections for the uplift forces.

| Item No. | Observation | Recommended Action Plan | Recommended Timeline |
|---|---|---|---|
| 16 | Lightweight roofing (Medical and Sub-station Building) | The factory engineer is required to investigate and replace the wooden frame with engineered structure if required. | 6-weeks |
| 18 | Lightweight roofing (Medical and Sub-station Building) | Implement the remedial works as recommended. | 6-months |

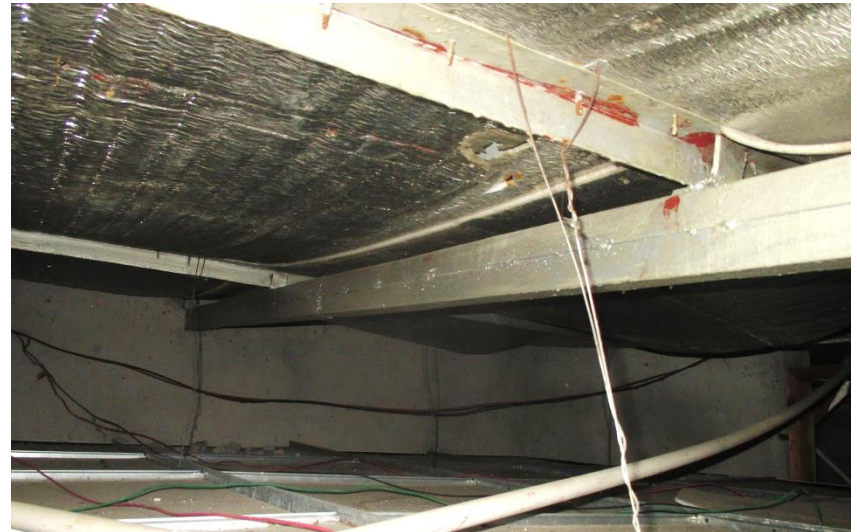
Lightweight roof on Sub-station Building

| Item No. | Observation | Recommended Action Plan | Recommended Timeline |
|---|---|---|---|
| 17 | Lightweight roofing (Medical and Sub-station Building) | The factory engineer is required to check the adequacy of steel frame and their connections for the uplift forces. | 6-weeks |

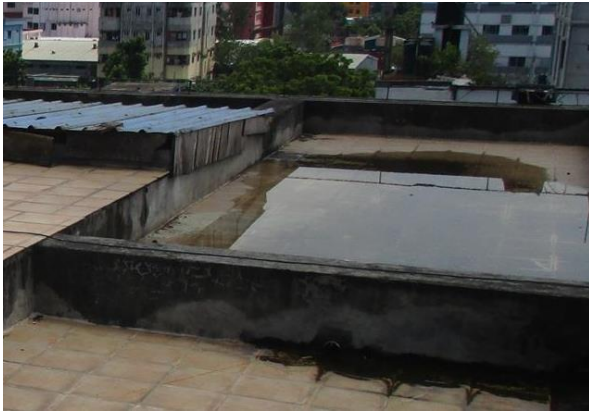
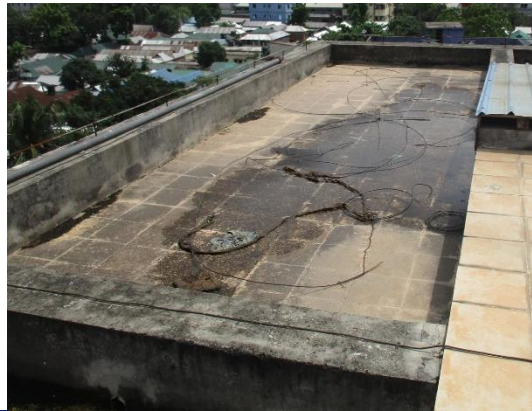
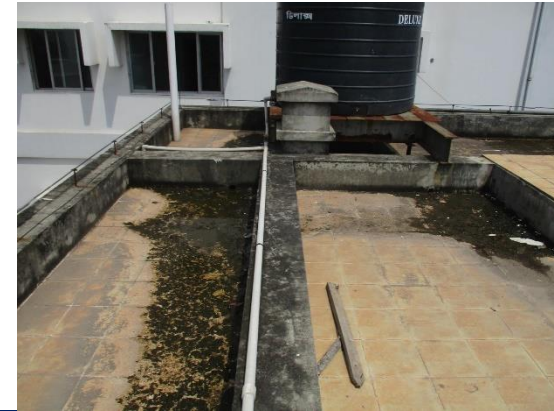
Water ponding was observed on the roof of Medical Building.

| Item No. | Observation | Recommended Action Plan | Recommended Timeline |
|---|---|---|---|
| 19 | Water ponding and dampness (Medical and Sub-station Building) | Improve drainage system on roof with adequate slope. | 6-weeks |
| 20 | Water ponding and dampness (Medical and Sub-station Building) | The factory engineer is required to investigate the damaged area and suggest proper remedial actions. | 6-weeks |
| 21 | Water ponding and dampness (Medical and Sub-station Building) | Implement remedial actions, as necessary. | 6-months |

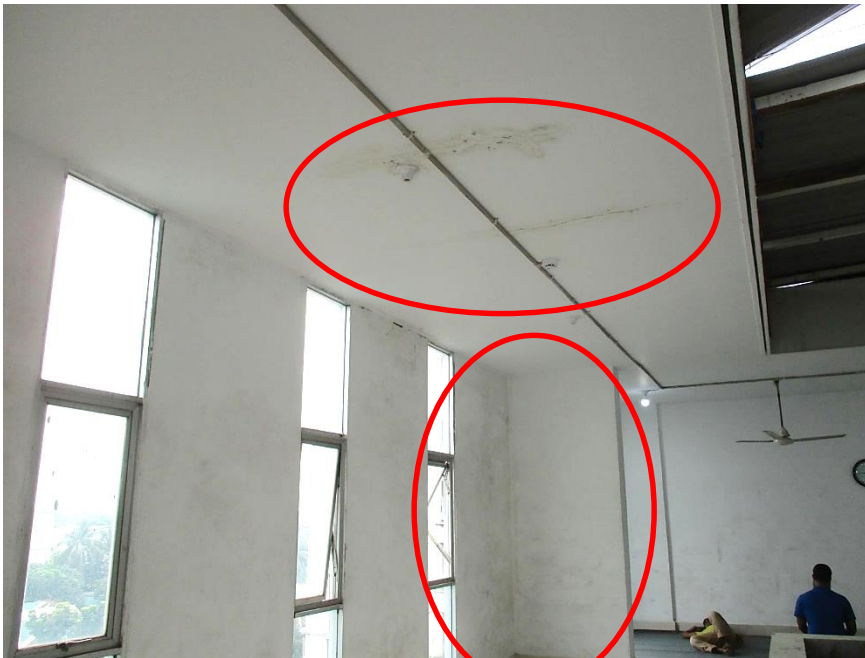
Sign of water damage of Medical Building.

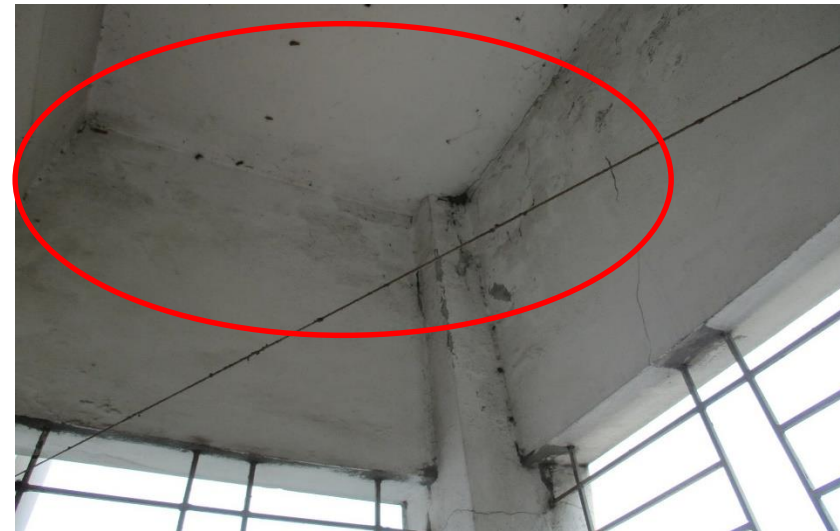
Water ponding was observed on the roof and dampness was observed on wall. Building engineer to apply proper repair method.
