# Fakir Fashion Ltd (Extension 2)

Dohargaon, Baliapara, Rupgonj  
(23.785597, 90.587278)

27<sup>th</sup> August 2019

# Observations

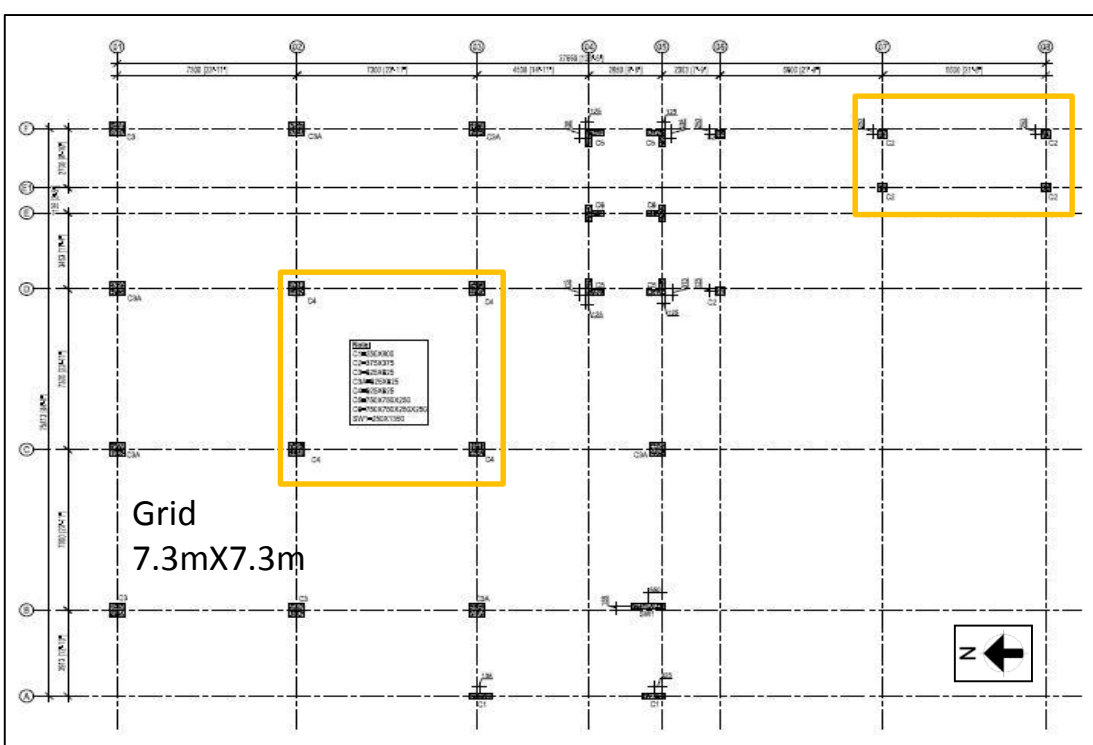
Column Layout plan

**Columns are stressed above normal design limit  
considering prepared load plan**

Cursory calculation indicates that the marked columns are stressed above normal design limit considering prepared live load plan of 5 kPa and assuming minimum concrete strength of stone chips. Building engineer is required to review design, load & column stress in the area identified above.

24.1 MPa (3500 psi) concrete strength mentioned in general note. Calculation and sufficient test report not present during inspection.

| Item No. | Observation | Recommended Action Plan | Recommended Timeline |
|---|---|---|---|
| 1 | Columns are stressed above normal design limit considering prepared load plan.(Building 6) | Maintain loading below 3 kPa until further review. | 6-weeks |
| 2 | Columns are stressed above normal design limit considering prepared load plan.(Building 6) | Factory Engineer to review design, loads and columns stresses in area identified above. | 6-weeks |
| 3 | Columns are stressed above normal design limit considering prepared load plan.(Building 6) | Verify in situ concrete stresses either by 100mm dia. Cores(Min. 4 nos.) or existing cylinder strength data. | 6-weeks |
| 4 | Columns are stressed above normal design limit considering prepared load plan.(Building 6) | Produce and actively manage a loading plan for all floor plates within the factory considering floor capacity and column capacity. | 6-weeks |
| 5 | Columns are stressed above normal design limit considering prepared load plan.(Building 6) | Carry out any remedial works where necessary | 6-months |

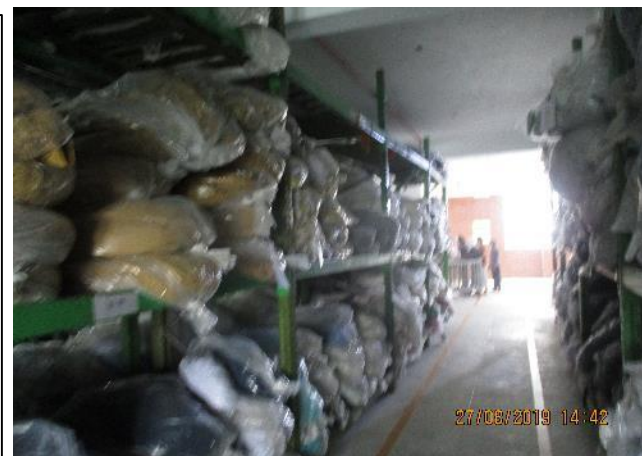
5 kPa live loading observed. Also considered in Load Plan

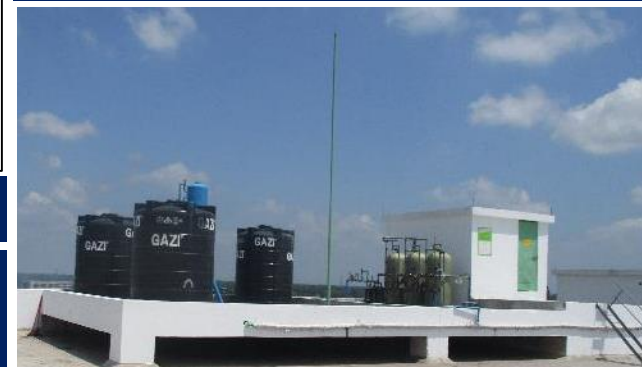
5000L water tanks with 200 mm additional slab

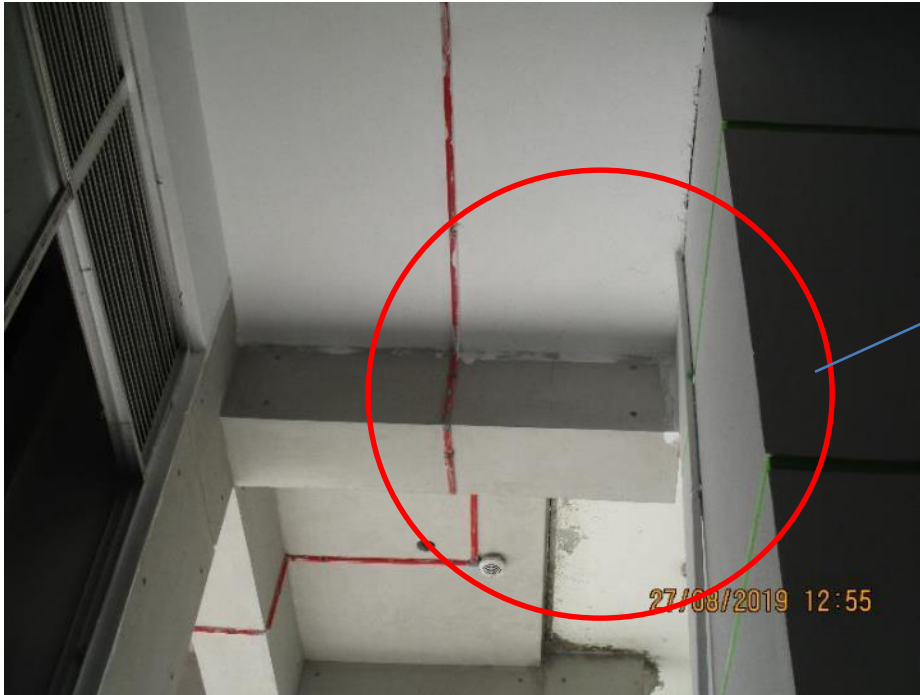
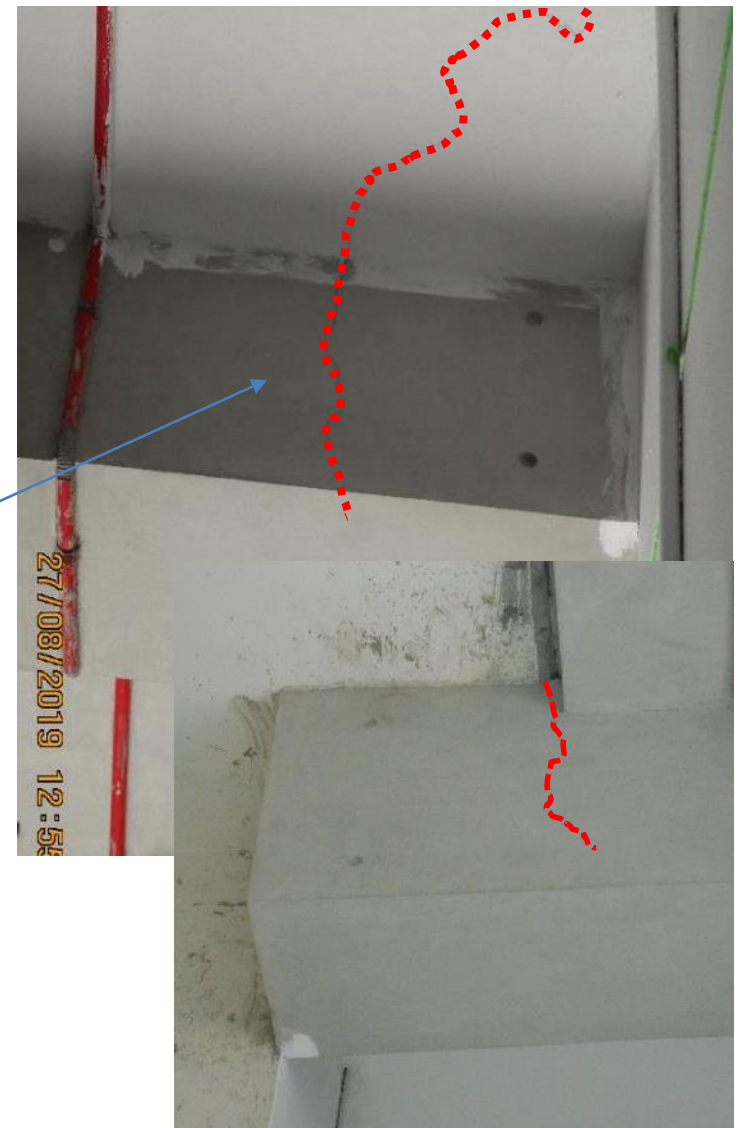
## Cracking in cantilever beam & slab

Cracks observed in cantilever beam and slab. Building Engineer to check the extent of the cracks.

| Item No. | Observation | Recommended Action Plan | Recommended Timeline |
|---|---|---|---|
| 6 | Cracking in cantilever beams.(Building 6) | Building Engineer to check the extent of the cracks and suggest suitable remedial works where necessary. | 6-weeks |
| 7 | Cracking in cantilever beams.(Building 6) | Carry out any remedial works where necessary. | 6-weeks |

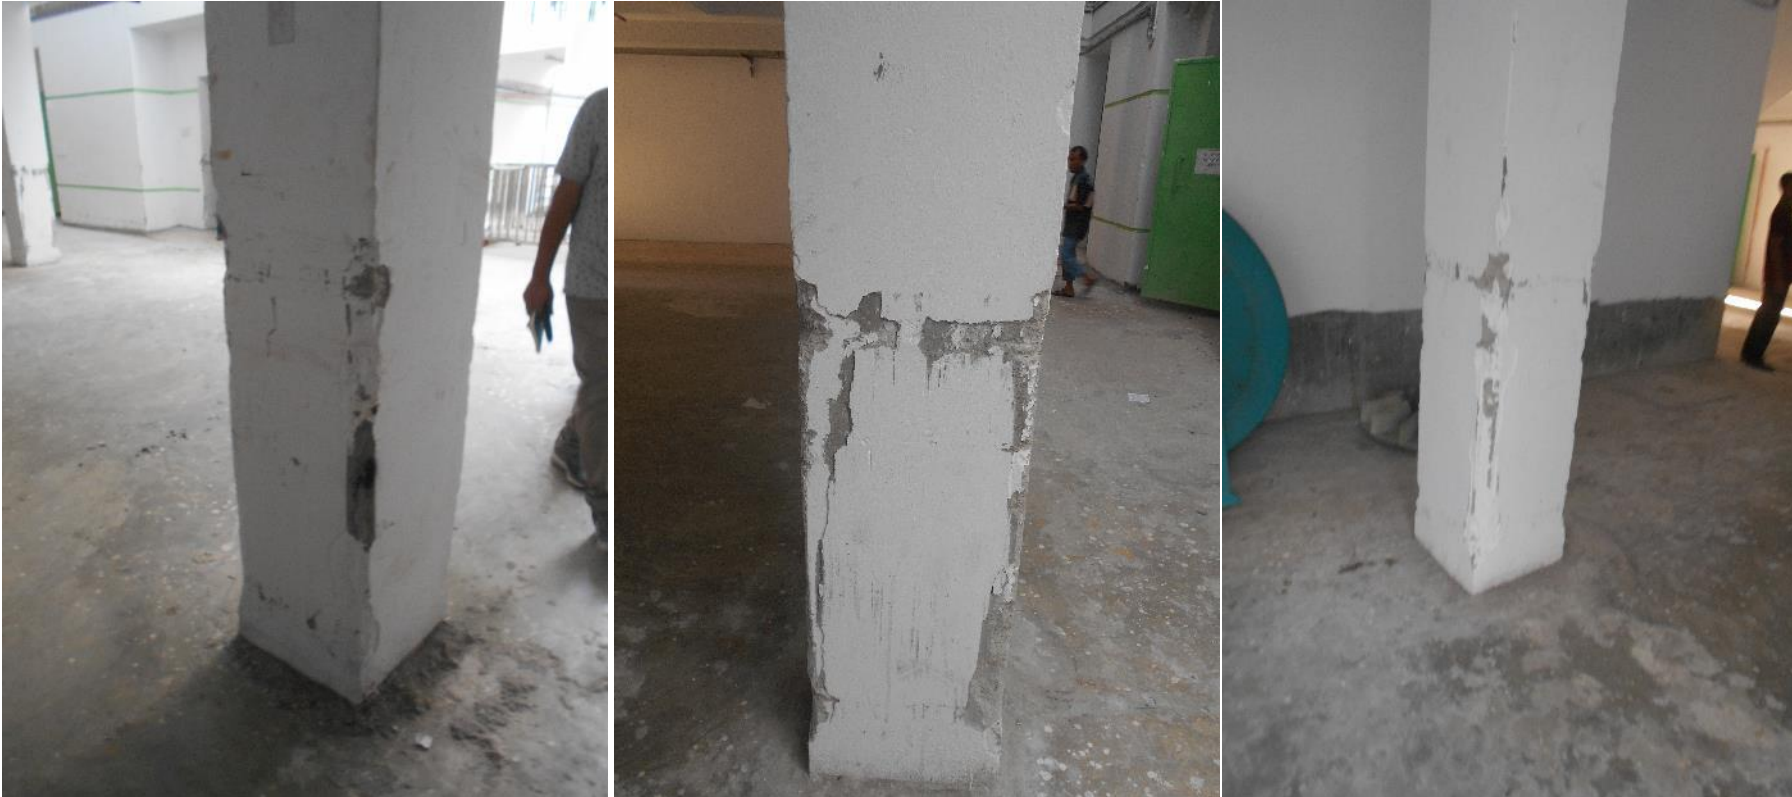
## Damage at column edge

Damaged column observed on ground floor area. Building engineer is required to check the extent of damage and suggest required remedial works considering possible impact loading.

| Item No. | Observation | Recommended Action Plan | Recommended Timeline |
|---|---|---|---|
| 8 | Damage in column edge.(Building 6) | Building engineer is required to check the extent of damage and suggest required remedial work . | 6-weeks |
| 9 | Damage in column edge.(Building 6) | Carry out any remedial works where necessary. | 6-weeks |

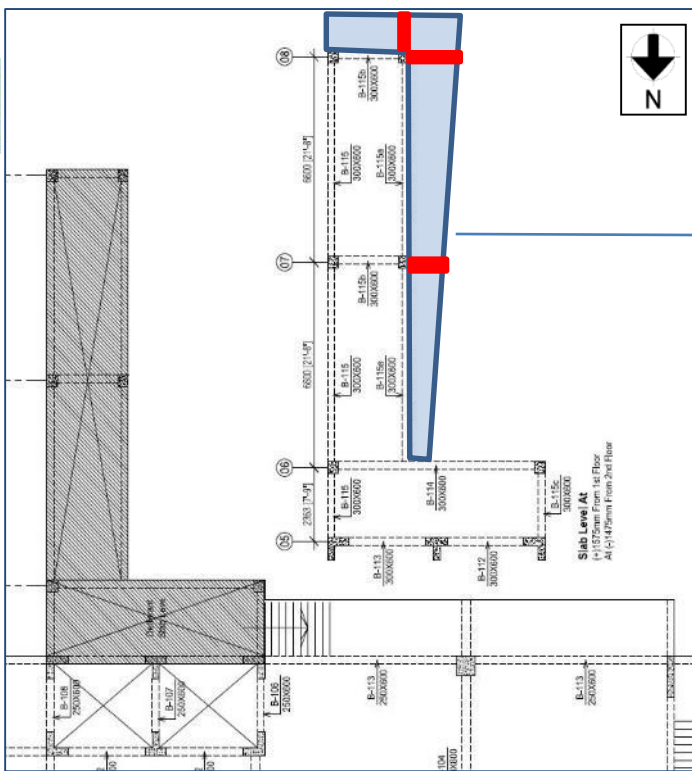
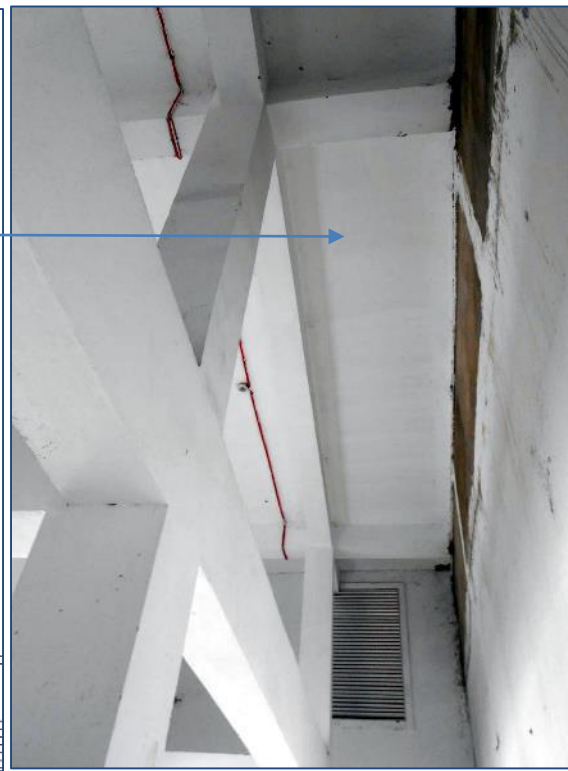
## Discrepancies in as-built drawings

There are anomalies between as-built drawings and as constructed structure for the cantilever slab outline and beam. Also, rebar in C2 type column was found less than shown in column schedule. On one face, the number of rebar was found 3 instead of 4.

| Item No. | Observation | Recommended Action Plan | Recommended Timeline |
|---|---|---|---|
| 10 | Discrepancies in as-built drawings.(Building 6) | Factory engineer is required to survey all the structural elements properly and produce correct as built drawings. | 6-weeks |

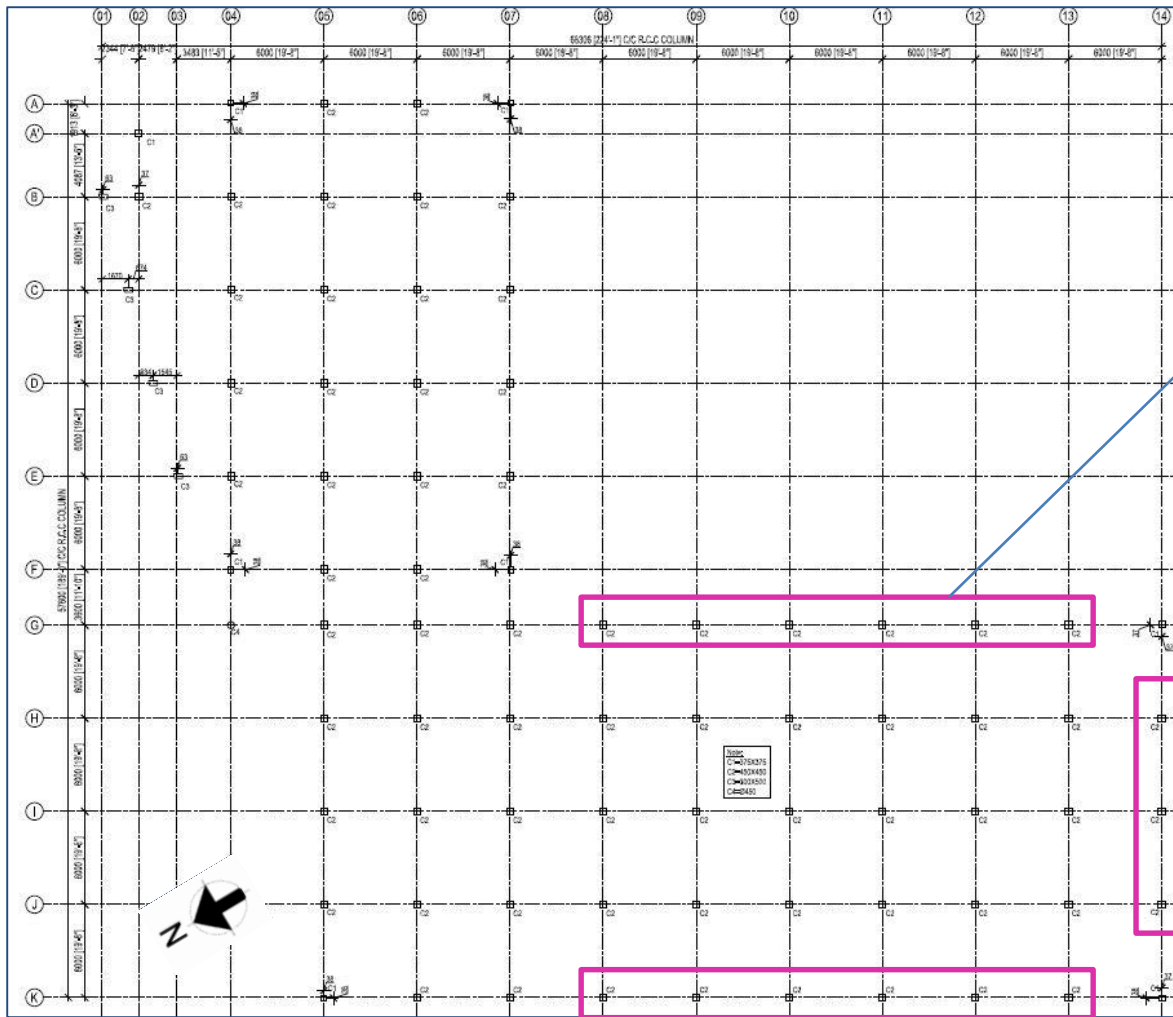
Column Layout

**Discrepancies in as-built drawings.**

Rebar number of exterior column, (C2 type) was found less than mentioned in column schedule. On one face, the number of rebar was found 3 instead of 4.

| Item No. | Observation | Recommended Action Plan | Recommended Timeline |
|---|---|---|---|
| 12 | Discrepancies in as-built drawings.(Building 7) | Factory engineer is required to survey all the structural elements properly and produce correct as built drawings. | 6-weeks |
| 13 | Discrepancies in as-built drawings.(Building 7) | If the number of rebar found less than the actual design, building is required to review the design & column stresses. | 6-weeks |
