# NRG Knit Composite (Unit-1)

Enayetnagar, Volail, Fatullah  
(23.619136N, 90.477915E)  
29<sup>th</sup> January 2019

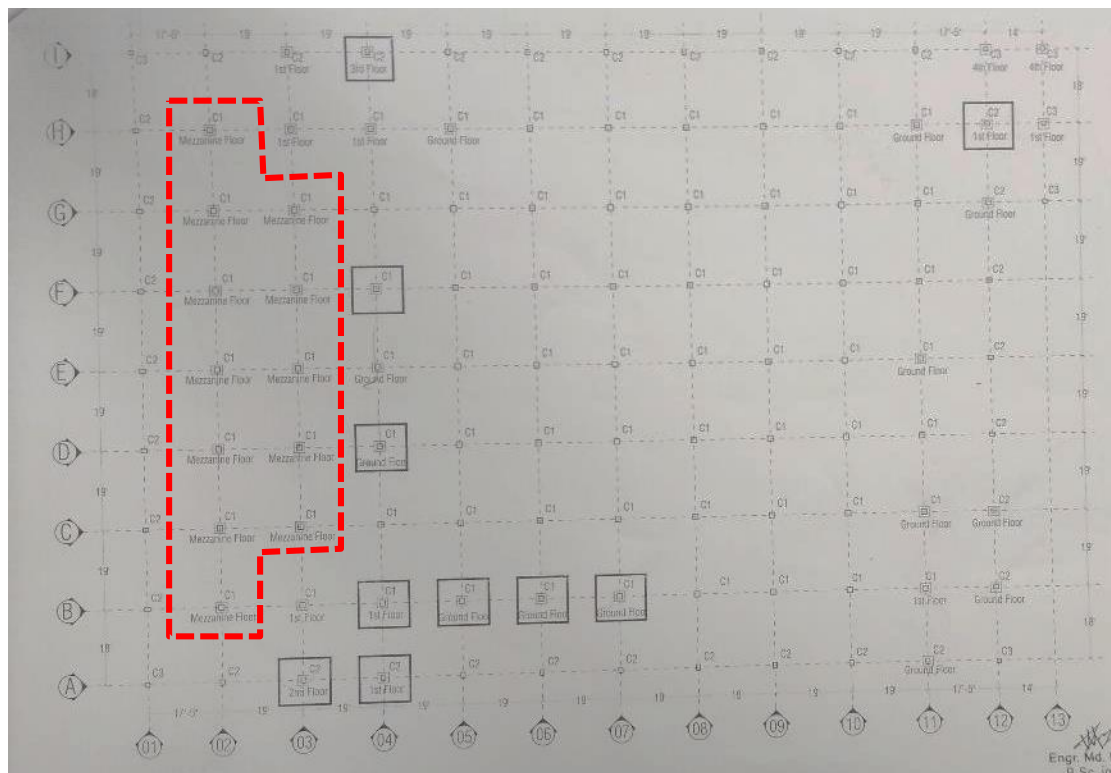
Retrofitting column layout plan

In the provided retrofitted column layout, the marked columns were shown as retrofitted up to top slab of mezzanine floor. Whereas, the columns were found to be retrofitted till bottom slab of mezzanine floor. Factory is required to submit the design report to ACCORD for review and carry out remedial works coming from detail engineering assessment after reviewing by Accord.

| Item No. | Observation | Recommended Action Plan | Recommended Timeline |
|---|---|---|---|
| 1 | Design Report required to be reviewed by Accord | Design report to be submitted to Accord for review. | 6-weeks |
| 3 | Design Report required to be reviewed by Accord | Complete remedial works coming from detail engineering assessment after reviewing by Accord. | 6-months |

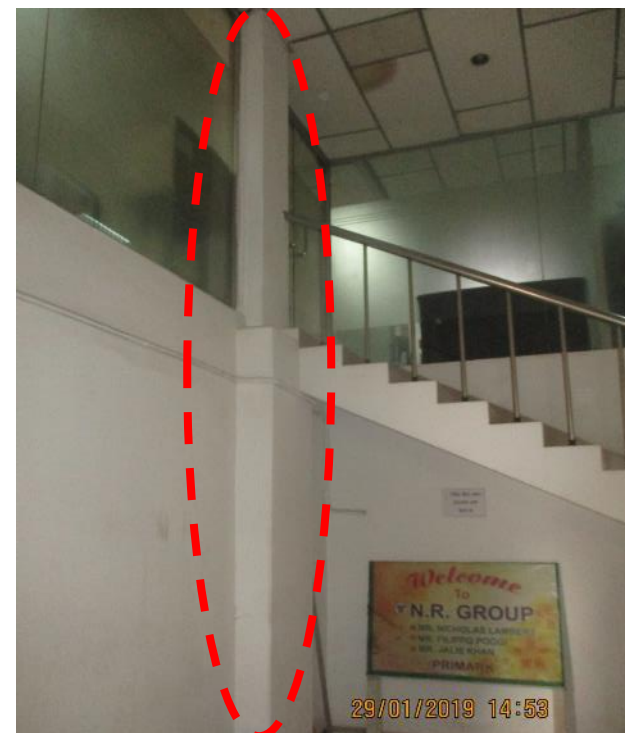
Columns were retrofitted up to bottom slab of mezzanine floor

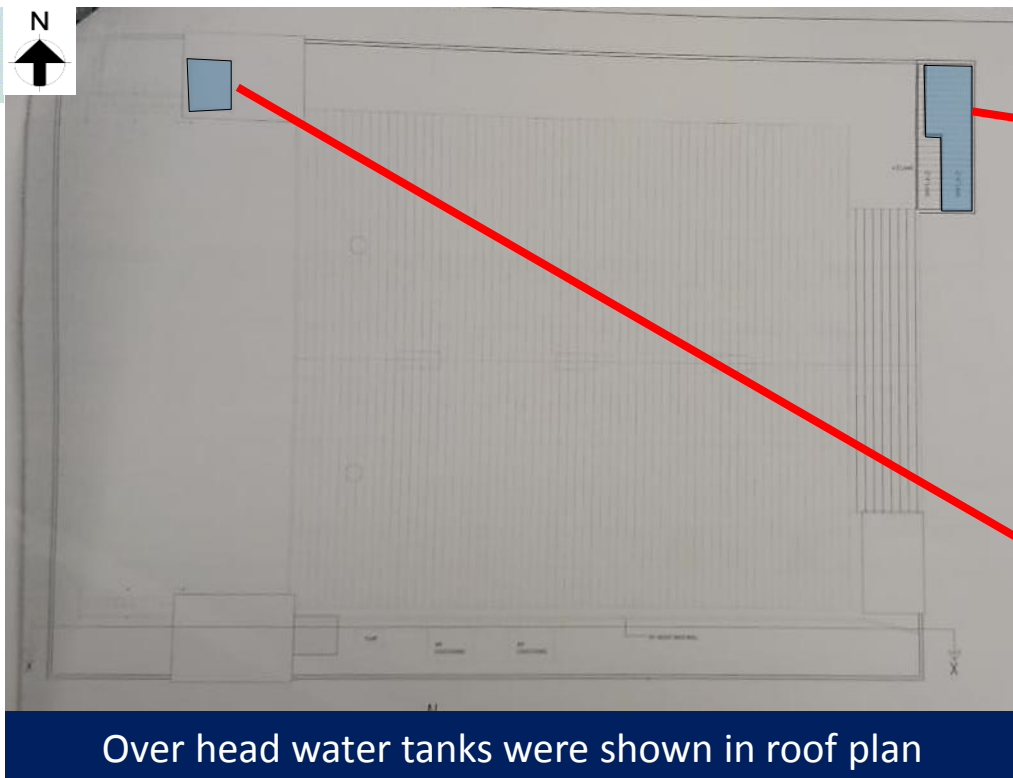
Over head water tanks were shown in roof plan

In the provided drawing, no detail was found regarding the over head water tanks. Factory is required to produce the as built drawing addressing the detail of water tanks on roof.

| Item No. | Observation | Recommended Action Plan | Recommended Timeline |
|---|---|---|---|
| 5 | Missing information in provided as-built drawing | Factory engineer is required to survey the structural elements properly and produce correct as built drawings. | 6-weeks |

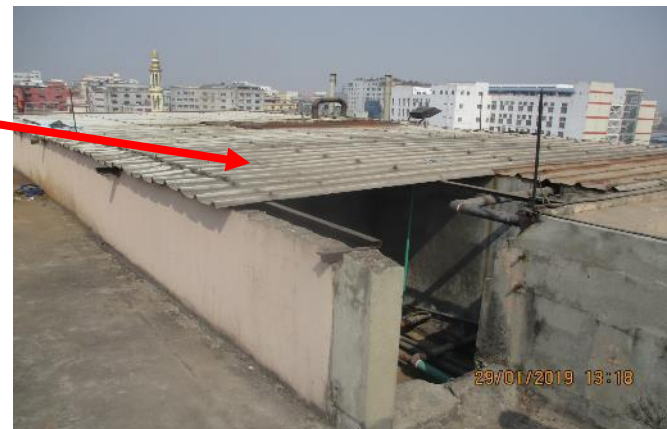
RCC water tank on existing roof

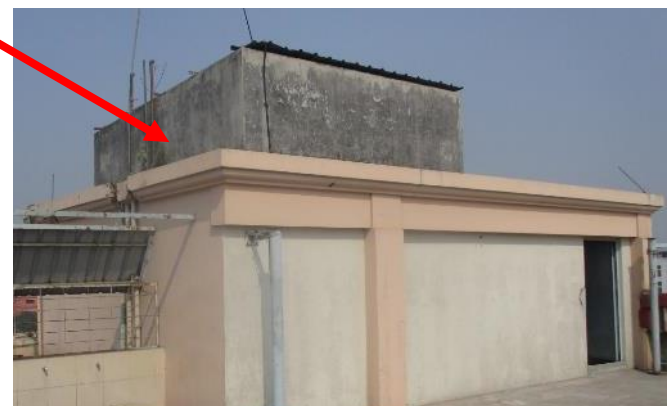
RCC water tank on existing stair case

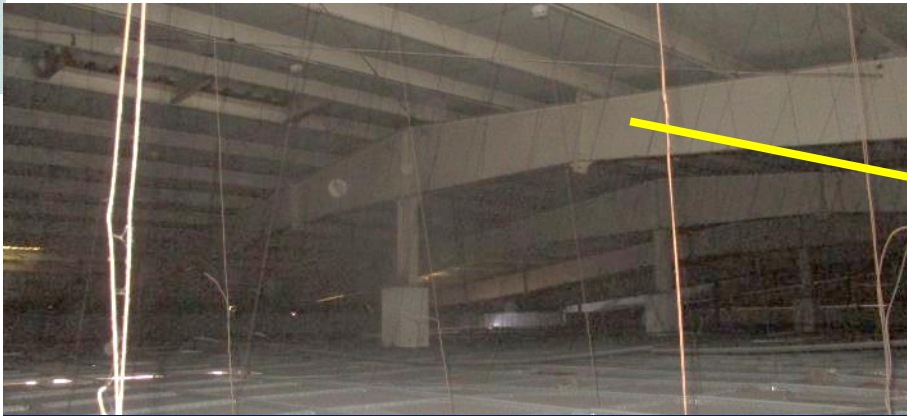
Dimension of rafter was found less than provided drawing

The rafter was divided into three part. The width of 1<sup>st</sup> part, 2<sup>nd</sup> part and 3<sup>rd</sup> part were measured 145mm, 160mm and 200mm respectively whereas the width was mentioned 250mm for three part in drawing. Factory is required to update the drawing and revise the analysis report.

| Item No. | Observation | Recommended Action Plan | Recommended Timeline |
|---|---|---|---|
| 6 | Discrepancies between as-built drawings and on-site observation of roof top shed | Factory engineer is required to survey the structural elements properly and produce correct as built drawings. | 6-weeks |

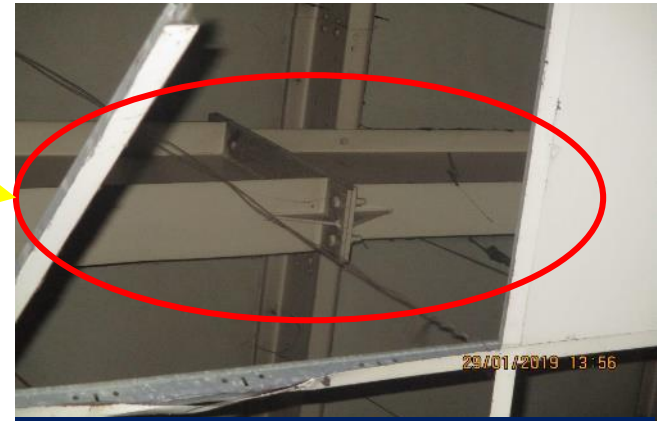
Different rafter width was found on site
