H.I Apparels Ltd.

4th August 2019

Observations: Production Building

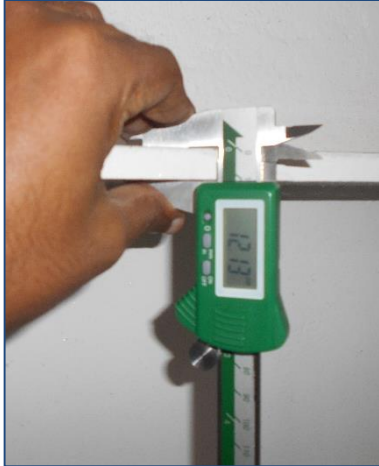
Flange thickness of secondary beam at 3rd floor did not match with the provided drawings. Also, C-channel found instead I-beam at north side stair landing. Building engineer is required to produce an “as constructed” drawings with complete structural information.

12 mm thickness of flange instead of 14 mm

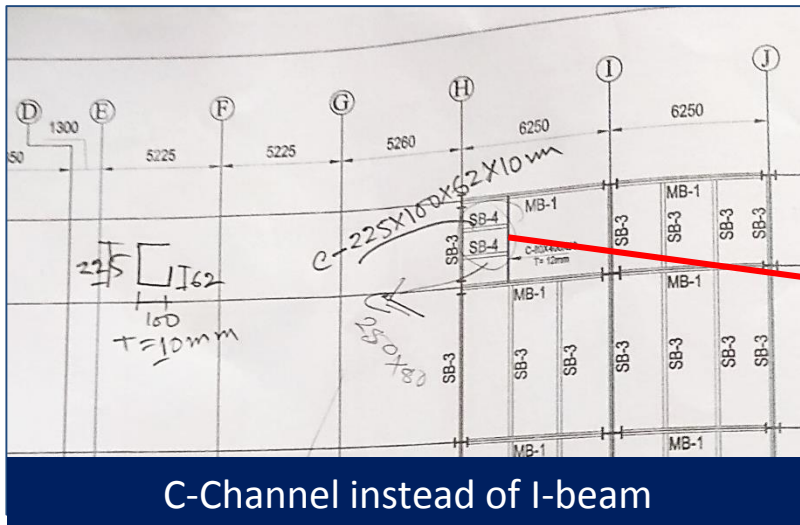
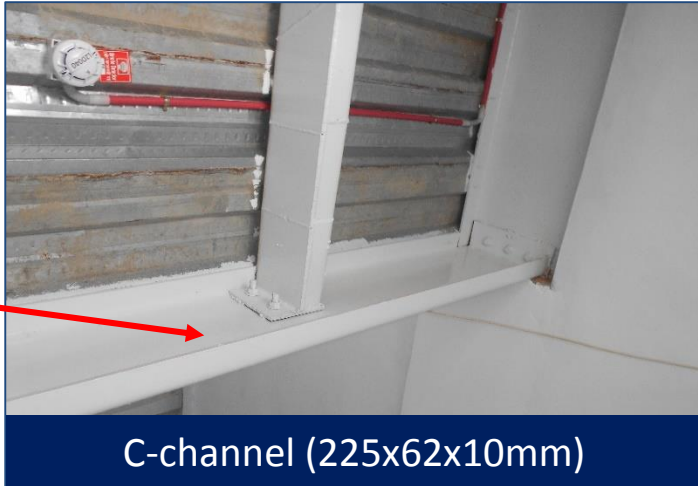
C-channel (225x62x10mm)

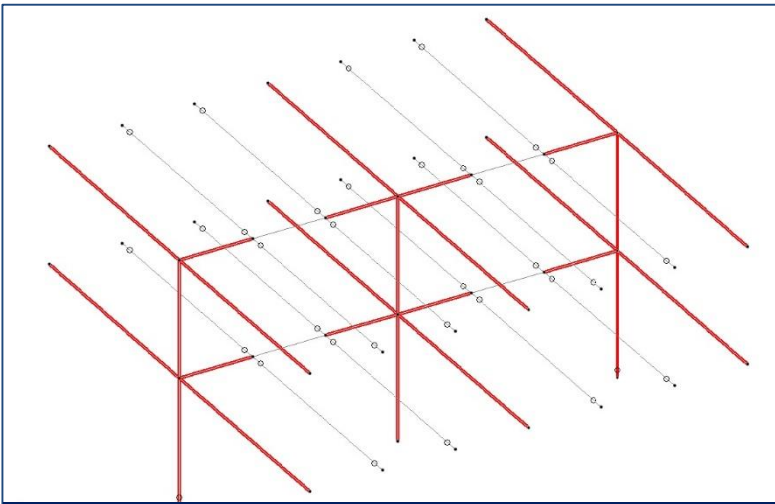
Beam-column rigid connection in the FEA model.

As per the provided Finite Element Analysis (FEA) model, the beam-column connection has been considered as rigid. But the beam detail indicates that the beam ends are not rigidly connected with columns. In addition, the top flange of some framing beams were found cut-off to accommodate the connections. So that, connection rigidity is required to be verified for those beam connections

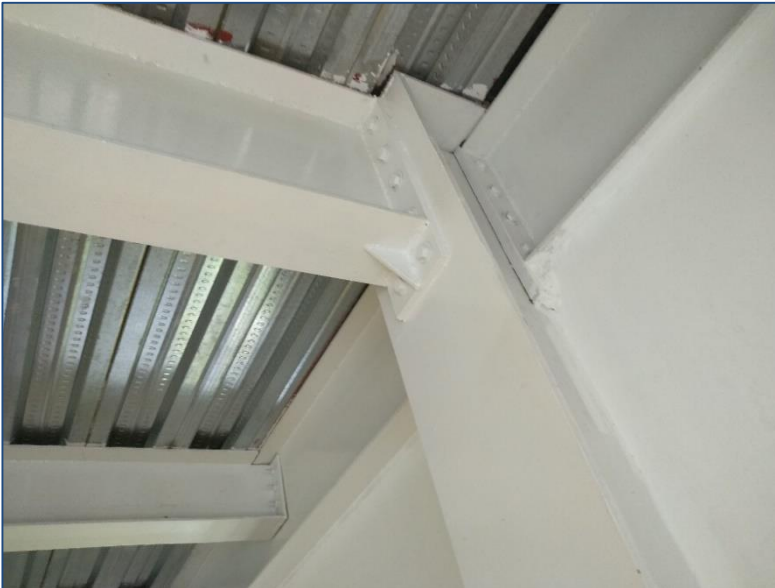
Beam-column joint at top level

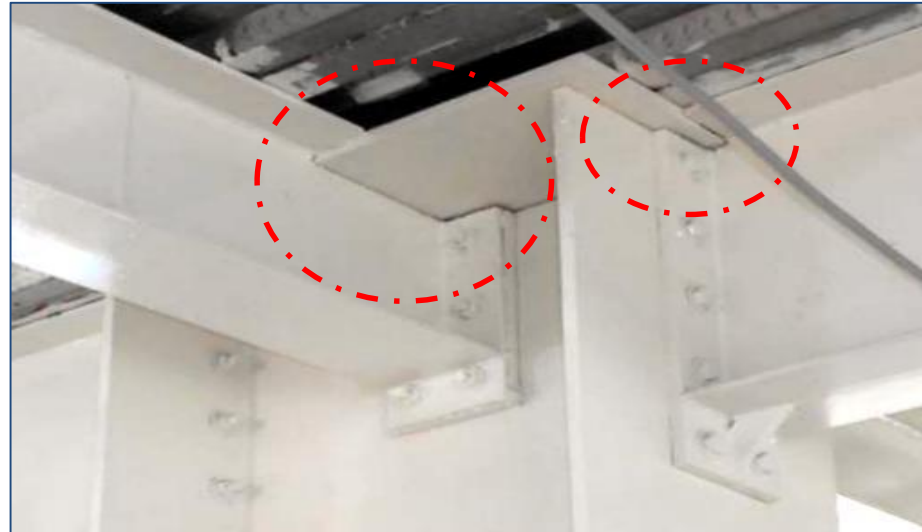
Top flange found cut near the joint

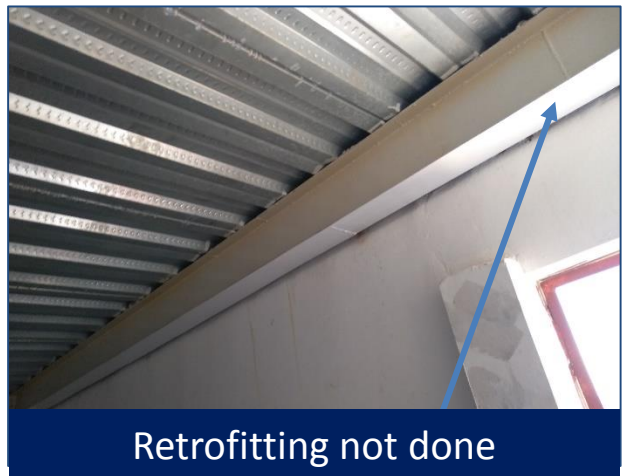
As per the provided DEA report, the factor of Safety (FoS) of some pile foundations are below the allowable limit of 2.50 (BNBC-06, Sec-3.11.1.11). Also, required retrofitting works of secondary beams are not completed marked location. Factory is required to revised the DEA.

Retrofitting not done

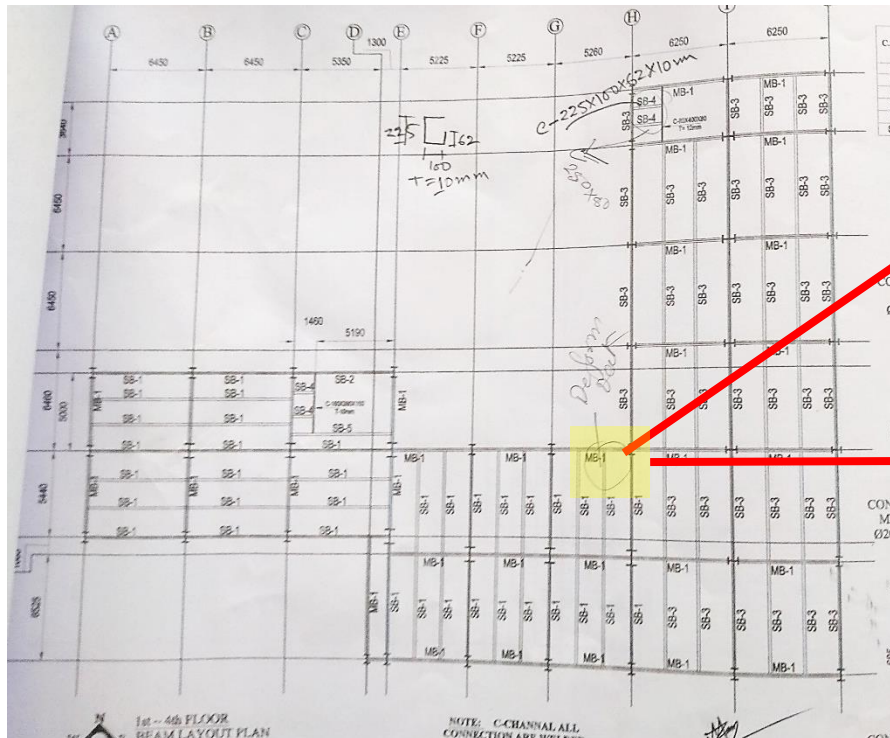
Sub beam layout

Minor deflection was found at deck slab on 2nd floor roof. Factory engineer is required to monitor the deck slab deflection and keep record.

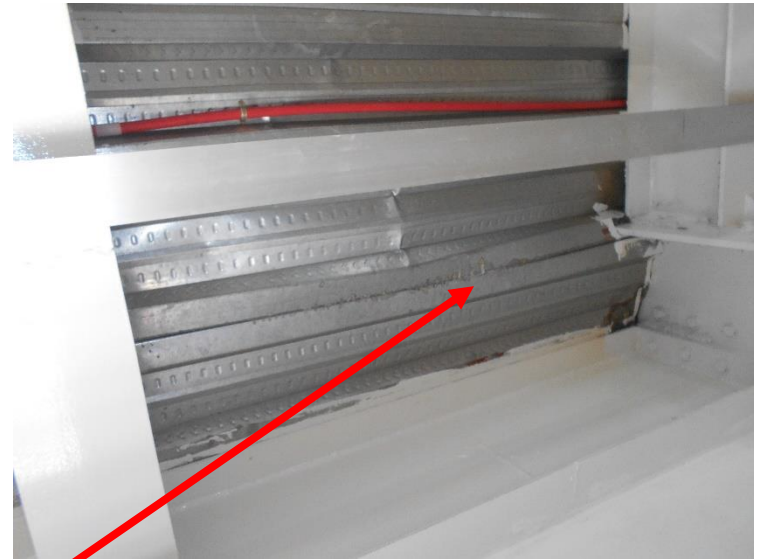
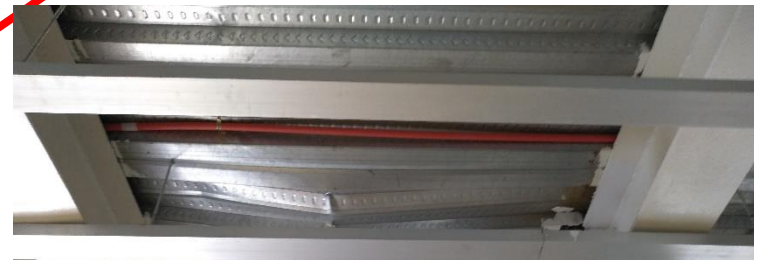
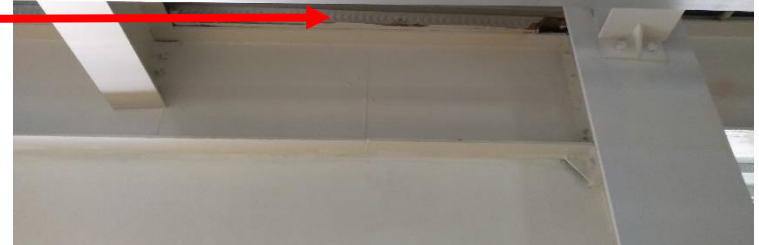
Deflected portion of deck slab

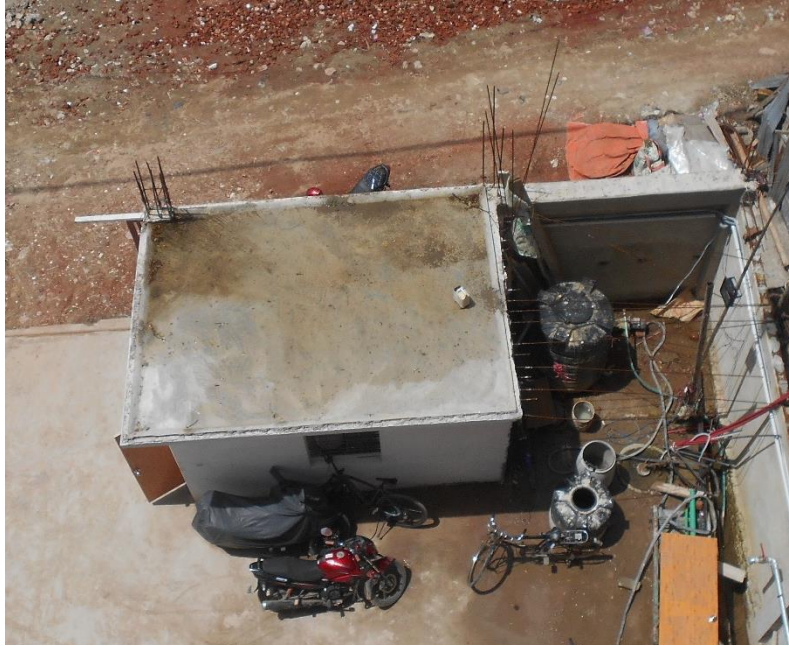
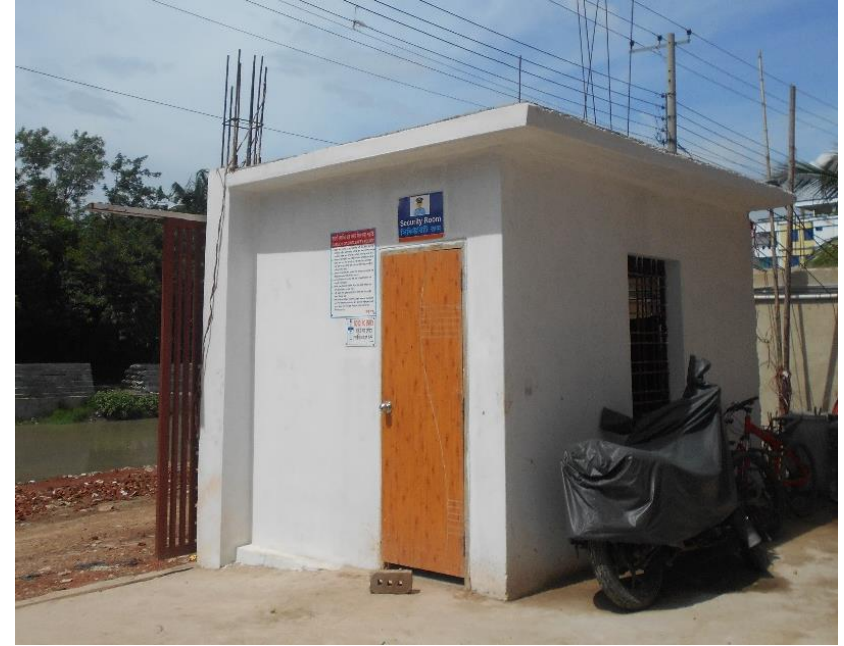
No documentation was available onsite for utility shed.

9	Drawings not available	Prepare “as constructed” drawings which reflect the actual site dimensions with complete structural information.	6-weeks
