# Libas Textiles Ltd (9500)

Nishchintopur, Mouchak, Kaliakoir, Gazipur, Bangladesh.

22.MARCH.2014

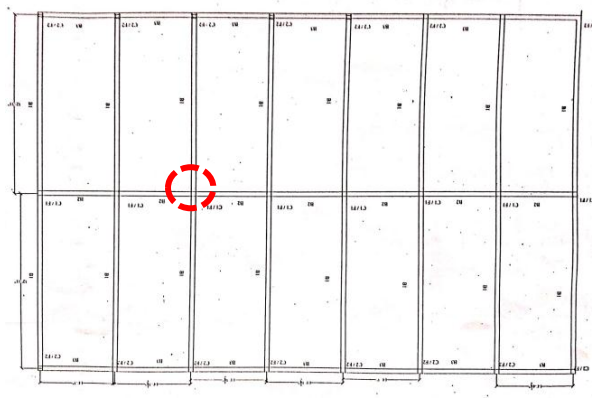
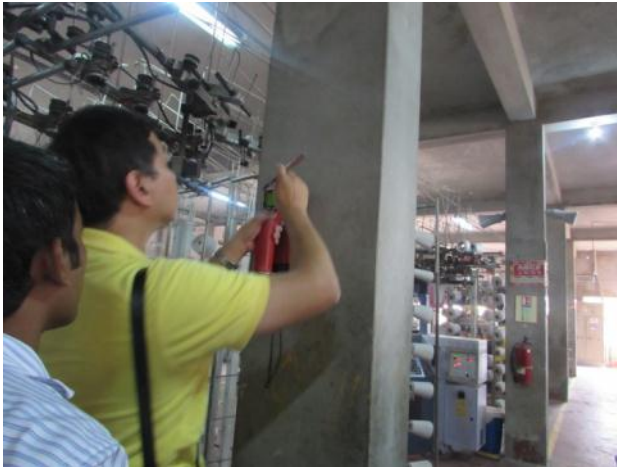
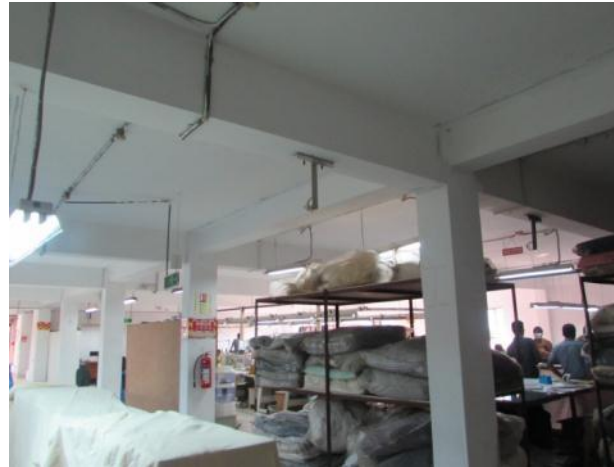
Based on the load rundown analysis following the agreed minimum design live load assignment, the columns seem significantly insufficient in carrying the dead and live loads from the 3 storey in building 02, giving a firm RED warning. The building was constructed before 2005, with brick aggregate, with total of 3 storeys (including roof). In addition, the ferroskan indicated a steel provision which was not in accordance with the record drawings

**Building 2 Column rundown with scanned rebar is insufficient (RED)**

Building 02 is deemed unsafe for usage due to unsafe structure on all aspects.

- Cease operations in Building 02 immediately
- It is deemed that the building is unusable based on the current structural layout

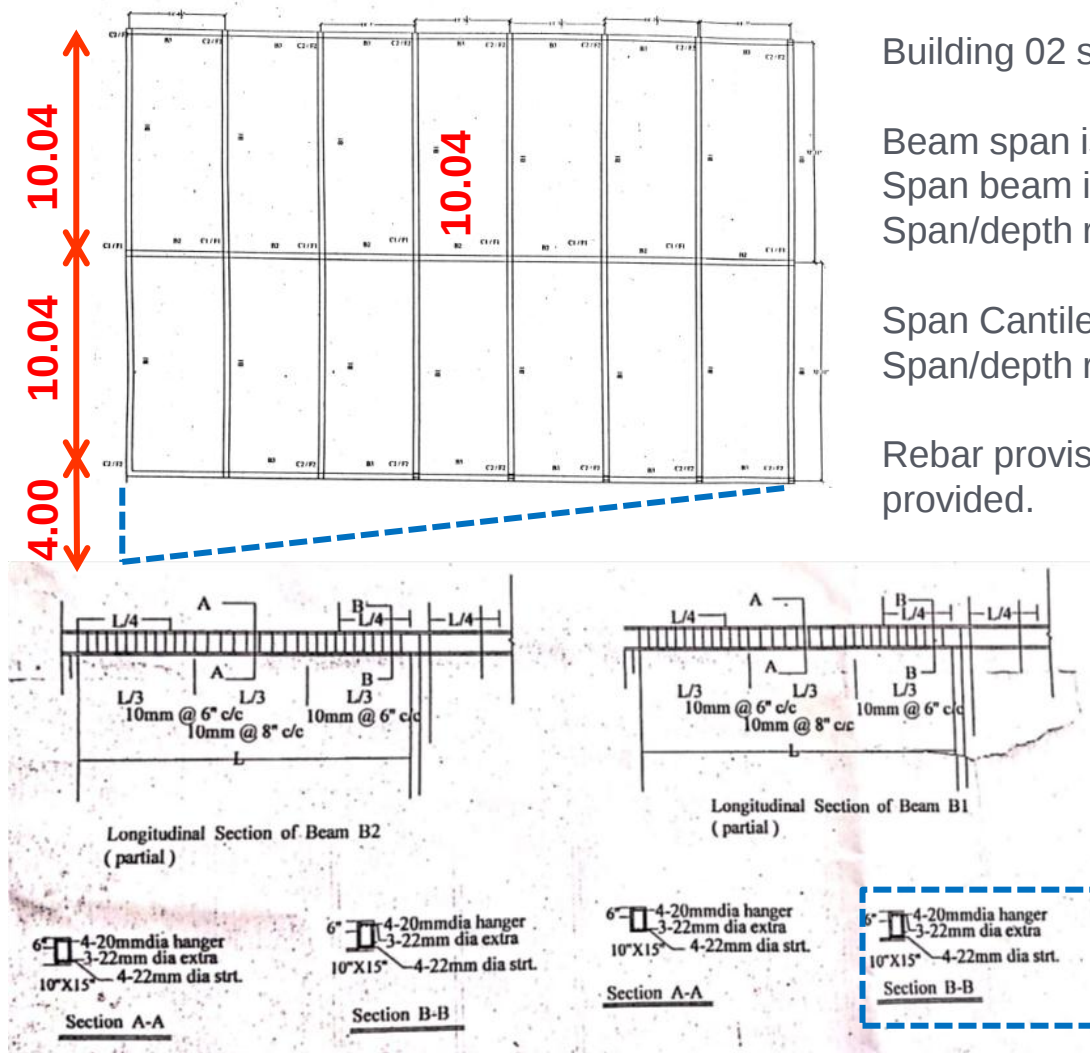
Building 02 structural layout appears to be dangerous:

Beam span is excessive, and beam size is too small.  
Span beam is 10.04m ,beam size is 381x254 mm:  
Span/depth ratio is  $10,040/381 = 26.35 > 20.0$

Span Cantilever is 4.00m Beam section is 381x254 mm :  
Span/depth ratio is  $4,000/381 = 10.5 > 7.0$

Rebar provision also appears to be seriously under-provided.

Building 02 structural layout appears to be dangerous

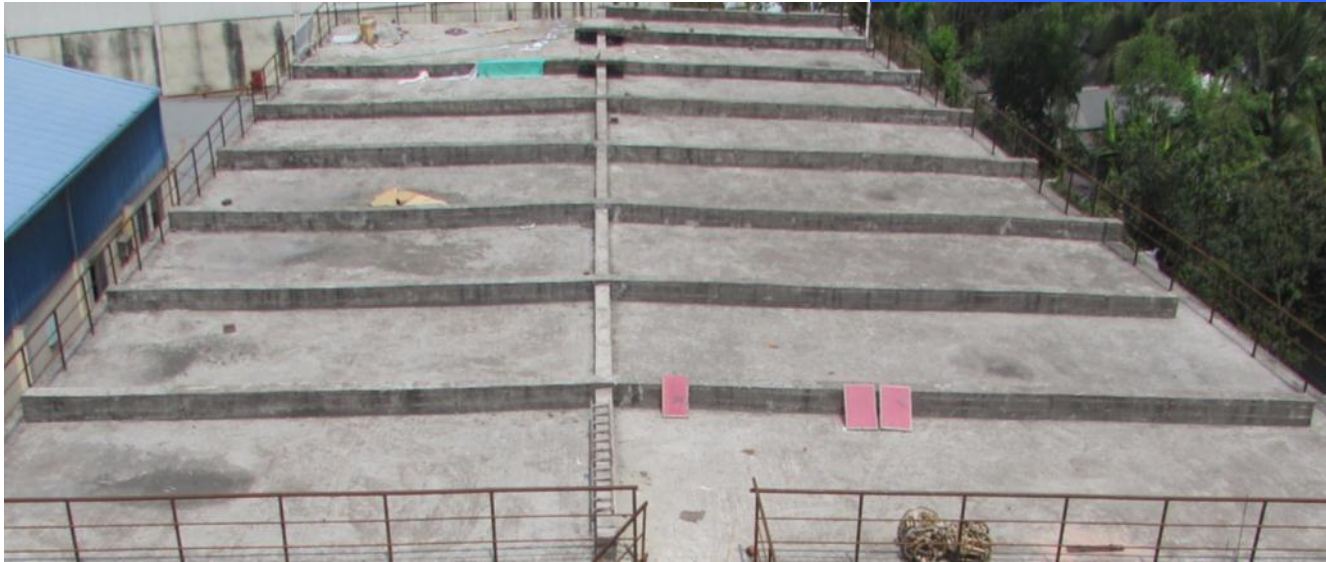
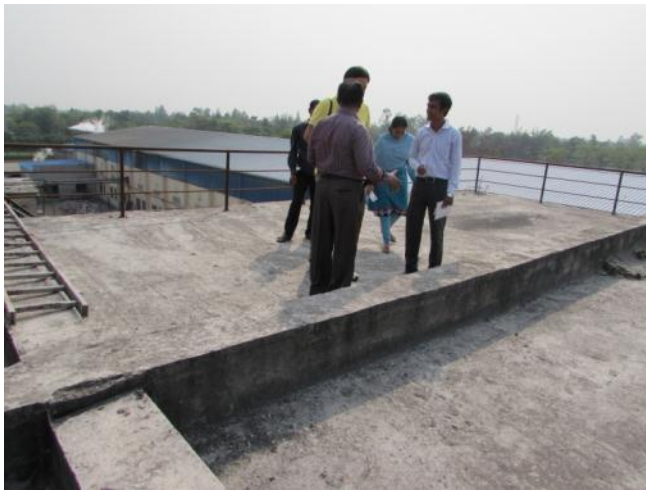
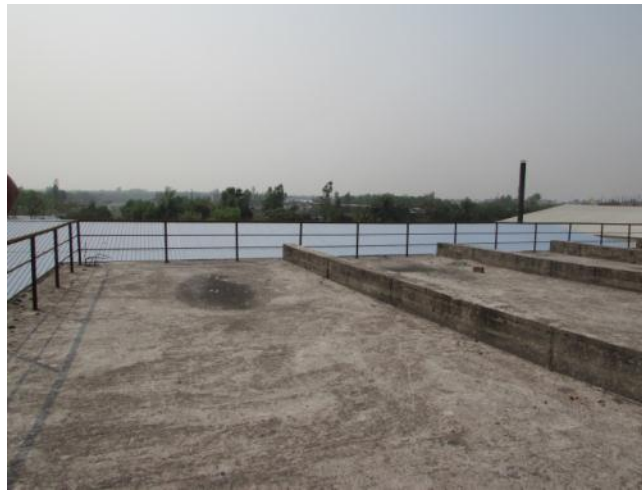
During the inspection, we accessed the roof. Even a slight foot shuffle caused major vibration of low frequency to the structure, and deflection of the roof was physically detectable by visual as well as feel. As can be seen the upstand beam has a span of 10m, and appears to be seriously undersized.

**Building 2 Vibration on roof is a significant cause for concern**

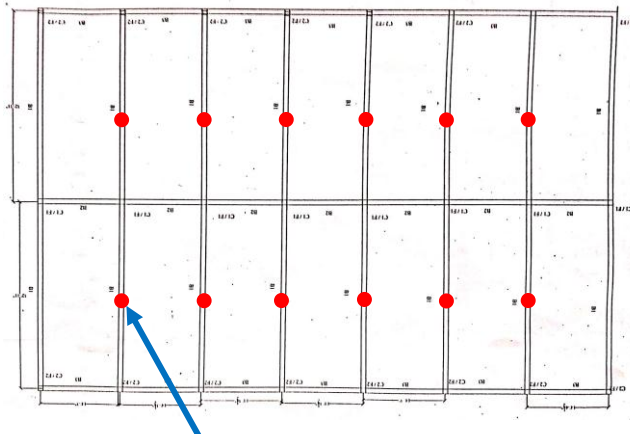
Temporary steel post

A previous inspection by a structural engineer also proved that the structural integrity of this building is of major concern. Steel props have been added to the mid-span of the beam as a temporary measure to provide stability, however their installation was not considered to be safe, as none of the surface finishes of the beam were removed, and the punching shear on the floor slab is also of major concern, as there is no foundation directly beneath these posts.

**Building 2 Beam is propped at midspan by temporary steel post on ground-bearing slab**

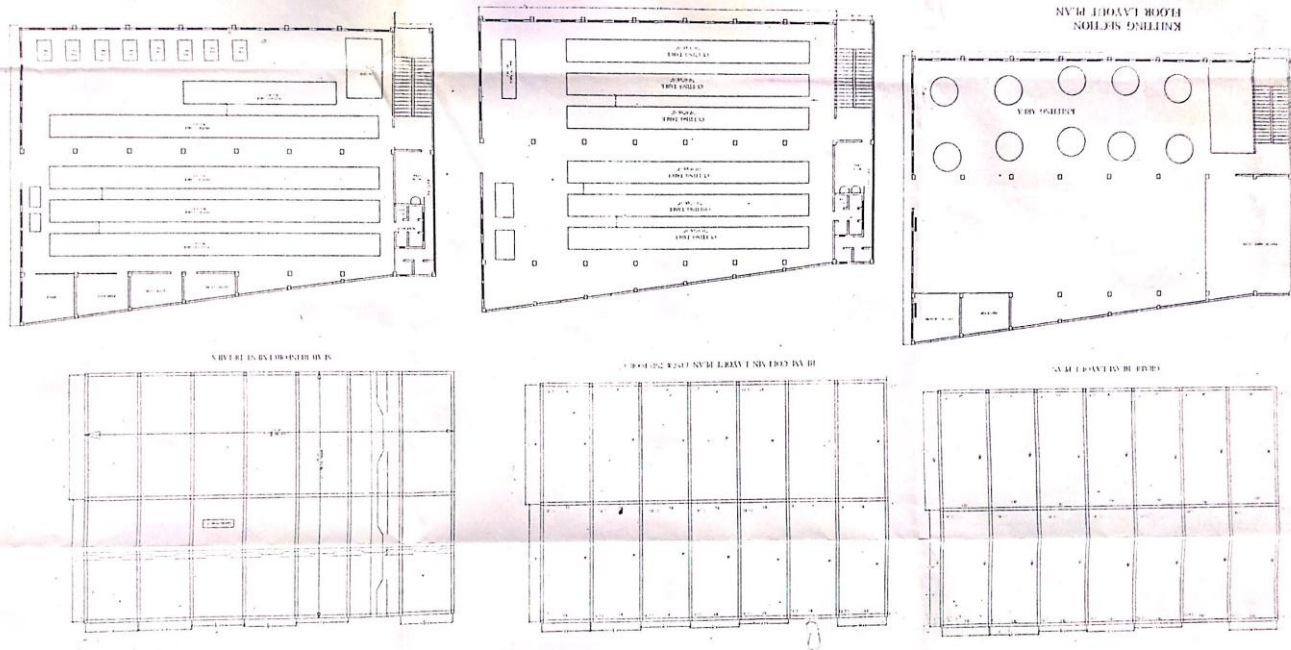
According to the original layout drawings, the architectural layout and structural layout are different. The architectural drawing shows the tapered edge of the building, whilst the structural plan remains rectangular.

The tapered section of the building is completely cantilevered, with no columns or footings to support.

**Building 2 Old structural plan does not reflect structural layout, and new structural drawings are incorrect**

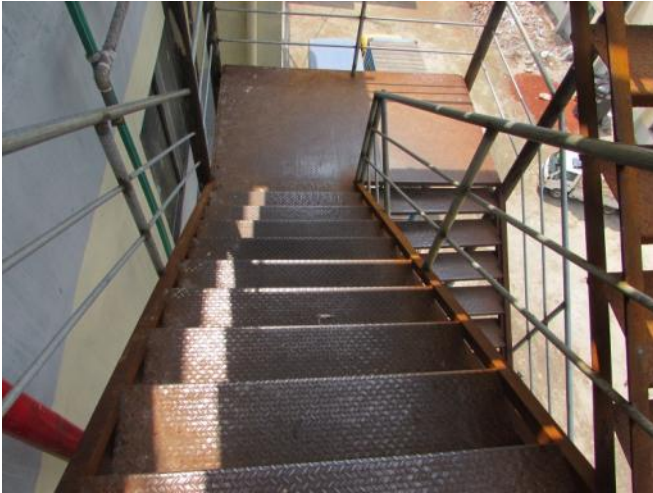
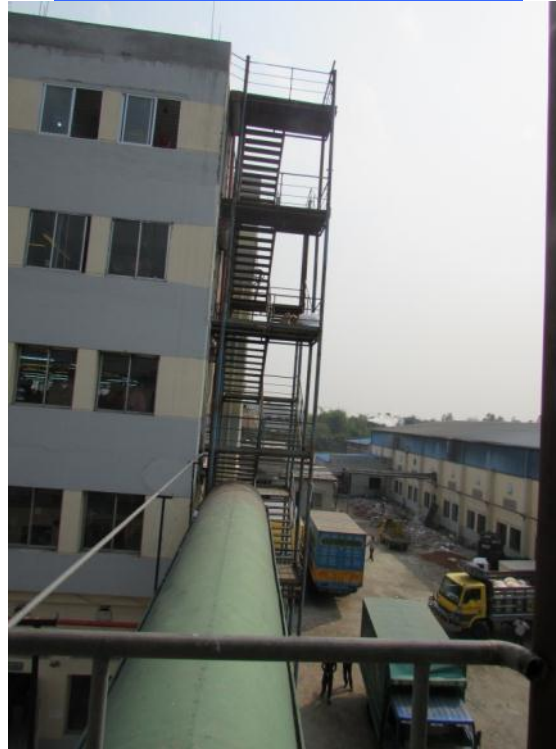
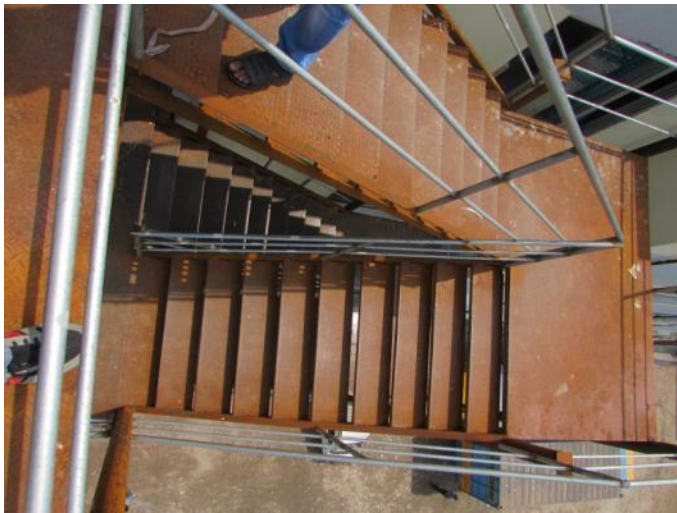
The fire escape staircases were added by the factory owner after completion of the building.

These staircases are deemed to be unfit for their purpose as the structural framing does not appear to be able to withstand emergency crowd loading. The balustrades are also not designed to take lateral crowd loading, and all the members have not been galvanised. Significant rusting of all the steel members was observed

**Fire escape staircases are not suitable for emergency use**

- Consider to replace the staircase and design in accordance with emergency escape regulations with regard to loading
- Apply galvanised coating to all steel members if a new steel structure is chosen.

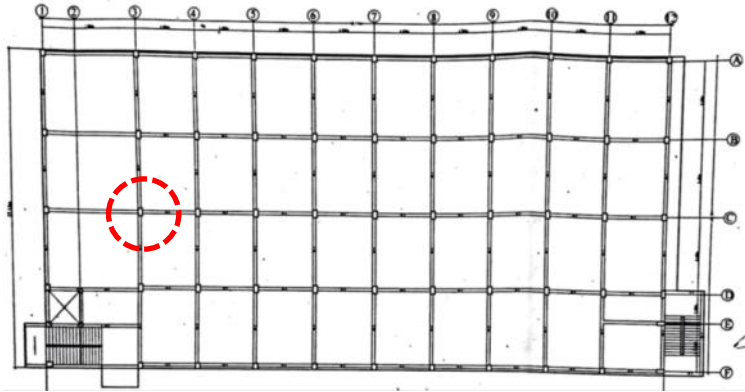
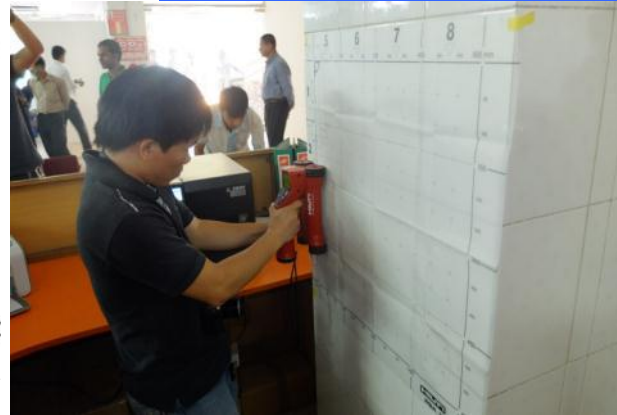
Rebar number of Column C11 is not in accordance with structural drawings. On site condition rebar number of column C11 is 10 $\varnothing$ 25 only, instead of 16  $\varnothing$ 25 as shown in the drawings

Rebar of Column C11 is not in accordance with structural drawings

- Building Engineer to fully check loading from the building from both current loading as well as future loading cases to establish whether or not the as-built column is able to sustain the loading

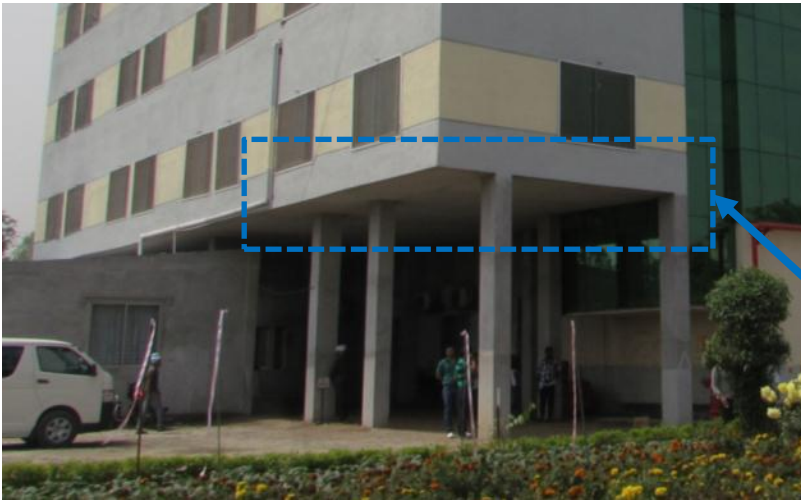
Flat slab structural  
on site condition.

It was advised that the flat slab was 229mm thick, although this could not be confirmed

**Flat slab of extension of Building 1 has no detail. A full structural inspection and checking is required.**

- Carry out full building survey using both intrusive and non-intrusive techniques.
- Carry out concrete cores of structural elements to determine concrete strength

- Based on the building survey, develop full structural records, and also propose strengthening works or repair works if the as-built structure appears to be insufficient in any way.

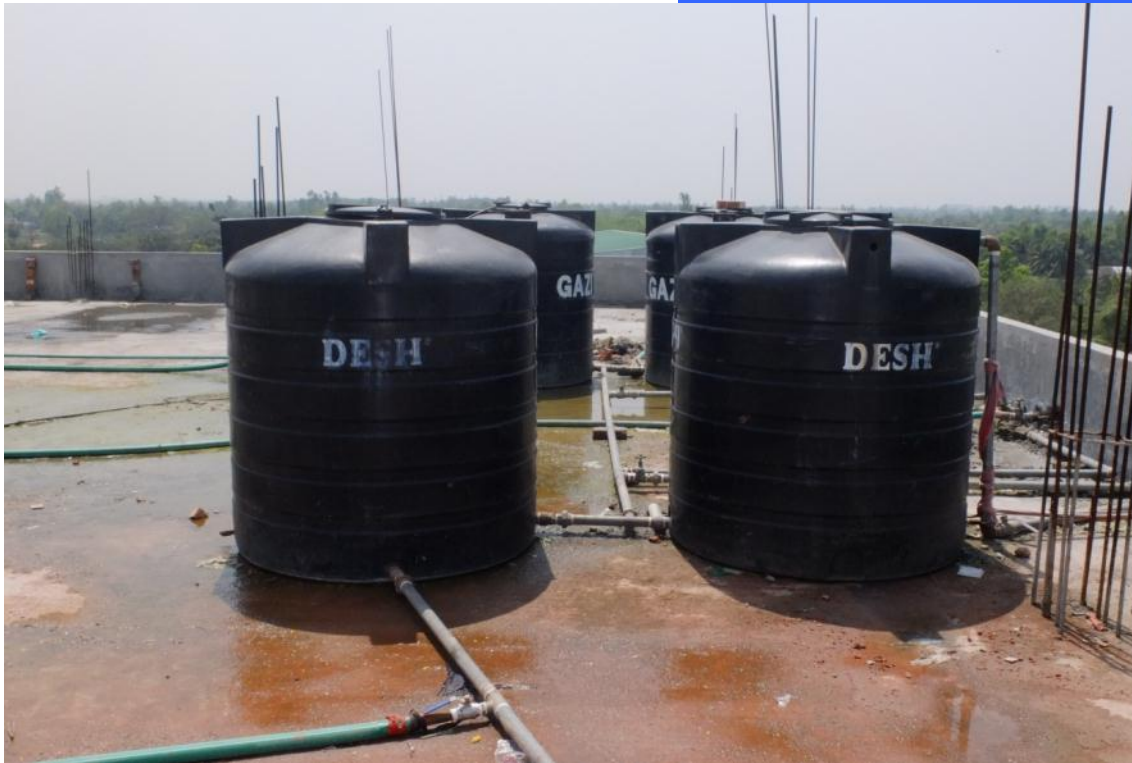
Each water tank is estimated to have a maximum weight of approximately 2000kg. As there are 4 tanks arrangement is closed the total weight of 4 tanks is about 8000kg. (78.5kN) . Based on a plan area of 3.5mx3.5m, the equivalent live load is estimated to be:  $78.5\text{kN}/(3.5 \times 3.5)\text{m}^2 = 6.4\text{kPa}$ . The allowable live load is believed to be max. 3.0kPa in Building 01

**Water Tank are arranged close on Roof at Building 01**

- Re-arrange the water tanks on roof , and ensure that the live load is less than 3.0Kpa
