# Denim Processing Plant Ltd

Belashahor, Chandina, Comilla-3510  
(23.486273, 90.986197)

15<sup>th</sup> October 2019

# Observations

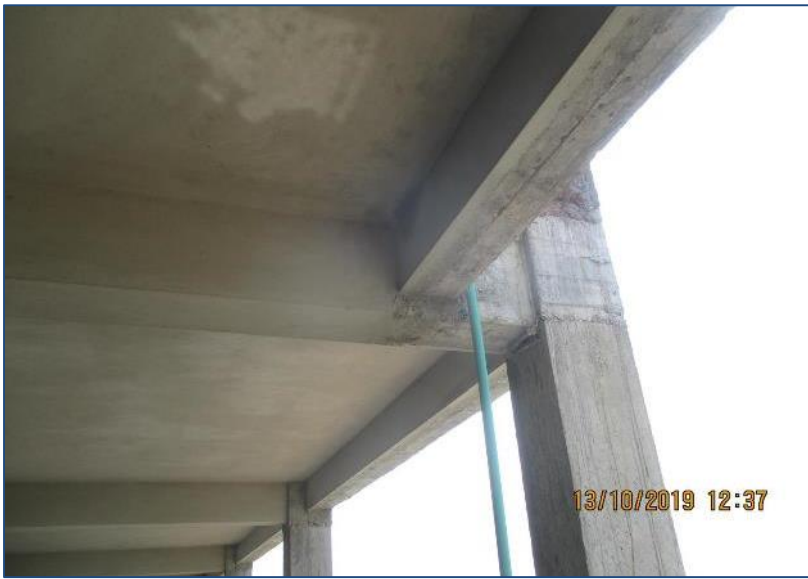
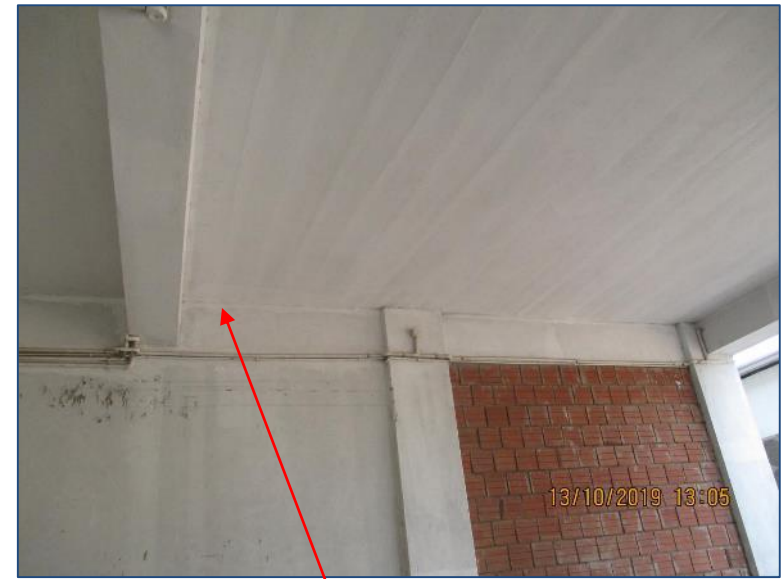
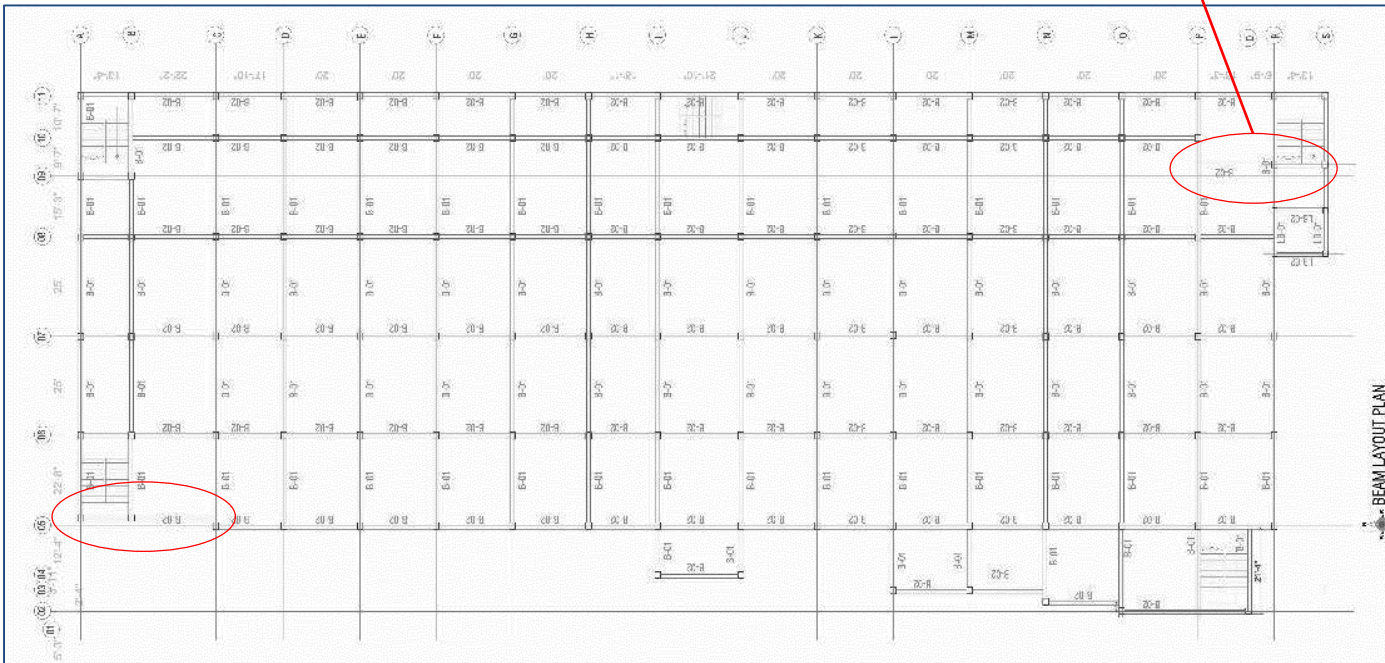
# Discrepancy between as-built drawing and site condition

Beam offset was found in the as-built drawing, but the extension of offset & details was not provided in the drawing.

| Item No. | Observation | Recommended Action Plan | Recommended Timeline |
|---|---|---|---|
| 3 | Discrepancy between as-built drawing and site condition. (RMG building) | Building engineer is required to survey the structure and update the as-built drawings. | 6-weeks |

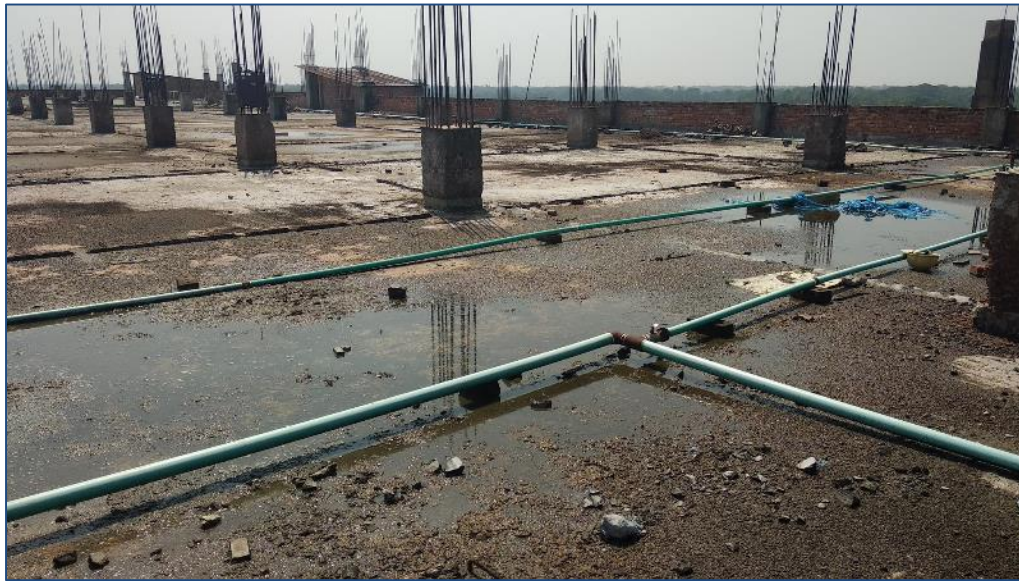
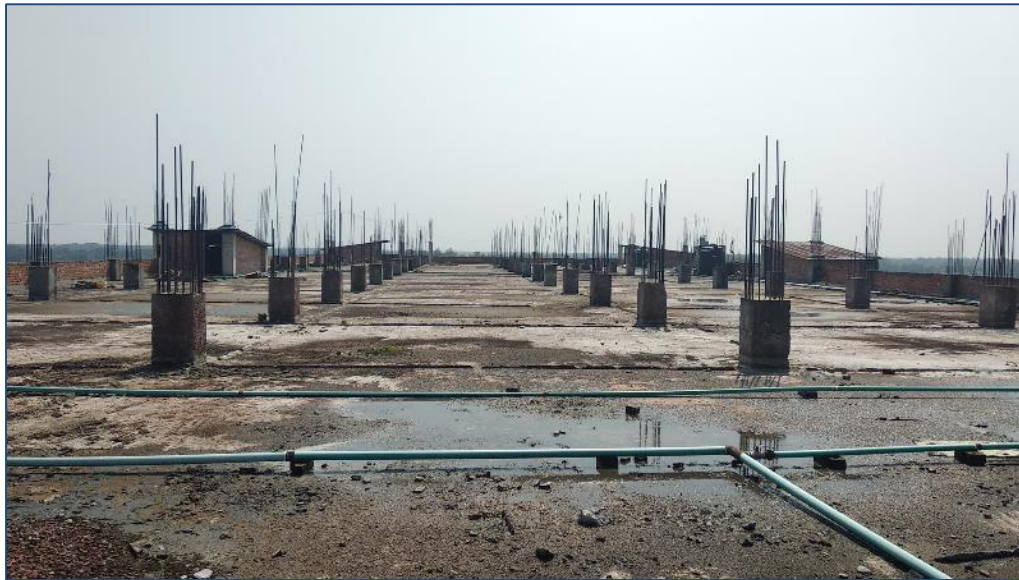
## Water ponding on the roof

Water ponding was found on the roof. Factory is required to improve the drainage system and apply suitable method of water proofing on the roof.

| Item No. | Observation | Recommended Action Plan | Recommended Timeline |
|---|---|---|---|
| 6 | Water ponding on the roof. (RMG building) | The roof slab drainage system should be improved. In addition waterproofing material is to be applied on the roof slab. | 6-weeks |

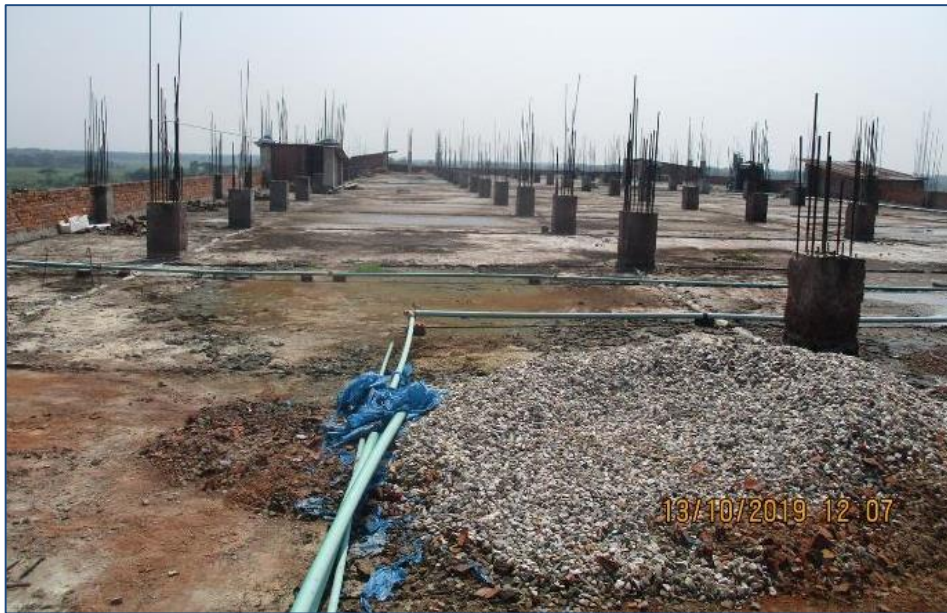
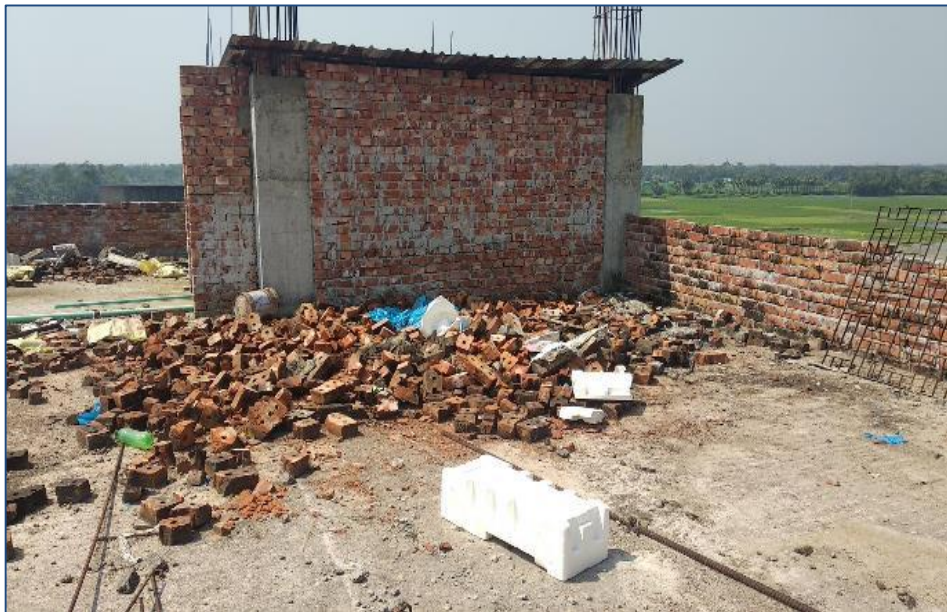
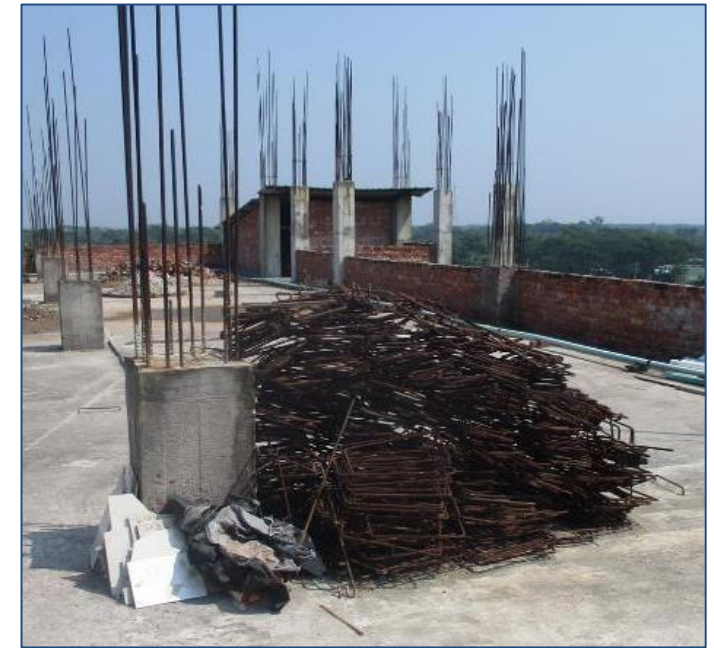
## Construction material on roof

Piling up of construction material on the roof may cause overloading. Building engineer required to remove all the construction materials.

| Item No. | Observation | Recommended Action Plan | Recommended Timeline |
|---|---|---|---|
| 4 | Construction debris on the roof. (RMG building) | Remove all the construction debris from the roof. | Immediate - Now |
| 5 | Construction debris on the roof. (RMG building) | Implement better supervision of loadings in all level. | 6-weeks |

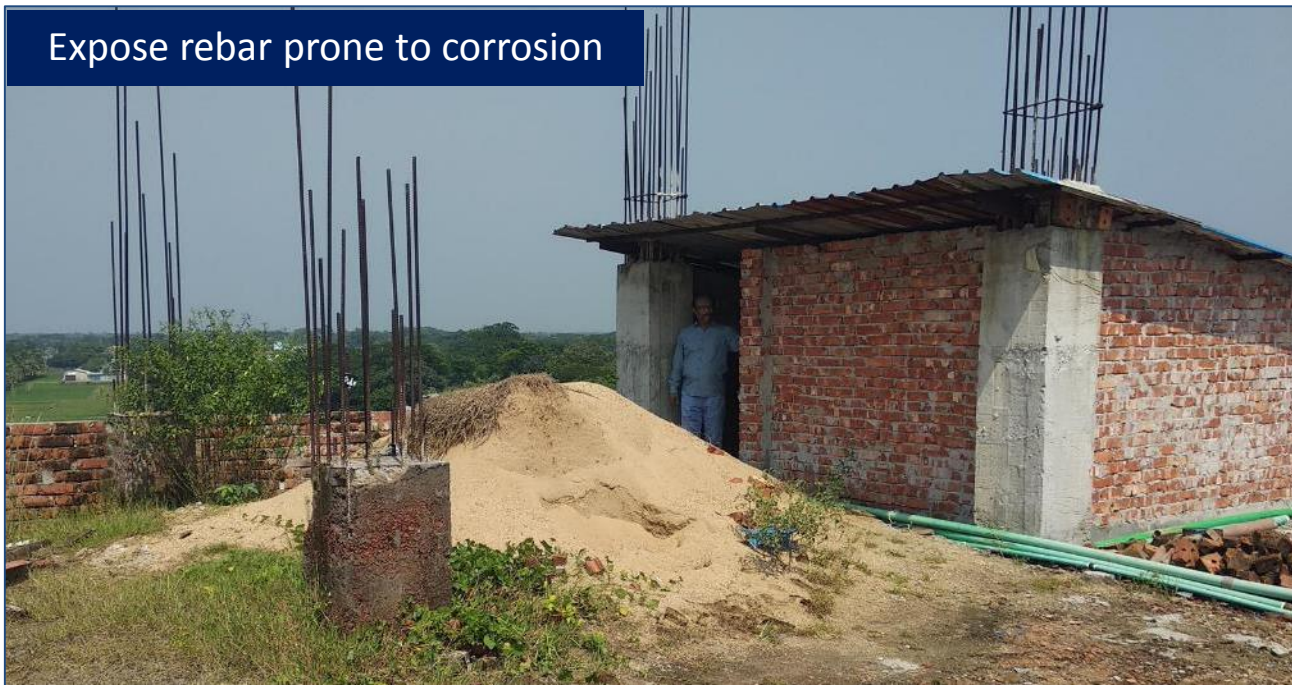
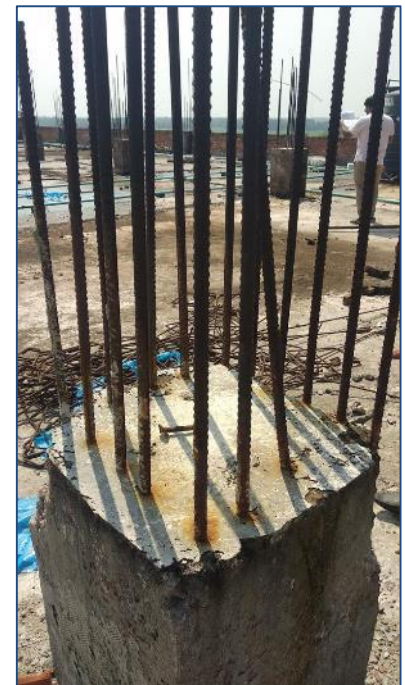
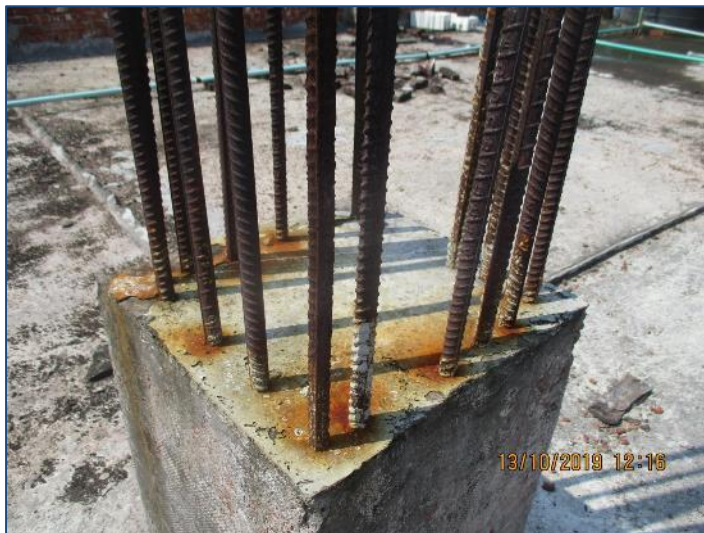
## Exposed rebar on the roof

Expose rebar prone to corrosion

Rebar was found exposed on the roof. Factory is required to take necessary measure to protect the rebar from corrosion.

| Item No. | Observation | Recommended Action Plan | Recommended Timeline |
|---|---|---|---|
| 7 | Exposed rebar susceptible to corrosion. (RMG building) | Factory is required to take necessary measure to protect the rebar from corrosion. | 6-weeks |

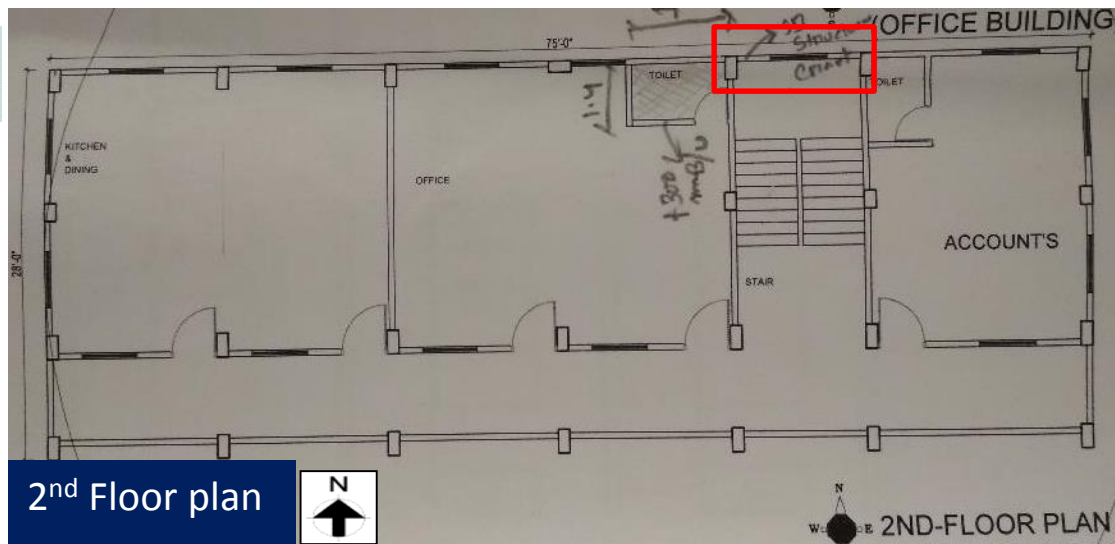
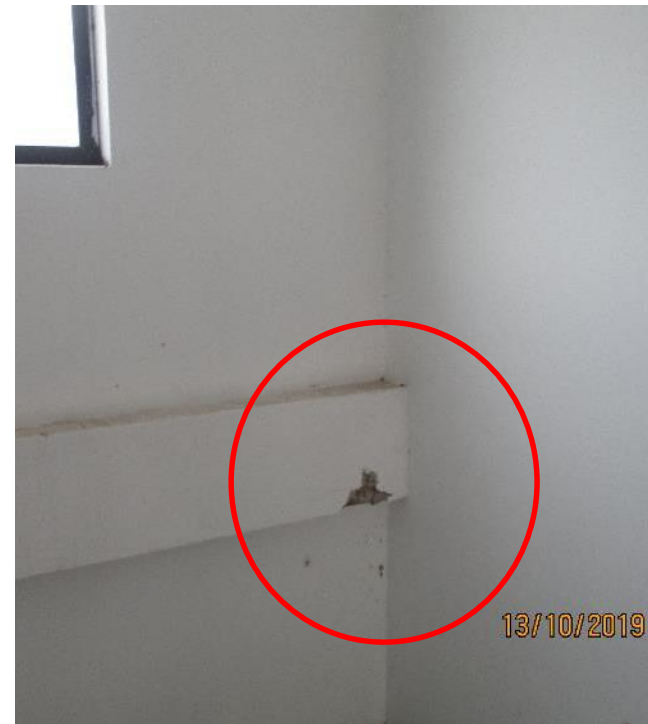
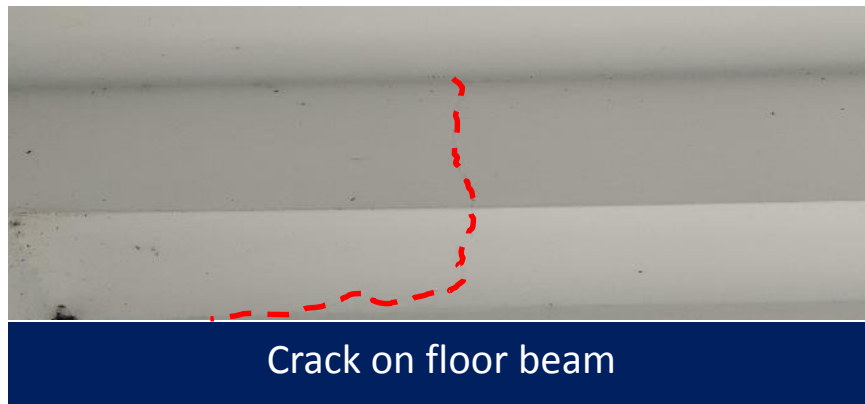
Crack on floor beam

Cracks were observed on floor beams. Building engineer is required to investigate the cracks and carry out suitable repair work as per recommendation of investigation report. Provide temporary prop support to the cracked stair beam until further investigation and completion of remediation.

| Item No. | Observation | Recommended Action Plan | Recommended Timeline |
|---|---|---|---|
| 8 | Crack on beams. (Office building) | Provide temporary prop support to the cracked beam. | Immediate - Now |
| 9 | Crack on beams. (Office building) | Building engineer is required to carry out the investigation and suggest remedial works. | Immediate - Now |
| 10 | Crack on beams. (Office building) | Carry out suitable repair works as per investigation report. | 6-weeks |

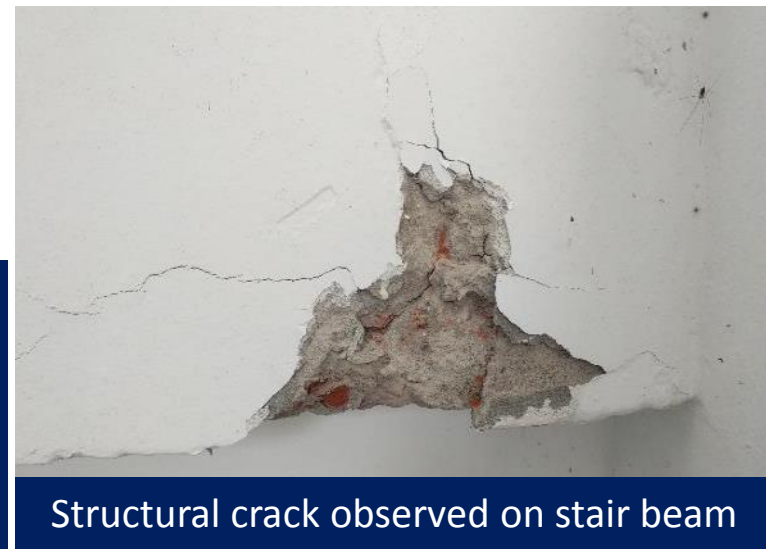
Structural crack observed on stair beam

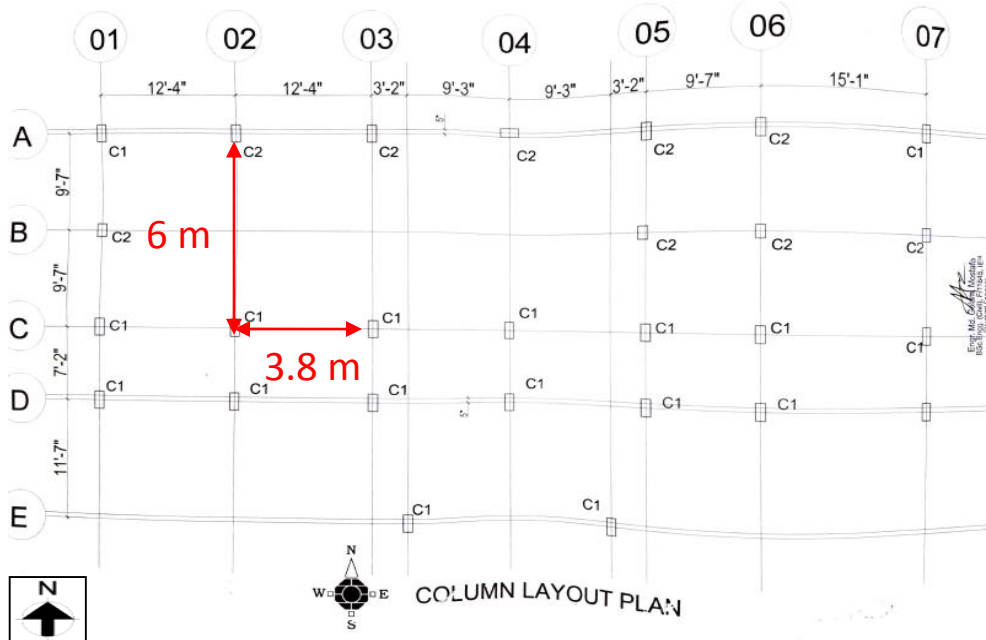
Column layout plan

**Cursory calculation indicates column stress above  
normal design limit**

Cursory calculation indicates that columns are stressed above normal design limits considering 2 kPa live load on typical floor & minimum concrete strength for brick chips.

C1 column-4-16 mm bar & rebar strength considered 275 MPa.

| Item No. | Observation | Recommended Action Plan | Recommended Timeline |
|---|---|---|---|
| 11 | Cursory calculation indicates column stress above normal design limit. (Office building) | Factory Engineer to review design, loads and columns stresses. | 6-weeks |
| 12 | Cursory calculation indicates column stress above normal design limit. (Office building) | Verify in-situ concrete stresses by 100mm dia. cores from min. 4 no. column from lower tier. | 6-weeks |
| 13 | Cursory calculation indicates column stress above normal design limit. (Office building) | Produce and actively manage a loading plan for all floor plates within the factory considering floor capacity and column capacity. | 6-weeks |
| 14 | Cursory calculation indicates column stress above normal design limit. (Office building) | Carry out remedial works where necessary. | 6-months |

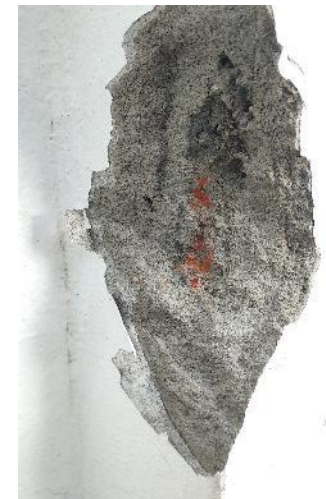
Brick chips aggregate

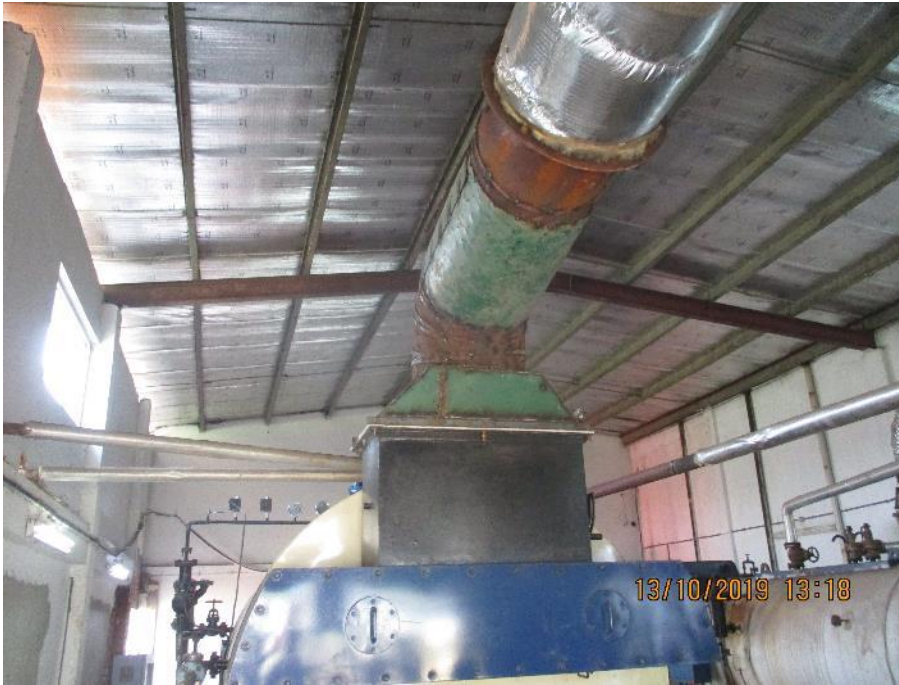
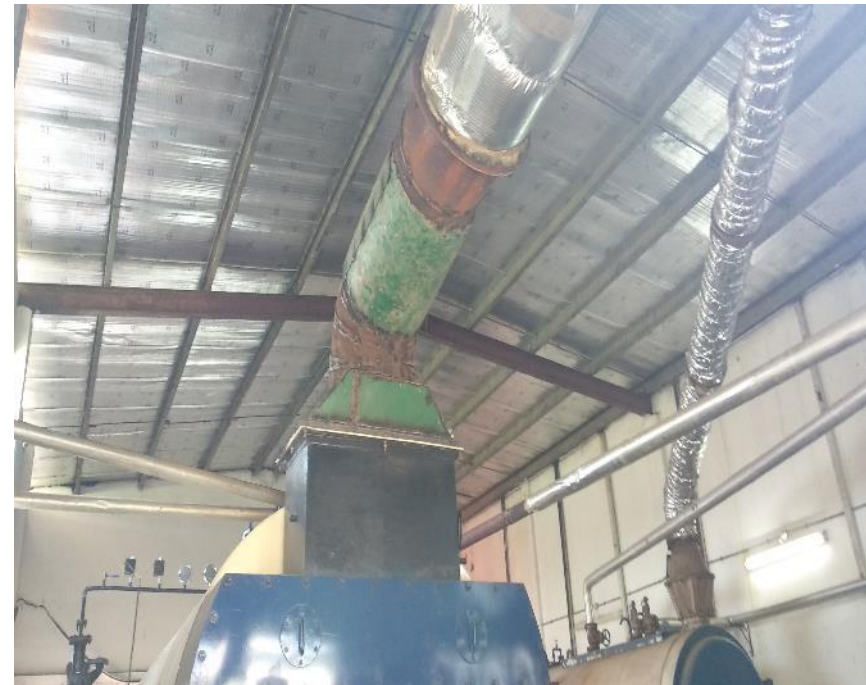
## Lack of lateral stability system

No lateral stability system (roof bracing, wall bracing, compression strut) observed. Building engineer is required to carry out an engineering assessment to check the lateral stability of the shed.

| Item No. | Observation | Recommended Action Plan | Recommended Timeline |
|---|---|---|---|
| 15 | Lack of lateral stability system. (Shed-2) | Building engineer is required to check the lateral stability & serviceability against the lateral load as per BNBC. | 6-weeks |
| 16 | Lack of lateral stability system. (Shed-2) | Carry out remedial works where necessary. | 6-months |

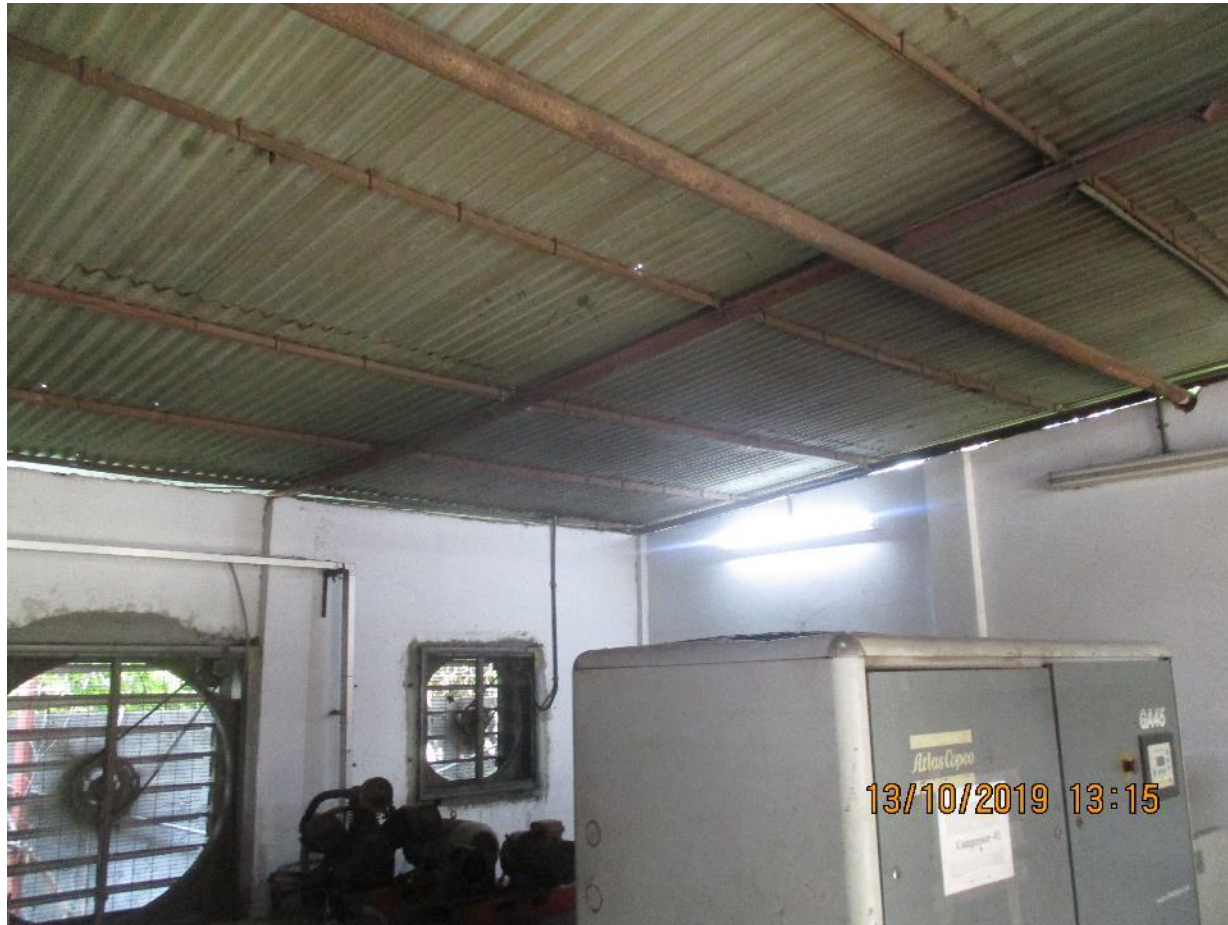
## Non engineering shed

Apparently non engineering shed: poor connection details, inadequate member sizes and corroded steel members.

| Item No. | Observation | Recommended Action Plan | Recommended Timeline |
|---|---|---|---|
| 17 | Non engineering shed. (Shed-3) | Building engineer is required to suggest any alteration/demolition of the shed. | 6-weeks |
| 18 | Non engineering shed. (Shed-3) | Carry out alteration/demolition works. | 6-months |
