Tropical Knitex Ltd.

Chandra, Kaliakoir, Gazipur-1751, Bangladesh

24th September 2019 , 6th October 2019 & 15th October 2019

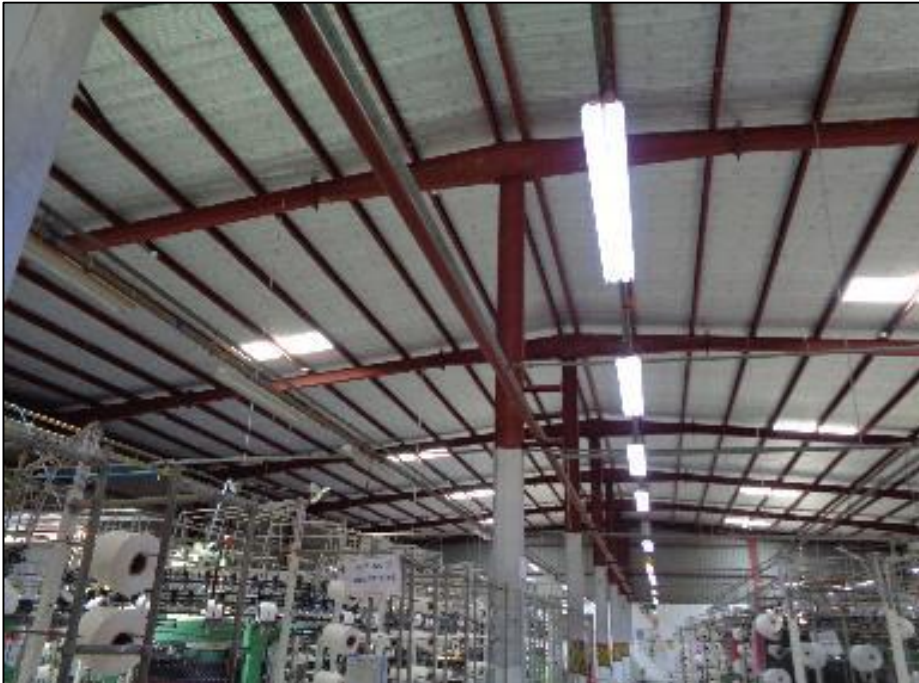
Building 2

No horizontal, vertical bracing and compression strut observed

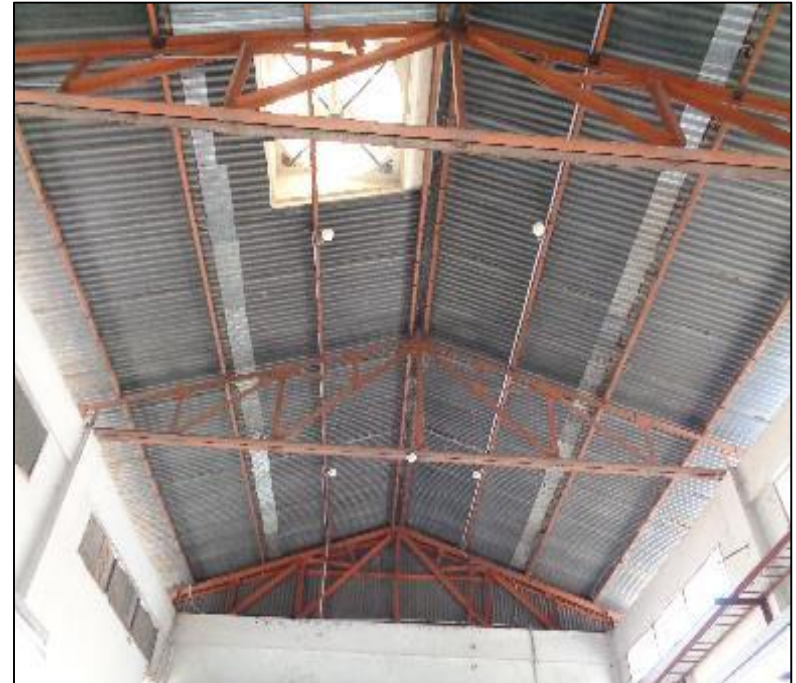
Building 3

No connection details between steel roof truss and RC frame was available. The connections need check against the uplift forces to ensure structural stability.

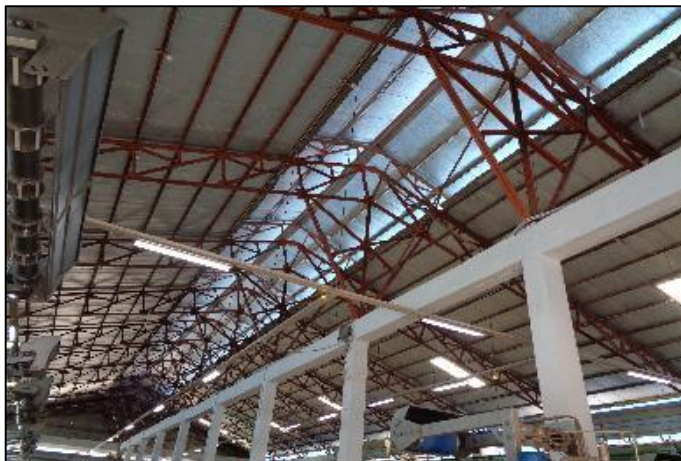
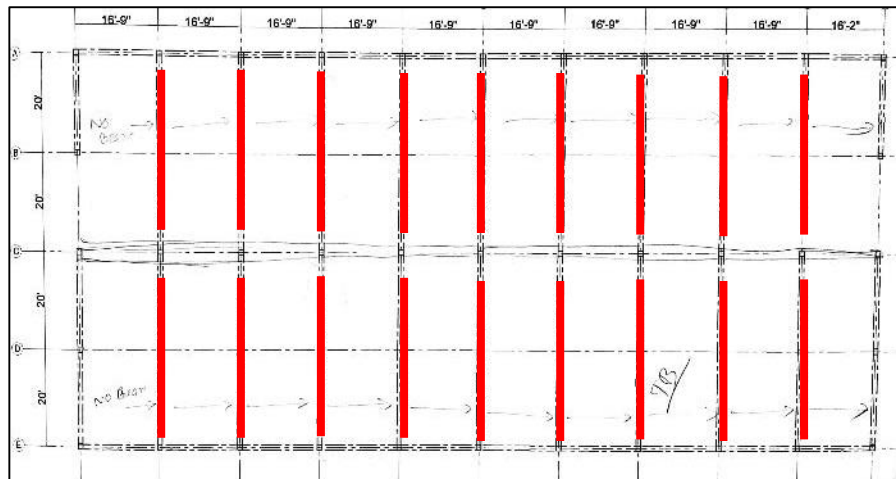
Missing beams are marked in Beam Layout plan.

Missing tie beams in short direction. No horizontal bracing was found. And connection details unknown. Check for lateral stability and uplift is required to ensure building safety.

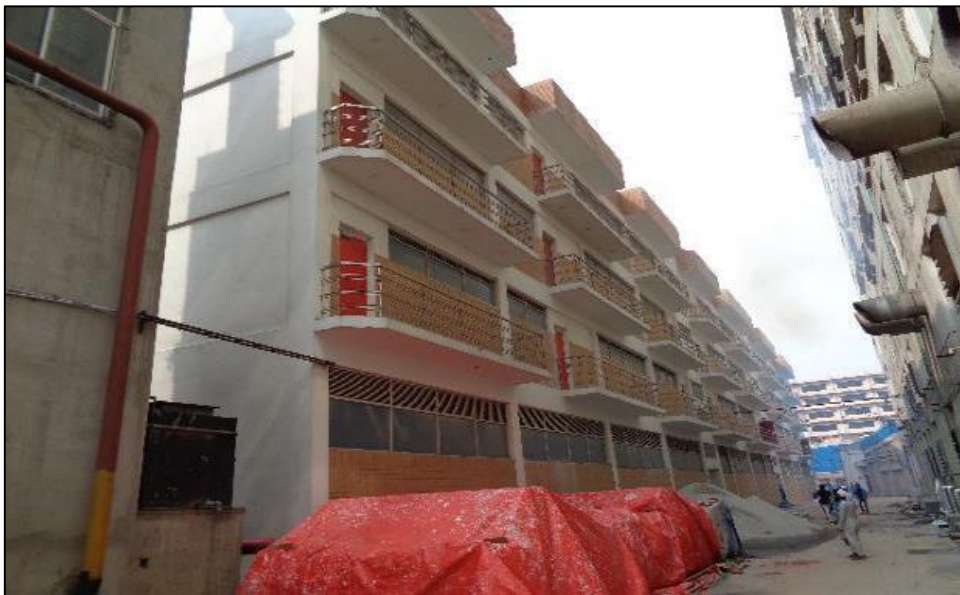
Floor plan

Apparently Building 9 is a slender building. Only one bay in weak direction. Lateral stability check is required.

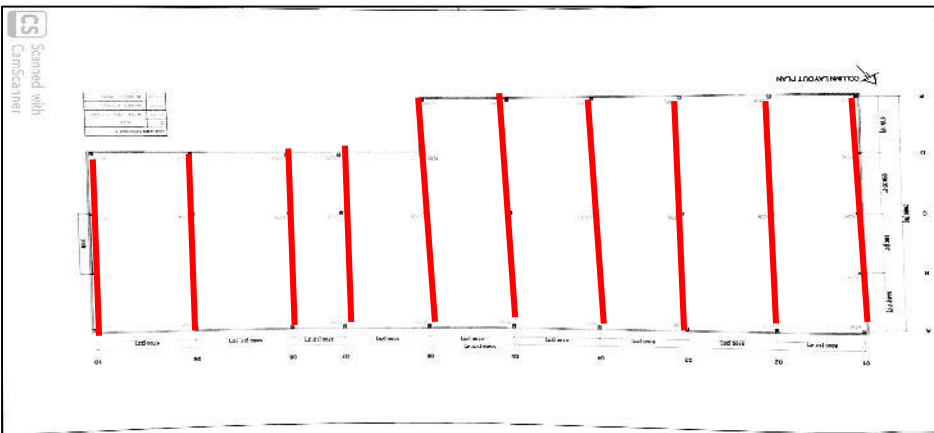
Rafters marked in Plan

As per drawings, the marked rafters should have a width of 300 mm but on site the rafters width was found 250 mm.

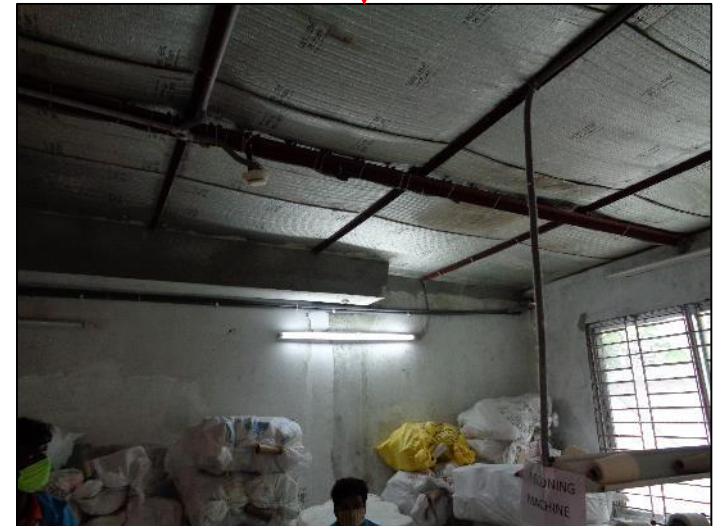
Inside undocumented portion

An extra undocumented portion was found which is not shown in the as built drawings.

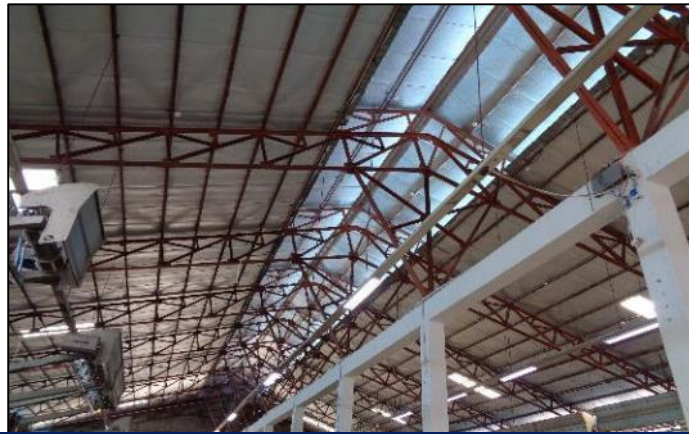
Steel Column Rafter system

As per beam layout the beams in the lateral direction were not observed during inspection.

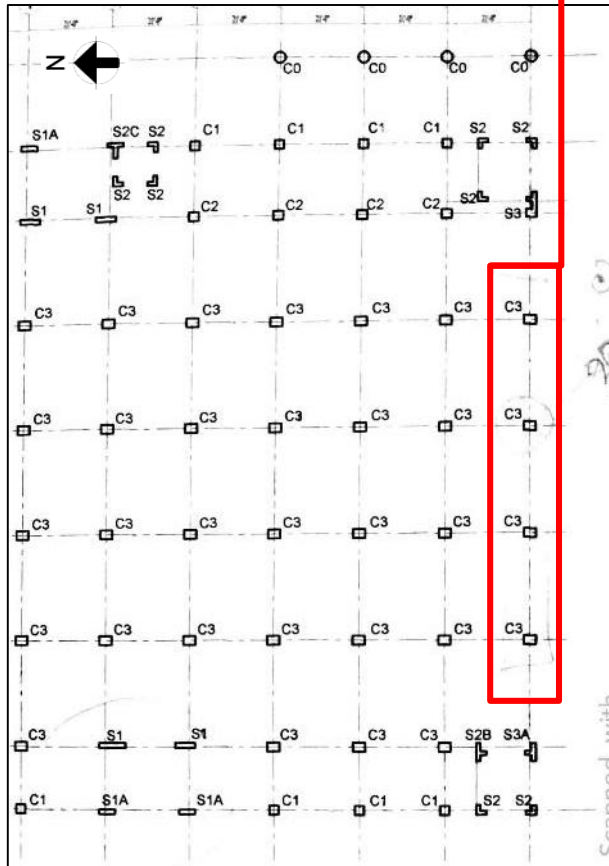
Partial Column Layout

C3 column size in column schedule is mentioned to be 36" x 27"

During inspection, the marked columns in the column layout were found smaller than the indicated size in as built drawings. C3 column size in column schedule is mentioned to be 36"x 27". But during inspection, the column was measured 32" x 27".

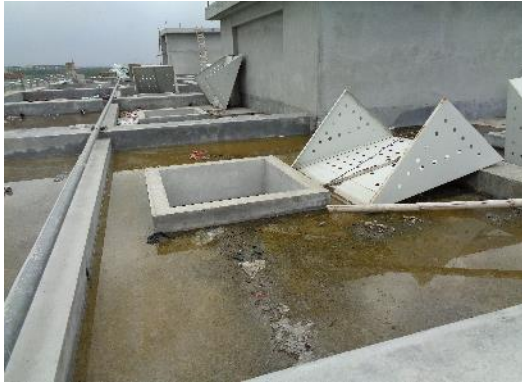
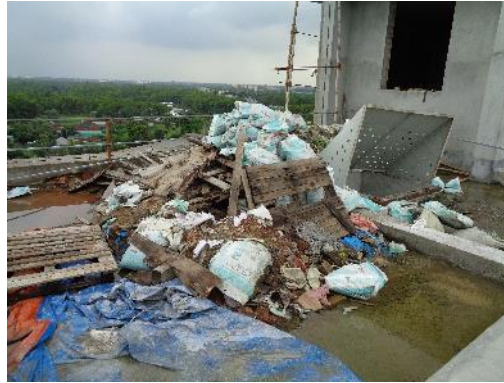
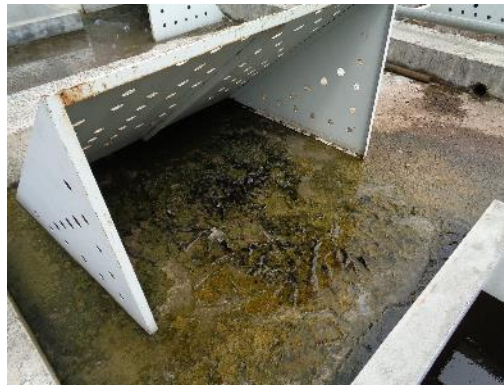
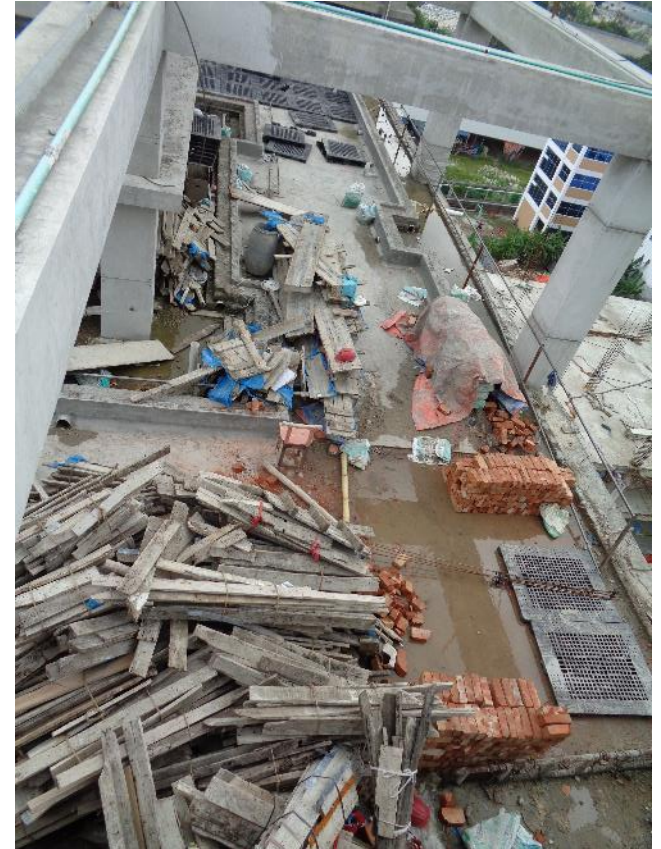
Water clogging , Construction materials stacking, and Vegetation was observed in the roof and 7th floor.

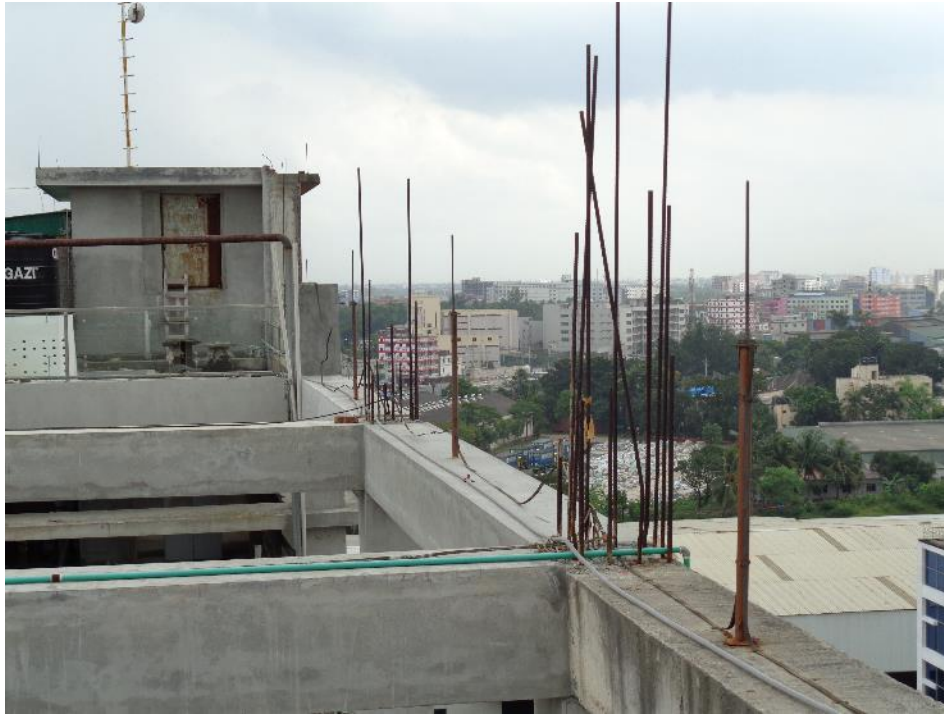
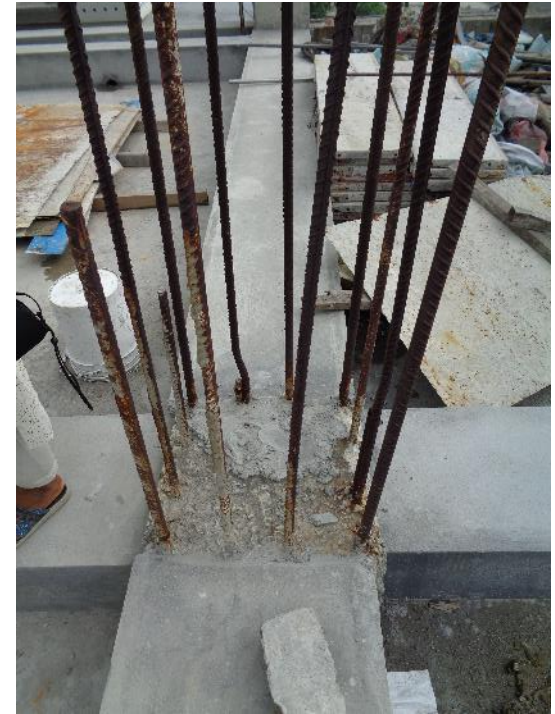
Exposed corroded rebars were found on the rooftop.

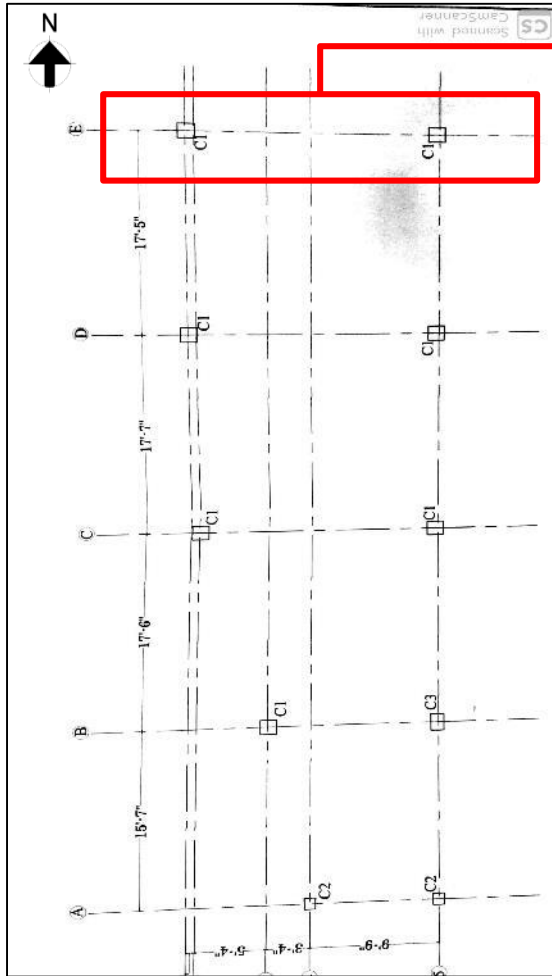
Column Layout

C1 column size in column schedule is mentioned to be 15" x 15"

During inspection, the marked columns in the column layout were found smaller than the indicated size in as built drawings. C1 column size in column schedule is mentioned to be 15"x 15". But during inspection, the column was measured 12" x 12"

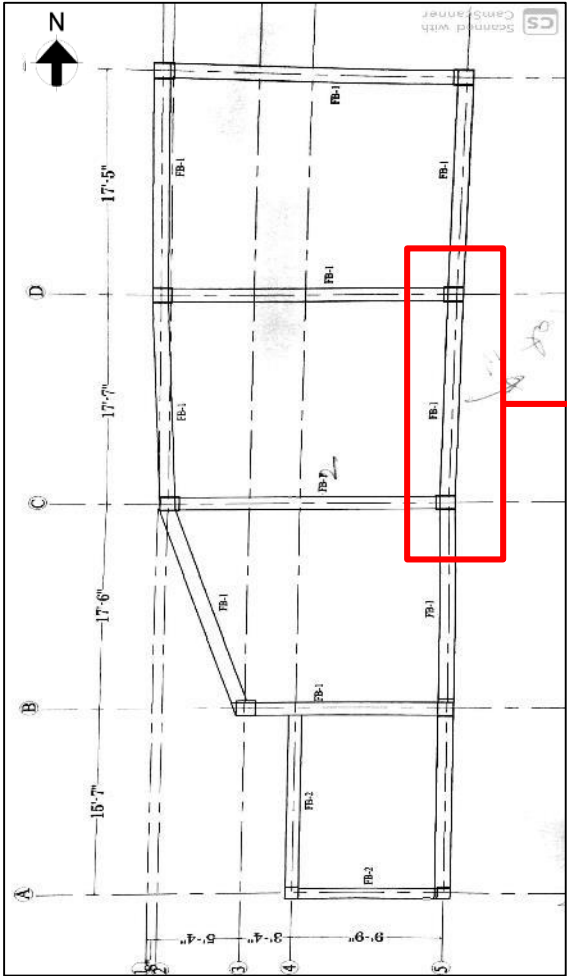
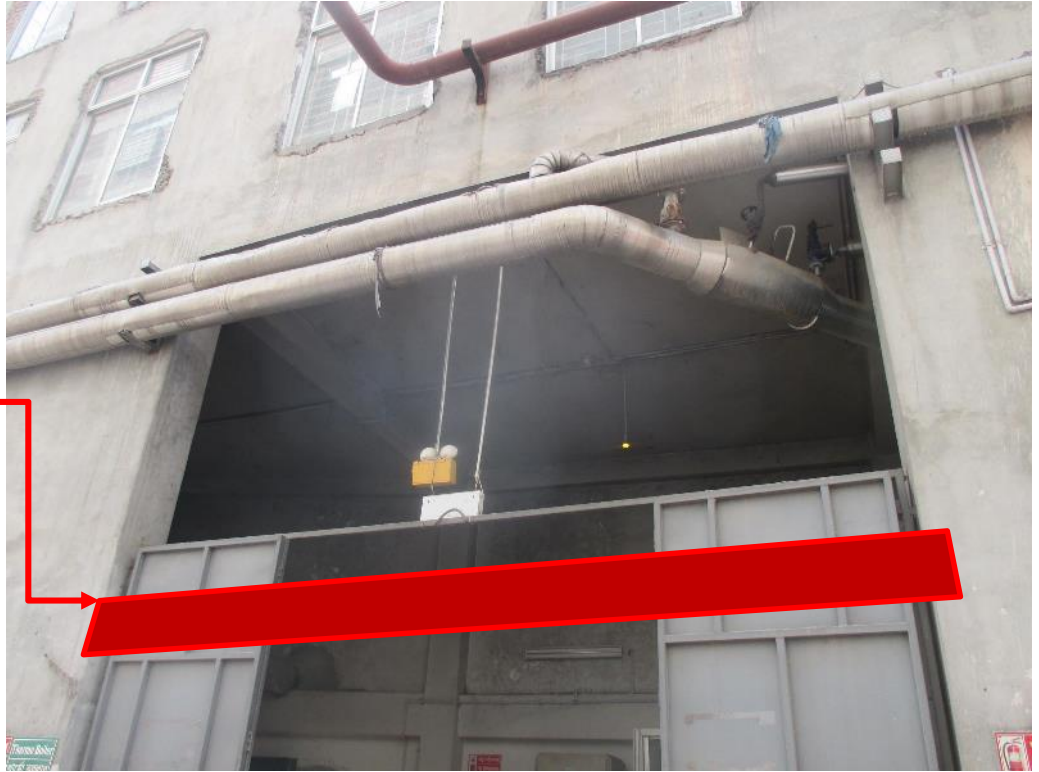
Beam Layout

During inspection, the marked beam in the beam layout was found missing at 11' level.

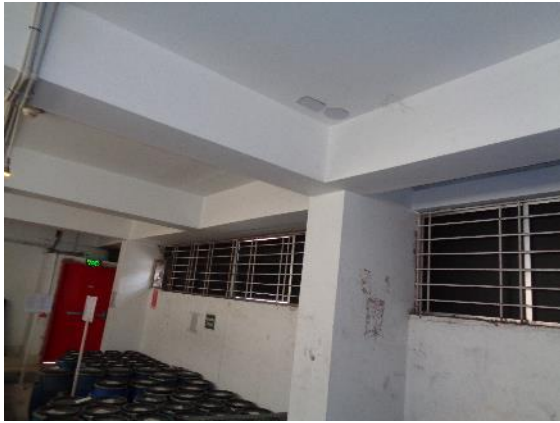
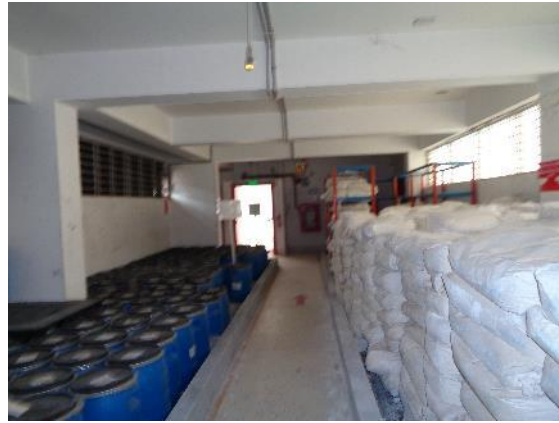
Retrofitted columns

Factory has completed retrofitting works in Building 9 and constructed a strap footing around the building. But no analysis report of these retrofitting works were available. Moreover, the load paths to ground aren't clear.

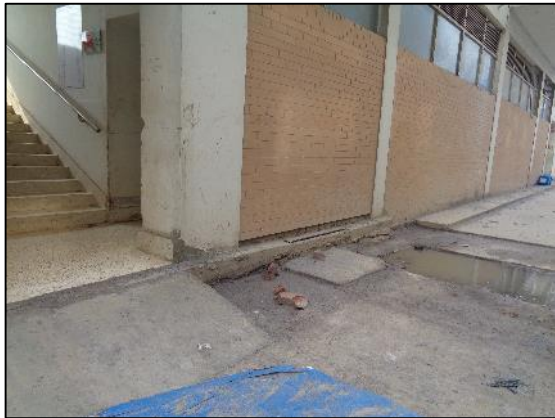
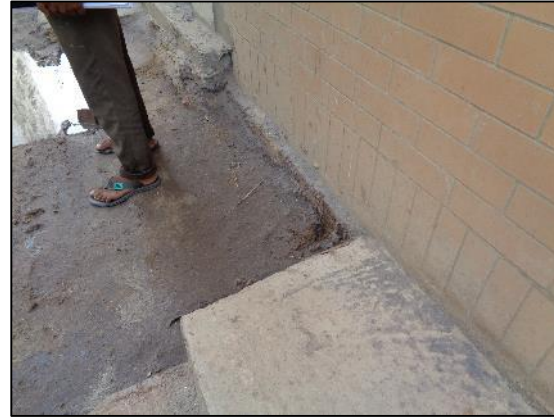
Discontinuous strap footing above ground.

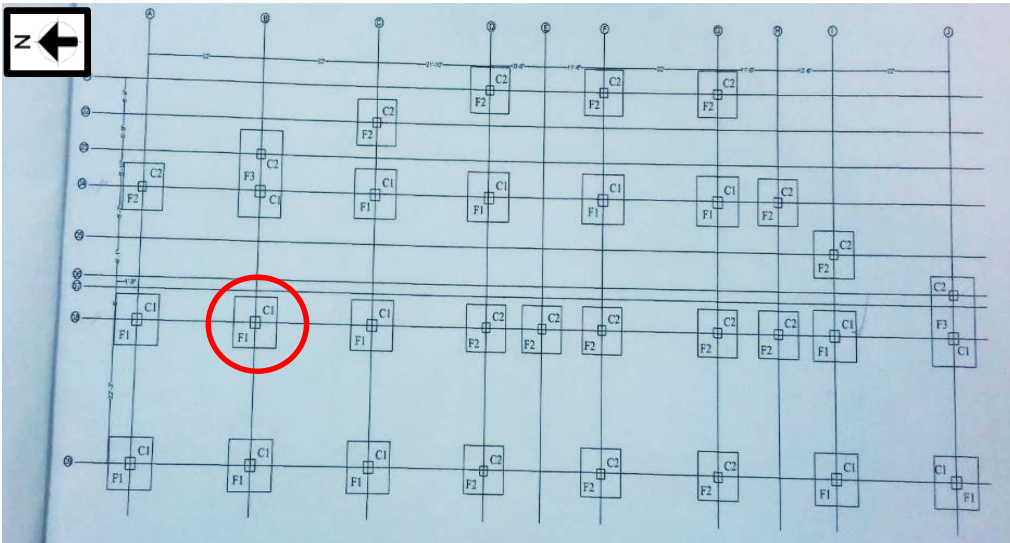
Red marked footing found over stressed

Cursory calculation indicates that the soil below isolated footing appears to be stressed above normal design limit considering the recommended soil bearing capacity in geotechnical investigation report and footing sizes mentioned in the provided drawing. Factory engineer is required to review the adequacy of footings and comply with BNBC.

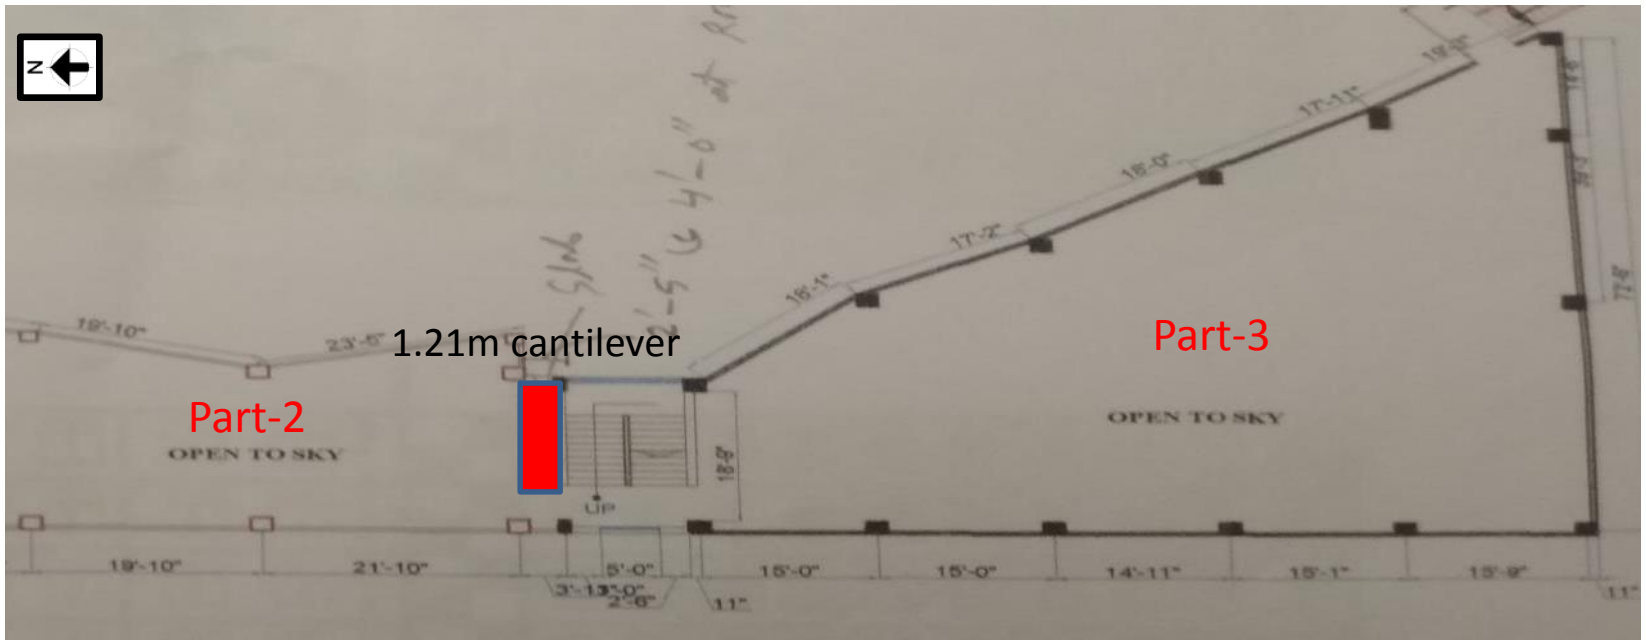
The cantilever slab of Part-3 was not mentioned in the as-built drawing.

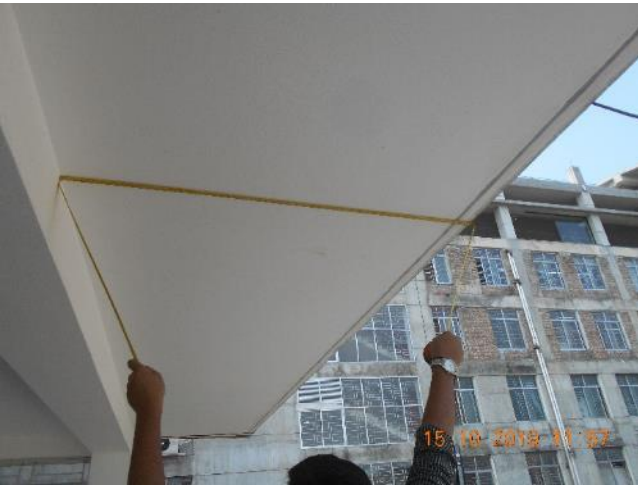
1.21m cantilever at stair top

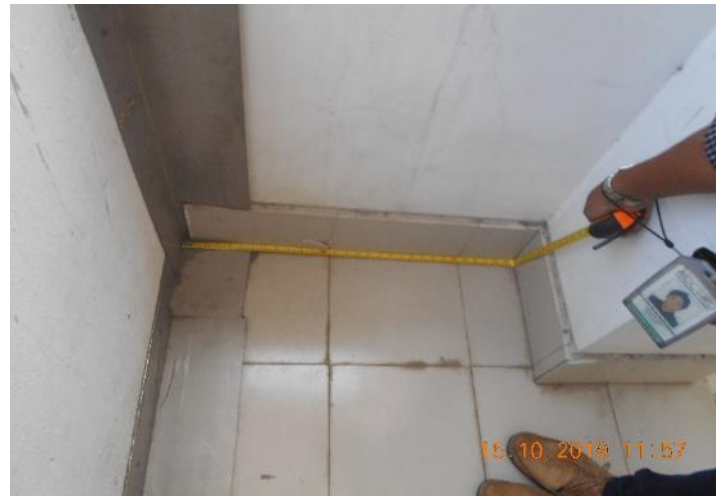
0.8m cantilever at floor level

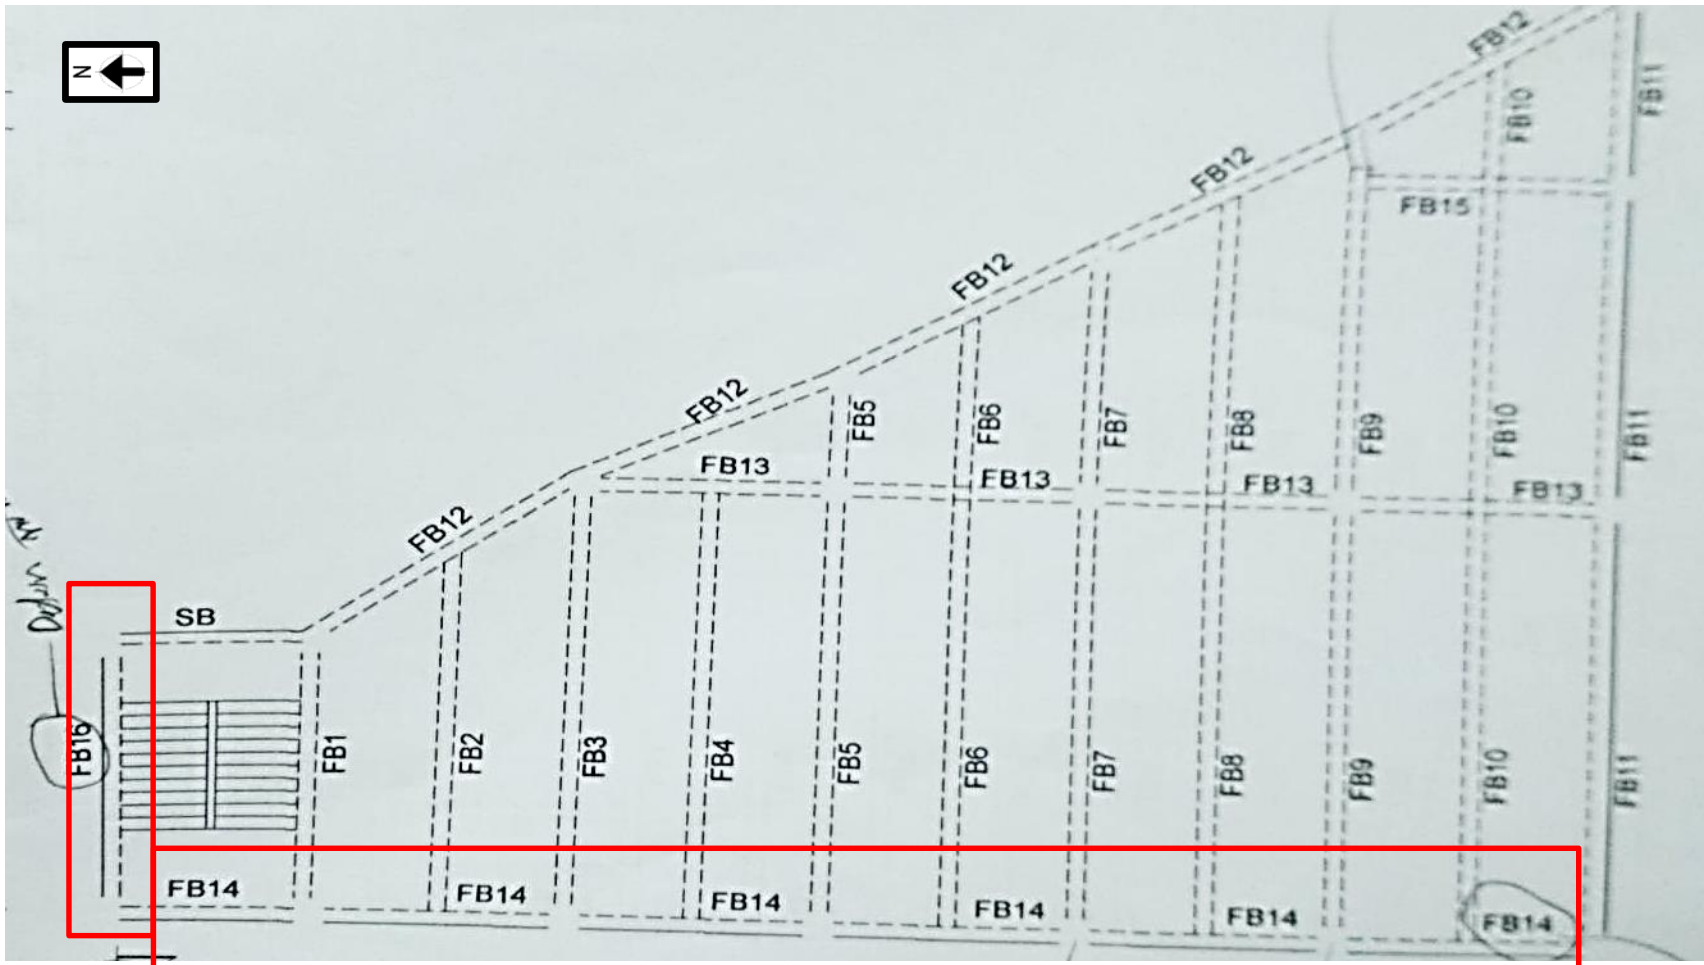
Structural Details of FB14 & FB15 was not found in as built drawing. Factory engineer is required to update the as built drawing as per actual site condition.

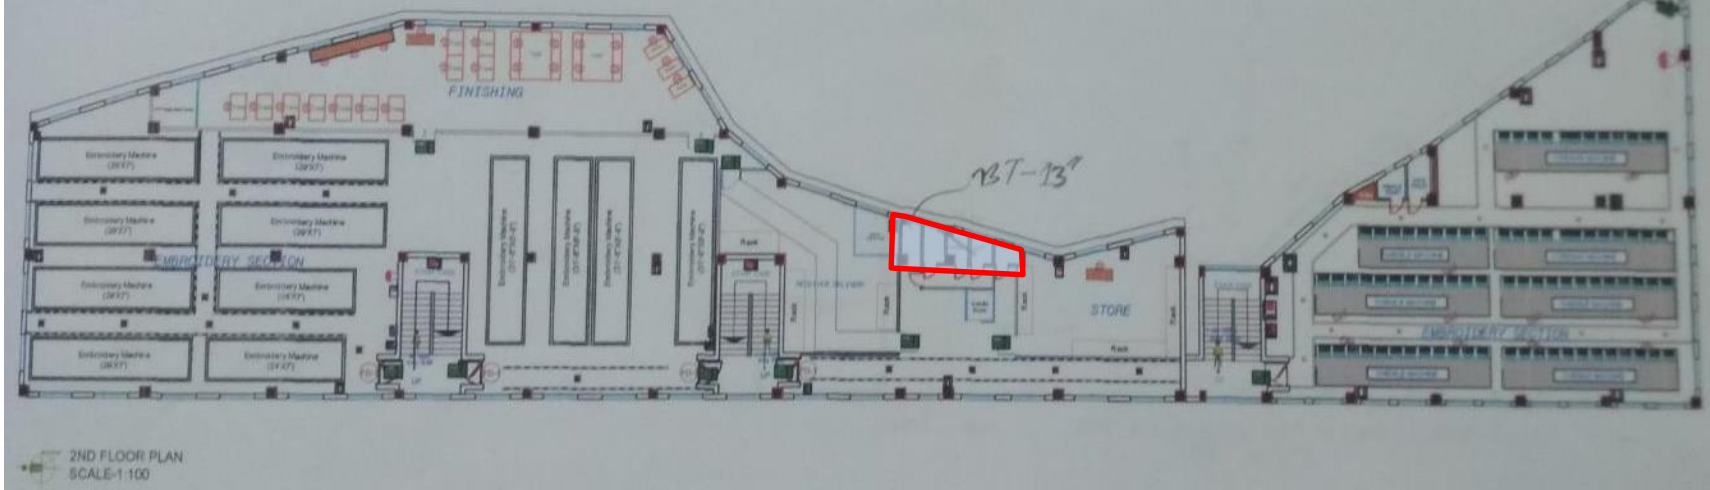
Floor Layout

325 mm high build up was found at toilet zone on 1st & 2nd floor. No information has been provided regarding build up in as built drawing. Factory engineer is required to survey the whole structure and produce as built documentation.

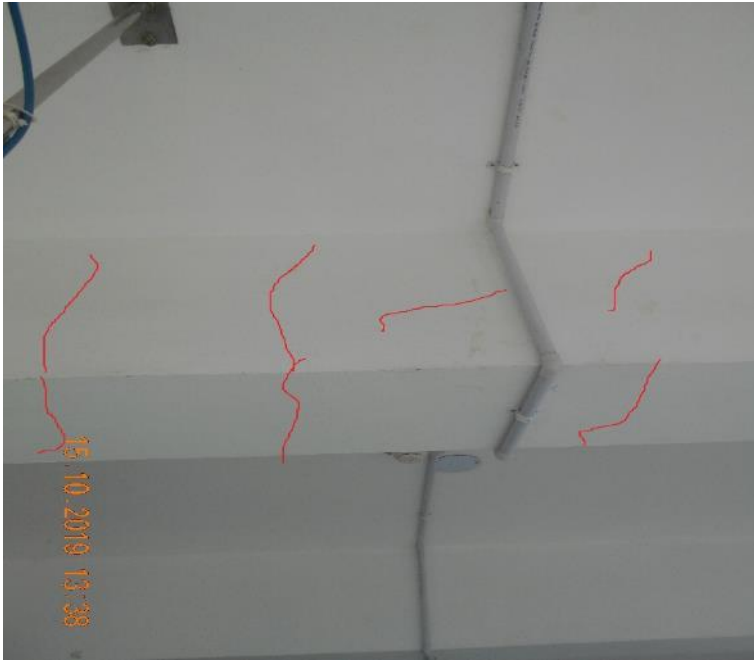
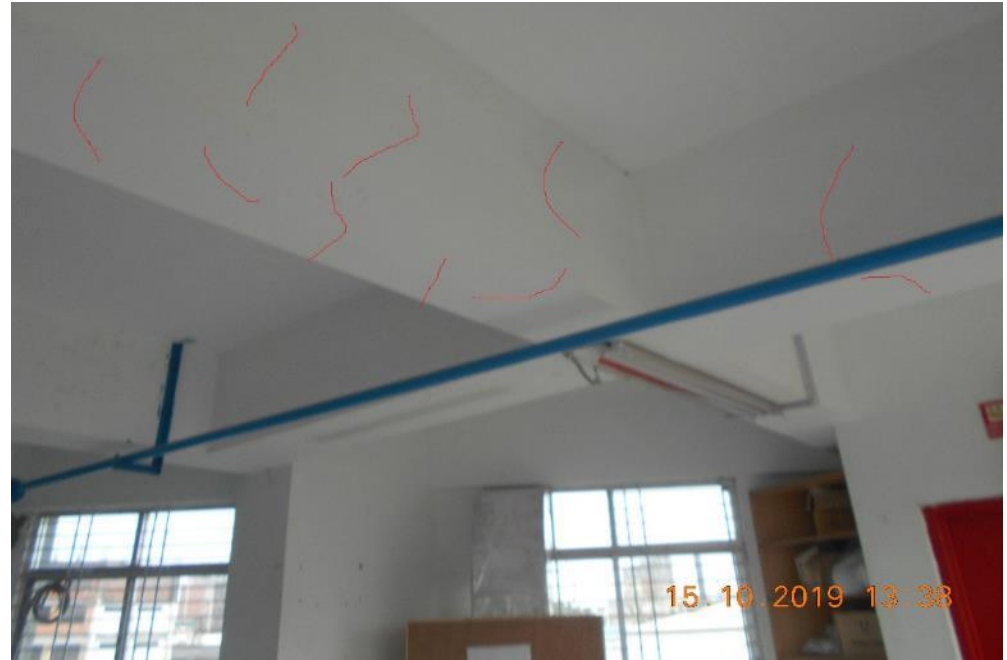
Hairline crack was found in beam at several locations of the structure. Factory engineer is required to investigate the reason and extend of cracks and produce an investigation report including the remedial measures.

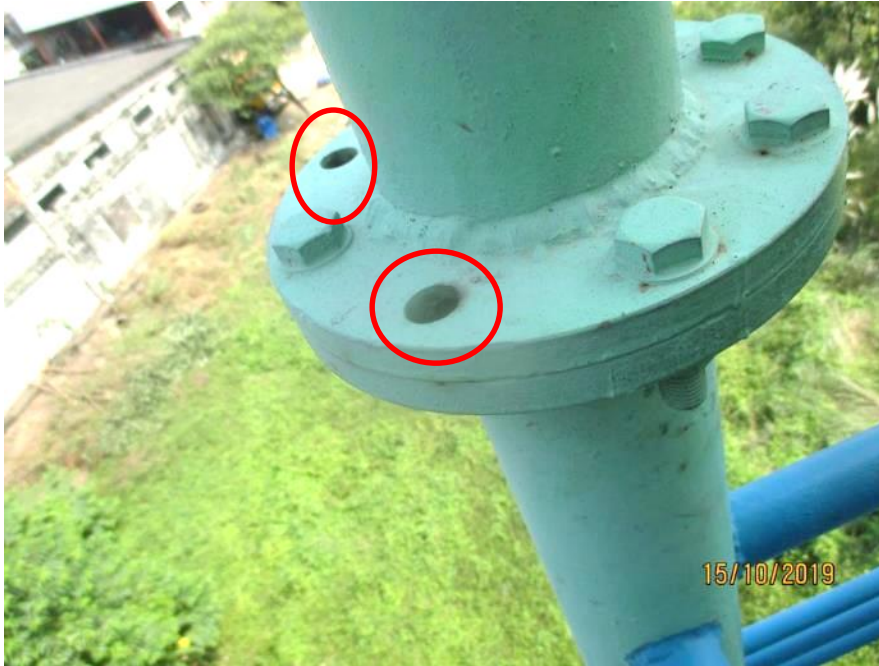
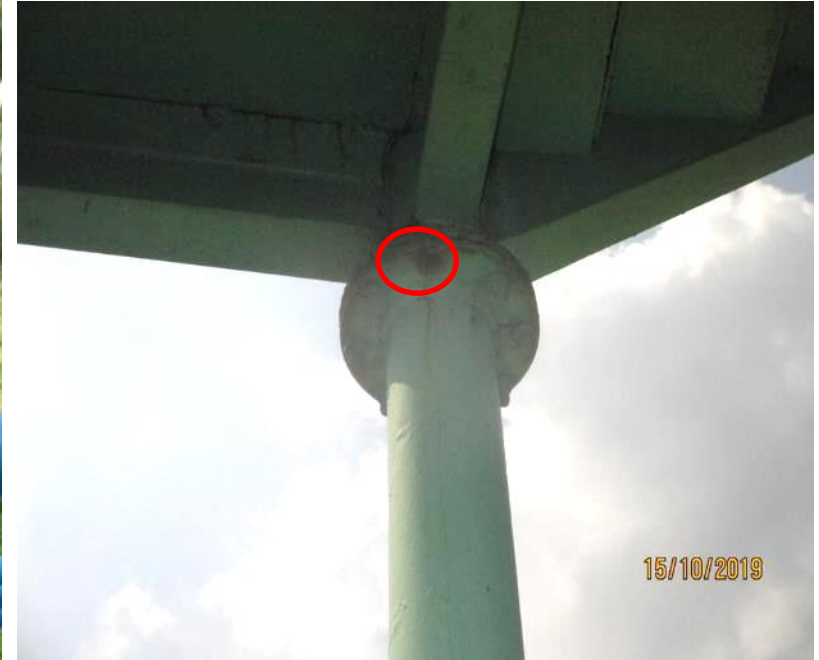
Bolt was found missing at several column joints. Factory engineer is required to installed the missing bolt where required.

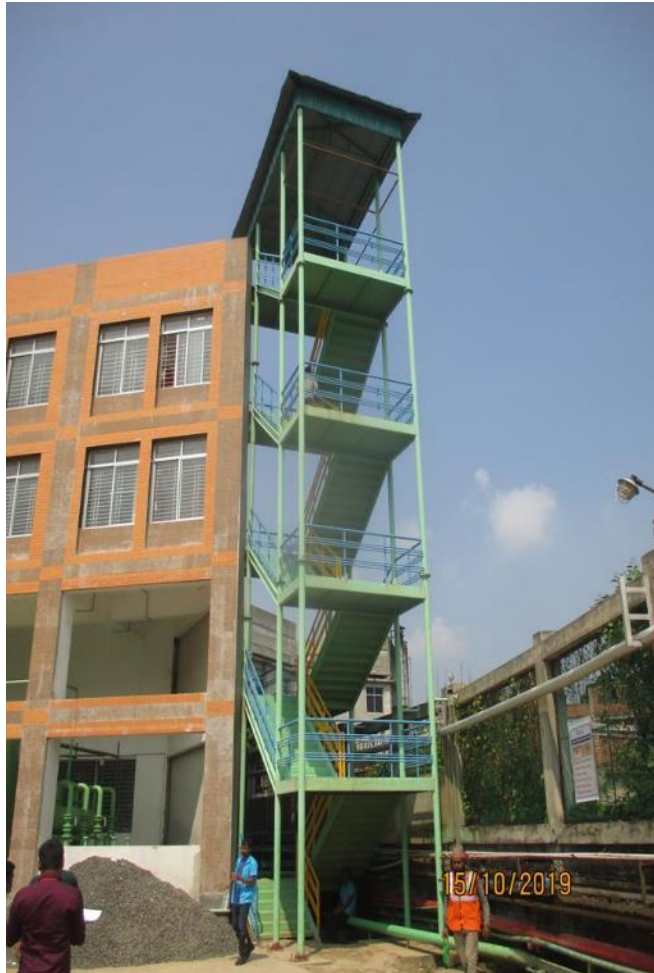
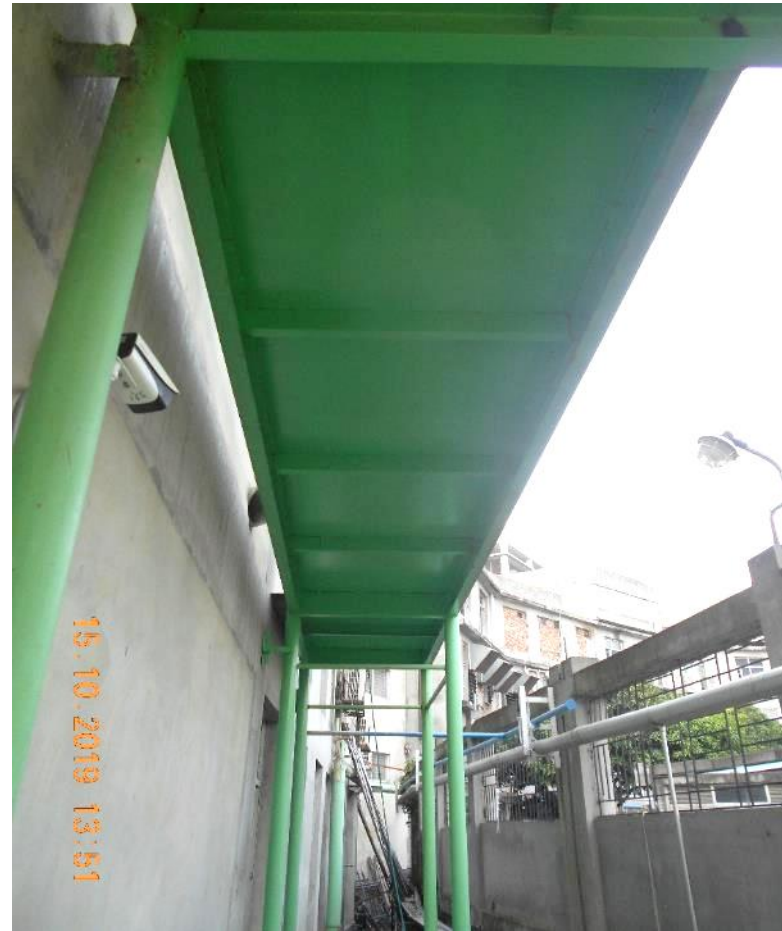
No obvious lateral load resisting system of the steel stair was found. Factory engineer is required to check the stability of the steel stair against lateral loading.

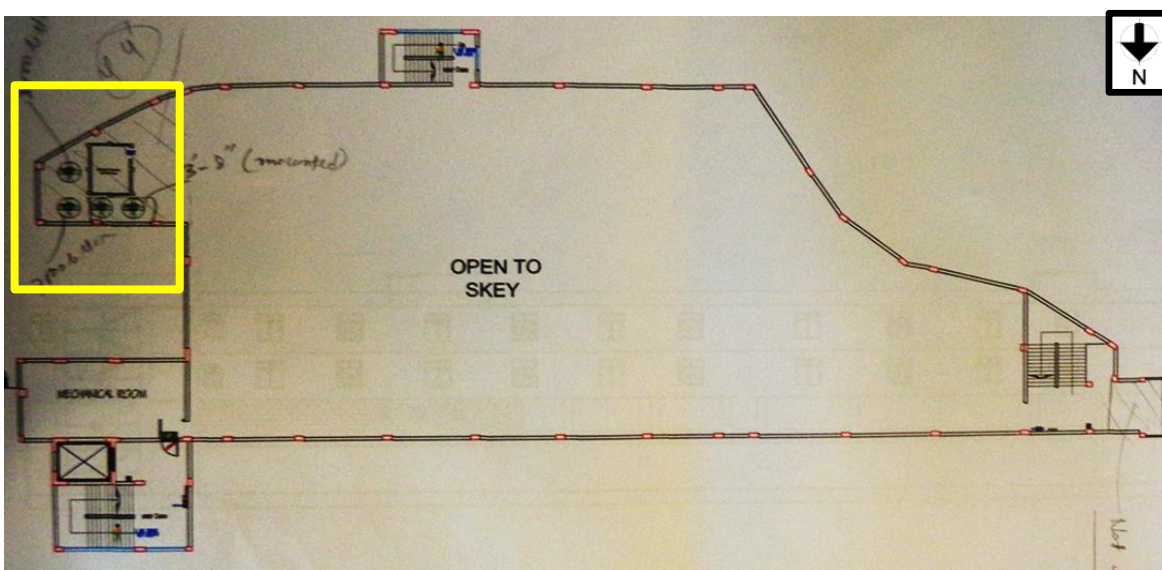
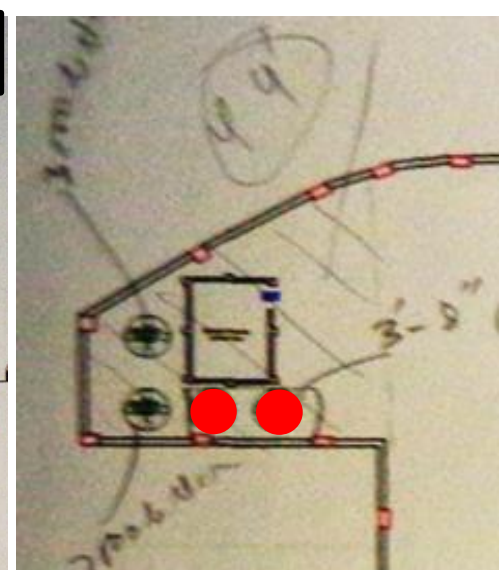
Roof floor Layout plan. Location of plastic water tank

At roof, 1.12 m pedestal was found supporting plastic water tank. No information regarding the pedestal has been provided in as-built drawing. Factory engineer is required to assess the capacity of the slab, carrying the load of plastic water tank & pedestal.

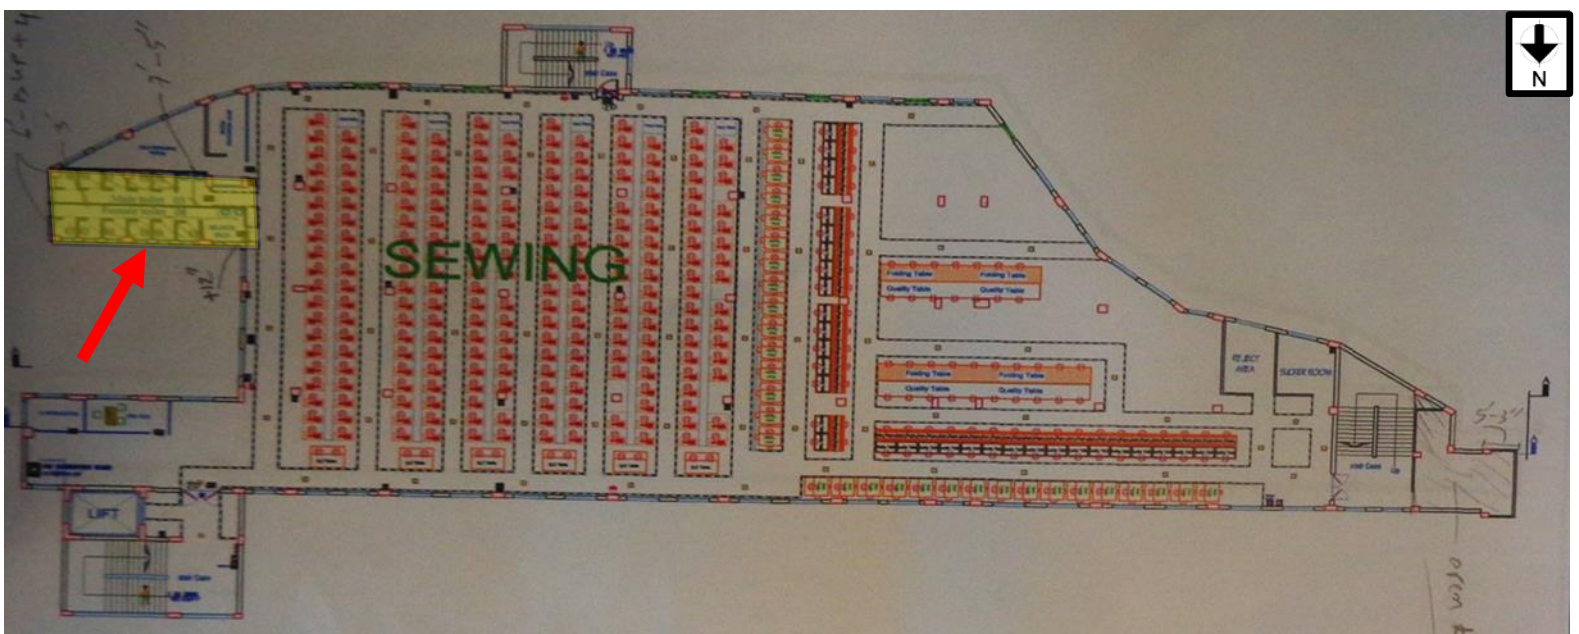
Floor Layout

250 mm high floor build-up at toilet zone. No information has been provided regarding build up in as built drawing. Factory engineer is required to survey the whole structure and produce as built documentation.

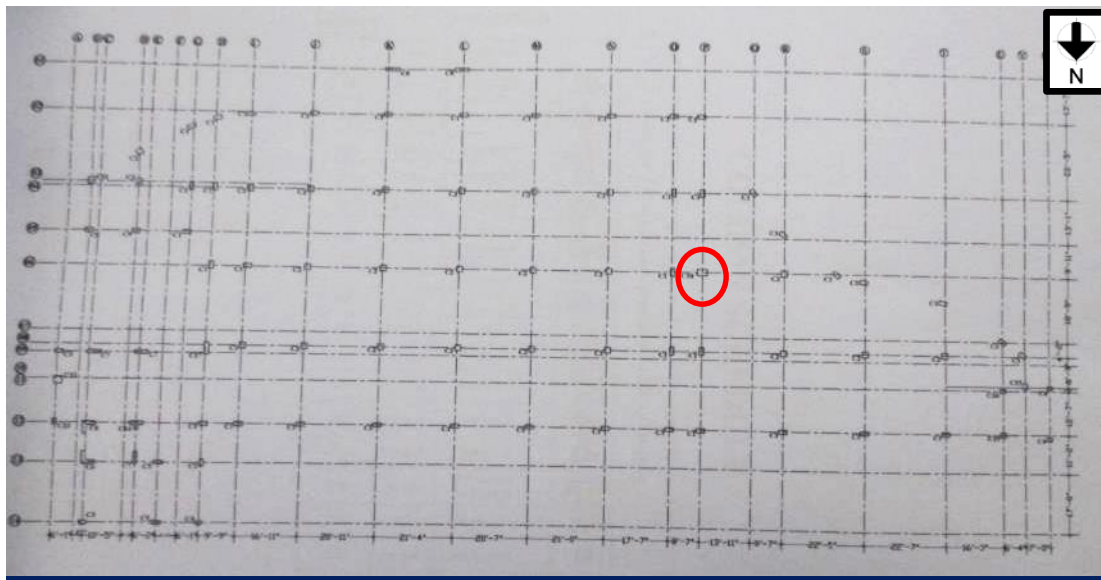
Column Layout plan.

Size of C10 column has been shown 825 mm X 550 mm

Size of C10 at grid P/6 column has been shown 825mm X 550mm. But at actual site condition the column size was found 500mmX500mm. Factory engineer is required to survey the structure and update the column schedule with re-bar details.

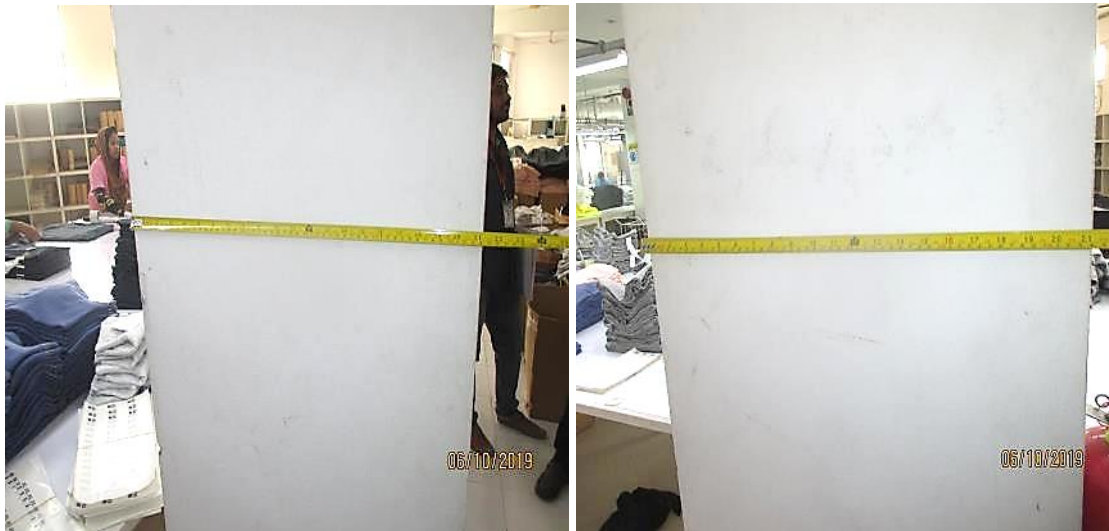
Size of C10 column was found 500mmX500 mm

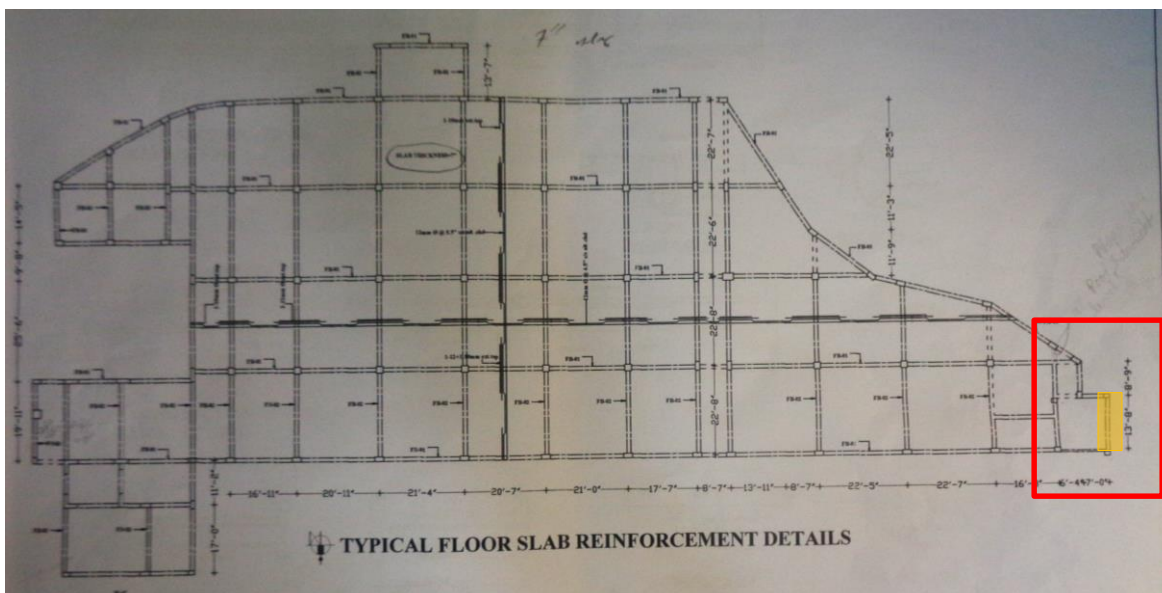
Beam & slab re-bar Layout plan.

1.6 m cantilever slab was found at west side of the building. The slab details has not been added in as-built structural drawing. Factory engineer is required to develop accurate as-built drawing and assess the load bearing capacity of the cantilever slab.
